STRUCTURAL INSPECTION REPORT
OF
OUTBUILDINGS
AT
HENDRE FARM
BODFARI

Huxtable Hodgson
Consulting Civil and Structural Engineers
100 Brook Street
Chester, CH1 3DU
Tel: 01244 409490
Fax: 01244 409022
e-mail: hux@huxtablehodgson.co.uk

DHU/PAW/8190e

09 March 2007

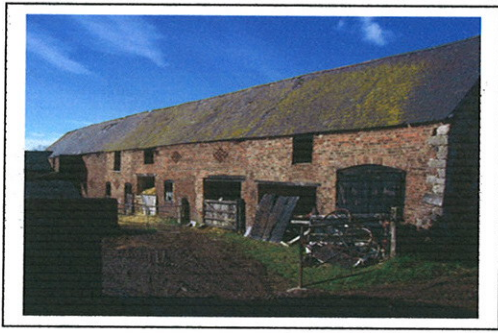
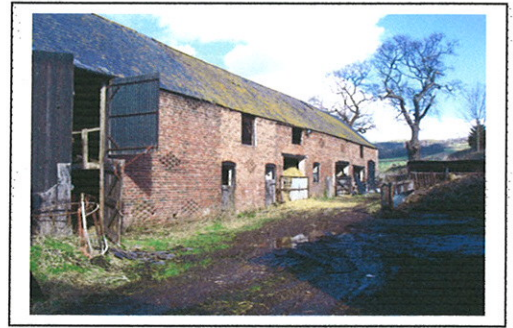
- 2.1 Distorted and cracked masonry around right hand end. Wide door opening together with severely out of plumb gable corner return.
- 2.2 Sagging timber lintel above wide opening.

- 2.3 Butt joint brickwork jamb to the right dips to the right.
- 2.4 Repaired brick jamb.
- 2.5 Steel beams across wide opening with original timber beam above.

- 2.6 General out of plumb and some bulging to first floor masonry above openings.
- 2.7 Various areas of cracking above openings.
- 2.8 Wall in overall reasonable condition. Wall in the order of 100mm out of plumb over its height.

- 2.9 Timber beam above wide opening.
- 2.10 Missing section of brickwork at low level.
- 2.11 Stepped butt joint above first floor level.
- 2.12 Wall in reasonable condition.

- 2.13 Wall in reasonable condition.
- 2.14 Weathered brickwork and eroded joints to lower three courses.
- 2.15 Wall appears in reasonable condition above single storey lean-to roofs.

- 2.16 Thick joint/poorly bonded brickwork at vertical junction.
- 2.17 Large water filled vertical gap between brickwork and stone section.
- 2.18 Fairly widespread weathered brickwork.

- 2.19 Wall out of plumb over its height and basically takes a 'S' form when viewed in section.

Most affected is the stone gable Elevation G (2.53) which is severely out of plumb associated with the distortions and cracking to its returns along Elevation F (2.39) and Elevation D (2.1-2.7); these areas merit reconstruction.

Repairs to the remainder of Elevation D could be subject to some discretion. Length (2.8) and across to (2.10) exhibit some out of plumb and age related deterioration but could be repaired. The remaining length from (2.12) and (2.19) appears in reasonable condition and are suitable to remain. The end section (2.19) is fairly heavily weathered with some distortions meriting reconstruction.

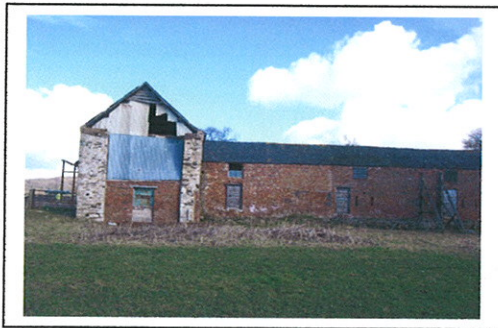
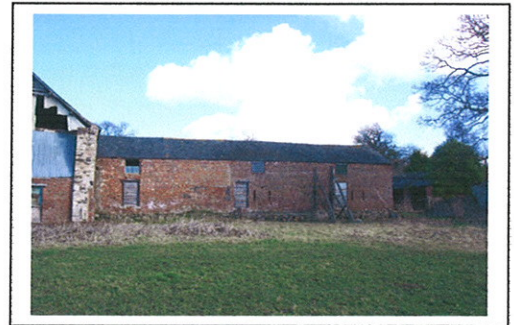
2.28 Diagonal cracking.

2.33 Wall in the order of 125mm out of plumb in the area of the raking shores.

2.35 Wall in poor aesthetic appearance with many areas of roughly mortar patched masonry and other areas of general weathered brickwork and eroded mortar joints. Wall is in the order of 50-75mm generally out of plumb.

2.36 Large stone piers topped with masonry, which is in poor condition. Piers are out of plumb.

2.37 Infilled brickwork at ground floor in poor condition.

Raking shores have been introduced on Elevation E to limit lateral movements; the opposite Elevation G1 mirrors these movements (2.61) but has remained stable probably due to its thickness being 328mm brickwork rather than the thinner 215mm brickwork opposite.

The adjoining length of Elevation E (2.35) is built in a poor quality brick and exhibits many patches of roughly repointed bricks; again we would choose to reconstruct this area as opposed to attempting to cut out and replace weathered brickwork.

The gable end to Elevation E consists of two basically freestanding stone piers with the infill brickwork at ground level and corrugated sheeting/timber support above. The piers have undergone movement and will need to be better restrained/bonded to the 'presumed' new first floor and roof to ensure stability.

If required, structural remedial works could be investigated in order to retain these walls and our initial view would be to resupport the trusses (to avoid the current eccentrically applied loads on the walls) and introduce ties/patress plates across the building. From an aesthetic viewpoint however we cannot foresee a pleasing final appearance and we would choose to reconstruct these areas.

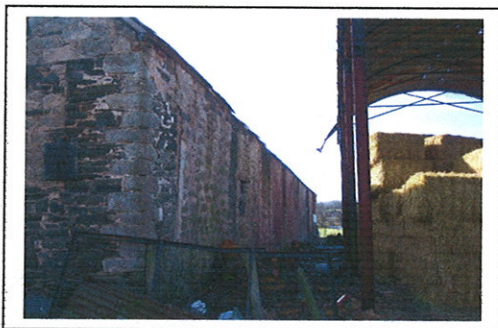
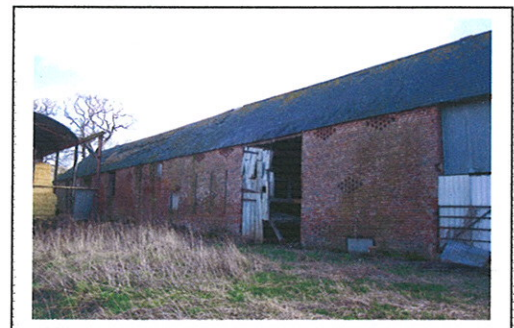
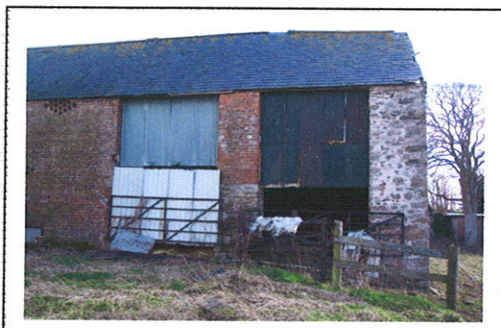
2.40 Very large filled vertical crack and severely distorted gable end return.

2.41 Out of plumb stonework.

2.42 Missing section of stonework.

2.43 Full height butt joints.

2.44 Damp section of wall below damaged roof.

2.45 Very weathered patches of brickwork.

2.46 Damp sections of brickwork below damaged roof.

2.47 Sagging timber lintel and bulging brickwork above.

The remainder and majority of Elevation F appears in reasonable condition accepting that typical repairs are required ie replacing weathered brickwork, resetting top courses under the eaves and repointing throughout.

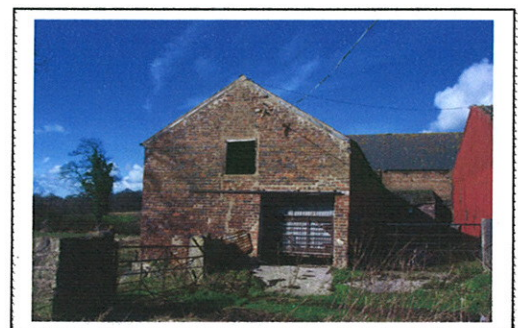
Elevation D1

- 2.20 Timber beam across wide opening.
- 2.21 Stone rubble base courses.
- 2.22 Repointed presumed former wavy vertical crack.
- 2.23 Repointed sections.
- 2.25 Brickwork supported on timber surround to first floor opening.

2.26 Wall appears in serviceable condition accepting poor aesthetic appearance.

The single storey leg (elevation E, D1 and G1) exhibits fairly widespread distortions most noticeable towards its gable end where the end three roof trusses are supported on brick piers, which are built off timber corbels at mid height of the wall.

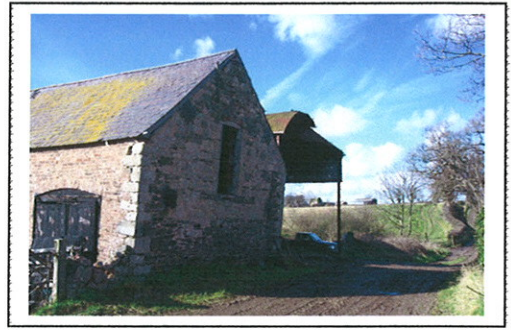
Elevation G

- 2.52 4 No pattress plates.
- 2.53 Stone wall exhibits significant out of plumb over its height.
- 2.54 Top of wall leans out noticeably above abutting lean to corrugated roof.
- 2.55 Timber lintel supporting outer leaf unsupported inner 9".
- 2.56 Poor condition bricked in former opening.
- 2.57 Bricked in former openings.
- 2.58 Butt joint.
- 2.59 Weathered brickwork and eroded mortar joints to lower four courses.
- 2.60 Repointed corner.
- 2.61 Wall exhibits noticeable out of plumb to window head height in the order of 50-75mm.

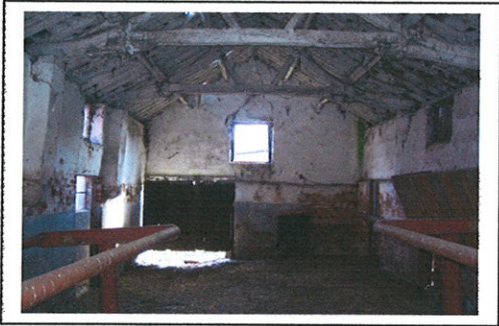
Room G7

- 2.74 Concrete floor, part rendered, part white washed brick walls, trussed roof supporting canted purlins and timber rafters.
- 2.75 Trusses supported on brick piers, which terminate on timber corbels at mid height. Piers are out of plumb consistent with distortions noted externally.

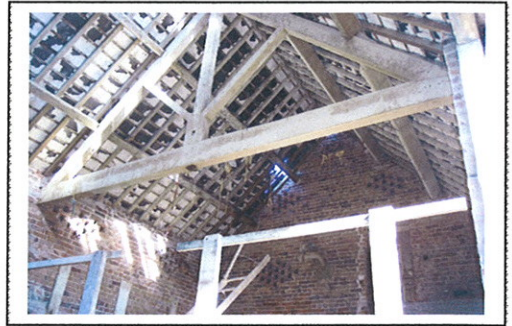
Room G5

- 2.69 Straw covered floor, exposed brick walls, timber joisted first floor over part of room.

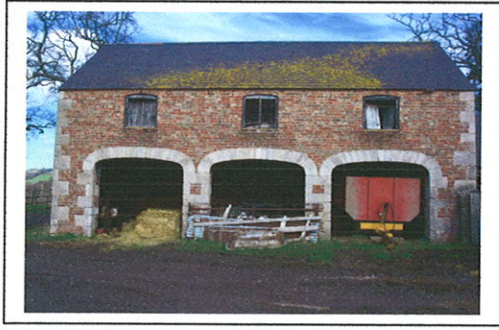
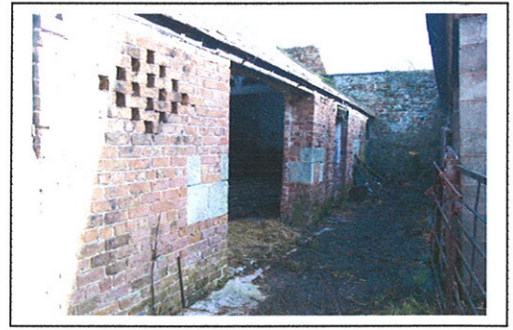
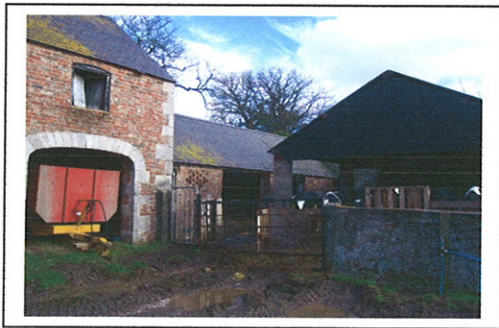
- 2.79 Main two storey section in good condition.
- 2.80 Wall leans out in the order of 50mm.
- 2.81 Wall leans out in the order of 100mm.
- 2.82 Wall leans out in the order of 50-75mm.
- 2.83 Low level weathered brickwork and eroded mortar joints.

Elevation A consists of 3 No wall panels in between 4 No door openings. The middle section (2.81) exhibits the most noticeable lean and should be reconstructed, the remaining sections are less distorted and could remain but our preference would be to rebuild them. Notwithstanding the design of the roof structure will need to be reviewed to minimise the potential for future roof spread.

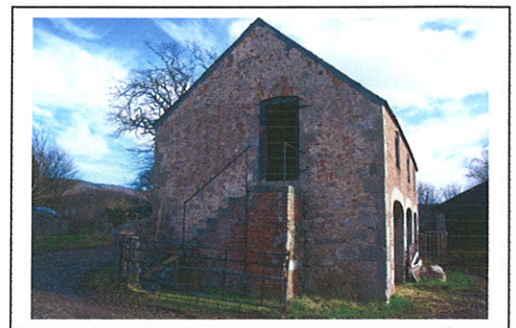
Elevation B

- 2.84 Brick and stone steps in poor condition.
- 2.85 A series of slight wavy vertical cracks.
- 2.86 Wall appears in overall reasonable condition.

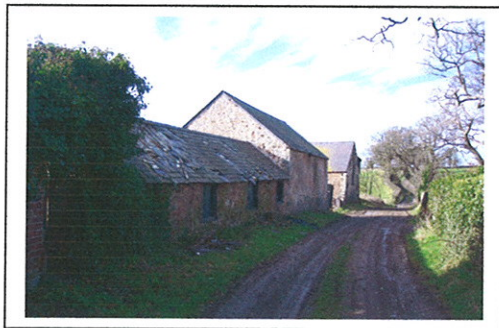
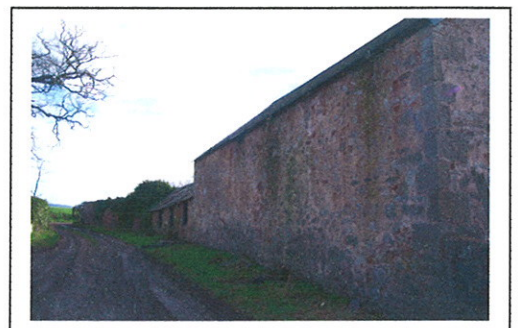
Elevation C

- 2.87 End of wall covered in ivy.
- 2.88 Top of wall in part loose due to water ingress from damaged roof.

- 2.89 Wall in serviceable condition.
- 2.90 Damp sections of wall below damaged roof.
- 2.91 Wall appears in overall reasonable condition, no significant out of plumb noted.

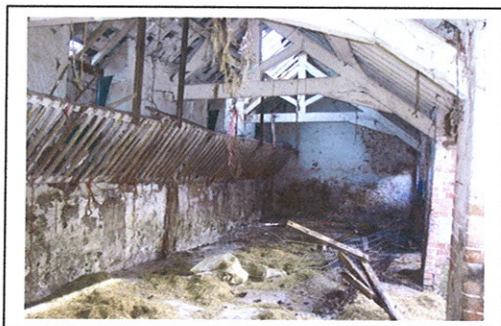
Room G2

- 2.93 Concrete floor, mix of rendered and whitewashed stone and brick walls. Raised collar timber truss roof supporting canted purlins and timber rafters.
- 2.94 Lower 1m height of wall acts as a retaining wall and exhibits dampness and general tendency to lean inwards.
- 2.95 Diagonal cracking to side of window.
- 2.96 Diagonal cracking to both sides of timber truss bearing.
- 2.97 Damp wall at low level.
- 2.98 Damp wall and weathered brickwork at high level.

- 4.5 It is clear that the two storey section of the building was built to a good standard and remains in a very reasonable condition suitable for conversion without the need to undertake major rebuilding or repairs.
- 4.6 The single storey external walls have undergone lateral movements due to roof spread and most noticeable along Elevation A. The opposite wall (Elevation C) also acts as a retaining wall and exhibits general out of plumb and dampness alongside its length (2.94).

The lower retaining wall section of Elevation G will need to be strengthened in order to demonstrate future stability; works could be undertaken from inside accepting some loss of internal space.

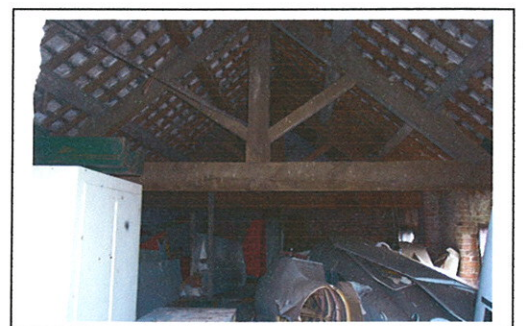
Room F1

- 2.99 Timber first floor, many stored items, exposed brick wall, 2 No king post timber trusses supporting canted purlins and timber rafters.
