Monitoring and Recording the Scheduled Hulk Number 3 on Ynyslas Beach, Ceredigion (June 2015)

Prepared by: **Malvern Archaeological Diving Unit**
17 Hornyold Road
Malvern
Worcestershire
WR14 1QQ

Date: **June 2015**

Report Ref: **MADU – Ynyslas – 2015**

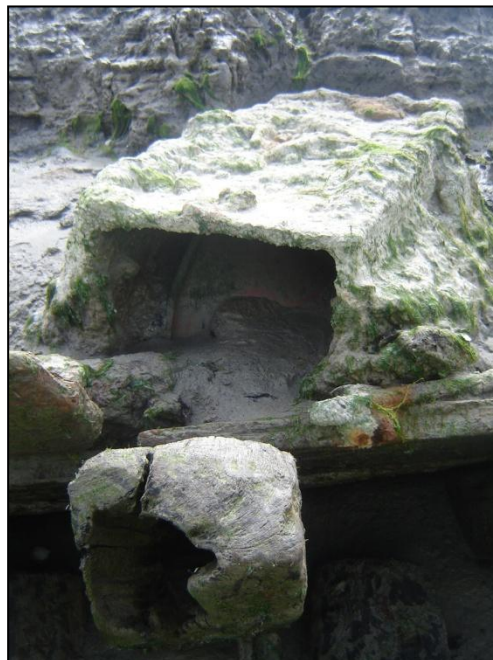
Figure 5. Possibly the galley stove with a cooking vessel still in the oven.

In addition to the above, numerous artefacts have become exposed including a wooden stave bucket the remains of which were removed from the site by DAT in September 2014, and what is thought to be the vessels cooking stove complete with a ceramic cooking pot still in the oven (see Figure 5).

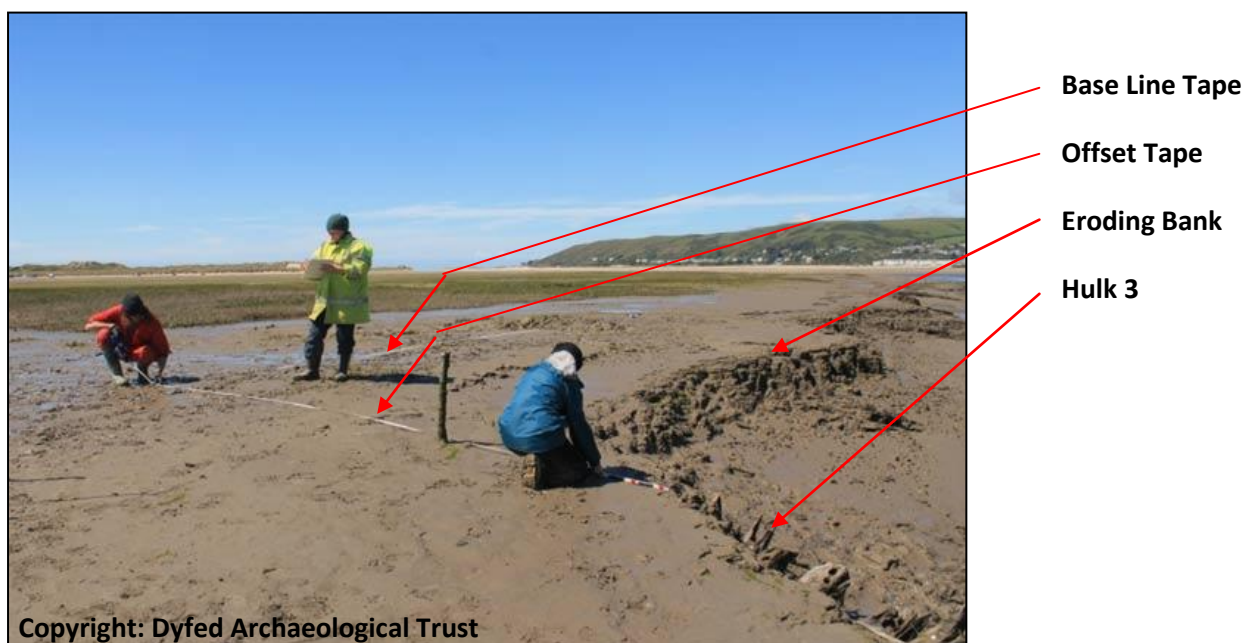
Figure 6. Carrying out an Offset Survey of the Afon Leri's eroding bank (DAT).

The first contemporary reporting of Hulk 3 was included in the RCAHMW report *Remains of the Derwenlas Fleet at Ynyslas* (Groom 2010) following a survey of the wreck which was carried out in June 2010. Since the wreck was brought to their attention in October 2012, MADU have been recording the location of the top edge of the receding bank of the Afon Leri adjacent to Hulk 3. Repeating this exercise during this season's June 2015 site visit would therefore provide a comprehensive 5 year overview of the rate of erosion of the bank and the resultant emergence of the wreck.

In October 2012, two semi-permanent survey datum pegs were placed in the beach 38m apart above the wreck and set back from the edge of the bank of the Afon Leri. This enables a survey tape to be run out between the two pegs approximately parallel to the river and used as a base line datum from which offset measurements can be recorded at 1m intervals. This simple method for surveying the bank has worked well enabling comparison rates of erosion to be viewed following each subsequent visit (see Figure 6).

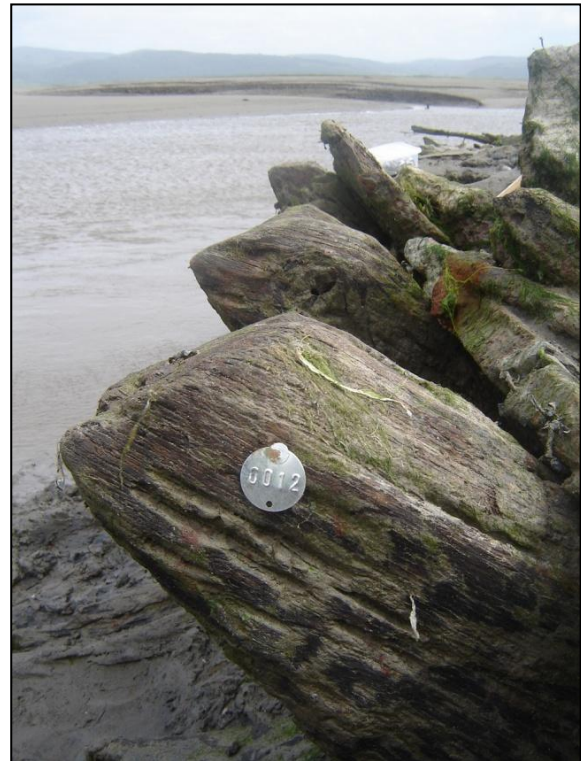
Figure 7. A starboard frame showing it's associated embossed label.

James, Hubert and Felicity had arrived on Saturday 30th May and over the course of the weekend they had cleared most of the seaweed from the wreck and cleaned the exposed timbers. They had also made a start recording the frames on the north (starboard) side of the site that remain integral with, and attached to, the wreck. As described above, the exposed timbers were labelled using individually numbered embossed metal tags (see Figure 7) and recorded using DAT Timber Recording Forms.

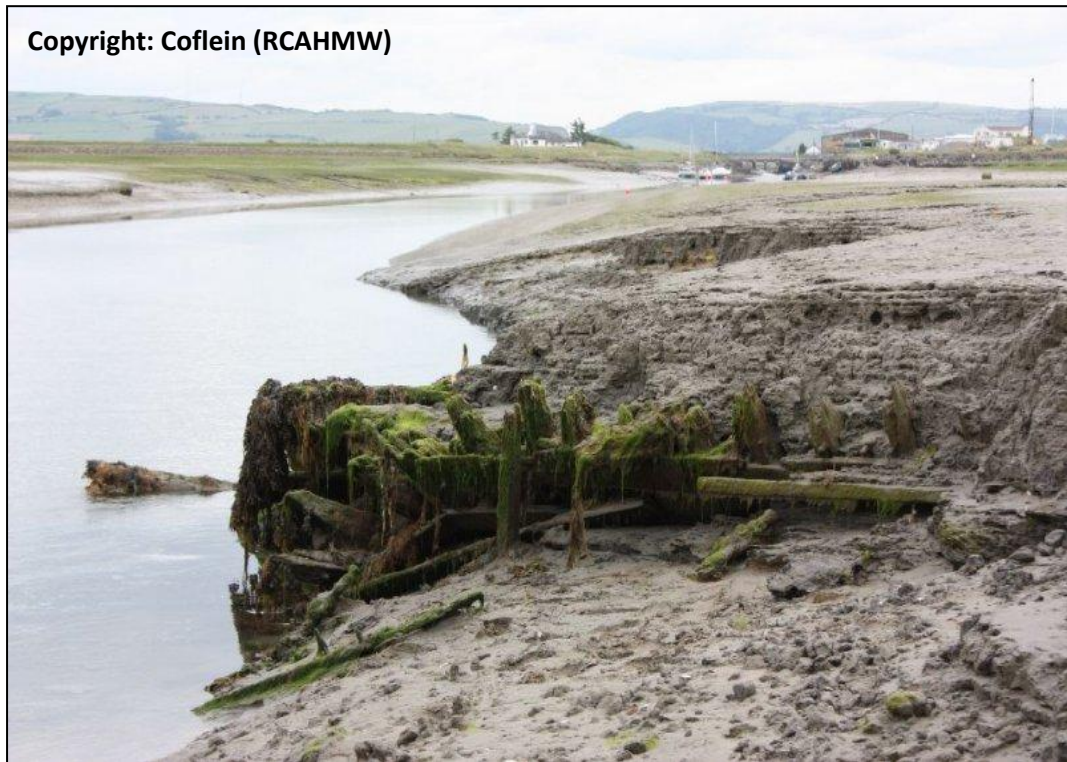
30th June 2010

Since this description was recorded in October 2010, Hulk 3 has changed considerably (see Appendix II). The bank of the Afon Leri has continued to erode, with the top edge of the bank having moved west by around 4m since June 2010 (see Appendix V). This has resulted in approximately 80-90% of the starboard side (including cant frames leading in towards the bow) and 30-40% of the port side of the wreck having become exposed.

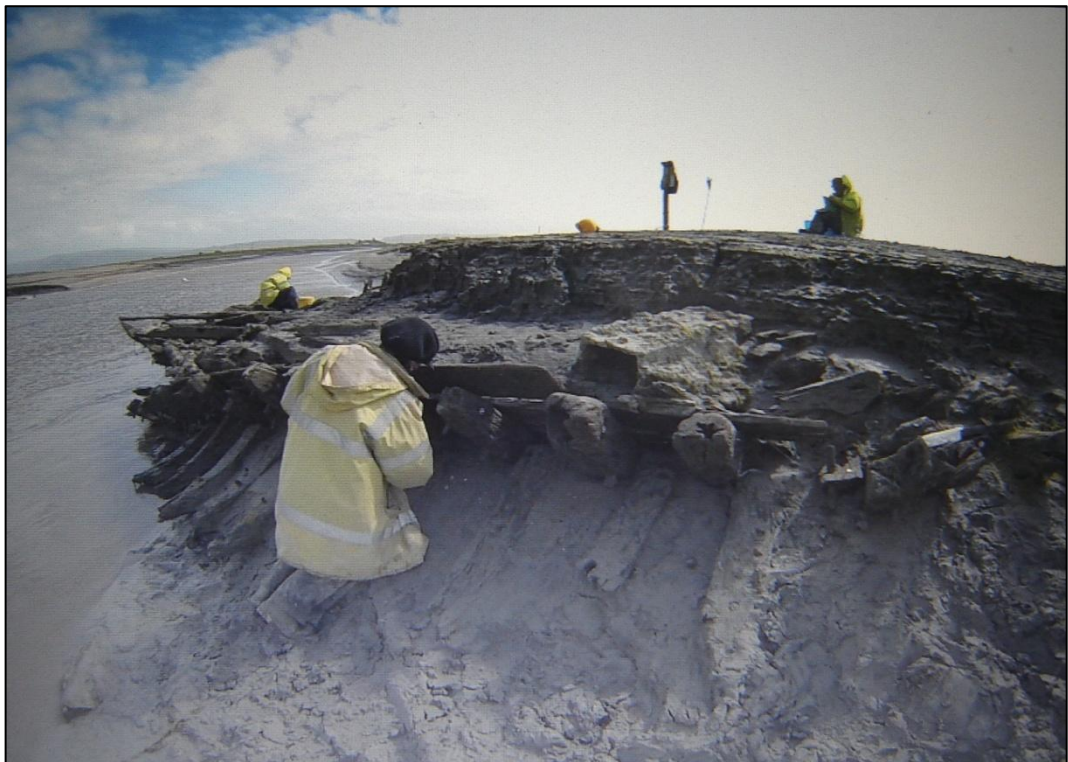
2nd June 2015

There are no longer any signs of the overhanging stern timbers reported in Coflein, and the continual drying out, followed by repeated submersion of the wreck at high tide, has resulted in almost all the exposed outer planking together with the intermediate filling frames on the starboard side to have fallen away. As the vessels main timbers and planking have become disarticulated, they have become mobile as subsequent tides cover the site, eventually floating away and disappearing altogether.

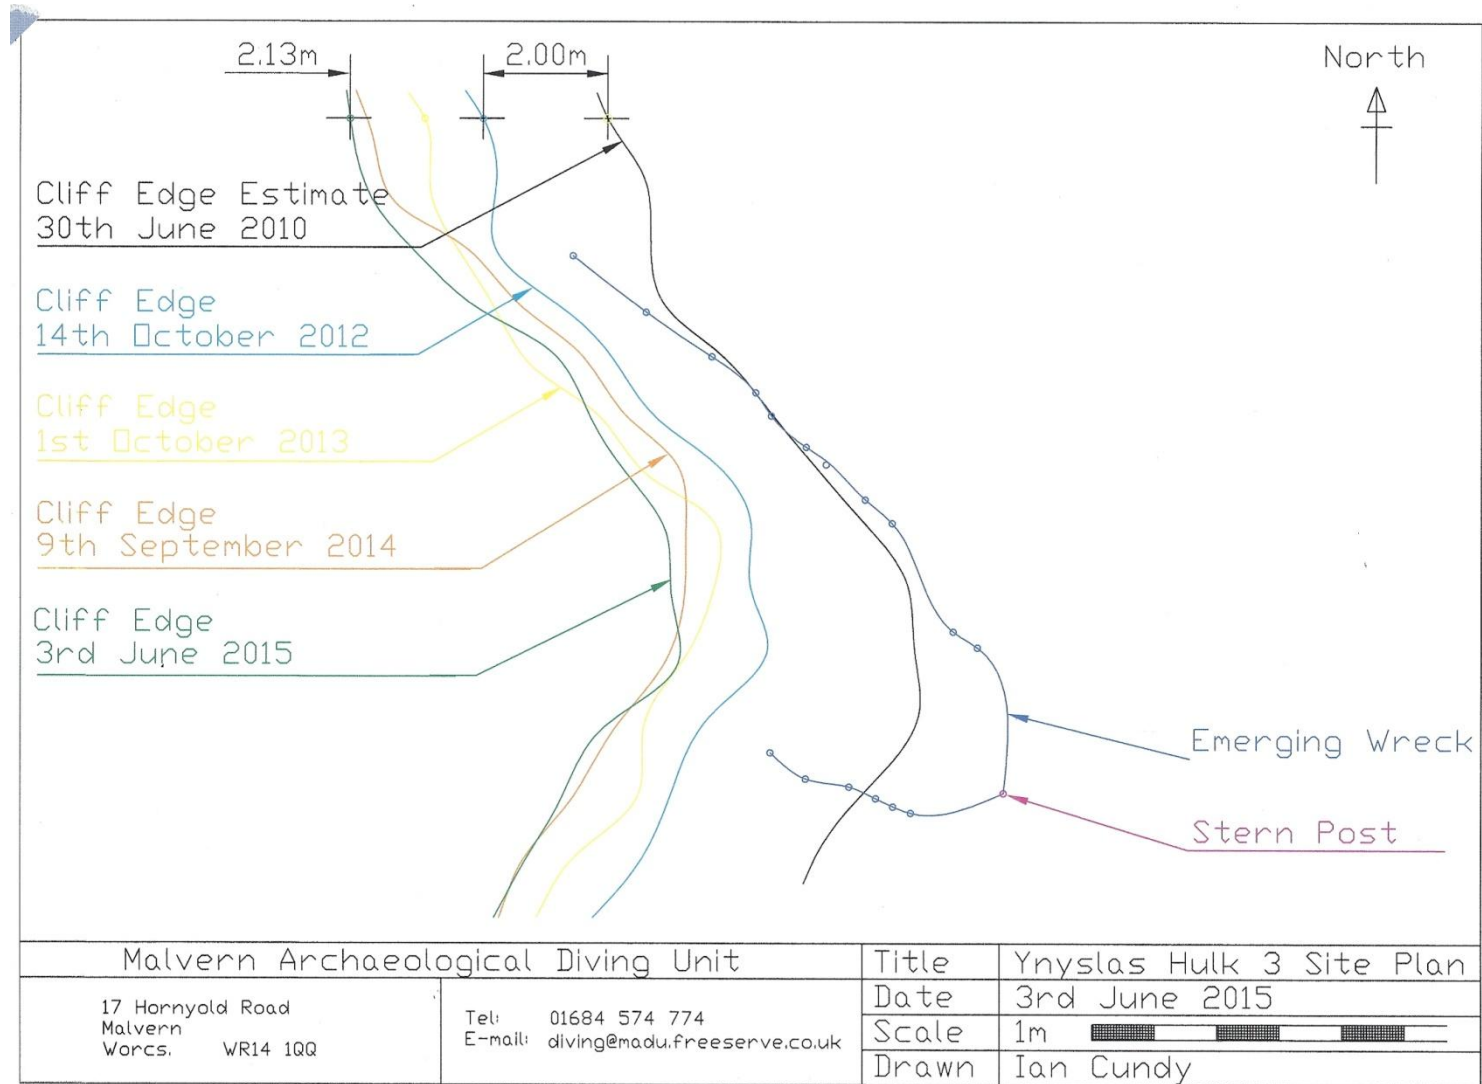
Appendix V – Afon Leri Bank Erosion (2010 to 2015)

The rate at which the bank of the Afon Leri is continuing to erode adjacent to Hulk 3 remains both significant and alarming (see Appendix V). With measured and recorded figures now established dating back to October 2012, together with additional estimates dating back to June 2010, we can now see the trend for a full five years, and can confidently confirm that the bank is eroding at an average rate of approximately 0.8m per year. The effect of this is that the timbers of Hulk 3 are continuing to become exposed and significantly affected by the continual cycle of drying out and becoming completely submerged twice a day by the incoming tide. This destabilises the structural integrity of the vessel, the timbers become detached, fall away, and are eventually lost (see Appendix II). In addition, artefacts and other potentially significant features that could provide important information about the vessel, and the period in which it operated are similarly disappearing.

At the current rate of exposure, we anticipate that within 2 years the wreck is likely to be exposed from bow to stern on the starboard side, and the entire vessel will eventually be lost forever.
