ARCHAEOLOGICAL

WATCHING BRIEF

WB01/BR/07

Site at Canal Bank Brecon

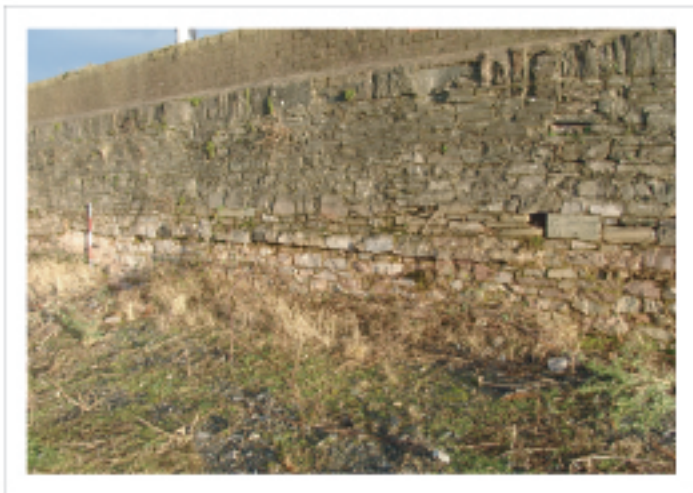
Plate 05: North boundary wall

An anomaly; both colour and construction width, can be seen running unevenly along the inside of the wall, about 1 m below the top of the masonry edge *plate 05*. This entire section of wall, separating the site from the canal, was removed to surface level. A section of the wall foundation was exposed during Phase 3 (*below*) and was observed to extend at least a further 2m' to a double course of dressed stone *Plate 07*. Unfortunately, it was not possible to examine the exposed foundation in any detail.

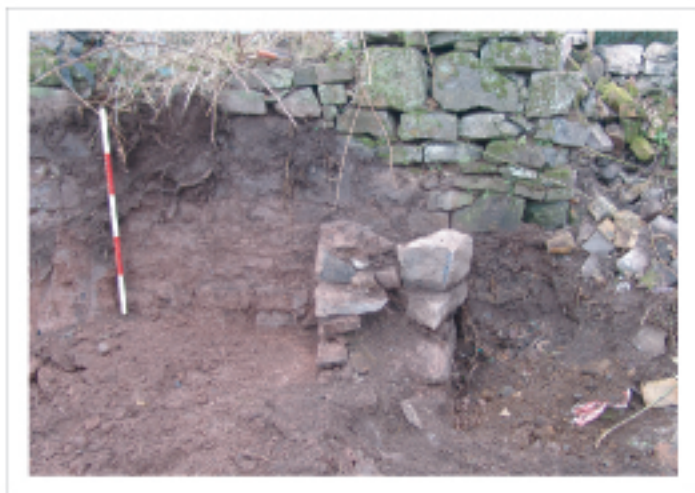
Plate 09: South wall & feature (2)

The southern section of wall is again of similar construction, height and condition to the east wall including the width reduction. *Plate 09* shows part of the south wall, at the point where feature (2) (*see below*) was exposed. The ranging rod is standing on the width reduction.

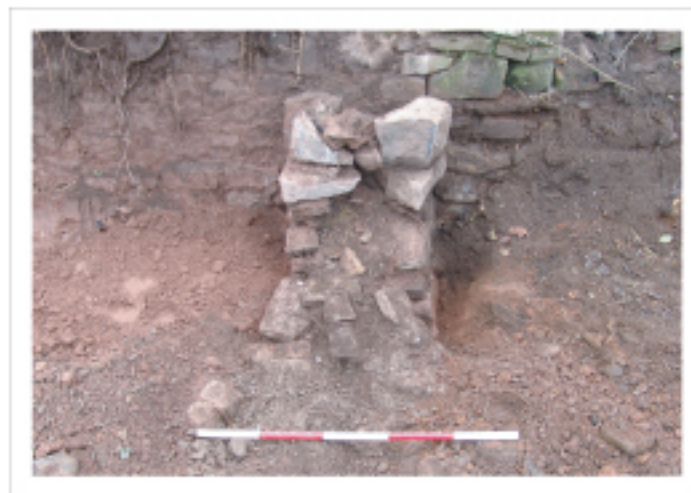
Plate 10: Feature (2)

This feature comprises a partial wall built of rough stone with mortar remaining to a height of 0.6m, for a distance of .75m, at a width of .65m. The base of the wall was excavated with a towel but no discernible foundation cut could be found *Plate 10*. The wall stood on a base of compacted red clay context [004]. To the east of the wall the fill was consistent with [003] but to the west the remains of a brown/black fill with ferrous streaks was evident [005]. Feature (2) was not attached to the south wall but butted against it.

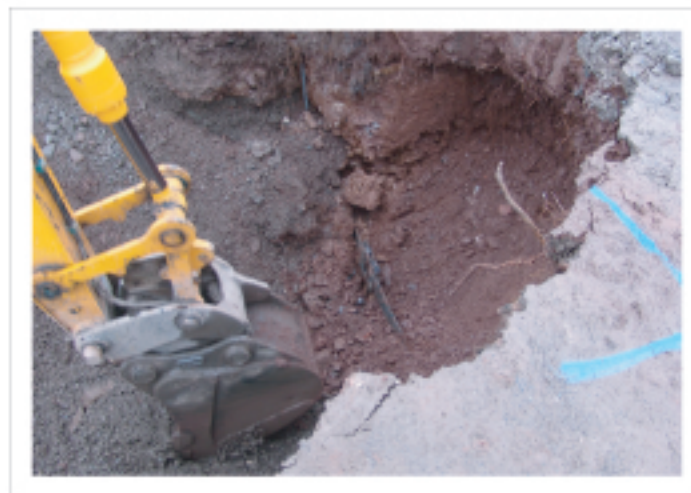
Plate 22: Pillar, feature (13)

As work on the removal of the gas holder progressed towards the north and west; feature (13), another of the support pillars similar to features (1) and (3) was uncovered and followed to a depth exceeding 2m *plate 22*. The pillar seems to have been built on top of a substantial foundation of river pebbles as hardcore but it was not possible to investigate this to any detail.

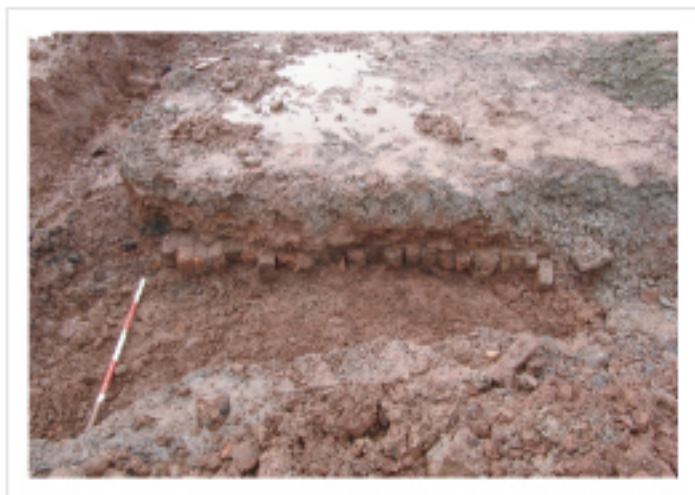
Plate 23: Brick floor, feature (7)

Feature (7) is a 2.3m length of brick floor exposed in the south side of the beam trench *plate 23*. The east edge has been lost during earlier remediation work as no evidence was found during this excavation. The western edge shows a slump of grey aggregate which was deposited when feature (4) was removed earlier, context [008]. The brick tumble, mentioned above during the description of feature (4) is the west section of feature, to the right of the plate (7).

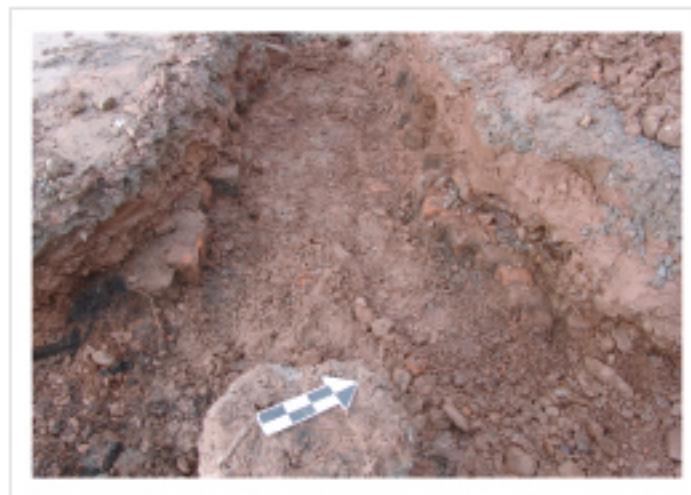
Plate 24: Brick floor, feature (7) & (8)

Feature (8) comprises three sides of a brick floor; exposed in three sections of the beam trench. It measures 2.8m by 2.90, most of which remained uncovered and so preserved in situ, *plate 24*. This section of floor is the same as feature (7) having been cut by the excavation for the beam trench. The east edge has been lost during earlier remediation work as no evidence was found during this excavation. The

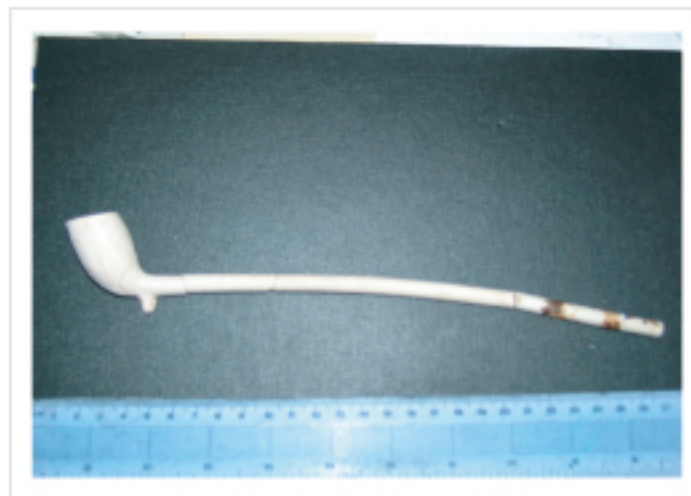
Plate 31: Churchwarden pipe

The site was remarkably sterile as far as finds were concerned, which does tend to support the efficiency of a proportion of the remediation works carried out in 2002. With the exception metalwork relating to the cast iron tanks, the only diagnostic find was a broken Churchwarden Clay pipe found on feature (5). The pieces of the pipe were refitted *plate 31* and dated to 1830-50, *Smith pers com*.
