A.P.A.C. Ltd.

**ARCHAEOLOGICAL
RECORDING & WATCHING BRIEF**

WB/GOV/10

Old Corn Mill, Govilon

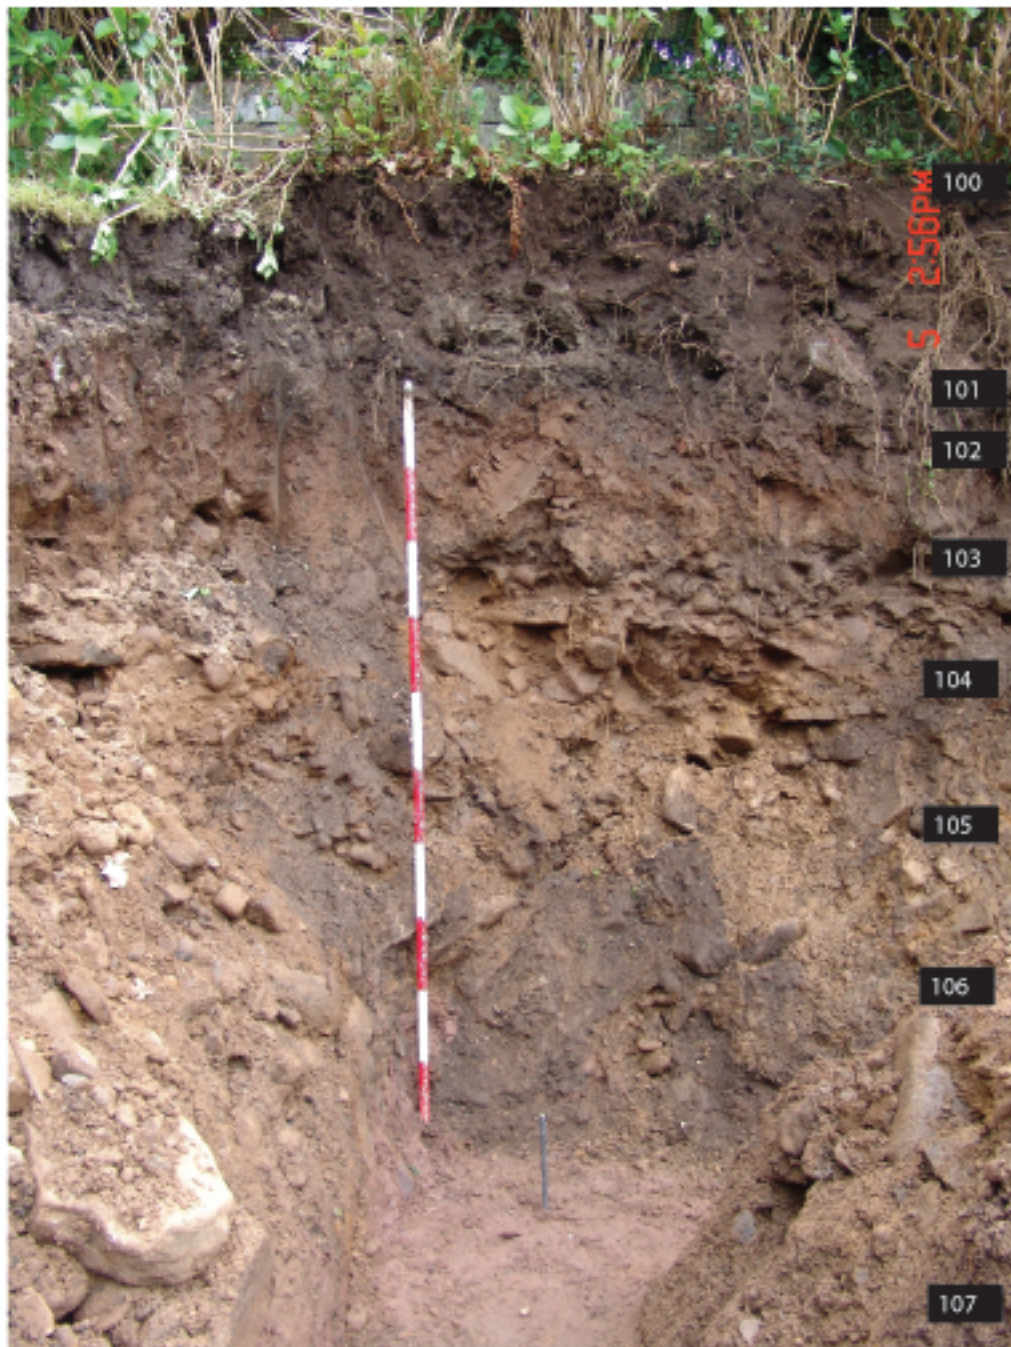
Fig 03: SE section

During excavation, the stratigraphic record and initial contexts were noted, with a brief description given where appropriate. The most complete stratigraphic record was found at the south of the site and an annotated photograph (DSCO6938) of the section is shown in fig 03.

Beneath the layer of building debitage, was a layer of river terrace deposit which itself overlay glacial deposits fig 03.

Great care was taken along the southern edge where the retaining bank and partial retaining wall to the next property was constantly monitored for collapse, Plate 04 and fig 03.

- 100 Top soil, black sandy loam, 0.2-0.3m
- 101 Grey black, loam with small angular stone and plaster 0.2m
- 102 Black loam with coal 0.09m
- 103 Orange sandy soil, with small angular stone. 0.17m

- 104 Orange sandy soil, no stone 0.2m
- 105 Grey brown coarse grits with small stone/pebbles 0.07m
- 106 Orange sandy silt, with large rounded stones and boulders, 1.32m
- 107 Red sandy clay with green and red sandstone rock

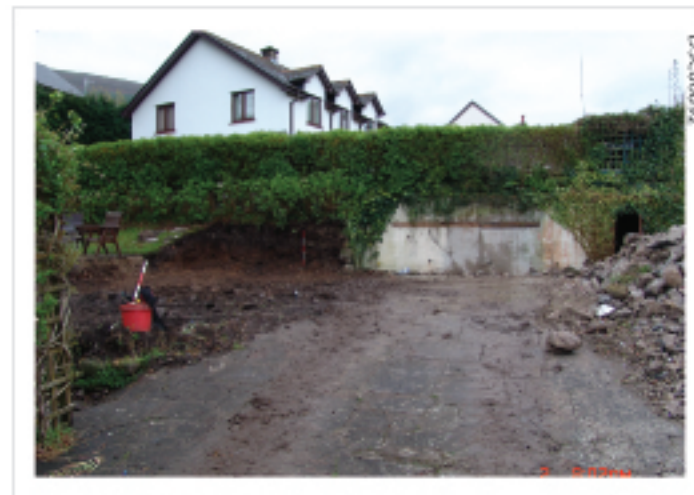
The garage site is bounded to the south by a high retaining wall for the property next door Plate 04. To the east is a raised patio Plate 05 which stands at the base of the old wheel race Plate 06. To the west is a walled stream Plate 01 and to the north the mill house and a paved area Plate 07.

Plate 04: South boundary, retaining wall.

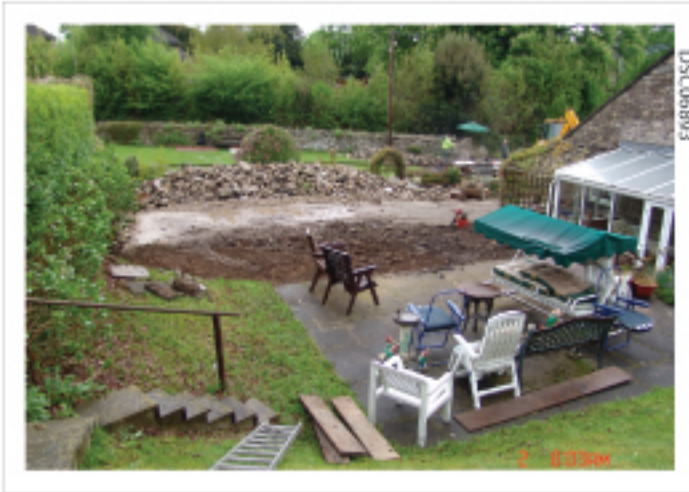
Construction work involved demolition and clearance of the garage building and floor, the removal and levelling of some of the raised patio Plate 05 and replacement of an earlier service pipe Plate 08. As the patio area, garage and earlier services were built by the present owner this part of the work was not covered by the watching brief.

Plate 05: Remaining raised patio after ground reduction.

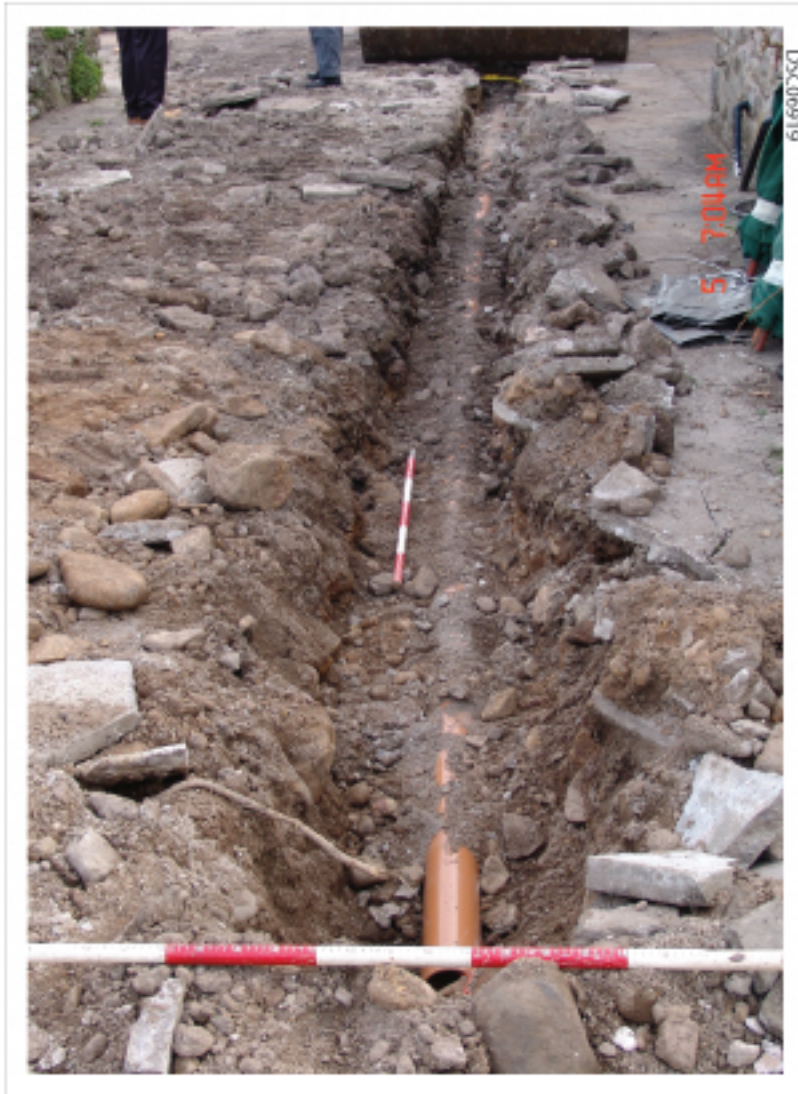
Plate 08: Service pipe replacement along western drive area

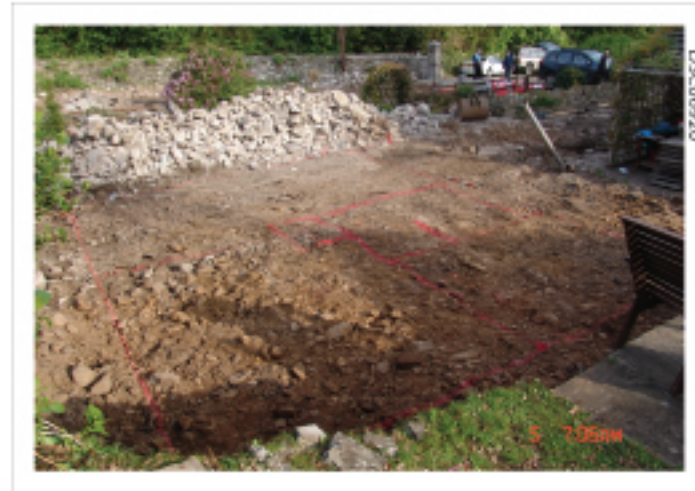
The watching brief was undertaken on work involving the excavation of foundation trenches within the levelled ground previously covered by the garage and raised patio Plate 09.

Plate 09: Trench layout

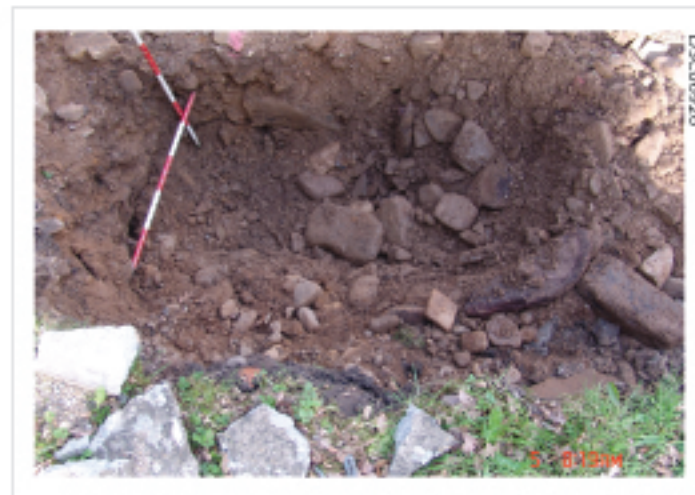
There was a very abundant mix of rounded stone and boulder within the lower deposit which made not only digging very difficult but also seriously affected the ground stability Plate 10.

Plate 10: Lower deposits

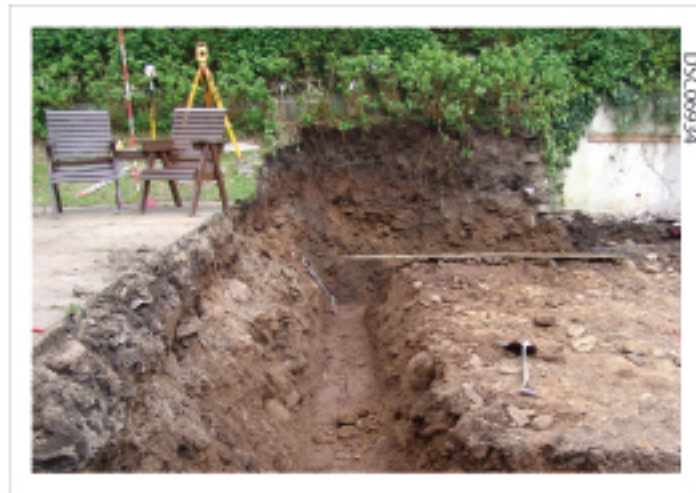
The foundation trenching was started in the south east corner, fig 03 and continued in the first instance along the east side Plate 11. A slight difference to the stratigraphy was evident in this area in that the ground had been made up to accommodate the raised patio.

Plate 11: Eastern trench.

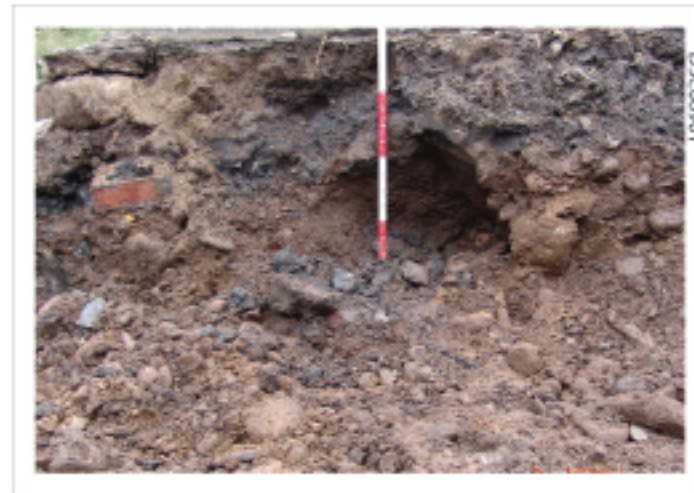
The raised ground consisted of black soil with bricks, large stones, building fittings including small lengths of mains cable, electrical switch boxes and plastic sheeting. Plate 12 shows a sample of the section; the large void having been left by a large stone.

Plate 12: Made up ground under patio.

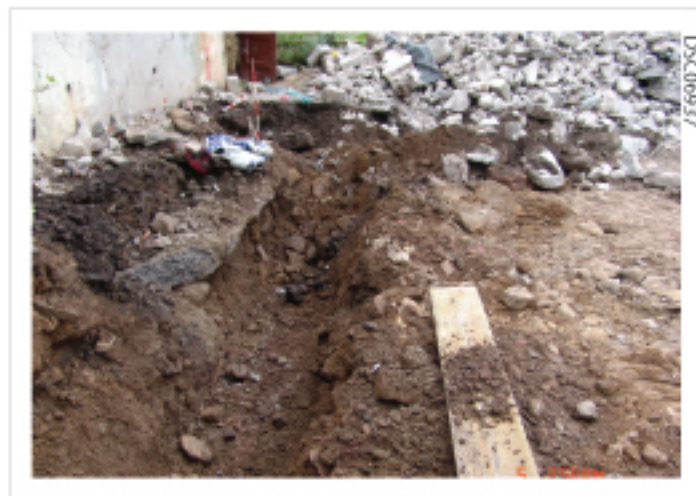
Excavation then began beneath the south retaining wall, where, as well as the danger of collapse, further obstacles were met when an area of concrete was found, butted to the retaining wall Plate 13. The concrete was carefully removed so as to cause as little disturbance to the retaining wall as possible. Plates 13 & 14, show views of the south and west trench giving some idea of the problems involved in the excavation. The Tesco bag, full of building debris and shown in the pictures, was found under the concrete floor and therefore provided confirmation as to the construction of the garage in the 1970s.

Plate 13: Concrete floor, connected to retaining wall, south trench.

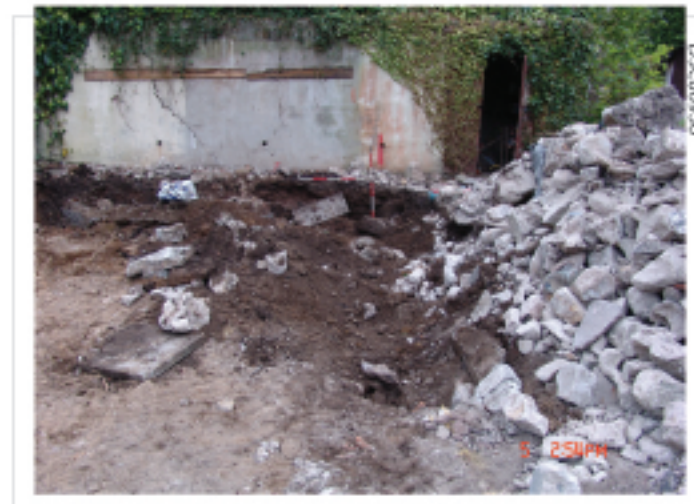
Plate 14: West trench and south boundary, retaining wall.
