**Grade II, BUILDING RECORDING SURVEY**

**Ty Ambrose Farm, Sebastopol.**

**Planning Application: 11/P/00576**

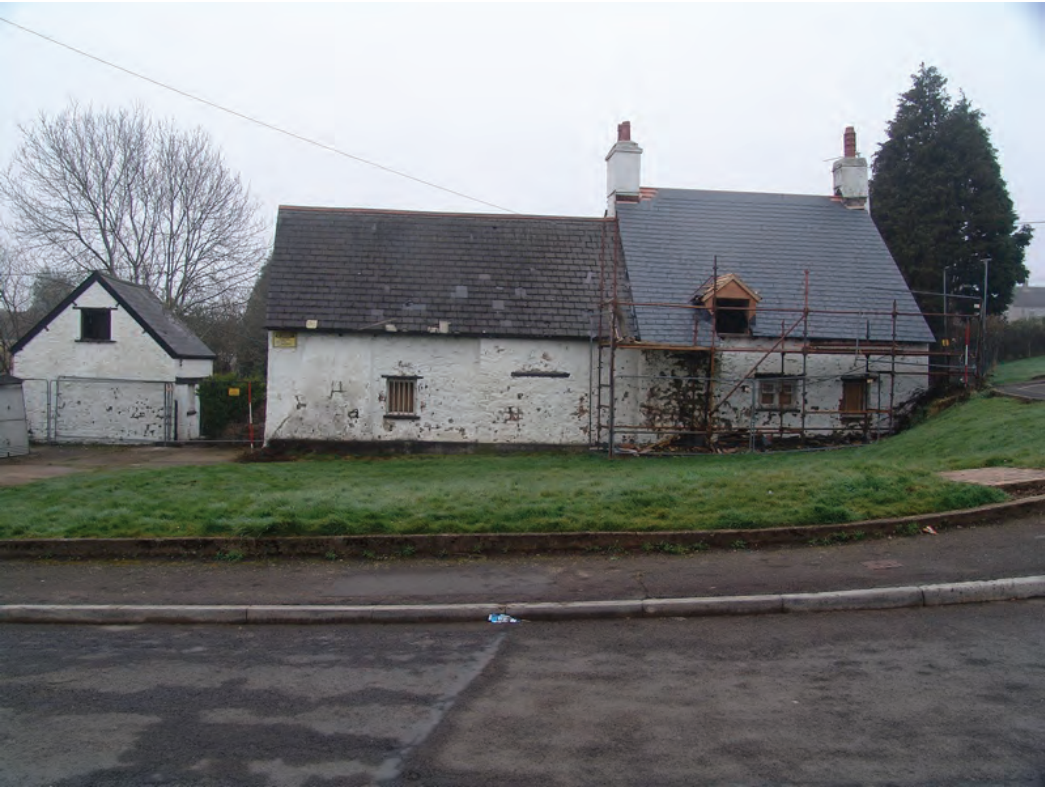
Reason for image    General view of entire external north wall

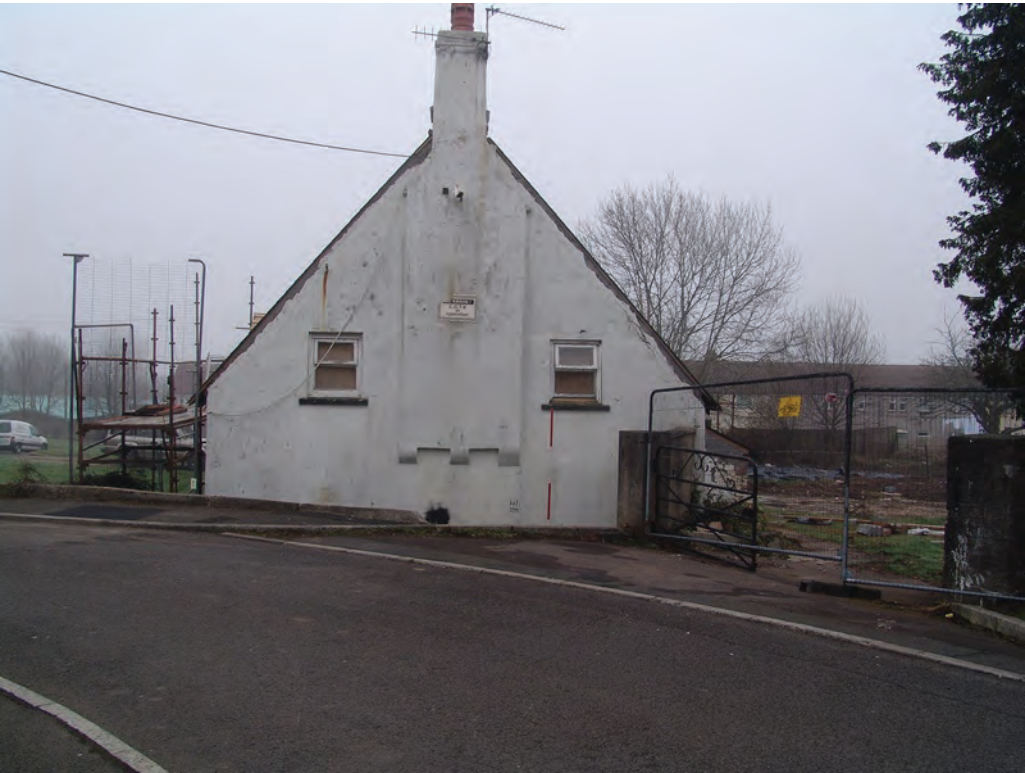
Reason for image    Detail of W gable    showing corbelled chimney breast

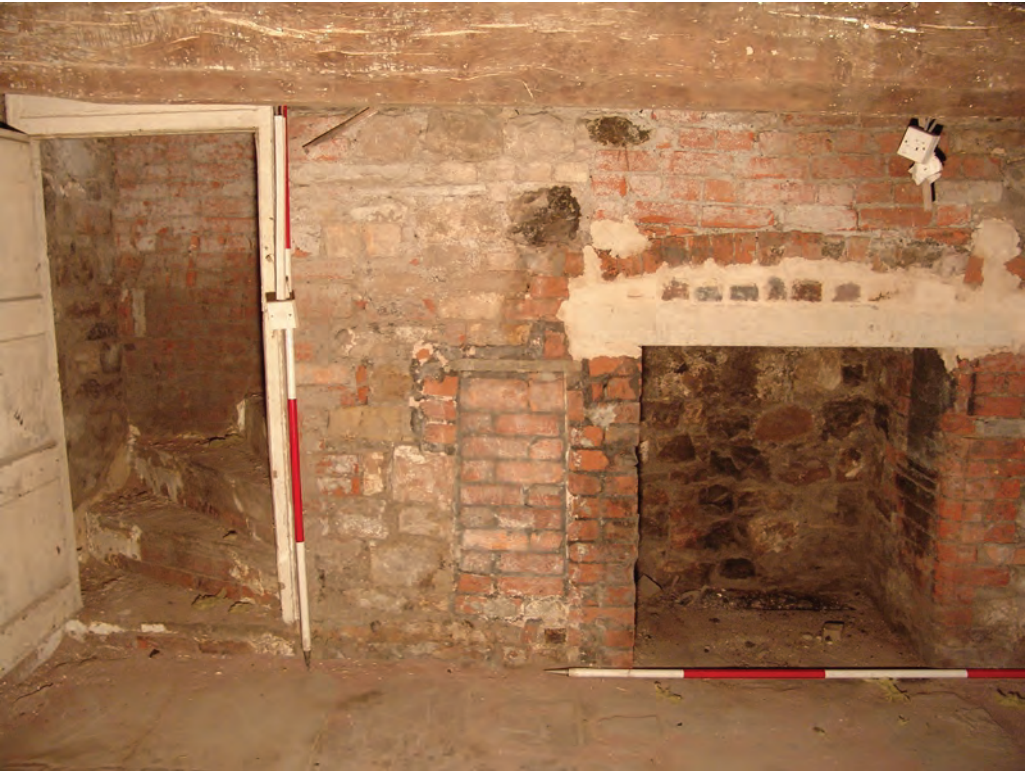
Site Ty Ambrose	Site code BS/TYA/12	Grid Ref: ST 28849800	Camera Sony DSC F28	Format Digital	File RAW	Dimensions 2048x1536	Size 17mb	Date 12/03/2012	Image no: DSC02694	PLATE 06
Direction of view: North east

Reason for image    Stairwell to left of fire place. Multiphase fireplace

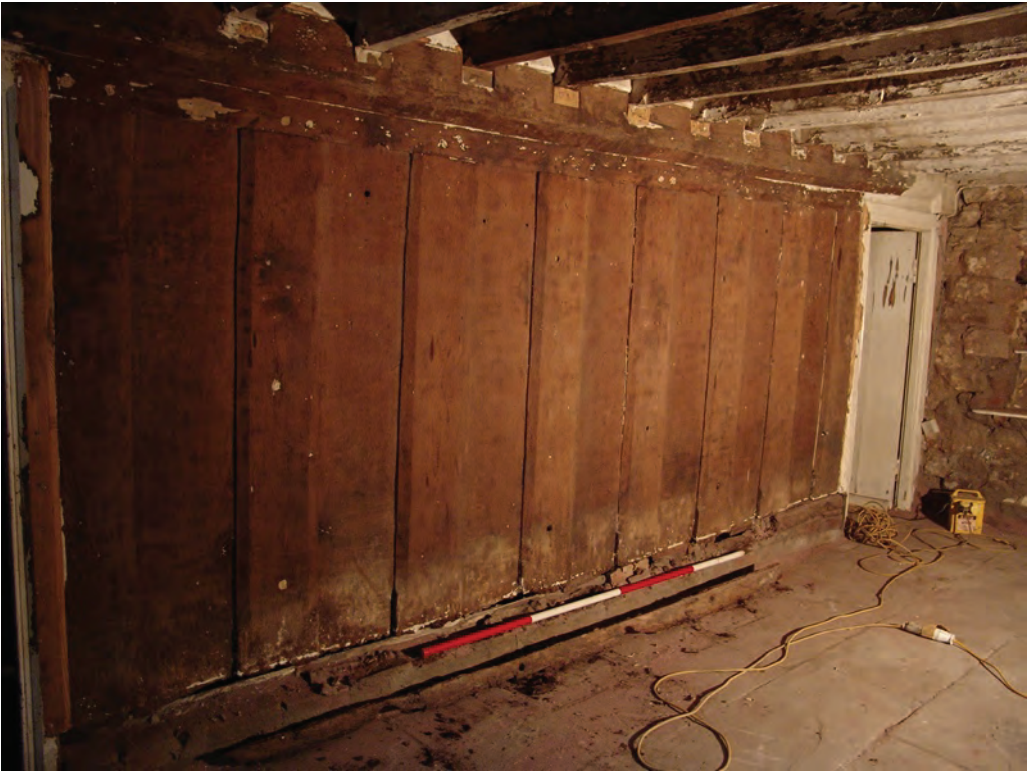
Reason for image   Plank Partition, chamfered side.

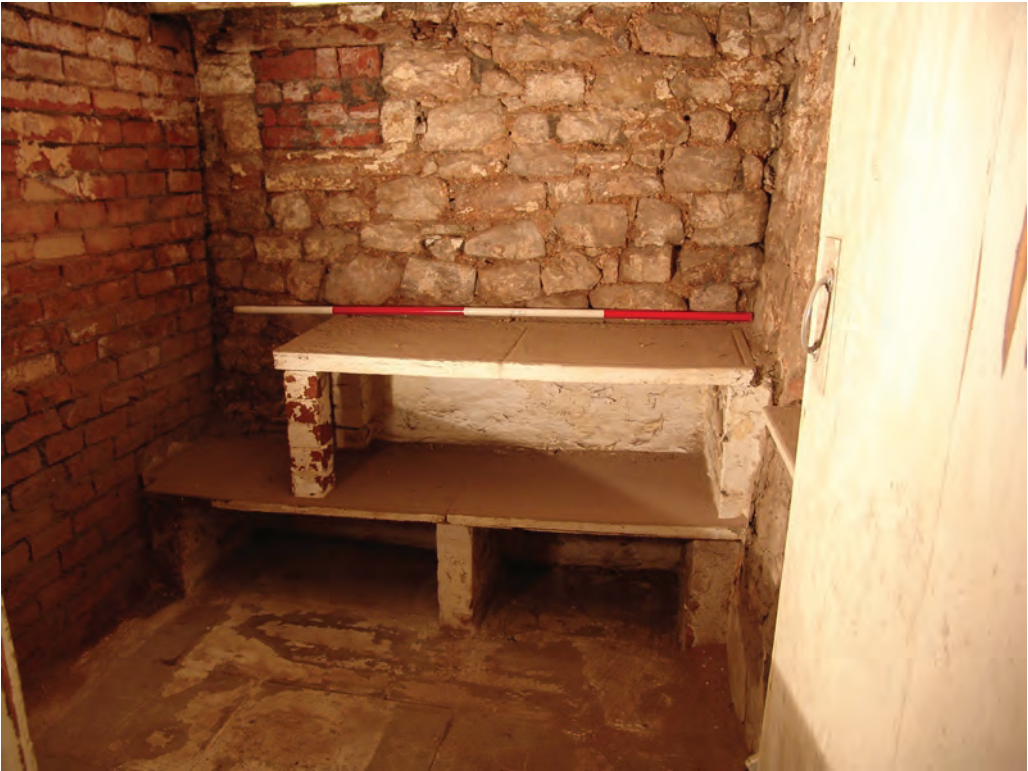
Site Ty Ambrose	Site code BS/TYA/12	Grid Ref: ST 28849800	Camera Sony DSC F28	Format Digital	File RAW	Dimensions 2048x1536	Size 17mb	Date 12/03/2012	Image no: DSC02690	PLATE 09
Direction of view: North east

Plate 08 also shows the two shelves of flat slabs supported on bricks which suggest the room was used as a cold store or Pantry as noted in the plan L1/01. The topmost slab has a drip gully.

Reason for image Cold slab shelving, Flag floor. Blocked external window and new brick partition

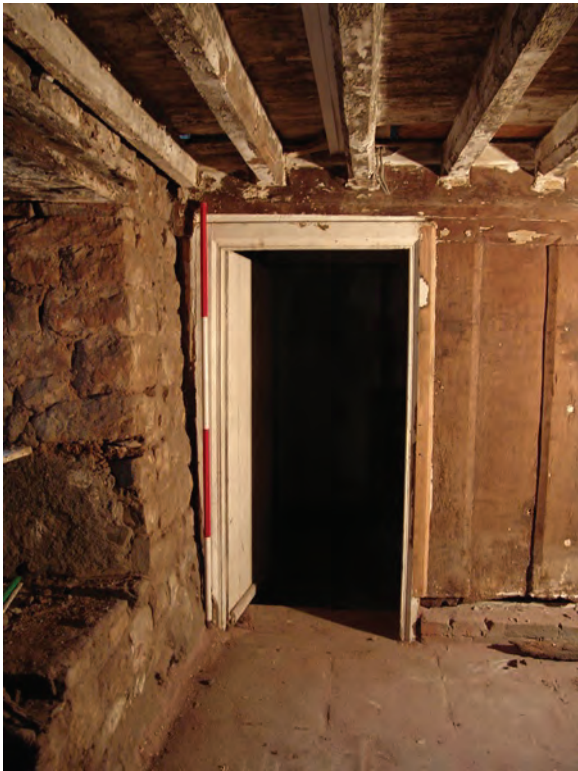
</div> <div>Reason for image   Profile south internal wall batter shown against vertical rod</div>							
<div>

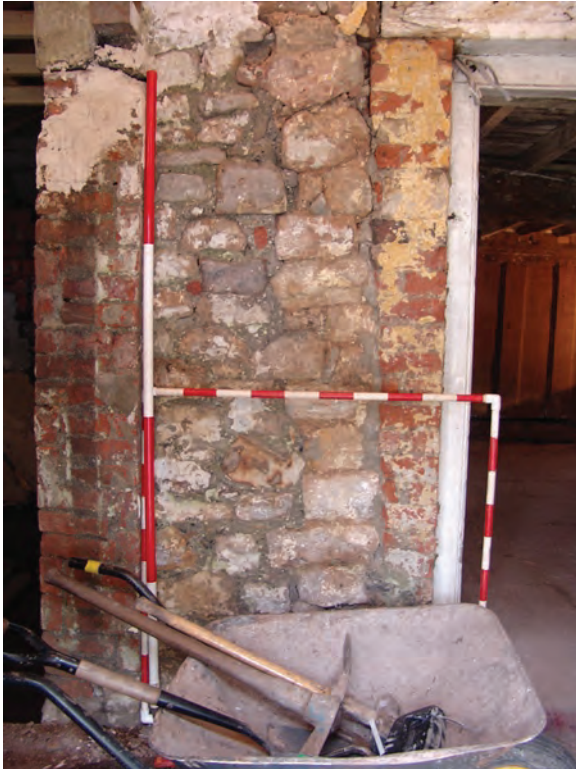
The fireplace wall then turns east to form a short passage, 1.25m to the doorway D13 the external view of which can be seen in Plate 12. Plate 12 shows the brick facing that has been added to the south wall in order to provide a vertical for the door frame; as was noted above at D5.

<p>Reason for image    Original, external south wall of house. Brick cladding for Kitchen 5 and new door with scales</p>

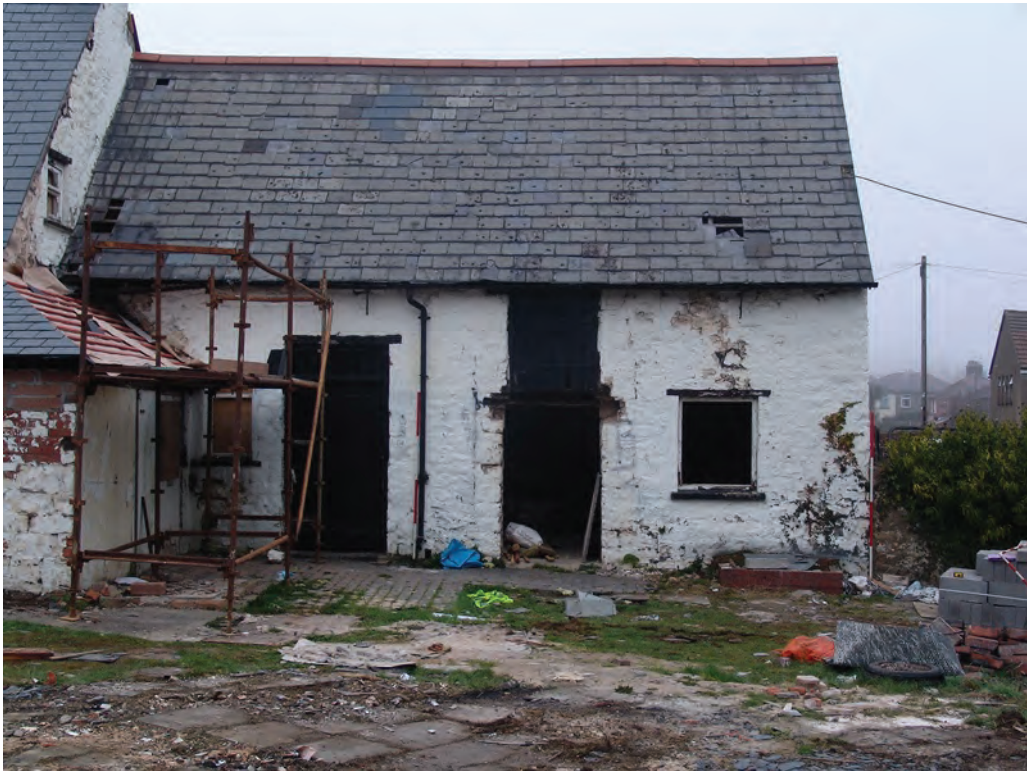
Site Ty Ambrose	Site code BS/TYA/12	Grid Ref: ST 28849800	Camera Sony DSC F28	Format Digital	File RAW	Dimensions 2048x1536	Size 17mb	Date 12/03/2012	Image no: DSC02650	PLATE 14
Direction of view: South

Reason for image    General view of 3/4 barn/cowshed

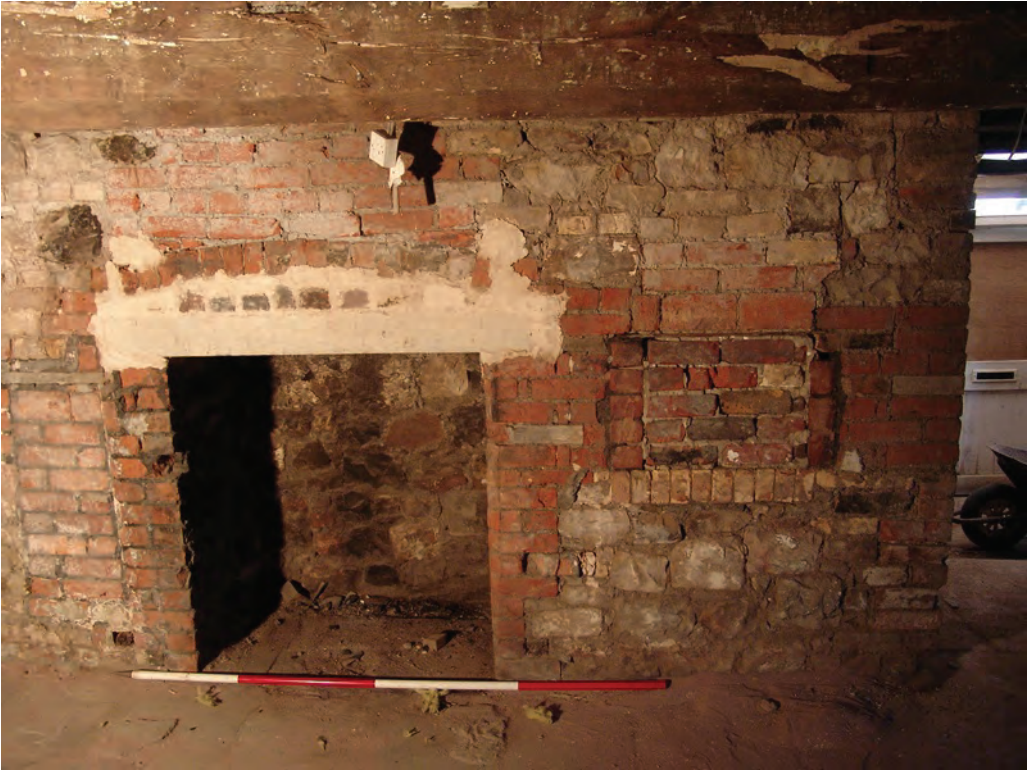
The brick support to the right of the fireplace is earlier than the repair to the left and features an edging of 'bullnose' bricks which are tied into another patch of rough dressed stonework, Plate 18.

Reason for image    Multiphase fireplace and later warm shelf? to right

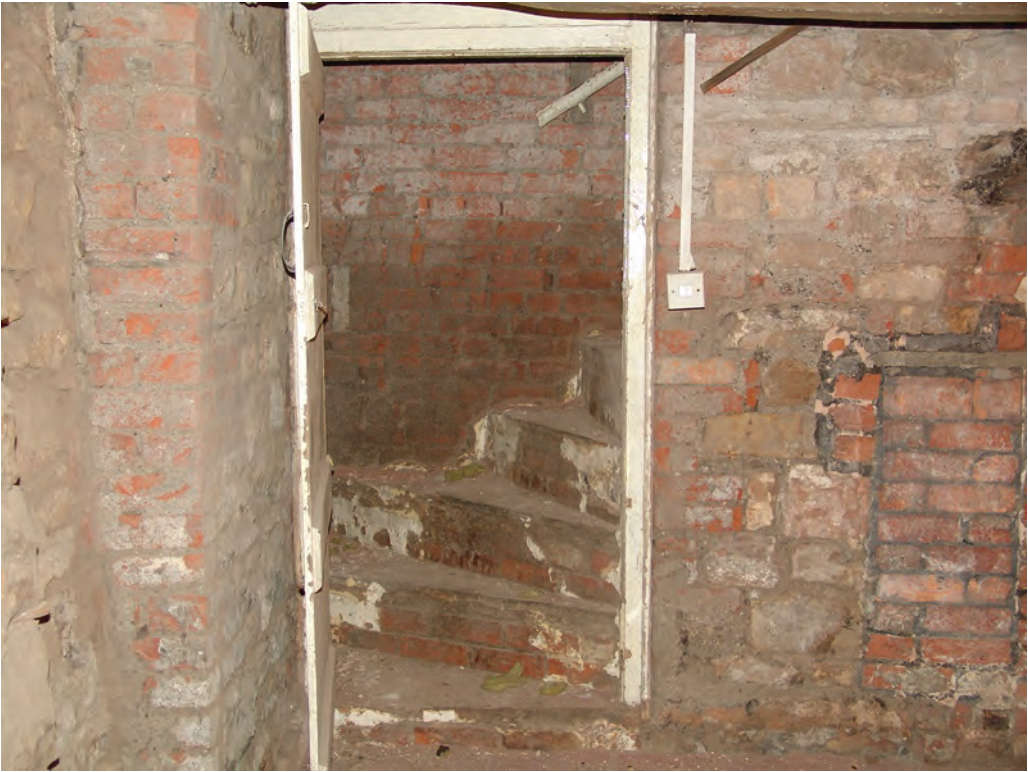
Site Ty Ambrose	Site code BS/TYA/12	Grid Ref: ST 28849800	Camera Sony DSC F28	Format Digital	File RAW	Dimensions 2048 x1536	Size 17mb	Date 12/03/2012	Image no: DSC02713	PLATE 20
Direction of view: South

Reason for image   Later phase brick N wall liner, stairwell and fireplace

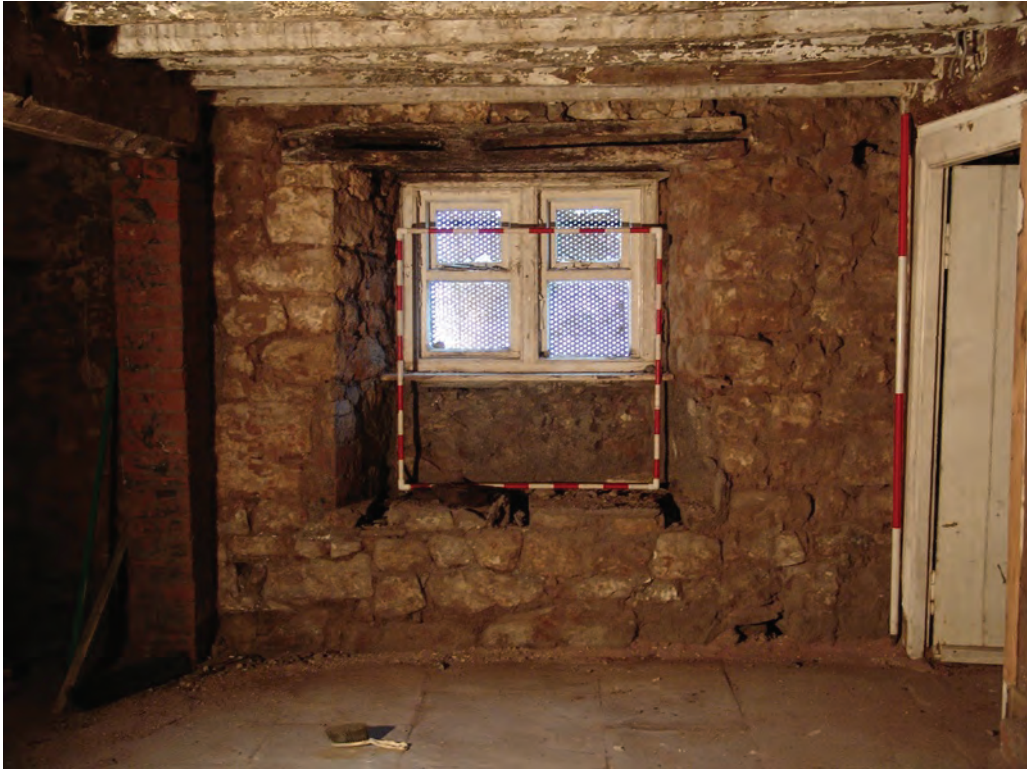
Site Ty Ambrose	Site code BS/TYA/12	Grid Ref: ST 28849800	Camera Sony DSC F28	Format Digital	File RAW	Dimensions 2048 x1536	Size 17mb	Date 12/03/2012	Image no: DSC02709	PLATE 21
Direction of view: South west

Reason for image    South wall and window. Later brick support for beam (left)

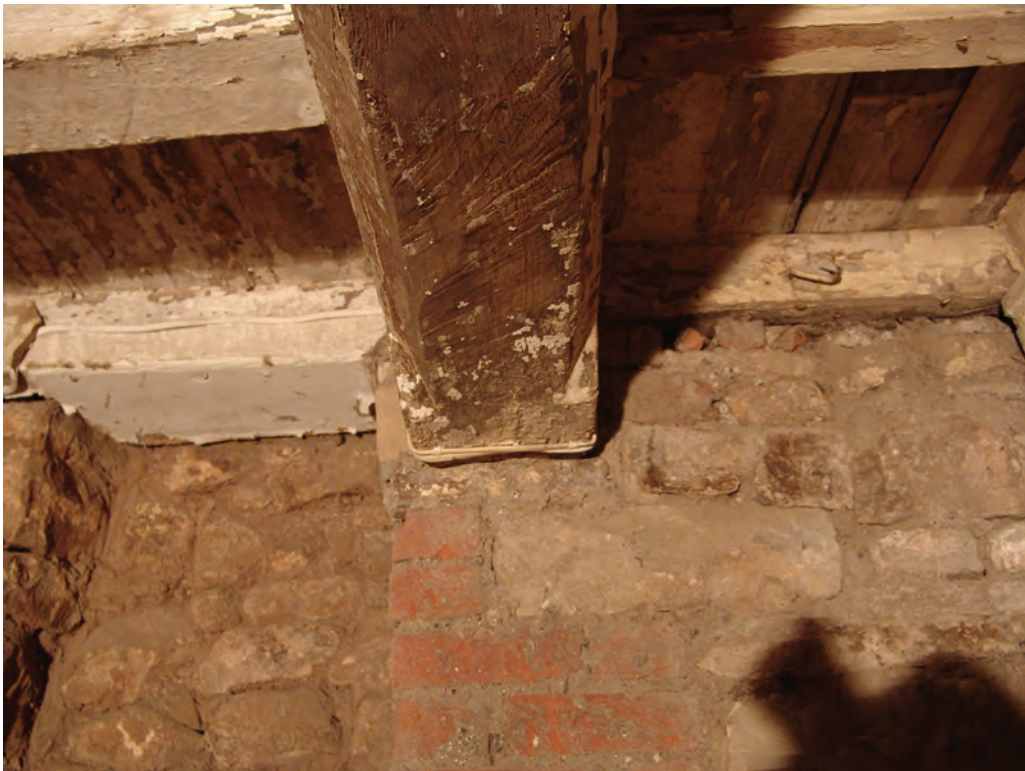
Site Ty Ambrose	Site code BS/TYA/12	Grid Ref: ST 28849800	Camera Sony DSC F28	Format Digital	File RAW	Dimensions 2048 x1536	Size 17mb	Date 12/03/2012	Image no: DSC02715	PLATE 23
Direction of view: South west

Reason for image   Ceiling beam at N wall recess. Diagonal cut stop moulding

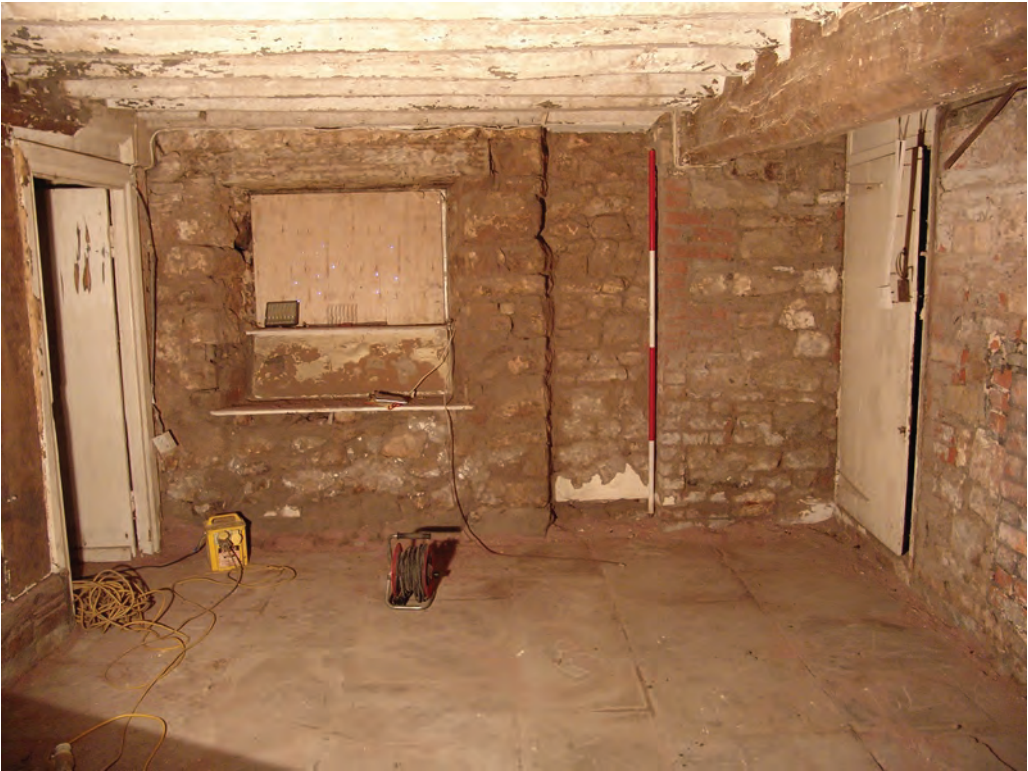
An unusual feature of the inner north wall is a reduction in wall thickness to the right of the window producing a floor to ceiling alcove 0.21m deep by 0.57m wide. The alcove has been produced by extending; the addition of the brick facing, providing the vertical door frame for D5 (discussed above), to provide a support for the main beam from the south wall, (also discussed above). Externally there is no evidence of any alteration, Plate 27, but a few mm further east, the wall juts out to form what was noted as a 'staircase projection', (Fox and Raglan, III, 169. 1994), Plate 01 *left of and beneath the dormer window*.

Reason for image    North wall of house showing recess to right of window

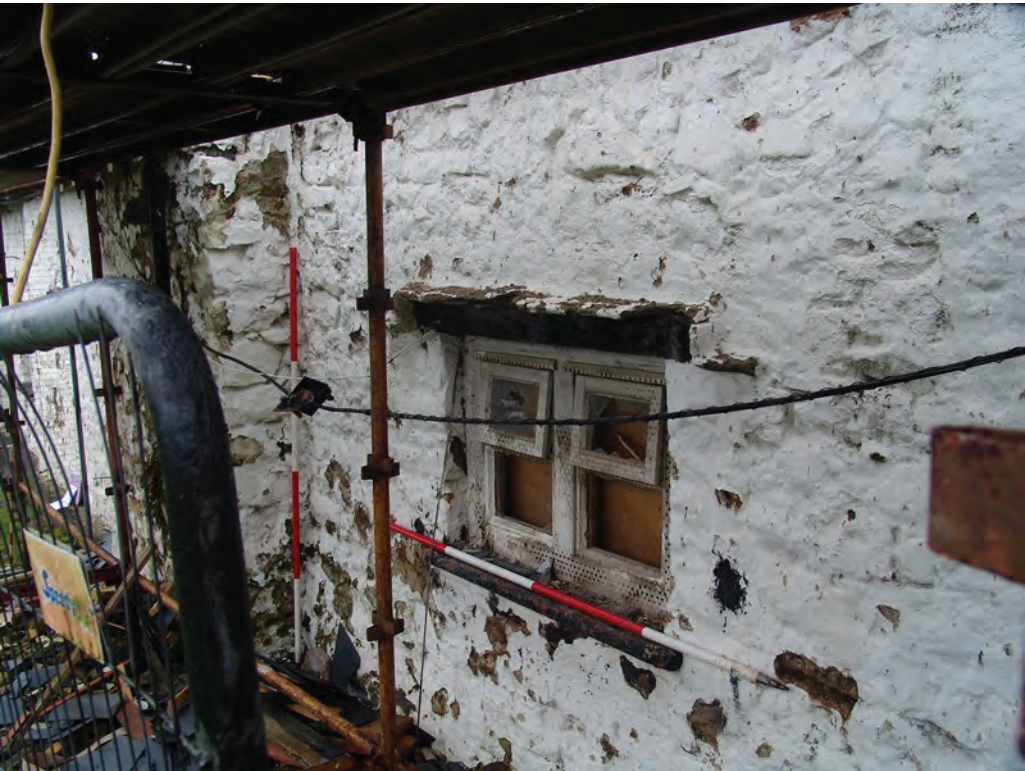
Site Ty Ambrose	Site code BS/TYA/12	Grid Ref: ST 28849800	Camera Pentax W-1G	Format Digital	File JPG	Dimensions 4288x3216	Size 4.2mb	Date 05/03/2012	Image no: IMGP1492	PLATE 28
Direction of view: West

Reason for image   Detail of dripstone above NE window of 1 living room and stairwell

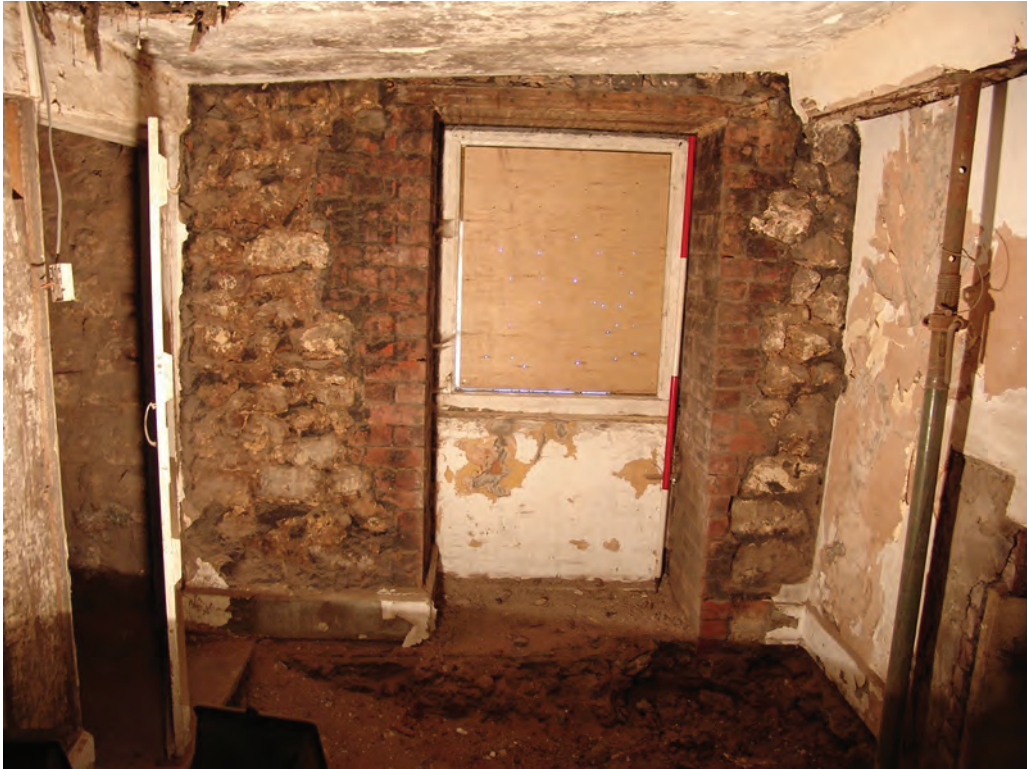
Site Ty Ambrose	Site code BS/TYA/12	Grid Ref: ST 28849800	Camera Sony DSC F28	Format Digital	File RAW	Dimensions 2048 x1536	Size 17mb	Date 12/03/2012	Image no: DSC02682	PLATE 31
Direction of view: West

**2b** has a bricked lined opening in the south wall, Plate 30, which at the time of survey was a window. The repair work in brick would tend to suggest that this window had once been an external doorway; however, it is likely judging from the damage to the stonework, and typologically significant examples of similar house plans, that the opening had originally been a window.

Reason for image   External doorway in the south wall of dining room 2a (Possible original window)

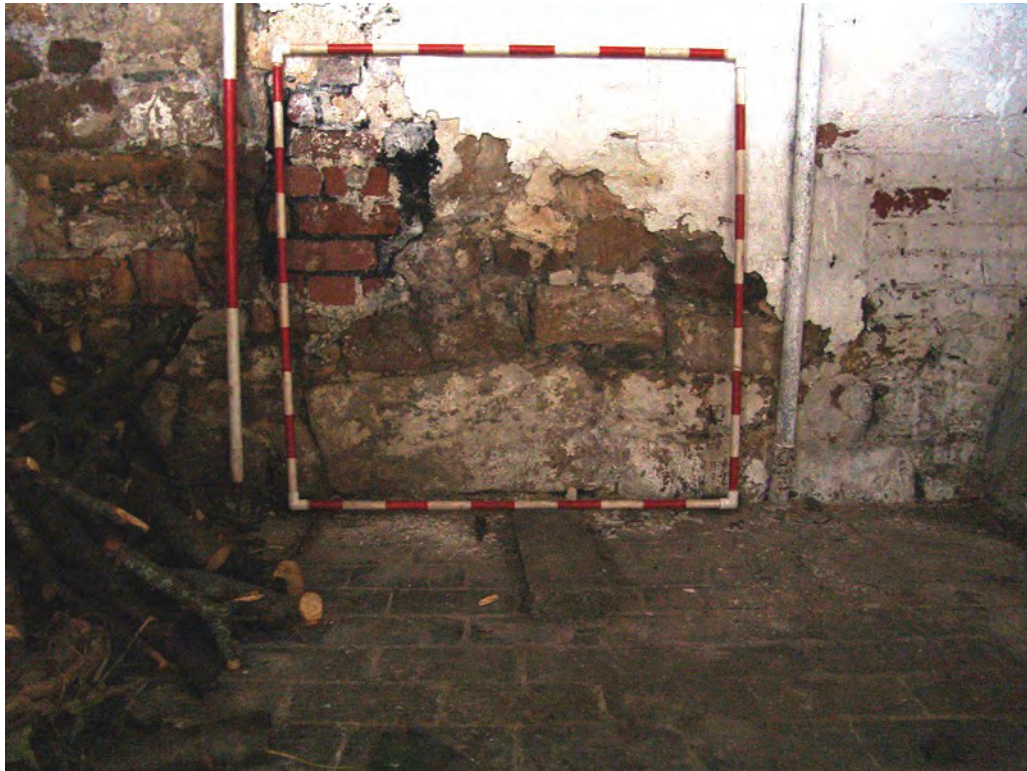
Reason for image    Wall repair in barn, behind fire place in living room 1

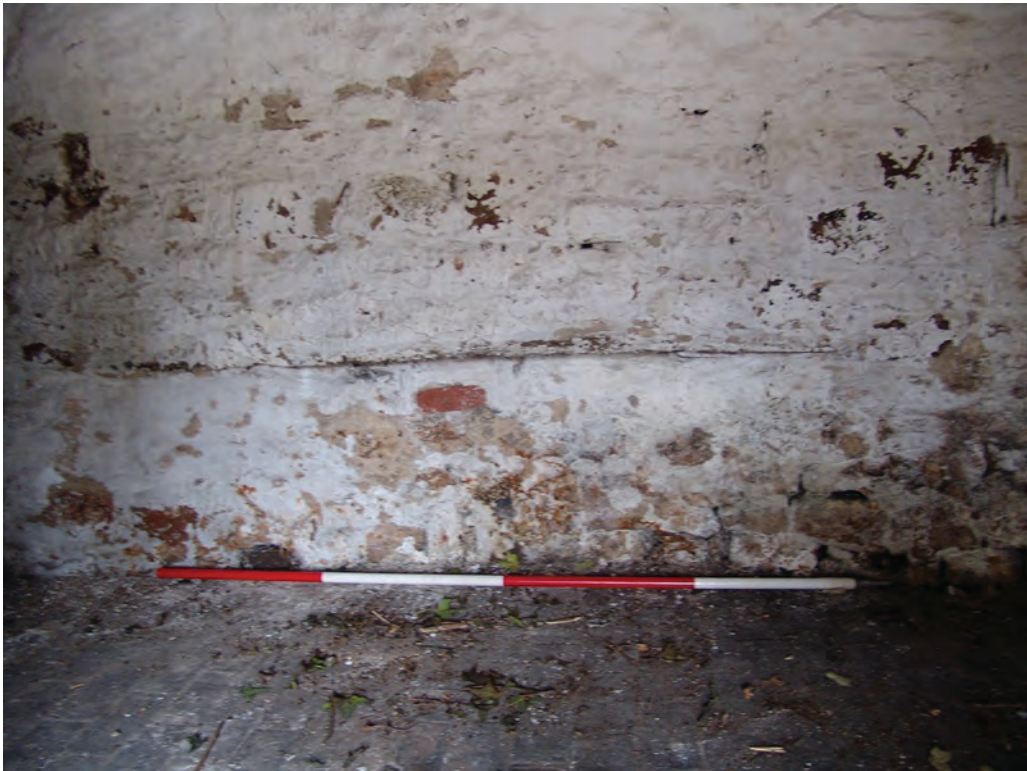
<p>adapted from: Living L1/01 2011</p>										
Object										
Material										
Period			<p>Reason for image    Undercut north wall of barn 1, related to blocked doorway?</p>

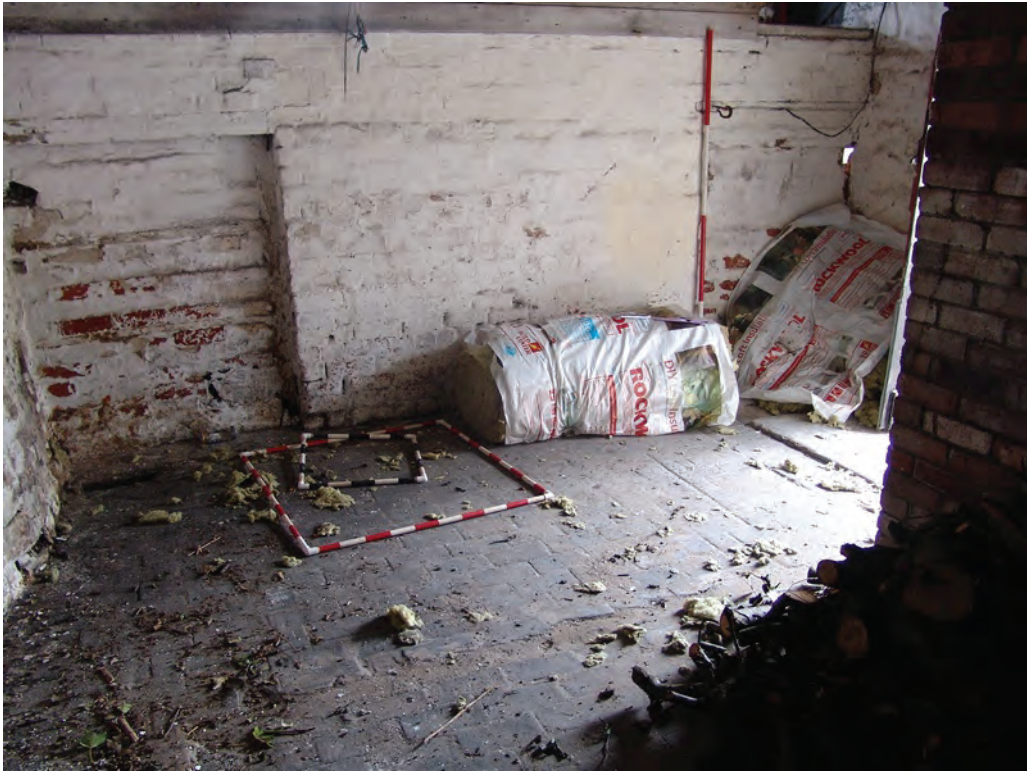
<p>adapted from: Living L1/01 2011</p>										
Object										
Material										
Period			Reason for image    Brick partition wall with two blocked doorways to cowshed 4

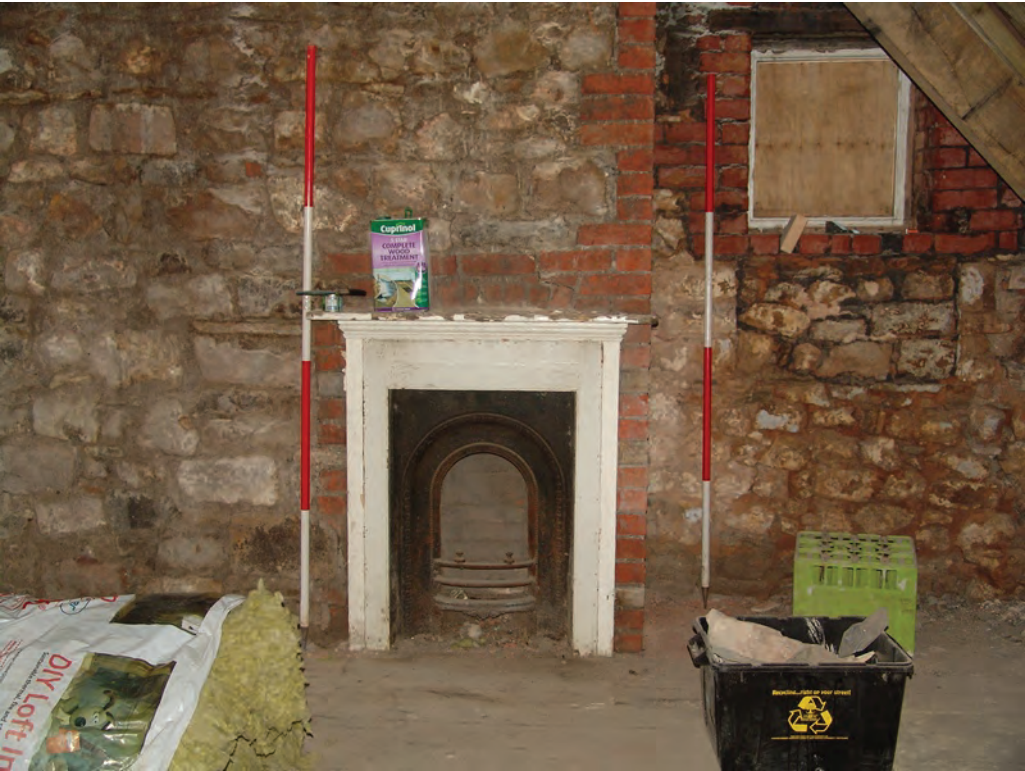
The east gable end of the 1<sup>st</sup> floor appears to have been extensively repaired with brick, possibly to accommodate the cast iron fire grate and its associated flue, Plate 41.

Reason for image    East wall, chimney brest and two phase windows

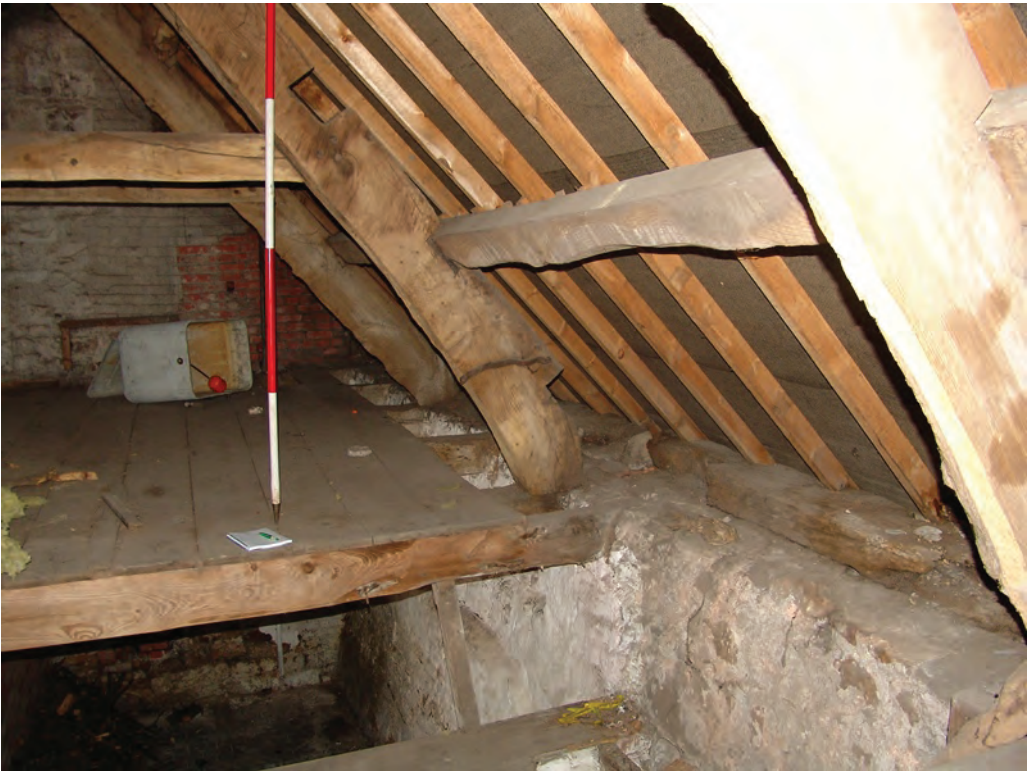
Site Ty Ambrose	Site code BS/TYA/12	Grid Ref: ST 28849800	Camera Sony DSC F28	Format Digital	File RAW	Dimensions 048x1536	Size 17mb	Date 12/03/2012	Image no: DSC02676	PLATE 43
Direction of view: West

Reason for image    Overview Oak upper cruck truss, collar an tie beam.    B2n

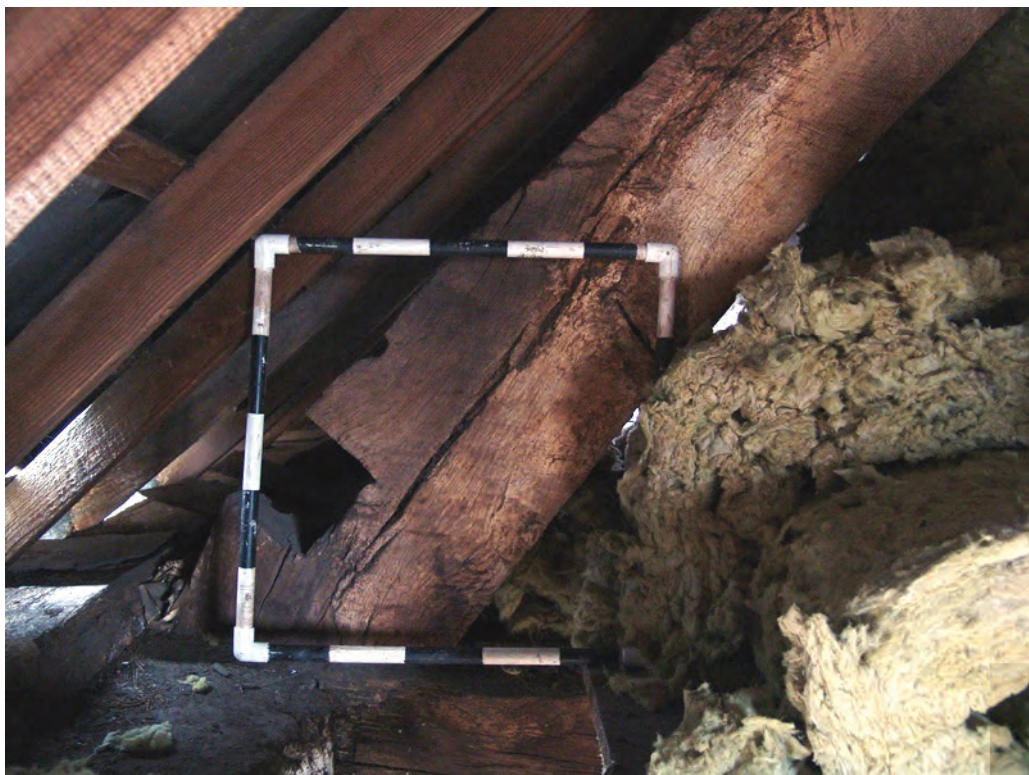
The foot of both cruck blades appear to be jointed to the tie beam, and the collar appears to be lap jointed. Both blades carry deep notches for purlins, now missing and have been refitted to take the current ones from B3 & B1.

Reason for image    Detail Oak upper cruck truss , at tie beam. Purlin missing measured B2s

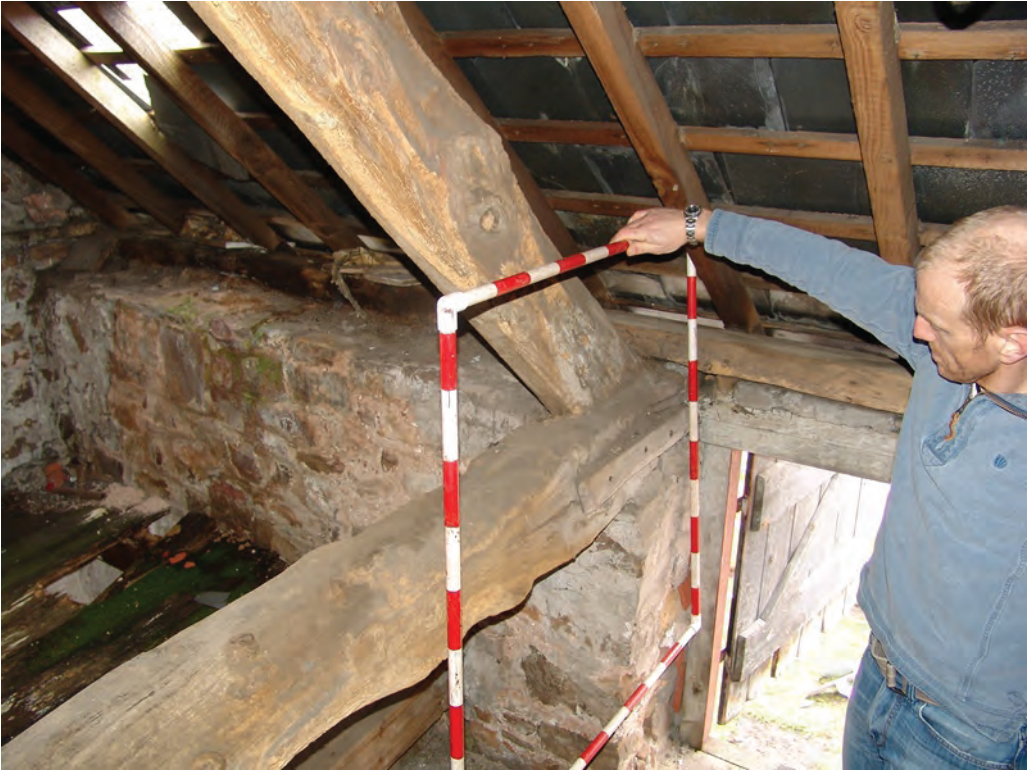
Site Ty Ambrose	Site code BS/TYA/12	Grid Ref: ST 28849800	Camera Sony DSC F28	Format Digital	File RAW	Dimensions 048x1536	Size 17mb	Date 12/03/2012	Image no: DSC02668	PLATE 47
Direction of view: East

Reason for image    Overview Oak truss and tie beam. (closed truss) oak plate added B1s

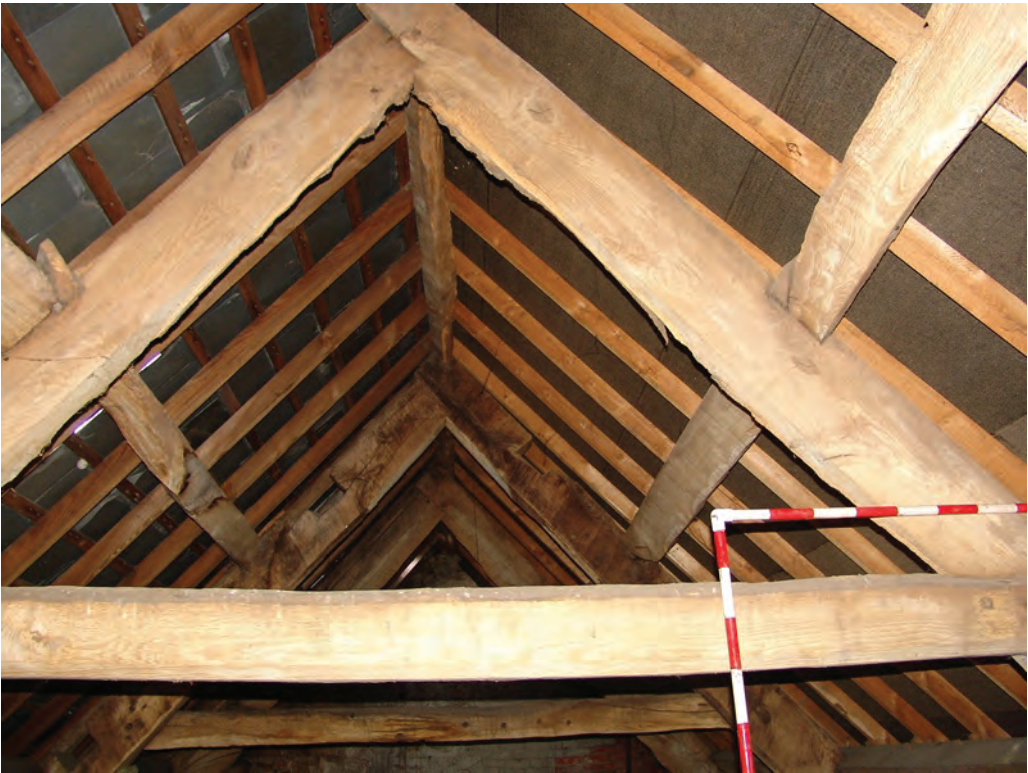
Reason for image    Overview Oak truss (closed truss) and collar. Wooden peg joints. B1
