# CASTELL LLWYD FARM, LLANFABON, CAERPHILLY, GLAMORGAN

WATCHING BRIEF ON GROUNDWORKS RELATING TO THE  
INSTALLATION OF A SINGLE WIND TURBINE

February 2016

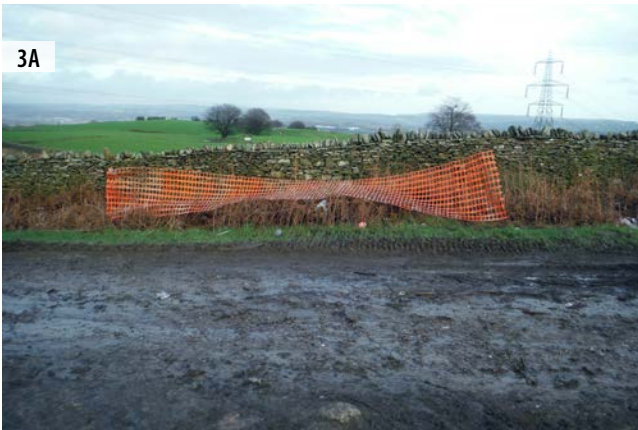
**ILLUS 3A** Cairn Cluster 1 at the edge of the drystone wall field boundary, facing north-east    **ILLUS 3B** Cairn Cluster 2 behind welfare units, facing west  
**ILLUS 3C** Cairn Cluster 3 at the edge of the access area, facing south-west

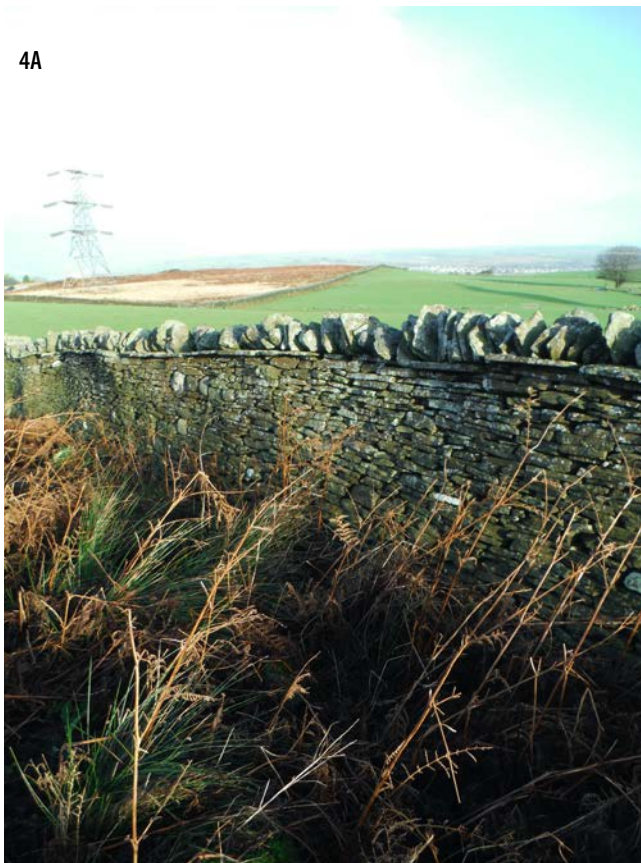
The wall showed signs of previous repair and reconstruction (ILLUS 4), with modern vented red bricks being used as through-stones in certain places and some parts of the wall showing some collapse of the structure. Disused red brick footings were recorded in one place by the foot of the wall, suggestive of a smaller, subsequently demolished, structure being there at some point.

**ILLUS 4A–B** Drystone wall [1001] showing clear signs of reconstruction, facing north-east

Numerous historic repairs and reconstructions of the drystone wall were noted along its length, but none were readily visible in the section that was breached. It is a possible concern that the drystone wall might need further consolidation, either side of the access, to stabilise it and prevent any collapse in the future.

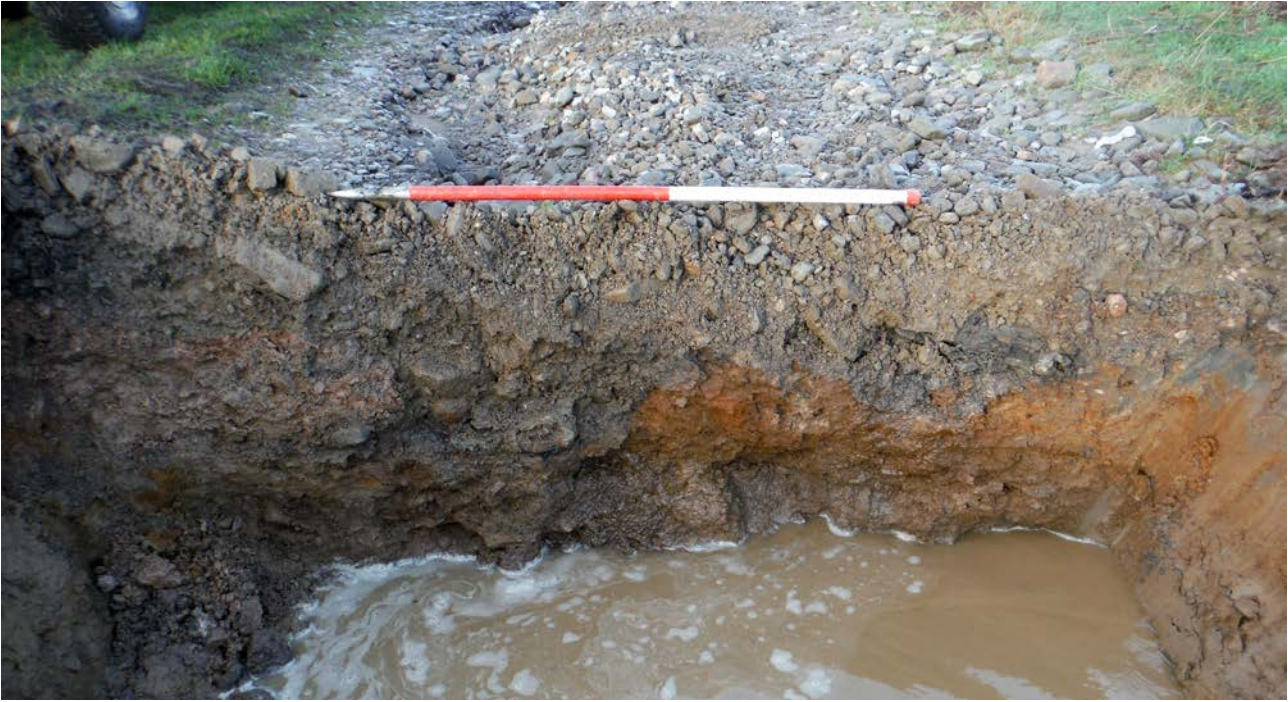
The trackway consisted of well sorted stone to a maximum depth of 0.30m and was slightly sunken toward its centre, creating an appearance of a hollow-way in places. It seems likely this sunken centre is from use rather than a deliberately constructed inverse camber. Both the morphology of the trackway and its apparent correspondence to the drystone wall boundary, suggested that it dates from the medieval period or later and is unlikely to be of Romano-British construction.

**ILLUS 6** South-east facing section of post-medieval trackway [2001] in Trench 2

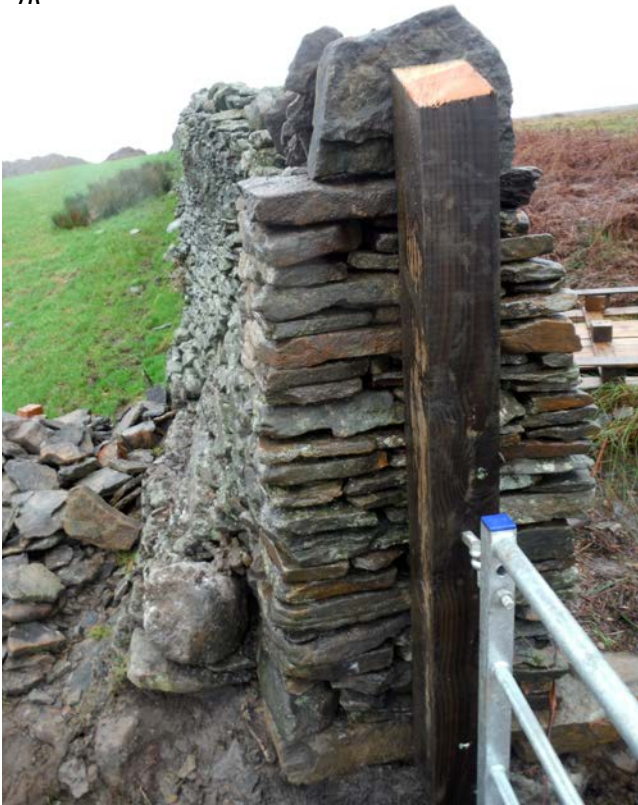
7A

Where the drystone wall was breached, a secure gated opening has been constructed. The two newly created terminals of the wall have been sympathetically reconstructed re-using the original stone, suiting its environment and setting (ILLUS 7). On the day of the site visit, the fencing that had been placed to prevent damage to a

ILLUS 7A–B Post-condition of drystone wall [1001]

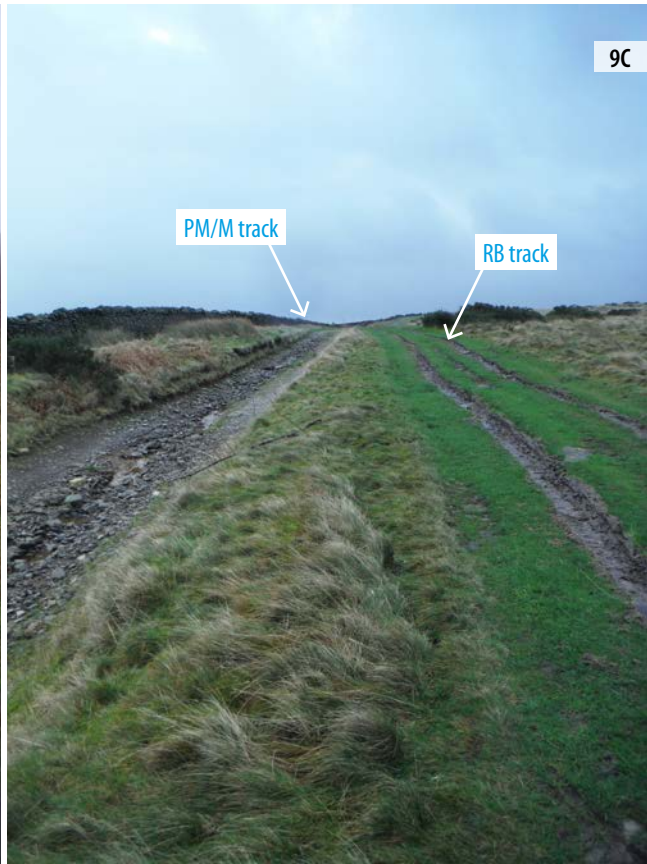
**ILLUS 9C** Post-medieval trackway [2001] showing verges and sunken centre, facing south-east
