CPAT Report No. 1637

St Bridget's Church, Llansantffraedjuxta-Usk

Archaeological Watching Brief

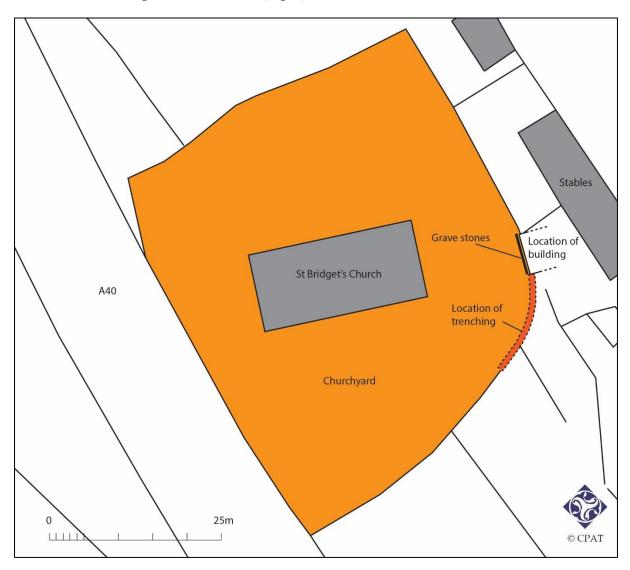
3.1. The groundworks involved the removal of a section of the boundary wall, and the removal and remortaring of the loose stonework on the surviving west elevation of the building to the north of it (Fig. 3).

Fig. 4 Groundworks location plan

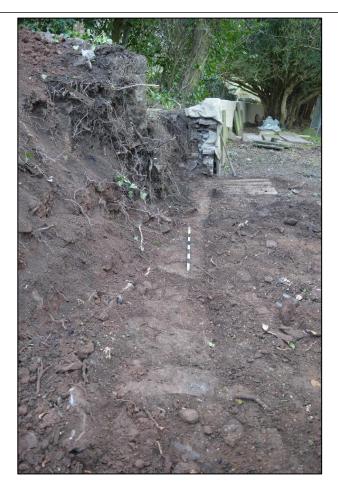
Fig. 5 View from the north-east of the churchyard wall foundation (105). Photo CPAT 4586-0003

- 3.4. The base of the sandstone rubble boundary wall (105) was set within a foundation cut [104] and extended approximately 15m in length, measuring 0.7m wide by 0.5m thick. The foundation was not continuous, a large root bole close to the northern end having displaced the stonework at this point.

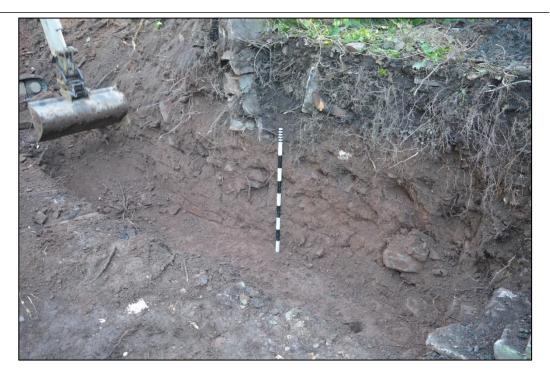
- 3.3. Soil deposition within the churchyard comprised a soft mid-dark brown silt topsoil (100), to a thickness of 0.25m, containing very dense root matter from an adjacent yew tree. Underlying the topsoil was a soft dark red silt (101), 0.25m thick, which sealed a compact light reddish silt (102) excavated to >0.1m.

Fig. 6 View from the north-west of the groundworks trenching. Photo CPAT 4586- 0009

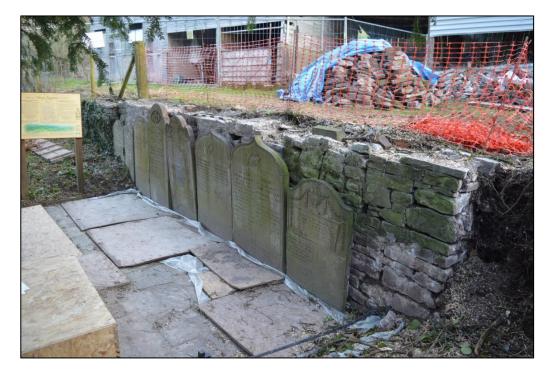
- 3.5. The boundary wall incorporated the west elevation of a building (Fig. 4), the walling for which measured 6.5m in length, 1.3m in height and >0.5m in width. Most of the elevation was obscured by a row of grave stones which had been resited against it (Fig. 7). Two infilled door or window apertures were visible in the elevation, approximately 0.75m above current ground level (Fig. 8).

Fig. 7 West elevation of building forming part of the churchyard boundary. Photo CPAT 4586-0002

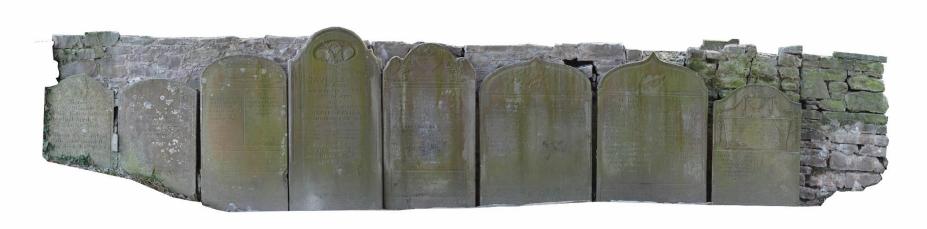
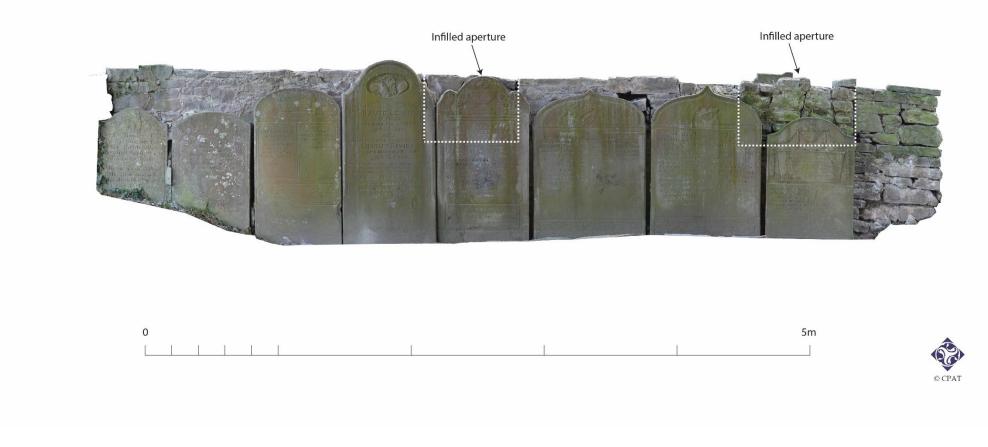
Fig. 8 South south-west facing elevation of building on eastern boundary of churchyard and grave stones
