A.P.A.C. Ltd.

WATCHING BRIEF

St Cenau's Church

Llangenny

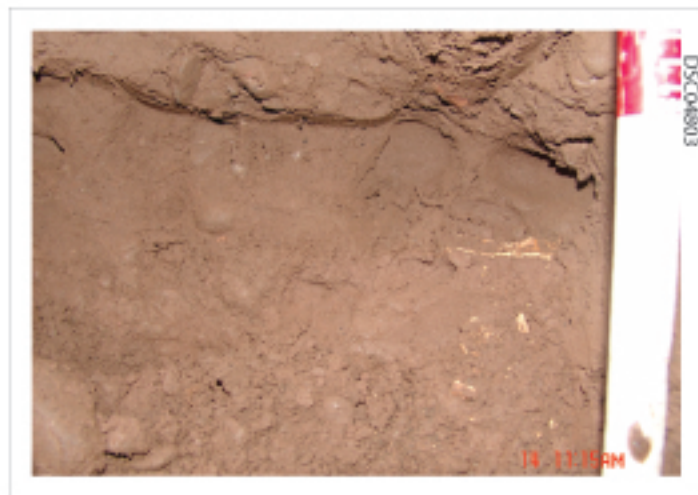
The N underpinning trench was dug in two sections; as already mentioned above, in order not to undermine too great a span of the wall. Plate 10 shows the trench on day two with the two concrete supports in place. The sequence of the trench was topsoil [100] and a cut [101] for a brick culvert [102]. The culvert consisted of a width of four bricks laid flat, in a continuous E/W run along the N wall. Beneath the culvert was a layer of red sandy soil interspersed with rounded stone of various sizes [103]. Under the N wall, within context [103] were found two areas of fragmented human bone, Plates 01 & 02.

The fragmented bones under the wall may be suggestive of work predating the present church fabric but they could also be indicative of animal disturbance. There is no real evidence either way to answer this question but hopefully the fact that they are recorded may help some future work.

Plate 01: N wall east trench, bone fragments

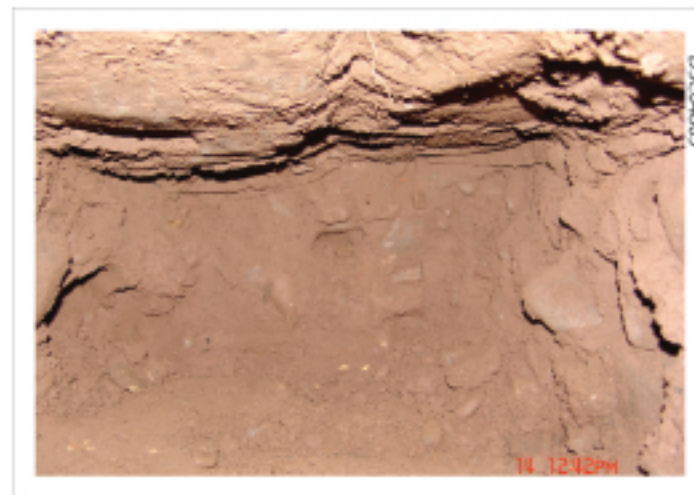
Plate 02: N wall, west trench, bone fragments

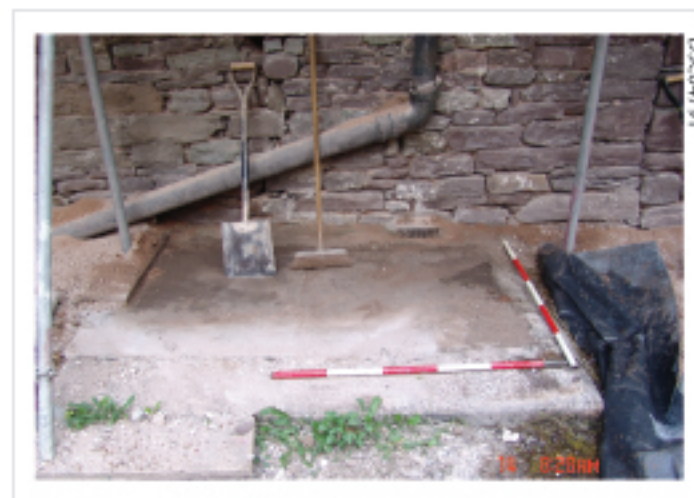
The long axis of the boiler house was aligned along the west wall of the church. A cover of two stone flags measuring 0.87m wide and 1.85m long had been cemented in place over the stairwell, Plate 4. The cover lay some 4.2m south of the NW corner. With the cover removed, a set of 8 stone steps became visible, Plate 5, leading to a small chamber, Plates 06 & 07.

Plate 04: Boiler cover

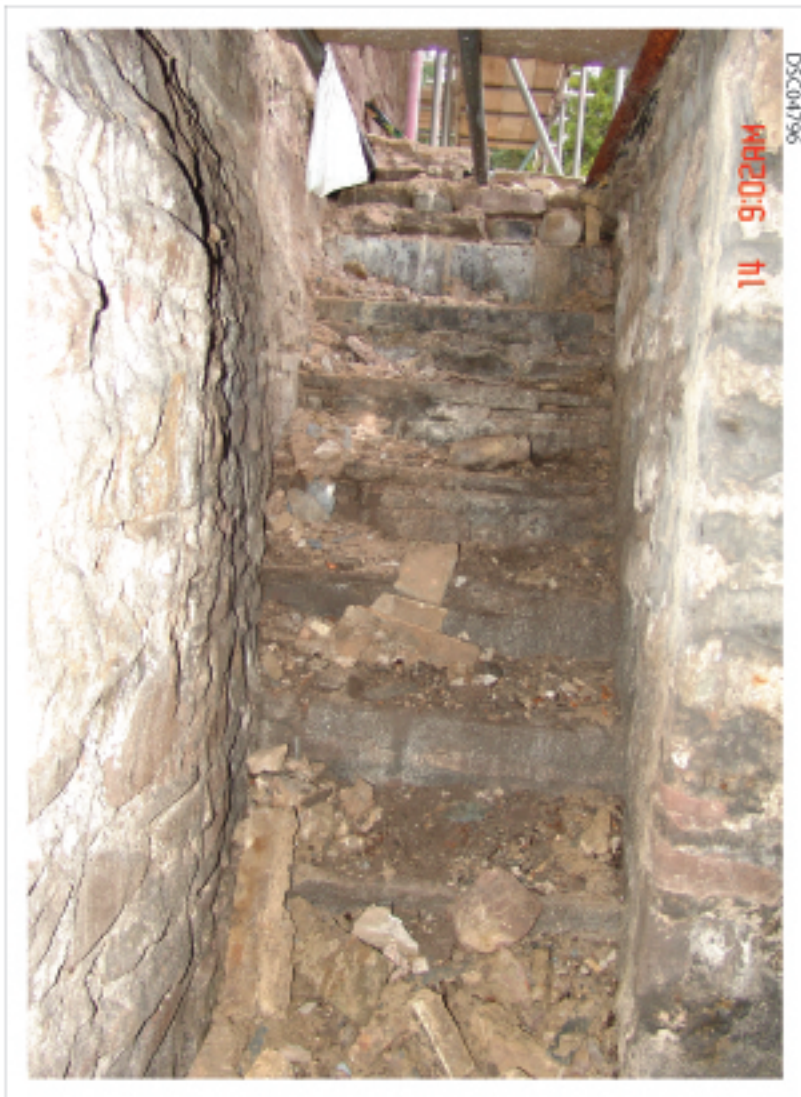
The 8 stairs had smaller stone risers, topped with flag steps and were only 0.64m wide over their 1.9m flight, Plate 05. The boiler room itself was some 2.1m in length by 1.35 m in width and just over 2m in depth. The N end had two side supports for a boiler shelf (*now gone*), Plate 07 and there were the remains of pipes and ducts in the N, Plate 08 and W walls, Plate 09.

Plate 05: Boiler house stairwell

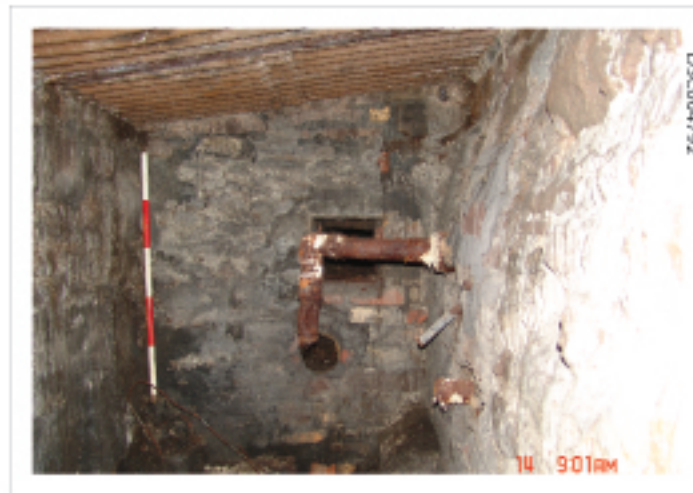
The underpinning work of this project is concentrated on the NW, corner possibly one of the earlier parts of the church. The necessity for the underpinning probably relates to the heating system which has made inroads into the structure of the wall at this corner.

Plates 06 & 09 also show how badly the west wall of the church as bulged outwards into the boiler house.

Plate 06: Boiler house, Bulging west wall of church

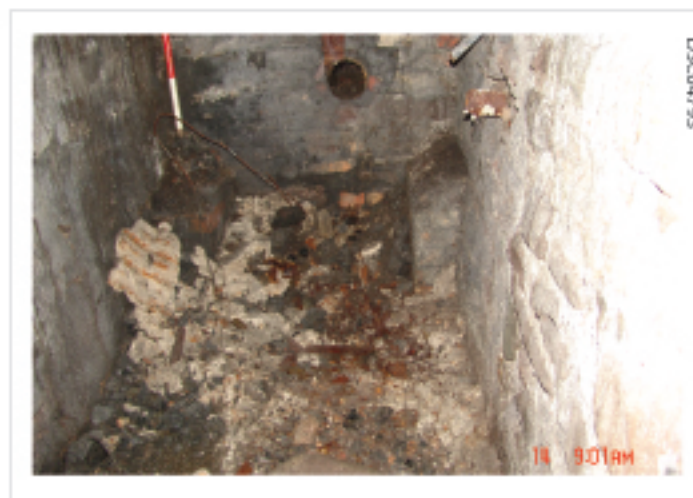
Plate 07: N wall boiler house

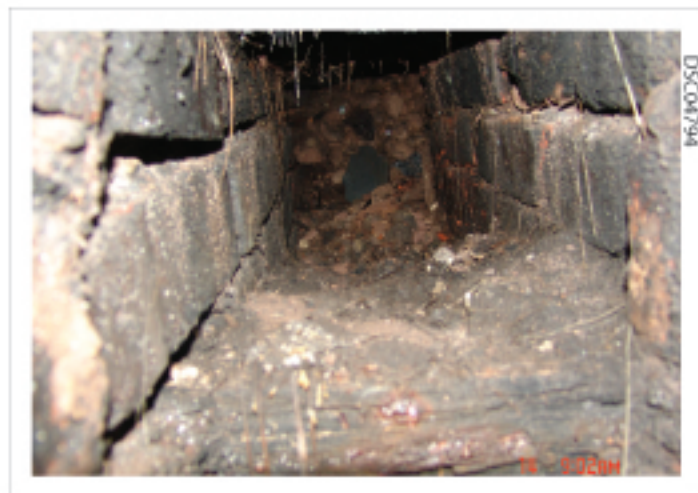
Plate 08: N wall boiler house. Flue duct

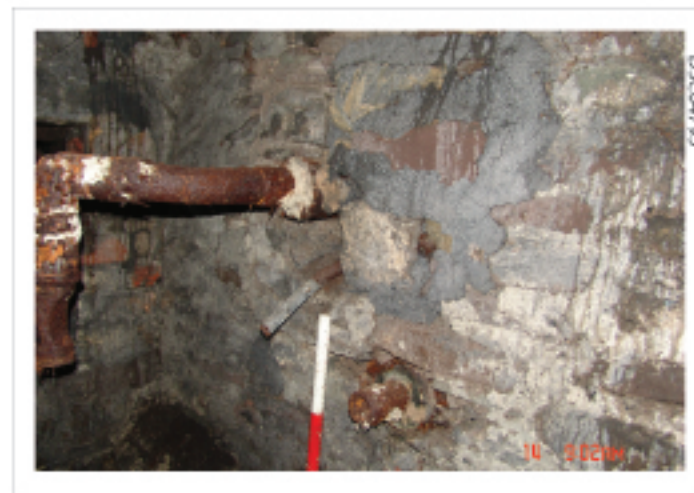
Plate 09: W wall, boiler house. Pies through W wall

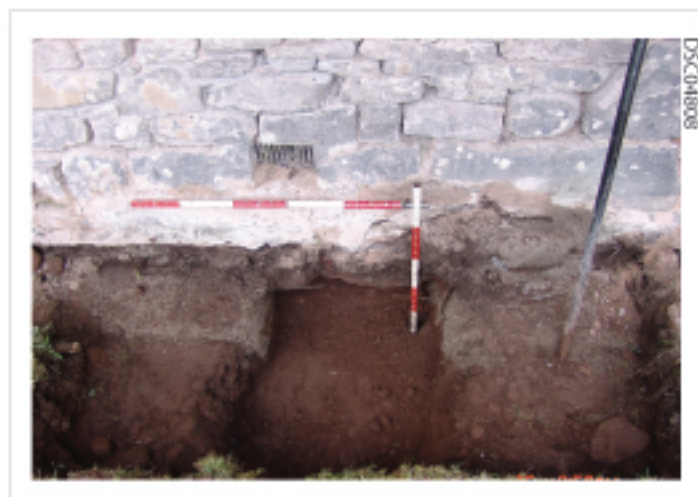
Plate 10: N wall underpinning

The underpinning work started on the north edge of the NW corner, with the removal of the brick lined surface drain before excavating two trenches 0.8 x 1 x 0.6m deep. These two separate trenches were then shuttered and filled with concrete and rebar. The following day the 0.6m gap between the two end trenches was excavated and later filled with concrete.

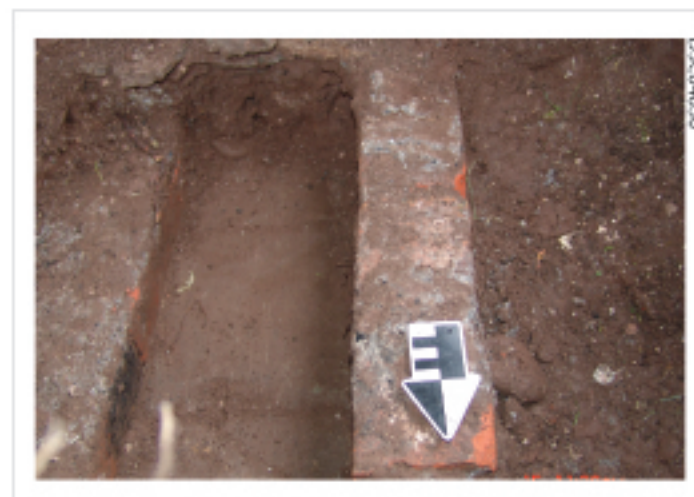
Plate 11: W wall flue

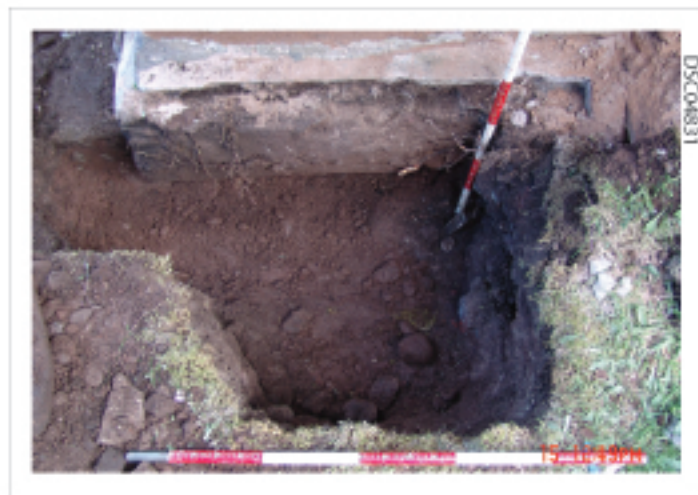
Context [104] reached a depth of approximately 0.35m; the same depth as the foundation wall, before meeting [103] Plate 12. Plate 13 shows the underpinning of the wall and two rebar ends b from the N side. Just below the end of the bottom rebar, are some more bone fragments.

Plate 12: W wall underpinning

The underpinning trench to the west consisted of one 1 x 1 x 0.6m trench at the corner and rebarred to the N trench.

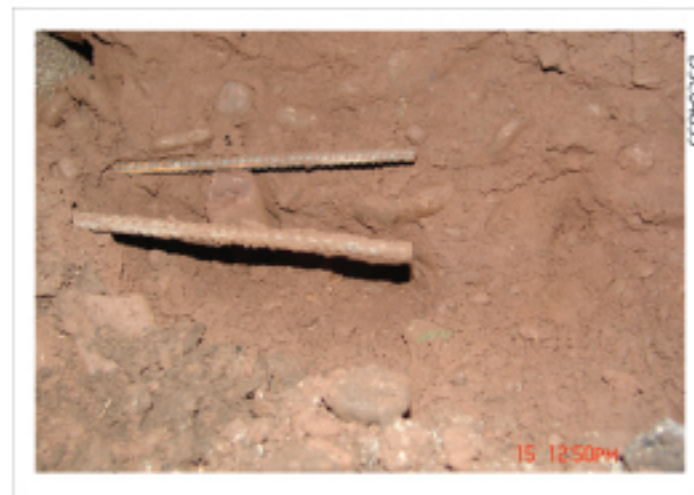
Plate 13: W wall, underpinning and N wall underpinning rebar
