**WATCHING BRIEF DURING
GROUNDWORKS
FOR REPAIRS TO BOUNDARY WALLS
AROUND THE CHURCHYARD OF ST
ELLYWE'S CHURCH, LLANELIEU
15/12456/FUL and 15/12457/LBC**

For: RV Williams Associates

April 2020

Trysor Project No. 2018/596

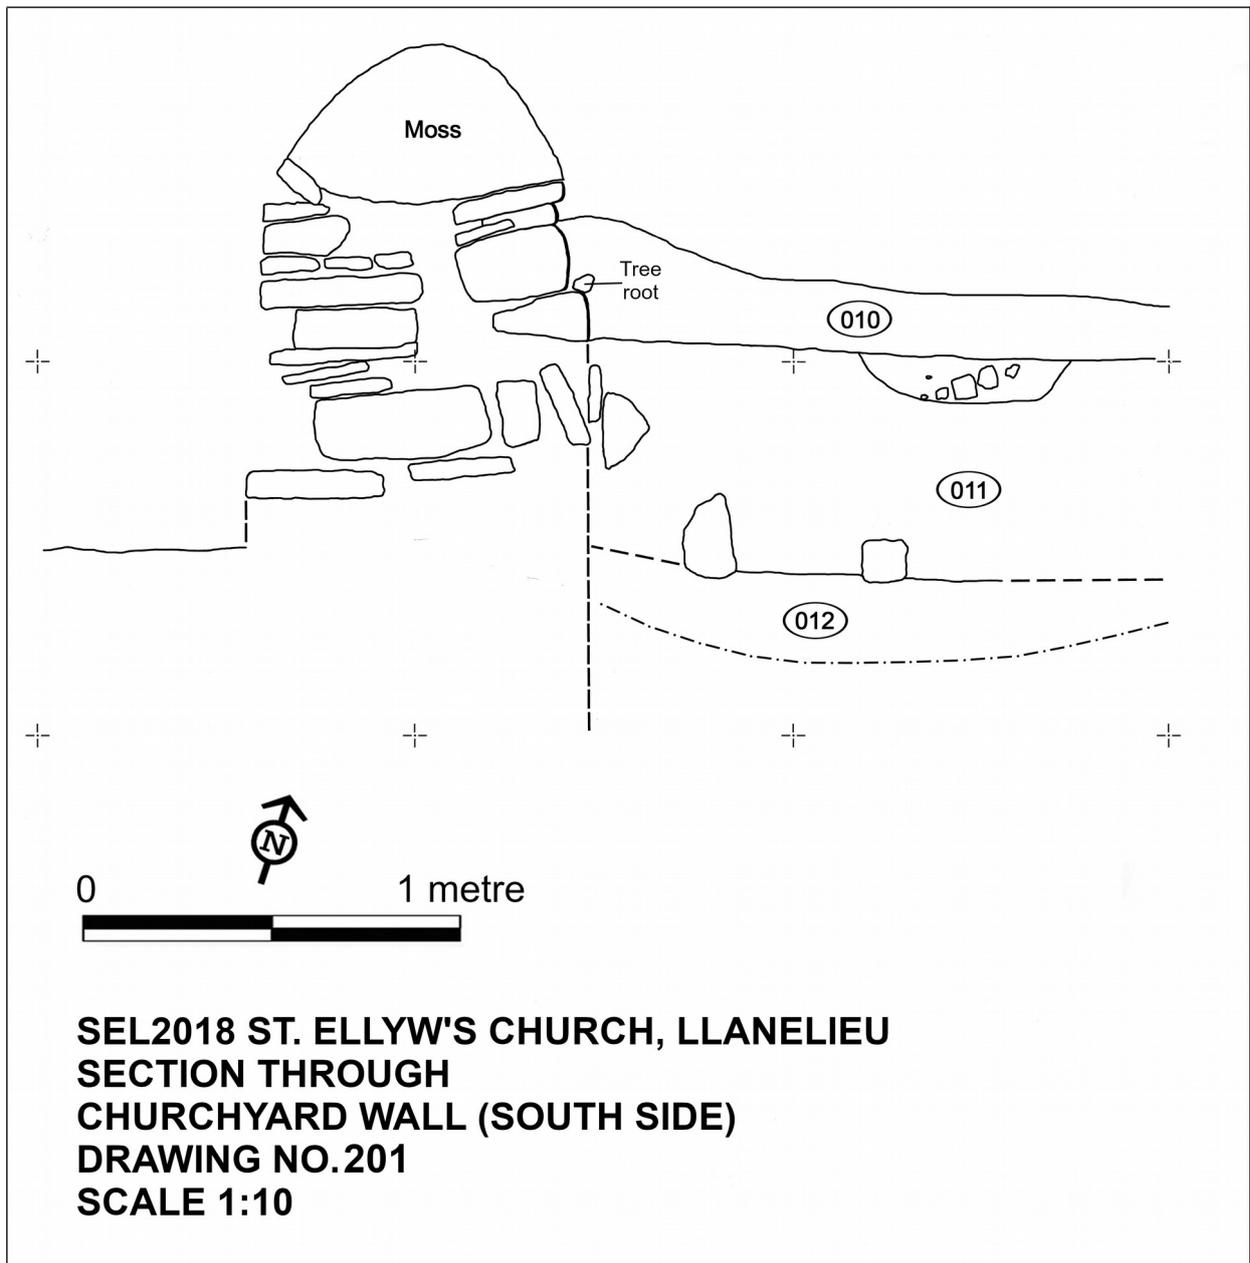
Figure 5: Section through the churchyard wall at SO1848834127

7.3 Three layers were observed. The topsoil (010) was reddish brown clay with few coarse components. It was generally 0.15 metres deep but up to 0.30 metres deep against the southern boundary wall. It overlay a layer (011), a reddish brown sticky clay with some small stones. This overlay a reddish brown clay with more coarse components gravel (012), part of the natural subsoil.

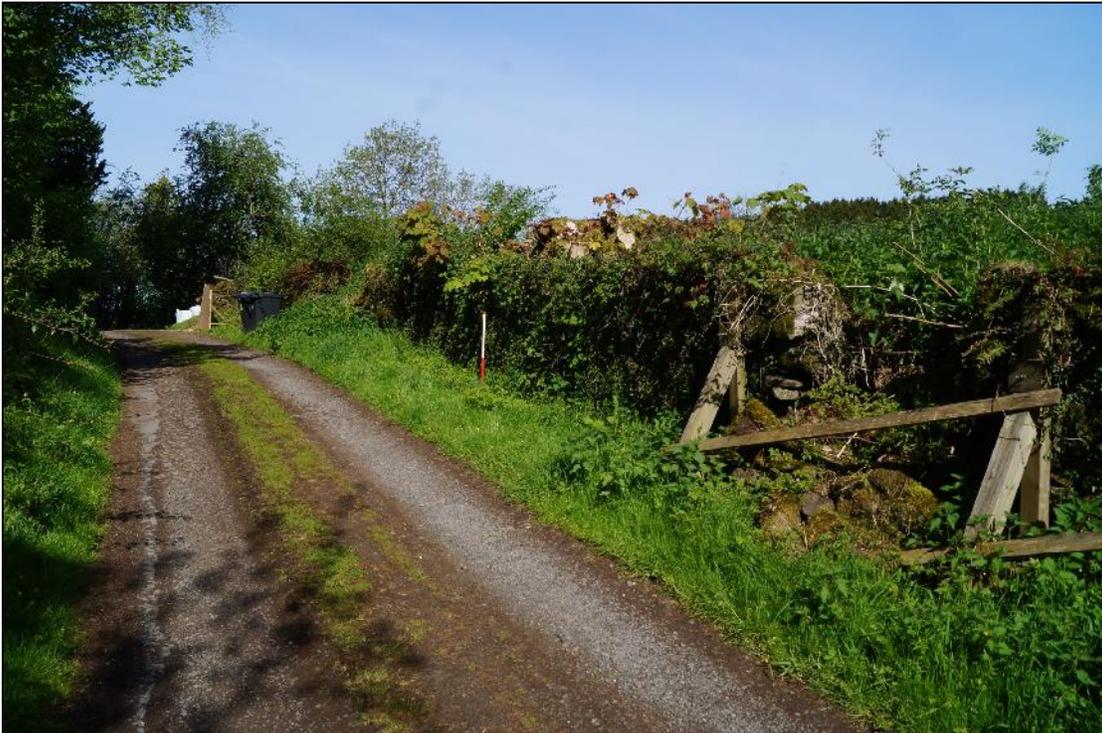
Plate 4: SEL2018_104, The southern part of the boundary wall looking west from the lane to the south. Note the shoring supporting the wall to the right of the photograph.

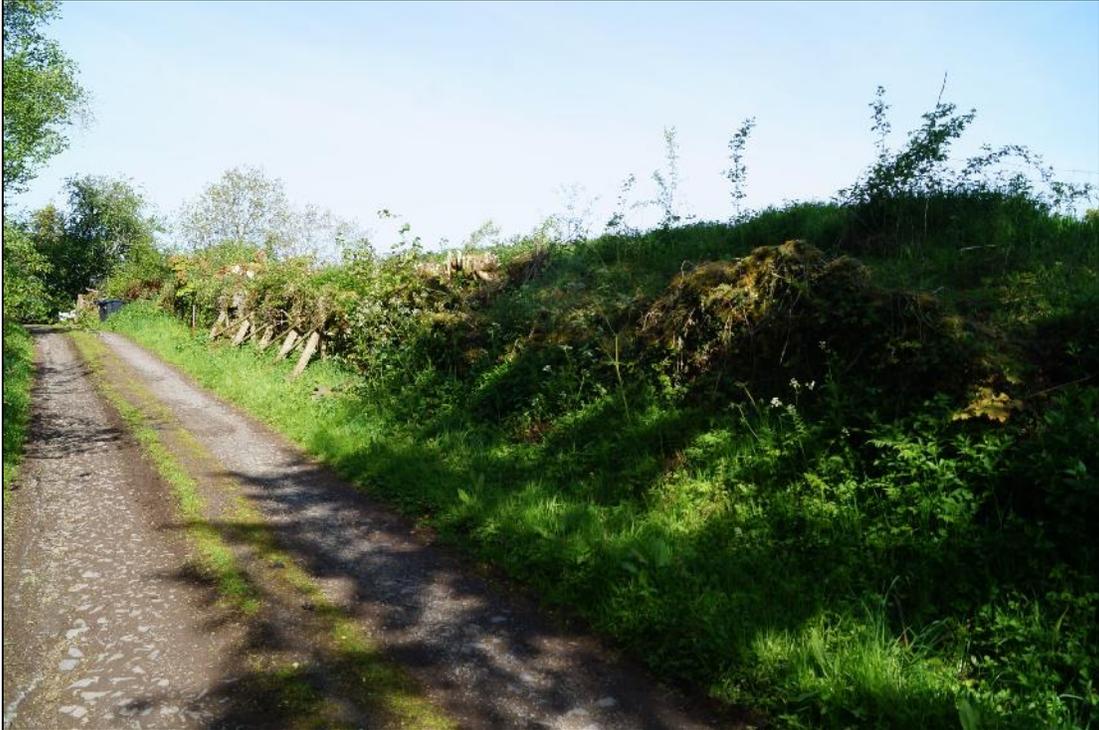
Plate 5: SEL2018_105, The southern part of the boundary wall looking west from the lane to the south. Note the shoring supporting the wall in the centre of the photograph.

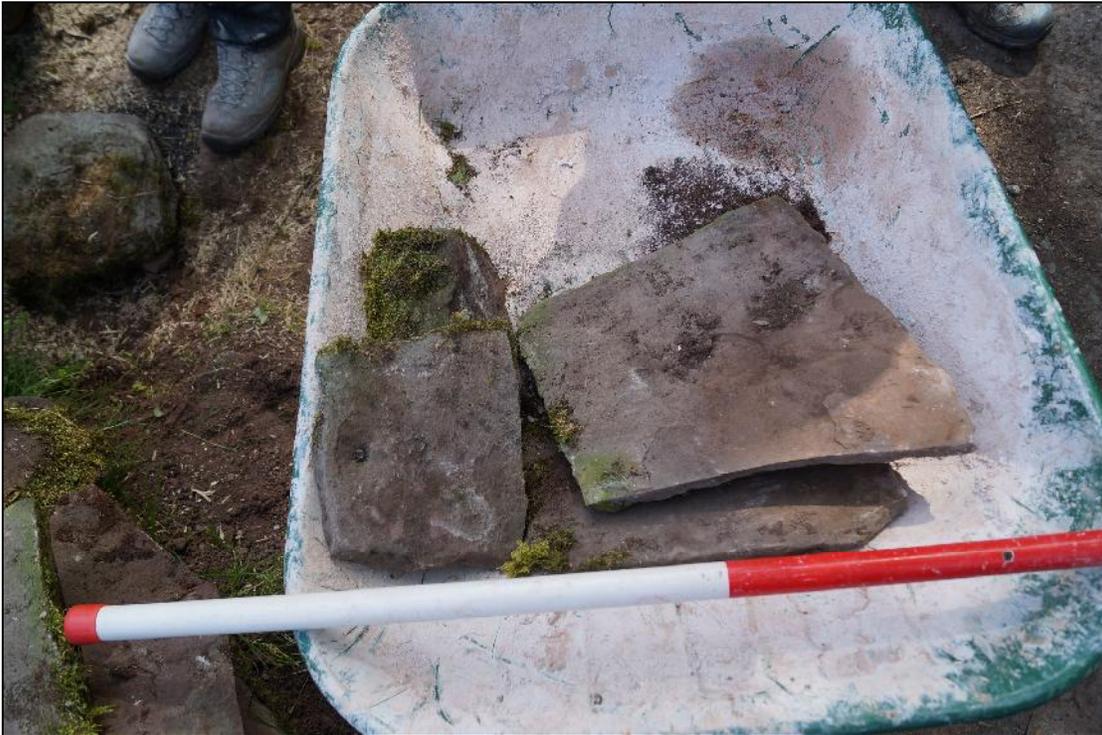
10.3 The western end of the south wall, to the east of the gateway, had been rebuilt or repaired in the past as evidenced by finds of modern materials within the wall.

Plate 9: SEL2018_109, Roof tile fragments found in dismantled wall.

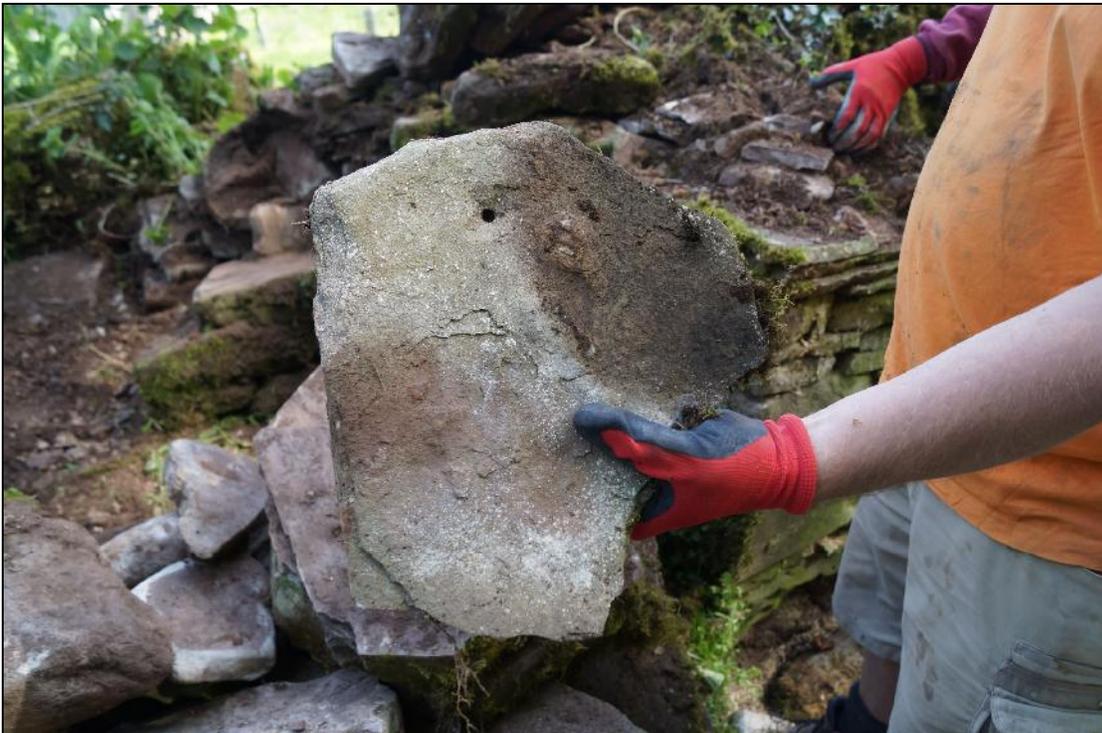
Plate10: SEL2018_110, Roof tile fragments found in dismantled wall.

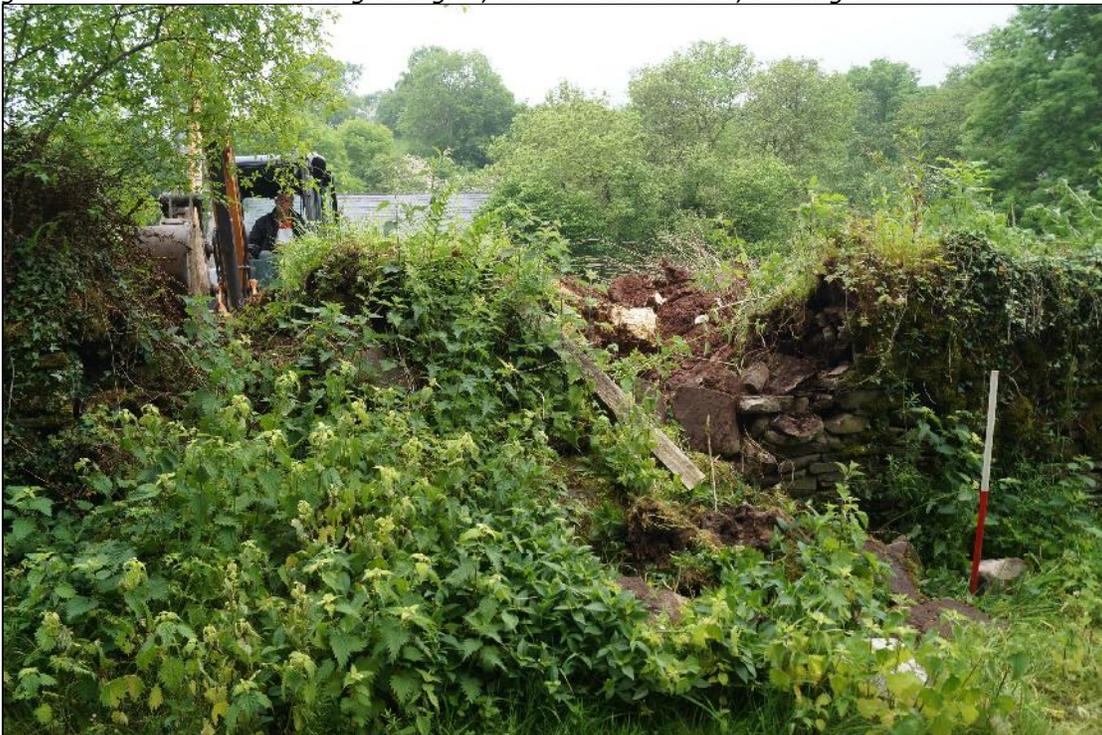
7.1 During works to repair Segment B of the southern part of the boundary wall, a large tree root/bole had severely damaged the wall and removing it created a void in the ground behind the wall. The opportunity to record a section through the wall and the ground to the north of it was taken.

Plate 16: SEL2018_116, Removing large tree bole and roots from the inside of the wall, the wall in this section was already partially collapsed, looking northeast.

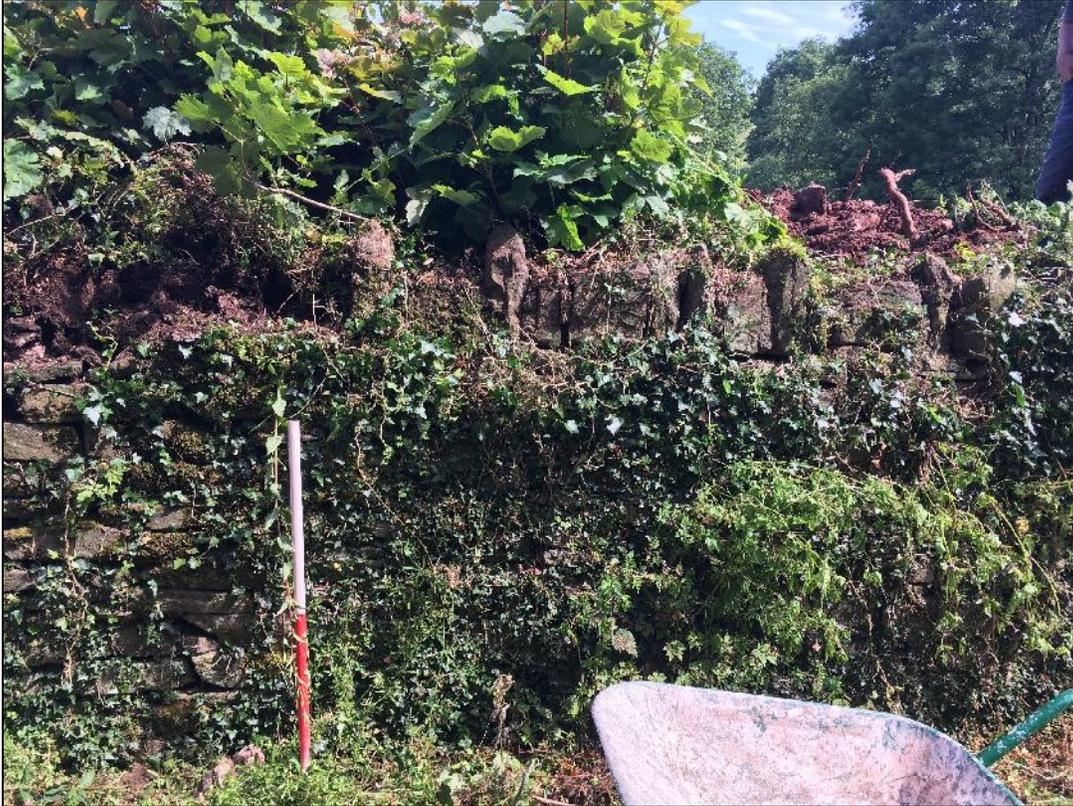
it was found. At 22.9 metres the coping on the top of the wall changed from all tall stones to tall, short, tall, short. The wall in this segment was 0.60 to 0.65 metres wide at base narrowing to 0.50 metres wide at the top. The wall was 1.46 metres high in total on the lane side (1.22 metres wall plus coping).
29/06/2019	Segment D, from 25.6 metres to 38.6 metres centred on SO1850734127	Plate 121. Tree root were removed from behind the wall and damaged parts of the wall were taken down. Generally in better repair than the rest of the wall, and needed to be taken down less.
29/06/2018 and 21/09/2018	Segment E from 38.6 metres to 48.3 metres centred on SO1852334127	Plates 122 to 124 and 126 to 132 Trysor recorded the steps through the wall at SO1852634128, and the rest of the southern boundary wall was taken down to a stable level. The four steps were not uniform in size, shape and material. Concrete was found under a grave slab which covered the lowest step. The other steps had been concreted over, but when this was removed crude stone steps were revealed. The steps were approximately 0.90 metres wide. See Section 8 for a description of the gravestone.

Plate 20: SEL2018_120, The wall still stood to full height at this point and the pattern of the coping stones changed, looking north.

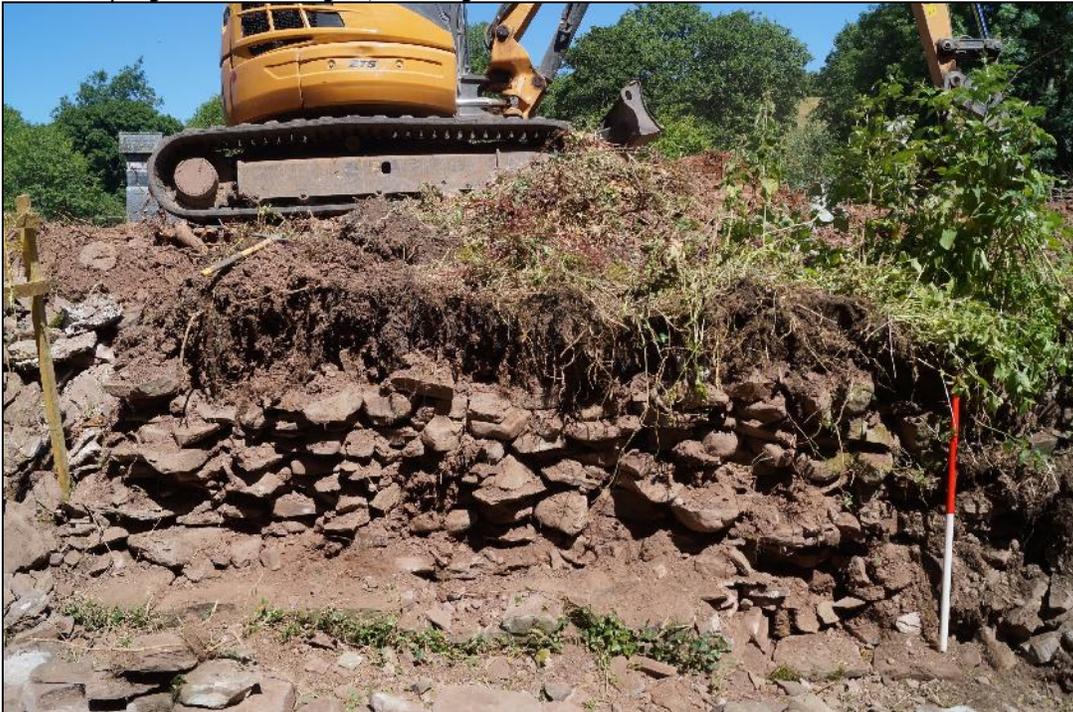
Plate 21: SEL2018_121, Section of the wall with the south face removed to show the rubble core of the wall, looking north. Occasional large stones act as tie stones.

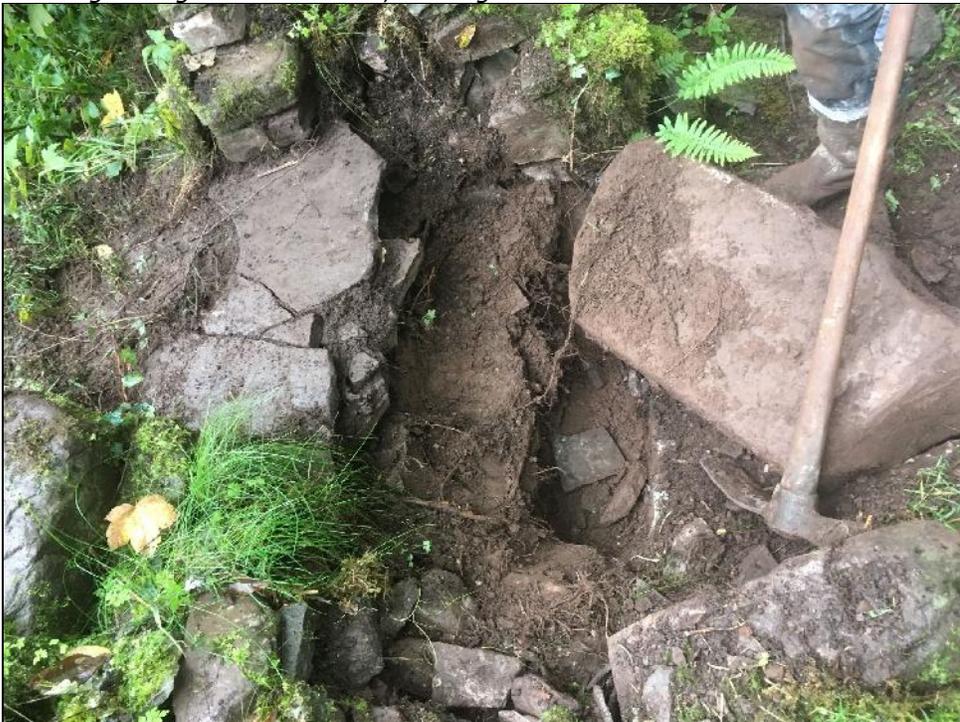
10.4 The steps through the eastern end of the boundary wall were of rough construction, and repaired at least once with concrete. The gravestone that lay across the bottom slab may have been used to block the steps.

Plate 30: SEL2018_130, The steps through the eastern end of the section E during removal of loose parts of the step, looking east-northeast.

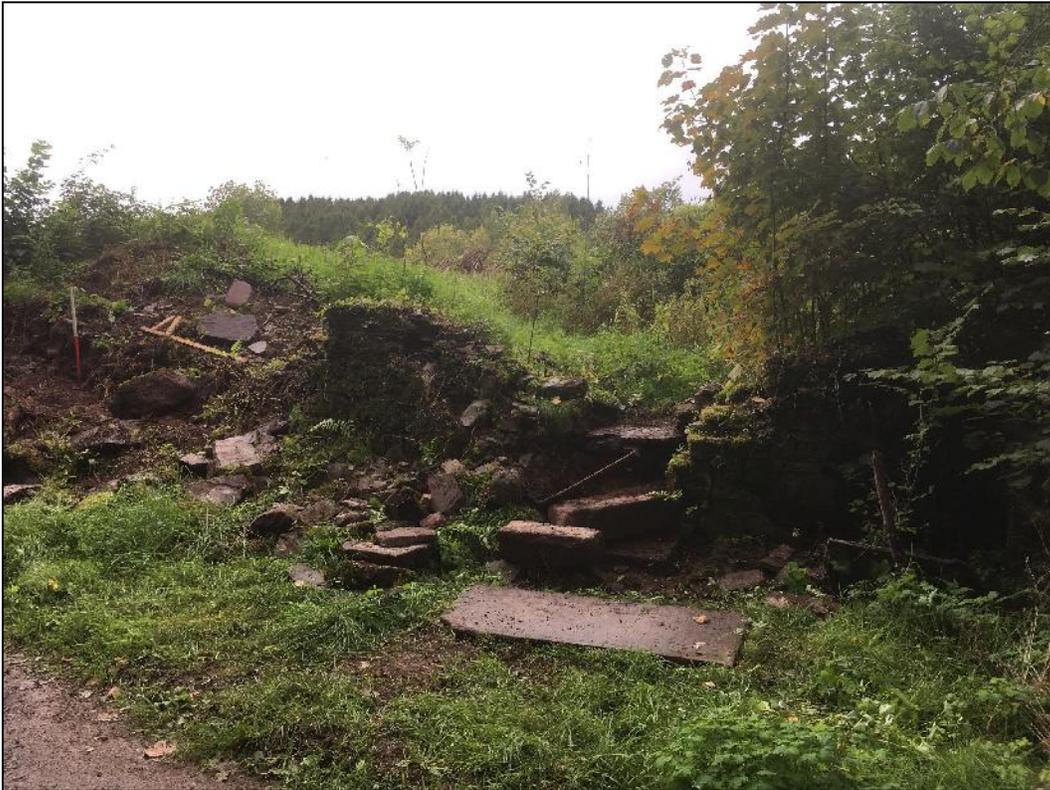
Plate 31: SEL2018_131, The steps through the eastern end of the section E during removal of loose parts of the step, looking northwest

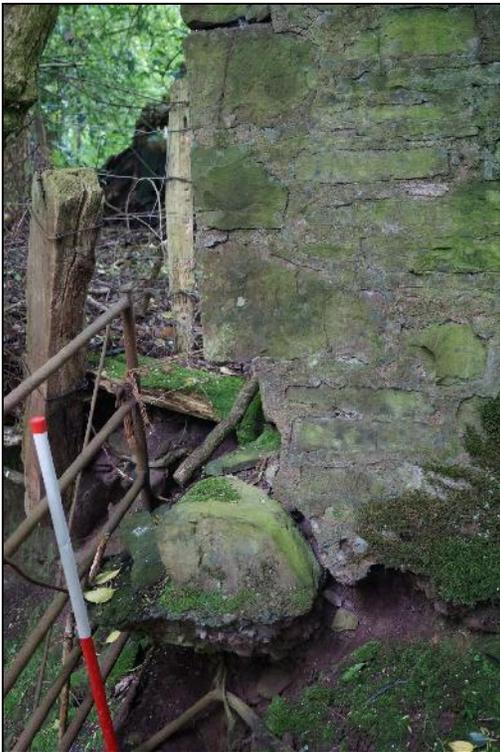
6.9.1 The soil under the wall had been washed away at this point, so the wall needed to be stabilised. The wall had been repointed previously and there were also signs that attempts had been made to underpin it (see Plate 34, SEL2018_134). The ground at the base of the wall was examined but seen to be natural subsoil and no archaeological deposits would be damaged by fresh underpinning of the wall.

Plate 34: SEL2018_134, The base of the northern end of the northwest wall, RV Williams Drawing number 3892/07, note 8. Underpinning previously attempted, looking east-northeast.

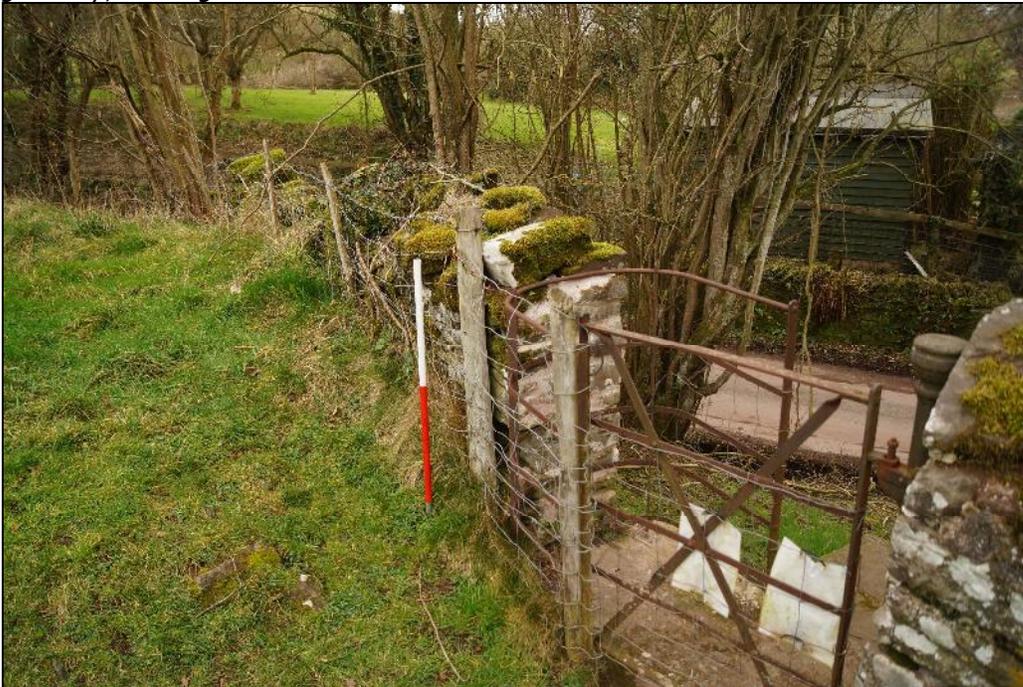
Plate 36: SEL2018_136, Repointed section of the western boundary wall just to the south of the gateway, looking southwest.

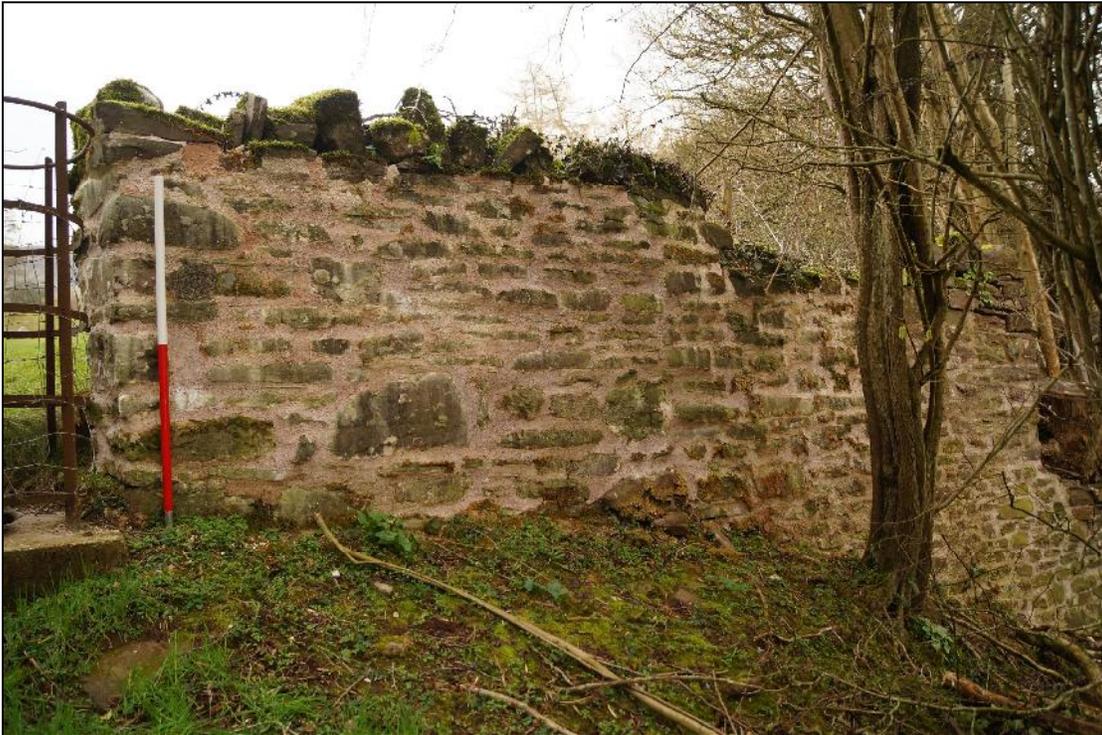
Plate 37: SEL2018_137, Repointed section of the western boundary wall just to the south of the gateway with coping stones to be reset, looking south-southeast

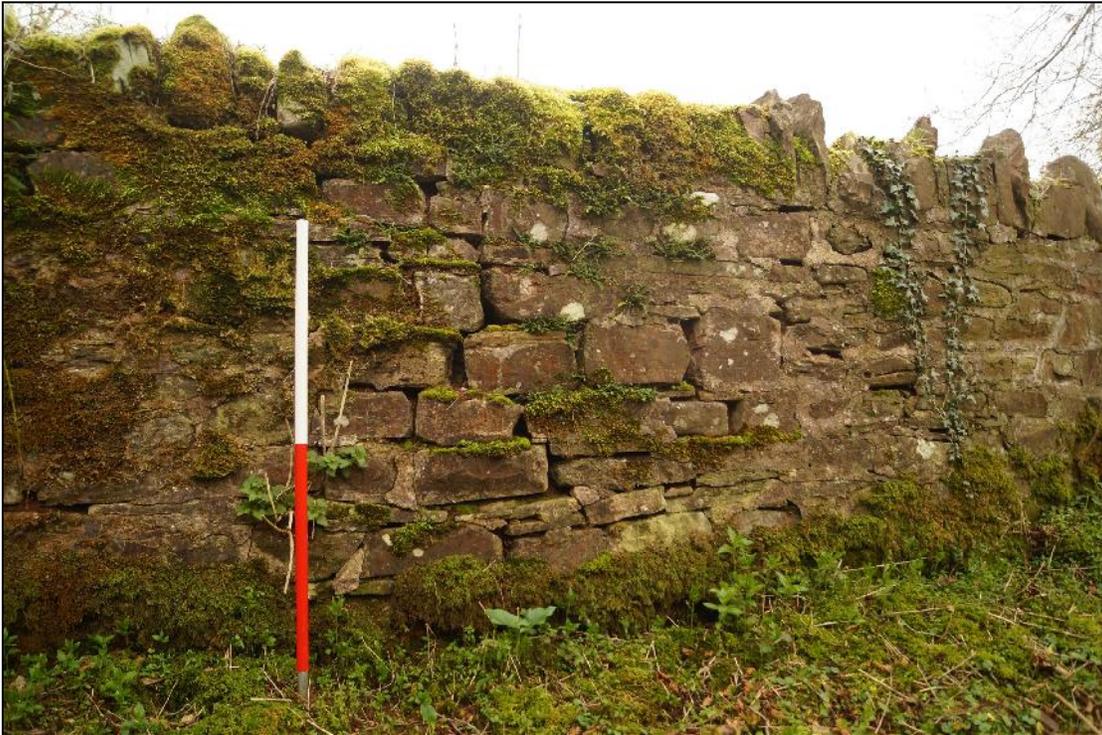
6.11.1 At SO1852834148 a tree was causing bowing and cracking of the wall so the tree was removed; there were no features of archaeological or architectural interest, See Plate 139, SEL2018_139).

Plate 39: SEL2018_139, Bulge in the east wall at SOXXXX, looking east (RV Williams Drawing 3892/08 Note 2.0) .

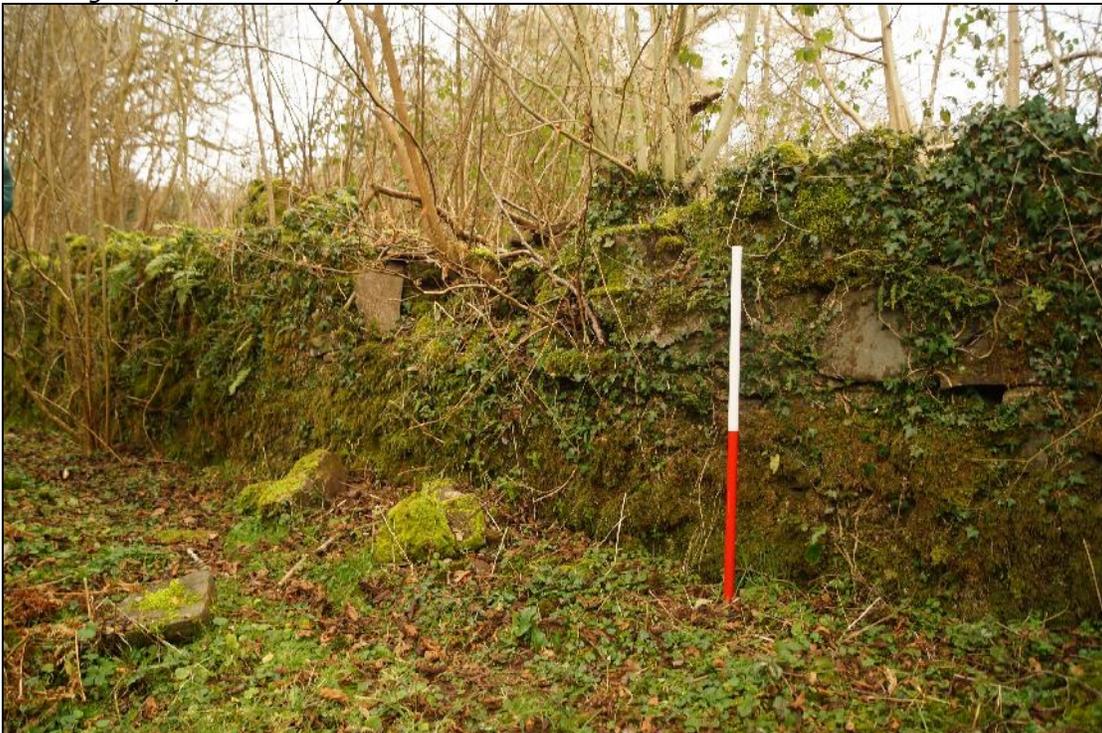
Plate 40: SEL2018_140, Section to eastern boundary wall to be repaired, looking southwest (RV Williams Drawing 3892/08 Note 1.0)

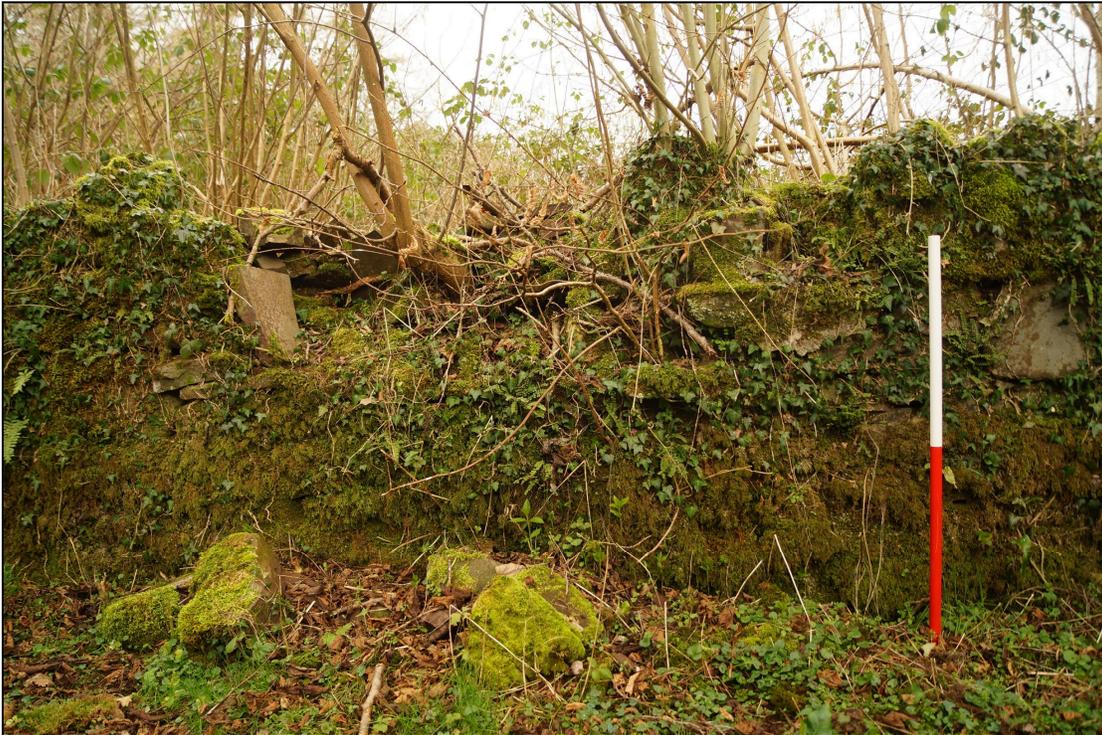
Plate 41: SEL2018_141, Section of the east wall to be repaired at SOXXXX, looking east (RV Williams Drawing 3892/08 Note 2.0)

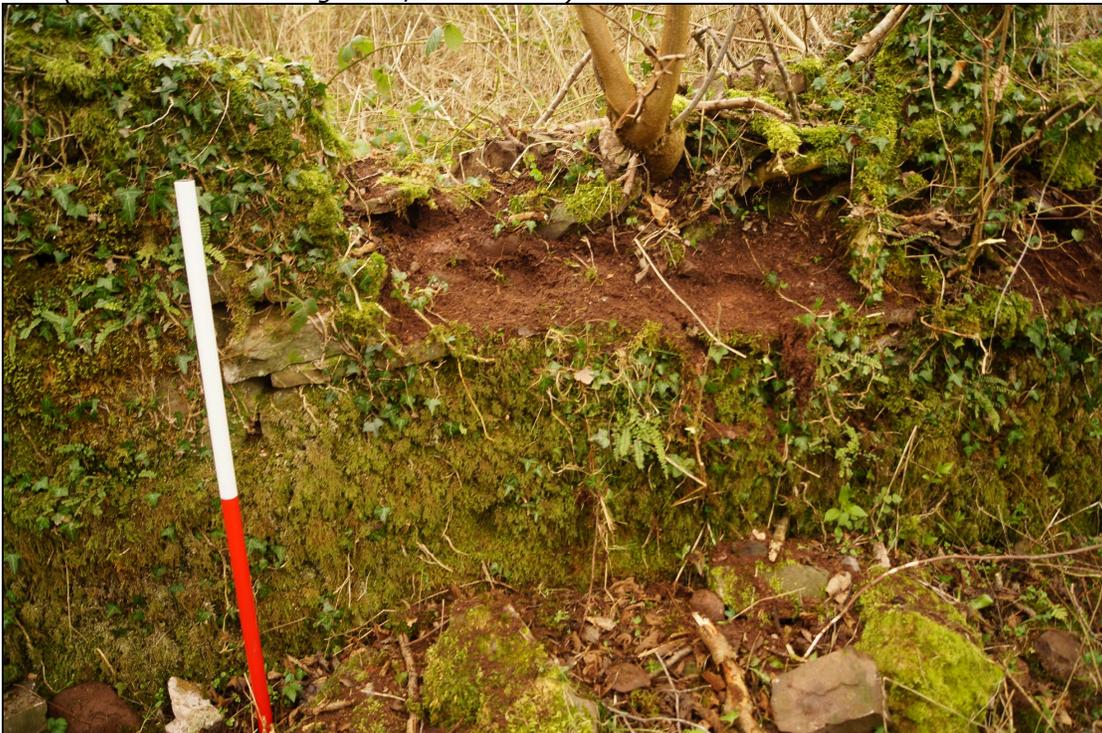
Plate 42: SEL2018_142, Loose stones removed from the section of the east wall to be repaired at SOXXXX, looking east (RV Williams Drawing 3892/08 Note 2.0)
