# **Pricaston Farmhouse, Castlemartin, Pembrokeshire**

## **Archaeological Watching Brief & Historic Building Record**

Prepared for  
**JOP Limited**  
on behalf of  
**Landmarc Support Services Ltd**  
By  
**Black Mountains Archaeology Ltd**  
18<sup>th</sup> November 2022  
Report No.273

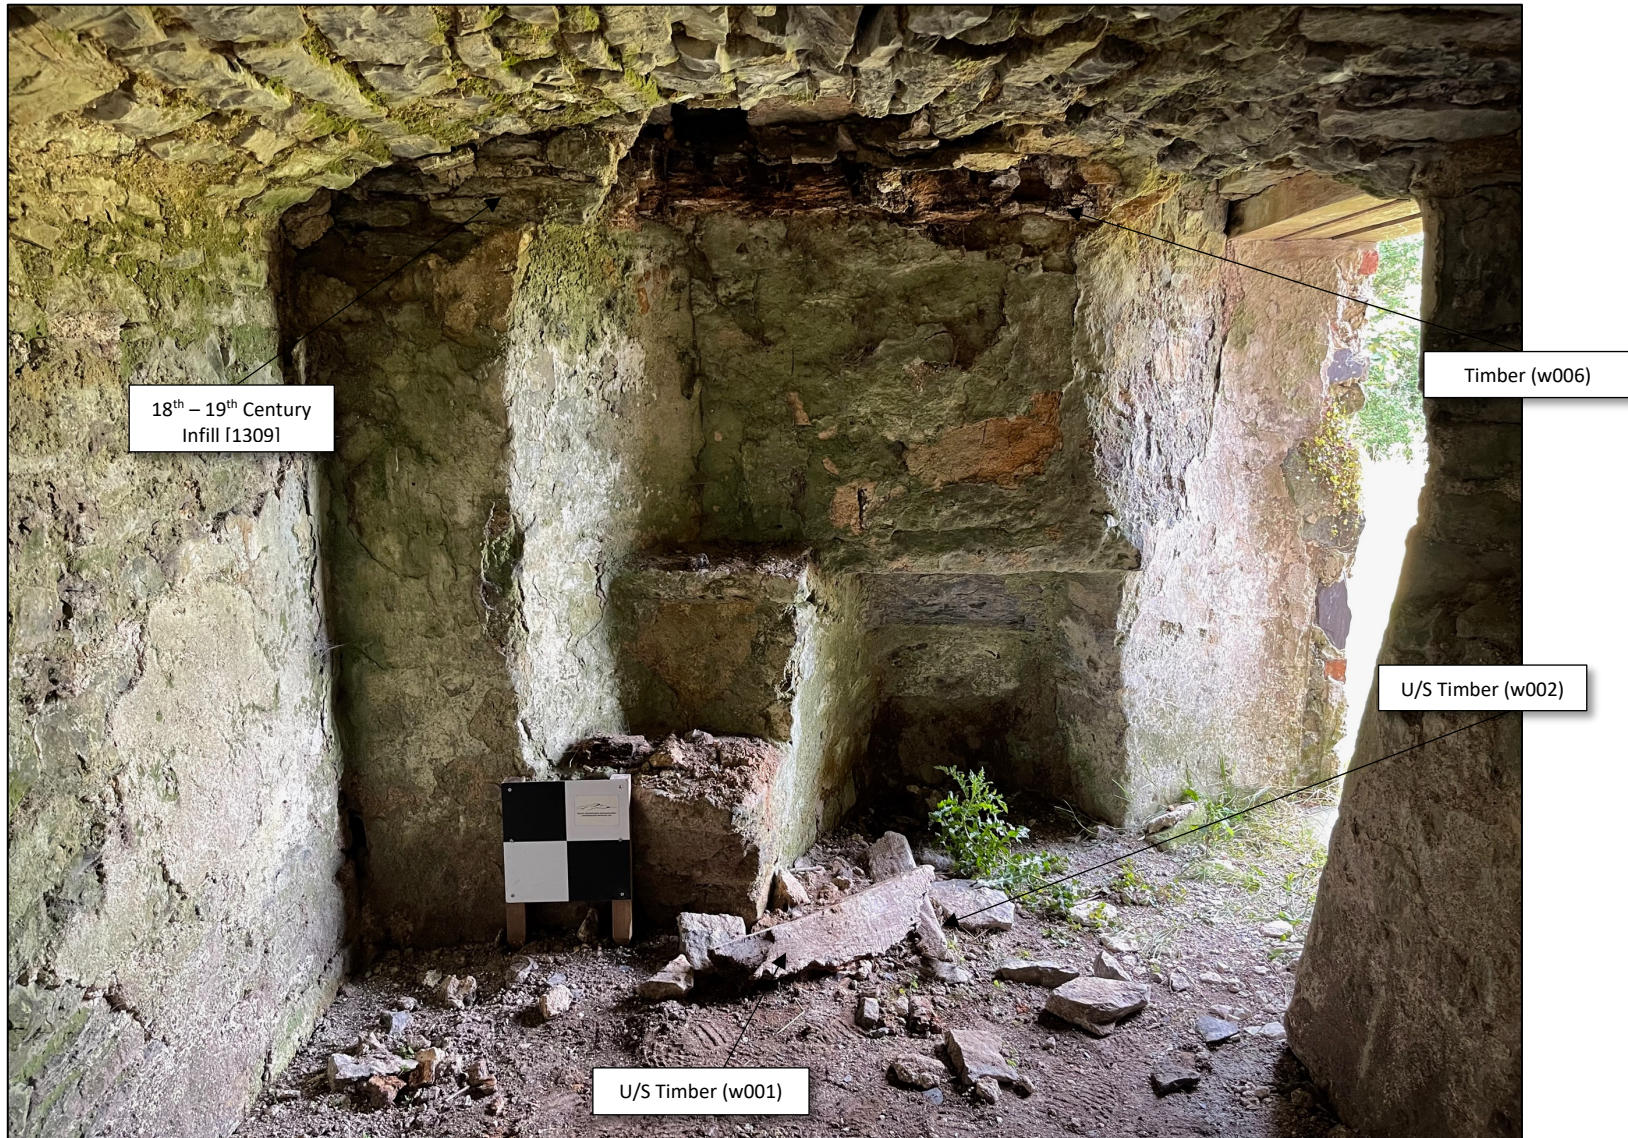
Plate 1. Location 13 NW Service Room, view to SW of hearth/fireplace, Timber (w006) and U/S Timbers (w001) and (w002) recovered from the floor.

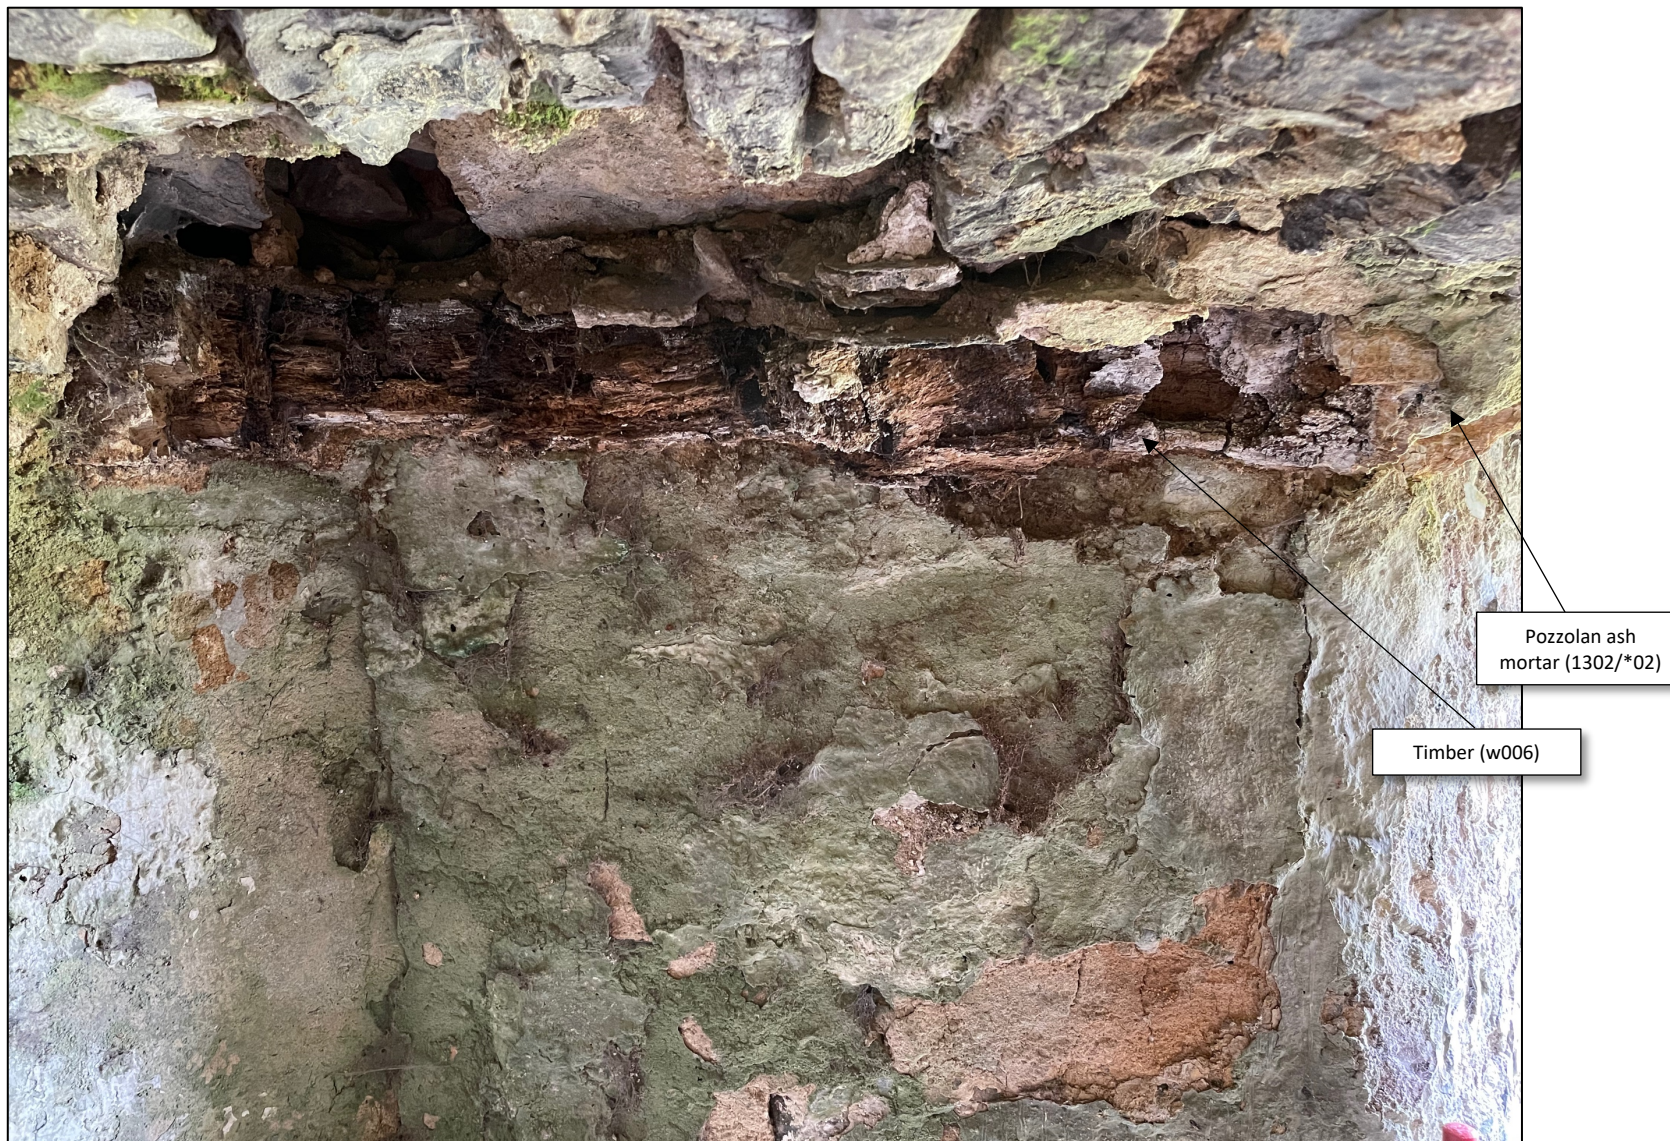
Plate 2. Location 13 NW Service Room, view to SW of Timber (w006).

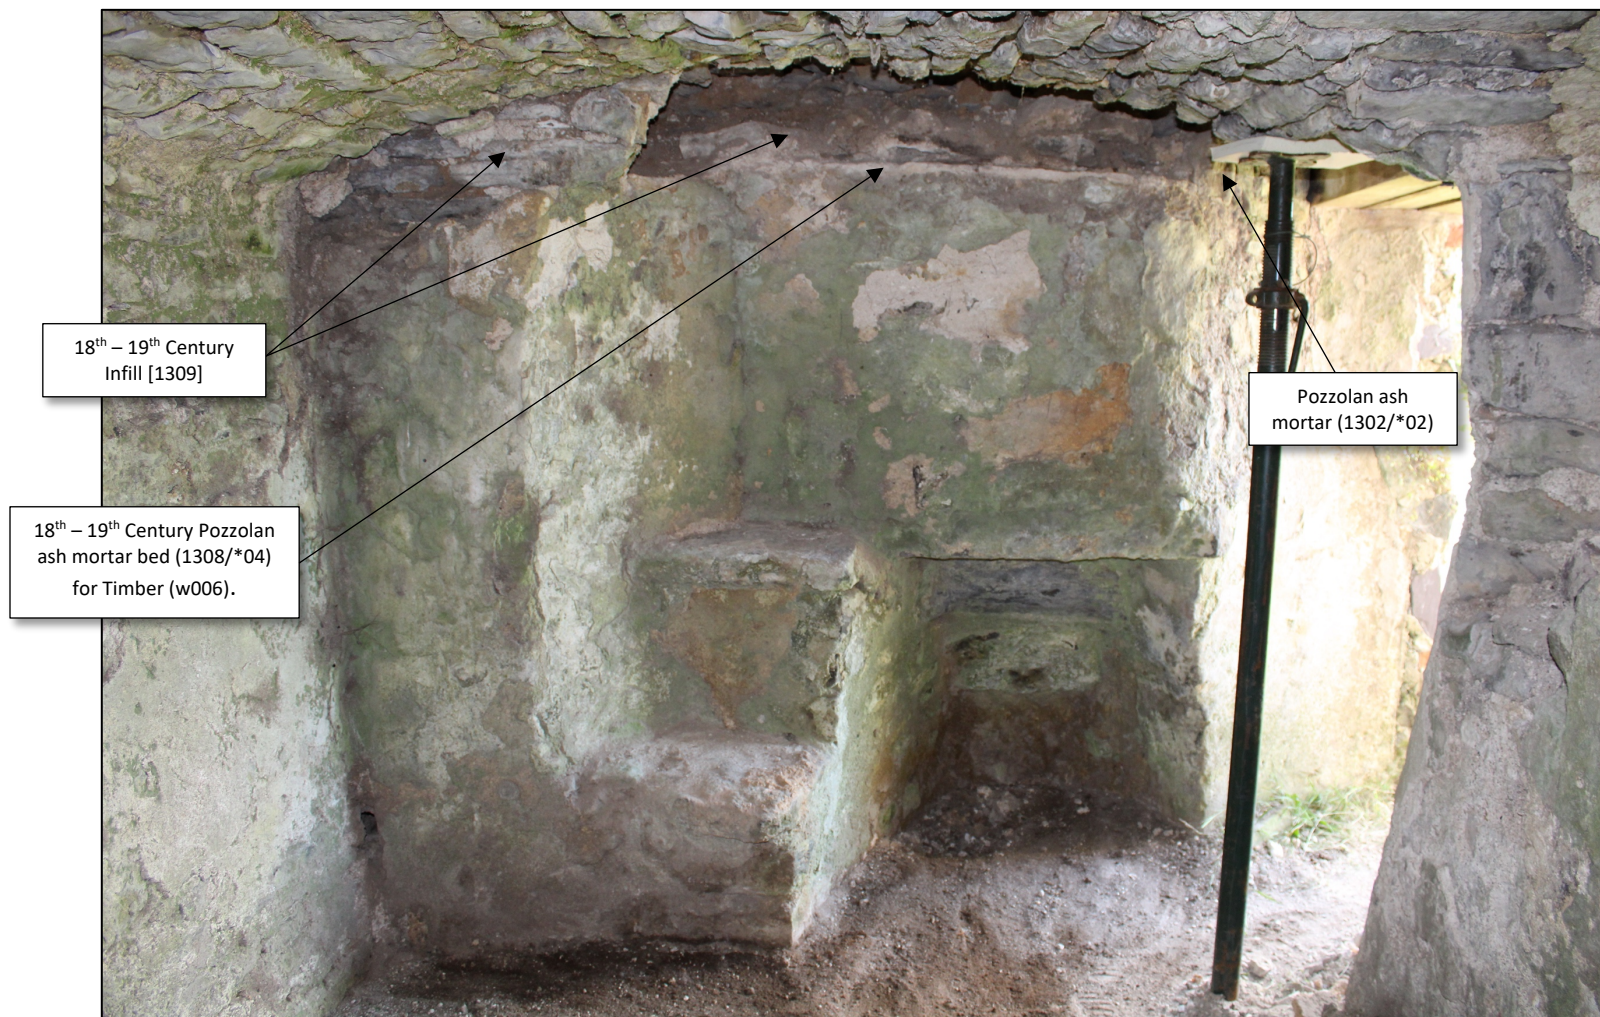
Plate 4. Location 13 NW Service Room, view to SW of hearth/fireplace following removal of Timber (w006).

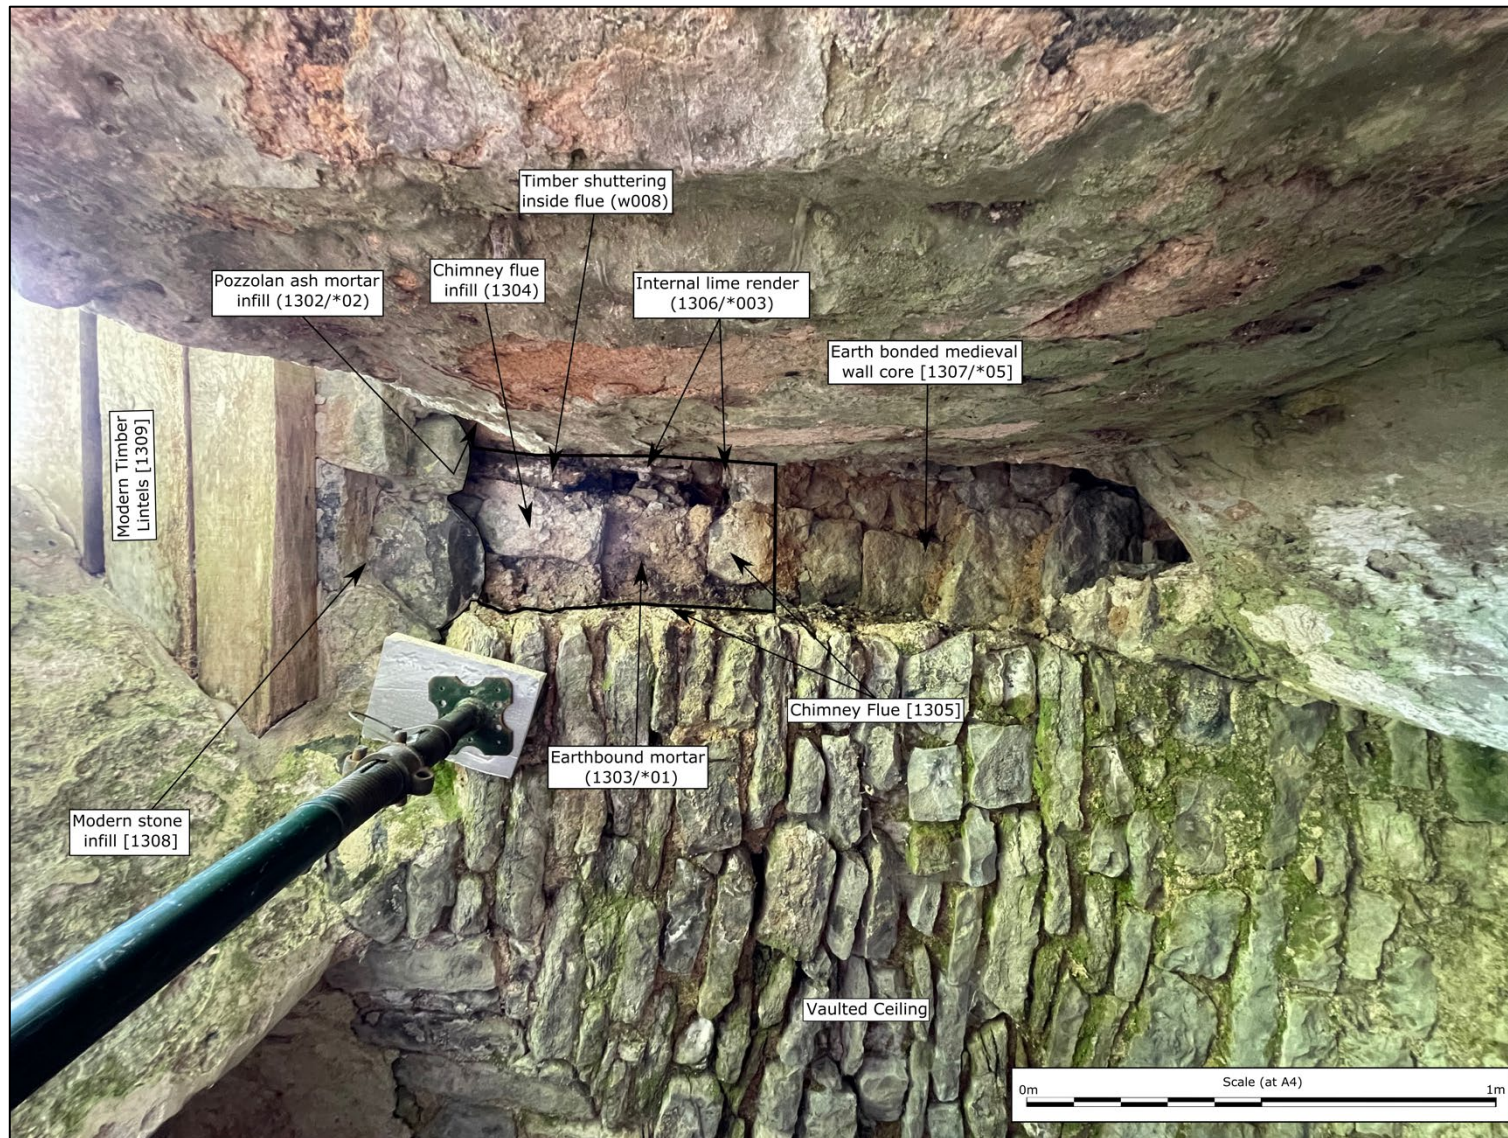
Plate 5. Location 13 NW Service Room, vertical view of hearth/fireplace chimney flue following removal of Timber (w006).

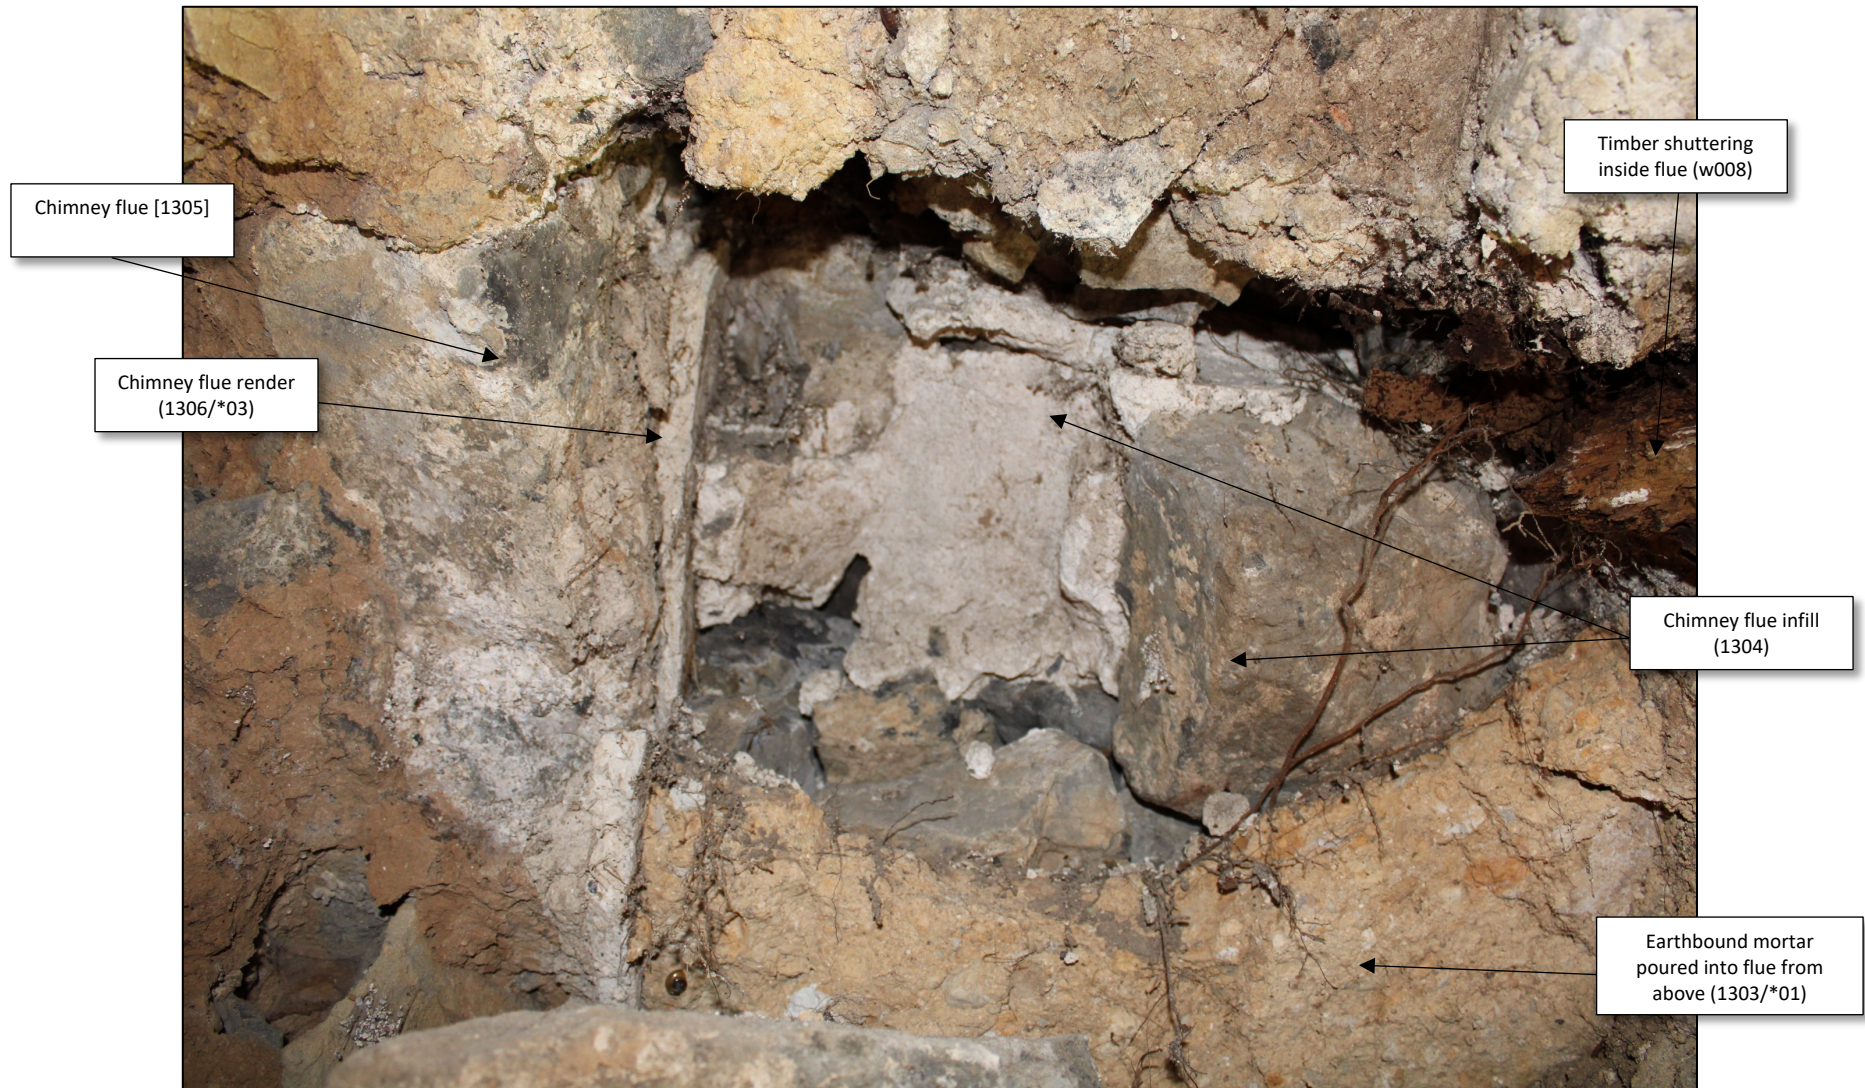
Plate 6. Location 13 NW Service Room, close view of chimney flue [1305], internal lime render (1306) and earthbound mortar infill (1303).

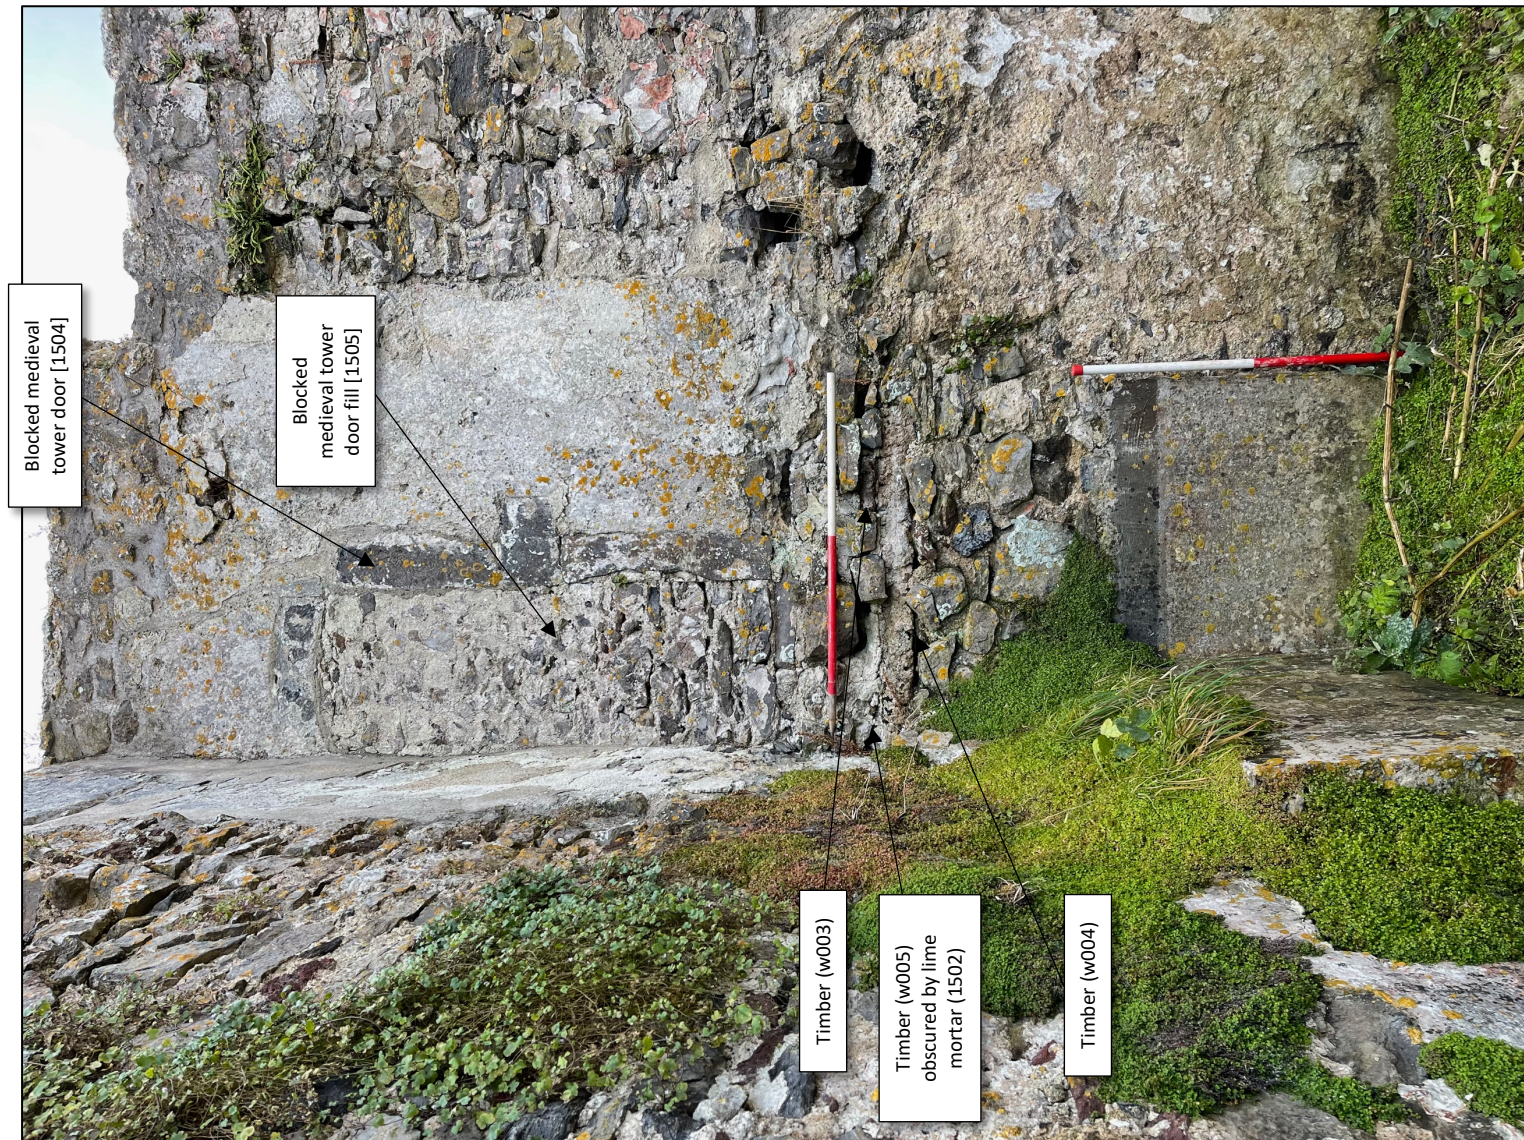
- 7.1.11 Timber (w004) was located in the NE facing internal medieval tower and later 19<sup>th</sup> century kitchen wall [1501]. A blocked medieval doorway [1504] and [1505] is partly visible as is a blocked first floor window and another door or perhaps fireplace to the west. Timber (w004) was carefully lifted out of the wall [1501] on the 17<sup>th</sup> August 2021. The timber (w004) was roughly sawn and recovered from within the masonry of the northeast facing wall, with bark and sapwood present on one narrow edge. A split through the timber was noted at one end. Overall, the timber was in a poor state of preservation. During mortar and stone removal to free timber (w004), two further timbers were recovered. The first, timber (w003), had been inserted over timber (w004) and positioned perpendicular and into wall [1501]. Timber (w003) is the possible remains of a tenon, with two pegs surviving *in-situ*. The timber's origins are possibly a timber building but not likely the farmhouse itself. The second timber (w005) was a small sawn roundwood with a right-angle notch on one end and a handmade wrought iron nail hammered into the notch. The timber was found hidden behind a hard grey lime mortar (1502), with frequent tiny dark stone flecks.

Plate 7. Location 15 Medieval Tower/19<sup>th</sup> Century Kitchen, view of NE facing wall with Timber (w004) *in-situ*.

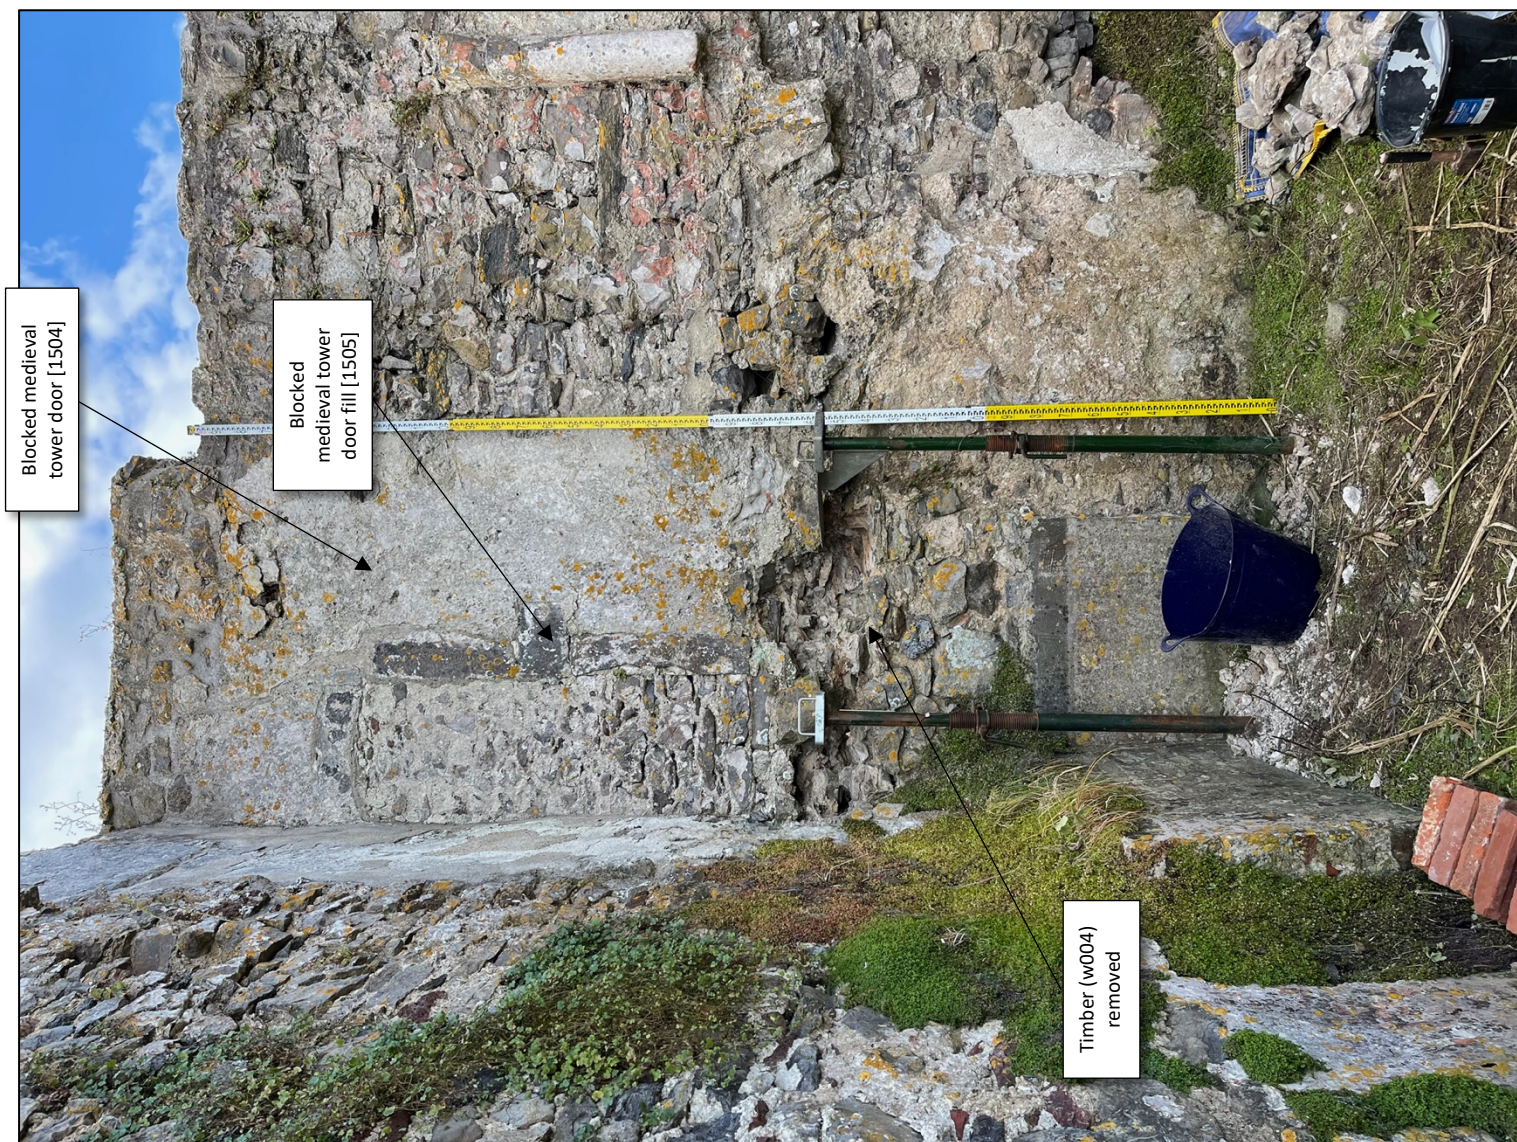
Plate 8. Location 15 Medieval Tower/19<sup>th</sup> Century Kitchen, view of NE facing wall with Timber (w004) removed.

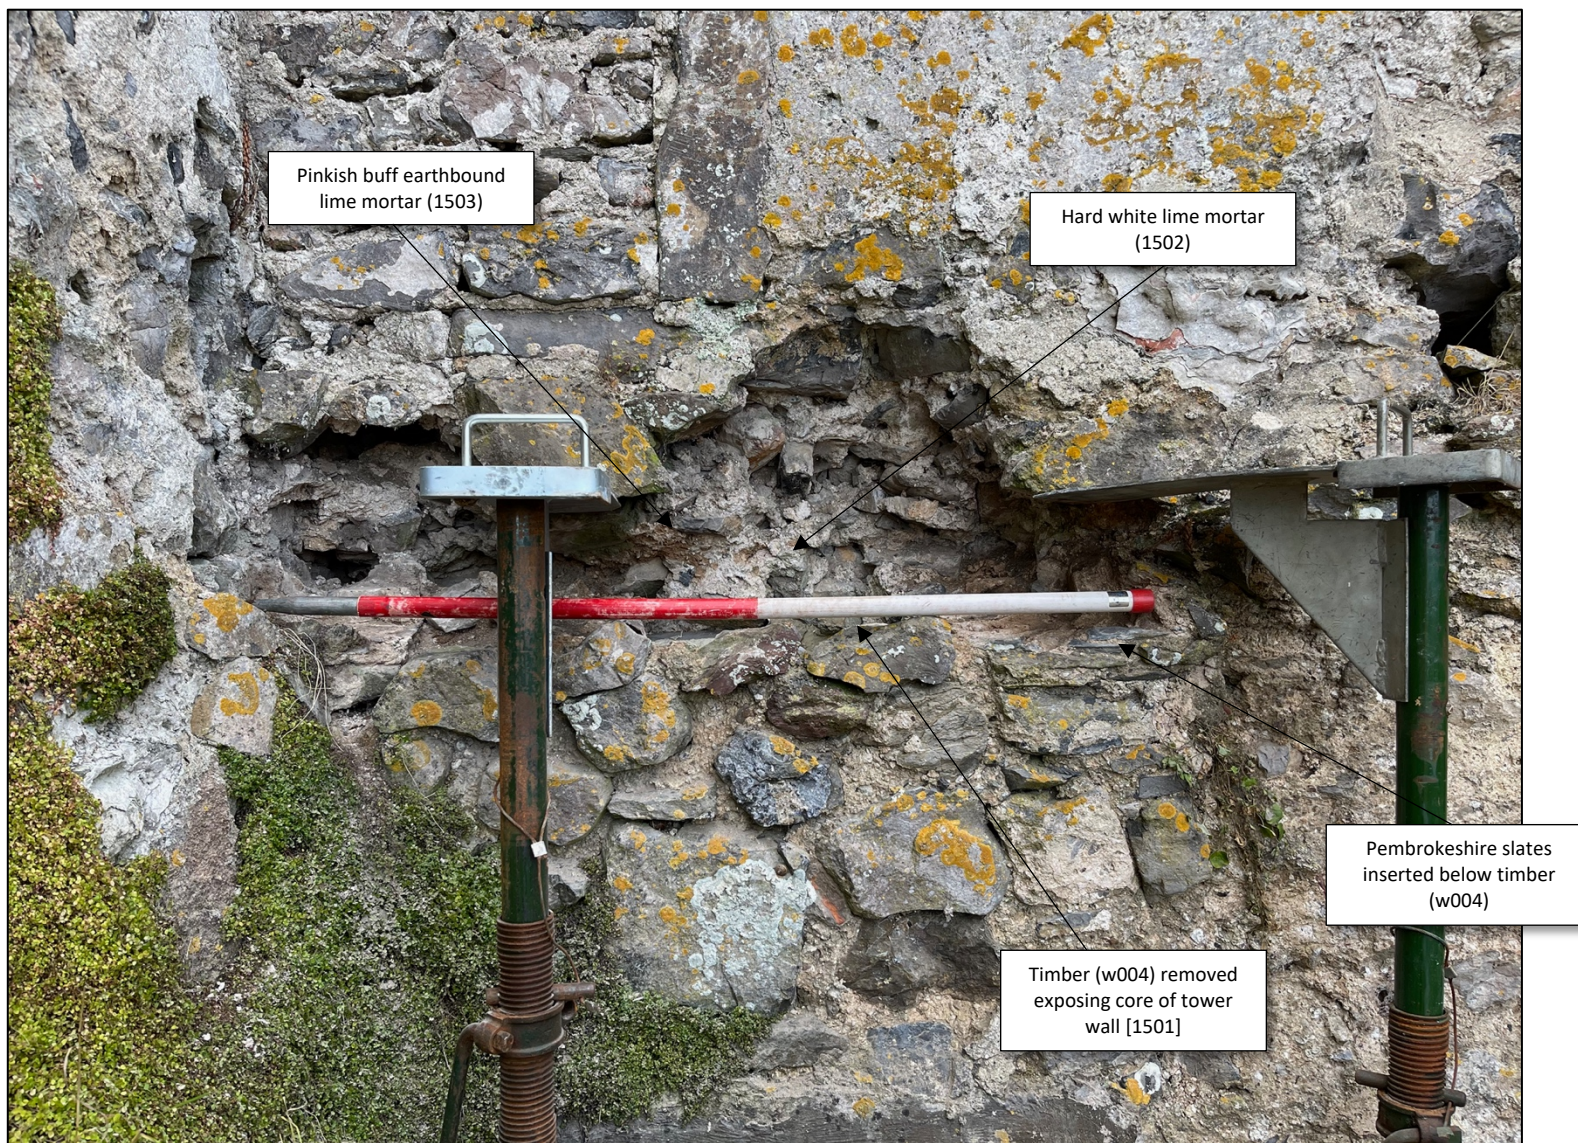
- 7.1.12 The phasing around the timber (w004) in Location 15 is a hotchpotch of later infilling but the earlier medieval tower wall core (1503) was noted once the timber and later in-filling was removed. The medieval tower wall core was bonded by pinkish-buff earthbound lime mortar (1503) with infrequent white lime flecks and moderately frequent gravel. Timber (w004) was mortared in place with a hard grey lime mortar with frequent tiny dark stone flecks, likely dating to the 19<sup>th</sup> century (1502). This hard mortar was found both inside the wall's core and on the wall's internal side.

Plate 9. Location 15 Medieval Tower/19<sup>th</sup> Century Kitchen, view of NE facing wall core.

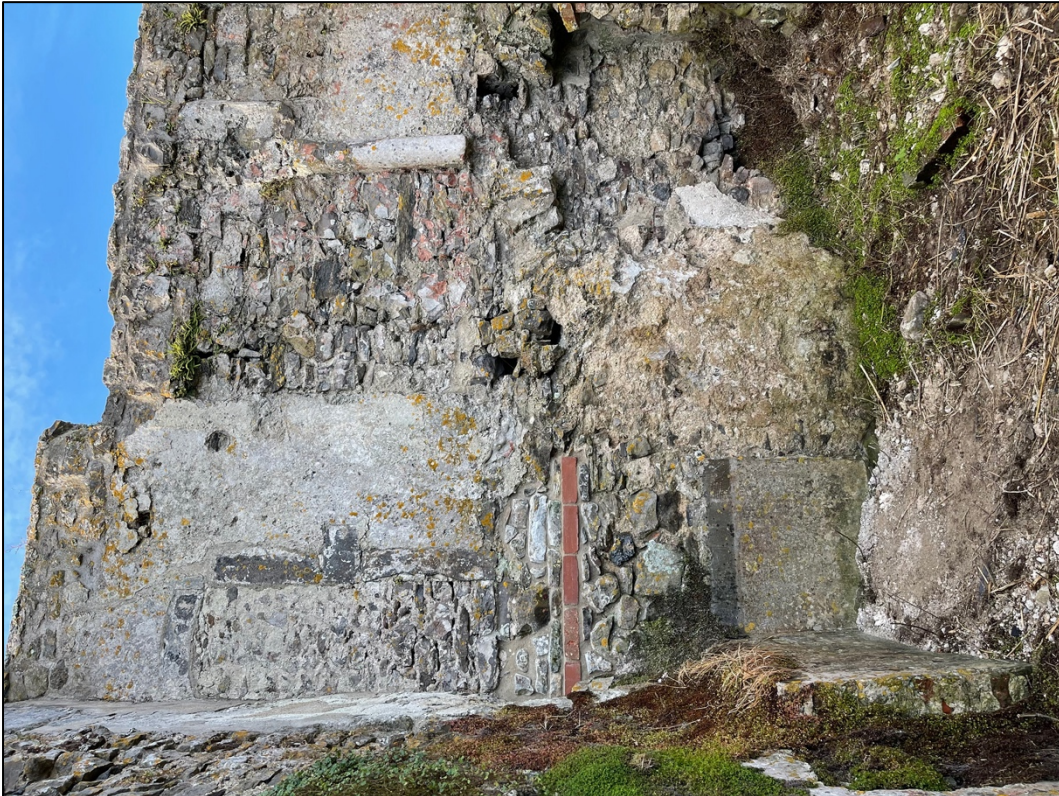
Plate 10. Location 15 Medieval Tower/19<sup>th</sup> Century Kitchen, view of NE facing wall repaired.

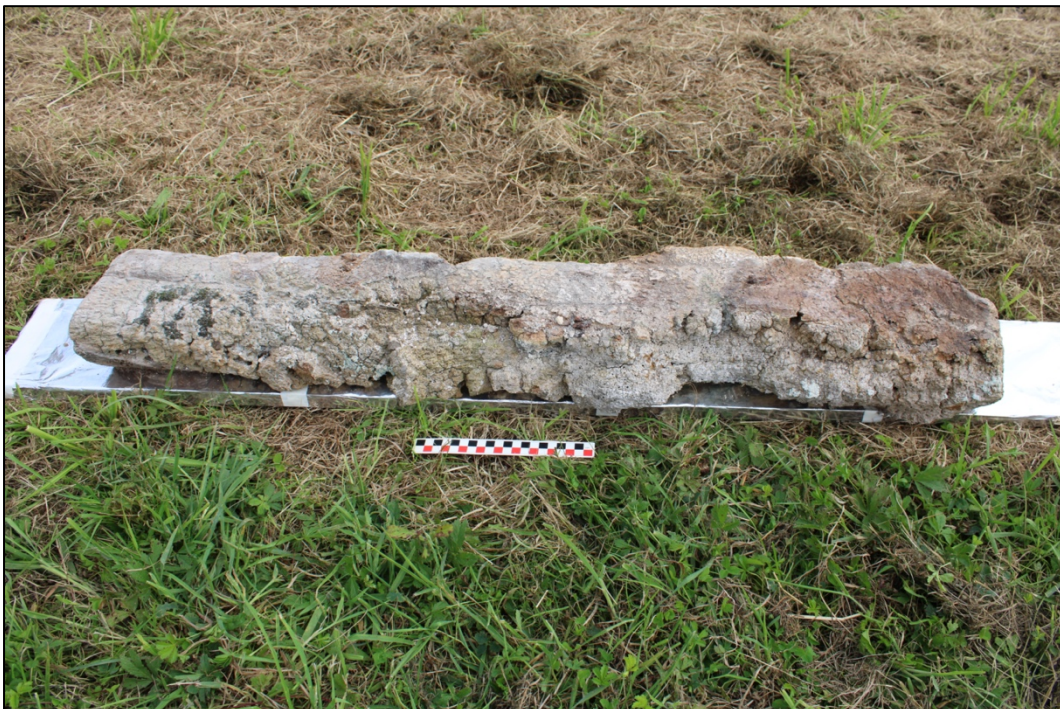
- 7.2.4 Find (w004) is a roughly sawn timber recovered from within the masonry internal northeast facing wall of the former medieval tower in Location 15. Bark and sapwood is present on one narrow edge. A split through the timber is noted at one end. Overall, the timber is in a poor state of preservation.

Plate 19. Location 15 Medieval Tower/19<sup>th</sup> Century Kitchen, reused sawn timber (w004) recovered from within the masonry internal NE facing wall of the former medieval tower [1501].

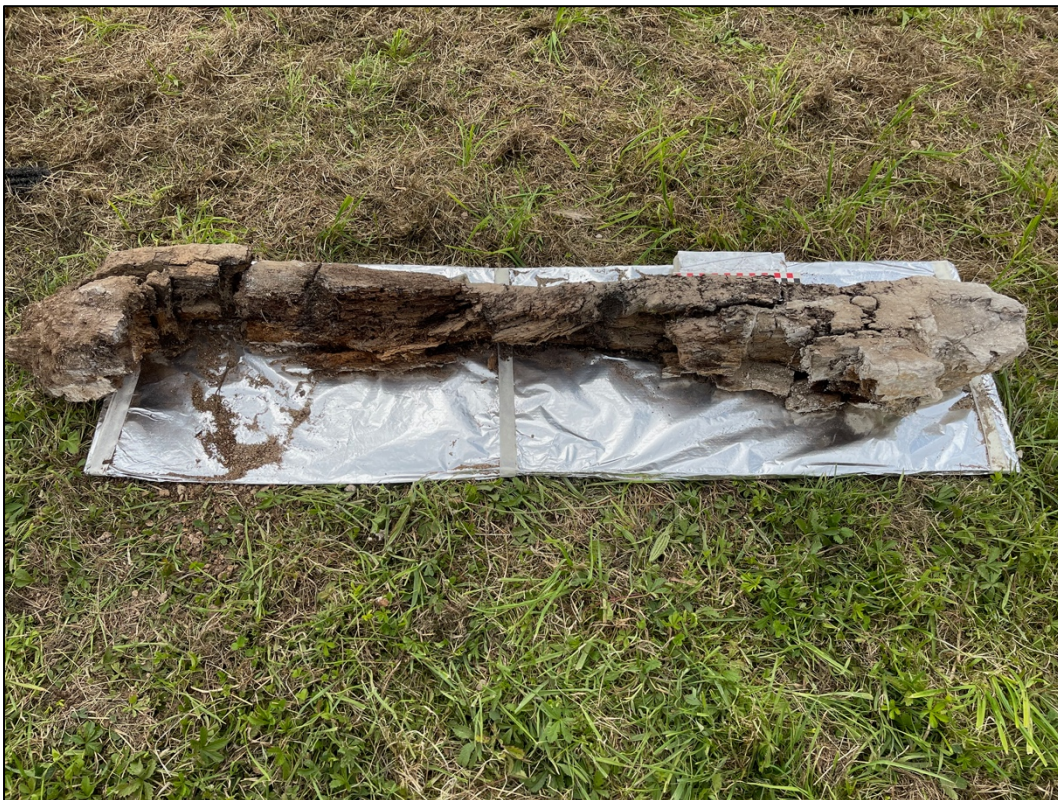
- 7.2.5 Find (w006) is a worked timber recovered from the medieval Northwest Service Room in the northeast facing internal wall. The reused timber had been inserted above a former hearth or fireplace and was found in an advanced stage of decay. During removal the timber fell apart into four pieces, despite significant care being taken. The timber was notched at a right angle at one end and then chamfered to a point. A total of four peg holes are present and three additional pegs were found *in-situ*. Over half of the timber's width has been lost with unstratified Timbers (w001) and (w002) found on the floor of the service room almost certainly belonging to Timber (w006). The timber is reused and its original function is unclear, it may have originally served as part of a screen or partition either in the farmhouse or one of the outbuildings.

Plate 21. Location 13 NW Service Room, worked timber (w006) reused inserted above a former hearth or fireplace and was found in an advanced stage of decay.

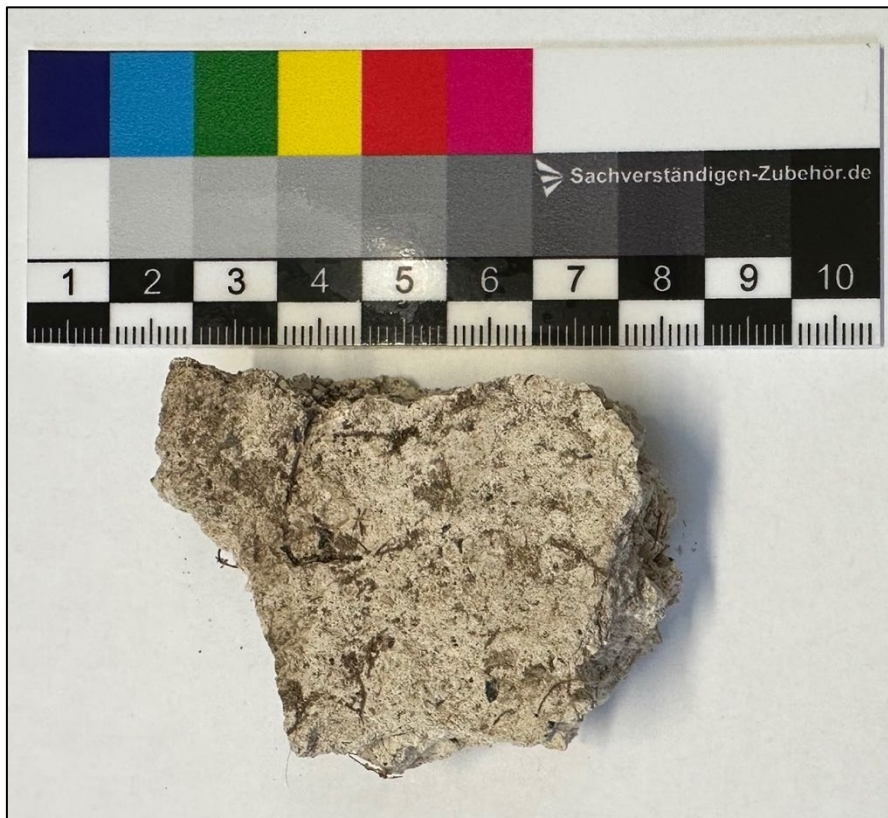
Plate 30. Location 13 NW Service Room, soft white render (\*03) applied to the interior of chimney flue [1305] with small black stone aggregate flecks and straw bonding. Lack of smoke blackening suggest only *in-situ* for short period of time before blocking occurred, 16<sup>th</sup> - 17<sup>th</sup> century.
