# **Castle Earthwork**

### **Scheduled Ancient Monument BR179**

## **Completion Report**

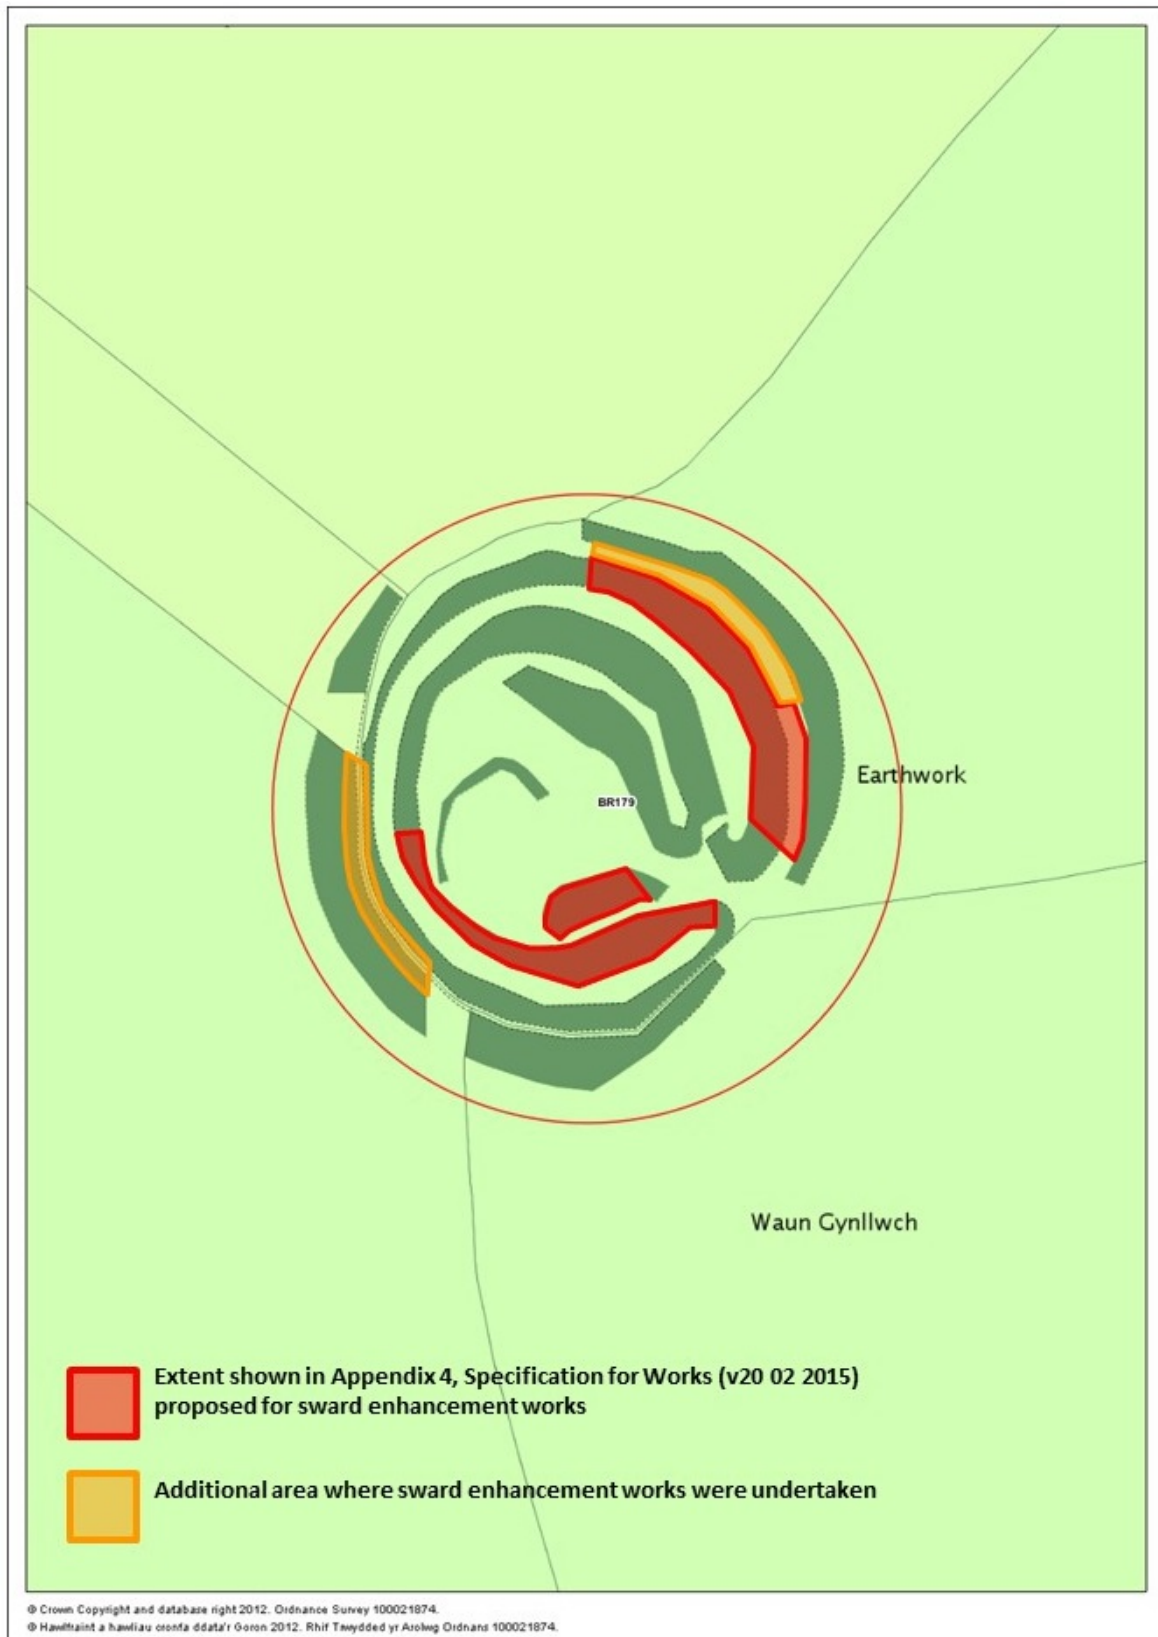
### Extent of areas where the first signs of erosion were evident

At the time of undertaking conservation works, the area of grass sward considered to be under stress was greater than that estimated at the time of preparing the Specification for Works (v20 02 2015). This extended area, as shown in orange on the plan at Appendix 5, was also treated as above.

- The extent of the stressed area was 'spiked' using a standard garden fork, at a spacing of approximately 150 mm and to a depth not exceeding 100 mm;
- Broadleaf P4 was introduced into the holes resulting from 'spiking' using a funnel;
- The extent of the stressed area was then treated with an extended release mini grain fertiliser (18% Nitrogen, 3.5% Phosphate, 8% Potassium and 1% Magnesium) applied by surface broadcasting at a rate between 25 and 35 grams per square metre.

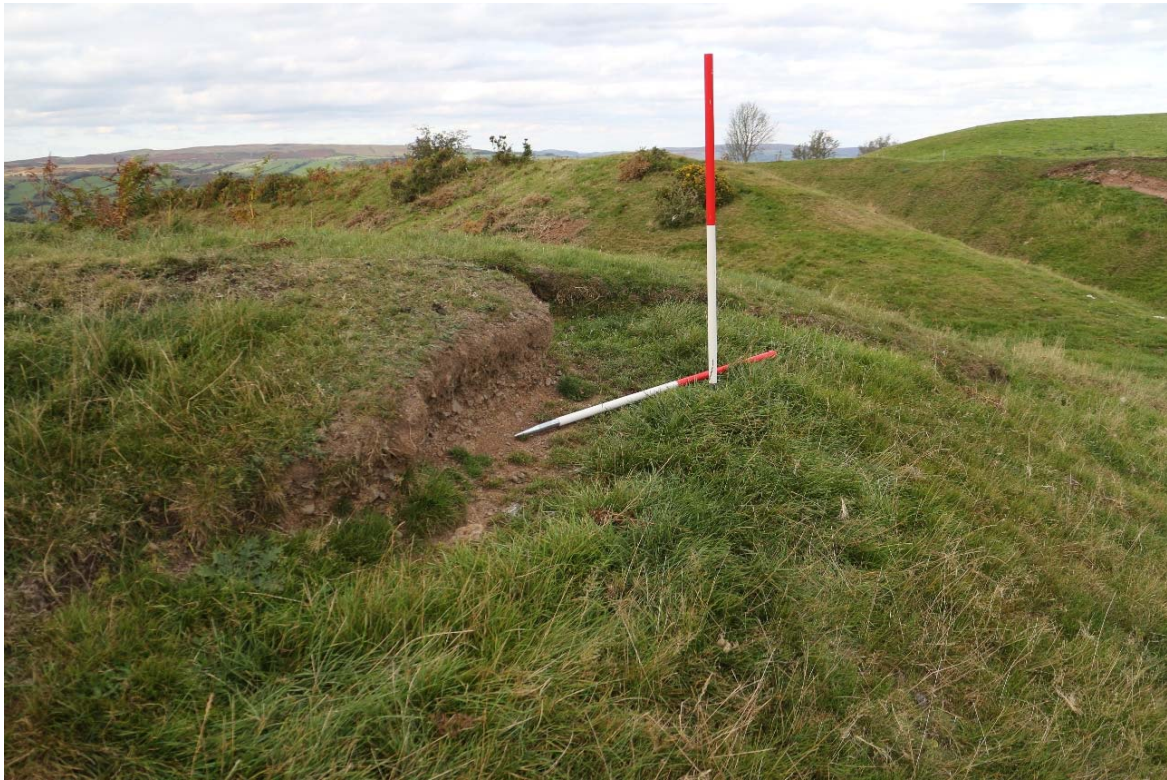
*1. Located on the SE side of the eastern inner bank. Measures 2.3m long by 1.4m deep and 0.4m high;*

*Location 1, before repair, IMG\_2483, 02.10.2014*

- The extent of each eroded area was infilled using imported topsoil, the surface of the area, after repair, being coincident with the adjoining ground surface. Imported topsoil was mixed with Broadleaf P4 (see Appendix 1) at a rate not exceeding 1 kilogram per cubic metre, to aid sward re-establishment;

- The repaired area was sown by hand broadcasting with a drought-tolerant grass seed mix comprising 35% tall fescue *Festuca arundinacea*, 35% rhizomatous tall fescue and 30% Topgun dwarf perennial ryegrass *Lolium perenne* at a rate of 35 grams per square metre;

- The repair was then covered with Greenfix Eromat Type 6S (see Appendix 2), the matting being laid so as to extend beyond the repair by no less than one metre. This matting was secured to the substrate using a combination of 100 mm and 150 mm Green Stakes (see Appendix 3), at a density not exceeding six per square metre. The use of this matting and these Green Stakes was a modification from the approved Specification for Works (v20 02 2015). This modification was intended to enhance environmental sustainability, together with safe and efficient working, while maintaining repair effectiveness and standards. It was approved by Cadw on 2 July 2015.

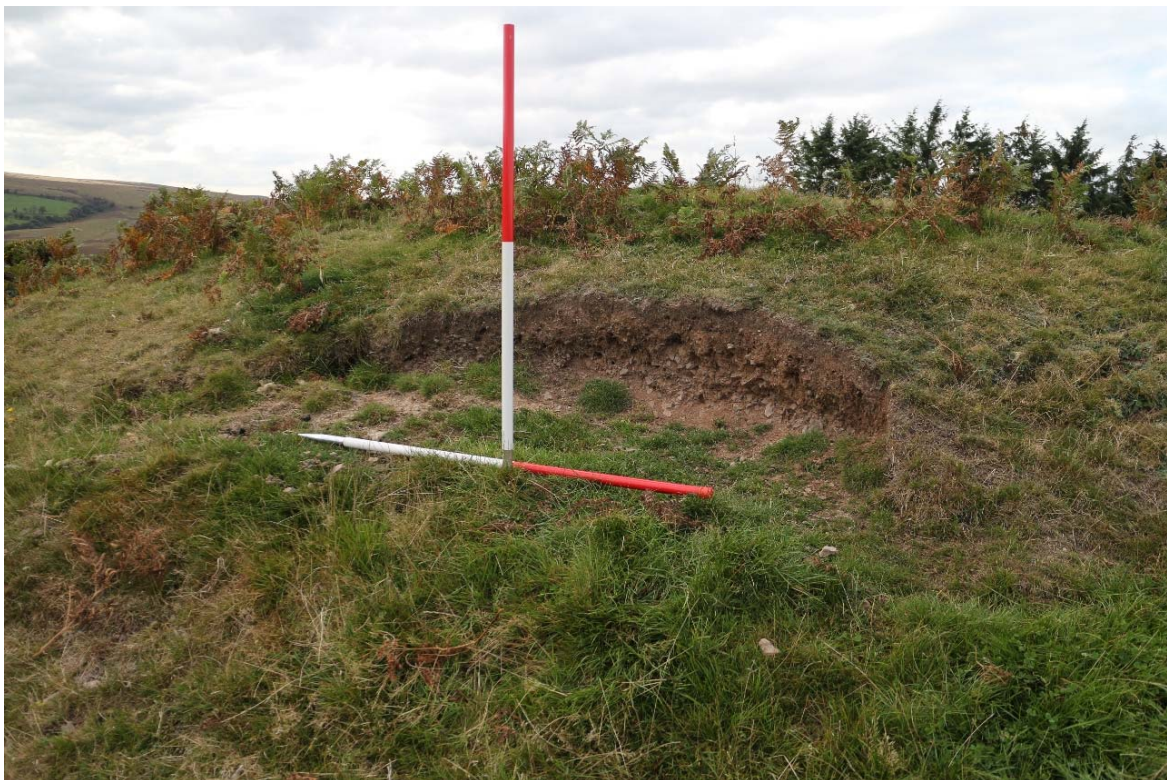
*2. Located 2m to S of scrape 1. Measures 2.7m long by 1m deep by 0.35m high;*

*Location 2, before repair, IMG\_2482, 02.10.2014*

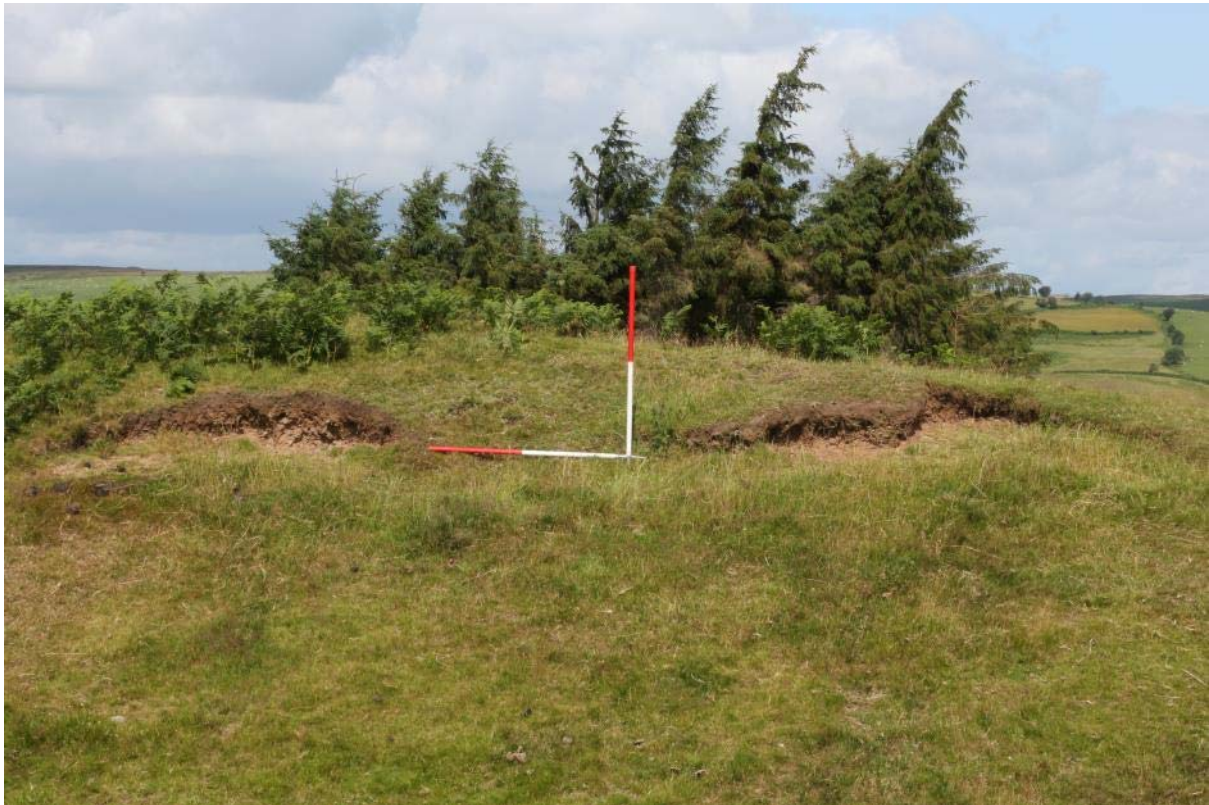
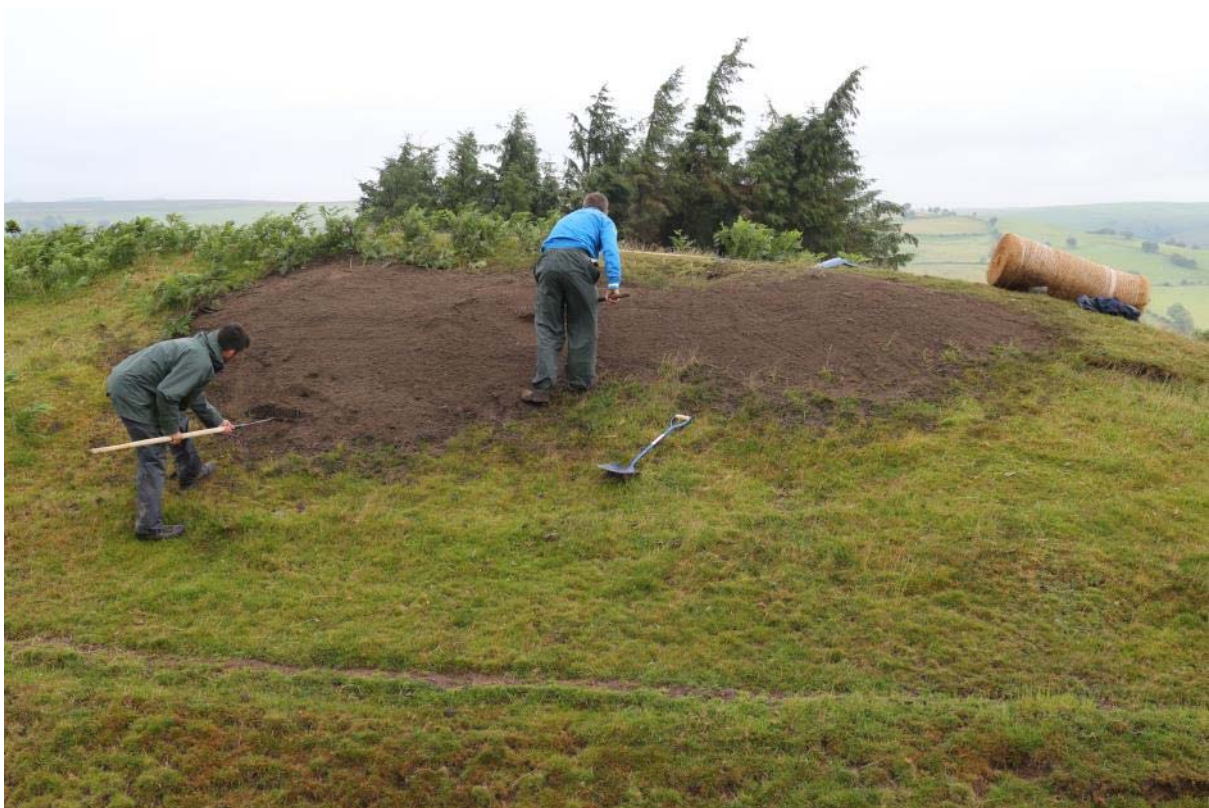
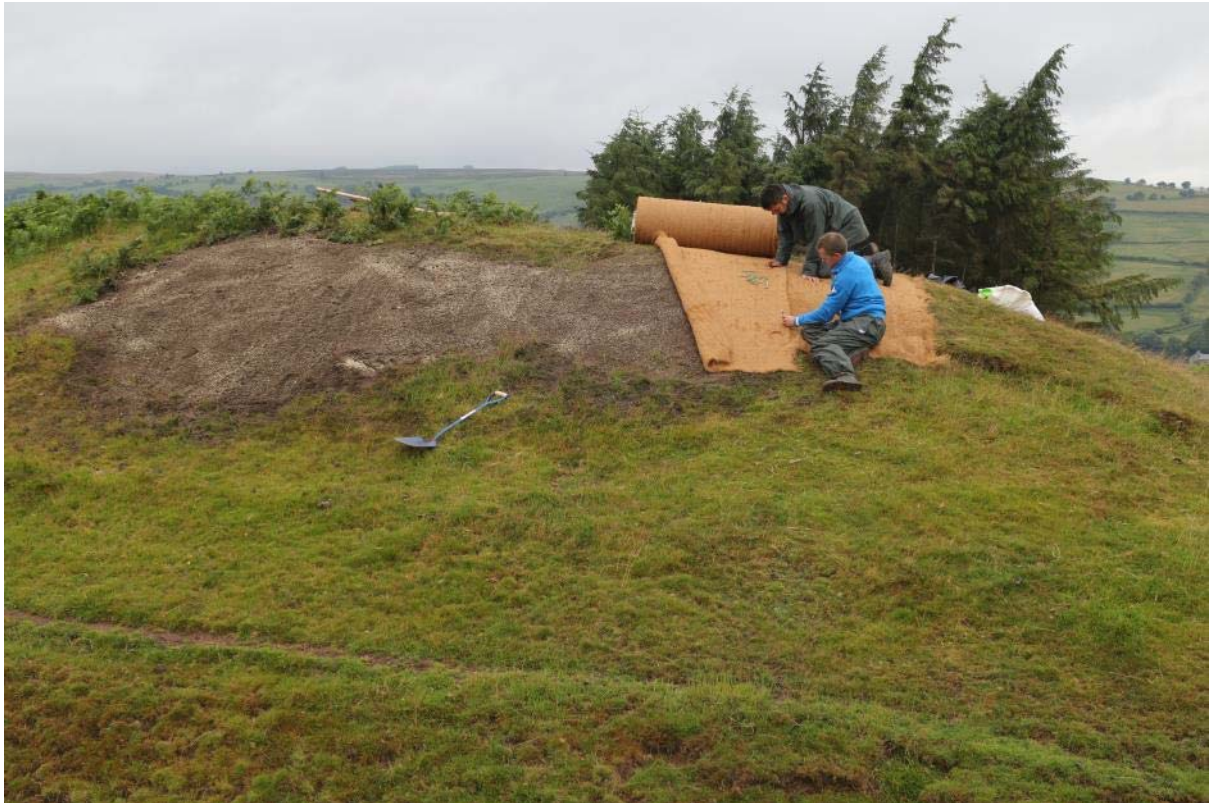
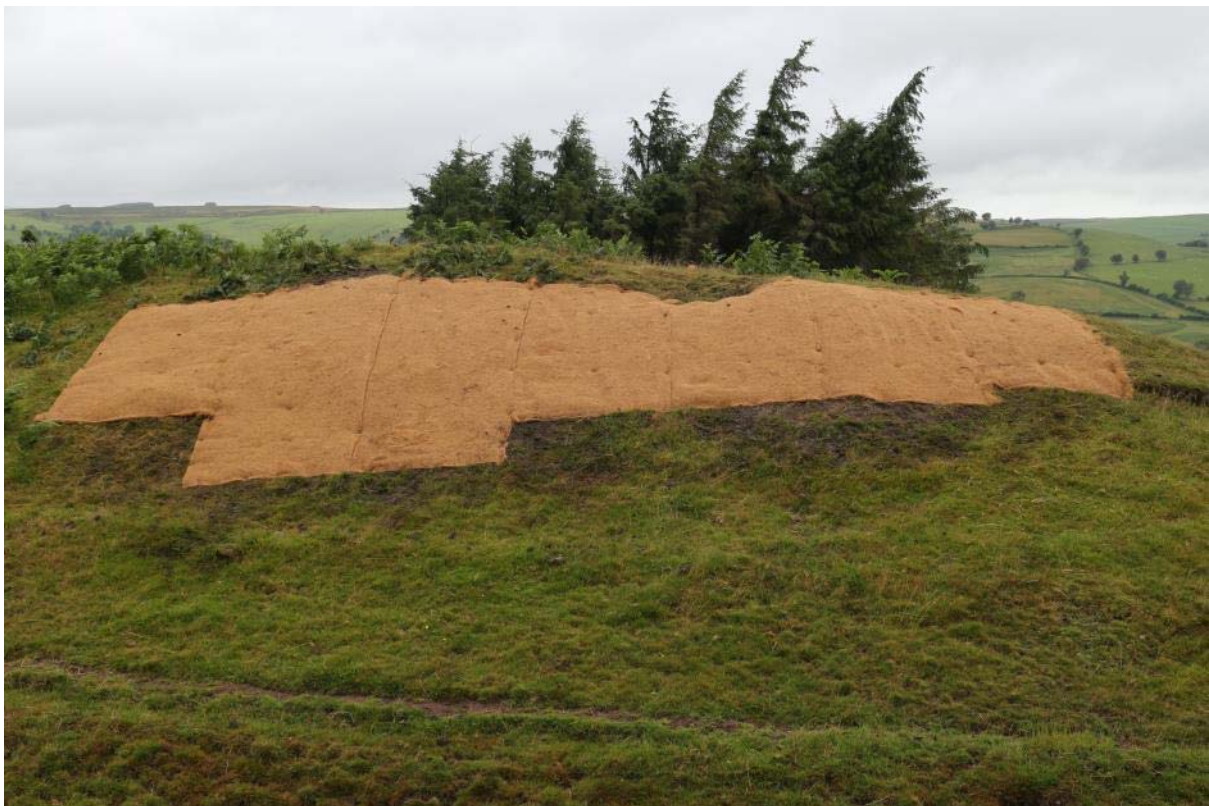
## Locations 1 & 2

*Locations 1 & 2, before repair, IMG\_7456, 18.07.2015*

*Locations 1 & 2, infilling and reprofiling, IMG\_7471, 20.07.2015*

*Locations 1 & 2, installing Greenfix Eromat Type 6S, IMG\_7478, 20.07.2015*

*Locations 1 & 2, completed repair, IMG\_7485, 20.07.2015*

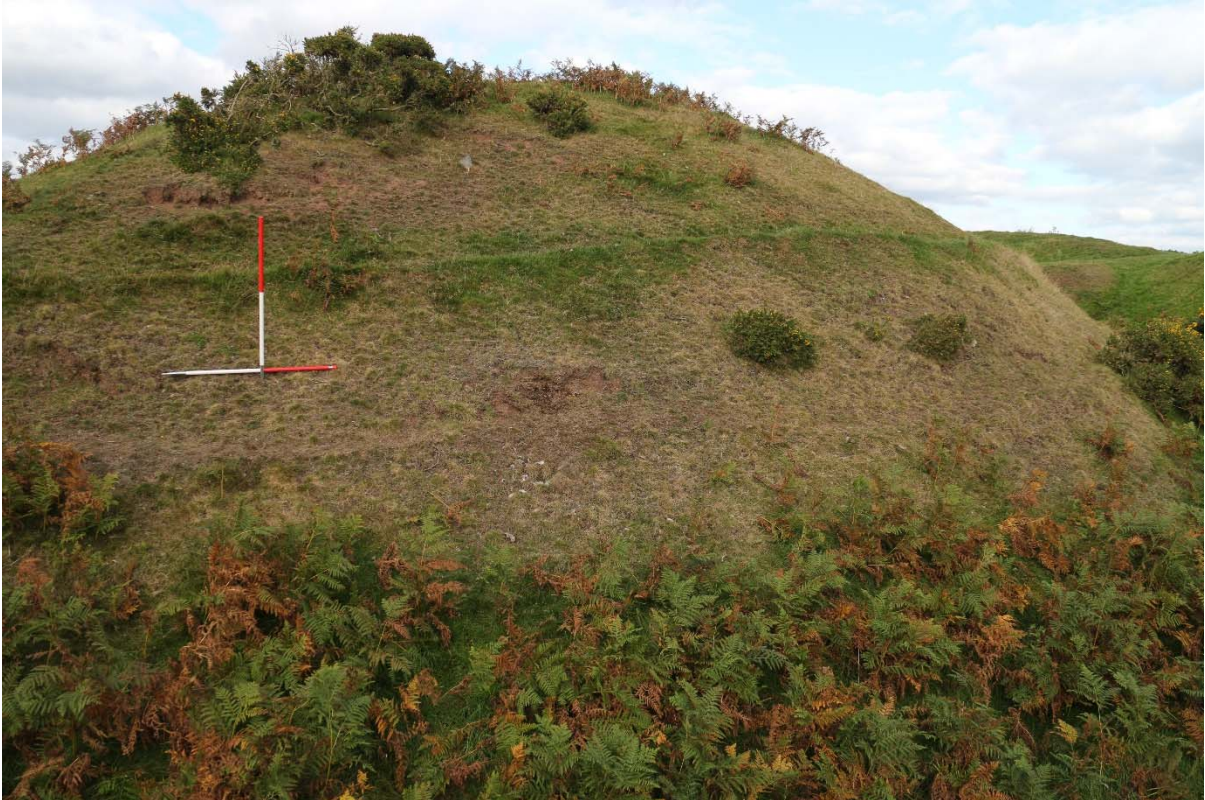
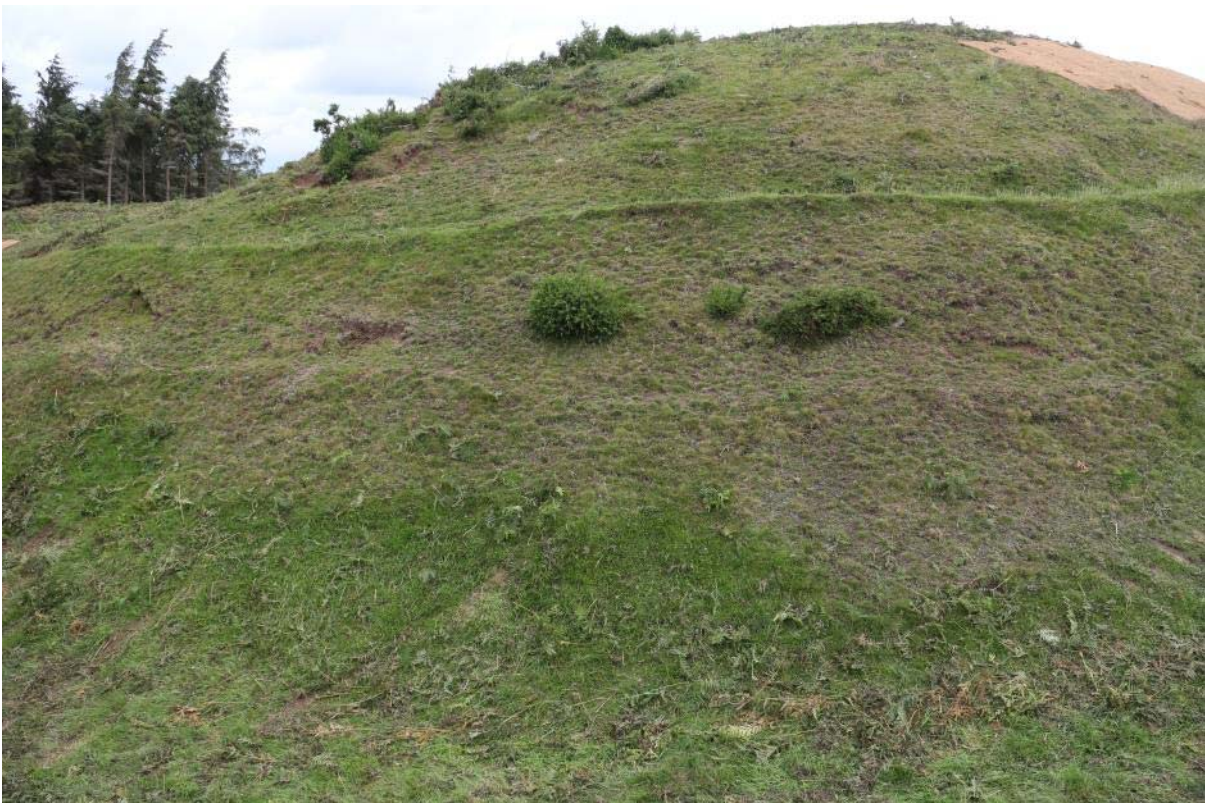
## Location 3

3. *Located on SW side of eastern inner bank. Four separate areas which are being used by sheep and are starting to erode;*
  4. *Located immediately at break of slope on inner edge of ditch on S side monument. Measures 1.9m long by 2m deep and 0.2m high;*

*Location 3, IMG\_2480, 02.10.2014*

*Location 3, immediately following sward enhancement works, IMG\_7645, 23.07.2015*

At the time of undertaking conservation works, AQB Historic Landscapes assessed that the erosion scars at Locations 3 and 11 should naturally re-establish a grass sward cover and thereby stabilise. Accordingly, they were treated using sward enhancement techniques, as described below, rather than by infilling with topsoil and matting.

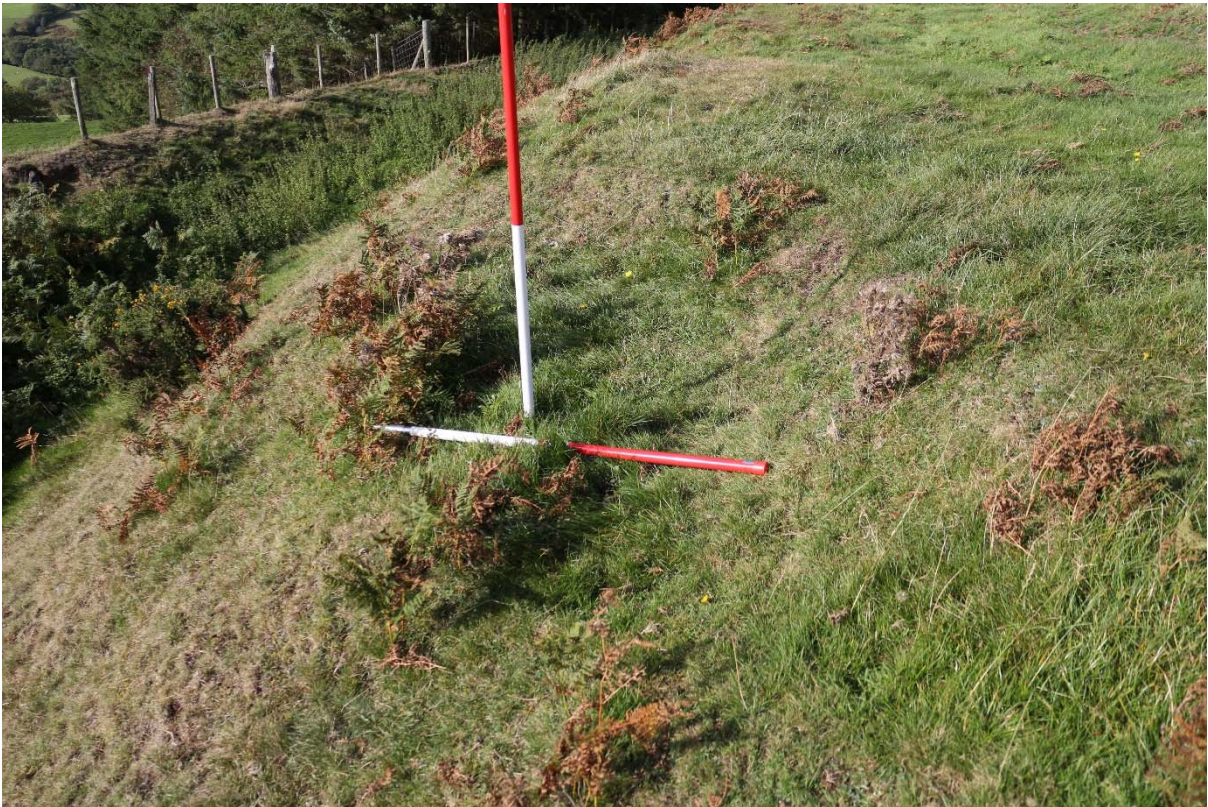
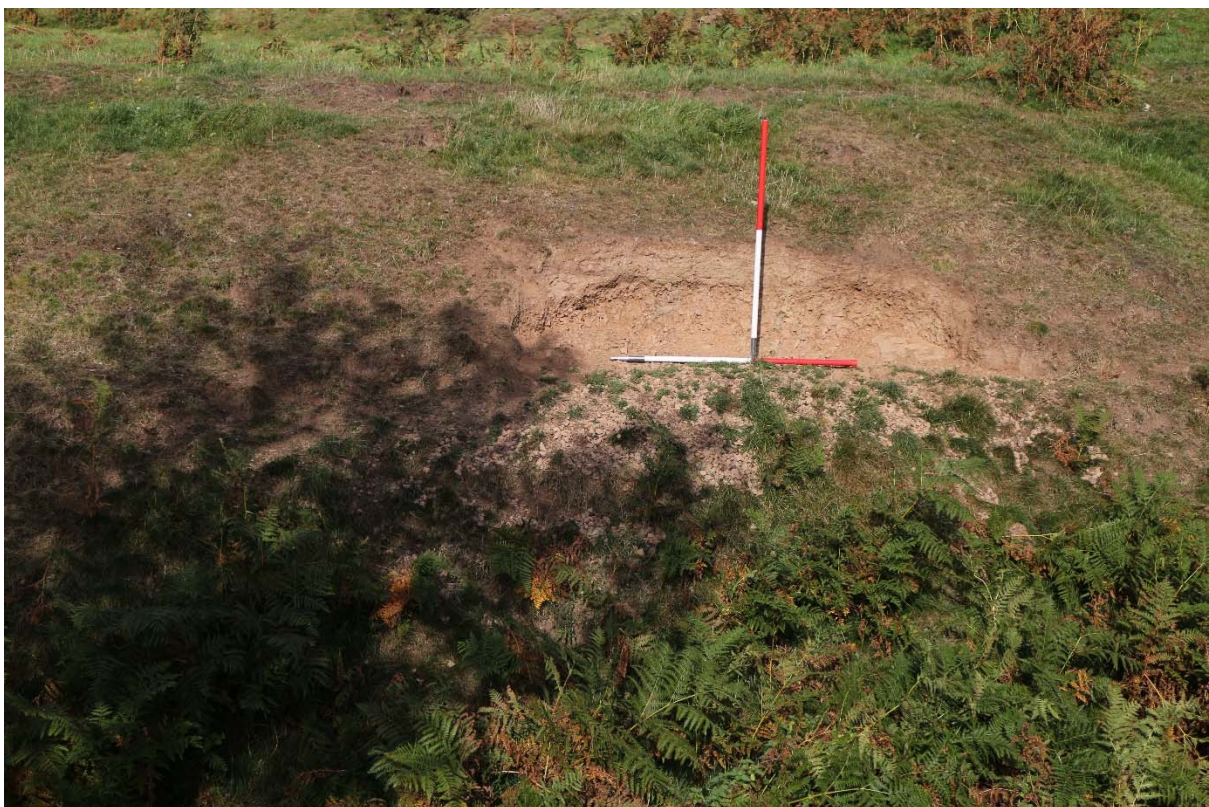
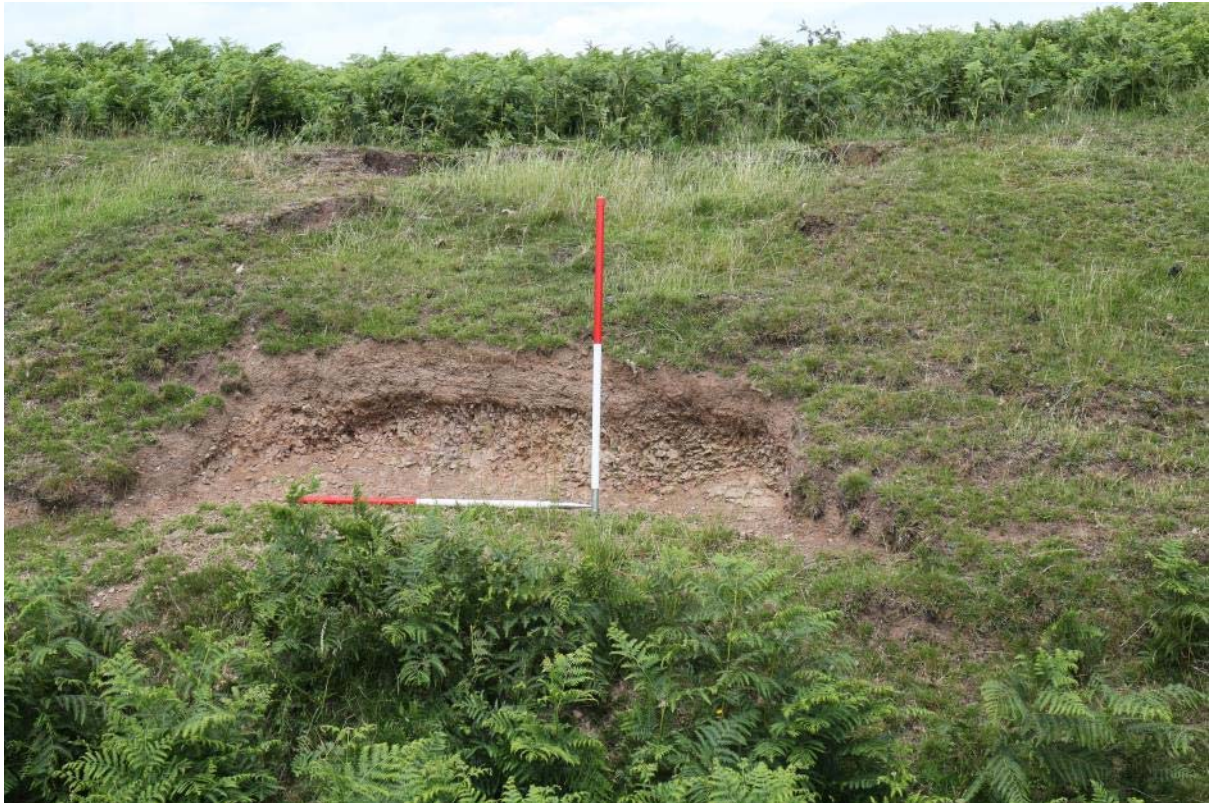
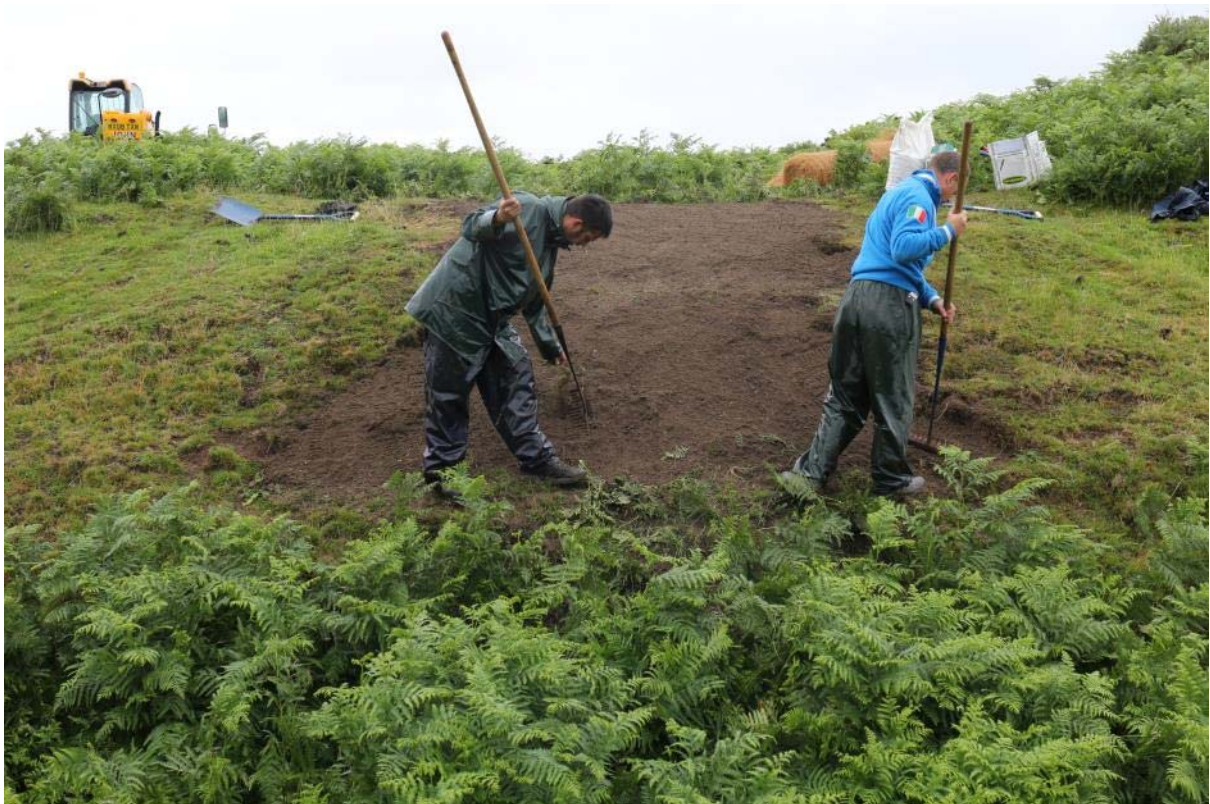
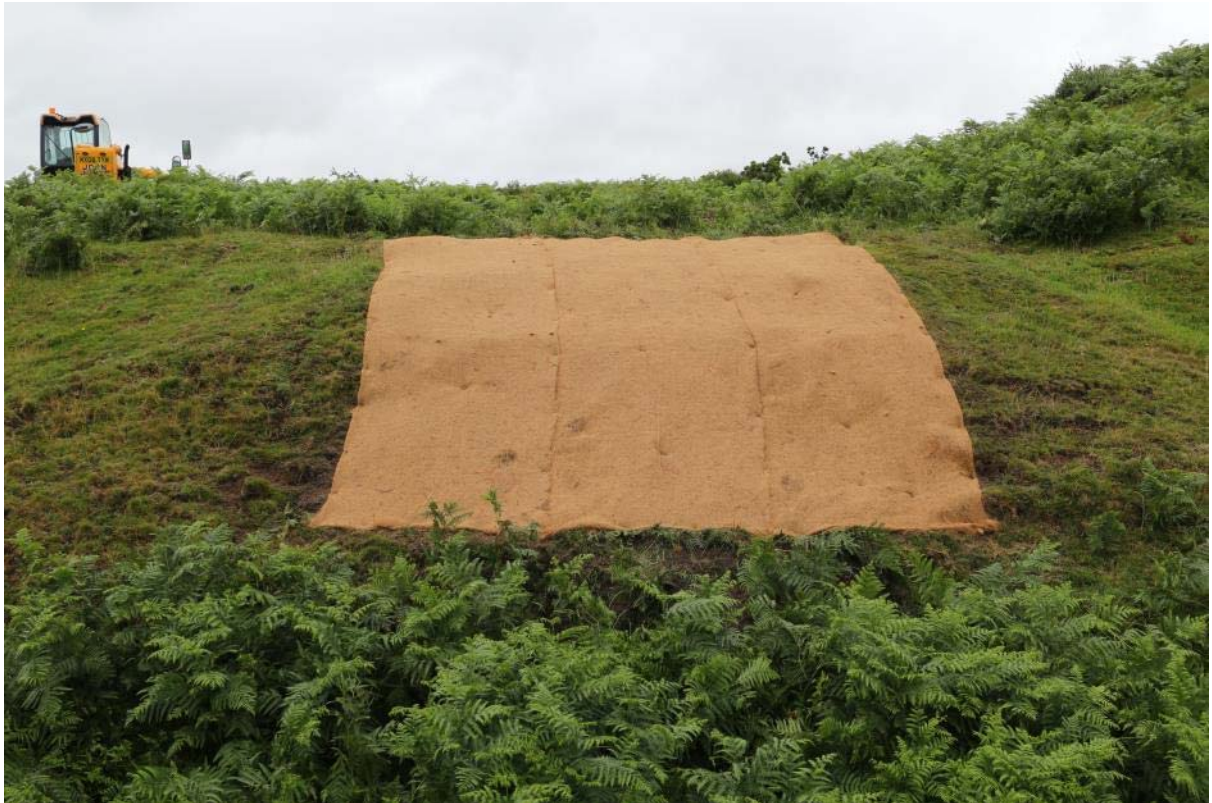
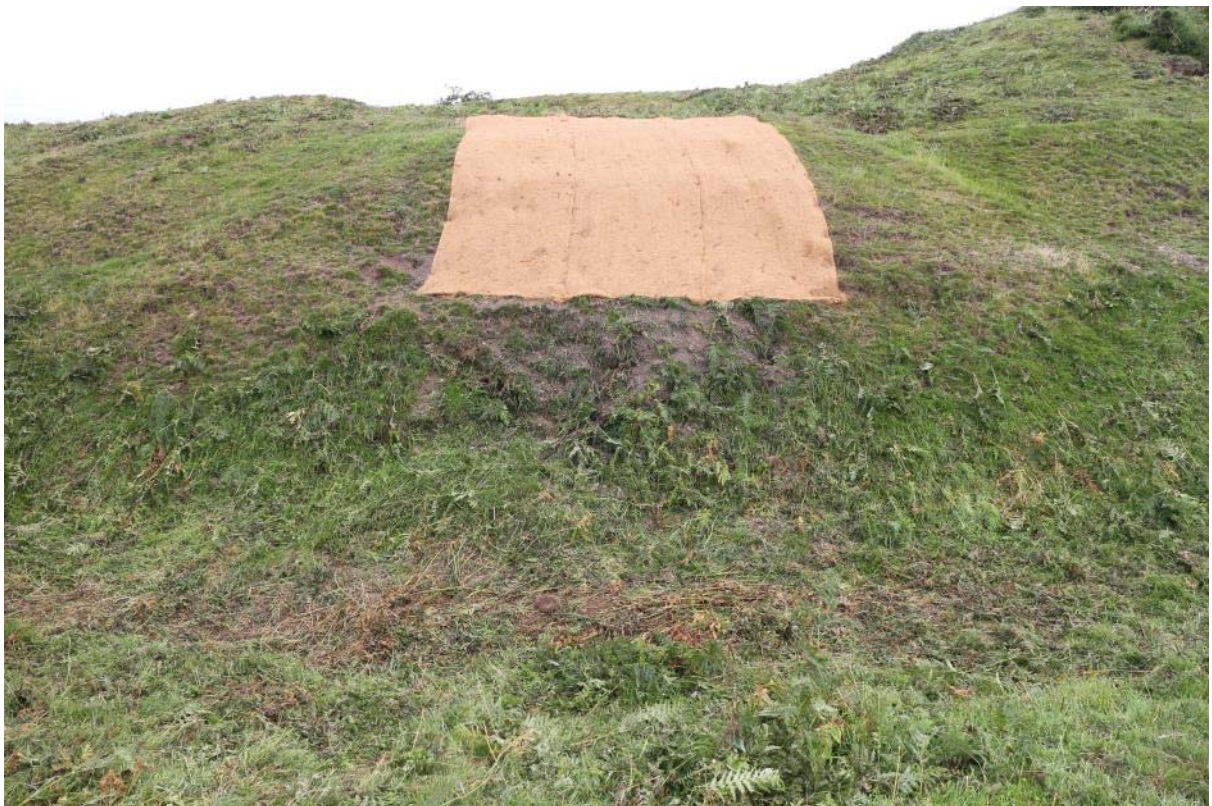
## Locations 4, 5 & 6

5. *Located midway down inner ditch edge on S side monument, immediately below scrape 4. Measures 2.4m long by 0.6m deep and 0.5m high;*
  6. *Located at base of inner ditch immediately below scrape 5. New area of erosion measuring 0.7m long by 0.3m deep and 0.5m high;*

*Locations 4, 5 & 6, before repair, IMG\_2470, 02.10.2014*

*Locations 4, 5 & 6, before repair, IMG\_2471, 02.10.2014*

*Locations 4, 5 & 6, before repair, IMG\_7466, 18.07.2015*

*Locations 4,5 & 6, infilling and reprofiling, IMG\_7483, 20.07.2015*

*Locations 4, 5 & 6, completed repair, 20.07.2015*

*Locations 4,5 & 6, after bracken strimming/crushing, IMG\_7627, 23.07.2015*

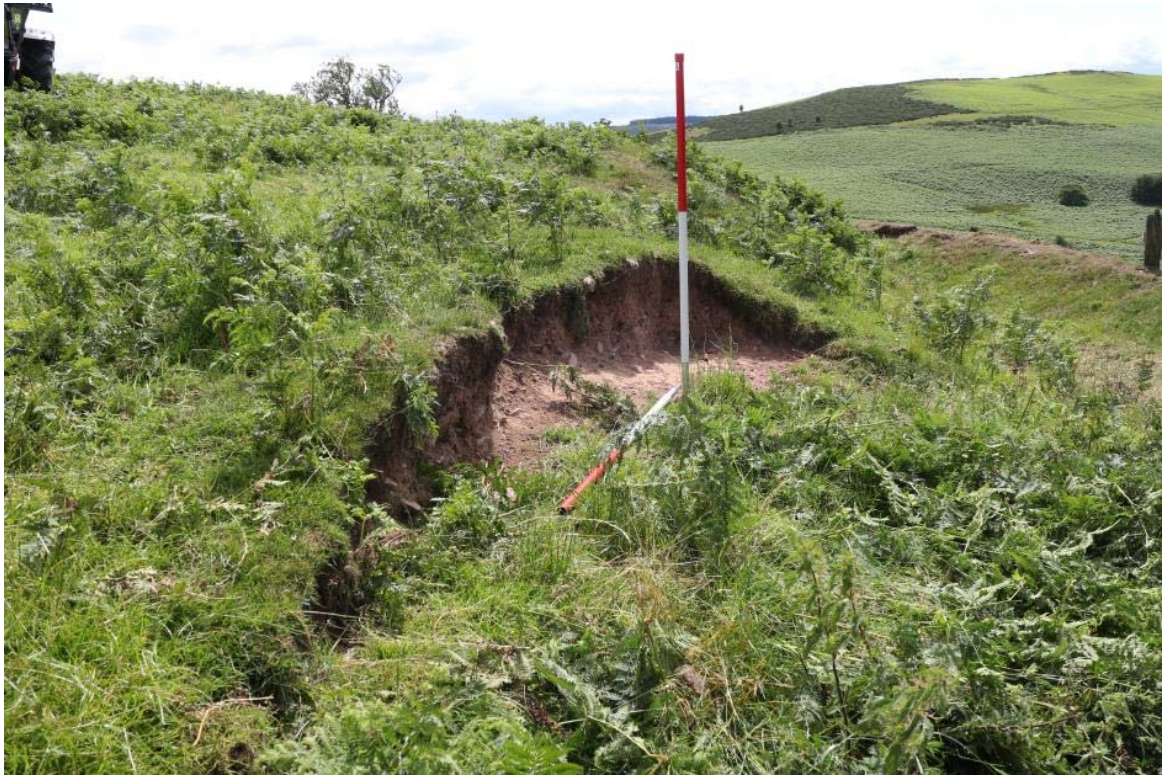
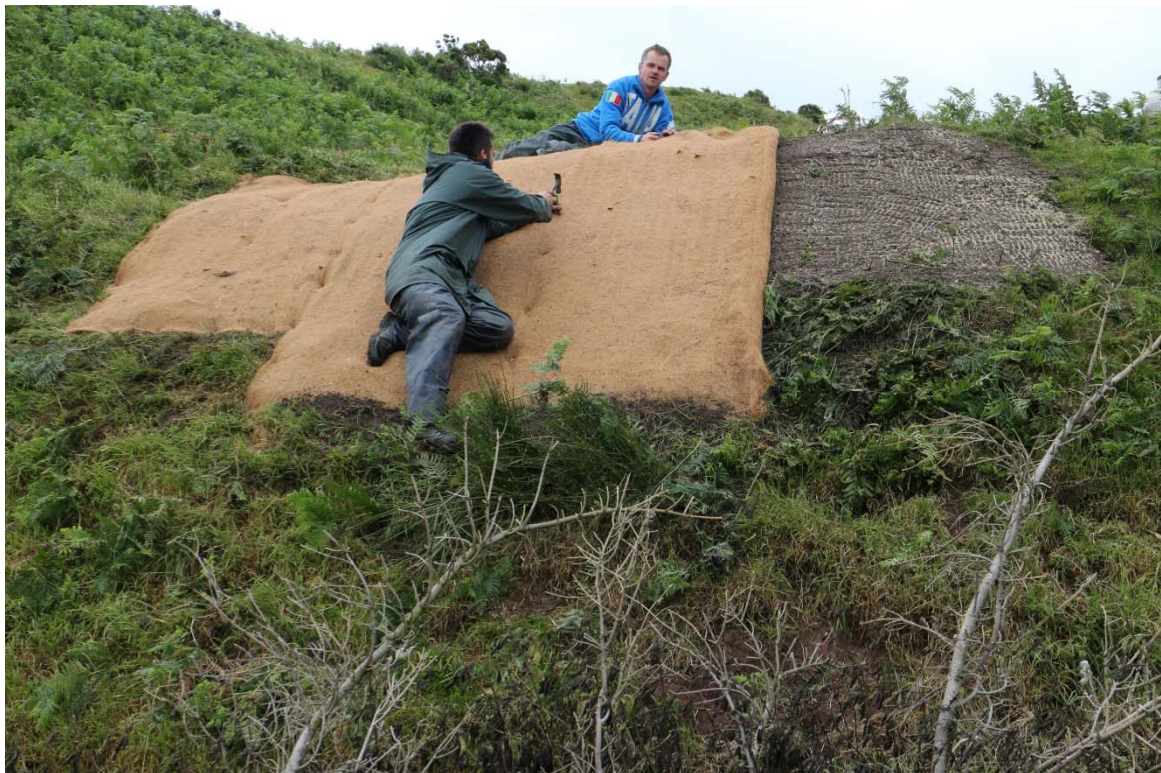
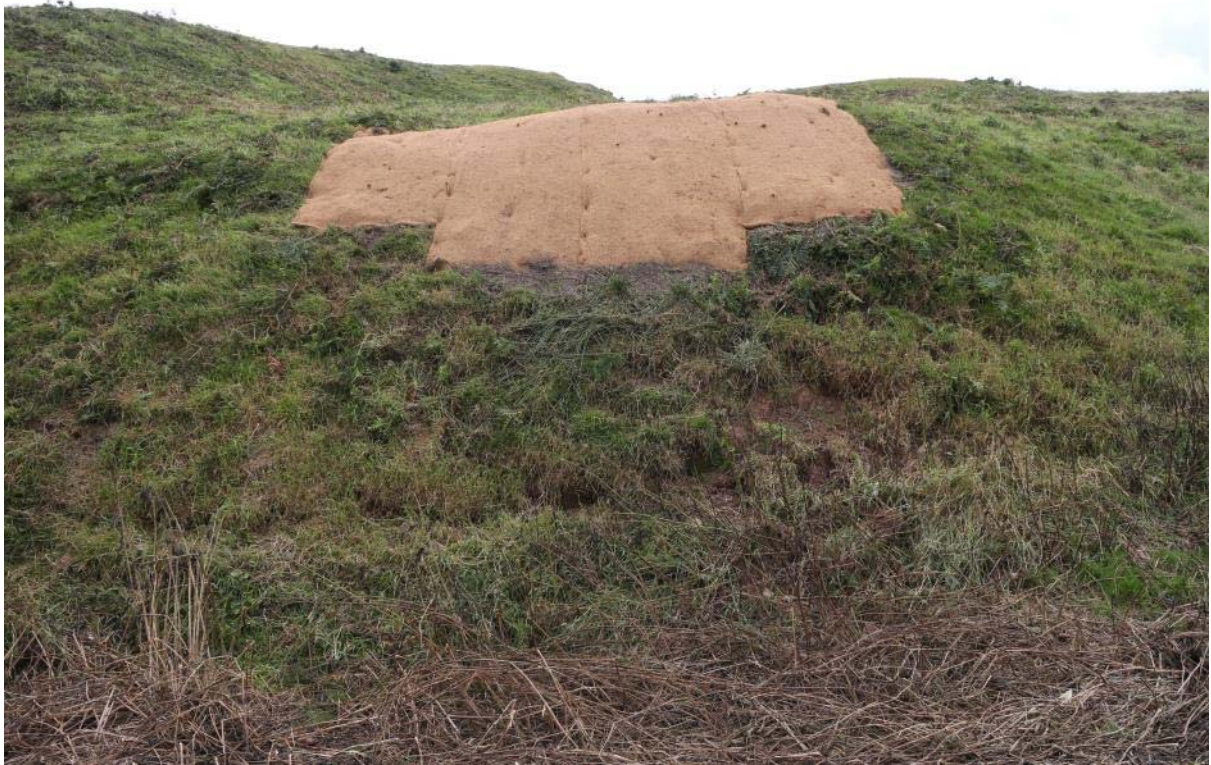
## Location 7

7. *Located on the NW side of the monument, at the break of slope on the inner edge of the ditch. Measures 3.7m long, 1m deep and 0.5m high;*
  8. *Located on the bank above the ditch on the northern side of the monument. Measures 11m long by 2m deep and 0.5m high;*

*Location 7, before repair, IMG\_7465, 18.07.2015*

*Location 7, infilled, reprofiled, installing Greenfix Eromat Type 6S, IMG\_7486, 20.07.2015*

*Location 7, completed repair, IMG\_7628, 23.07.2015*
