# **Castle Earthwork**

### **Scheduled Ancient Monument BR179**

## **Completion Report**

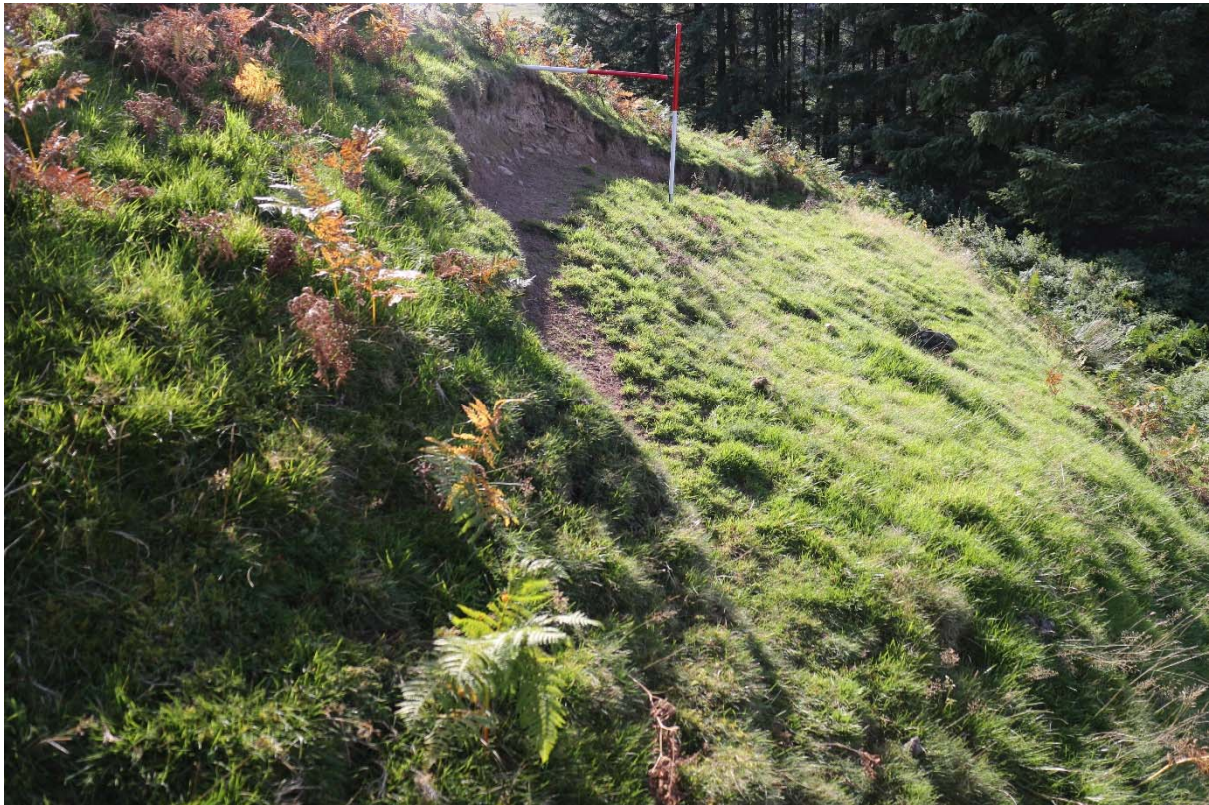
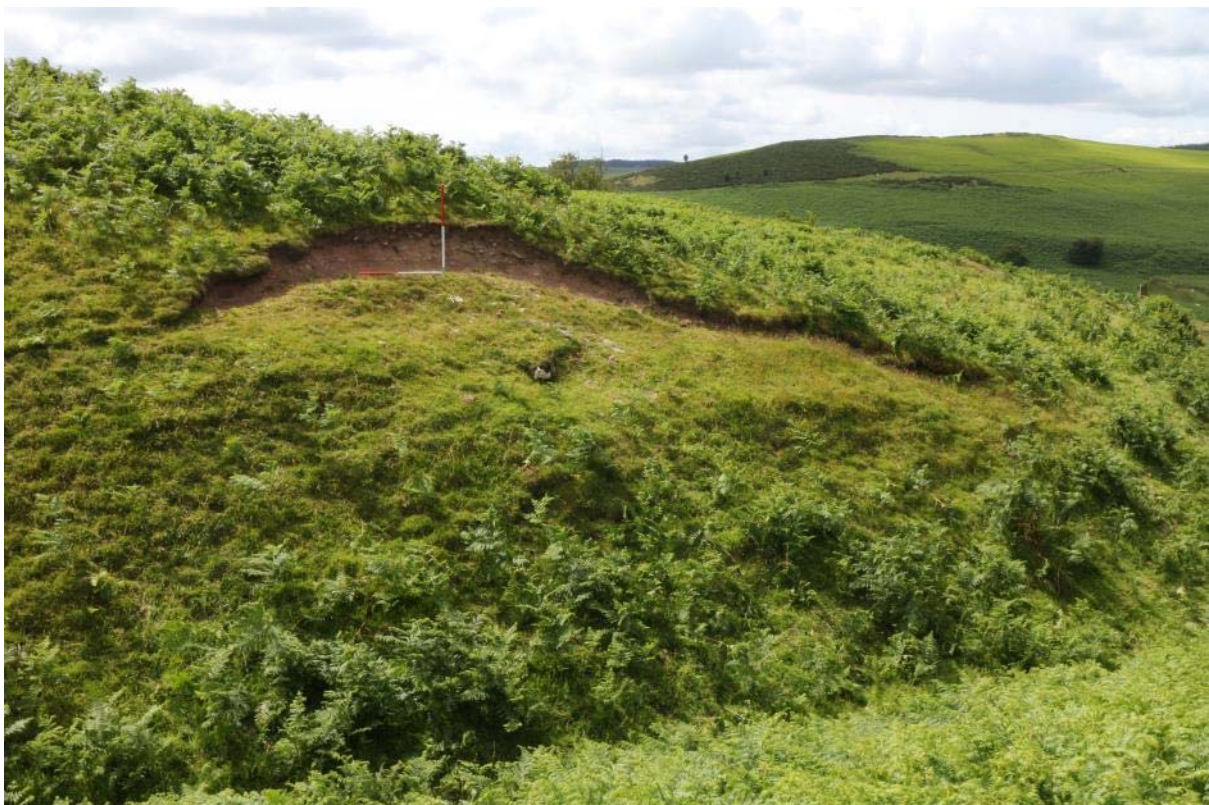
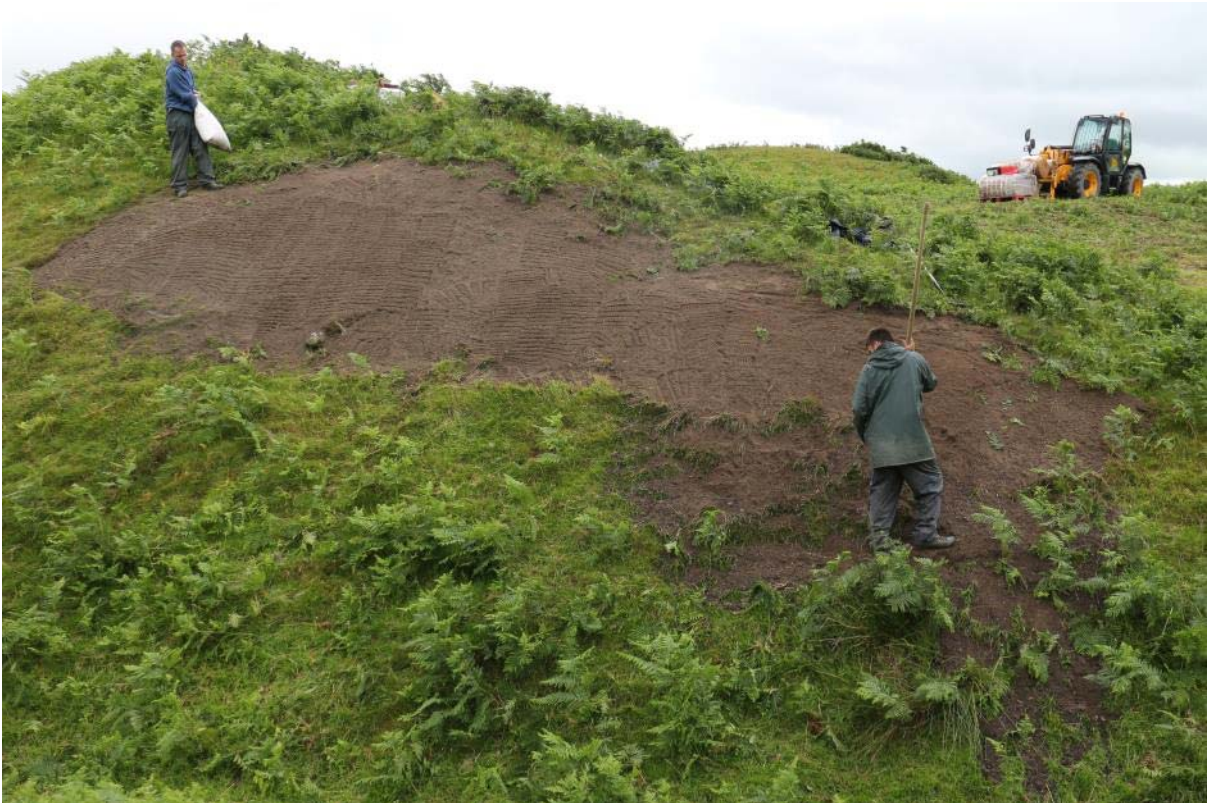
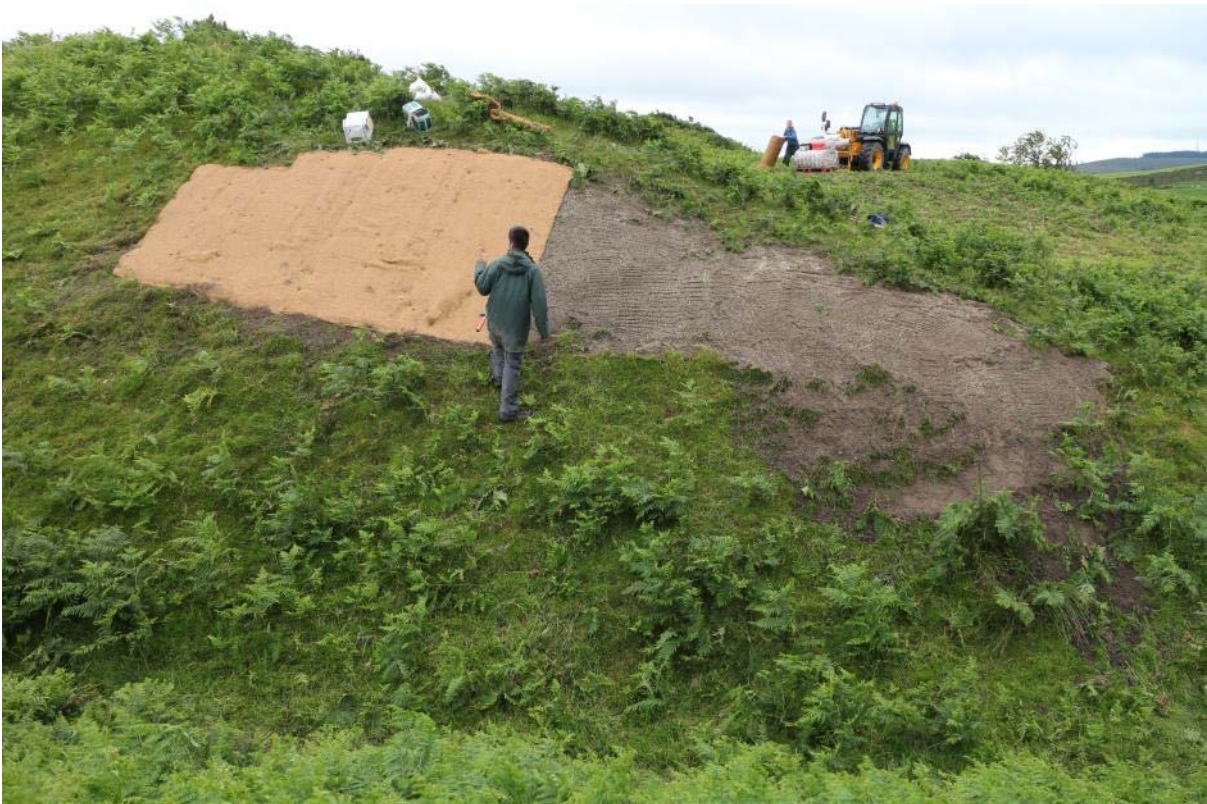
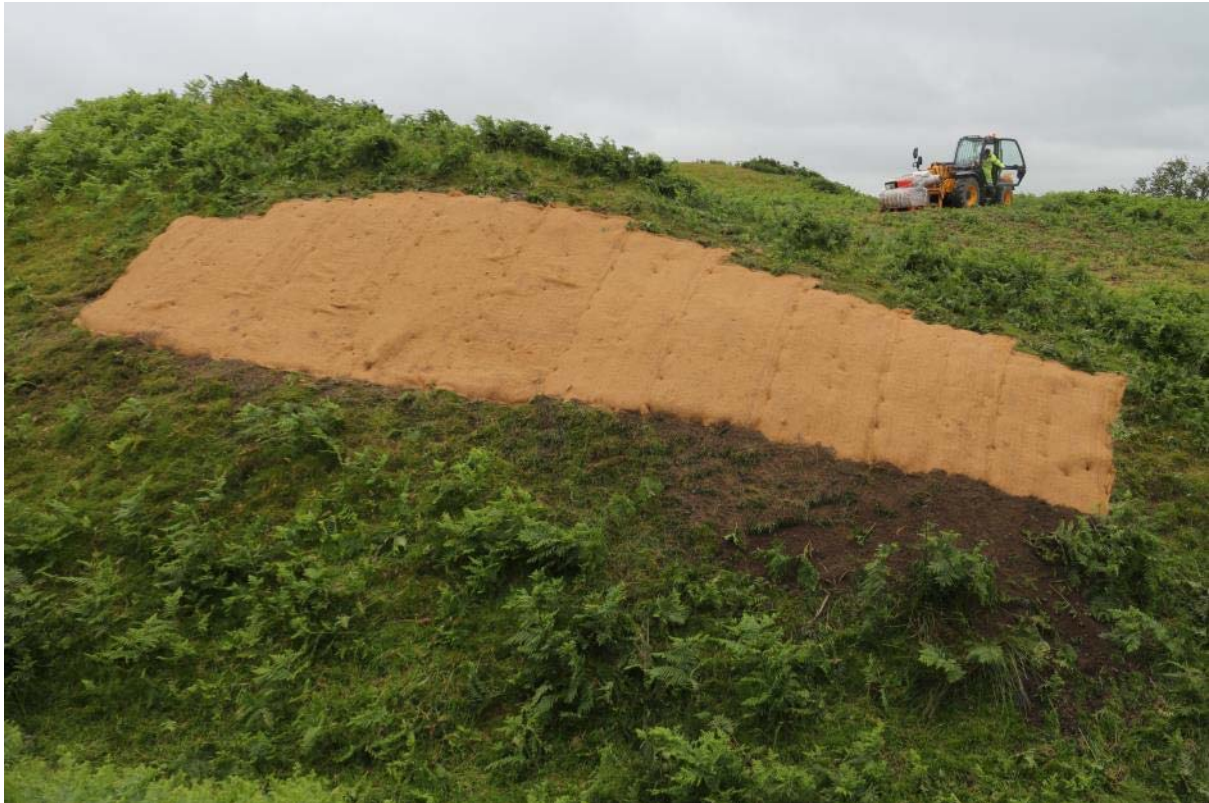
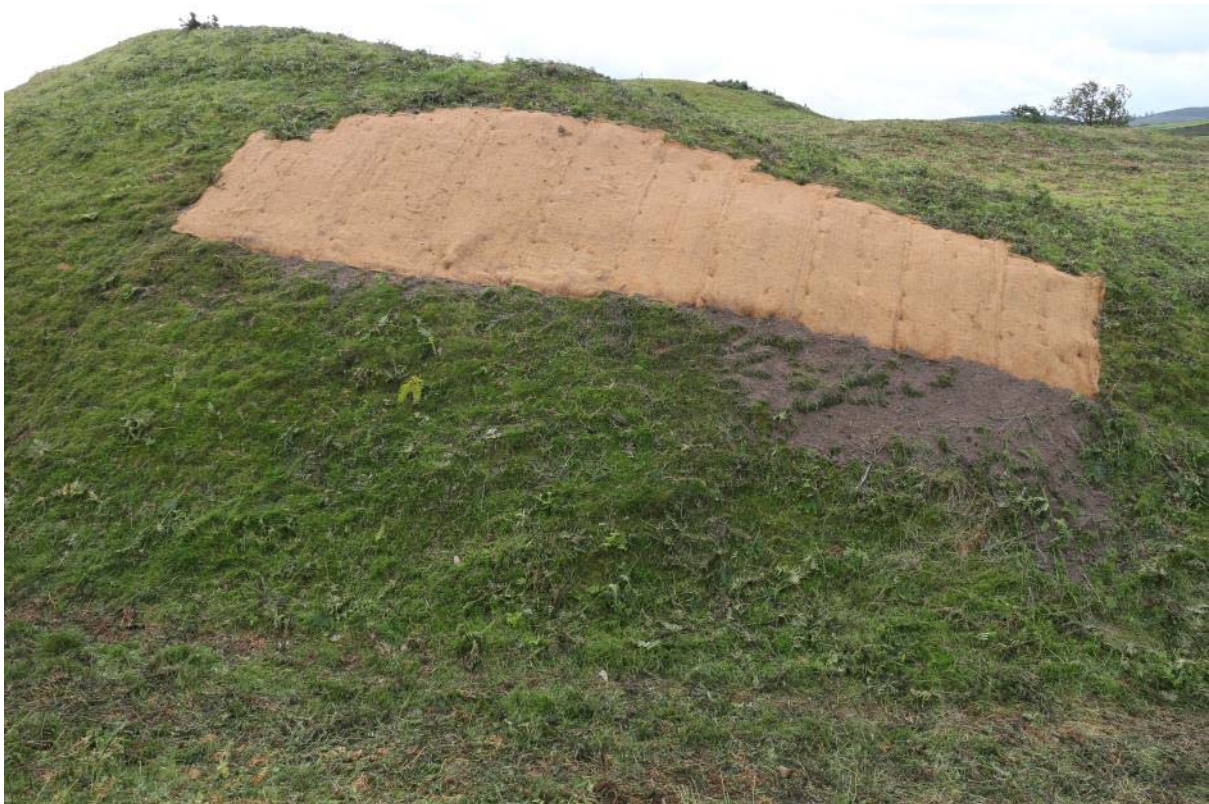
## Location 8

*Location 8, before repair, IMG\_2454, 02.10.2014*

*Location 8, before repair, IMG\_7457, 18.07.2015*

*Location 8, infilling and reprofiling, IMG\_7489, 20.07.2015*

*Location 8, installing Greenfix Eromat Type 6S, IMG\_7493, 20.07.2015*

*Location 8, completed repair, IMG\_7504, 20.07.2015*

*Location 8, after bracken strimming/crushing, IMG\_7630, 23.07.2015*

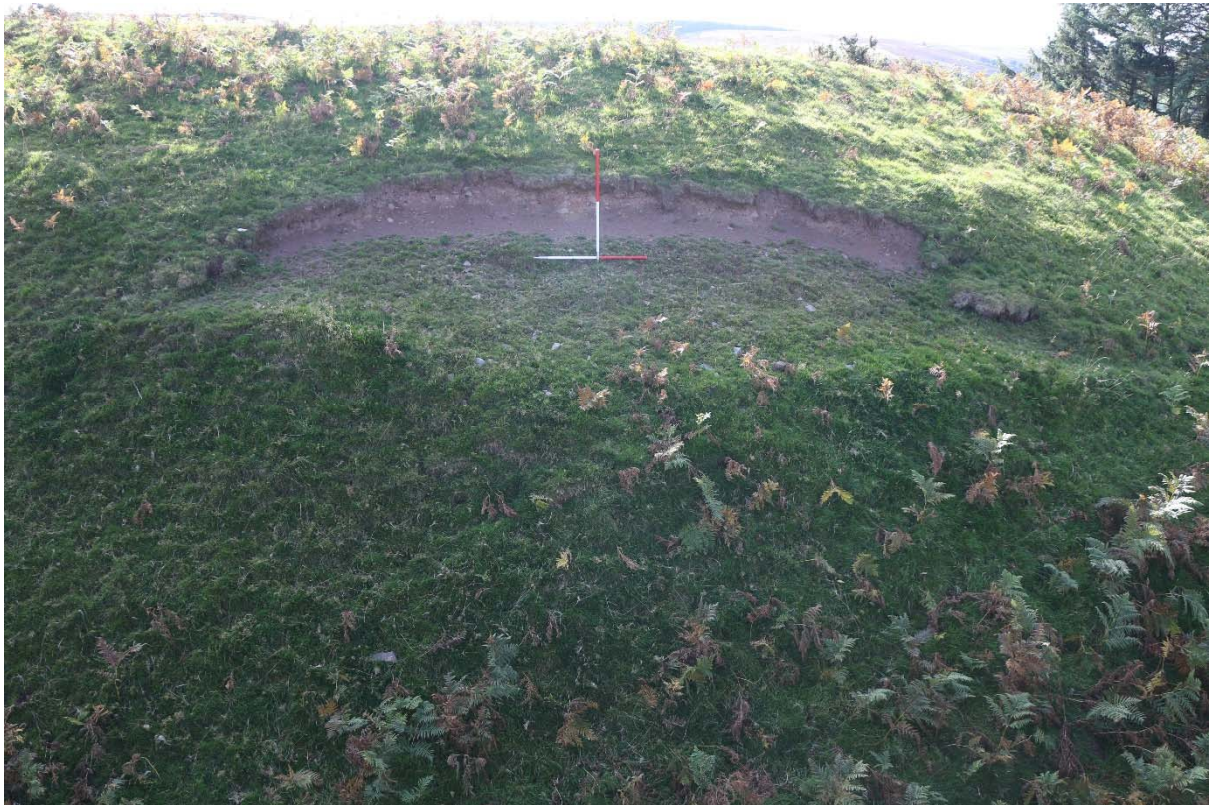
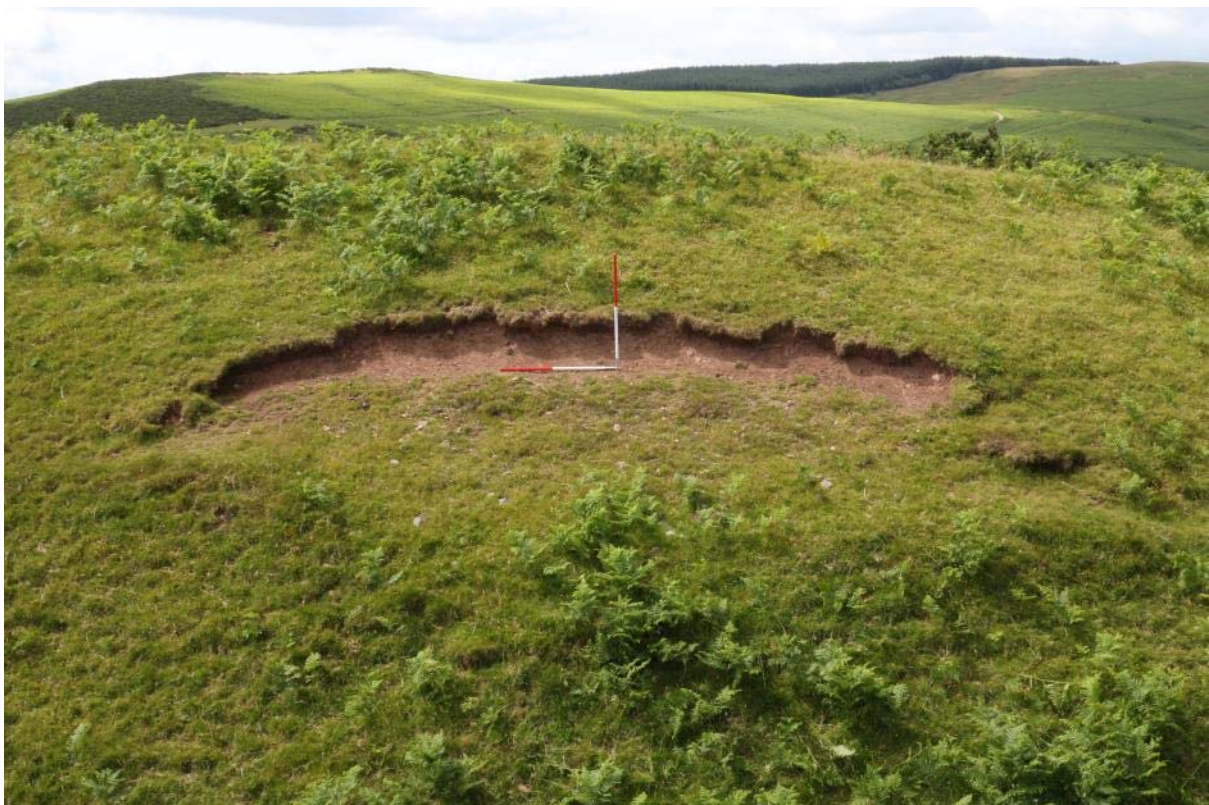
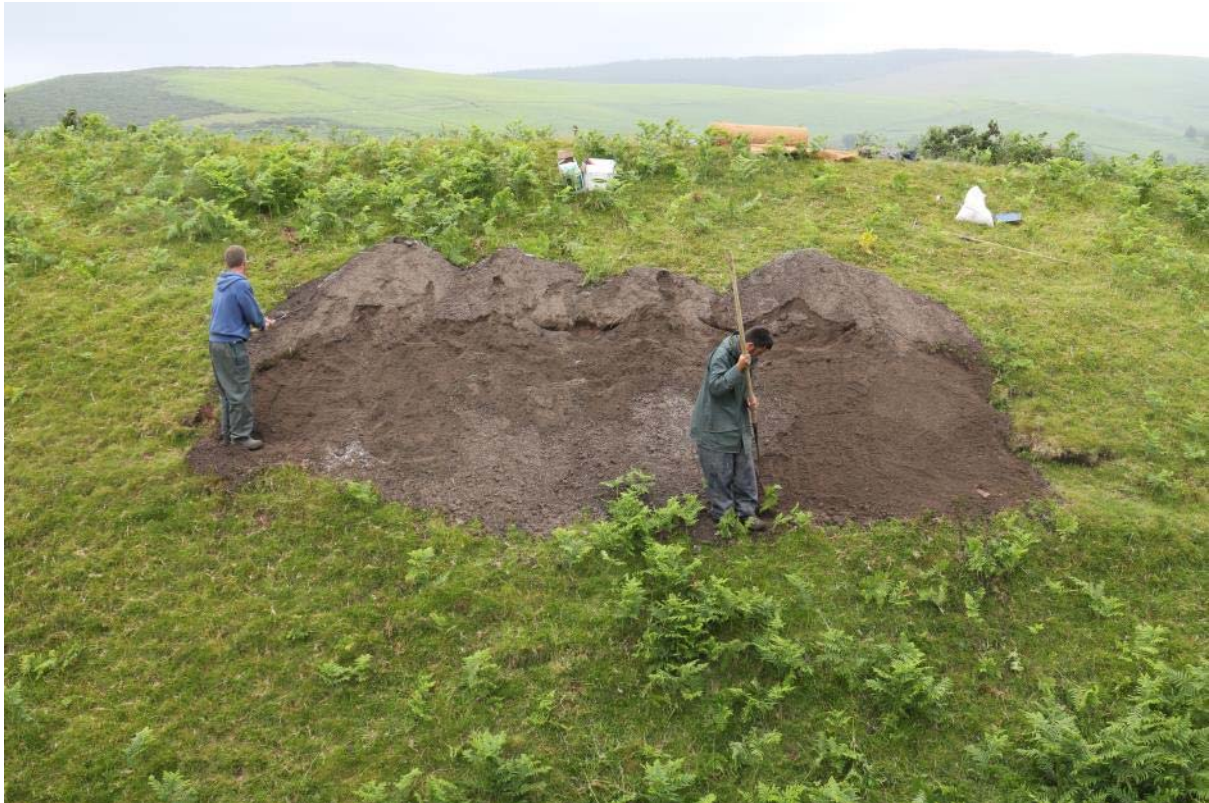
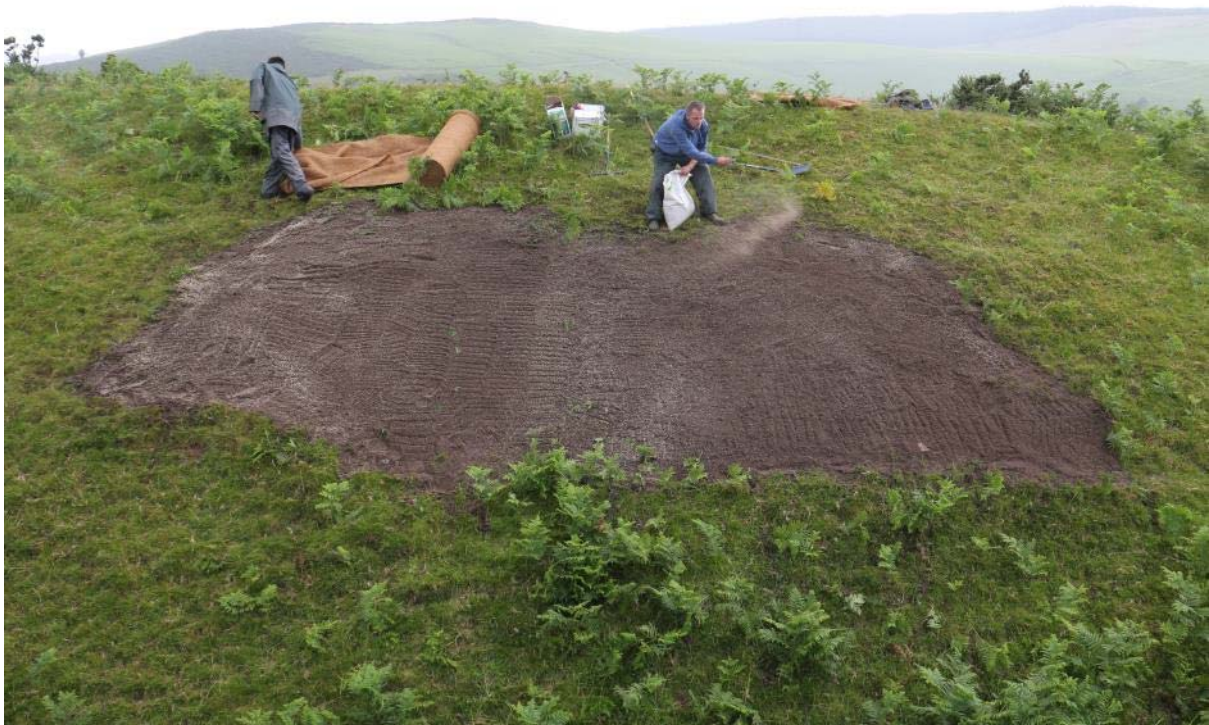
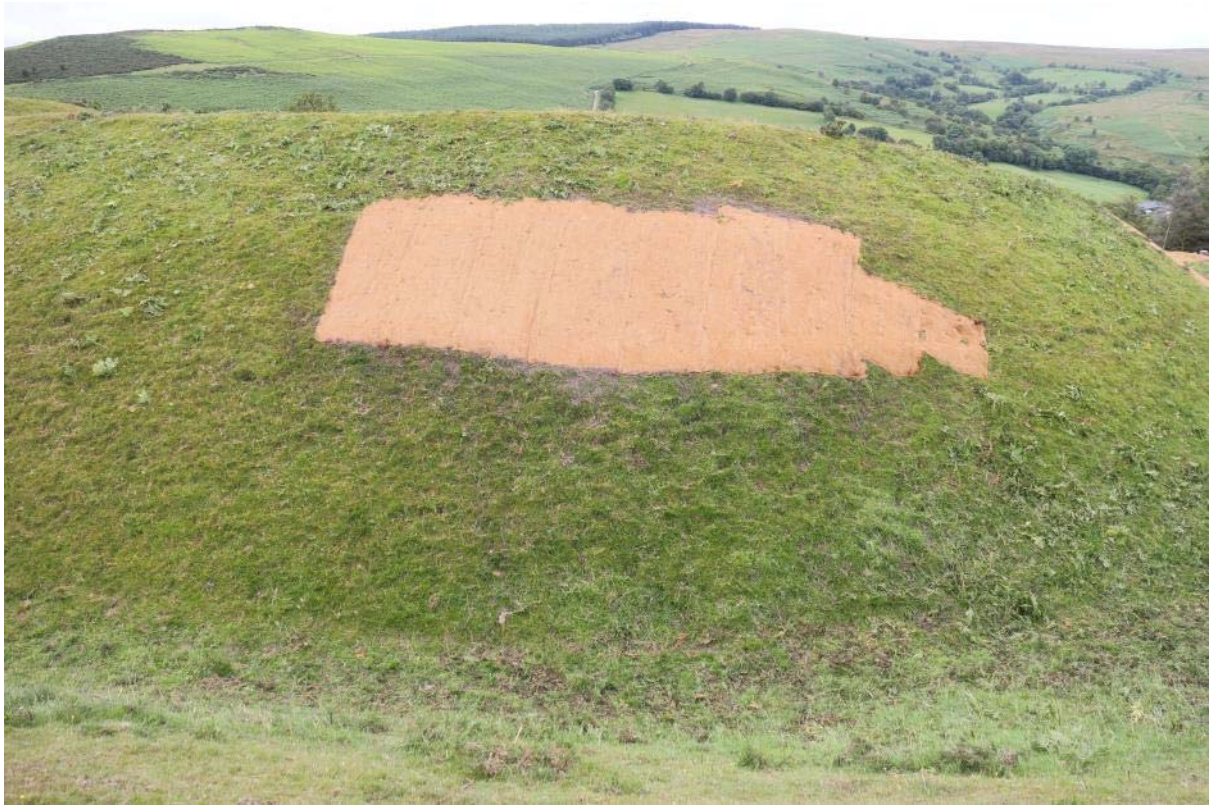
## Location 9

9. *Located 12m to the SE of scrape 8 on the bank about the ditch on the NE side of the monument. Measures 7m long by 2m deep and 0.4m high;*
  10. *A group of interconnected scrapes on the outer edge of the ditch on the eastern side of the monument. Collectively they measure 6m long by 1.5m deep and 1m high;*

*Location 9, IMG\_2446, 02.10.2014*

*Location 9, before repair, IMG\_7458, 18.07.2015*

*Location 9, infilling and reprofiling, IMG\_7507, 20.07.2015*

*Location 9, hand broadcasting grass seed before installing matting, IMG\_7508, 20.07.2015*

*Location 9, completed repair, after bracken strimming/crushing, IMG\_7631, 23.07.2015*

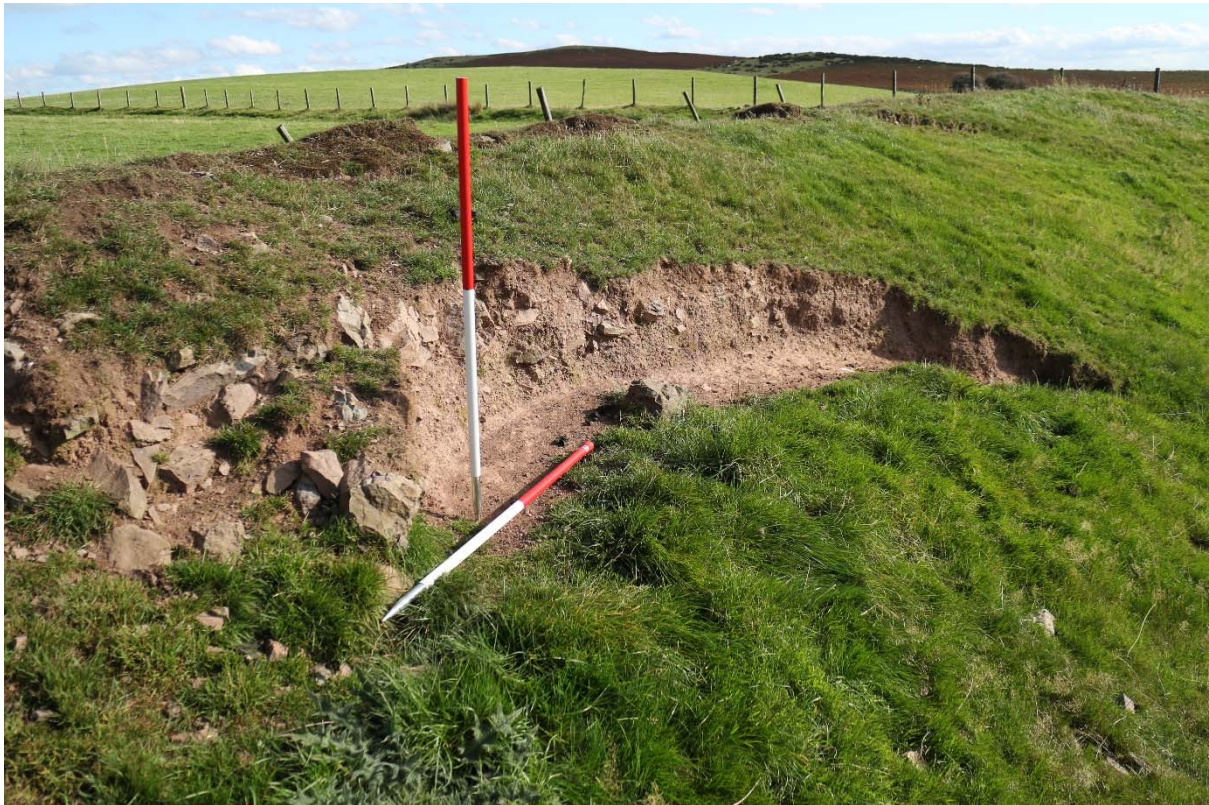
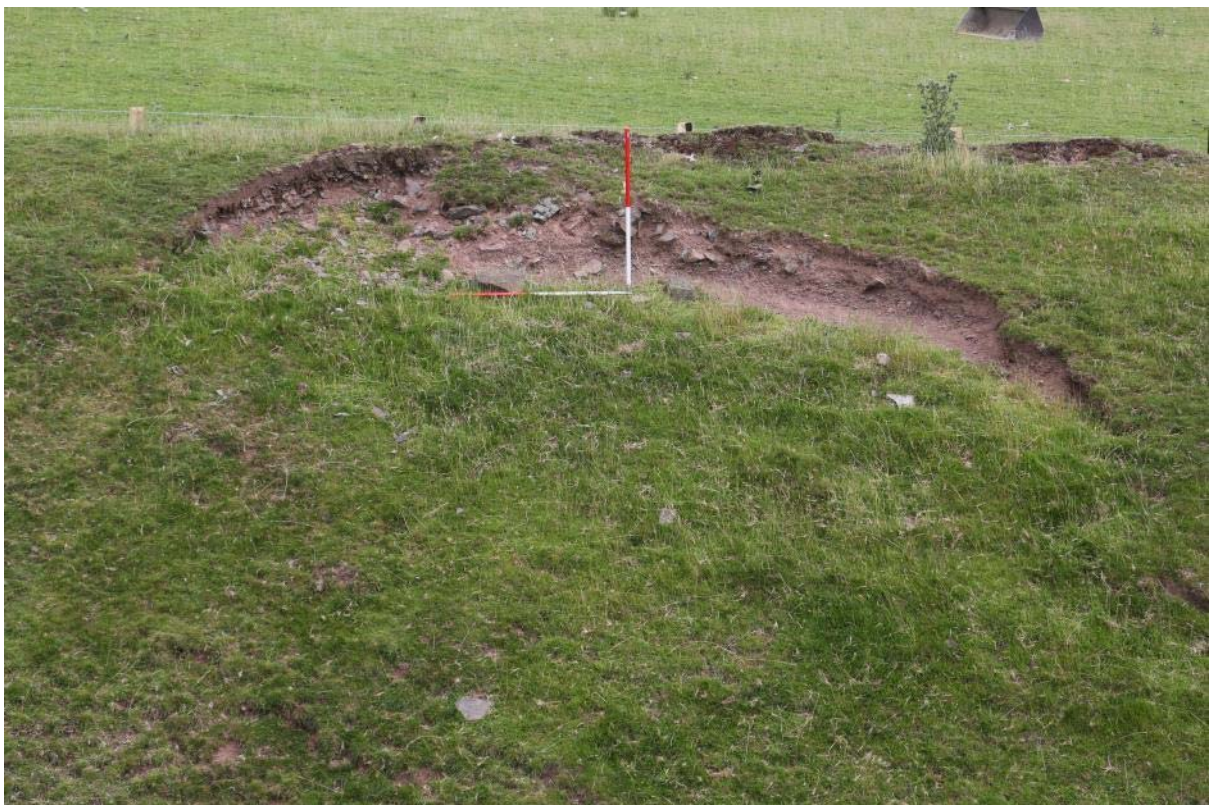
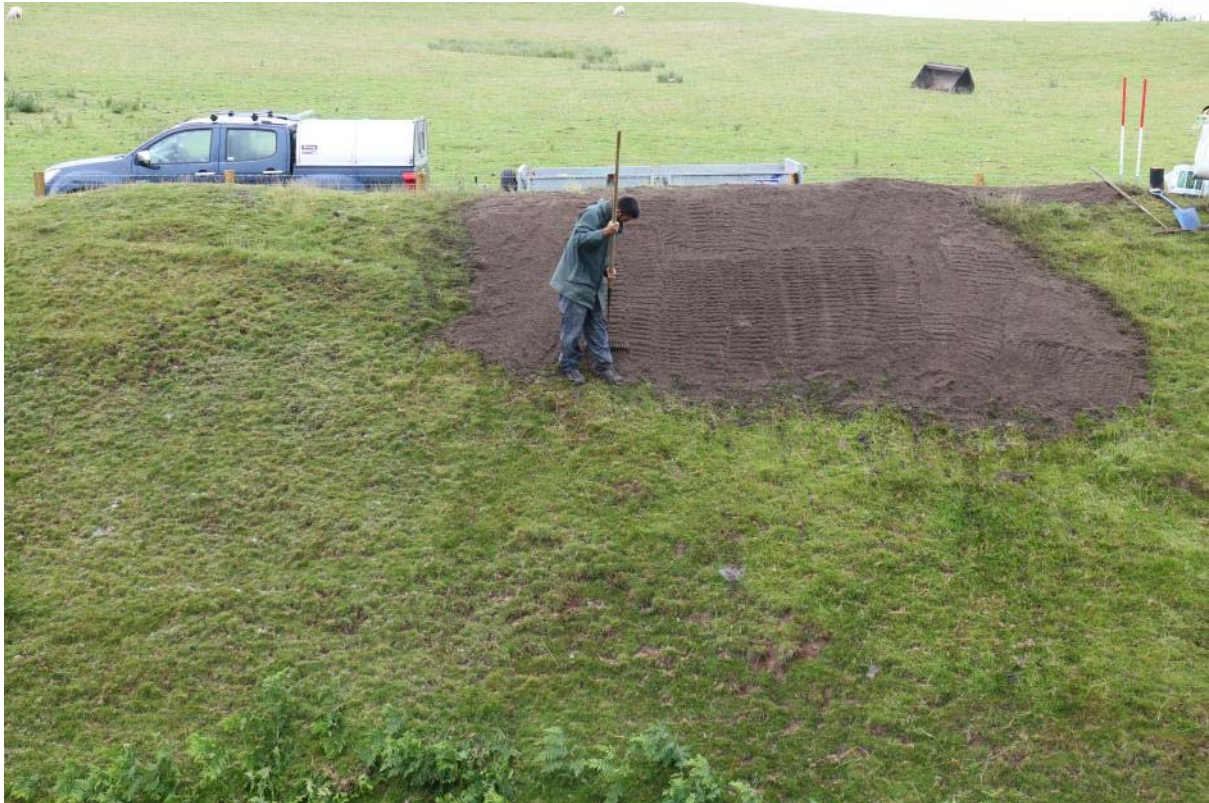
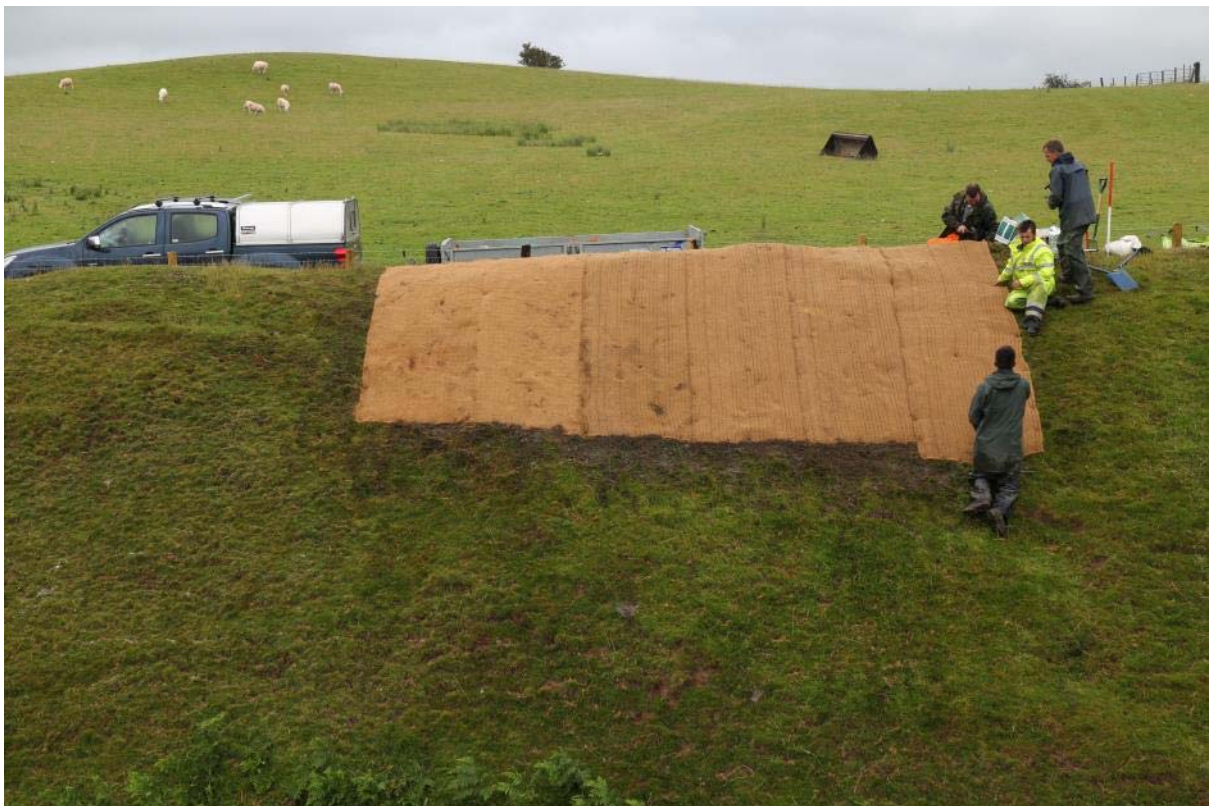
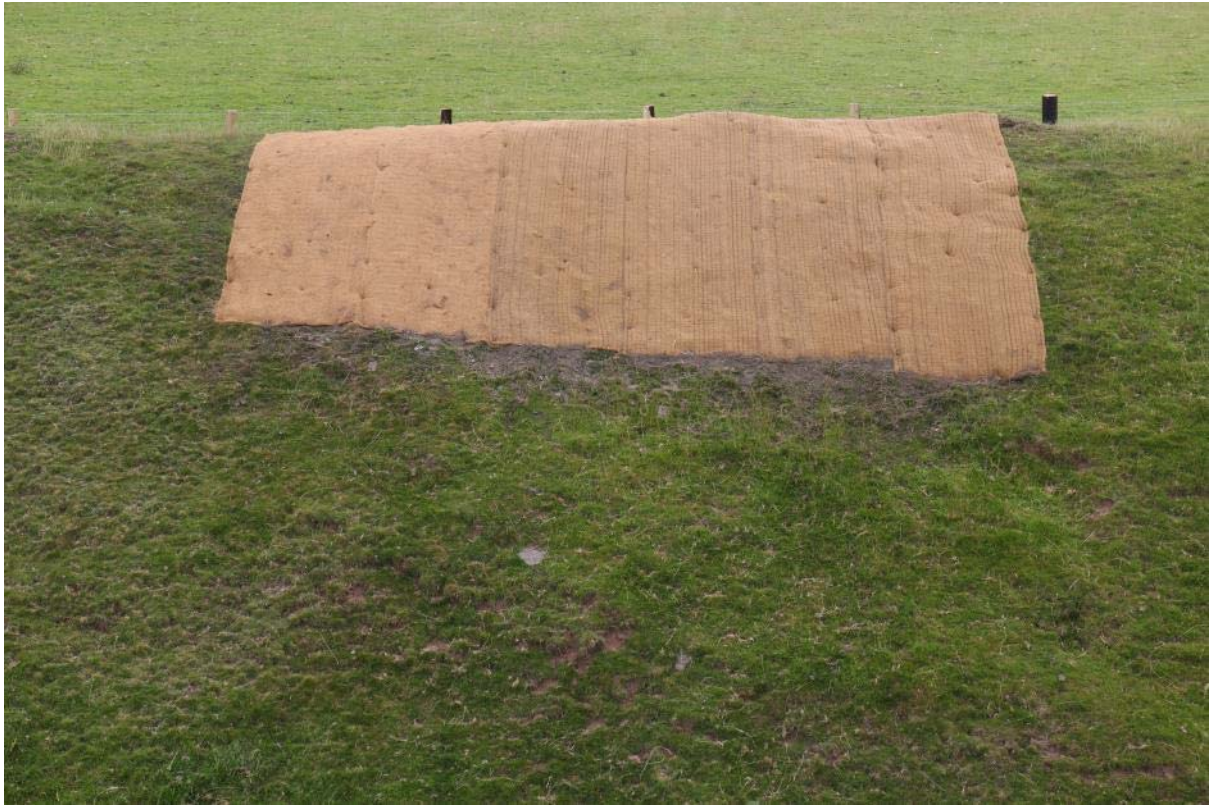
## Location 10

*Location 10, before repair, IMG\_2442, 02.10.2014*

*Location 10, before repair, IMG\_7469, 18.07.2015*

*Location 10, infilling and reprofiling, IMG\_7515 20.07.2015*

*Location 10, installing Greenfix Eromat Type 6S, IMG\_7519, 20.07.2015*

*Location 10, completed repair, IMG\_7635, 23.07.2015*

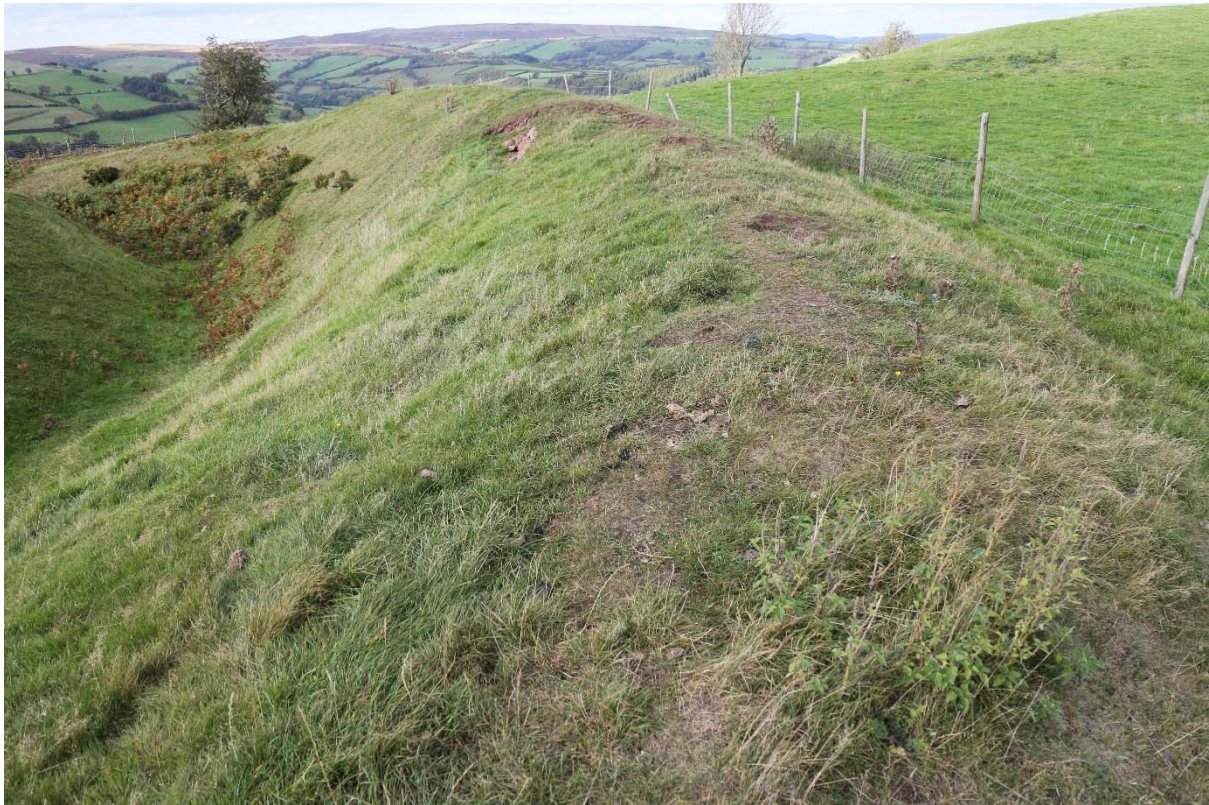
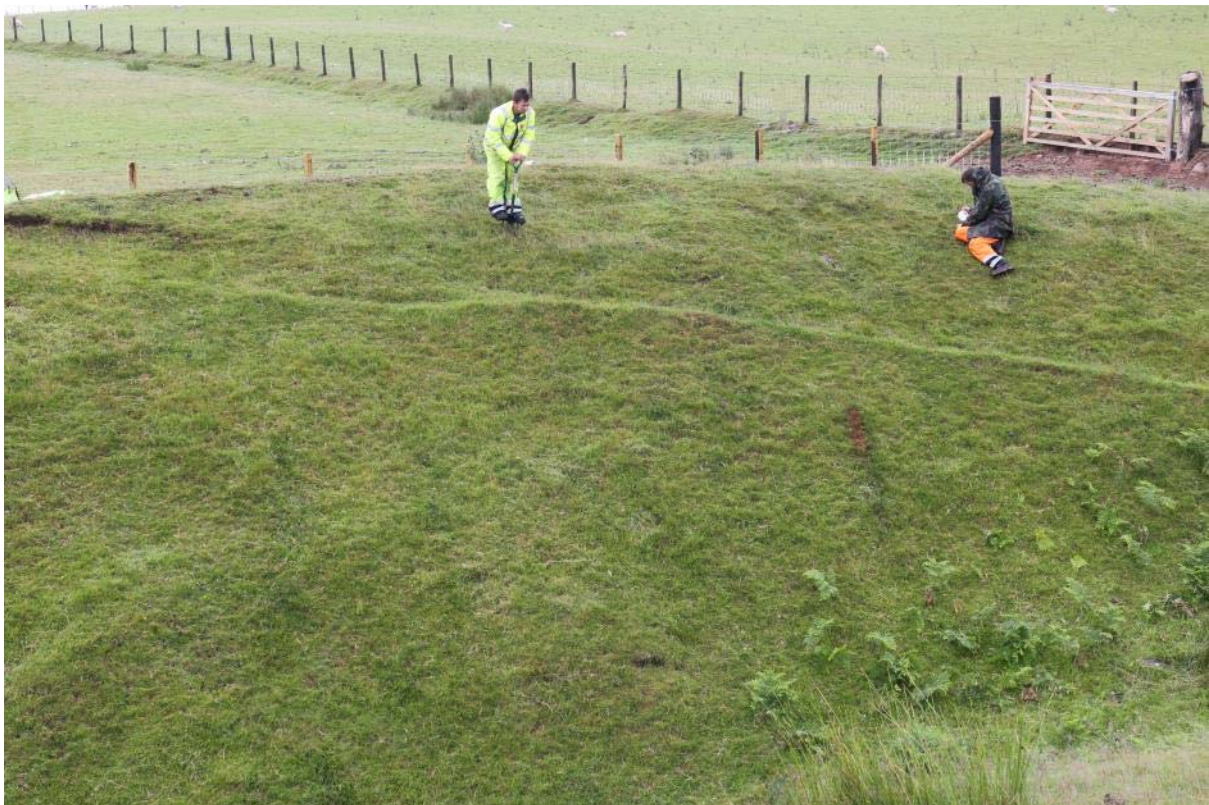
## Location 11

11. *A line of small scrapes and erosion scars along the top of the outer bank on the eastern side of the monument.*
2. *There are a number of areas where the first signs of erosion are evident;*

*Location 11, before sward enhancement works, IMG\_2506, 02.10.2014*

*Location 11, during sward enhancement works, IMG\_7518, 20.07.2015*

At the time of undertaking conservation works, AQB Historic Landscapes assessed that the erosion scars at Locations 3 and 11 should naturally re-establish a grass sward cover and thereby stabilise. Accordingly, they were treated using sward enhancement techniques, as described below, rather than by infilling with topsoil and matting.

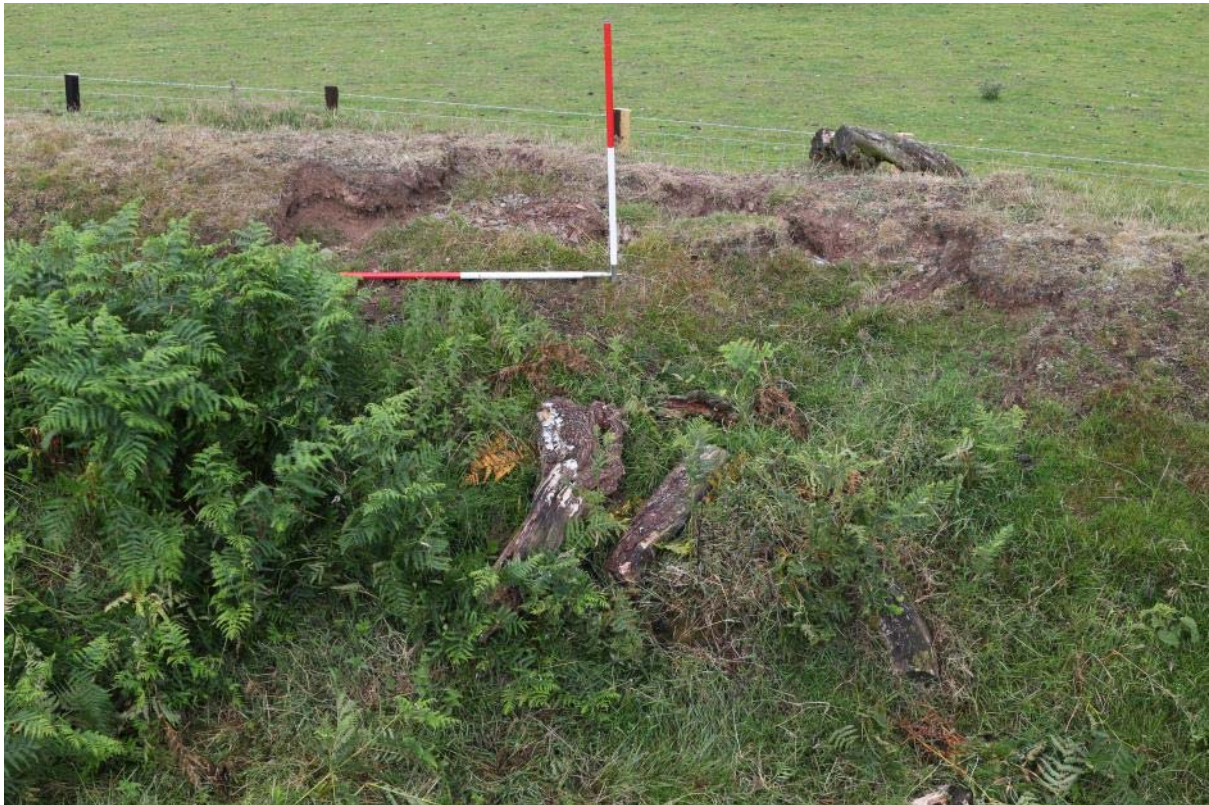
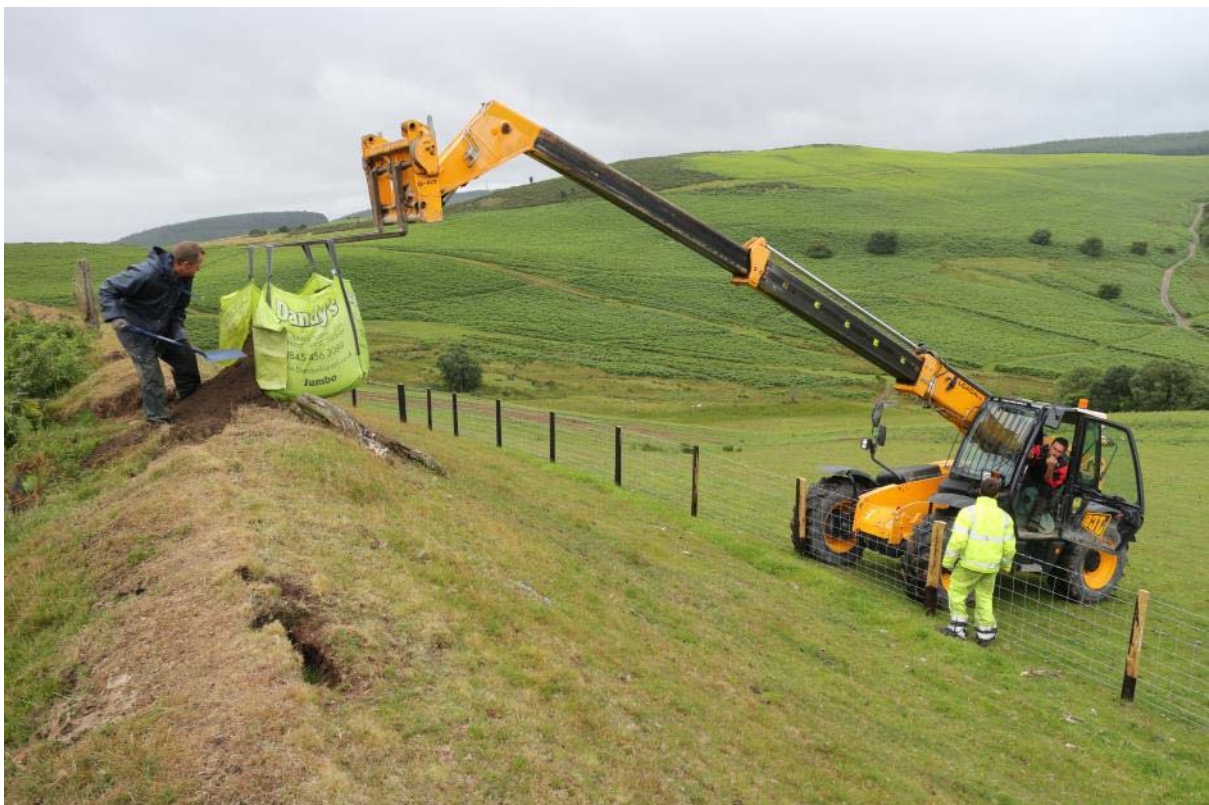
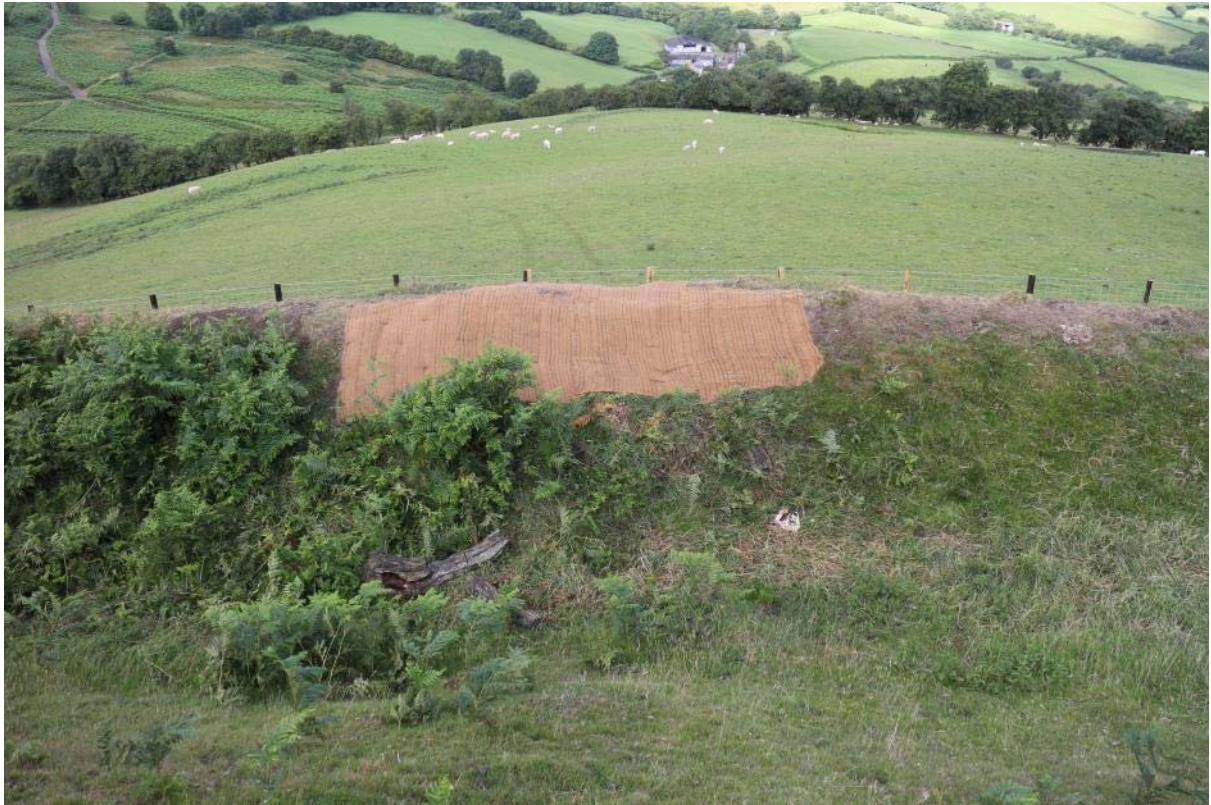
## Location 12

*Location 12, before repair, IMG\_7524, 21.07.2015*

*Location 12, commencing infilling and reprofiling, IMG\_7529, 21.07.2015*

*Location 12, completed repair, IMG\_7530, 21.07.2015*

This made available materials to repair two, more significant erosion scars additional to those included in the Scheduled Ancient Monument Management Plan (June 2014), shown as Locations 12 and 13 on the Plan above.

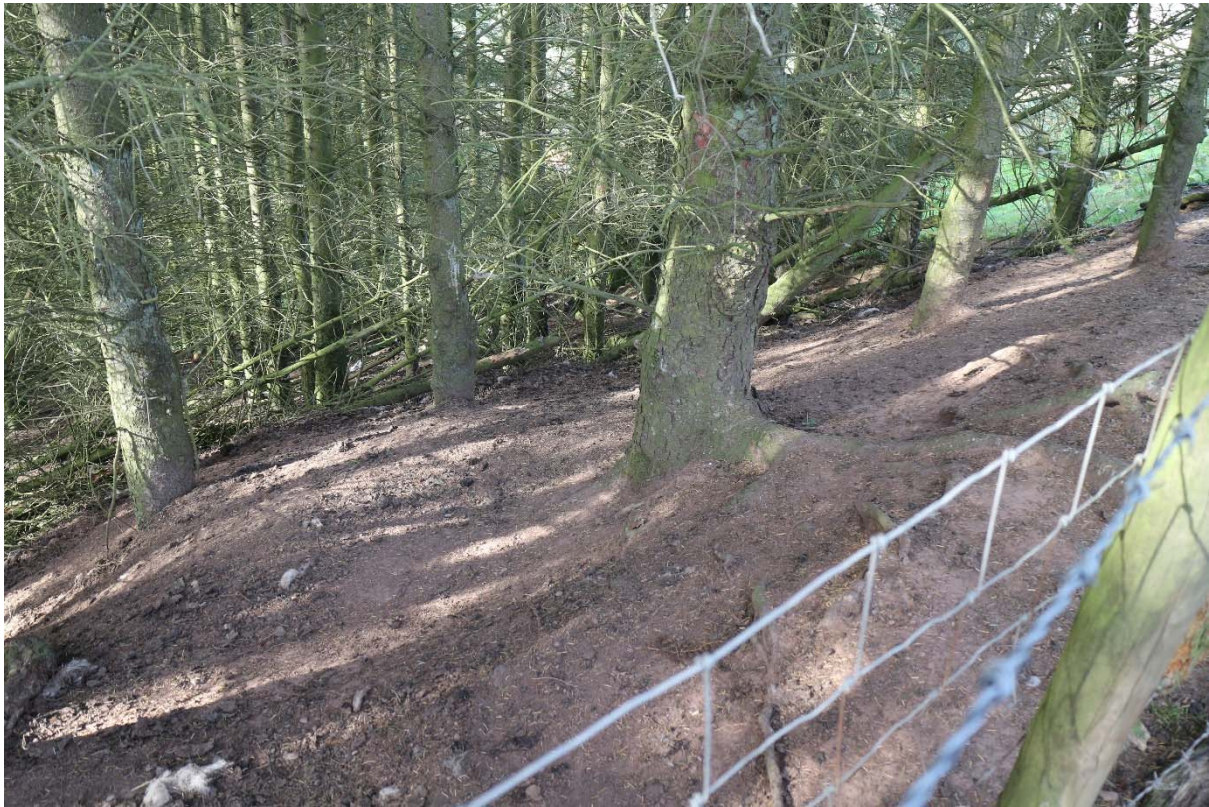
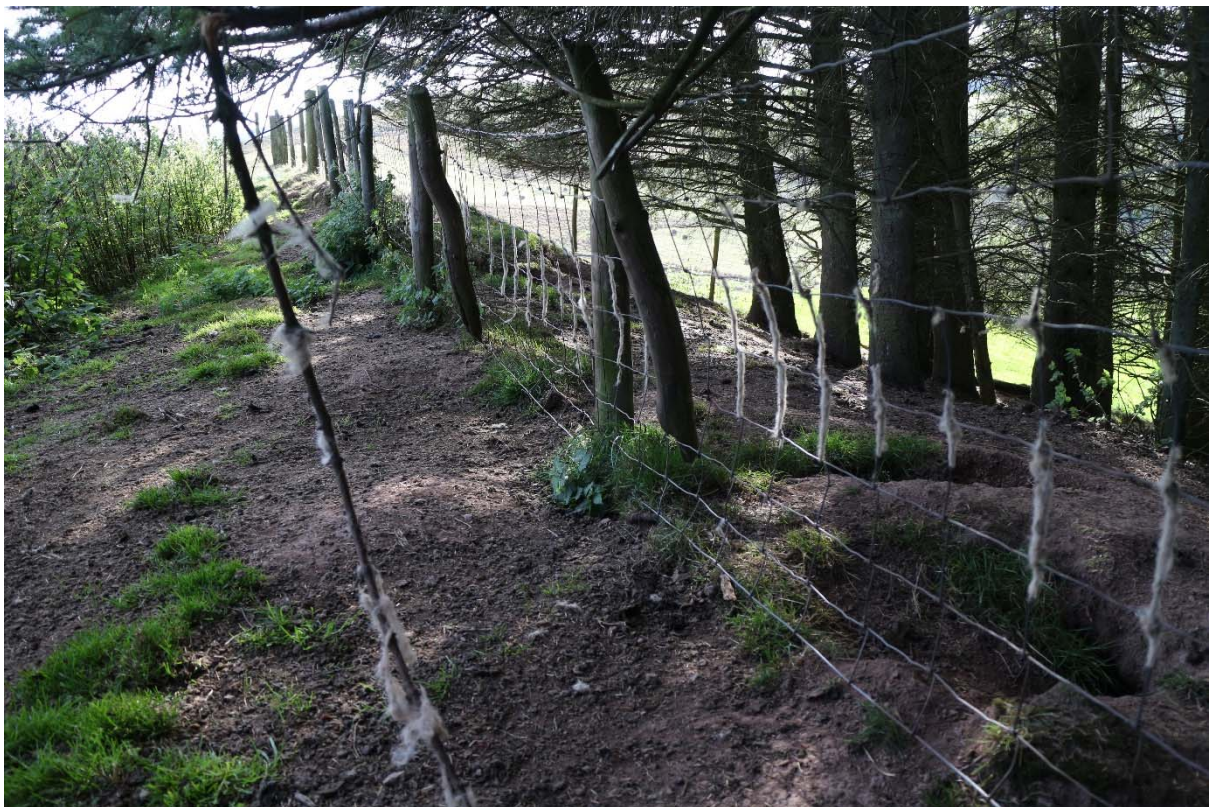
3. *On the NW side of the monument a conifer plantation has encroached on the external bank, with roots from a number of trees growing through the earthwork. The trees appear dilapidated and, should they fall, could cause considerable damage to the monument by removing material within the root plate. Dilapidated trees may shed limbs in the direction of the earthwork remains where they might cause damage. The overhanging branches also reduce light levels at the ground surface and inhibit the development of a grass sward.*

*Area of encroachment by conifers, showing underlying bare ground, IMG\_2459, 02.10.2014*

*Area of encroachment by conifers, showing underlying bare ground, IMG\_2460, 02.10.2014*

- *Fell plantation conifers within the scheduled area to prevent further damage to the earthwork caused by roots and to guard against more serious damage through trees falling. Removing the conifers will also enable the grass to regenerate in the western ditch. The felling work was undertaken by Mr Morgan prior to the conservation works described in this Completion Report being carried out.*
