# **Castle Earthwork**

### **Scheduled Ancient Monument BR179**

## **Completion Report**

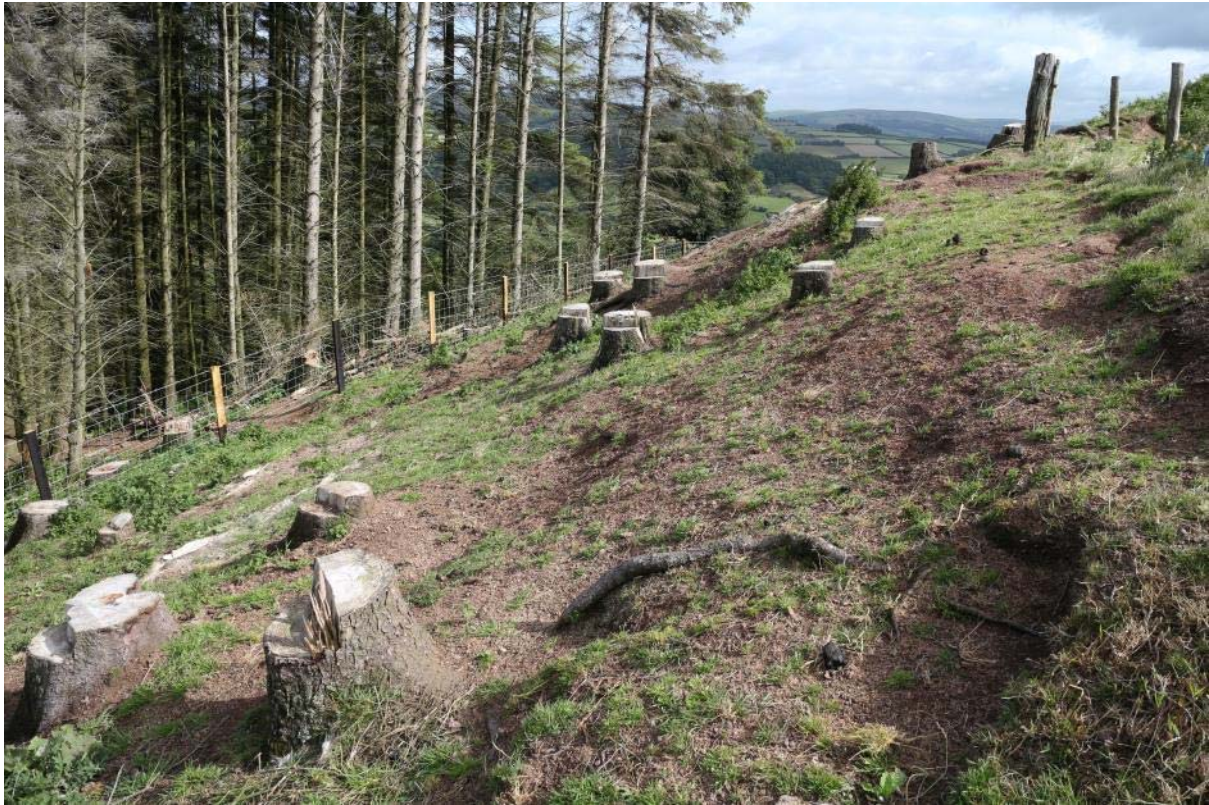
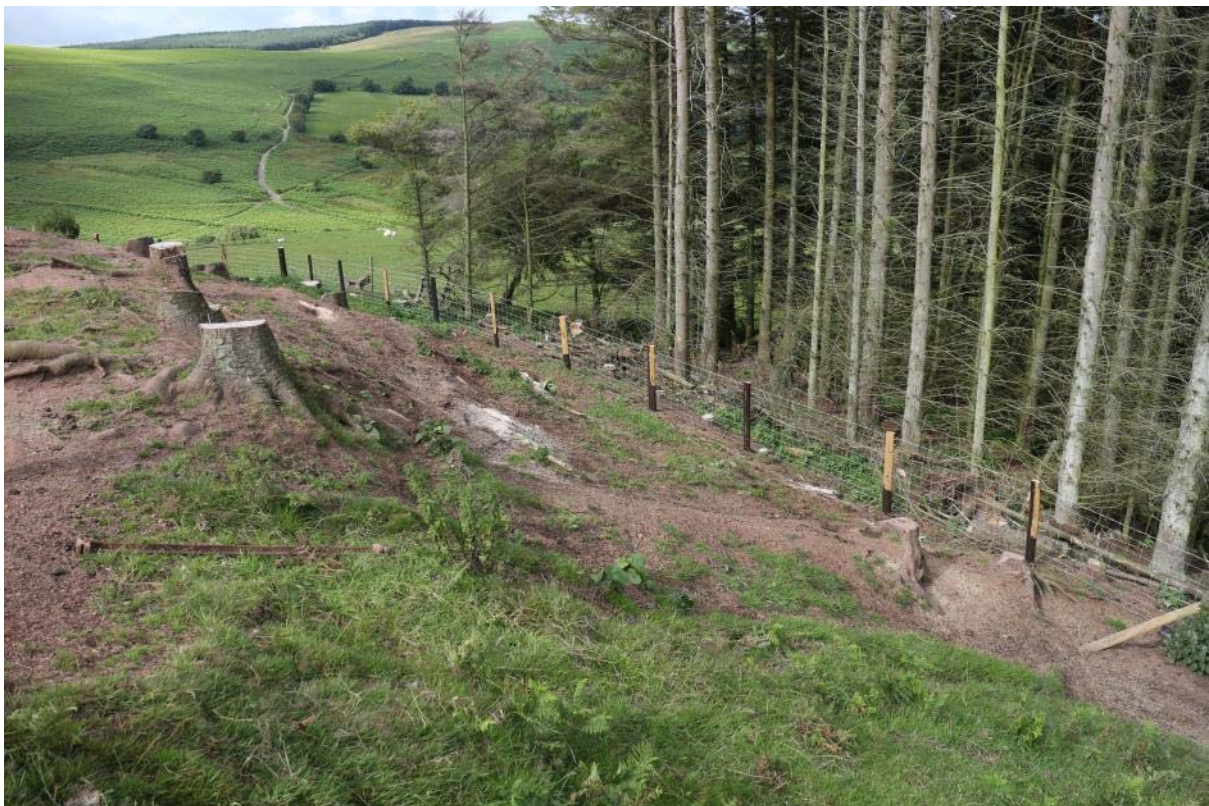
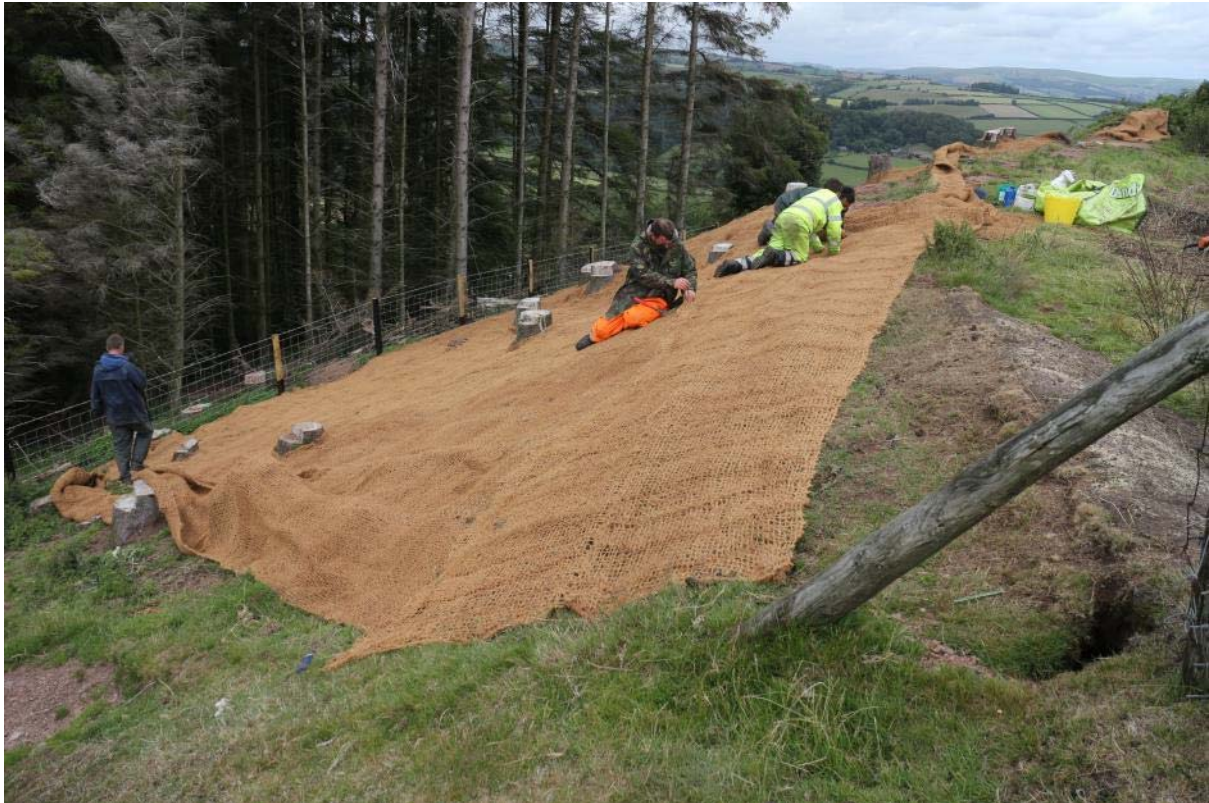
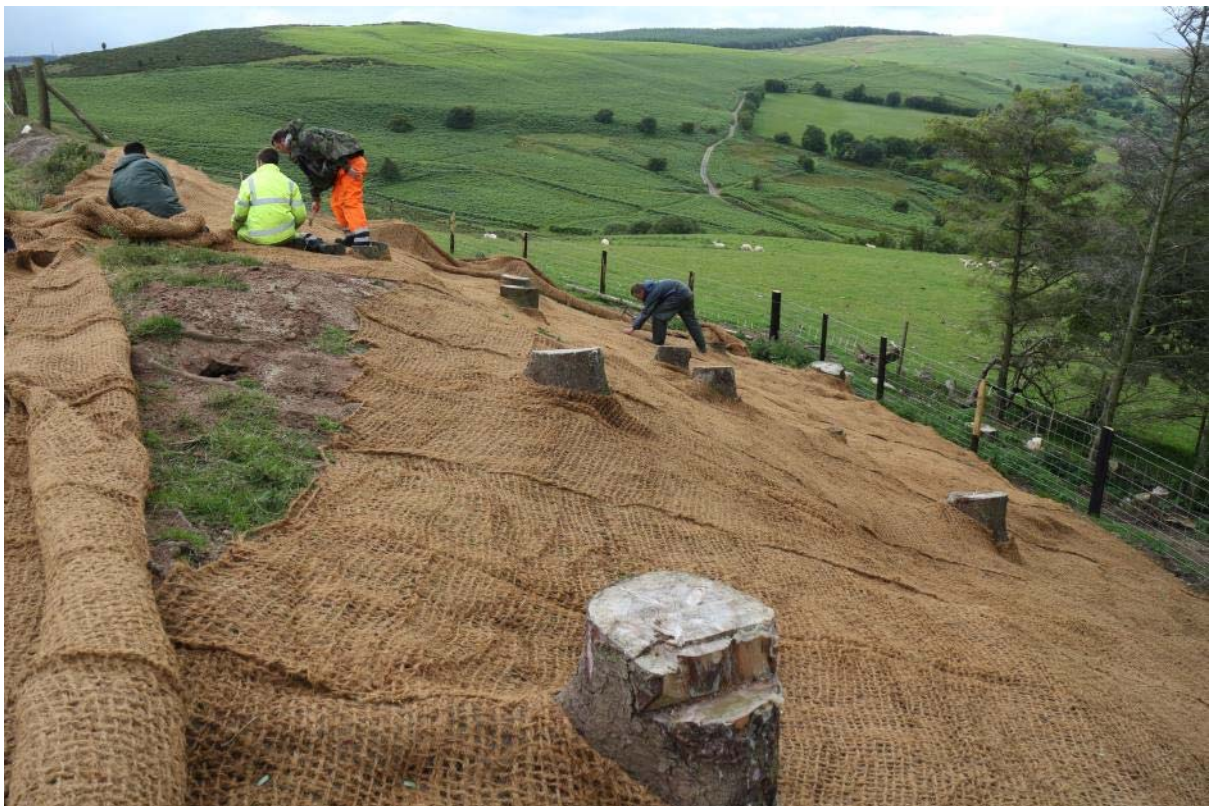
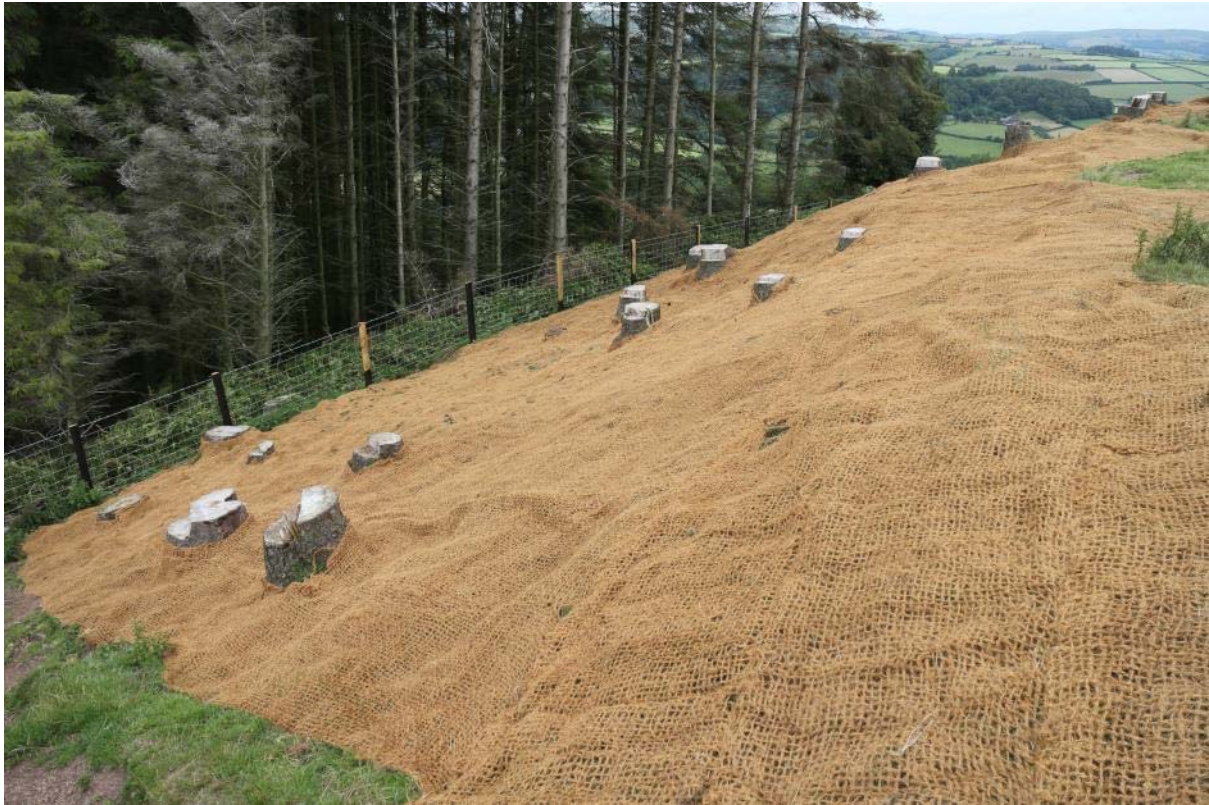
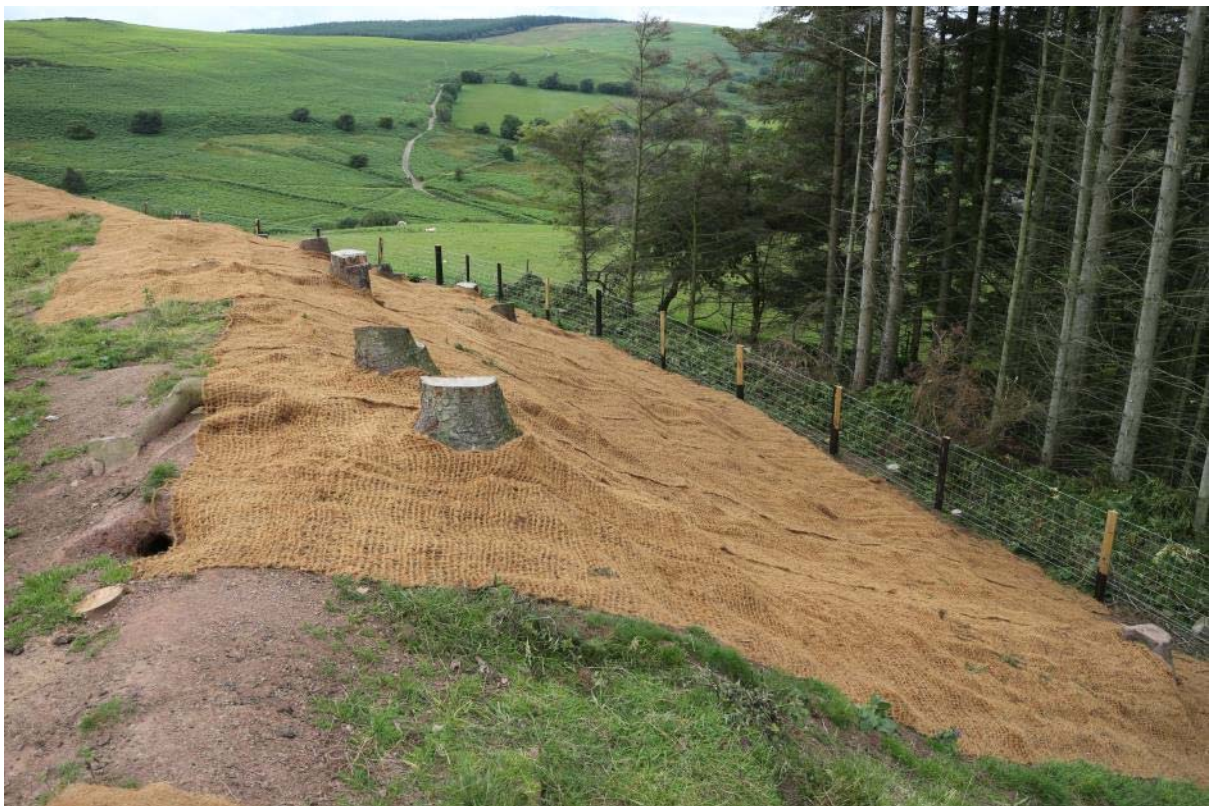
*After felling and re-fencing by Mr Morgan, looking east, IMG\_7533, 21.07.2015*

*After felling and re-fencing by Mr Morgan, looking west, IMG\_7534, 21.07.2015*

*Installing Geocoir 900 matting, IMG\_7537, 21.07.2015*

*Installing Geocoir 900 matting, IMG\_7542, 21.07.2015*

*Completed repair, looking east, IMG\_7620, 23.07.2015*

*Completed repair, looking west, IMG\_7622, 23.07.2015*

As part of conservation works, a limited amount of remaining brash was removed from the extent of the Scheduled Ancient Monument, with smaller stumps cut to ground level.

- Sown by hand broadcasting with the drought tolerant grass seed mix at a rate of 35 grams per square metre;
- Covered with Greenfix Geocoir 900 Matting (see Appendix 4), the matting being secured to the substrate using a combination of 100 mm and 150 mm long Green Stakes (see Appendix 3), at a density not exceeding six per square metre.
