**Mumbles Pier
Restoration and
RNLI Lifeboat
Station, The
Mumbles, Swansea**

**Historic Building
Assessment**

October 2010

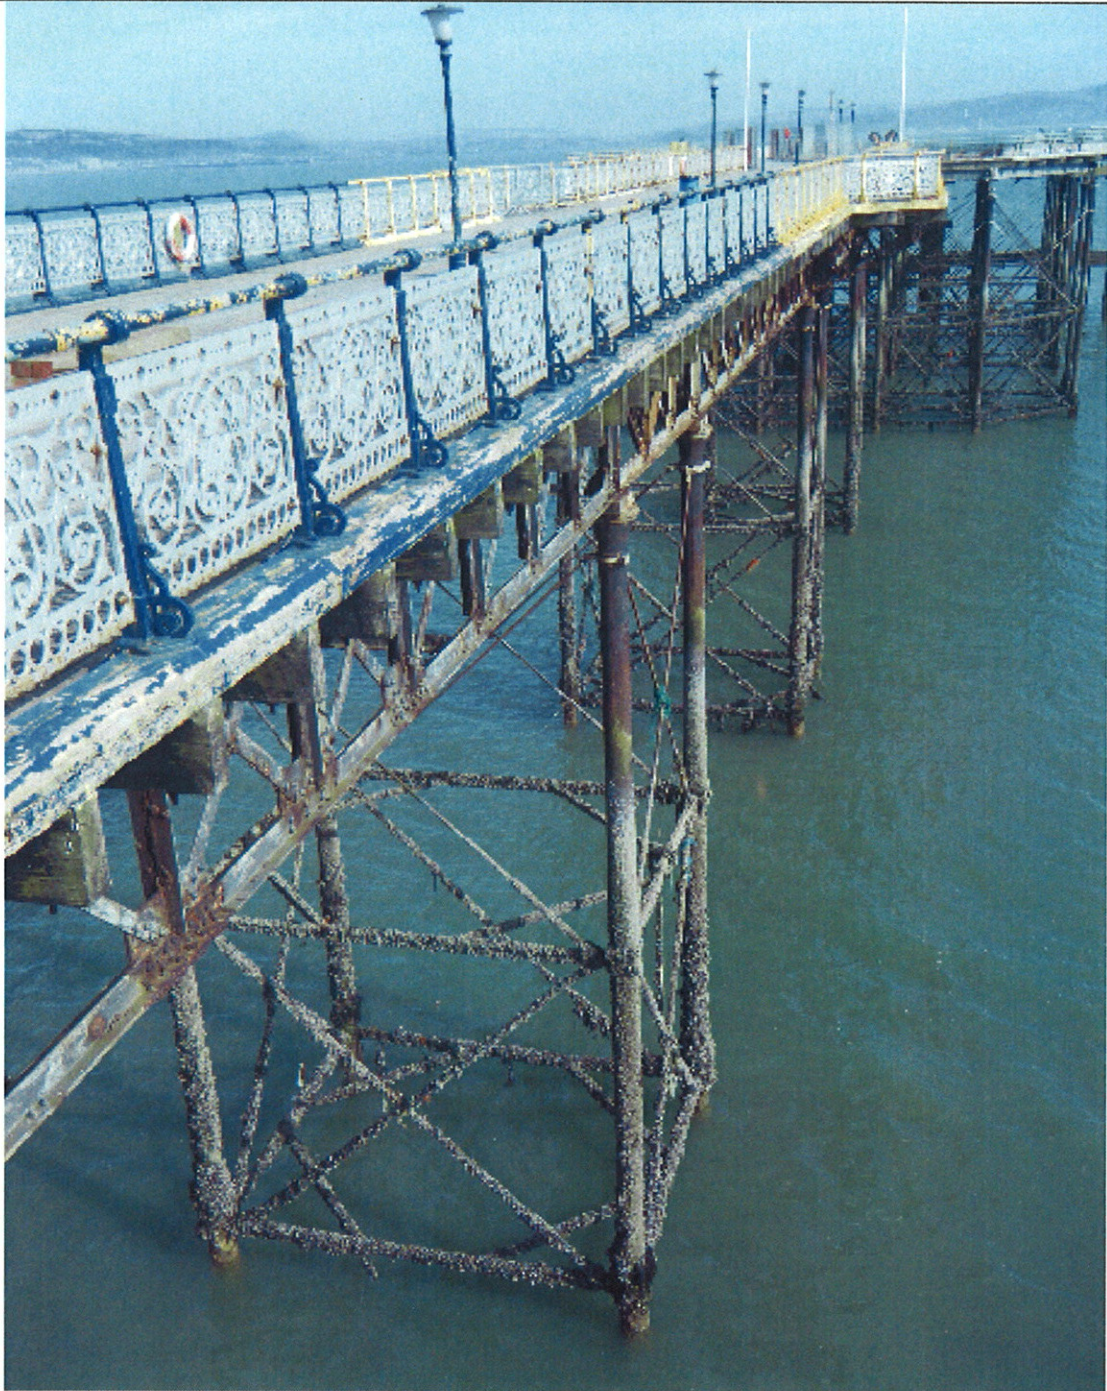
Plate 1	General view of south elevation of pier from centre waist
Orientation	Viewed from west to east
Structure	Mumbles Pier
Date	16/03/2010

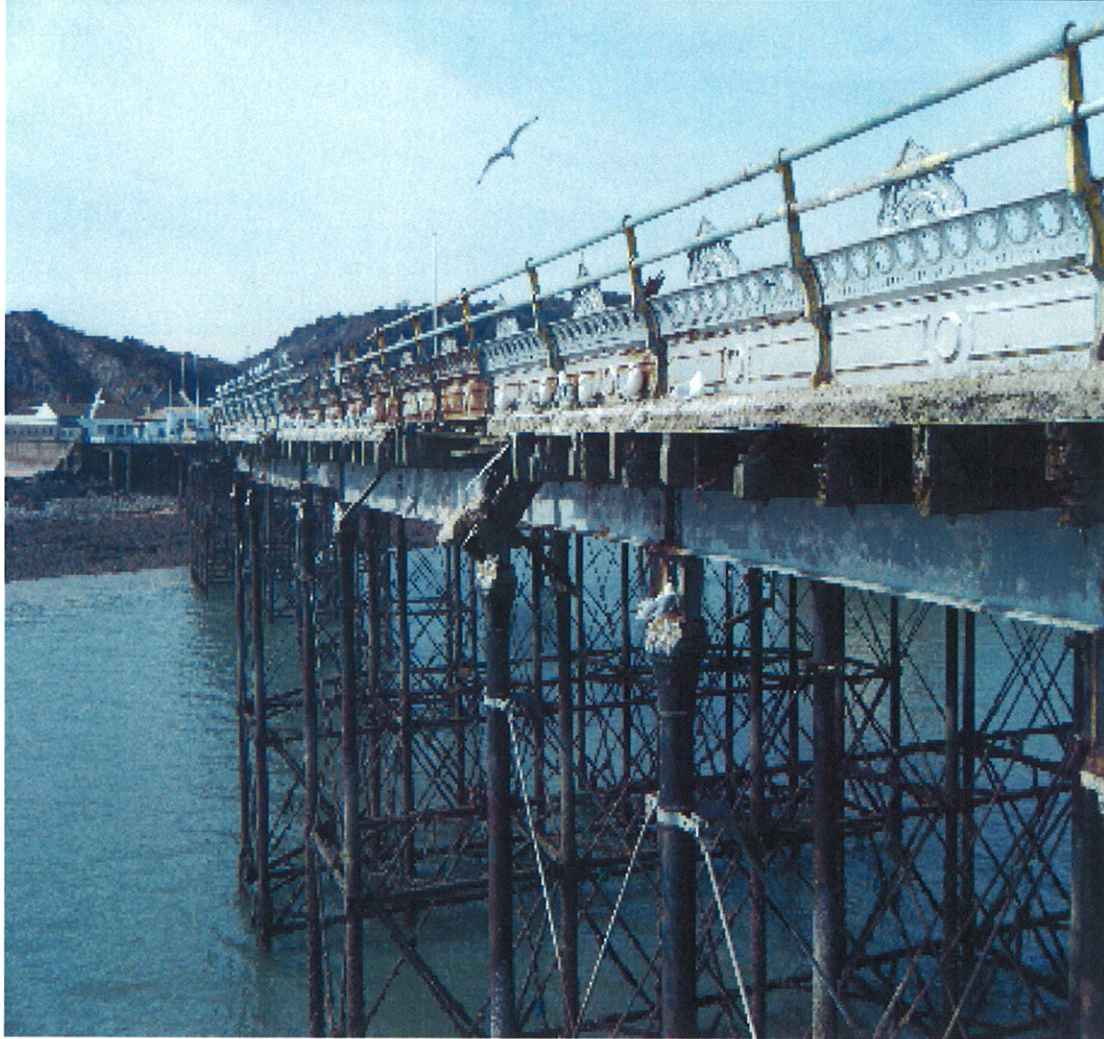
Plate 2	General view of south elevation of pier viewed from the landing stage
Orientation	Viewed from east to west
Structure	Mumbles Pier
Date	16/03/2010

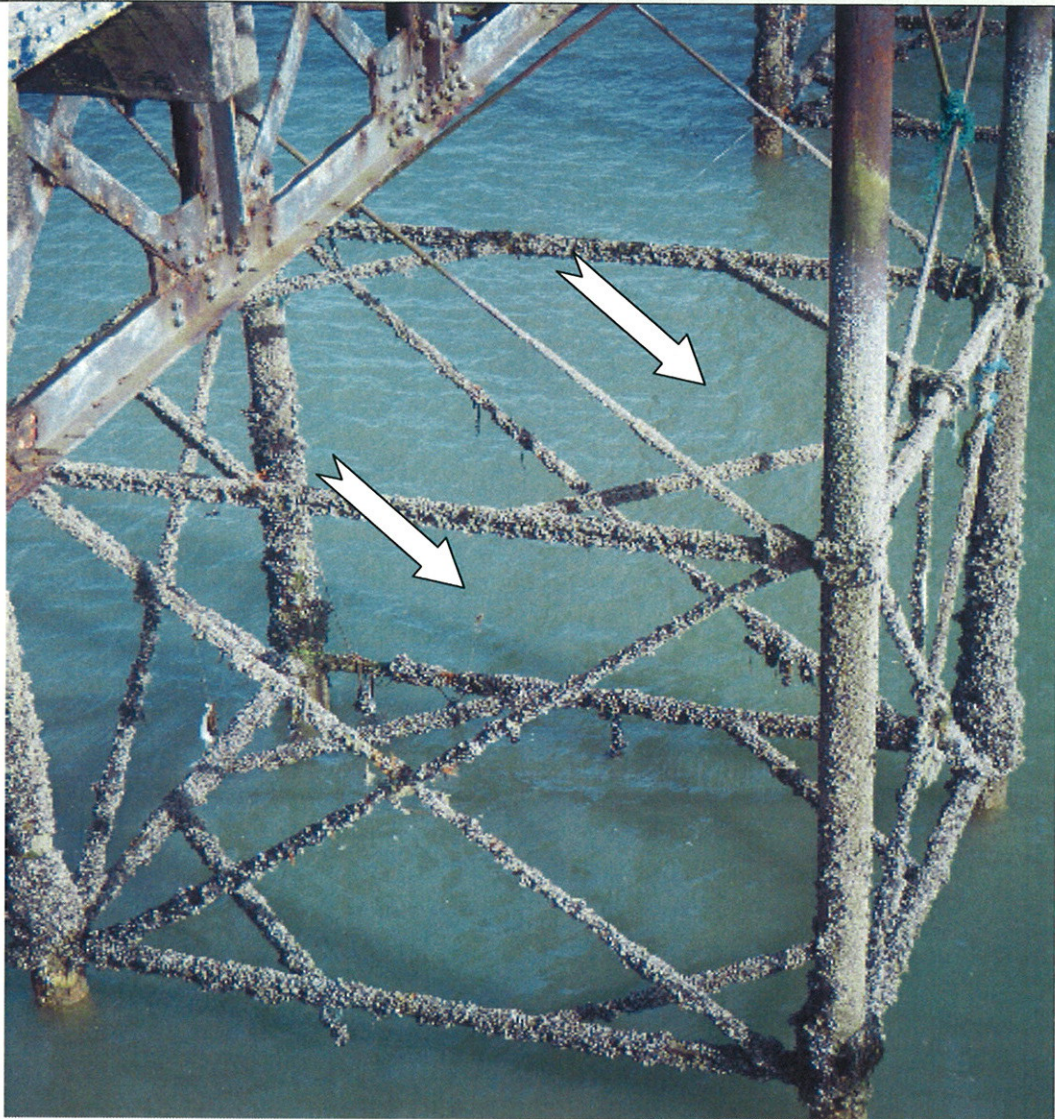
Plate 3	View of pile group showing missing diagonal bracing between piles 7 & 8 indicated by arrows
Orientation	Viewed from west to east
Structure	Mumbles Pier
Date	16/03/2010

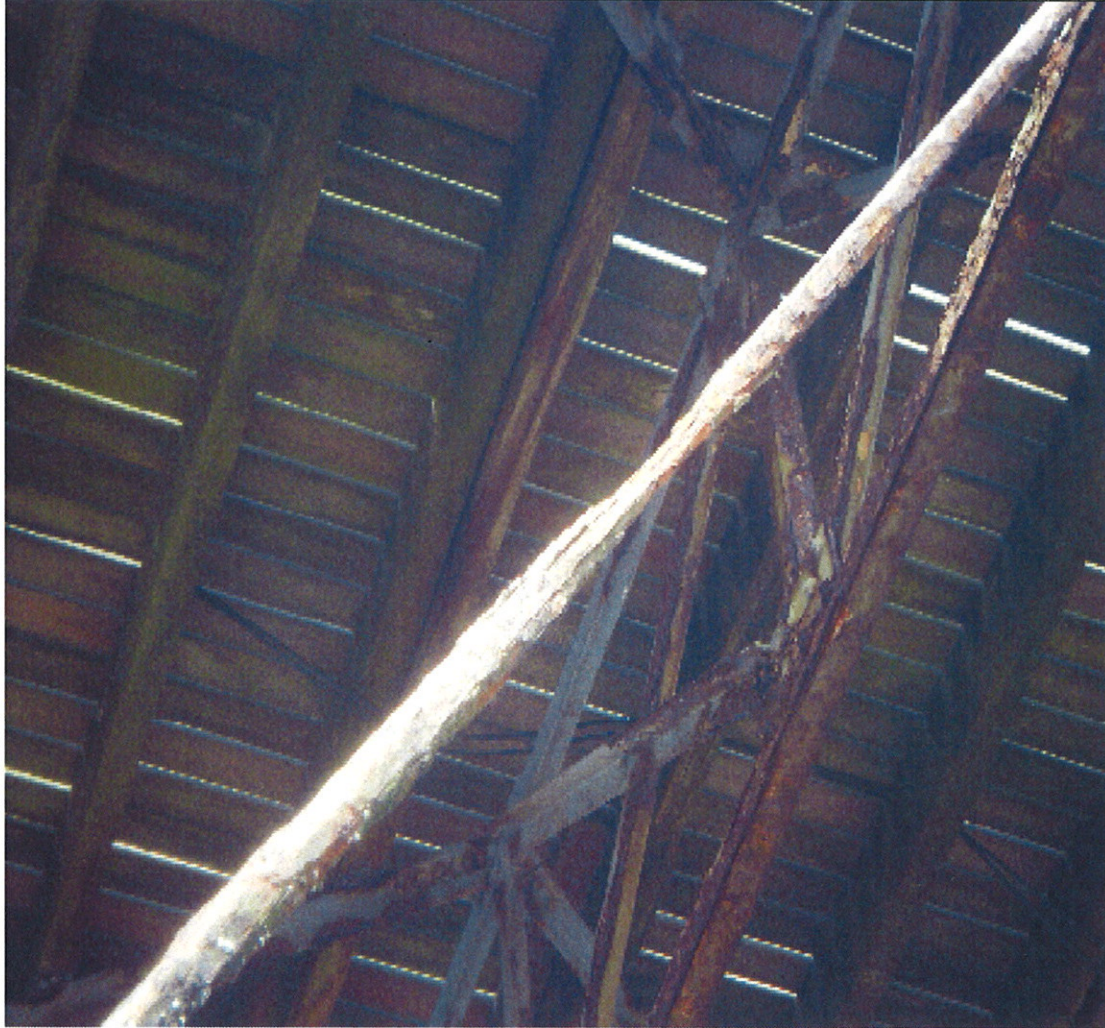
Plate 4	Depletion of diagonal tie bar between piles 5 & 7
Orientation	Viewed from west to east
Structure	Mumbles Pier
Date	16/03/2010

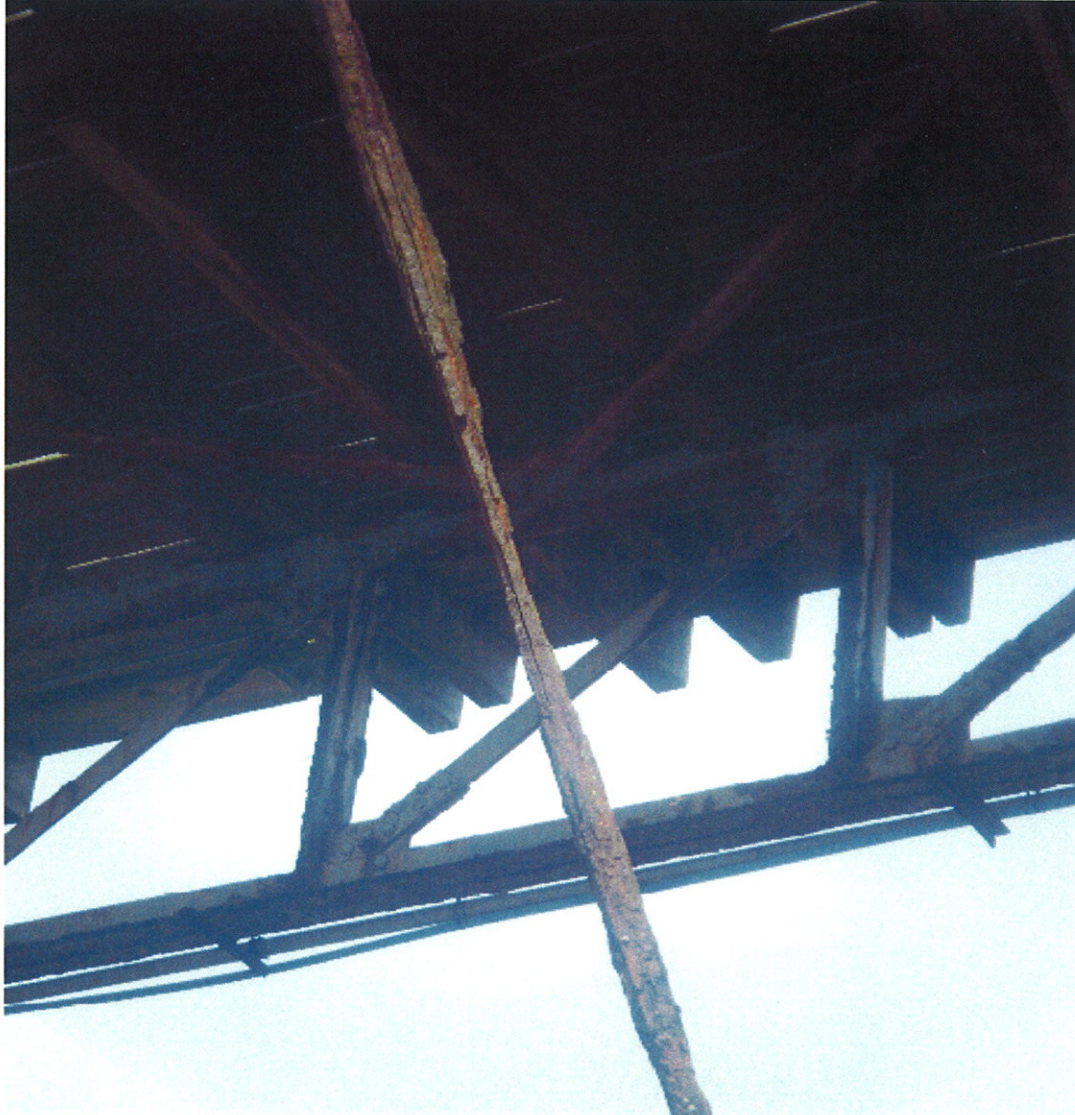
Plate 5	Depletion of diagonal tie bar between piles 7 & 8
Orientation	Viewed from south to north
Structure	Mumbles Pier
Date	16/03/2010

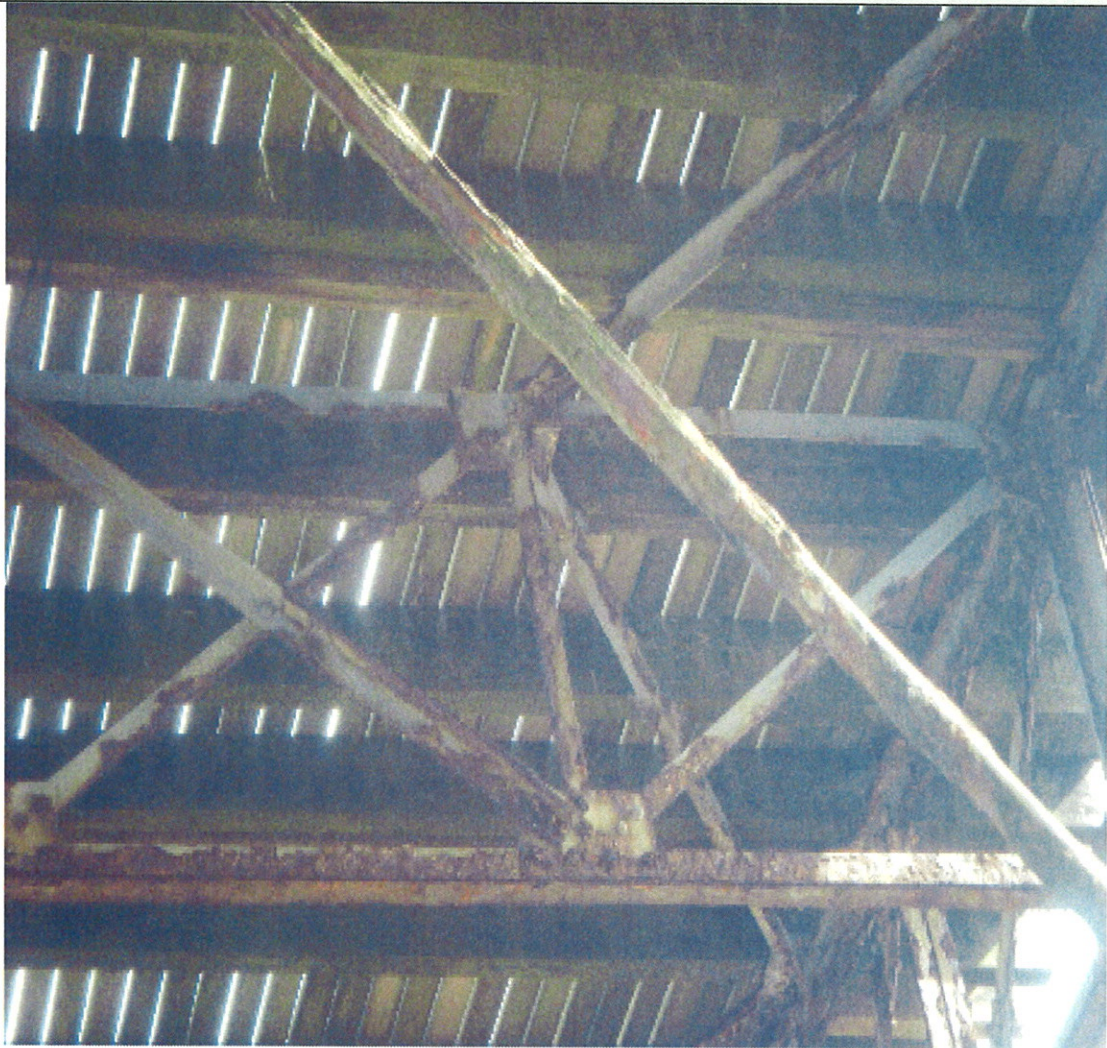
Plate 6	Delamination and depletion of diagonal tie bar between piles 5 & 6
Orientation	Viewed from west to east
Structure	Mumbles Pier
Date	16/03/2010

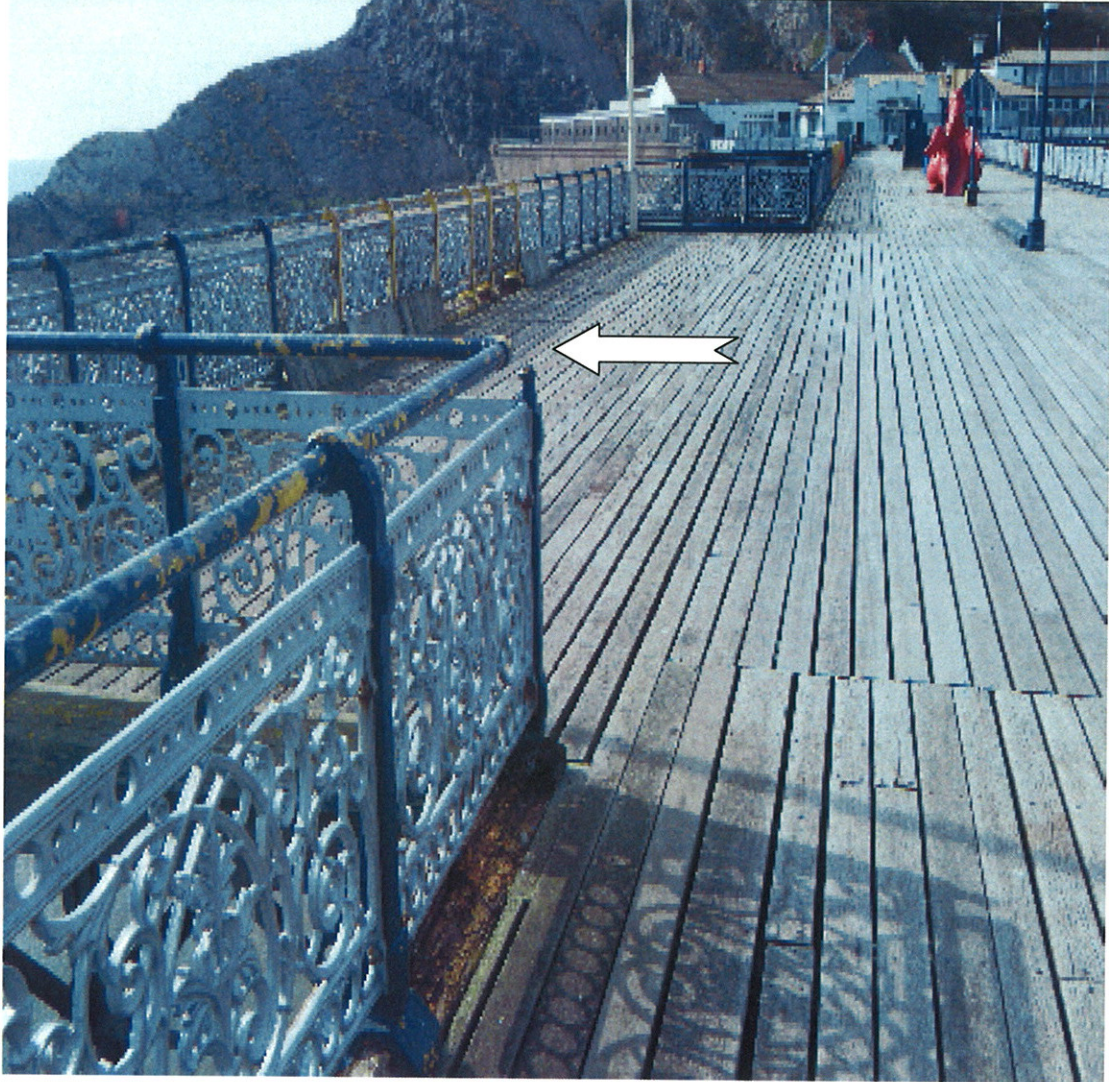
Plate 4	View of central waist showing general condition-note broken corner upstand to handrail indicated by arrow
Orientation	Viewed from east to west
Structure	Mumbles Pier
Date	16/03/2010

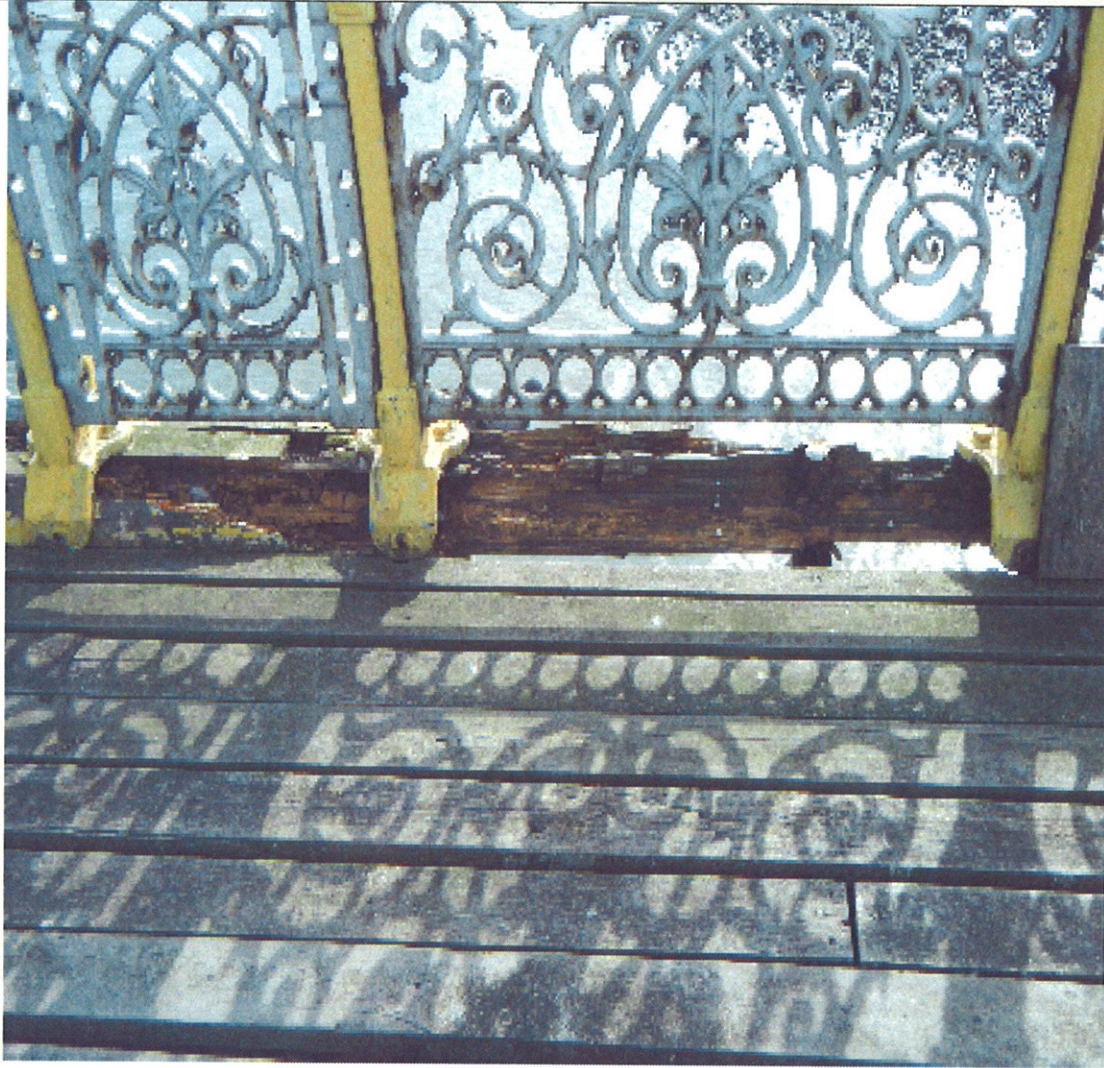
- 5.10 Furthermore, the waling timbers along both edges of the pier stem, which support the cast iron balustrades, were found to be in 'poor' condition at intervals along the length of the structure. Furthermore, 'severe' decay was identified in two locations on the north side of the pier and to a comparable extent on the south side.

Plate 5	Heavily decayed waling beam on south side of pier in central waist
Orientation	Viewed from north to south
Structure	Mumbles Pier
Date	16/03/2010

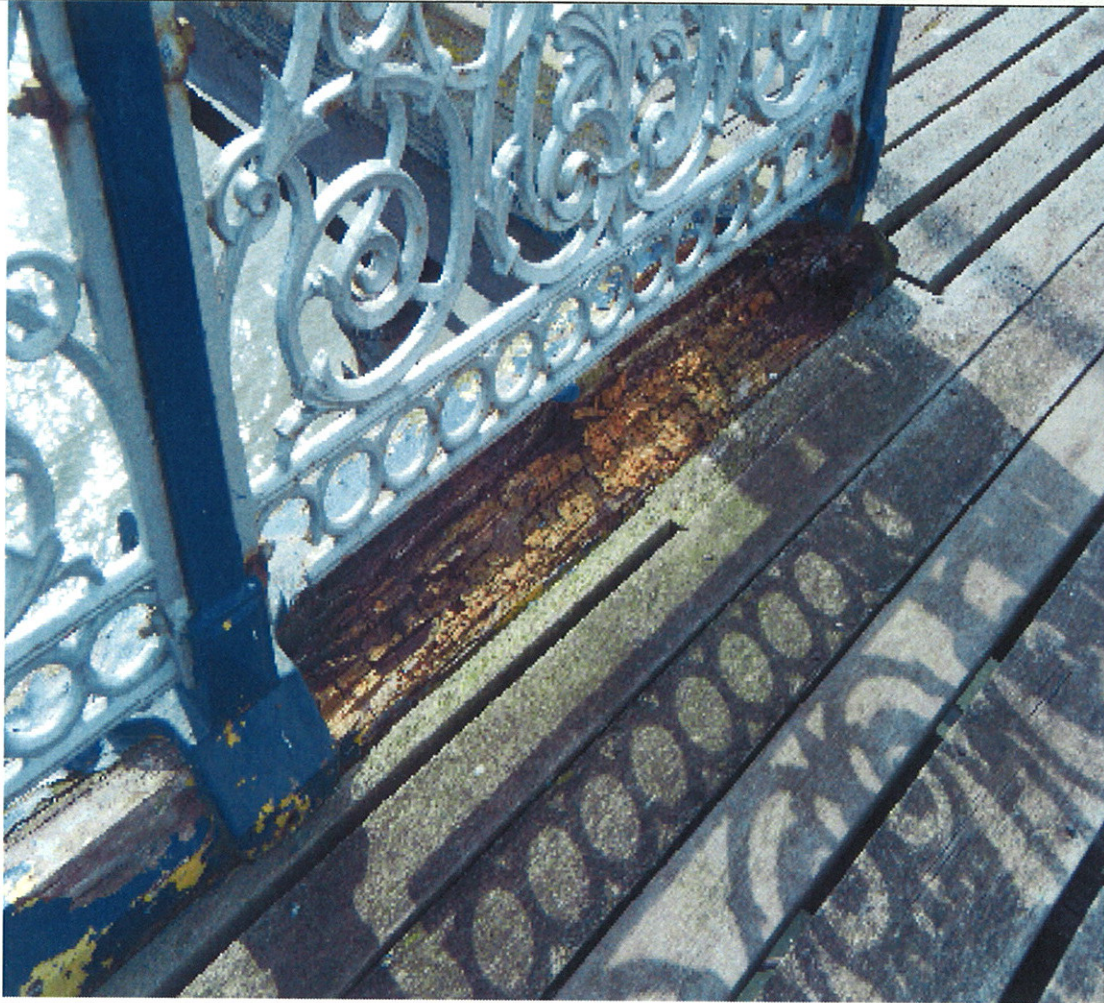
Plate 6	Advanced decay to waling timber on south side of pier to east side of central waist
Orientation	Viewed from northeast to southwest.
Structure	Mumbles Pier
Date	16/03/2010

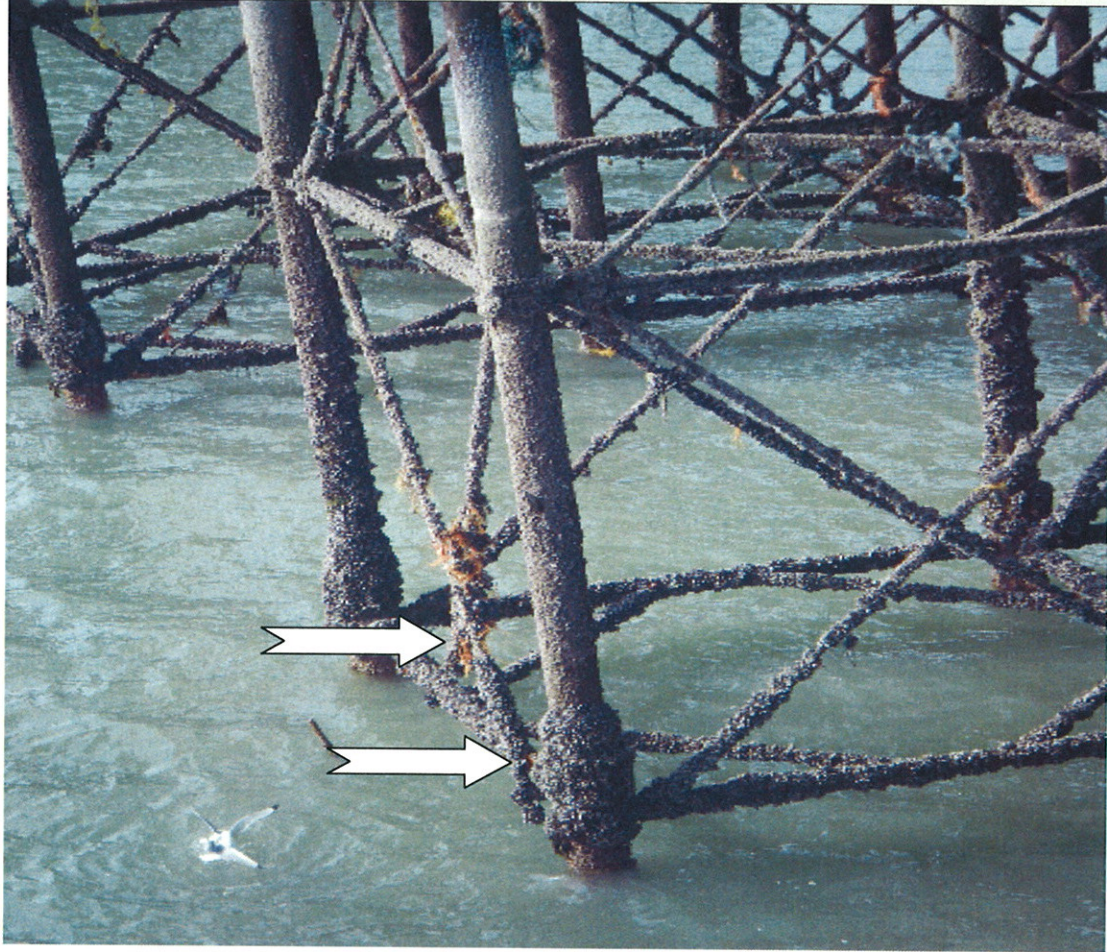
Plate 9	Detached tie rods between piles 65 & 71 as indicated by arrows
Orientation	Viewed from east to west
Structure	Mumbles Pier
Date	16/03/2010

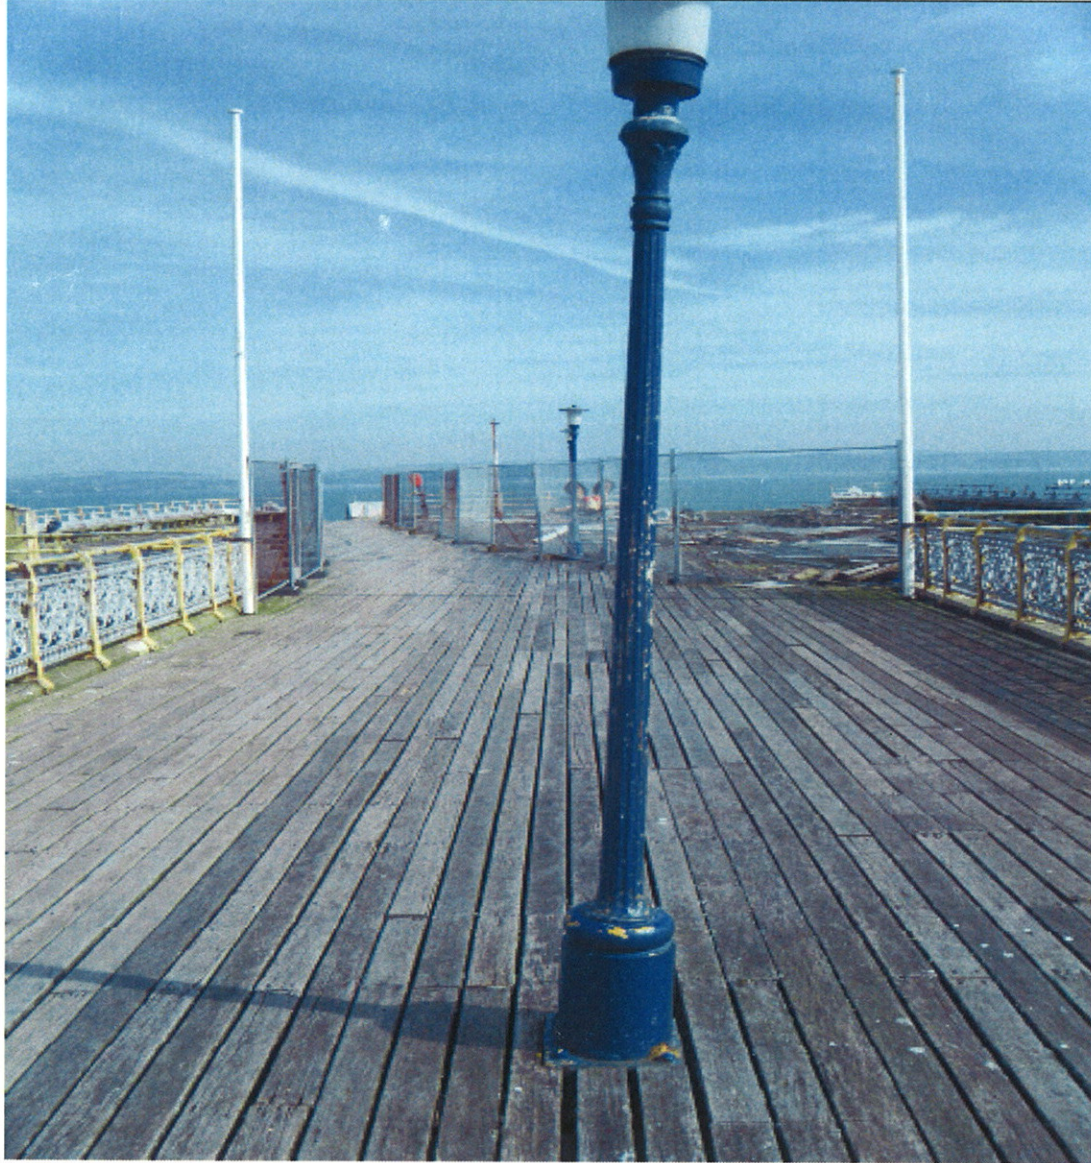
Plate 10	Lighting stand at approach to pier head leaning due to decayed timber at base. Deterioration since 2009 survey.
Orientation	Viewed from west to east
Structure	Mumbles Pier
Date	16/03/2010
