**PE273 PORTH-Y-RHAW CAMP**  
**FOOTPATH DIVERSION WORK**  
**COMPLETION REPORT**

**Prepared on behalf of the Pembrokeshire Coast National Authority by Tomos Jones, Community Archaeologist.**

**28 September 2023**

The following report provides details of work carried out at PE273 Porth-y-Rhaw Camp scheduled monument in April and May 2023. Specifically, work to remove the footsteps and cut through a post-medieval bank within the scheduled area as part of work to re-divert the coast path away from the scheduled monument area.

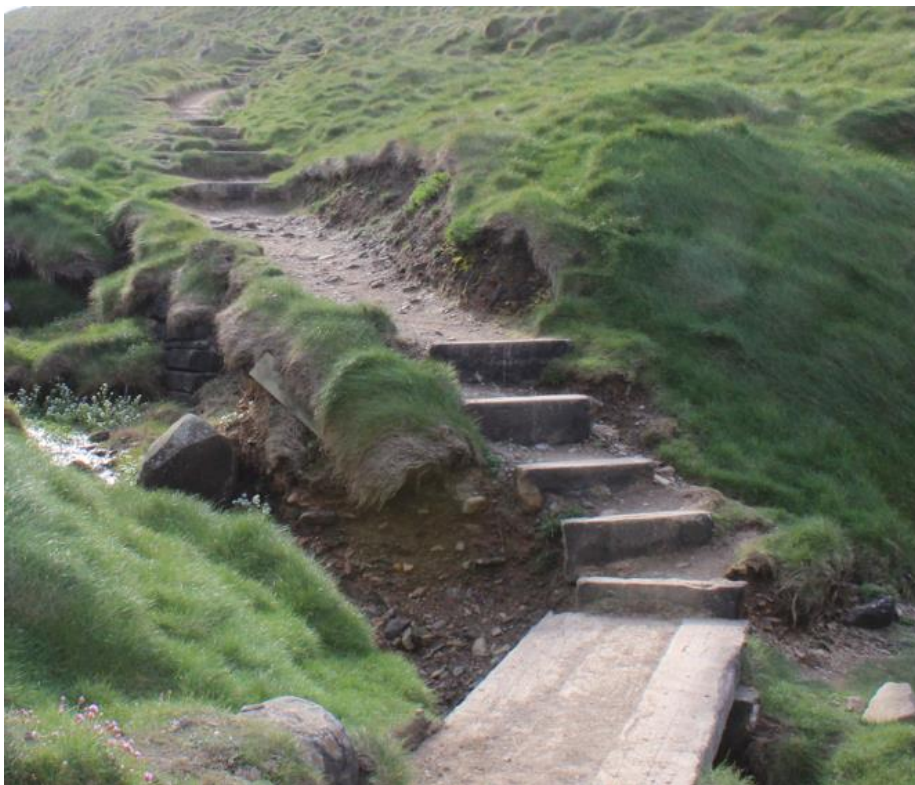
**Figure 2. Photo showing location of steps/foot bridge to be removed, pinch point erosion also visible.**

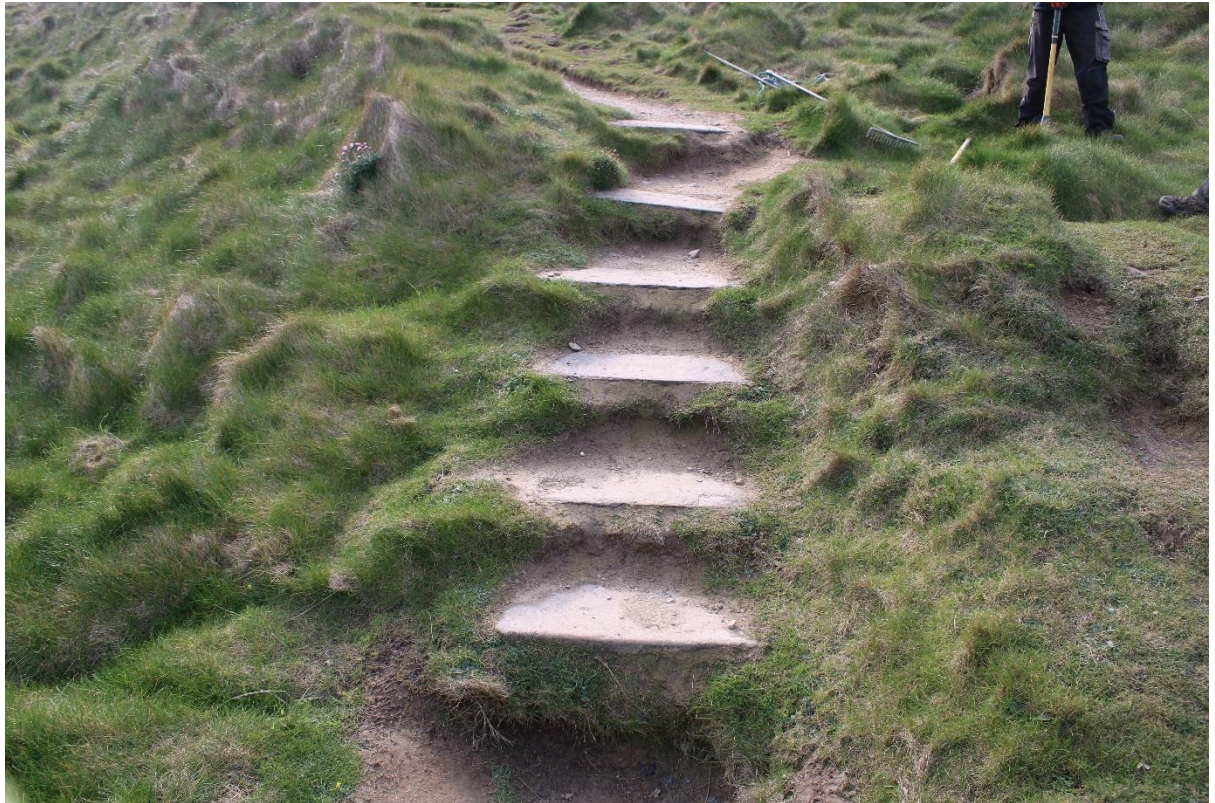
**Figure 3. Photo showing top group of steps prior to removal.**

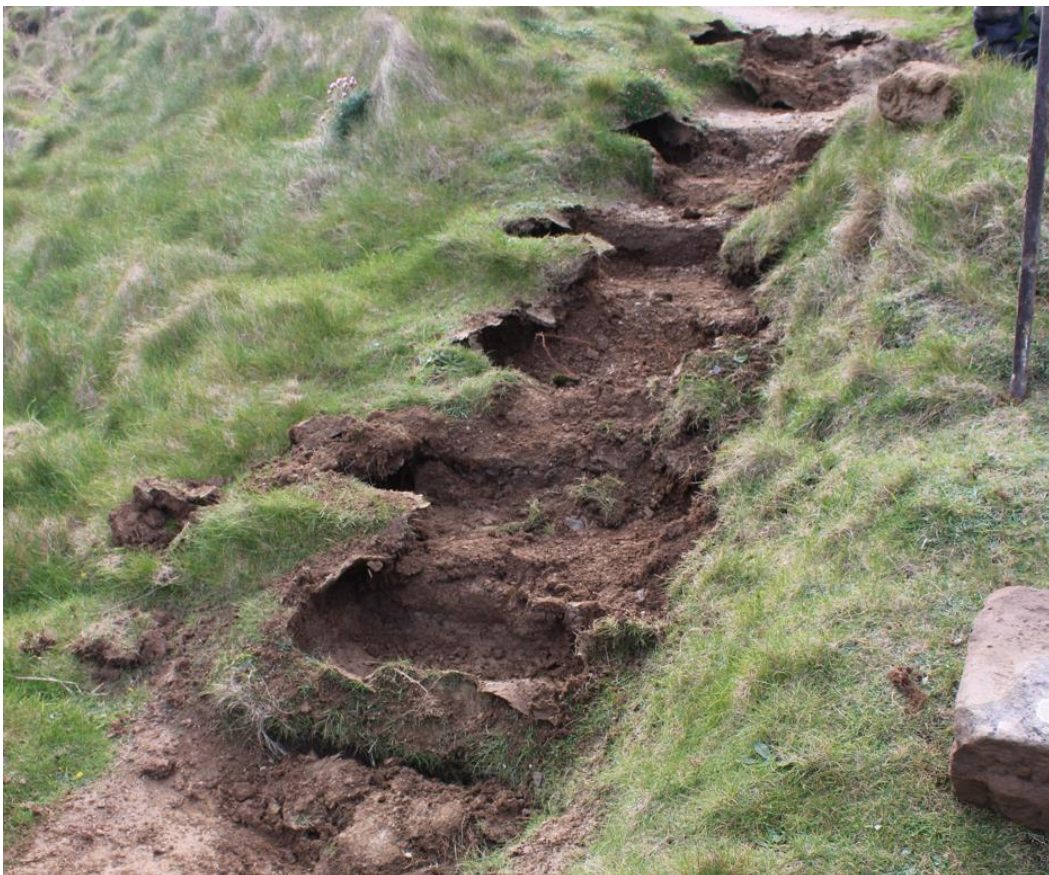
**Figure 4. Photo after removal of the top group of steps.**

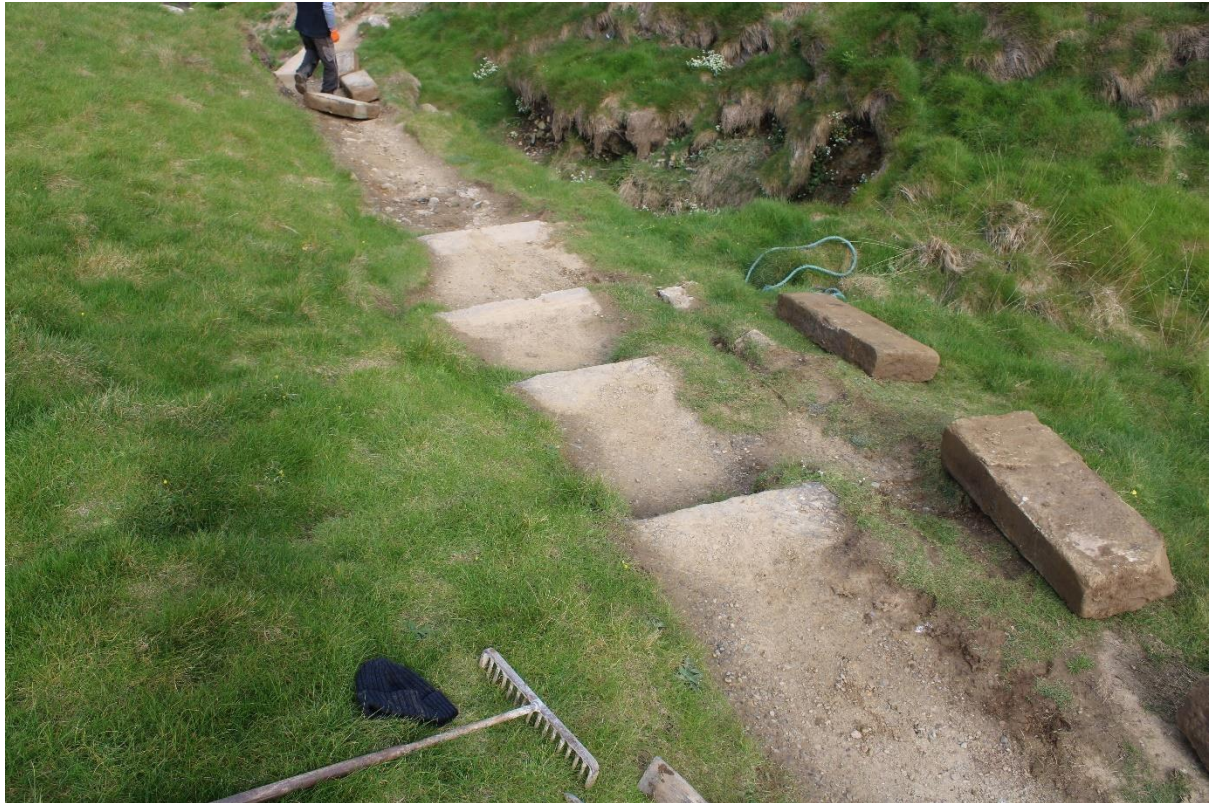
**Figure 5. Photo showing middle group of steps prior to removal.**

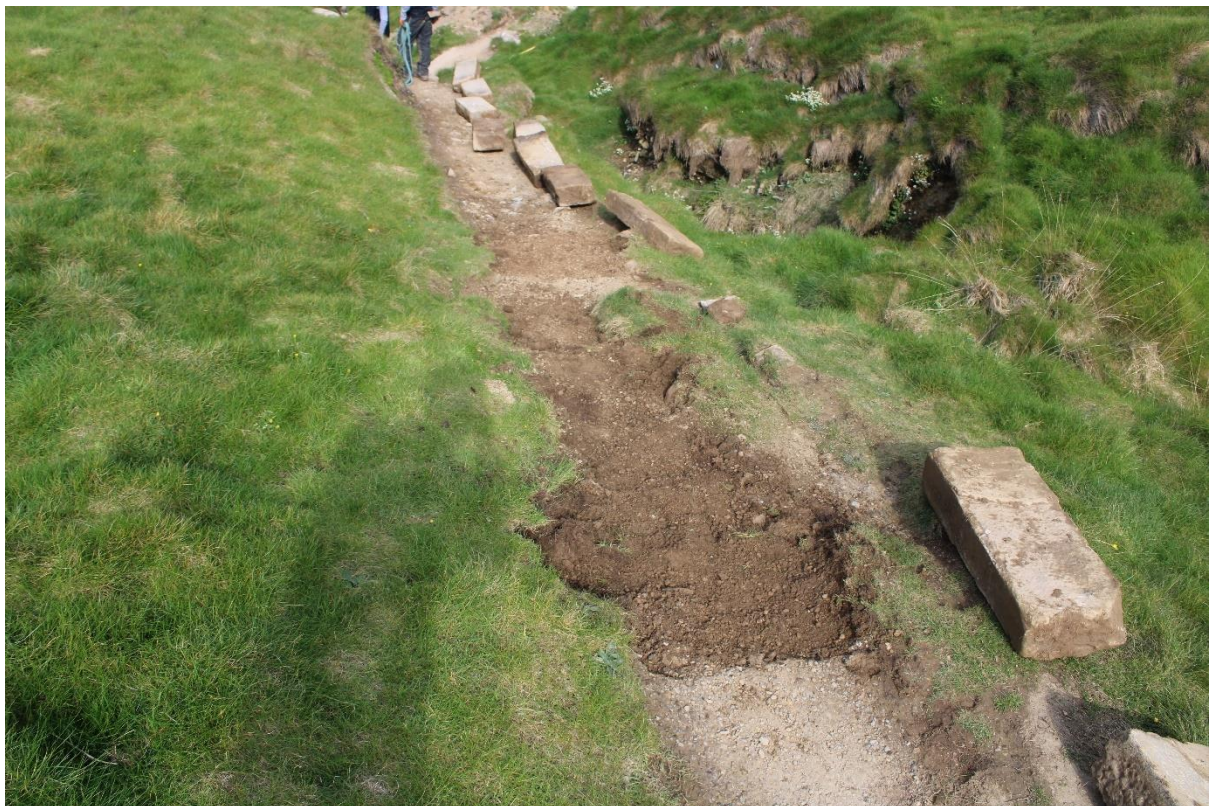
**Figure 6. Photo after removal of middle group of steps.**

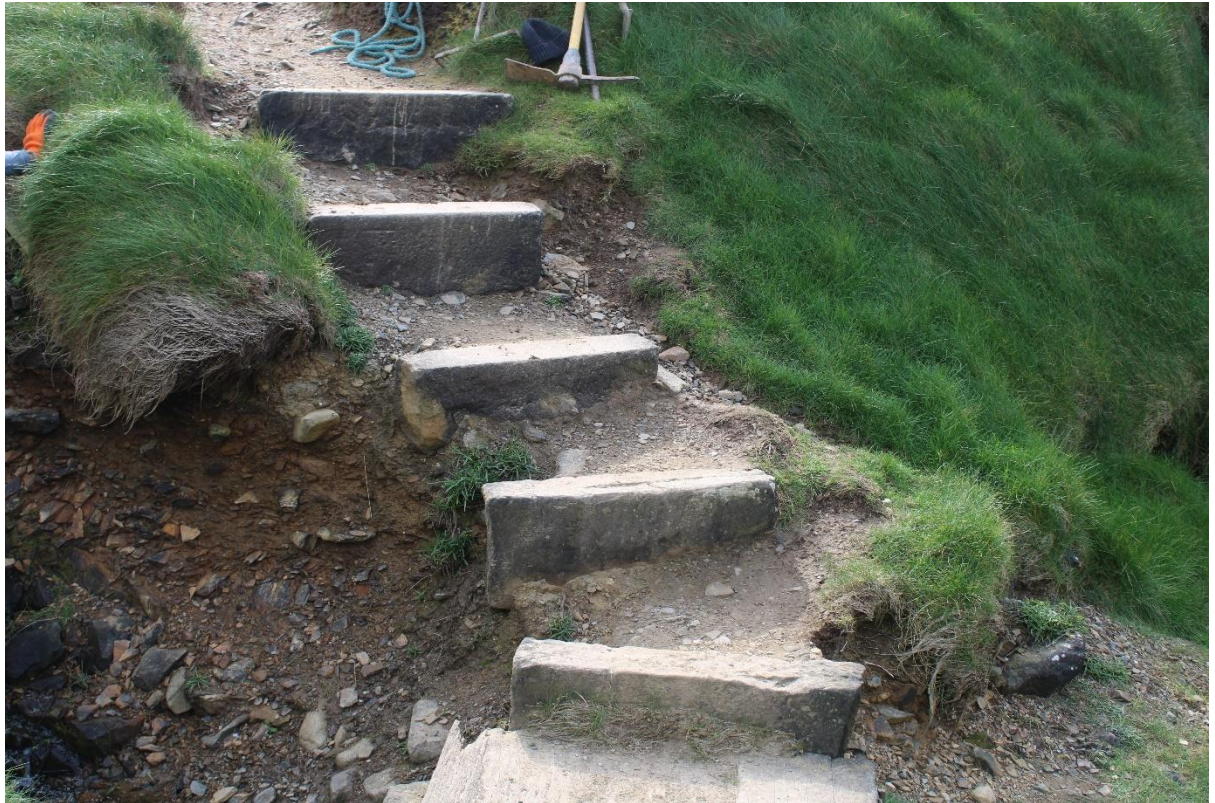
**Figure 7. Photo showing bottom group of steps prior to removal.**

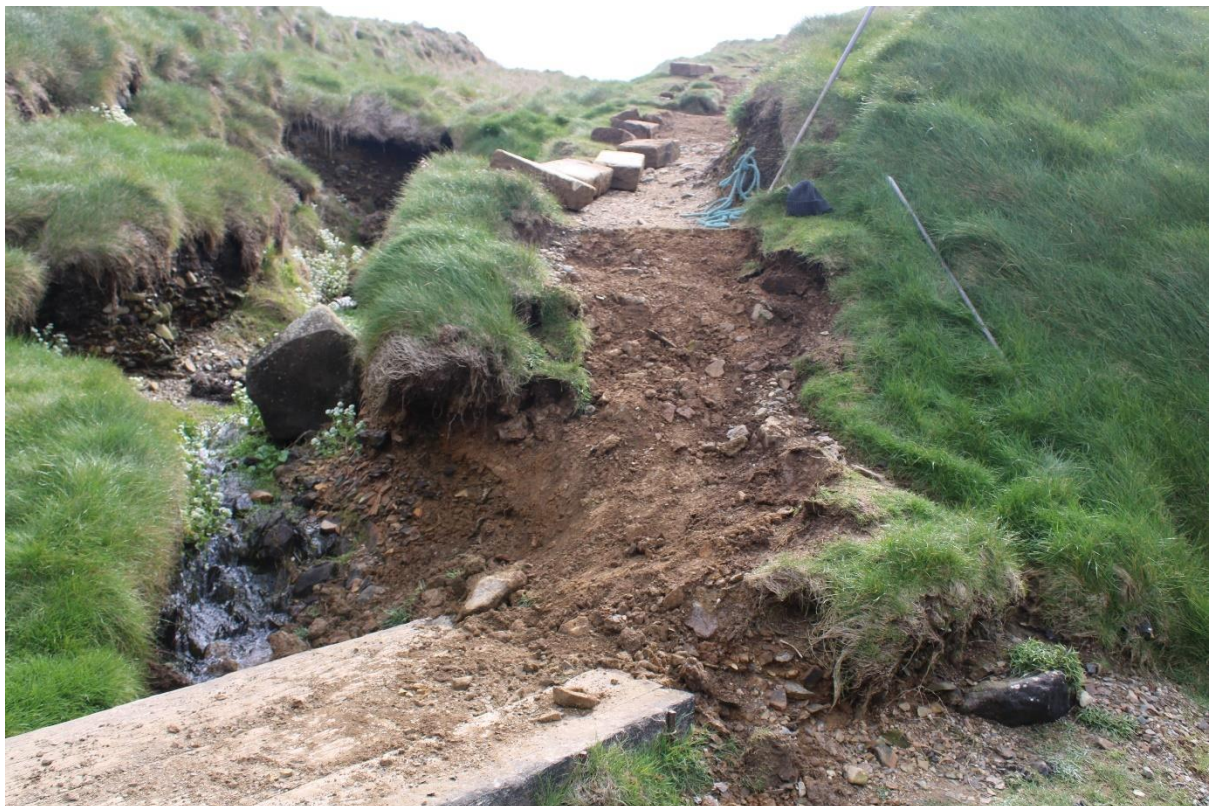
**Figure 8. Photo after removal of bottom group of steps.**

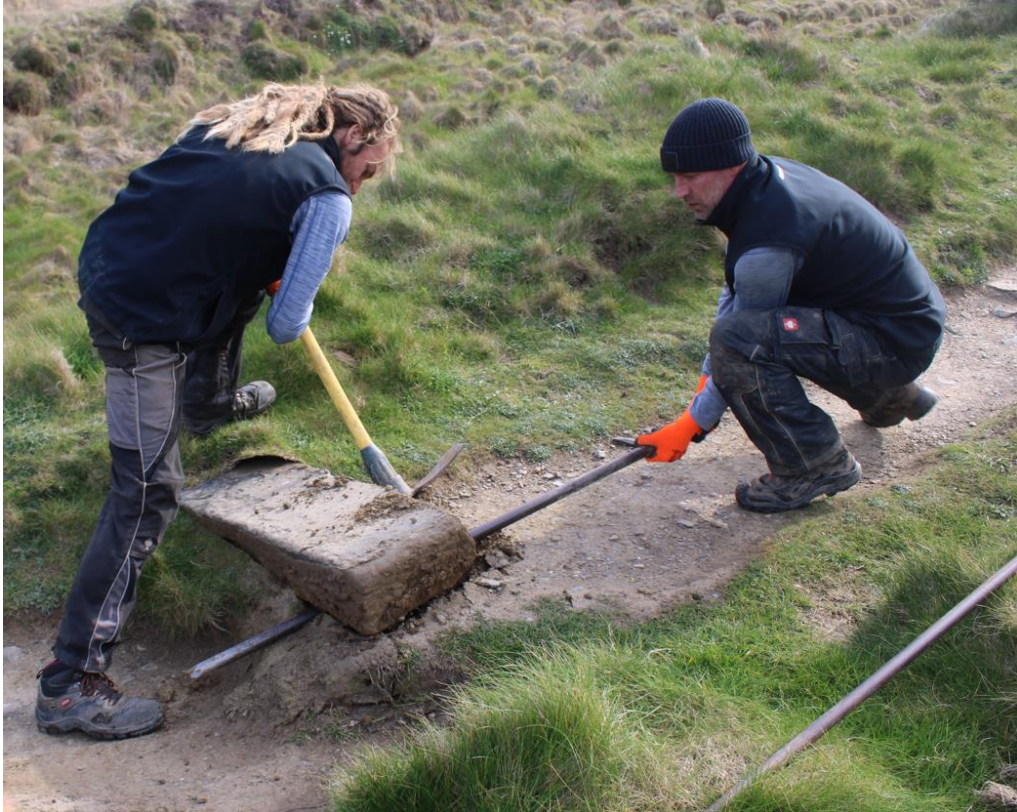
**Figure 9. Photo showing approach to remove steps, including pickaxe and then crowbar to help lift steps from the ground.**

- The steps were removed by hand, with hand tools used to loosen the step from the ground. The steps were then carried off the scheduled area by hand. Removal of the steps began with the top step and the wardens worked their way down to the bottom step next to the foot bridge.
- Once the steps were removed, the community archaeologist checked for any archaeological deposits or features, of which none were identified.

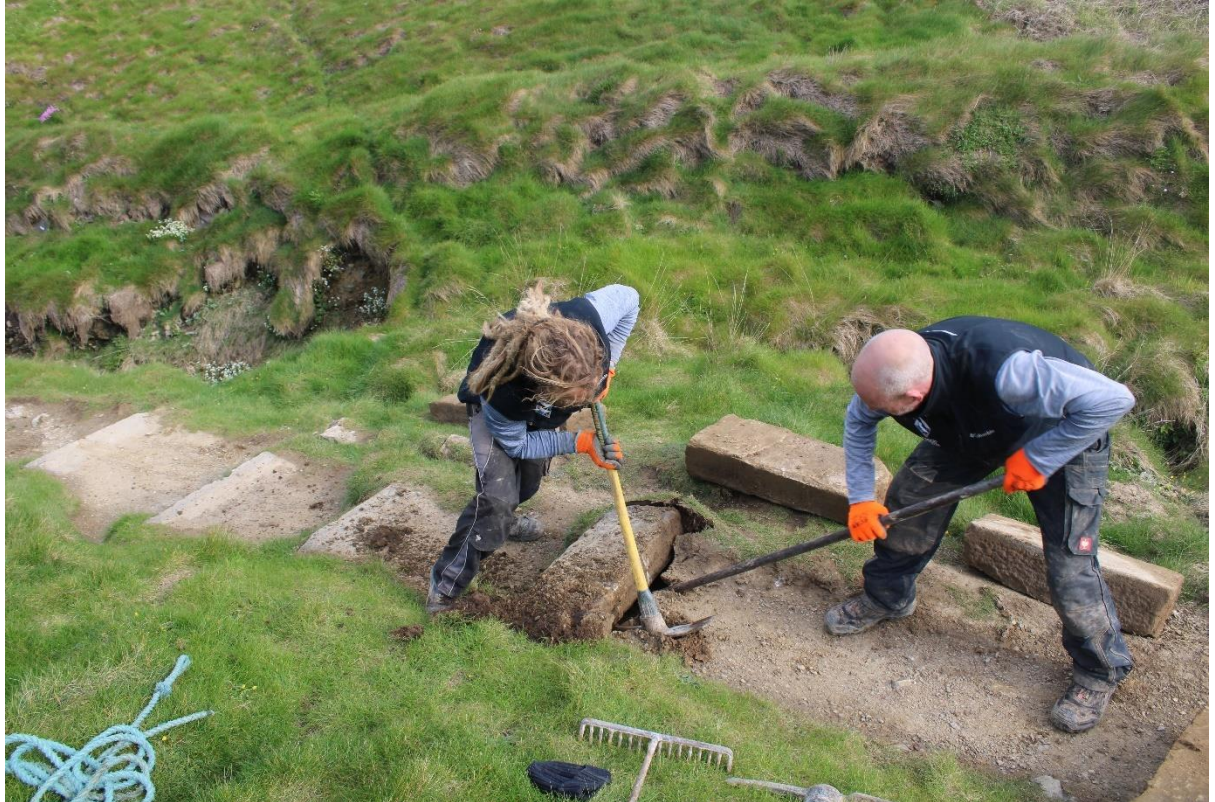
**Figure 10. Photo showing removal of steps using hand tools.**

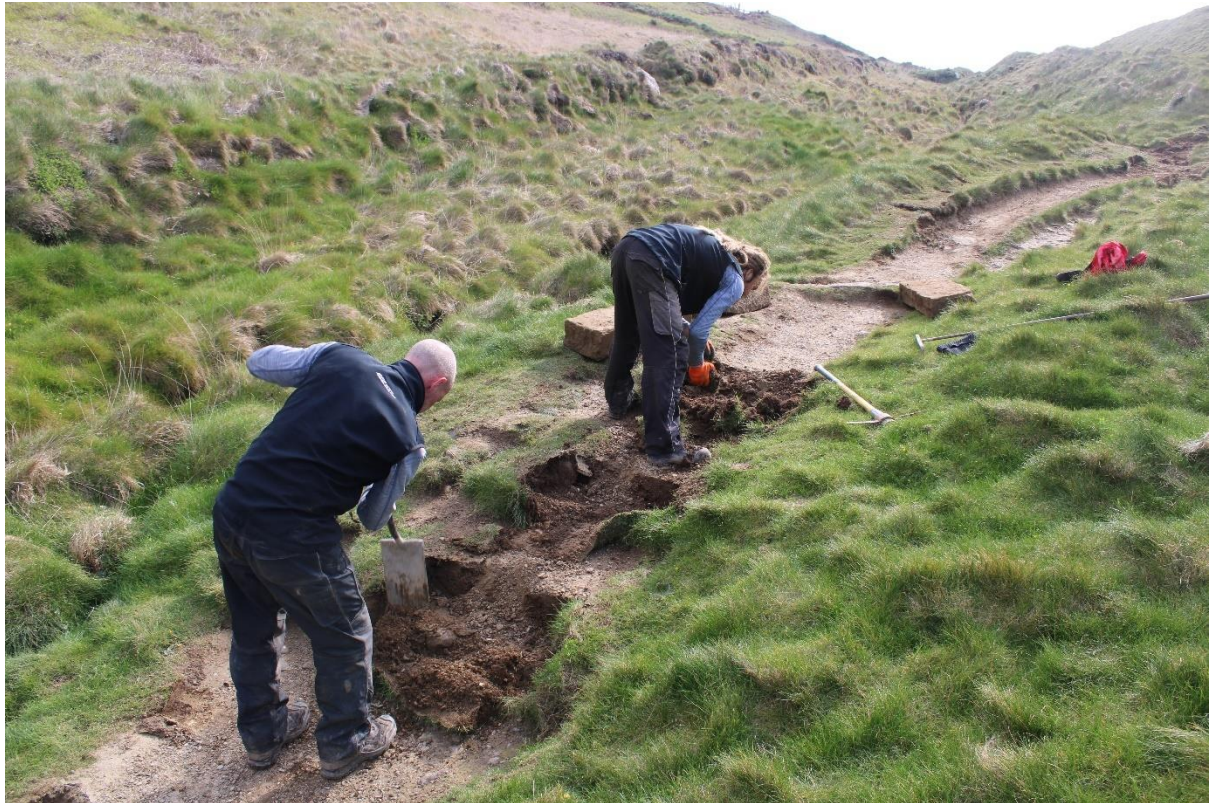
**Figure 11. Photo showing use of hand tools to re-profile the surface after removing the steps.**

- Following an archaeological check, the wardens reprofiled the area where the steps used to be with hand tools to smooth the surface. This approach meant that the soils were mixed which would help with re-growth of turf. The wardens also walked over the area to help compact the surface.

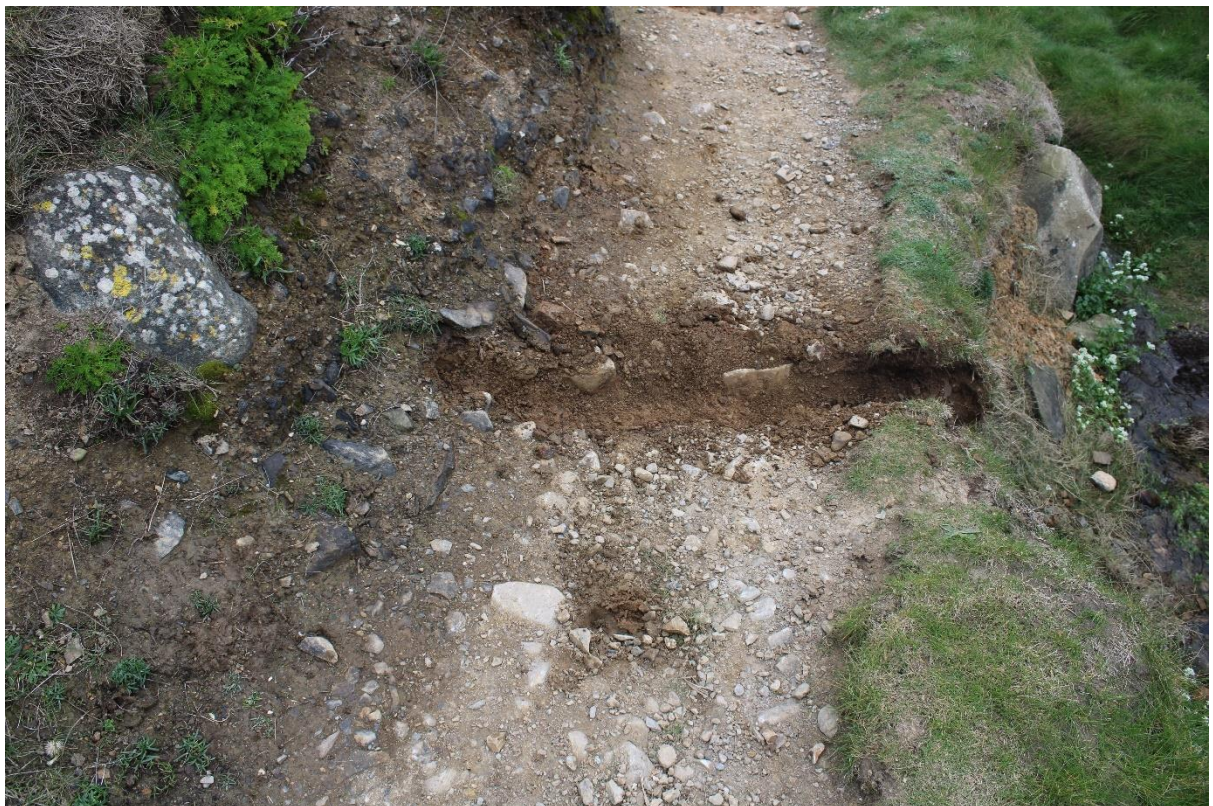
**Figure 12. Photo showing shallow drainage ditch created directly above the bottom group of steps that were removed.**

- To assist with water management and erosion following the removal of the steps, the wardens cut a shallow drainage ditch above the group of steps directly next to the footbridge. This would help encourage water to runoff directly into the stream rather than running down the surface of the monument.

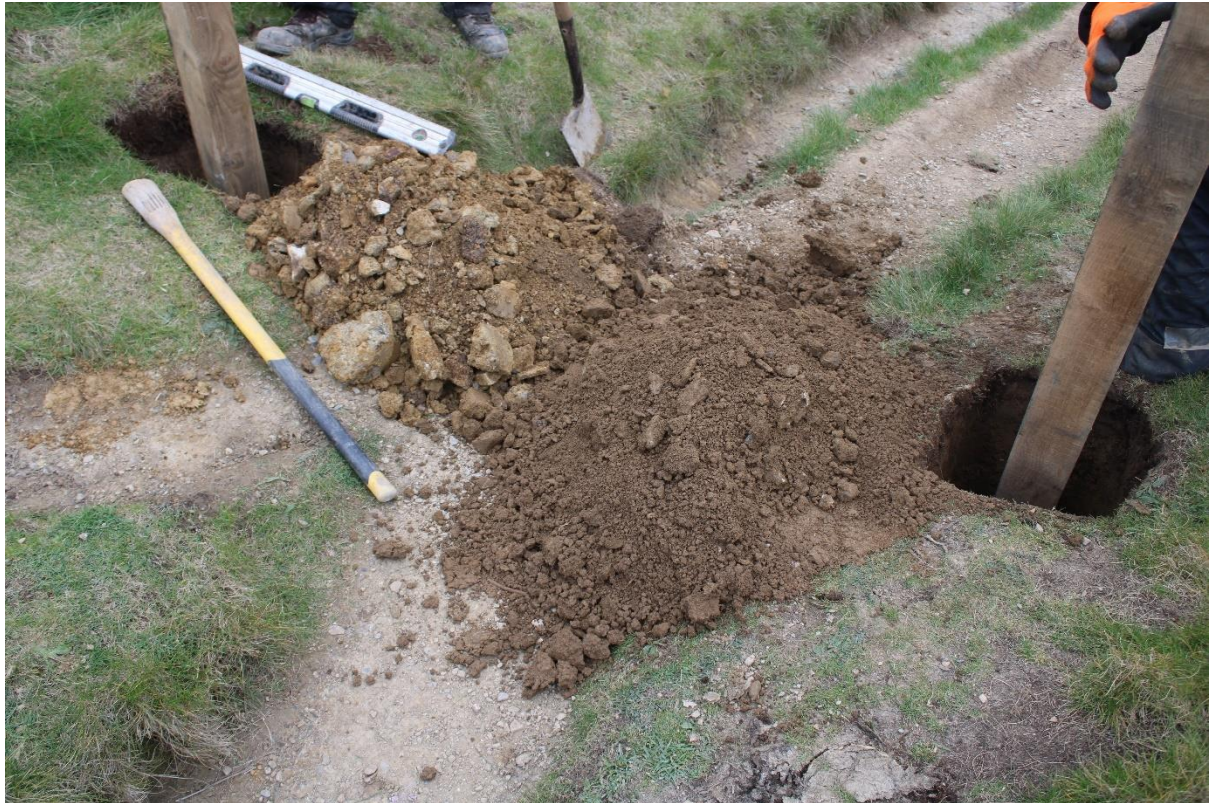
- Once the work on the steps had been completed, the wardens diverted their attention to the installation of the physical barrier. An attempt was made to drive the wooden posts directly into the ground, but this was not possible due to the hardness of the surface. As a result, pits were dug to accommodate the posts. The community archaeologist checked for any anomalies as the pits were created, but no archaeological feature or material was identified. However, there did appear to be a difference in colour and composition between the material removed from the two pits. Due to the small size of the pits, it was not possible to determine if there was any significance to this variation.

**Figure 13. Photo showing pits created to house the wooden posts of physical barrier. Note the colour and composition difference between the material from the two different pits.**

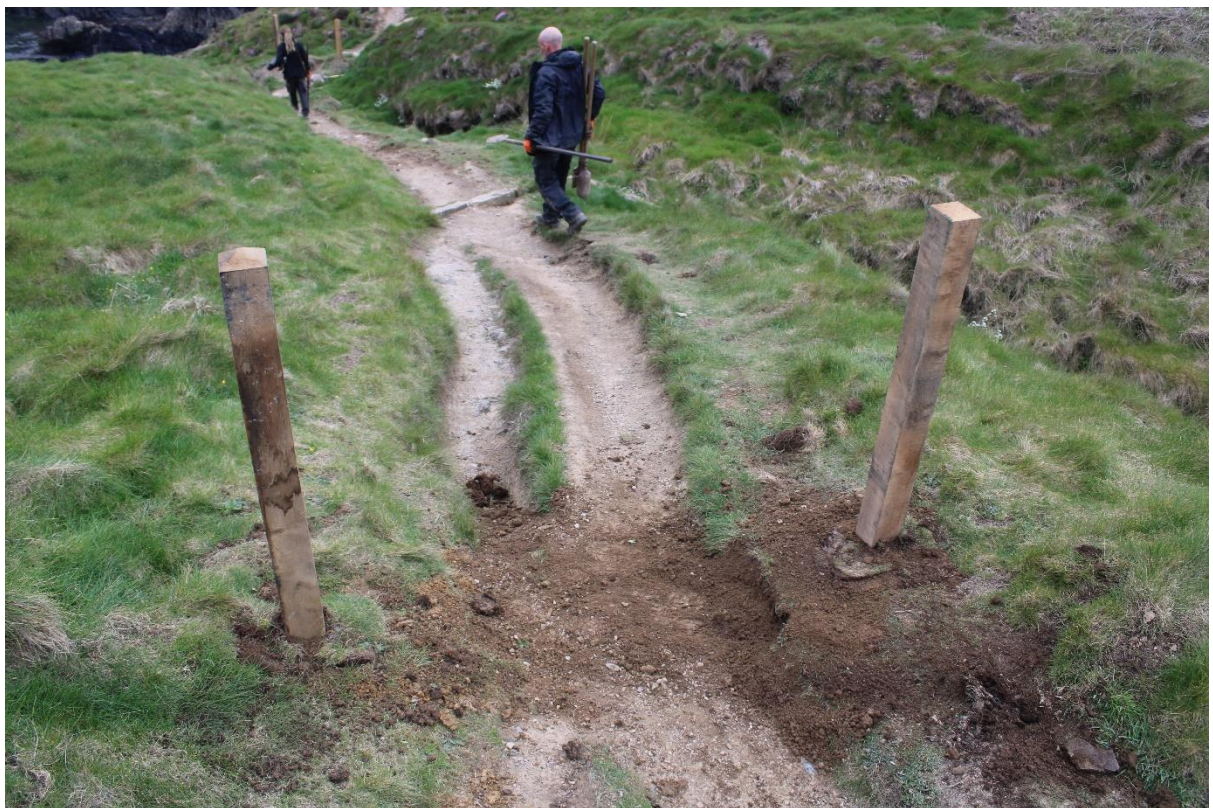
**Figure 14. Photo showing posts in place packed with the material dug out to create the pits.**

- Once the pits were created, the wooden posts were installed and packed with the material that had been dug out to create the pits. The timber frame connecting the posts was then added to complete the physical barrier.

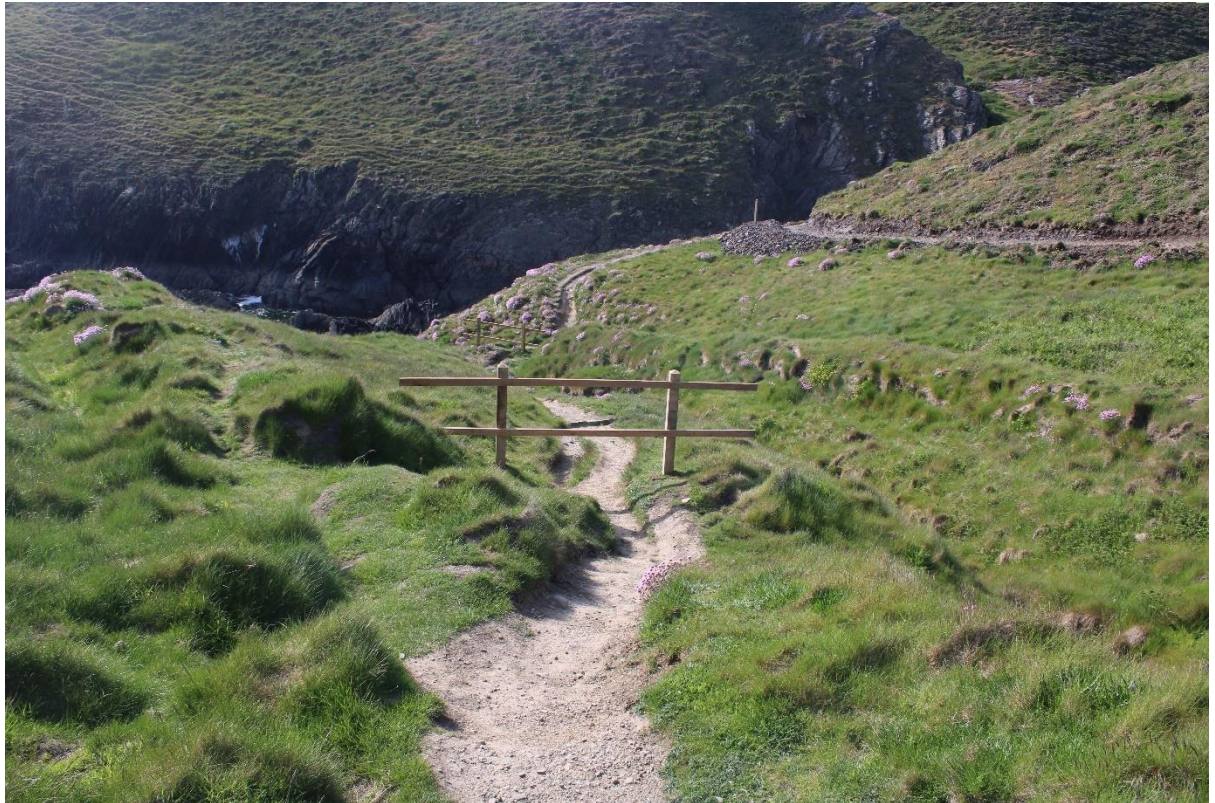
**Figure 15. Photo showing the completed physical barrier after a few weeks, also showing condition of surface where top group of steps were.**

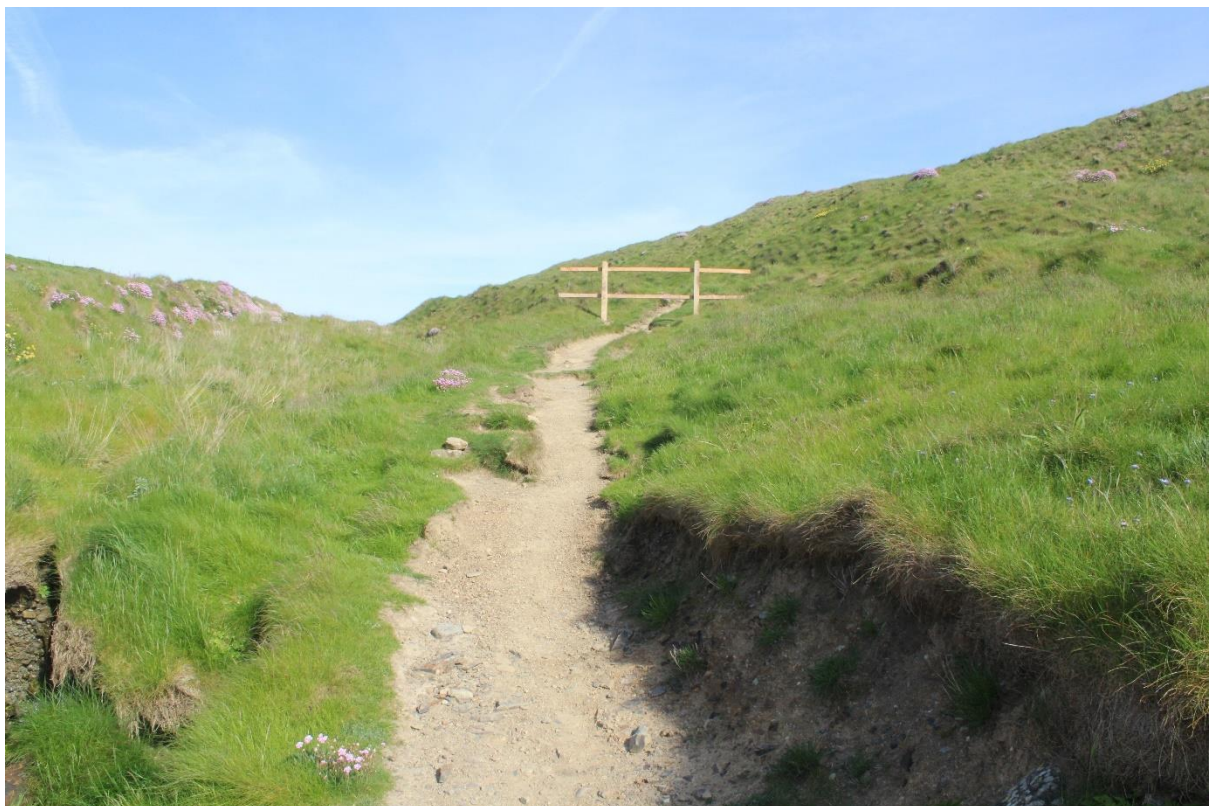
**Figure 16. Photo showing condition of surface where middle group of steps used to be after a few weeks. Also, physical barrier in background.**

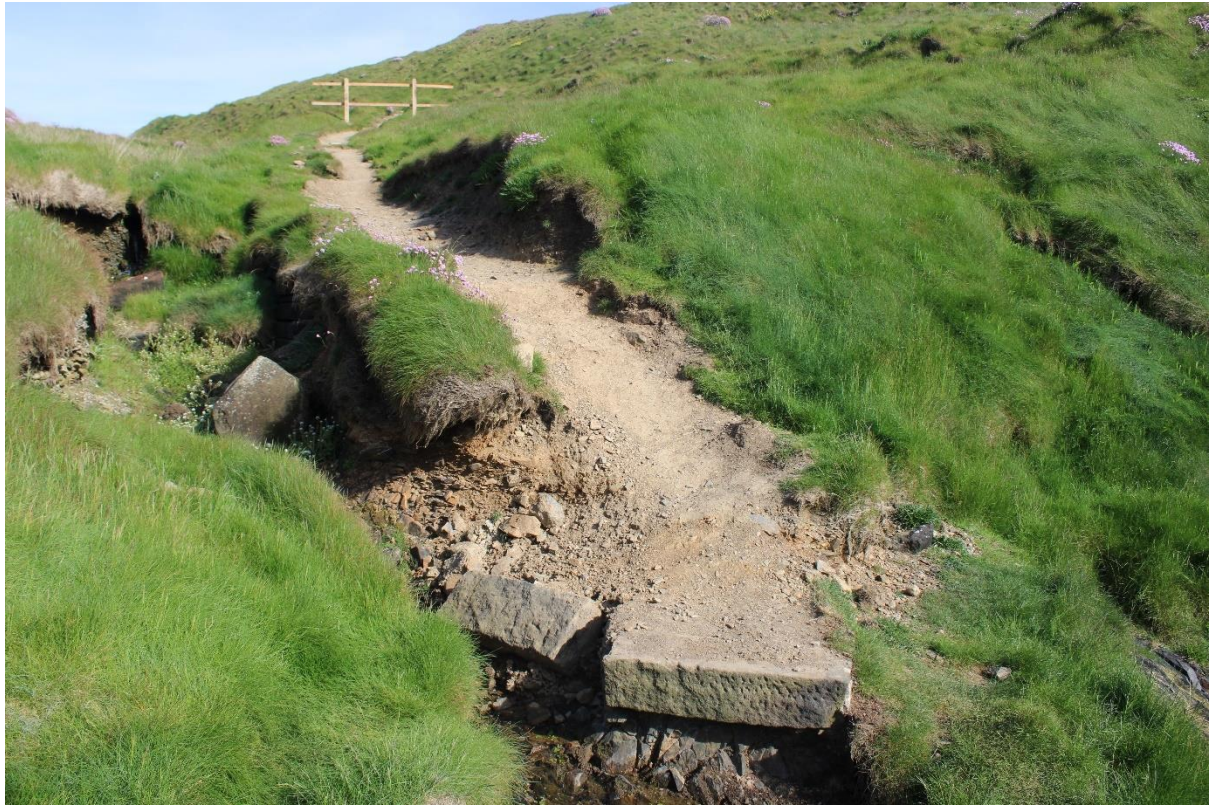
**Figure 17. Photo showing condition of surface where bottom group of steps used to be, also physical barrier in background.**

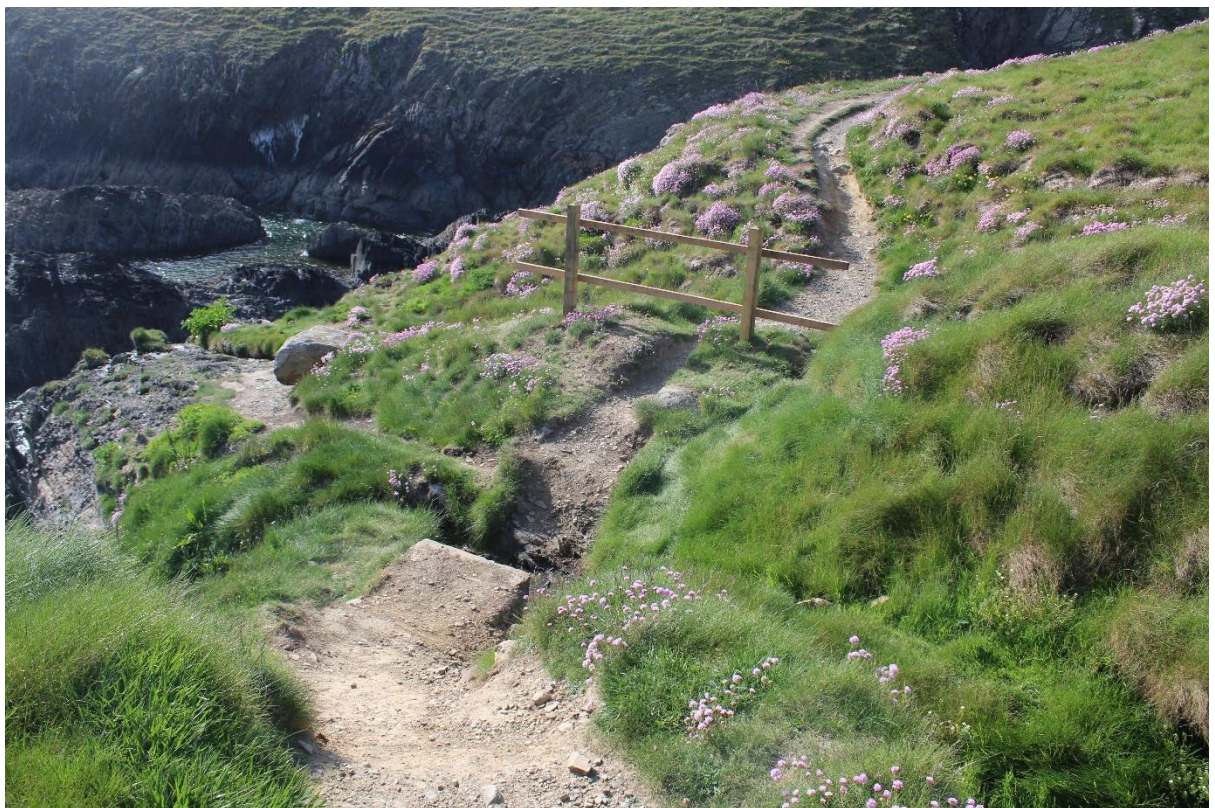
**Figure 18. Photo showing the absence of the footbridge after removal and also the physical barrier to deter visitors attempting to use the old path from a northwest direction.**

- Finally, the wardens removed the footbridge connecting the scheduled monument area to the surrounding path. On the outer side, a physical barrier was installed to deter visitors attempting to use this as a path.

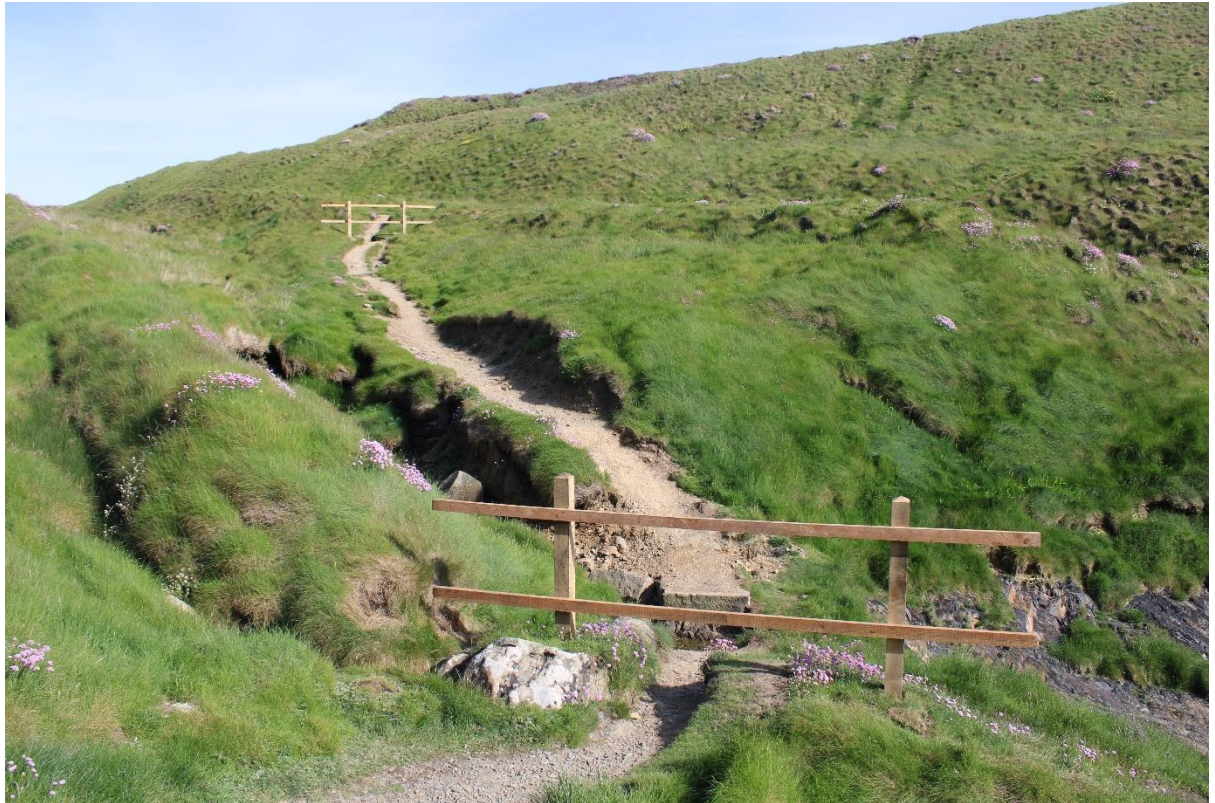
**Figure 19. Photo showing northwest corner of monument a few weeks after completion. There are no traces of steps, footbridge has been removed and physical barriers are in place from both directions to deter use of the old path.**

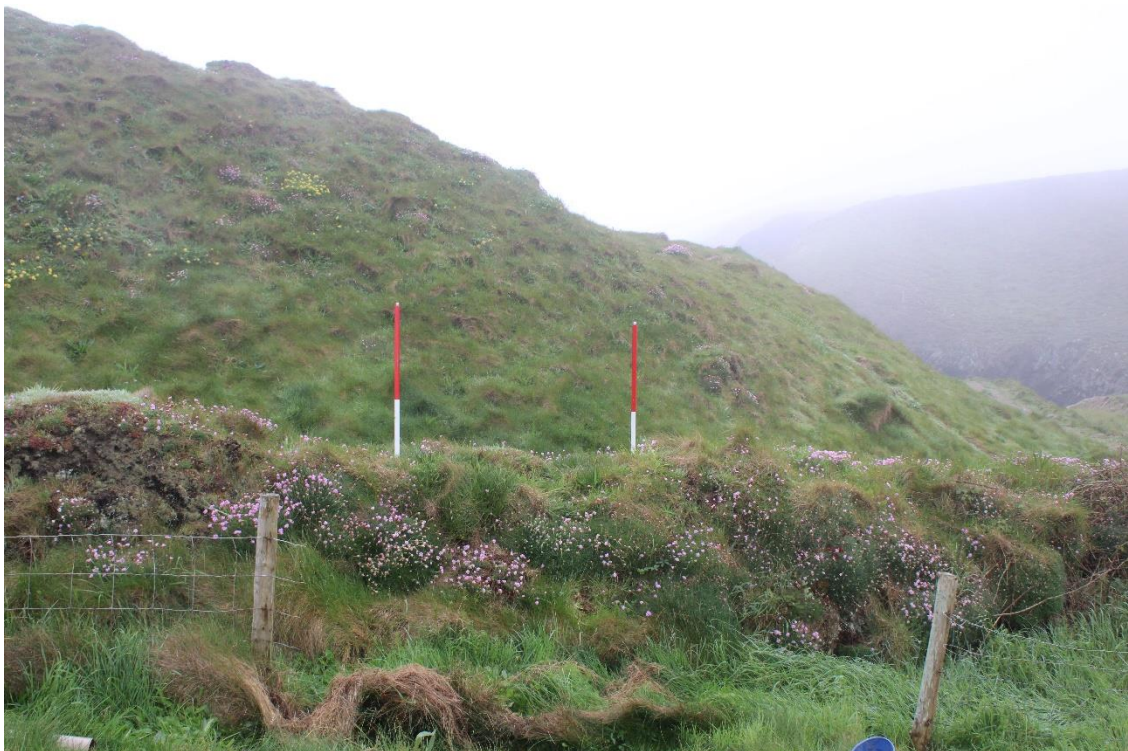
**Figure 20. Photo showing cut wire fence and ranging rods marking area to be opened in bank.**

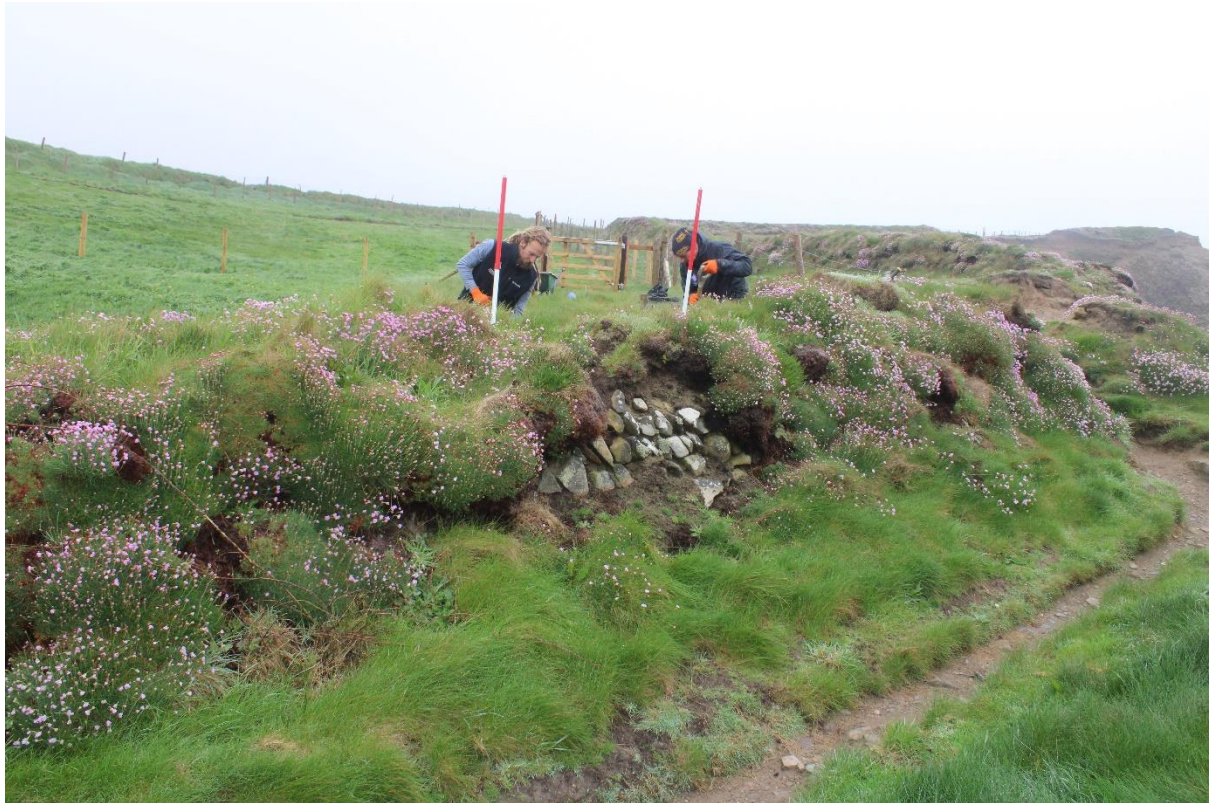
**Figure 21. Photo showing wardens removing vegetation from historic bank to expose earth and stone underneath.**

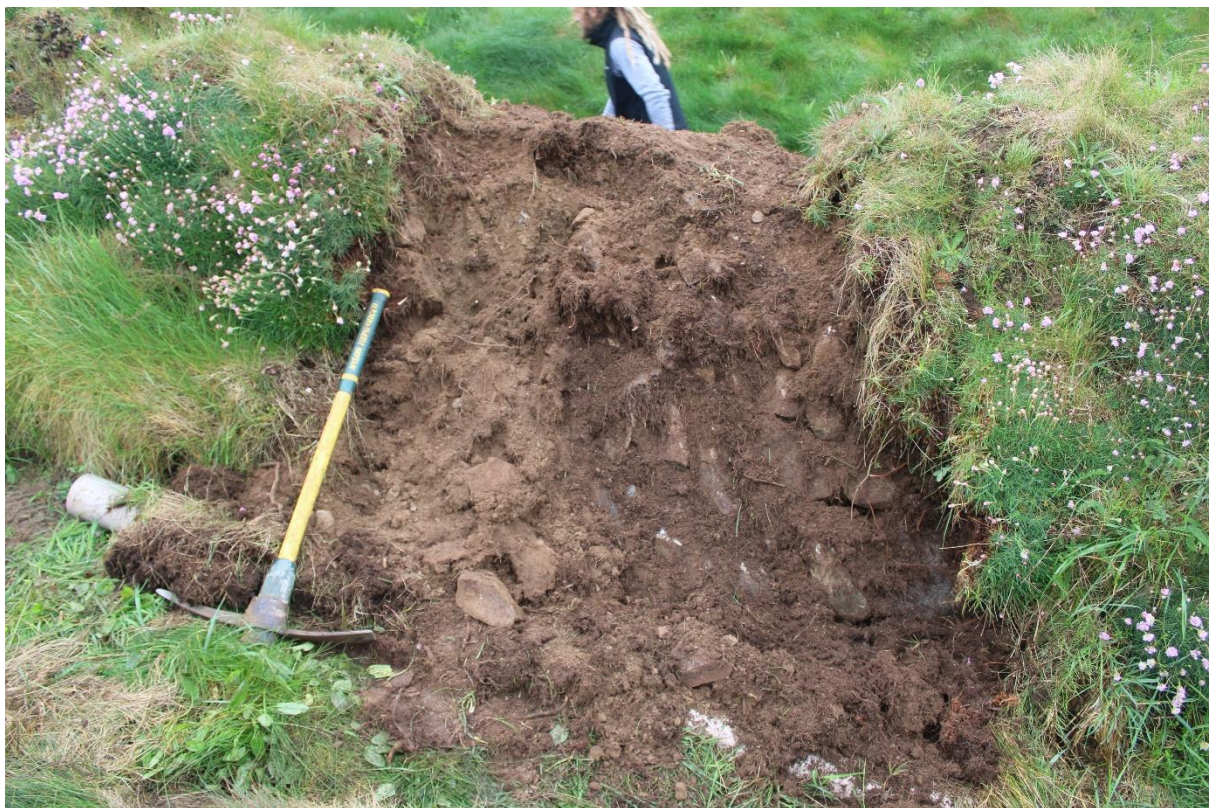
**Figure 22. Photo showing start of removal of earth and stones from the opening in the bank.**

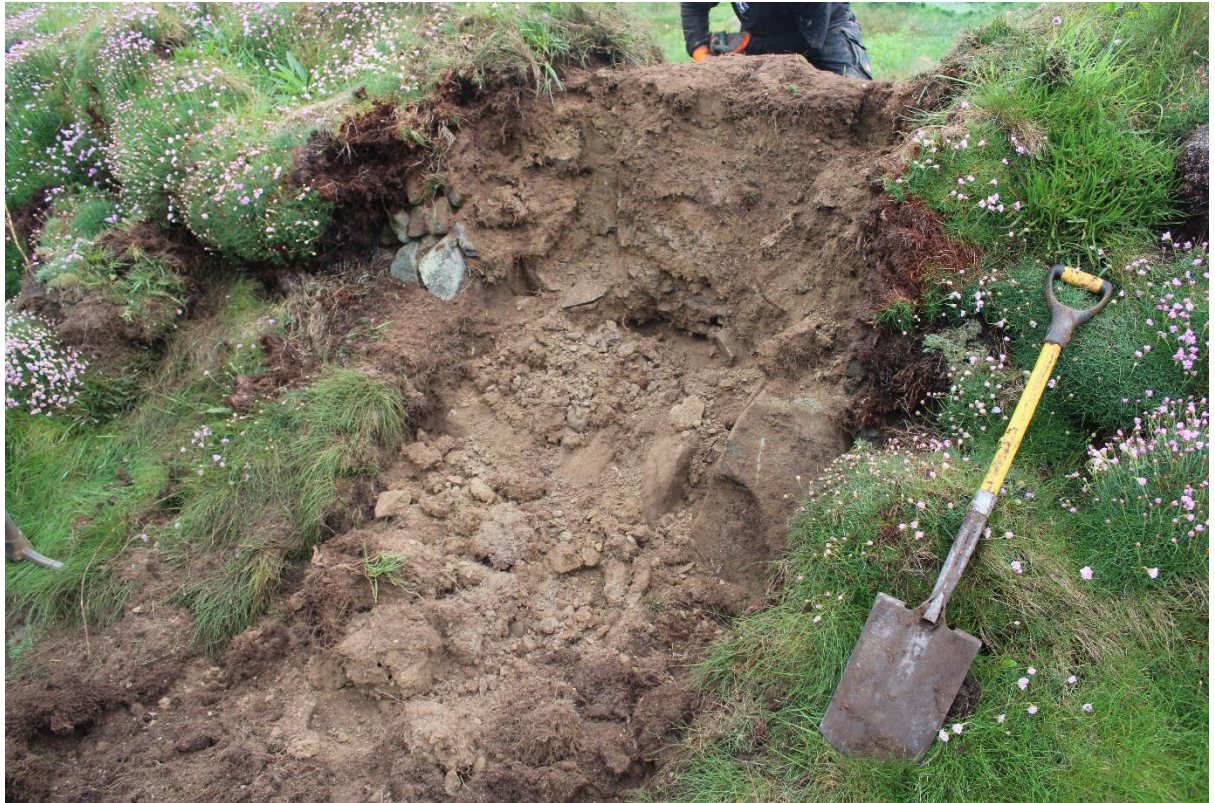
- The removal revealed that the banks were composed of soil and stones, with the largest stones being located at the base of the bank.
- Due to the different ground level between the scheduled monument side of the post-medieval bank and the outer side, the wardens used some of the soil to level this out, notably on the outer side of the monument.

**Figure 23. Photo showing the outer earth and stone from the monument side of the bank has been removed down to level required. Note large stone at base.**
