**PE273 PORTH-Y-RHAW CAMP**  
**FOOTPATH DIVERSION WORK**  
**COMPLETION REPORT**

**Prepared on behalf of the Pembrokeshire Coast National Authority by Tomos Jones, Community Archaeologist.**

**28 September 2023**

The following report provides details of work carried out at PE273 Porth-y-Rhaw Camp scheduled monument in April and May 2023. Specifically, work to remove the footsteps and cut through a post-medieval bank within the scheduled area as part of work to re-divert the coast path away from the scheduled monument area.

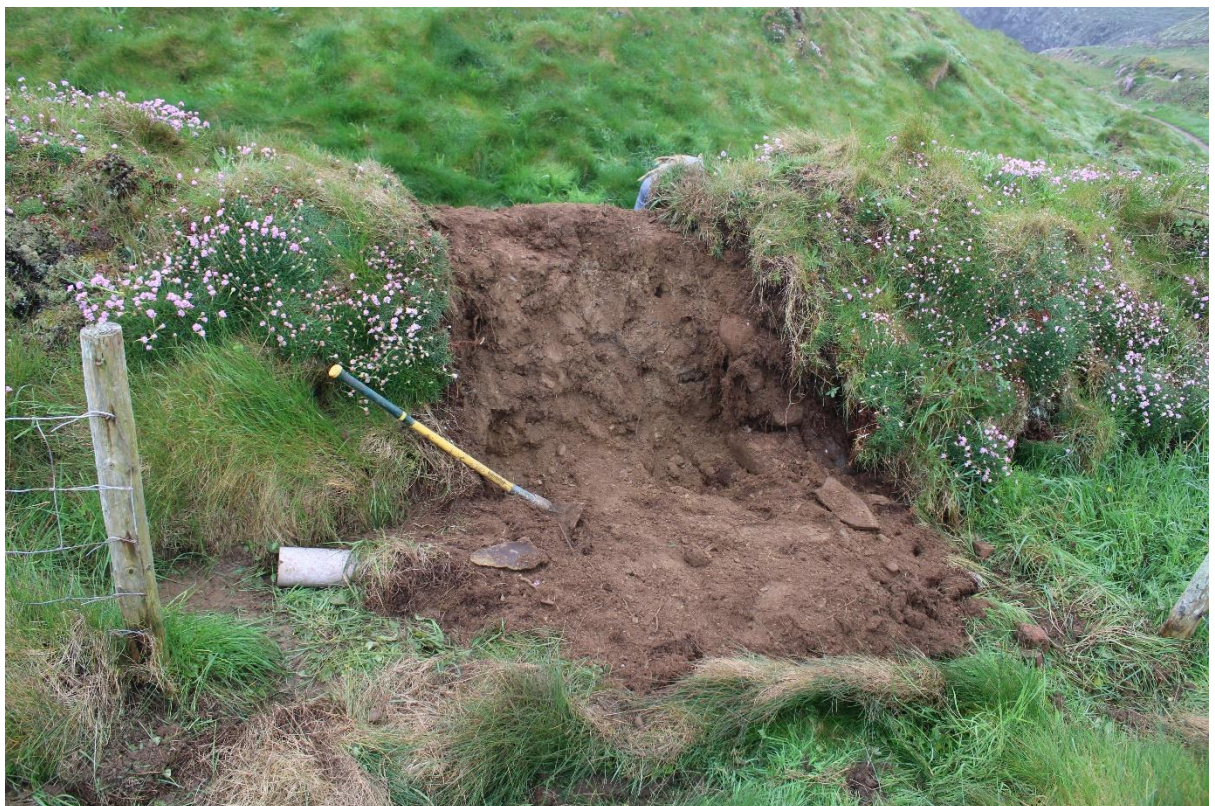
**Figure 24. Photo showing the outer earth and stone layer of the bank on the side outside the monument has been removed to the required level.**

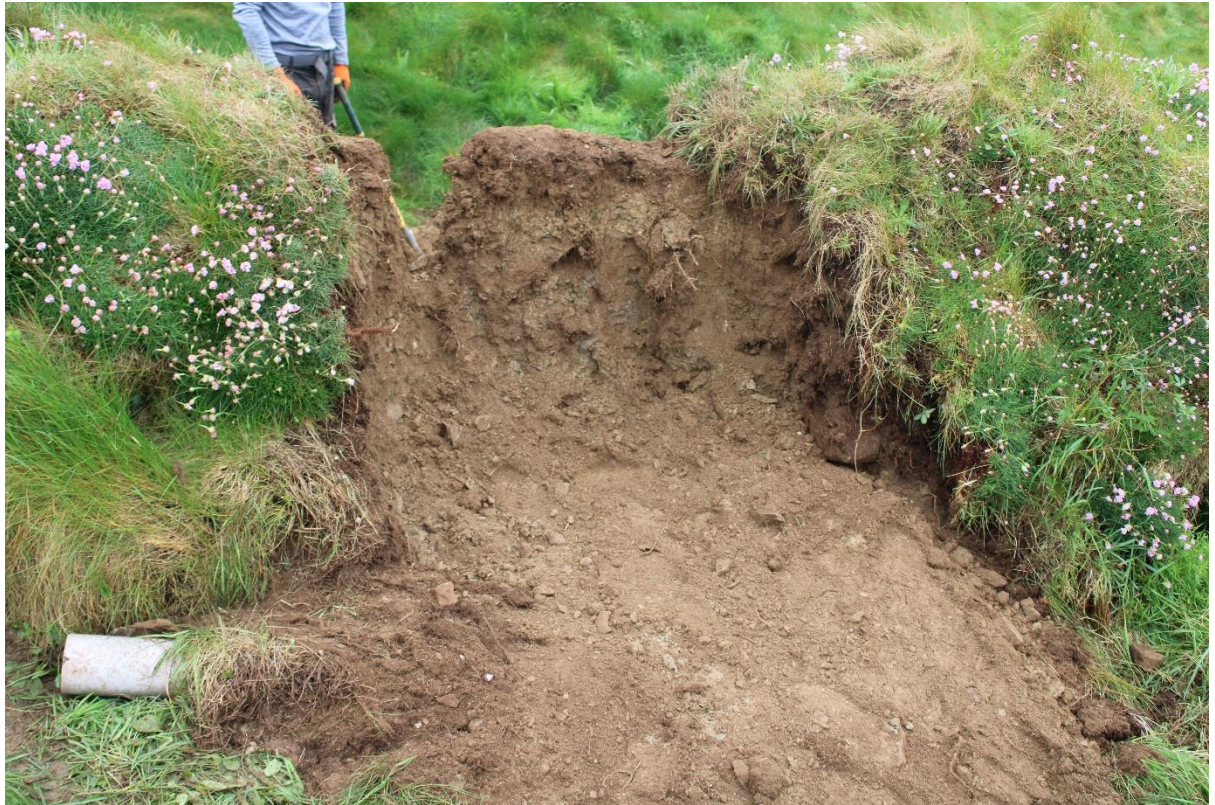
**Figure 25. Photo showing the final layer separating either side of the bank being removed.**

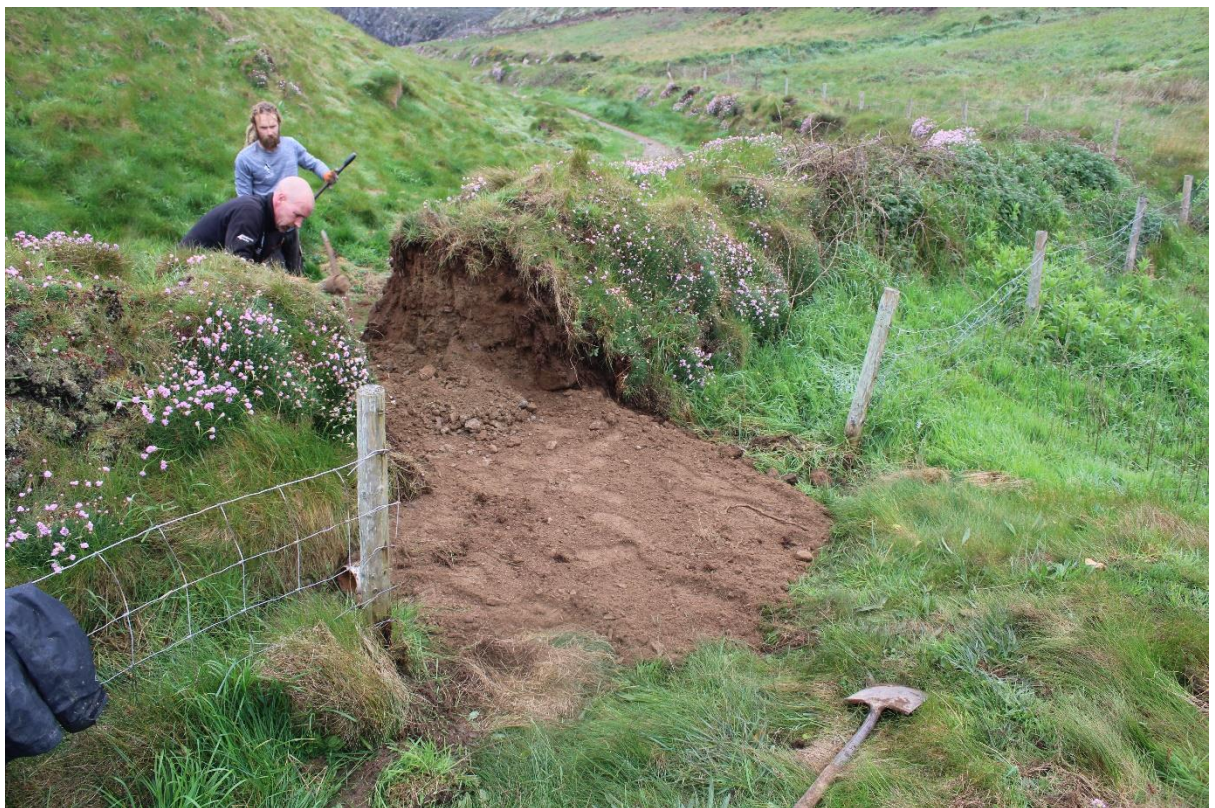
**Figure 26. Photo showing the new access through bank after removing the final partition layer. Note that some of the soil from the bank has been used to level the surface through this new access.**

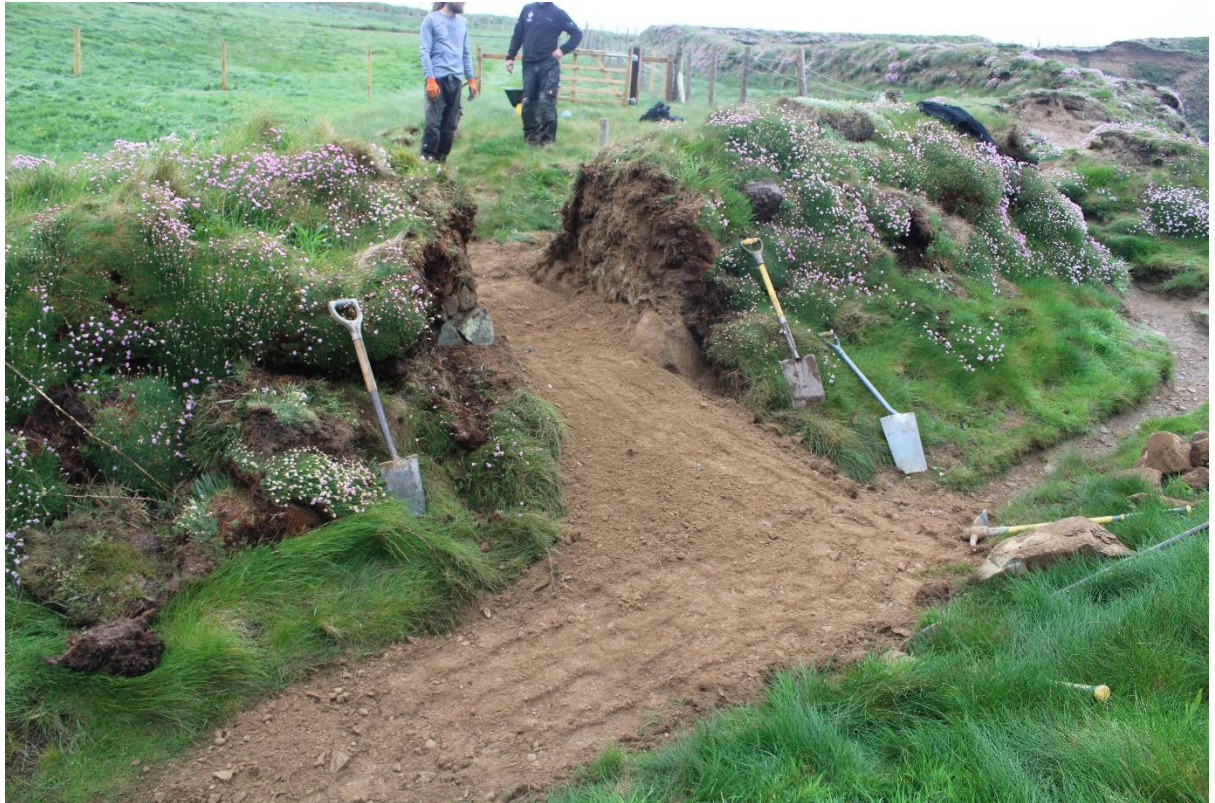
**Figure 27. Photo showing new access with levelled surface from scheduled monument side.**

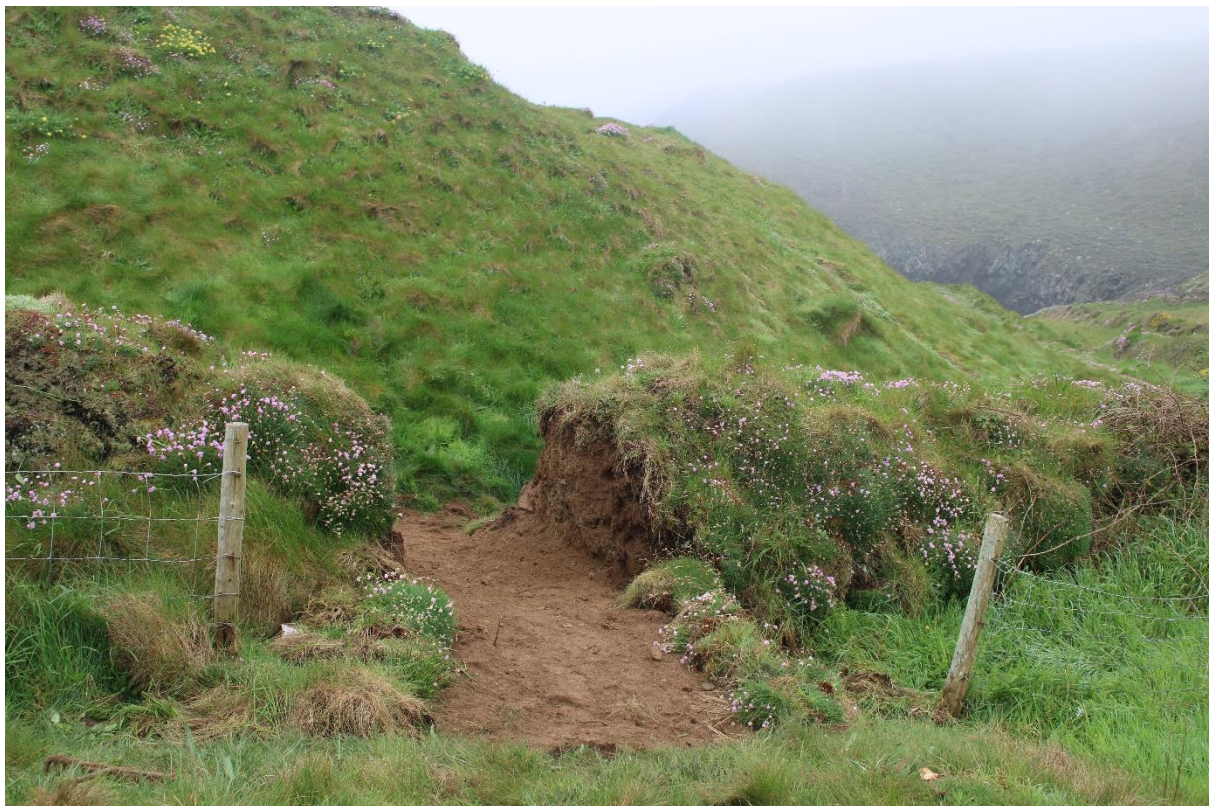
**Figure 28. Photo showing new access with levelled surface from outside scheduled monument.**

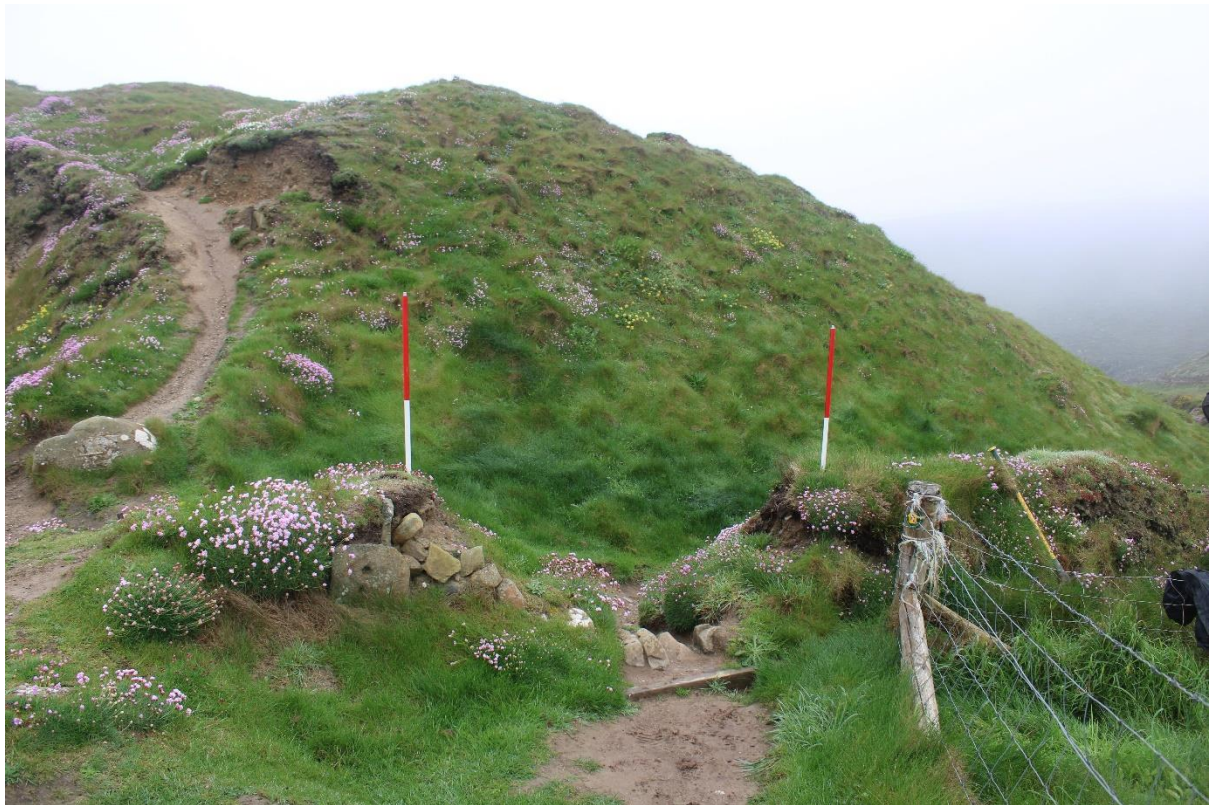
**Figure 29. Photo showing access through bank to be infilled to deter use of the old coast path.**

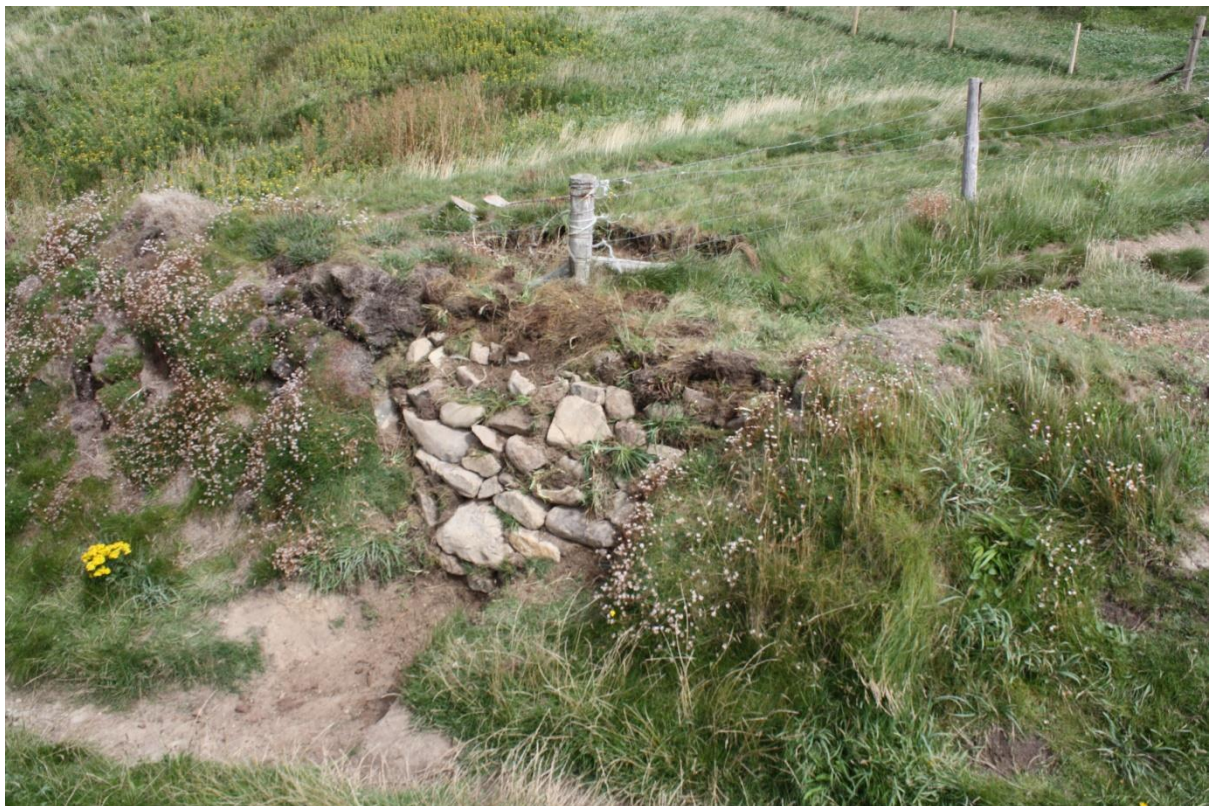
**Figure 30. Photo showing former access through bank filled with stones, earth and topped with turf using available repurposed material (view from inside scheduled monument).**

- Material removed from the post-medieval bank was then used to infill the old access through a post-medieval bank closer to the cliff edge on 11 August 2023. The larger stones were laid at the base, gradually reducing in size towards the top of the bank. The centre was infilled with soil and in-between stone layers, soil and turf were placed. At the top of the infilled bank, turf was placed.

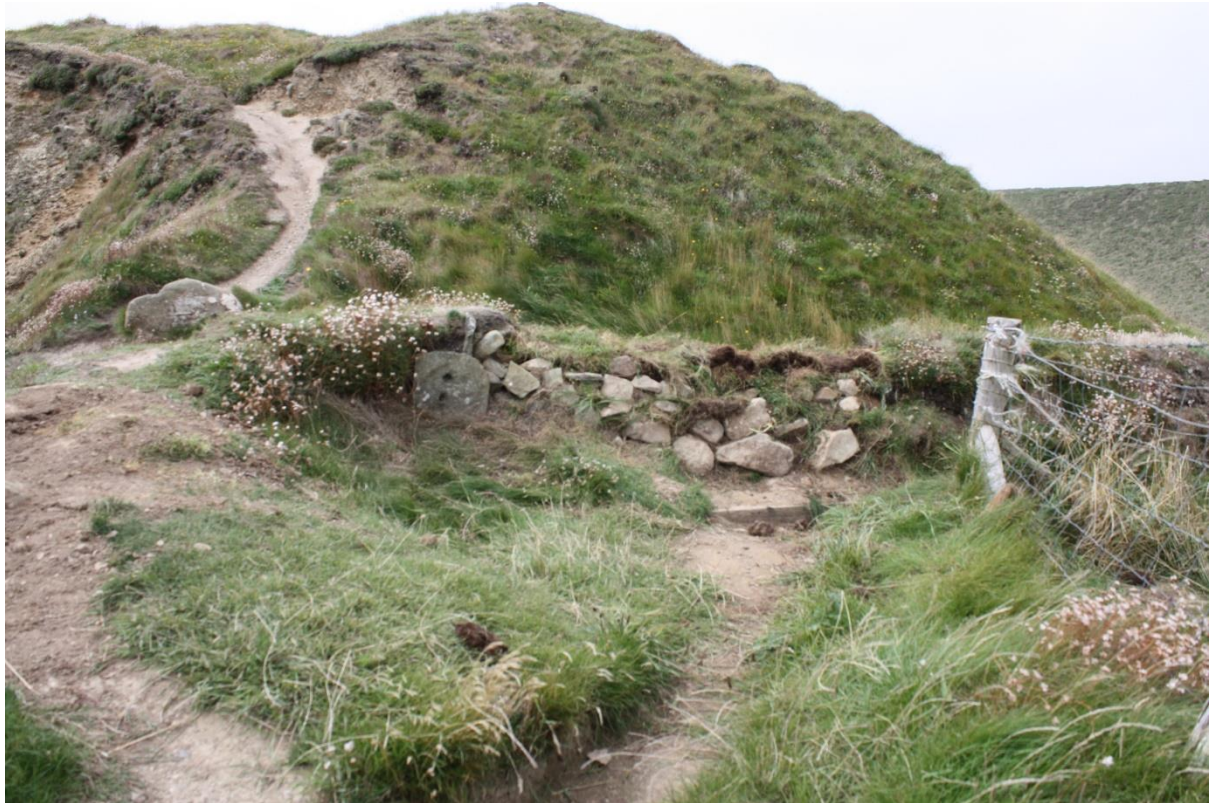
**Figure 31. Photo showing former access through bank filled with stones, earth and topped with turf using available repurposed material (view from outside scheduled monument).**

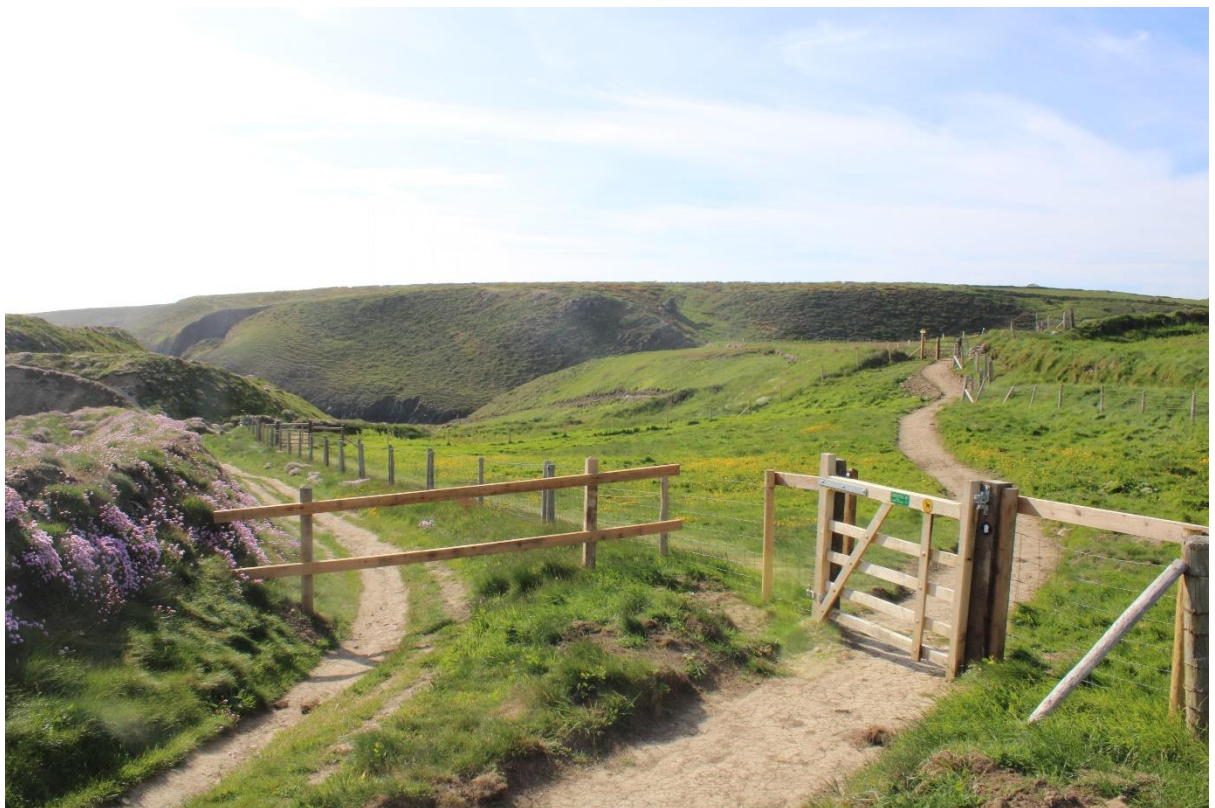
**Figure 32. Photo showing physical barrier to access the old path from an east direction, also view of new path heading towards the right in the image.**

- The old path leading to the monument from the east was blocked with a physical barrier to deter continued use by visitors. A post and way marker were also installed to indicate direction and access to the scheduled monument.

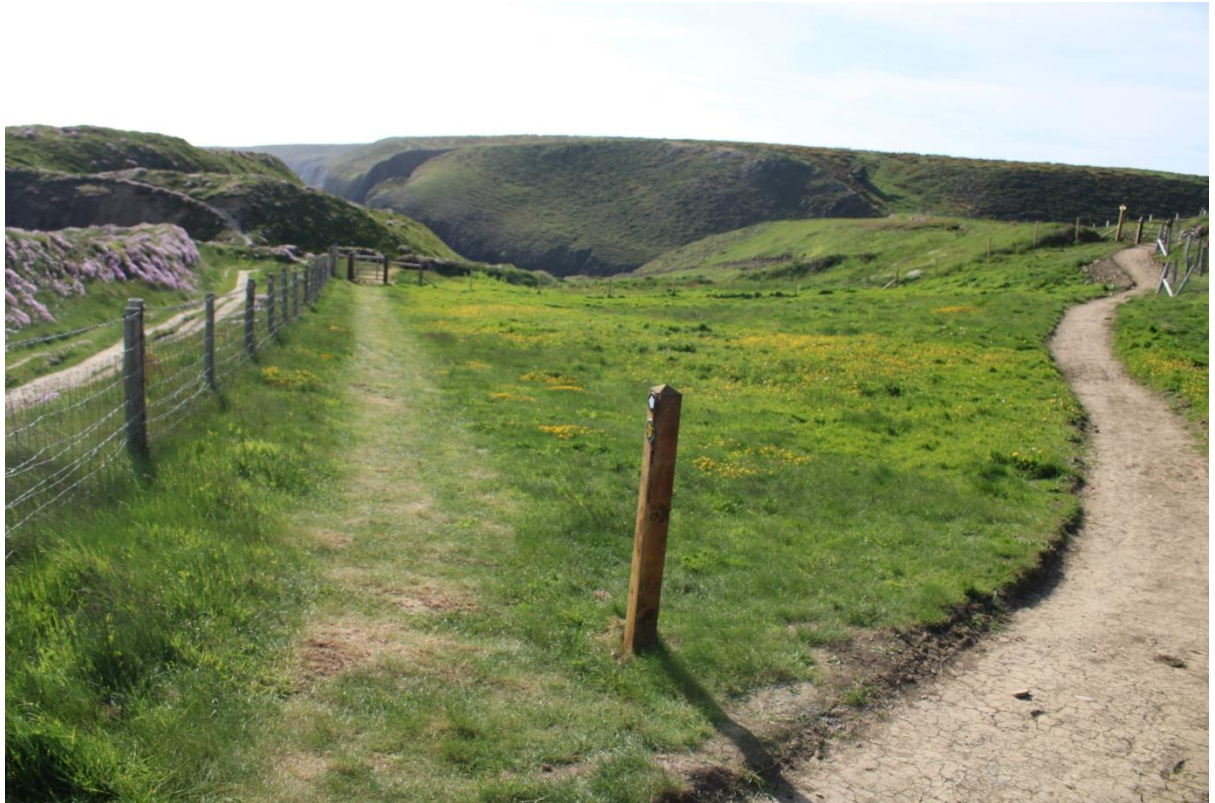
**Figure 33. Photo showing post and way marker to indicate new direction to access scheduled monument.**
