CPAT Report No. 1691

The Granary Barn, Penishapentre, Llanspyddid, Powys

Building Survey

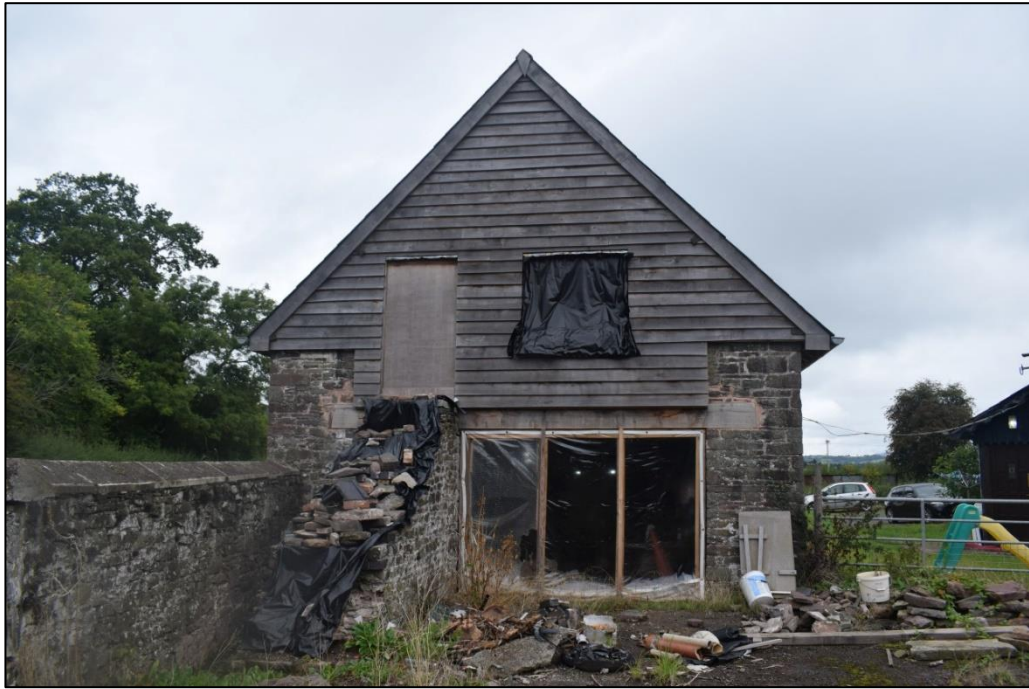
Fig. 5 South-west elevation Photo CPAT 4691-06

- 3.4. The south-west elevation of the granary faced onto the farmyard. It comprised an open gable end, with a wide low entrance on the ground floor to allow access for carts and trailers. The upper floor was clad with weatherboarding, which was accessed by a doorway, via a stone staircase. There was also an access hatch for a grain auger or elevator. The staircase partially obstructed the ground floor entrance and was a later addition.

- 4.3. A stone-built external staircase may have been constructed in the same broad period as the bee boles, although it could date from the post-fire rebuild of the granary.

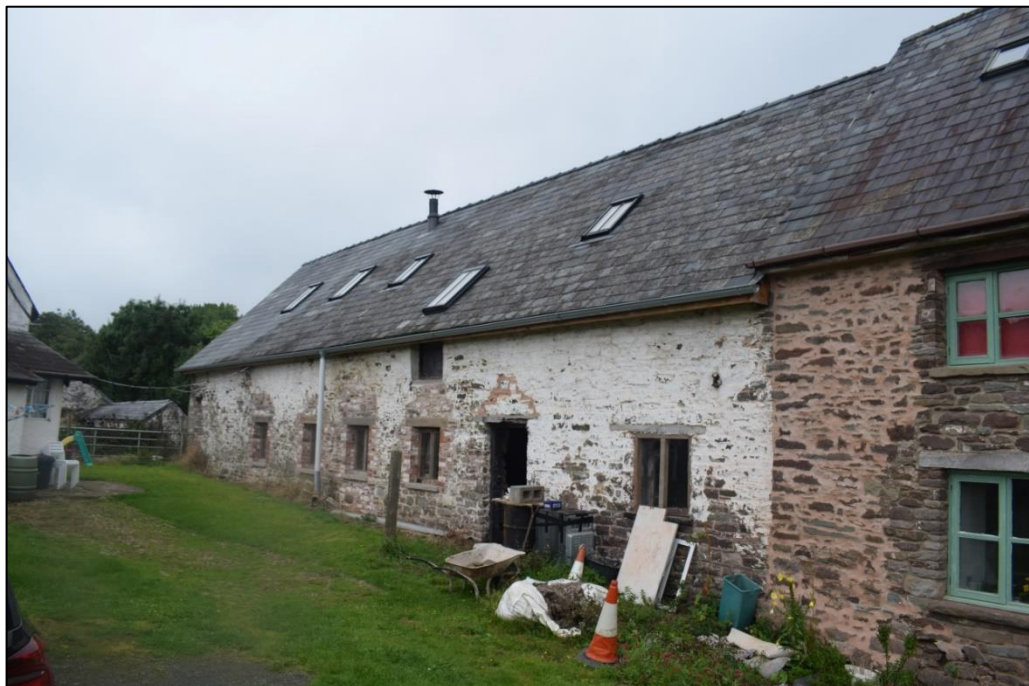
Fig. 6 South-east elevation viewed from the east Photo CPAT 4691-14

- 3.5. The south-east elevation had been considerably modified when the lower floor of the granary was converted into a workshop. Four windows had been inserted into the existing wall fabric. Railway track had been inserted through holes made in the wall fabric along this elevation to act as additional joists to support the upper granary floor. It was unclear exactly when these alterations were made but the owner suggested that the track, manufactured by GKN for the Great Western Railway circa 1929, was acquired following the closure of the northern extent of the Neath and Brecon Line in about 1969.

- 4.5. In the mid to late 20th century, the ground floor of the granary, which was still being used for its intended purpose was converted into a workshop, with the additional of four windows on the south-east elevation. An access hatch to the upper floor on this elevation also dated from this period. The reinforcement of the floor with joists made from railway track is likely to have been carried out 1969 when the track for the uppermost stretch of the Neath and Brecon railway was taken up.

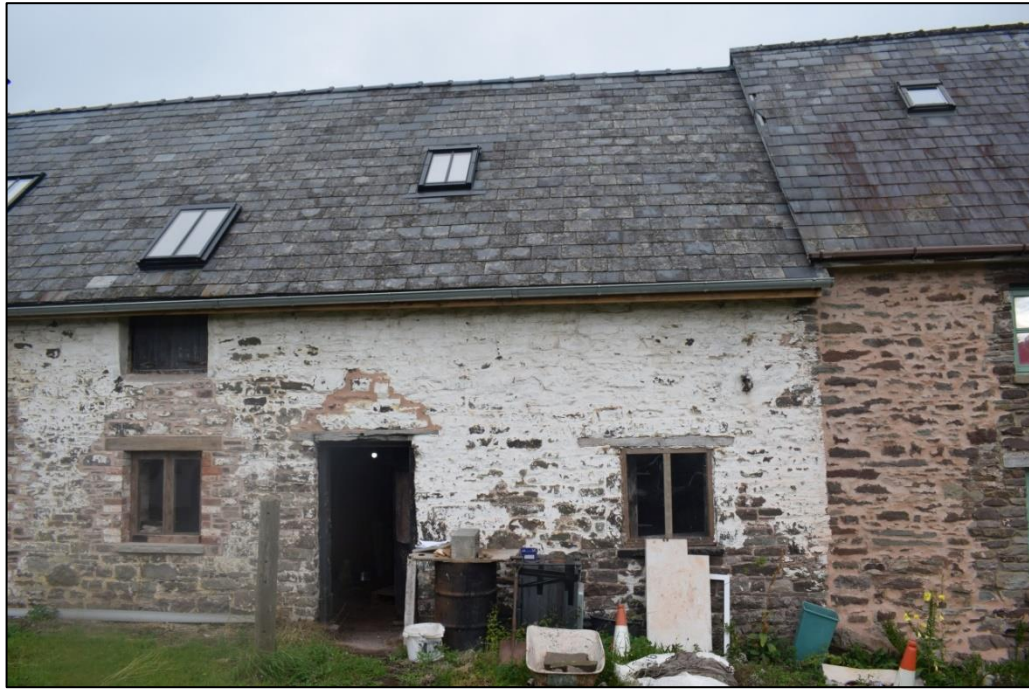
Fig. 7 Original doorway and mullion window in the south-east elevation Photo CPAT 4691-13

- 3.6. A ground floor doorway and an older mullion type window were located in the north-east end of the elevation, these were original features of the building. An access hatch to the upper floor was a later feature.

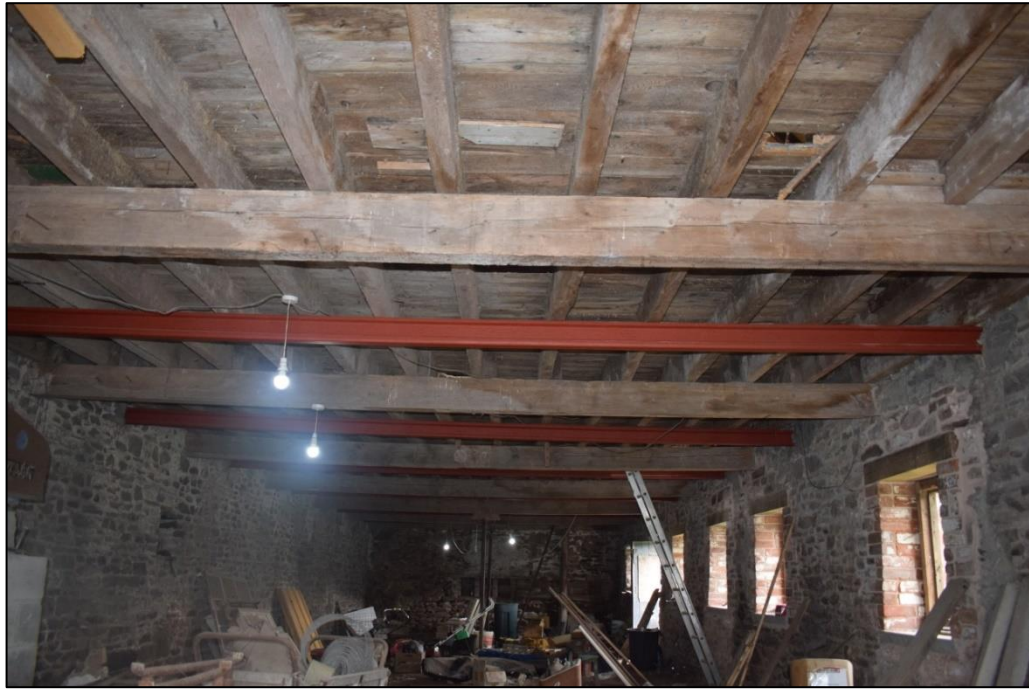
Fig. 9 Ground floor of the granary, viewed from the south-west Photo CPAT 4691-38

- 3.7. The ground floor of the granary comprised a single room with no evidence of subdivision. A modern grist mill on a blockwork plinth was located on the north-west elevation. There were three niches incorporated into the masonry of the north-west elevation for lamps or candles.

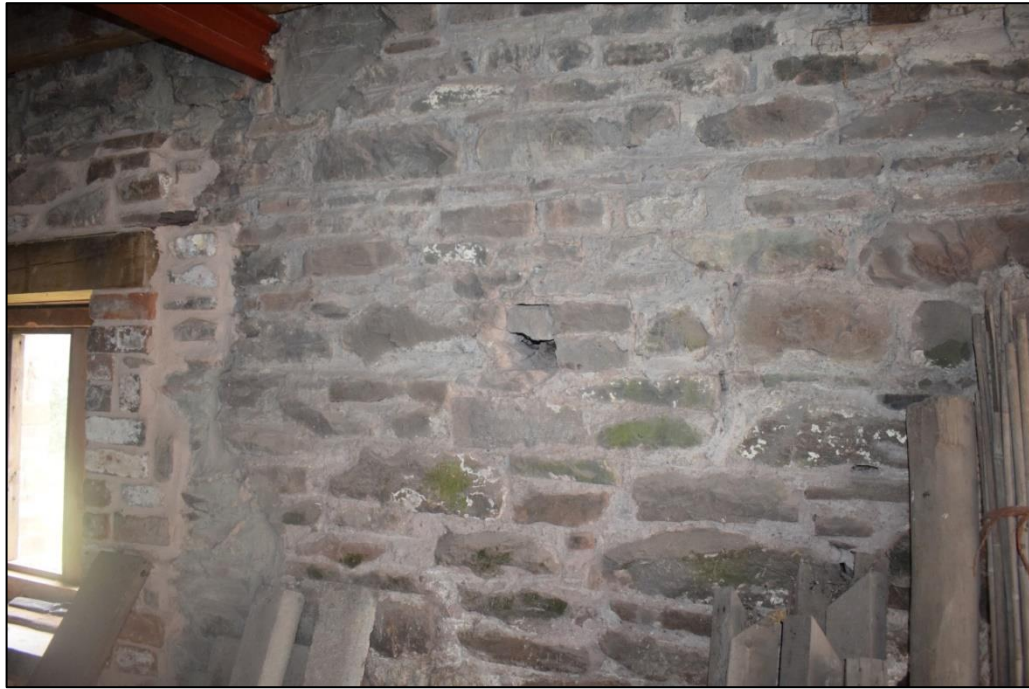
Fig. 11 One of a series of holes in the south-east elevation wall fabric Photo CPAT 4691-37

- 3.8. A series of five small, irregularly-spaced holes were visible in the stonework of the south-east elevation, at a height of 1.7m above floor level. These may have supported an internal structure such as shelves or racking. A niche for a light source was located close to the entrance at the south-west end.

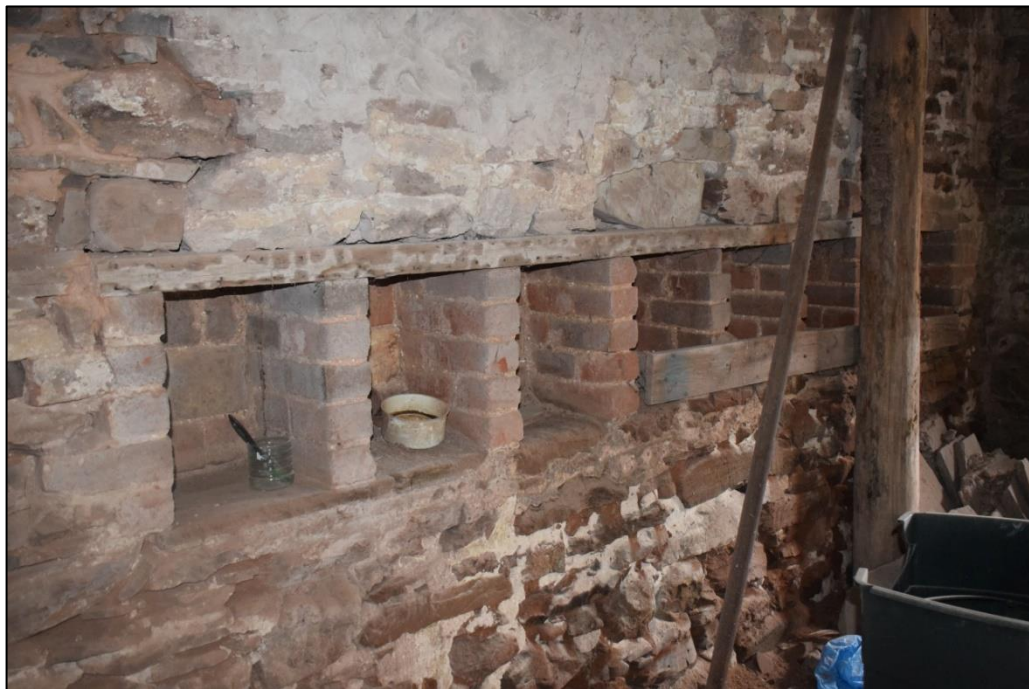
Fig. 12 Bee boles in the north-east elevation Photo CPAT 4691-28

- 3.9. There were a series of eight niches subdivided by bricks located in the north-east elevation, each measuring 0.4m in height, 0.3m in width and 0.3m deep. These were interpreted as bee boles of the type which were constructed inside buildings in order to store bee skeps during the winter months. The lintel over the niches was noted to have been reused, probably from part of a roof timber and there was charring on the inner beam, which suggests that the boles had been present when the building had been damaged by fire in 1877.

- 4.2. A series of bee boles were identified within the building which could be original features, although the use of brick is unusual within the building and suggests that they may have been added later. They were certainly present before a fire in 1877 since the original lintels were badly burnt and one lintel had been subsequently replaced with reused timber.

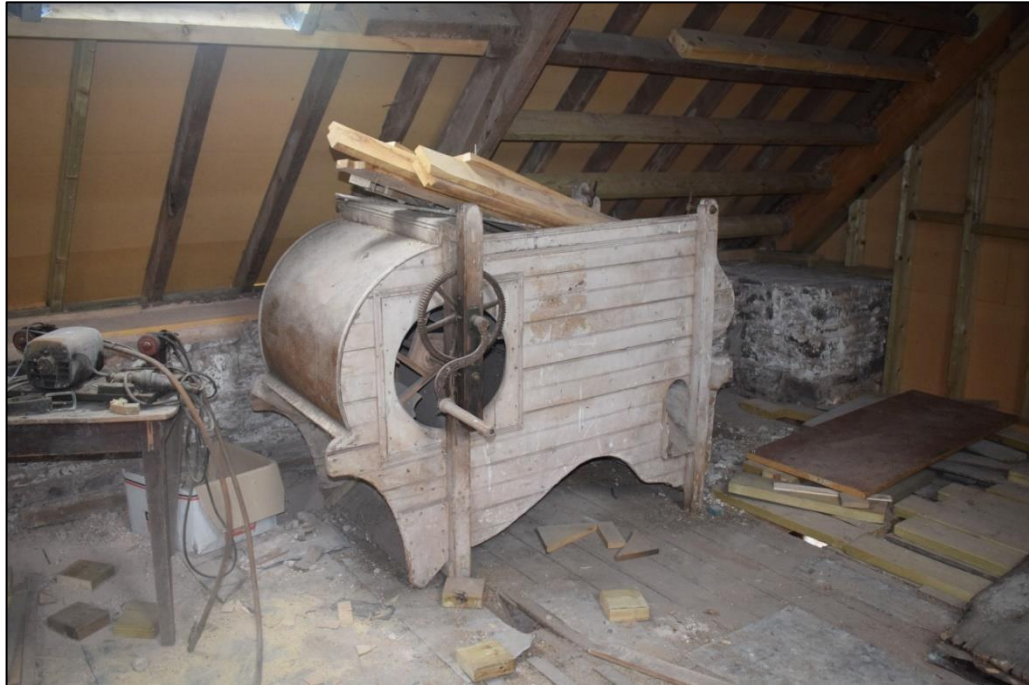
Fig. 13 Winnower and flooring on the upper floor of the granary including remnant skirting boards behind it Photo CPAT 4691-53

- 3.10. The upper floor of the granary was a single undivided space. It had been largely stripped of interior fittings, although the characteristic tightly fitted floor boards were still largely intact. The skirting around the edges of the room, which was necessary to avoid access by vermin but also to prevent grain escaping, had been removed except for a section in the south-east corner.

roof was either not affected by the fire or had been completely rebuilt subsequently. Likewise the floor was essentially in good condition, except for a few weakened areas caused by rot.

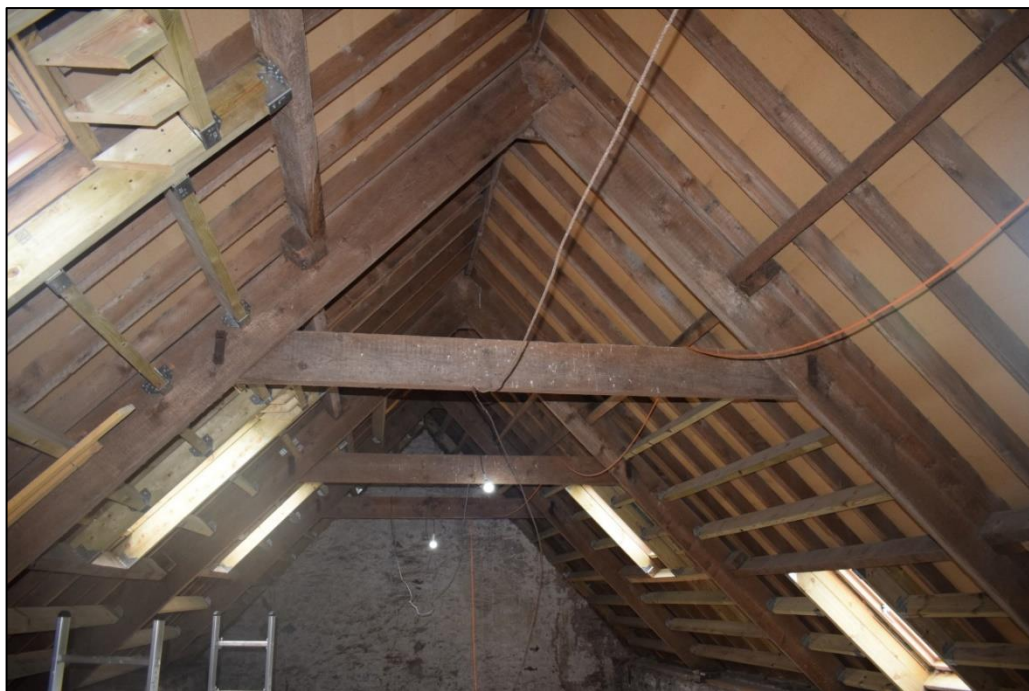
Fig. 14 Roof frame viewed from the south-west Photo CPAT 4691-57

- 3.11. The roof timbers had been exposed revealing the trusses, which were of the common rafter type with collar ties. The common rafters were seated on cruciform plinths rather than a continuous wall plate. The eaves had been boarded over to prevent access to the stored grain by birds.

- 4.4. The damage caused to the granary by the 1877 fire was not easy to determine, although the main roof trusses appeared to be undamaged and in very good condition, suggesting that
