CPAT Report No. 1503.1

Berain, Llannefydd, Conwy

Building Survey

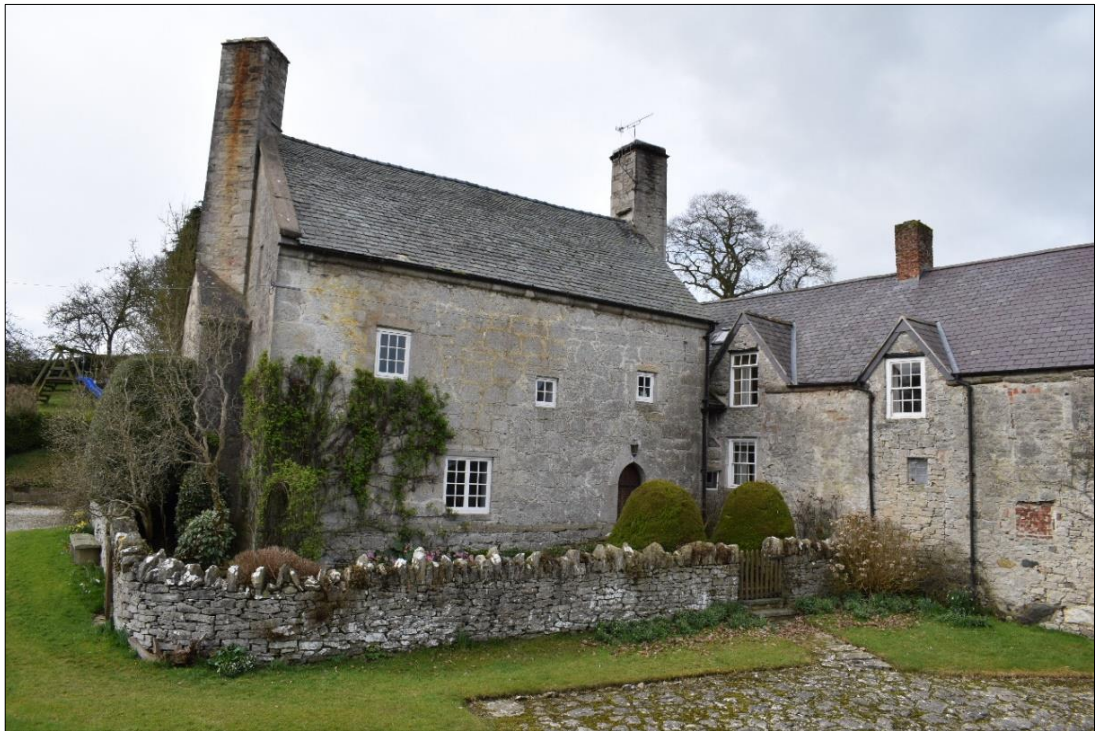
Fig. 2 Berain viewed from the west, showing the original hall range on the right and the later lodgings range on the left. Photo CPAT 4335-0036

- 2.7. A lodgings range was added in 16th century, probably by Katherine's father, Tudor ap Robert c. 1530; its closest parallel in inspiration and function is to be found a generation earlier, at Gwydir Castle, Llanrwst. The two-and-a-half storey range is curiously set at an angle to the hall. The addition of this range provided the hall range with a fine lateral fireplace, located at the dais end; thus the right-hand end chimney of the lodgings block serves the hall fireplace and not the latter.

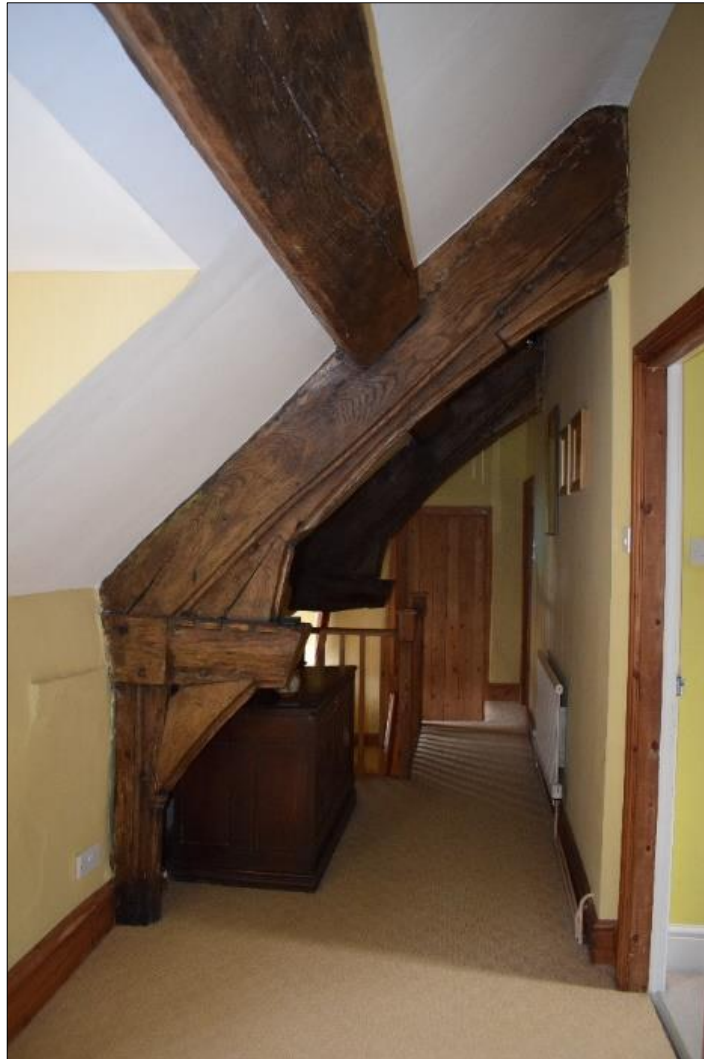
Fig. 4 Two of the hammerbeam principals associated with the original open hall (Trusses T4 and T5). Photo CPAT 4335-0005

- 2.3. The present house has three main components (Fig. 18), the earliest of which is a large hall range, the evidence for which consists of two hammerbeam principals and a moulded dais canopy beam (Fig. 19 trusses T4, 5 and 6, respectively), suggesting a three-and-a-half bay open hall (Fig. 3). The hall range was probably floored over in the 17th century.
- 2.4. The hall-house has been dated by the North West Wales Dendrochronology Project (Jones and Morgan 2015). Samples from a purlin from the main hammerbeam roof, a principal rafter from the side (bedroom) roof, and an axial beam in the ground floor

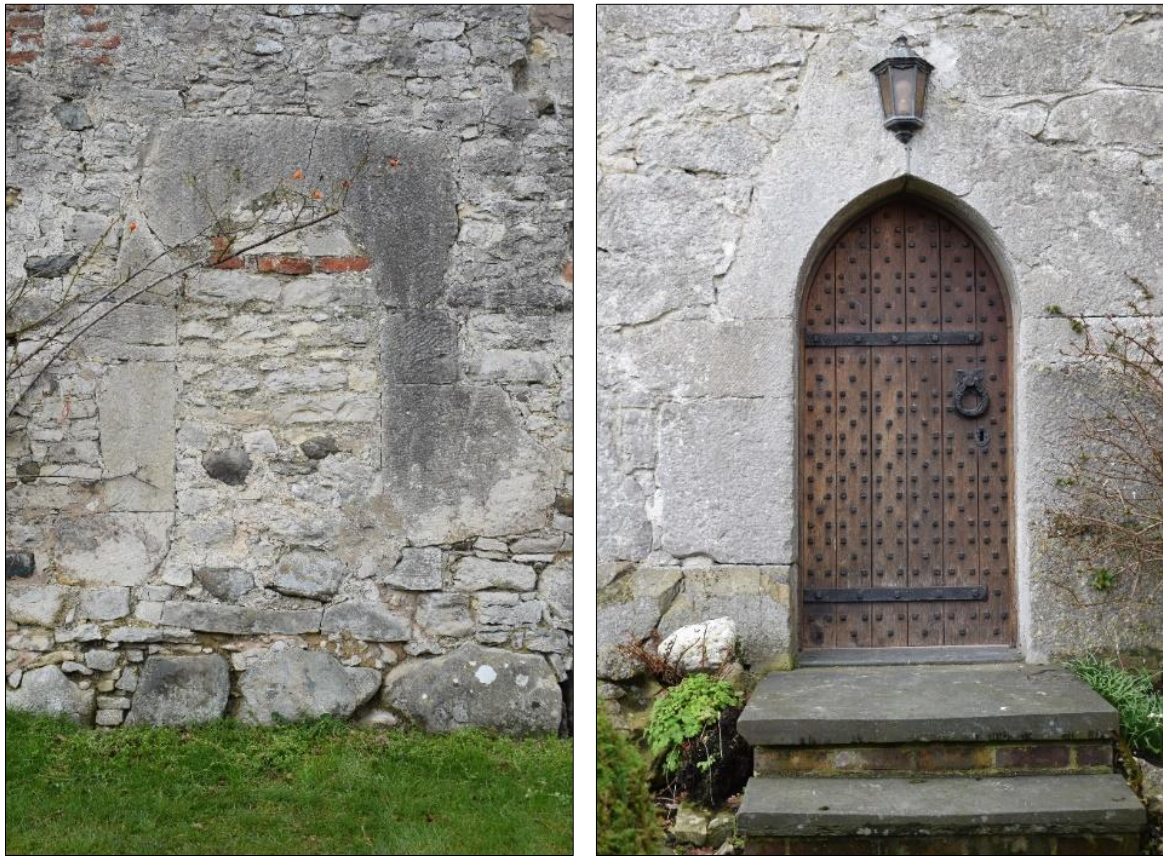
- 3.4. There are two blocked entrances, the most obvious and impressive being a pointed-arched cyclopean doorway, matching the entrance to the lodgings range, leading into what is now a barn.

Fig. 6 The blocked pointed-arched cyclopean entrance and the matching entrance into the lodgings range. Photos CPAT 4335-0031 and 4335-0040

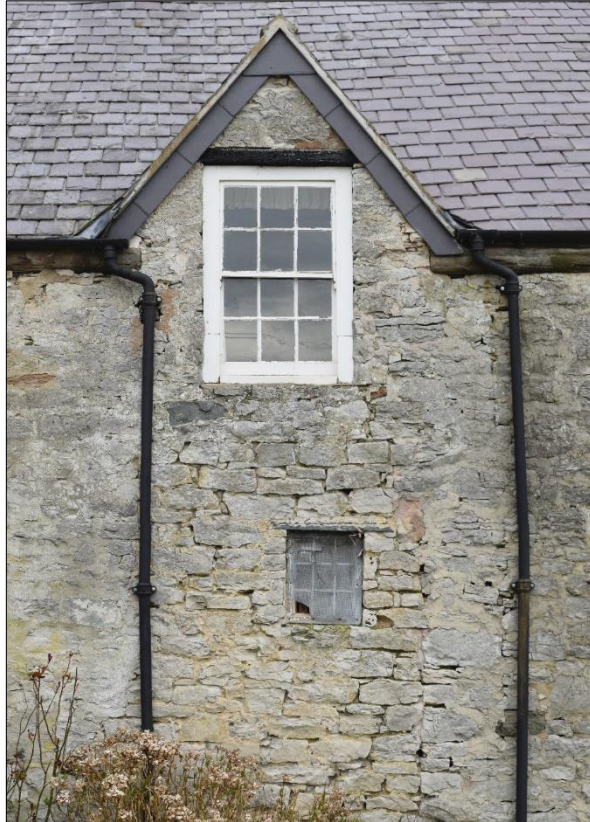
- 3.5. The other blocked entrance formerly opened into what is now the larder/pantry. It has an obvious masonry joint on its north-east side, but the other side is less well defined, while a small window occupies the upper part of the entrance. Above this is an inserted dormer window, probably replacing a small original window immediately below the eaves (Fig. 7).
- 3.6. Other blocked openings include a first-floor window and later, infilled, ventilation slit above and to the left of the cyclopean doorway (Fig. 8), a ground-floor window with brick infill between the two blocked doorways, and a first-floor window above (Fig. 9). The latter is of particular interest since the interior retains part of a sandstone window moulding, while it is also evident that the window was partly infilled to form a ventilation slit which itself was later blocked (Fig. 10).

Fig. 7 The blocked doorway and inserted dormer window in the south-east elevation. Photo 4335-0009/11

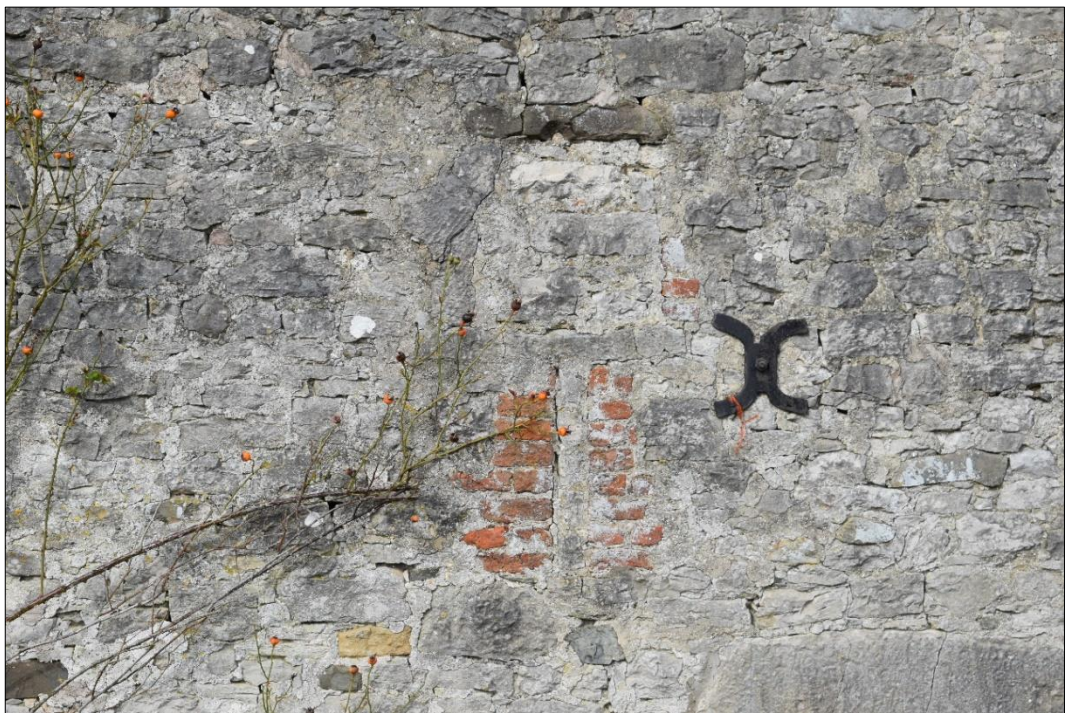
Fig. 8 The blocked first-floor window and later, infilled, ventilation slit above and to the left of the cylcopen doorway. Photo CPAT 4335-0039

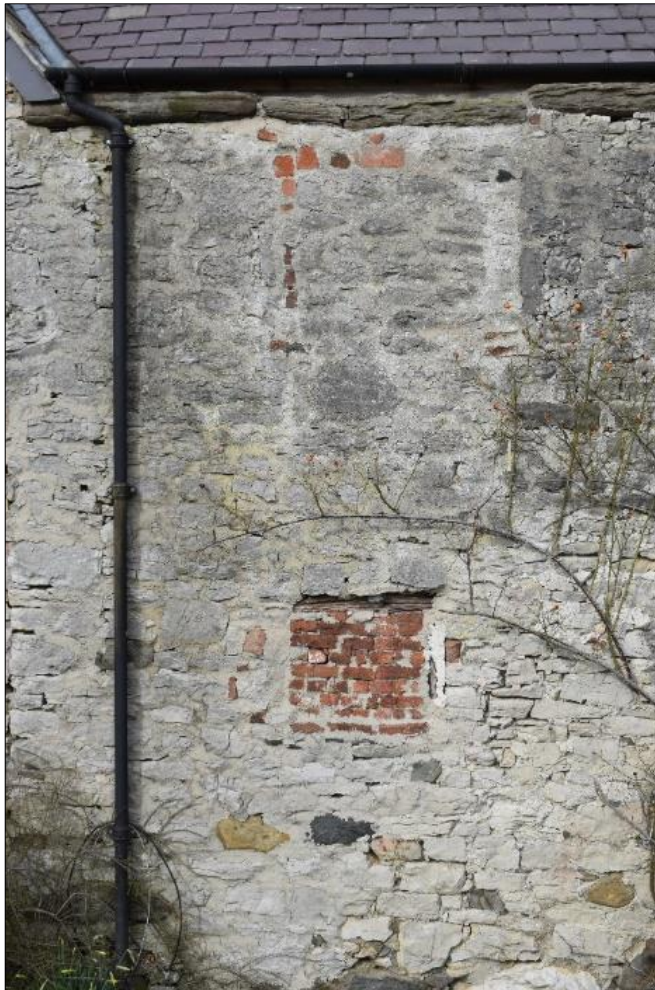
Fig. 9 Blocked windows in the south-east elevation. Photo CPAT 4335-0038

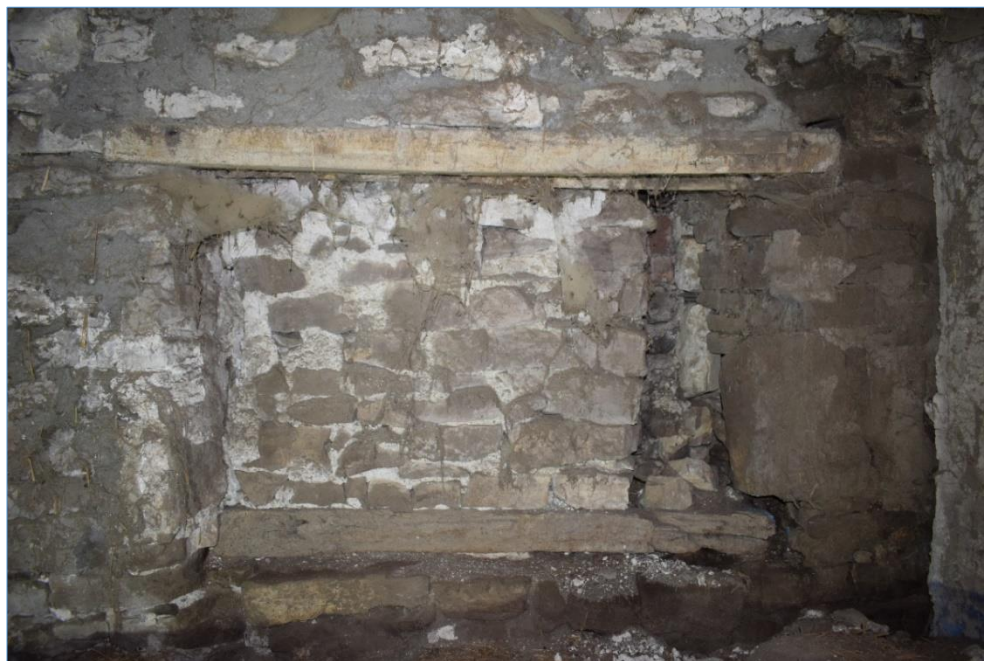
Fig. 10 Interior of the blocked first-floor window showing sandstone moulding and blocked ventilation slit on the left. Photo CPAT 4335-0068

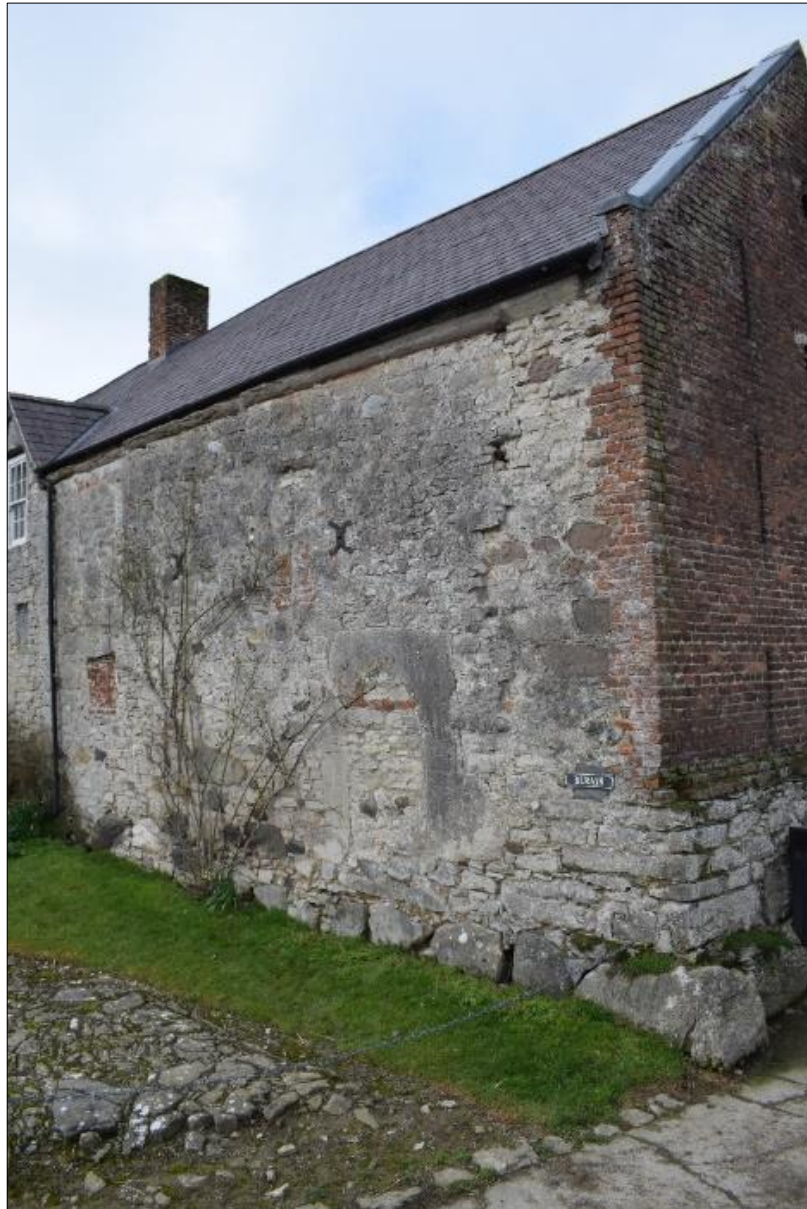
- 3.7. The north-eastern end of the range has two phases of plinth, the earlier being of boulders, with more regular stonework above. An obvious change in the masonry towards the corner appears contemporary with the later plinth and also the rebuilding of the gable wall in brick during the 18th century (Fig. 11). The implication is that the gable may have collapsed at the eastern corner.
- 3.8. The gable wall has three tiers of ventilation slits, a central boarded loading bay at first-floor level and an oculus to the gable apex. The brickwork below the loading bay shows clear straight joints, suggesting that there may have been a ground-floor opening which was later blocked.

Fig. 11 The eastern corner of the south-east elevation, showing the two-tier plinth, changes in the masonry and the brick gable. Photo CPAT 4335-0049

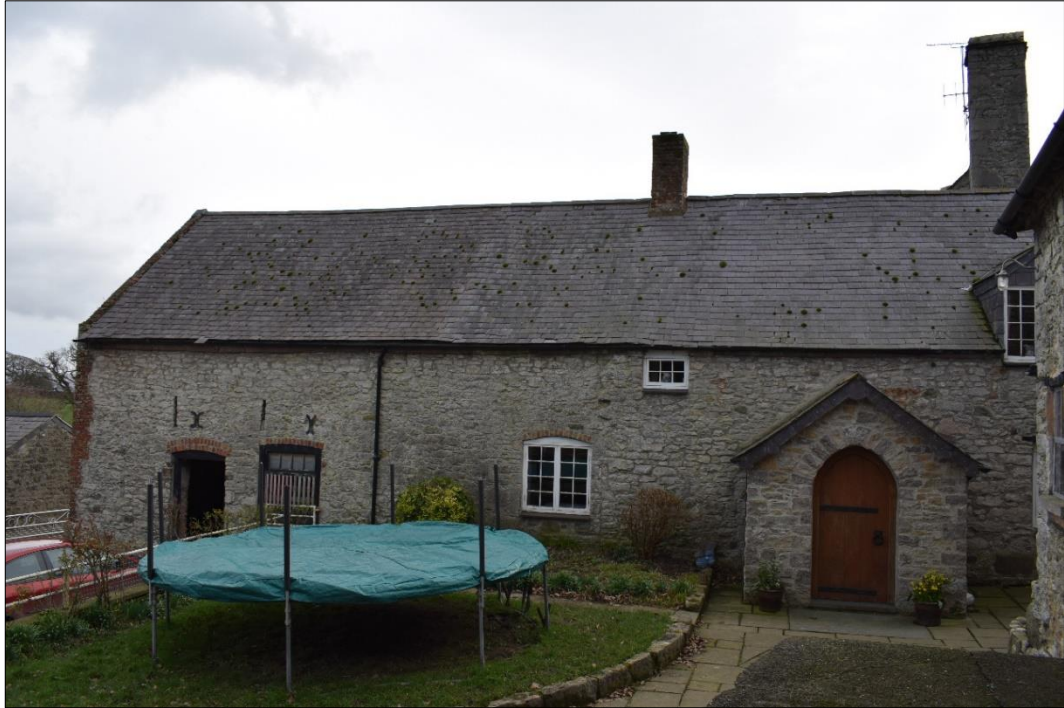
Fig. 12 The north-west elevation of the hall range. Photo CPAT 4335-0053

- 3.9. The north-west side of this range (Fig. 12) has a cambered-headed entrance into the barn with a boarded door and brick voussoirs, with a similar window to the right. Beyond this is a twelve-pane, 19th-century sash window with brick voussoirs. Joints in the masonry suggest that this may have once been a doorway, while the joint to the right shows clear signs of masonry rebuilding, the full extent of which is not clear. The continuation of the roll-moulded eaves suggests that they may have been reset above a rebuild, although a gap in the eaves course to the right may be original and is now partly occupied by a small first-floor window (Fig. 13).

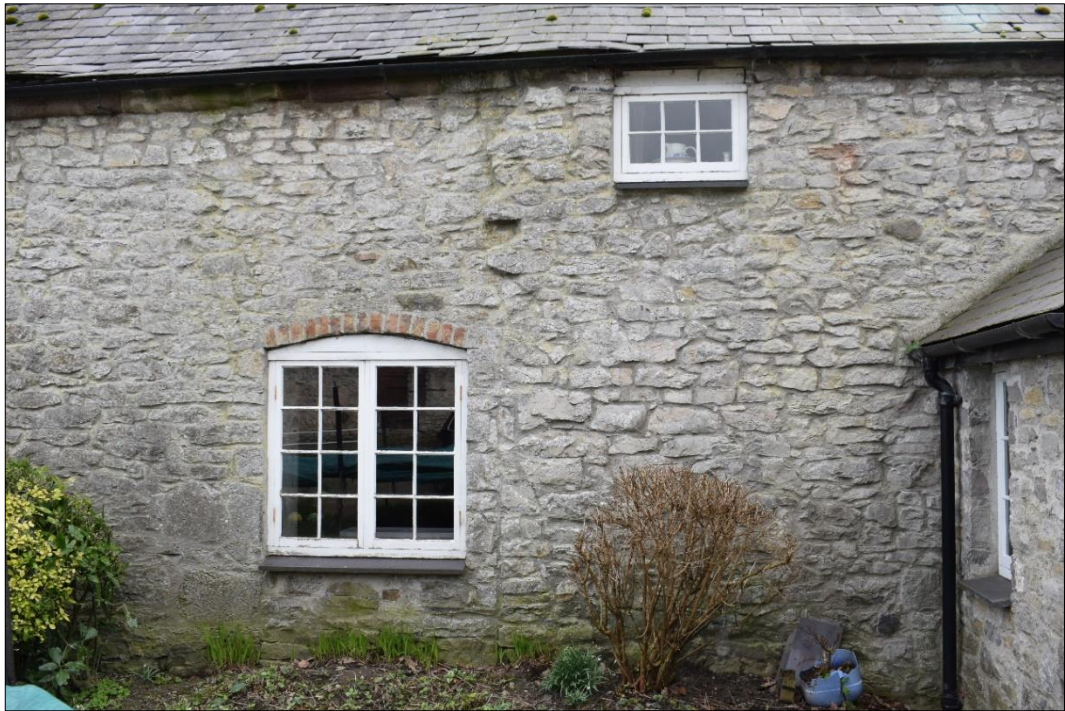
Fig. 13 The possible earlier doorway and obvious masonry joint. Photo CPAT 4335-0061

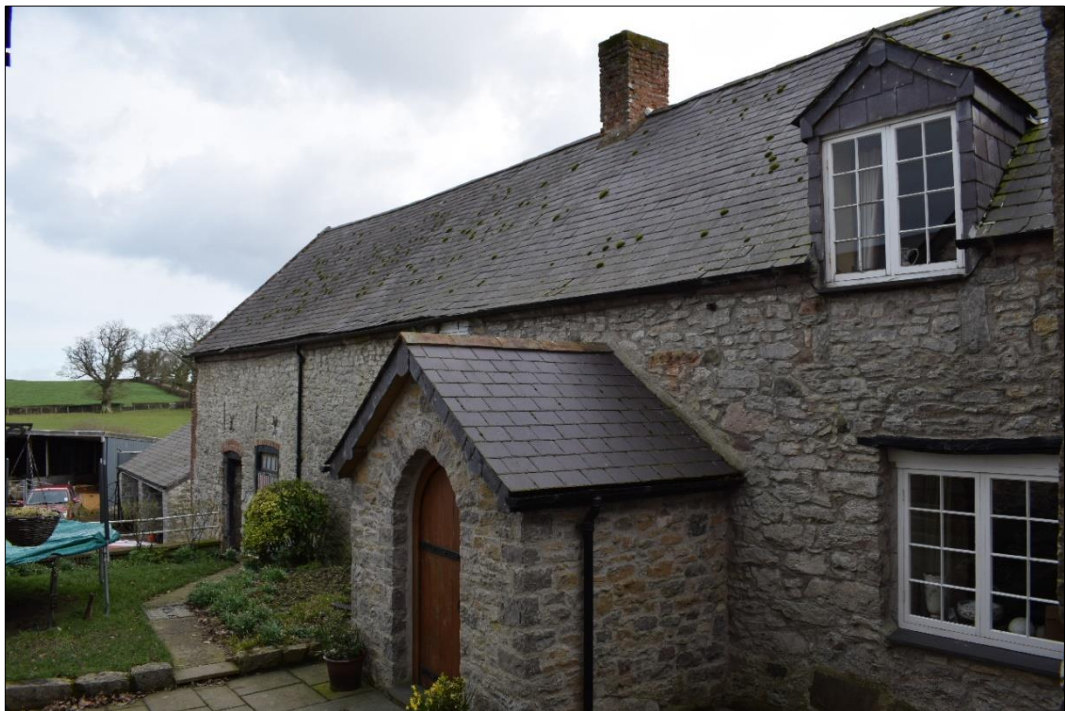
- 3.10. A porch has been added to the main entrance, beyond which is a ground-floor sixteen-pane window within an earlier (probably primary) opening; this has a moulded and stopped-chamfered external wooden lintel with inner moulded window lintel, probably originally associated with a three-light wooden mullioned window. Above this is a modern gabled dormer which replaced a small earlier window beneath the eaves (Fig. 14).

Fig. 14 The modern porch with adjacent windows with evidence for earlier openings. Photo CPAT 4335-0058

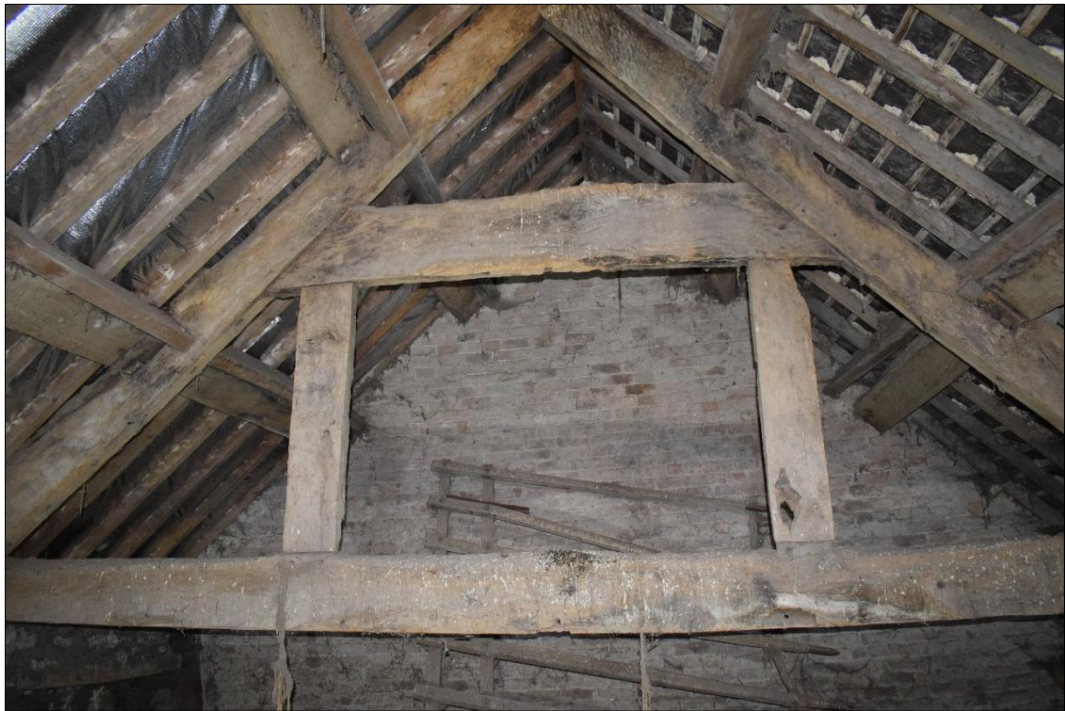
- 3.11. Internally, the barn retains two early roof trusses (T1 and T2), both with a tie beam and collar and a pair of posts between (Fig. 22). Peg holes in the collar of T2, and a groove in the top of the tie beam, show that the truss was originally infilled with

wattle and daub panels. The tie beam also has sockets for missing posts which would have formed a solid partition (Figs 15 and 22). The other truss (T1) has no evidence for infill.

Fig. 15 Truss T2 viewed from the north-east. Photo CPAT 4335-0064

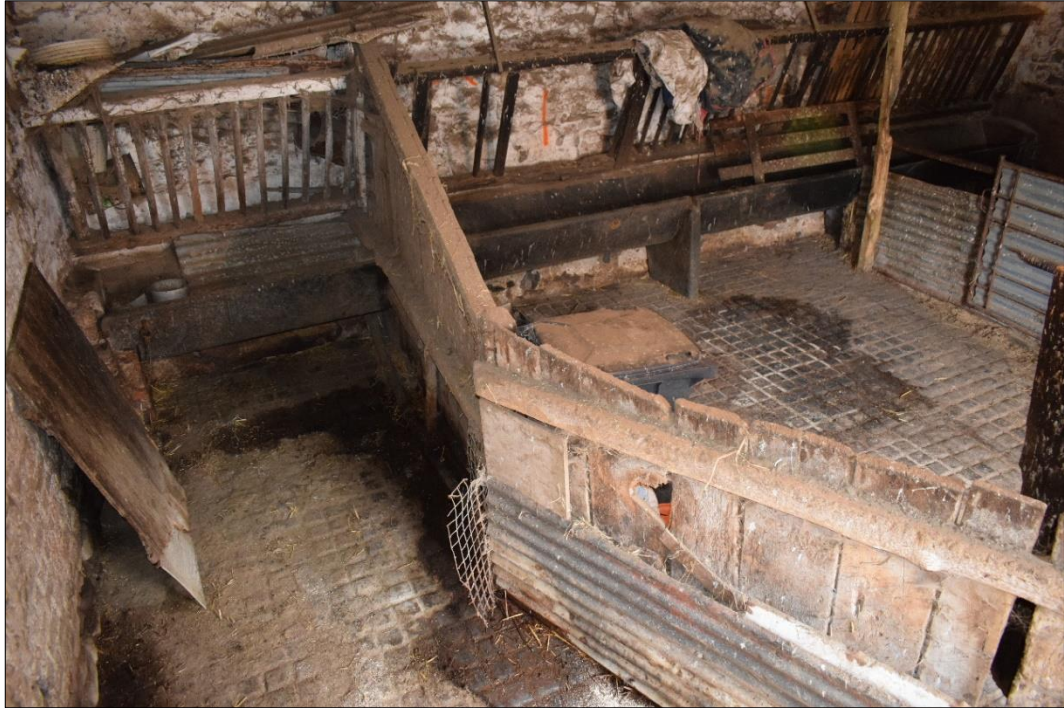
Fig. 16 The interior of the barn showing the brick floor, hay rack and stone feeding trough. Photo CPAT 4335-0086

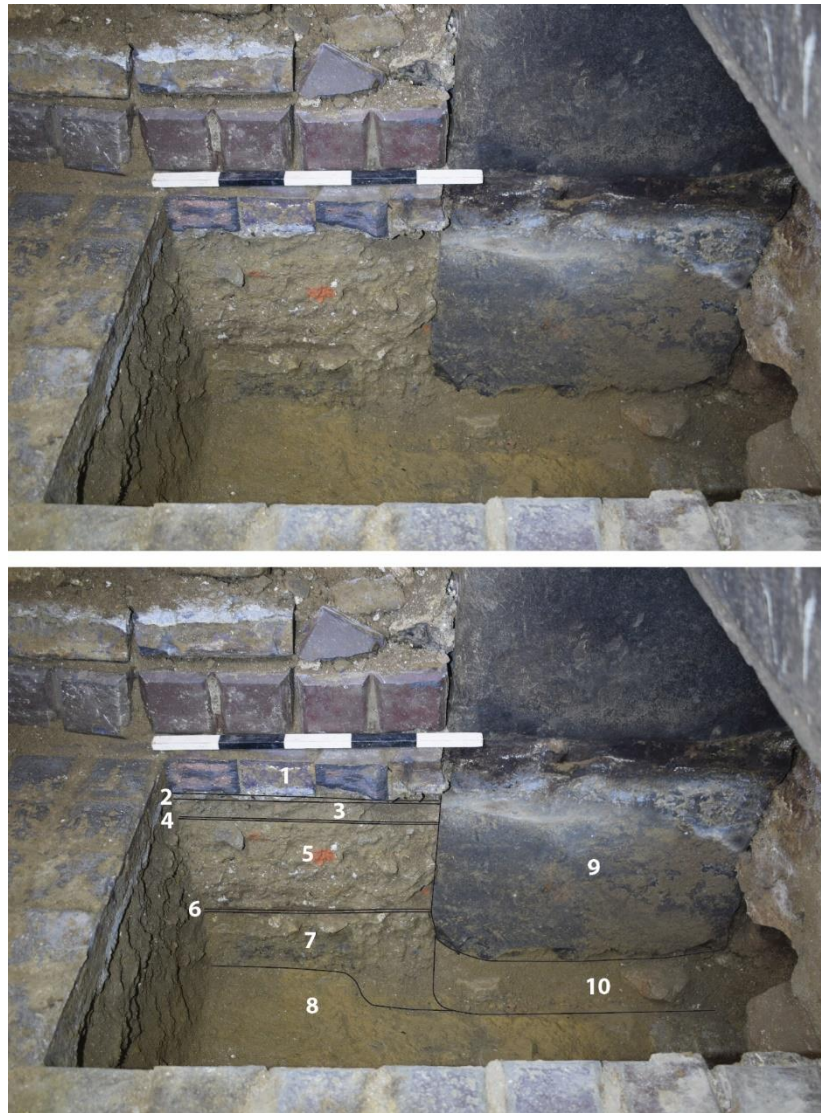
- 4.2. The test pit was positioned on the inside of the cyclopean door, lying partly beneath the feeding trough (Fig. 17). The brick paving (1) had been laid on a bed of cement mortar (2). Beneath this was a layer of loose, grey-brown silt (3) with flecks of lime, which sealed a compacted earthen floor (4). On the basis of material of 19th century date within the underlying deposit (5) the floor is also likely to be 19th-century in date. An earlier floor 6 may be contemporary with the 18th-century rebuilding of the gable end, the underlying deposit (7) containing fragments of clay pipe.

- 4.3. A flat stone was identified beneath the blocking material within the cyclopean doorway at a depth of around 0.47m below the brick floor which corresponds with the level of the threshold on the exterior. While the area immediately adjacent to this had been disturbed an earthen floor (8), comprising orange-brown clay and small stones, survived at roughly the same level in the north-western part of the test pit which may represent the original floor contemporary with the use of the doorway.

Fig. 17 The test pit excavated within the barn, showing the slate support (9) for the feeding trough. Photo CPAT 4335-0104

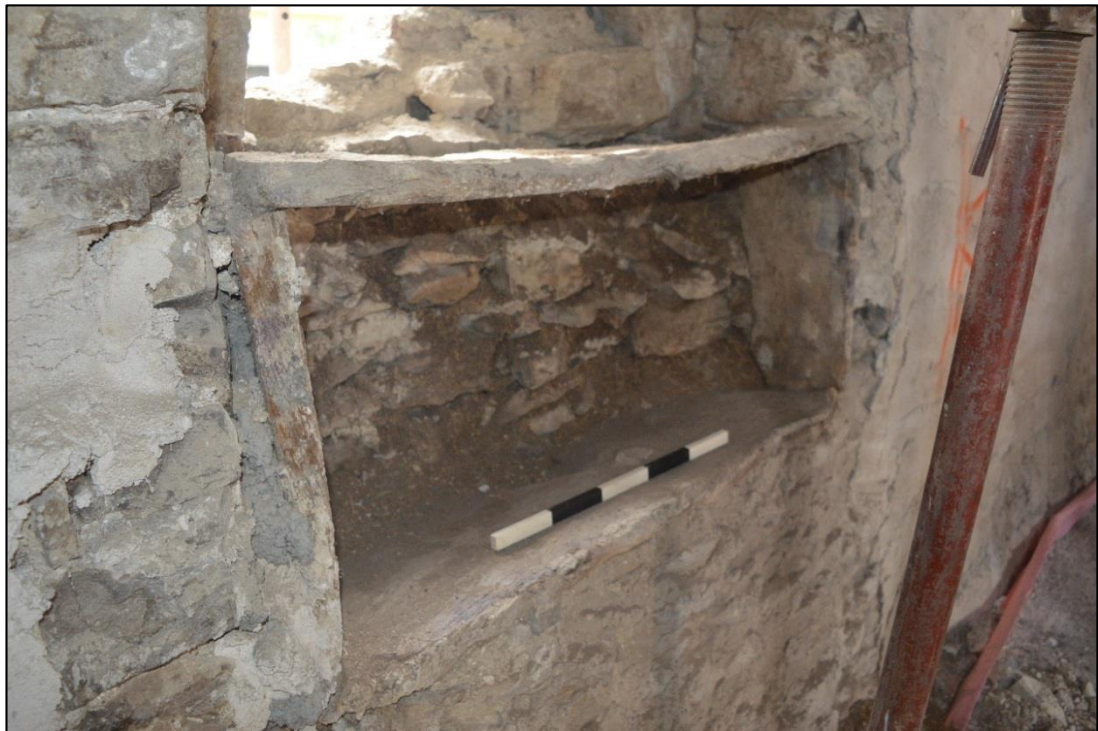
- 5.2. The work on the south-east elevation comprised the removal by the builder of all blocking material within the door and windows, with an archaeologist in attendance at all times. During the work, and at the archaeologist's discretion, the work was stopped to allow for photographic recording and drawing of any significant architectural features.
- 5.3. When the blocking material was being removed from the cyclopean door, a rectangular wooden box frame was revealed (101) which appeared to have been inserted into the middle of the doorway, with the top plank of the frame being approximately 0.5m below the central point of the doorway arch, and the lower plank 0.85m above the current internal surface of the barn. The frame was only visible on the internal face and did not continue through the full thickness of the wall.

Fig. 18: The wooden frame within the blocking material of the cyclopean doorway.
Photo CPAT 4335-0137

- 5.4. The frame was 1.2m wide by 0.55m high and 0.25m deep, and the individual sections were 25mm thick. Following the eventual removal of the frame as part of the required un-blocking process, it was clear that the wood had been worked (see Fig 19).
- 5.5. During removal of the blocking material from within the frame itself, a worked limestone block was identified (103), which had been placed on the lower strut. The block was L-shaped, measuring 0.6m long by 0.2m wide and 0.15m thick, with the 90 degree right-angle indicating quite clearly that the block had been shaped for use elsewhere and then subsequently moved.
- 5.6. Following the removal of all the blocking material from within the door recess, three significant architectural features of note became apparent, which indicated the developmental changes that may have occurred during the life time of the hall range.

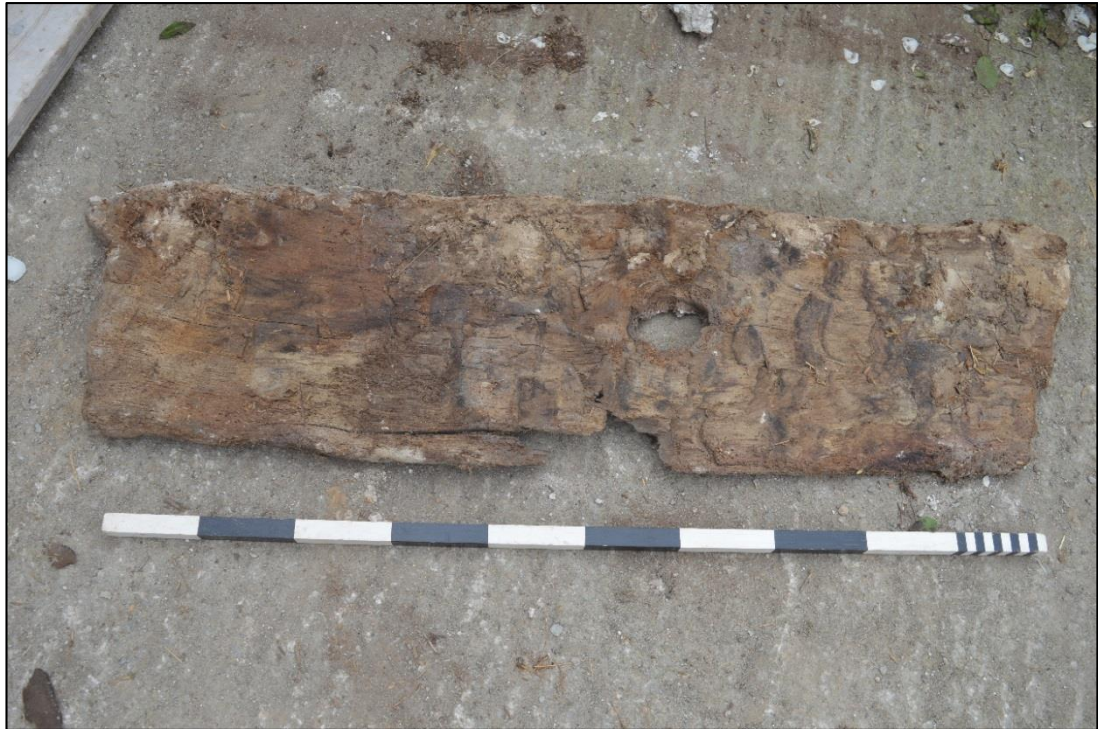
Fig. 19: Adze markings on part of the wooden frame from within the blocking material of the cyclopean doorway. Photo CPAT 4335-0146

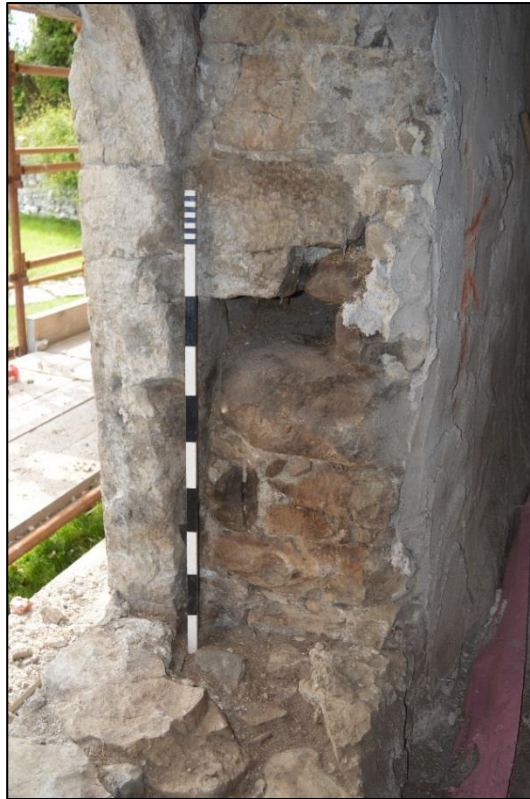
- 5.8. Looking from inside the building, on the right hand side of the door recess approximately 0.8m above the internal floor surface was a locating hole (104), for a wooden draw bar (see Fig 20). The opening was rectangular shaped measuring 0.3m wide by 0.15m high, and extended to a depth of 0.6m. Of note is the fact that the stone work immediately above the locating hole appeared to be tied in with the external wall of the range.

Fig. 20: The south-west side of the cyclopean doorway, note the slot for a wooden drawbar. Photo CPAT 4335-0139

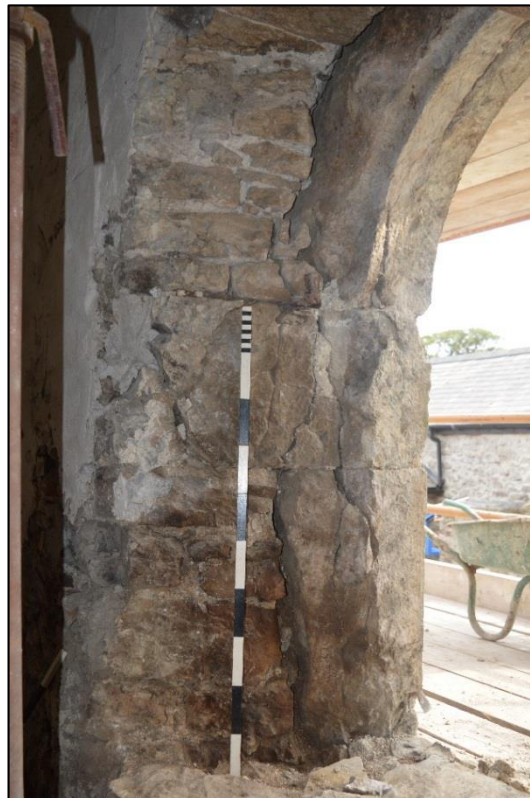
- 5.7. Once the blocking material had been removed from the doorway, it was clear that the internal face of the wall (102) was poorly linked to the external face (106), and in some places there were large gaps between the two (see Fig 21).

- 5.9. On the opposite side of the recess to the locating hole, just below the start of the curved arch of the doorway, was an iron hinge (see Fig 21). The diameter of the circular part of the hinge was 0.04m, suggesting it supported a heavy wooden door. At the base of the doorway, 0.25m of blocking material was left in situ and it is likely that this was masking a second hinge, located closer to the ground.

Fig. 21: The north-east side of the cyclopean doorway, note the iron hinge to the right of the top of the scale. Photo CPAT 4335-0140

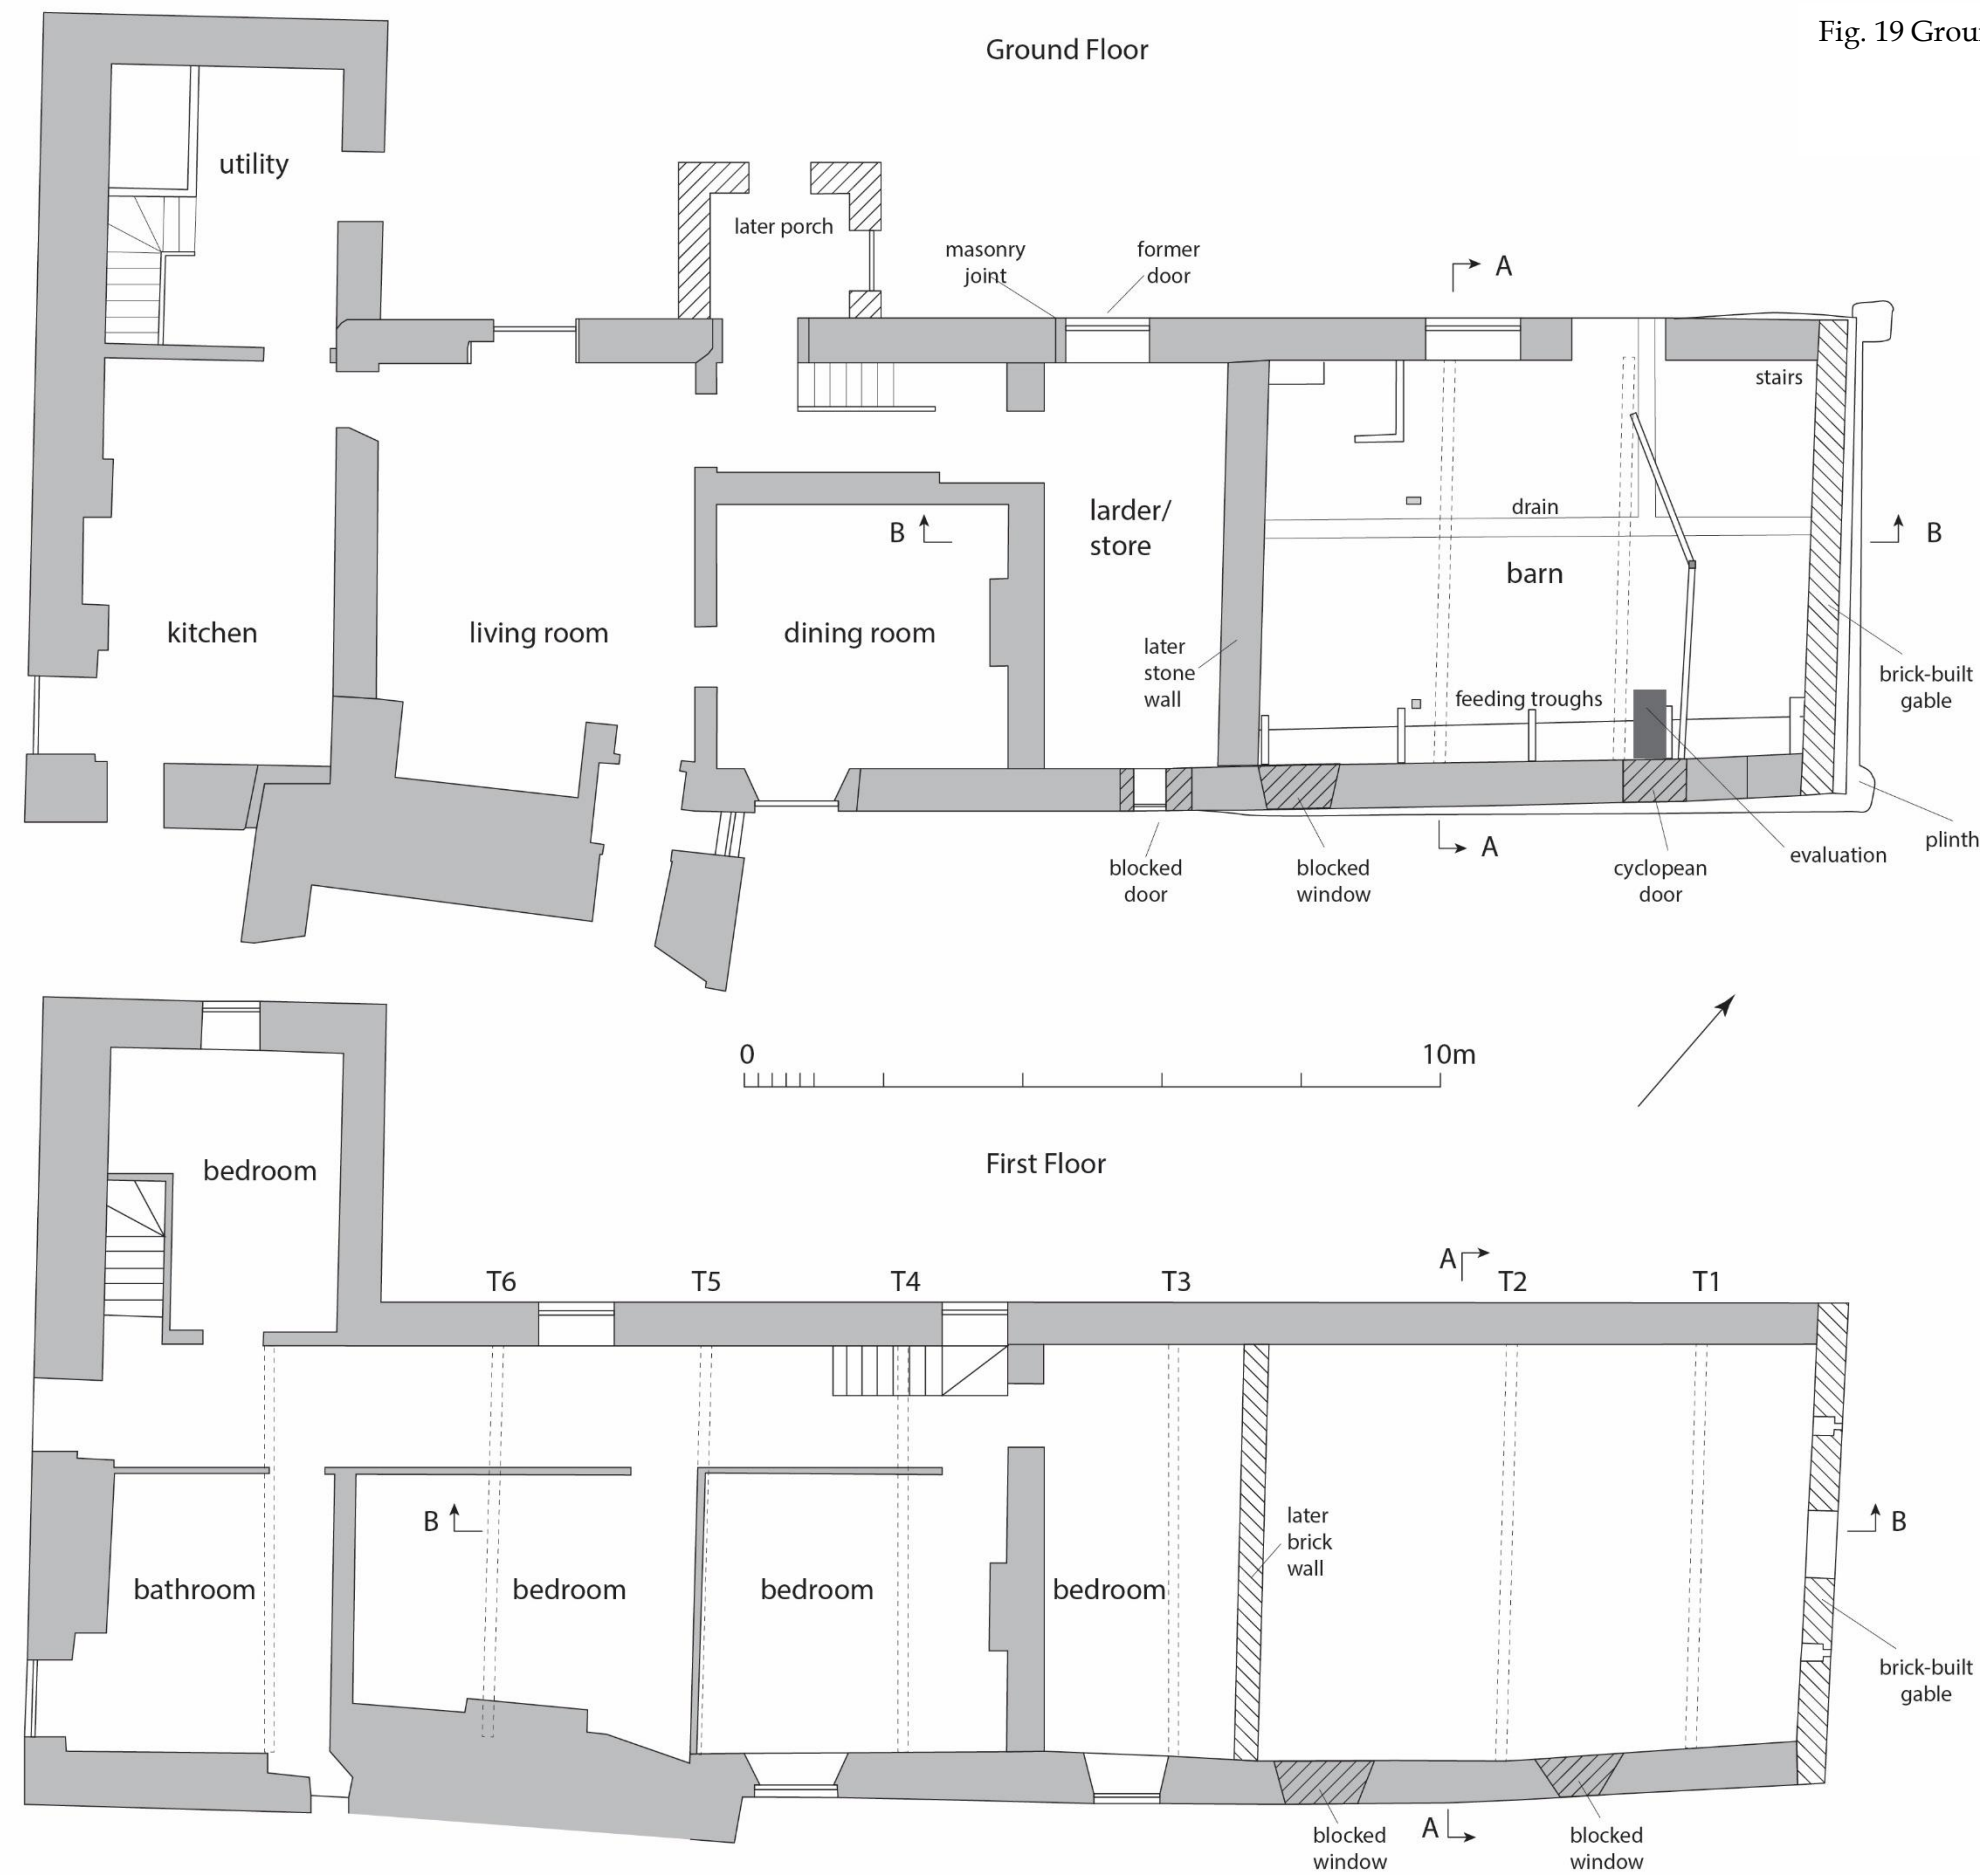
Fig. 19 Ground- and first-floor plans

- 3.12. The wall now dividing the barn from the rest of the range is obviously a later addition. On the ground floor this is stone and on the first floor it is brick. An examination of the plan of this range shows that this wall has changed the original divisions within the building. At first-floor level Truss T3, which is now within a bedroom, was clearly a dividing partition, the lower part of which has been removed, so that originally there was a room between T2 and T3 and another between T2 and the gable end. The original ground-floor configuration here is unclear and complicated by changes in floor level between the barn and the larder/store (see Fig. 19).
