CPAT Report No. 1503.1

Berain, Llannefydd, Conwy

Building Survey

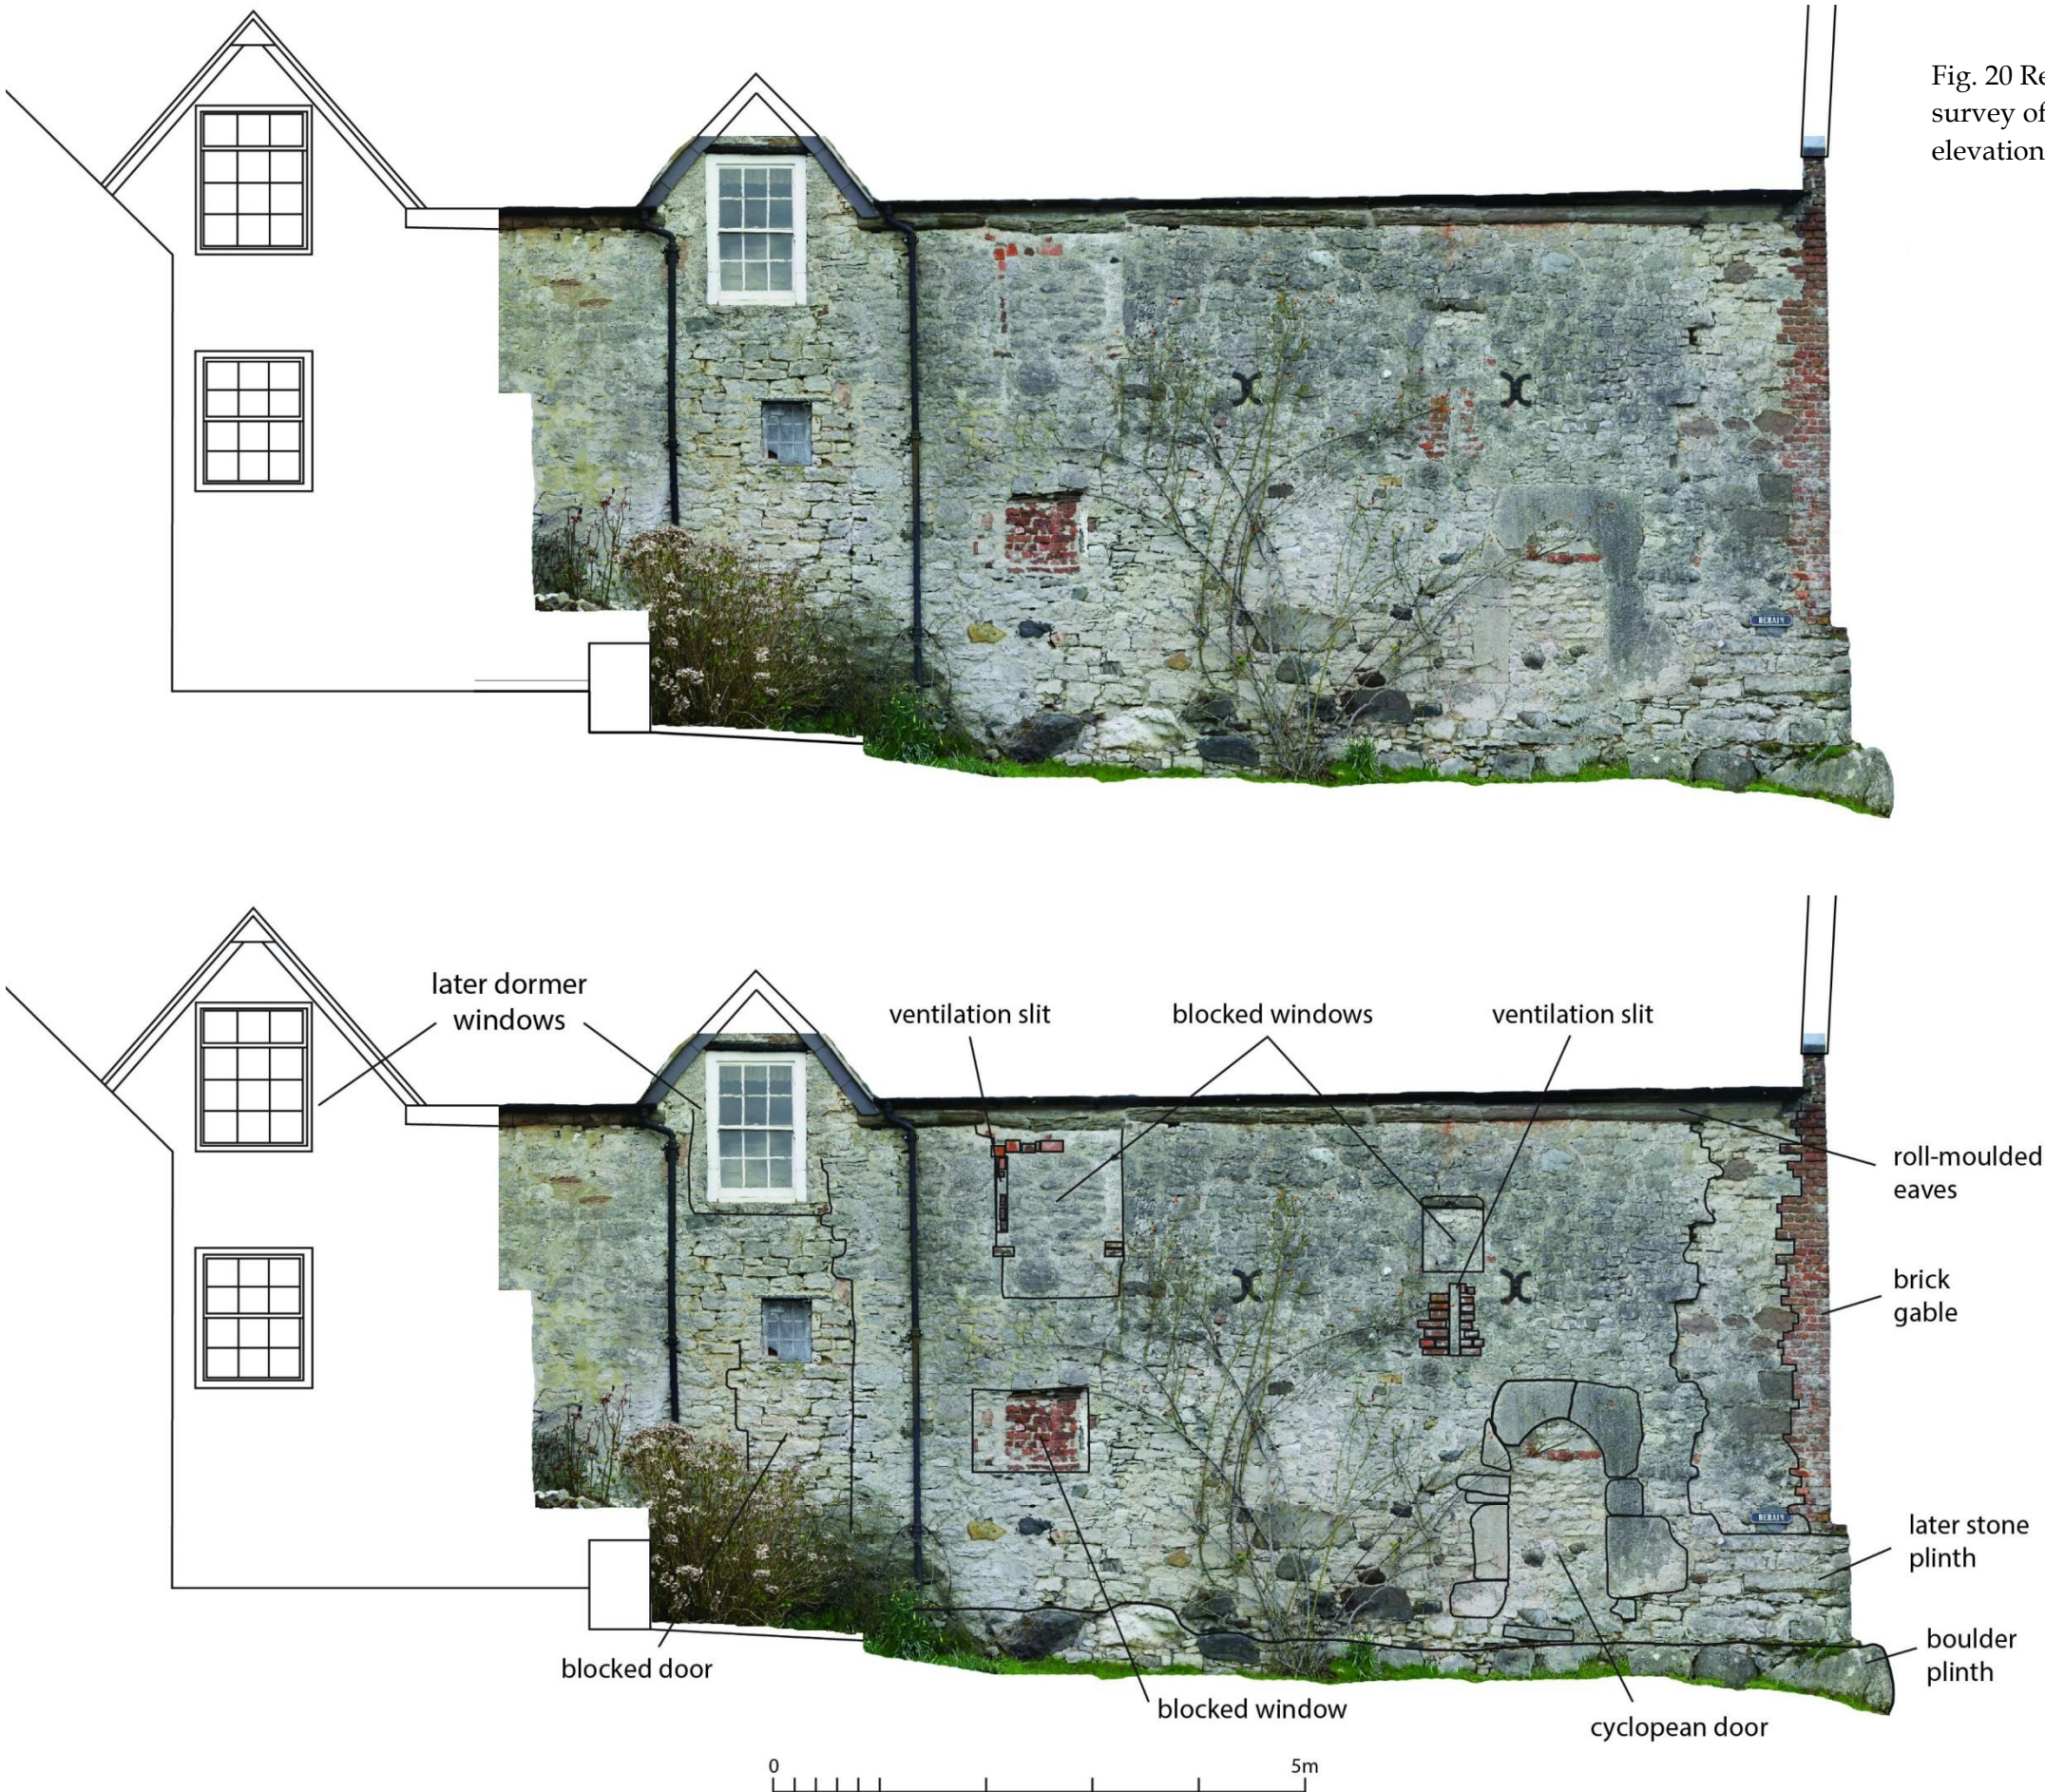
Fig. 21 Elevations and longitudinal section

- 3.3. The south-eastern elevation of the hall (Fig. 20) sits on a substantial stone plinth former of large boulders. While there have been significant alterations and insertions into the masonry the presence of a roll-moulded eaves course along virtually the whole elevation suggests that the surviving structure was all part of the original building. A matching eaves course also runs the length of the north-west elevation.
