CPAT Report No 1243

Llysun Motte Mg072, Llanerfyl Survey and Recording

Report Title: Llysun Motte Mg072, Llanerfyl, Survey and Recording
CPAT Report No: 1243
Report status: Final
Confidential: No

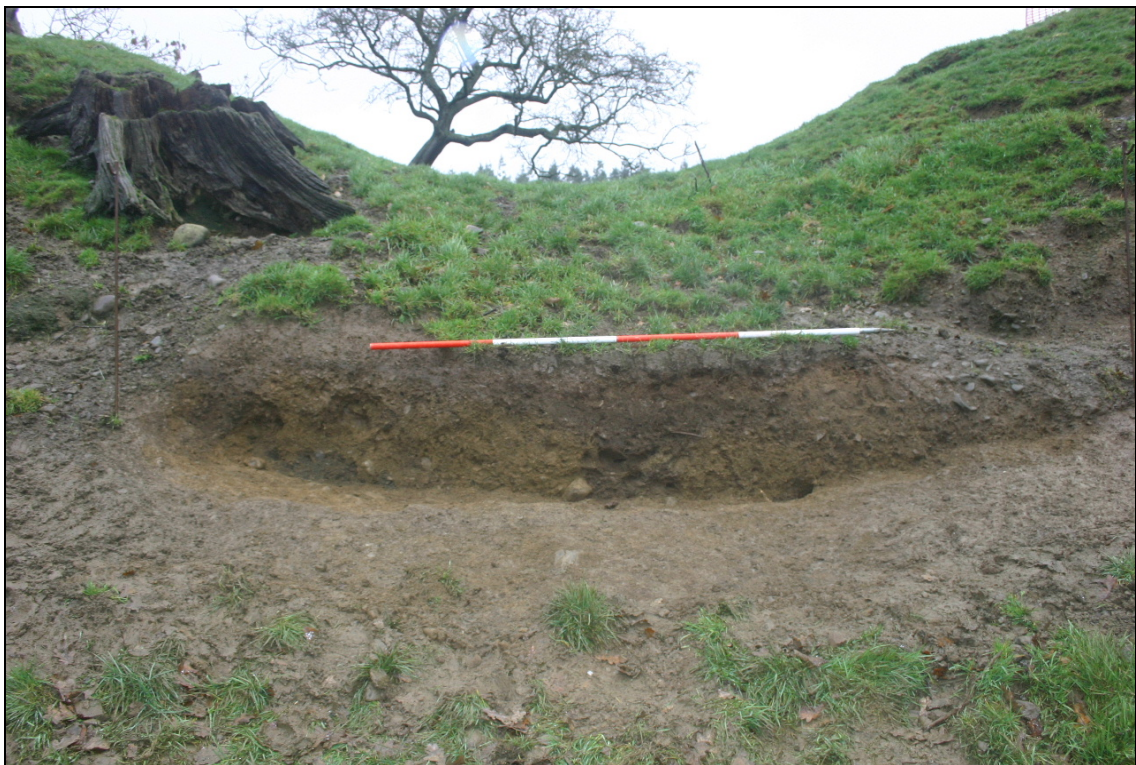
Fig. 7 Area A showing the exposed section a-b, viewed from the south-south-east.
Photo CPAT 3749-0024

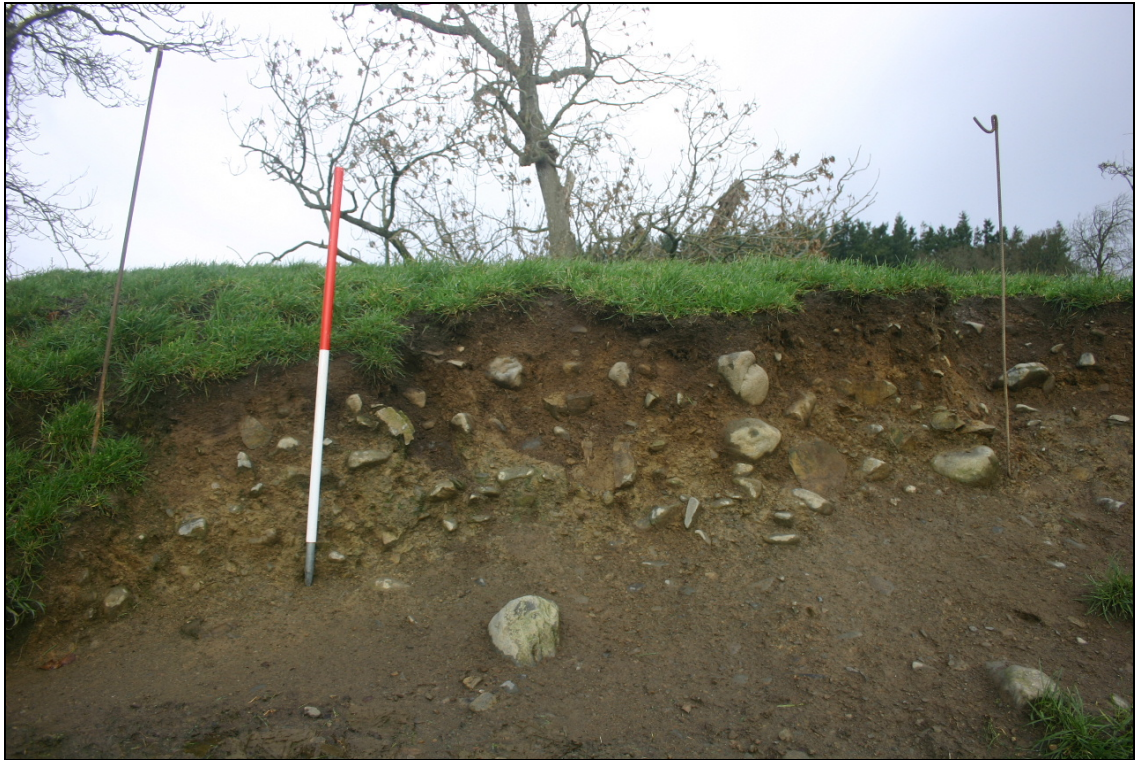
Fig. 9 Area B, section c-d, viewed from the south. Photo CPAT 3749-0033

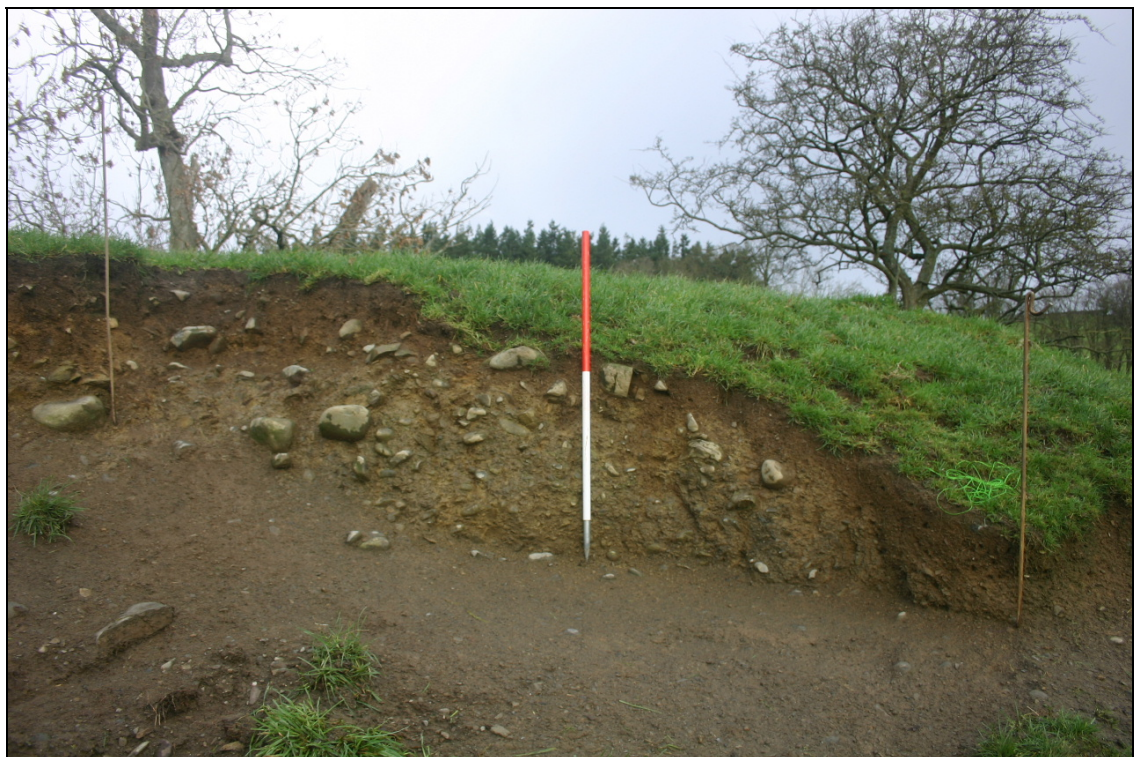
Fig. 10 Area B, section d-e, viewed from the south-west. Photo CPAT 3749-0031

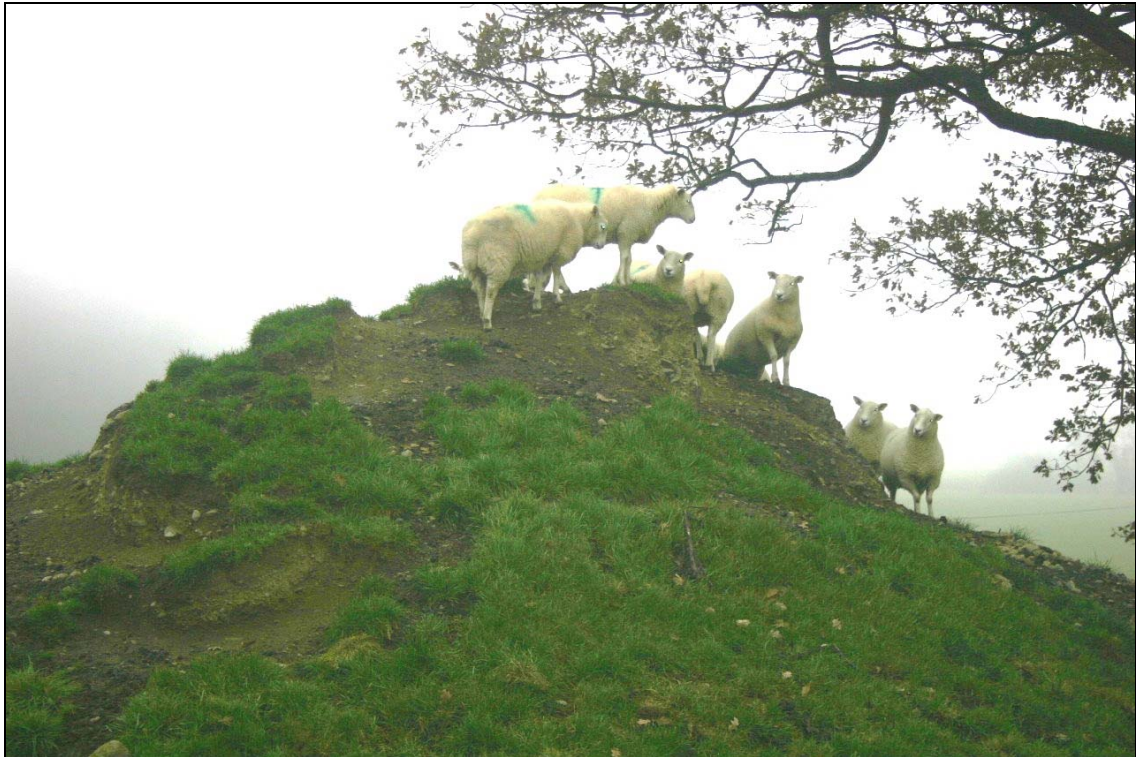
- 3.9 Area C investigated two sides of a small prominence measuring up to 3.5m by 1.7m, which stands at the highest point of the motte, and represents a block of in situ material which has been eroded on all sides. The rate of erosion is quite marked and was visibly advancing on a daily basis during the short period of time spent on the site. The summit of the motte was clearly an attractive place for sheep to clamber and indeed the Section g-h was being used as a step by the stock as the main access route up to the top of the motte. Any surviving archaeological deposits are therefore extremely vulnerable in this area.

Fig. 11 Area C showing the small prominence on the summit of the motte, viewed from the south-west. Photo CPAT 3749-0021

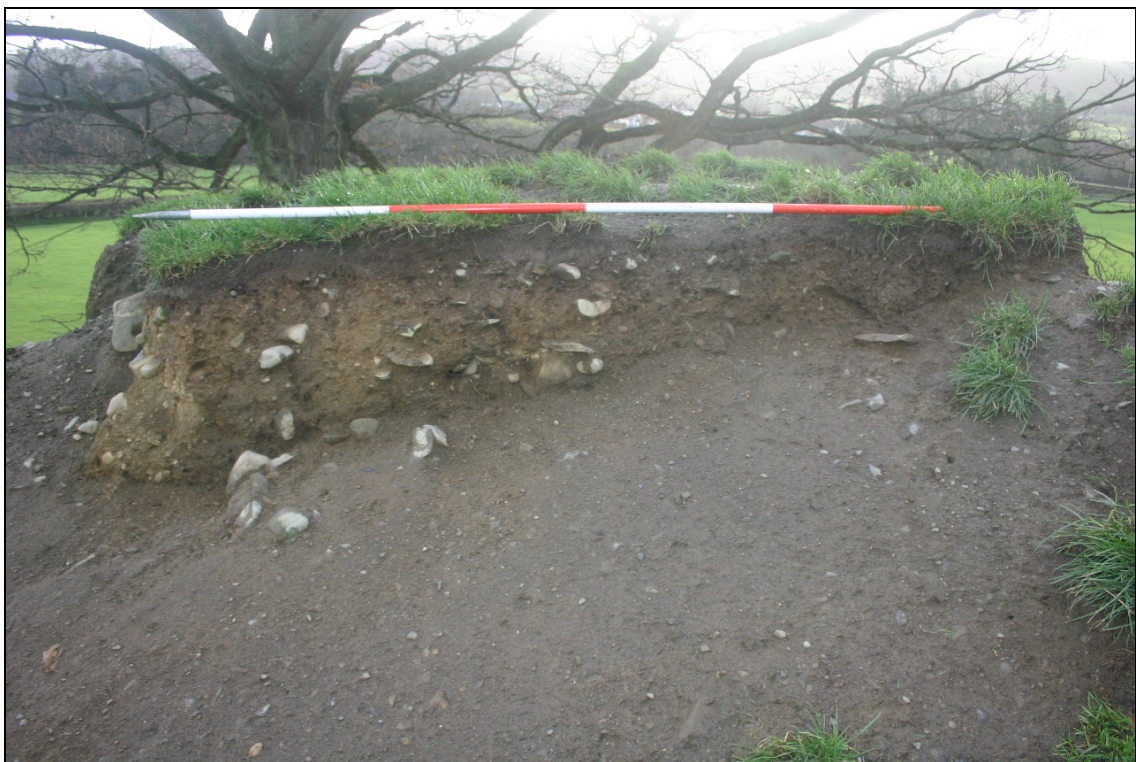
Fig. 13 Area C, section c-d, viewed from the north-north-west. Photo CPAT 3749-0039

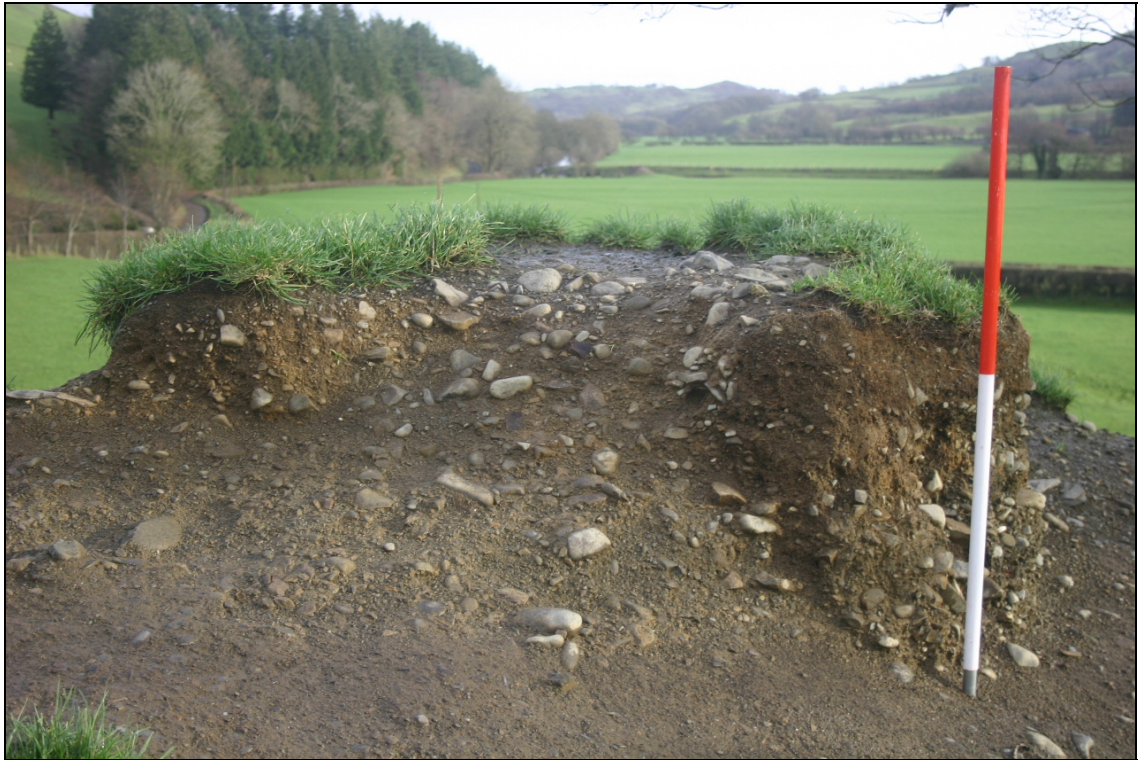
Fig. 14 Area C, section c-d, viewed from the west. Photo CPAT 3749-0043
