RADYR WEIR, CARDIFF

HISTORIC BUILDING RECORDING

commissioned by Dawnus Construction Ltd

July 2016

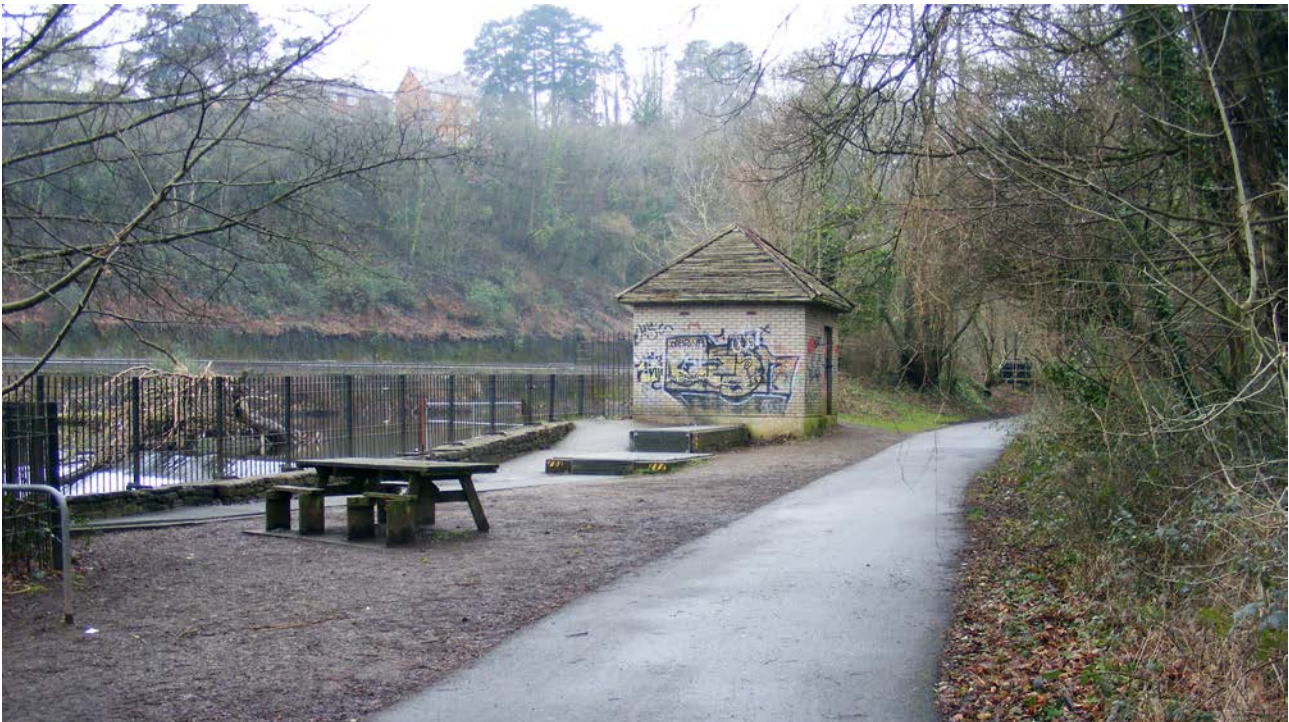
ILLUS 4 Fish pass and eastern side of weir prior to current development

Prior to the start of development, and photographed as part of the pre-determination desk-based study (Craddock-Bennett 2012), a subterranean fish pass was located adjacent to the weir on the east bank of the River Taff (Illus 4). The fish pass was visible from surface level as two metal grills overlying the fish transit channel and an associated brick built building measuring c.3.5m x 2m in plan. The building and fish pass, which dated (on the basis of form and materials) to the late 20th century were removed during the current development. Photographs of the subterranean structure were taken by Dawnus Construction during demolition (Illus 18).

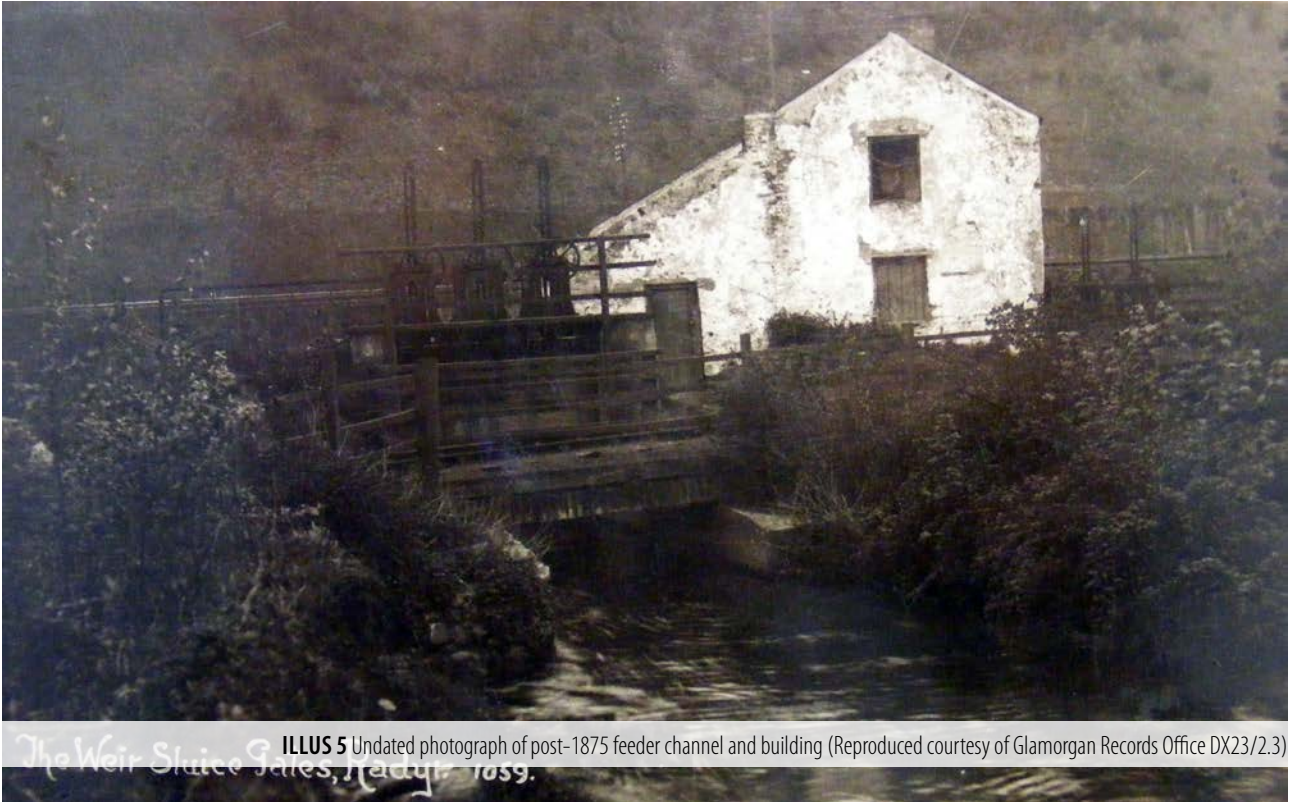
ILLUS 5 Undated photograph of post-1875 feeder channel and building (Reproduced courtesy of Glamorgan Records Office DX23/2.3)

An undated black and white photo held by Glamorgan Records Office shows the sluice gate mechanism and a small whitewashed building immediately to the north-west (Illus 5). The building which is no longer present was presumably connected to the operation of the sluice gate and feeder channel.

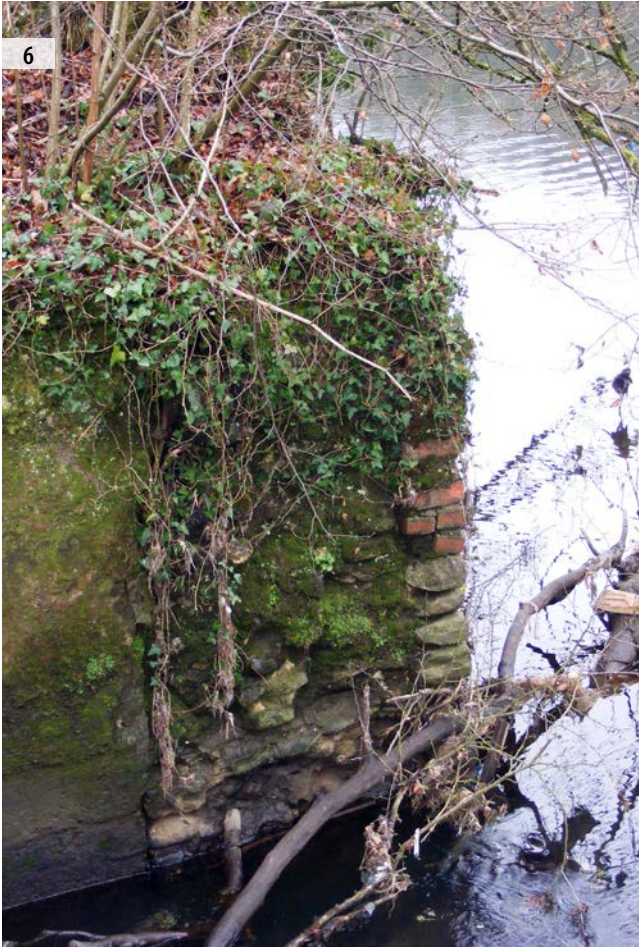
The entrance to the Melingriffith feeder channel is located c.60m to the north of the weir. Brick and stone wall termini (Illus 6), capped with concrete during the development (Illus 20) form the entrance to the channel which leads directly onto a set of sluice gates.

ILLUS 6 Corner of retaining wall on entrance to feeder channel (photograph taken prior to current development) **ILLUS 7** Overflow channel (photograph taken prior to current development) **ILLUS 8** Post-1875 sluice gates at western end of feeder channel (west elevation)

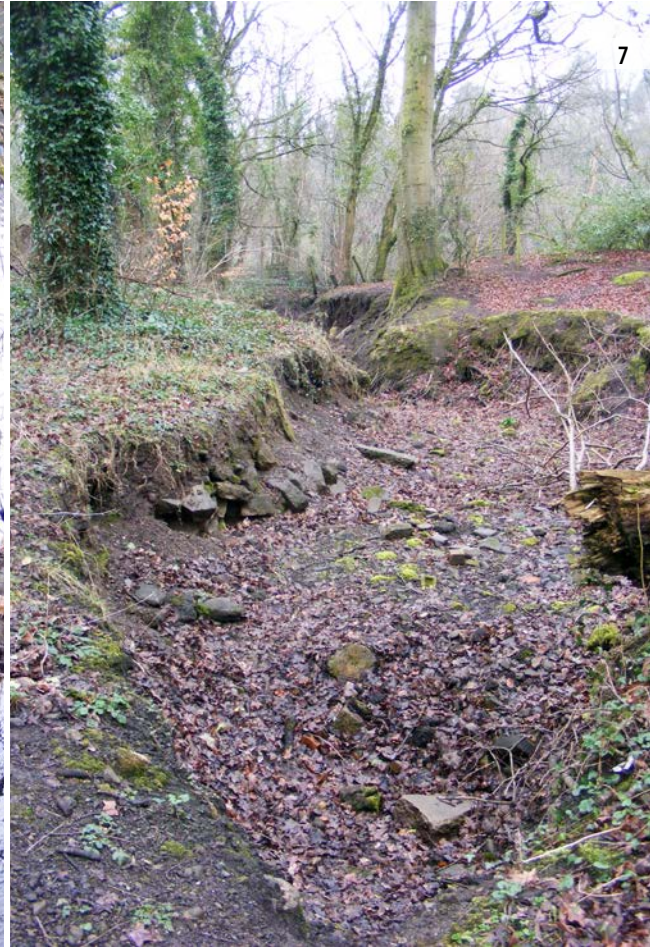
Photographs of the channel taken prior to the current development (Illus 7) show a sinuous channel, with masonry blocks eroding from the banks. As part of the development works the channel was backfilled with soil (Illus 16) and the feature is now only visible as an un-wooded path through the trees.

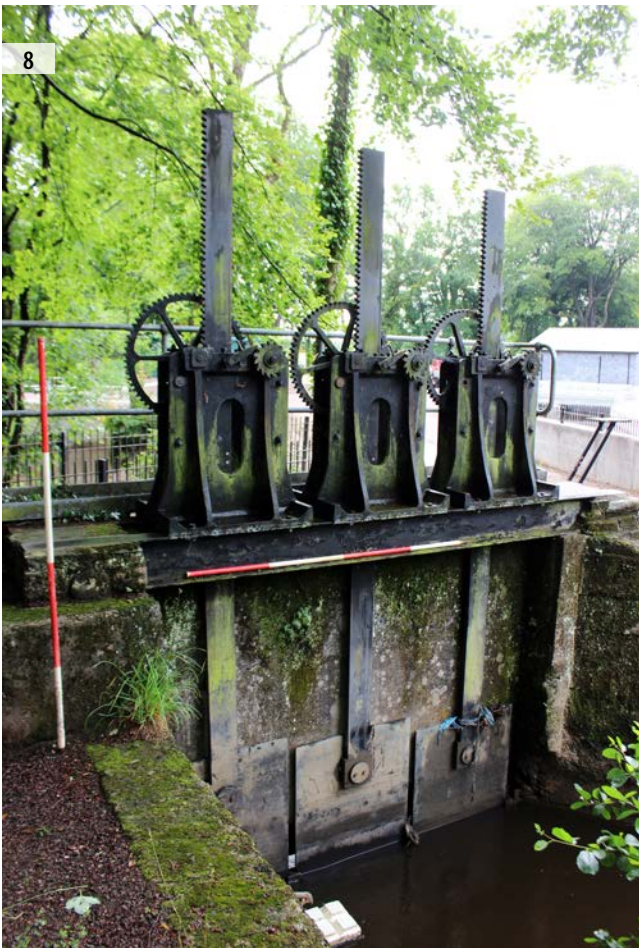
The sluice system is formed from a concrete dam measuring 3.2m in length, 2.3m in height and 0.61m in width (Illus 8). Three iron sluice gates of rack and pinion construction control the flow of water through the concrete dam. Each pinion, which is operated via a circular master cog measuring 0.74m in diameter (Illus 9), is connected to an iron gate measuring 0.9m x 0.9m. By engaging the rack and pinion via a removable handle the gates can be raised or lowered independently in order to control the flow of river water into the feeder channel.

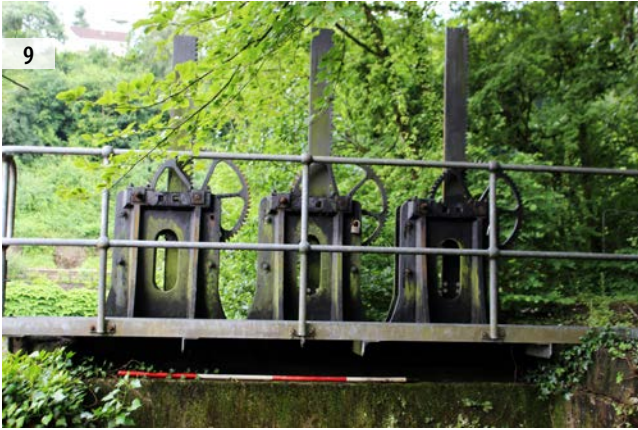
ILLUS 9 Post-1875 sluice gates at western end of feeder channel (east elevation) **ILLUS 10** Cobblestone wall forming southern side of feeder channel **ILLUS 11** East facing view along Mellingriffith feeder channel **ILLUS 12** Detail view of iron girders spanning northern end of overflow channel **ILLUS 13** General view of northern end of feeder channel **ILLUS 14** Southern terminus of overflow culvert **ILLUS 15** Detail of Mellingriffith & Pentyrch tramway

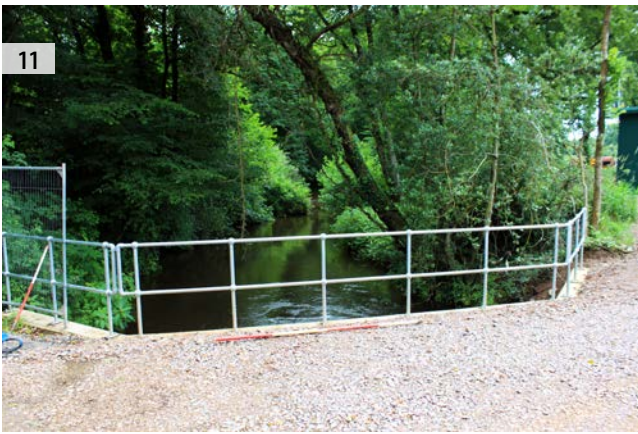
identified approximately 10m to the east of the feeder channel sluice gate. The wall, which survived to a height of c.1m above the water surface was constructed of cobblestone with evidence for modern cement pointing (Illus 10).

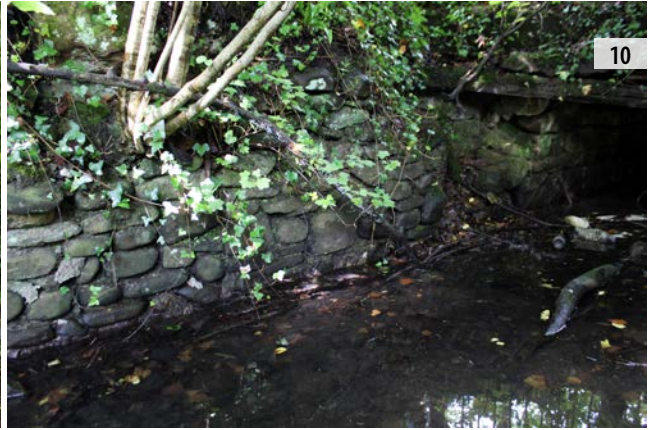
Approximately 65m along the course of the feeder channel, an overflow splits from the main channel in a southerly direction. The feeder, which measured 3.55m wide was canalised by means of limestone block walls (individual blocks measuring c. 0.30m x 0.15m x 0.15m). The walls were visible to a height of 0.96m (Illus 12 and 13).

At the northern end of the feeder channel, two parallel iron girders (each measuring 0.25m x 0.25m x 3.55m) were mortared into the upper stone courses of the channel sides. The girder arrangement bore similarities to the mounting points for the sluice gate system at the western end of the feeder channel; it is likely that a similar water management system was in operation here.

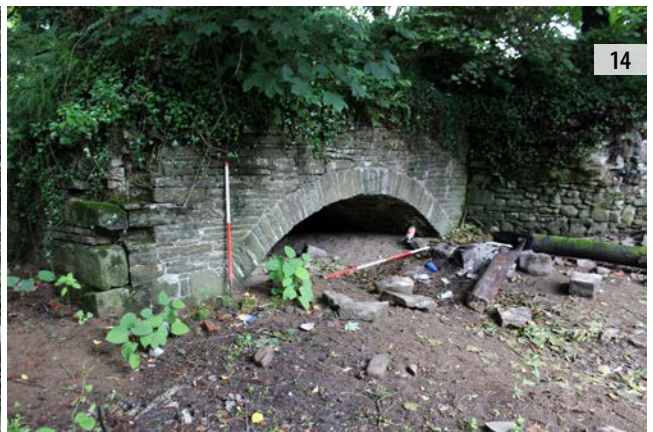
In order to carry the overflow channel beneath the former Melingriffith and Pentyrch Railway, a culvert constructed of limestone blocks was located at the southern end of the channel and adjacent to the north bank of the River Taff (Illus 14). The southern elevation of the culvert is formed from narrow limestone blocks (0.05-0.10m height x 0.30-0.40m width) measuring 5.40m in width and 1.80m in height. The elevation is dominated by a stone arch framing a semi-circular aperture measuring 3.40m in width and 0.90m in height. It appears that waterborne silt has partially buried the structure. Large quoin stones form the southwestern corner of the structure. To the south and east a cobble stone wall forms a riverbank revetment.

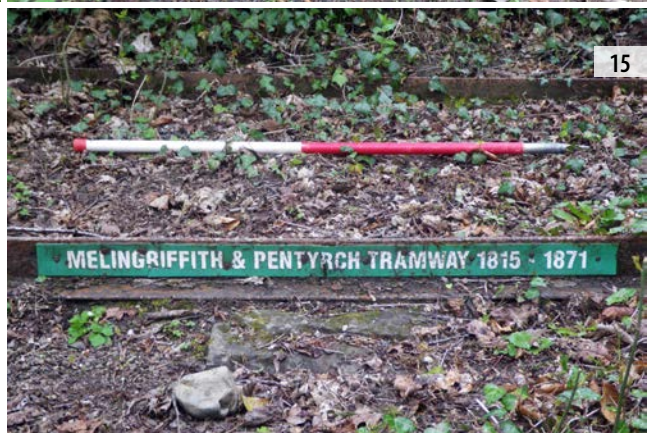
On the northern side of the current Taff Trail, at the southern extent of the development area, a section of the tramway is preserved (Illus 14). It is not clear whether the track is in its original location or whether it has been reconstructed in its current location.

The iron rails measure 0.09m in width and are positioned 1.33m apart. Each rail comprises two sections of track, each measuring 0.91m in length. The rails are located upon limestone sleeper pads, each measuring c.0.4m x 0.4m and located 0.60m apart.

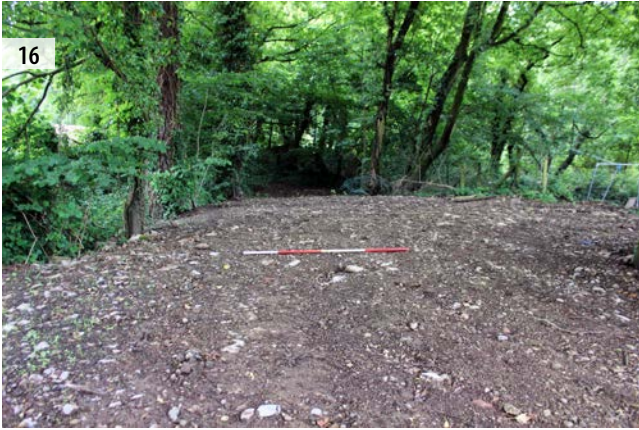
The only significant alteration to the post-medieval features on the site, is the backfilling of the overflow channel, however the most significant aspect of this feature, the southern outflow has not been affected by the development.

ILLUS 16 Section of backfilled overflow channel (following completion of site works) **ILLUS 17** Excavation of hydroelectric plant footprint (photo courtesy of Dawnus Construction) **ILLUS 18** Demolition of 20th century fish pass structure (photo courtesy of Dawnus Construction) **ILLUS 19** Demolition of section of retaining wall to create feeder channel for Hydroelectric plant (photo courtesy of Dawnus Construction) **ILLUS 20** Corner of retaining wall on entrance to feeder channel (following development) **ILLUS 21** Eastern end of weir (following development) **ILLUS 22** Hydroelectric plant and fish pass following development

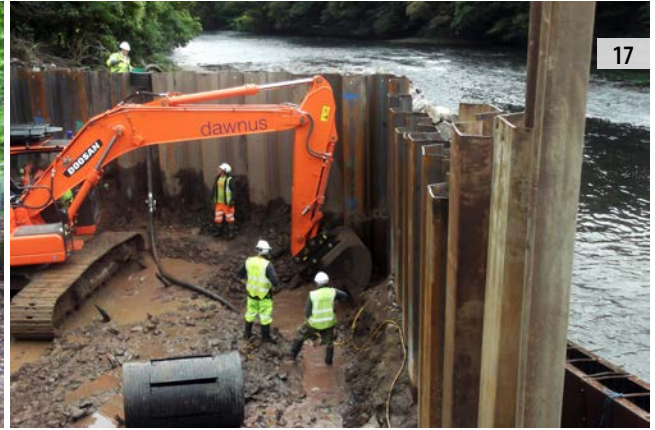
A new fish pass (Illus 22) was constructed as part of the current development, removing all traces of the previous structure. Excavations were undertaken to a depth of approximately 9m below ground level (Illus 17).

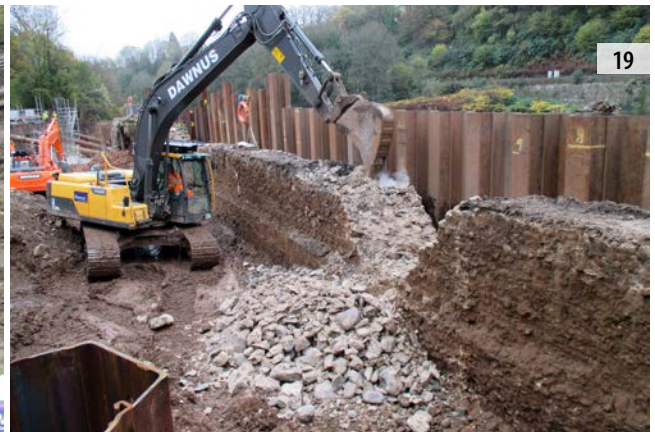
A stone retaining wall which formed the northern bank of the River Taff was partially removed (Illus 19) to the north of the weir face in order to channel water into the hydroelectric turbines. No recording was undertaken on this structure.
