ARCHAEOLOGICAL WATCHING BRIEF

REPORT

WB/CM/14

27 KINGSMARK LANE, CHEPSTOW

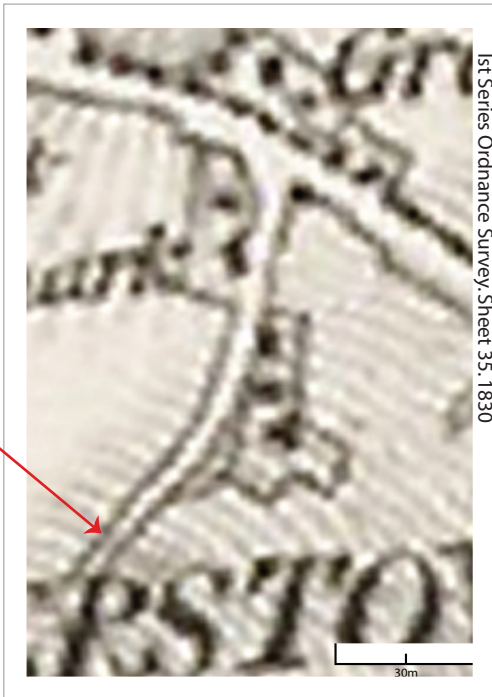
Fig 04a

The first series, Ordnance Survey, 1830 Map, fig 04a records the name of the area, a road and some structures to the east of the road; however, they are probably to the north of the present site, although it is difficult to be very accurate with these early maps.

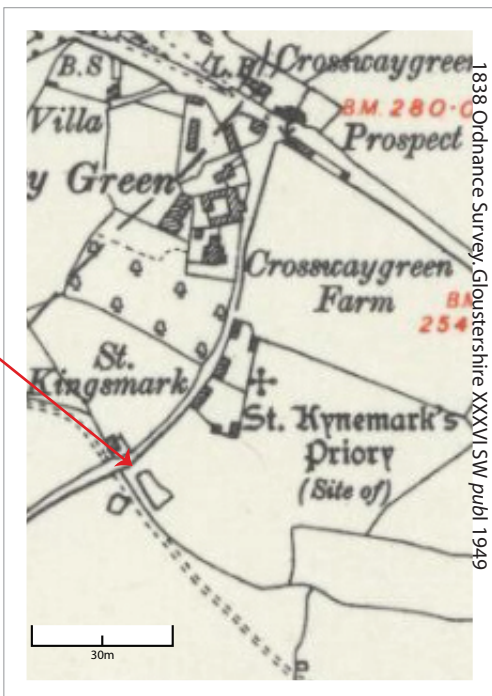
Fig 04c

The situation had changed little by 1938, fig 04c, however the later development of the present estate in 1977, (EMS4709a P6), which can be surmised from plate 4d, had removed the ponds and surrounding pasture yet retained the route of the road and the boundary; now a path.

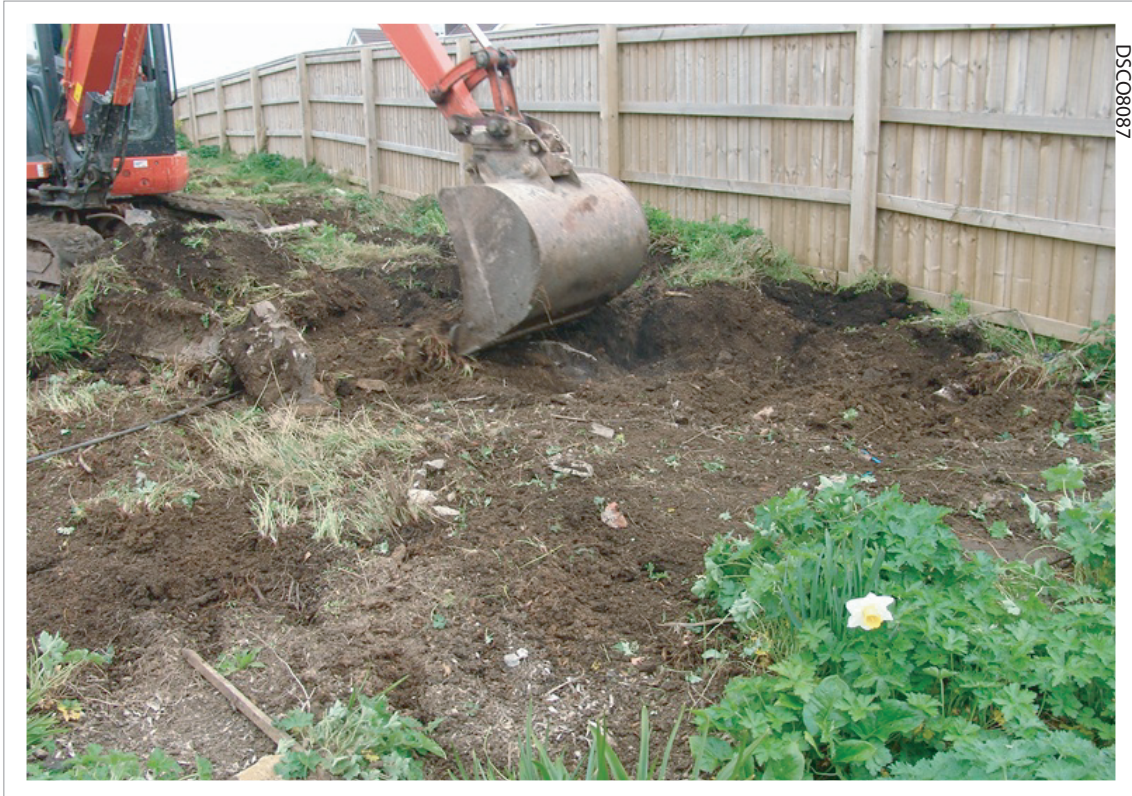
DSC08087

Two exceptions to the sequence were found along the east and west boundaries where areas of cultivated garden remained; readily identifiable by a deposit of rich black humic loam, Plate 01 (*against the fence post*).

Plate 01: Eastern boundary, Context [101] isolated patch of black loam in raised garden bed. Bedding wall being uncovered under digger bucket

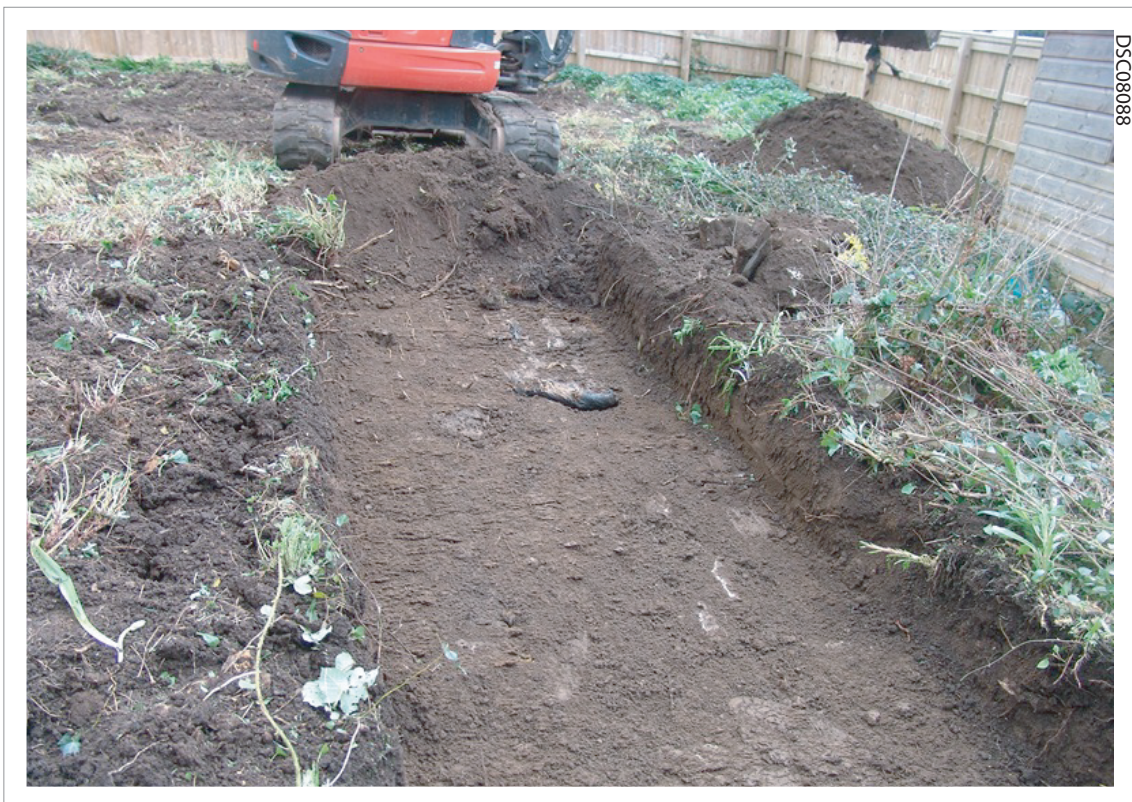
DSC08088

Work began at the site with the removal of the vegetation PL01 and around 200mm to 300mm of topsoil, [100] exposing the underlying subsoil [102], dark brown silty clay, Plate 02.

Plate 02: Soil strip [100] & [102]. One of three black plastic bags with pet burial remains

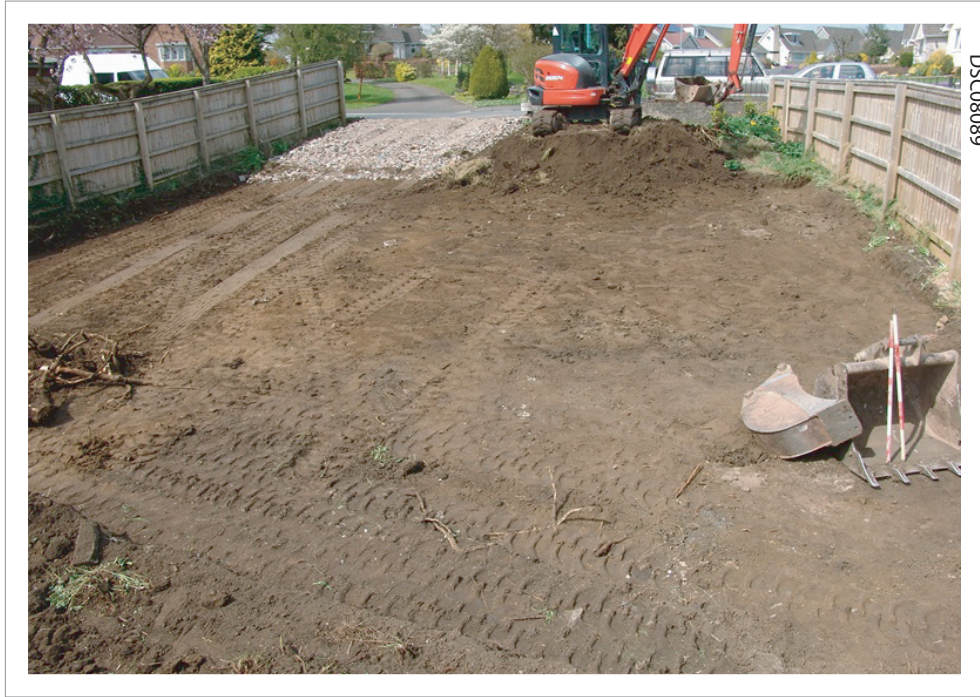
Once the surface had been cleared back, PL03, the site was marked out and excavation of the foundation trenches begun.

Plate 03: Site stripped of top soils [100], [101], & [102]

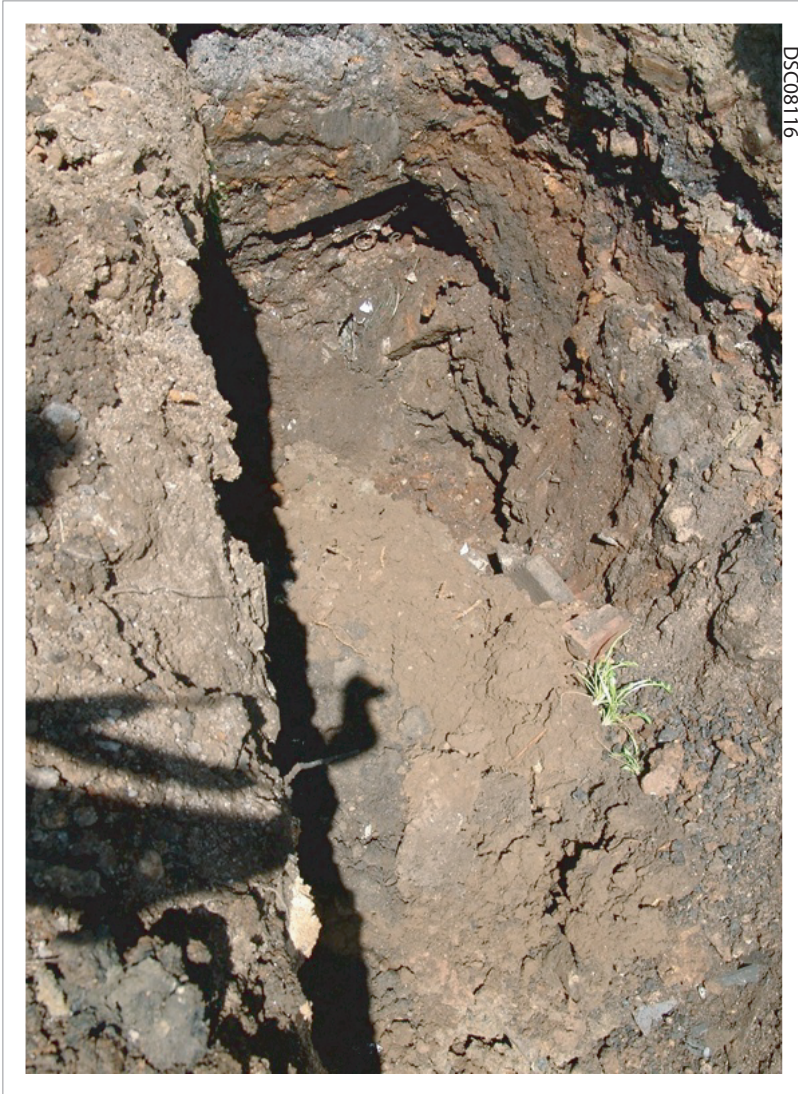
DSC08116

Plate 05: Trench 3, northern corner with second collapse

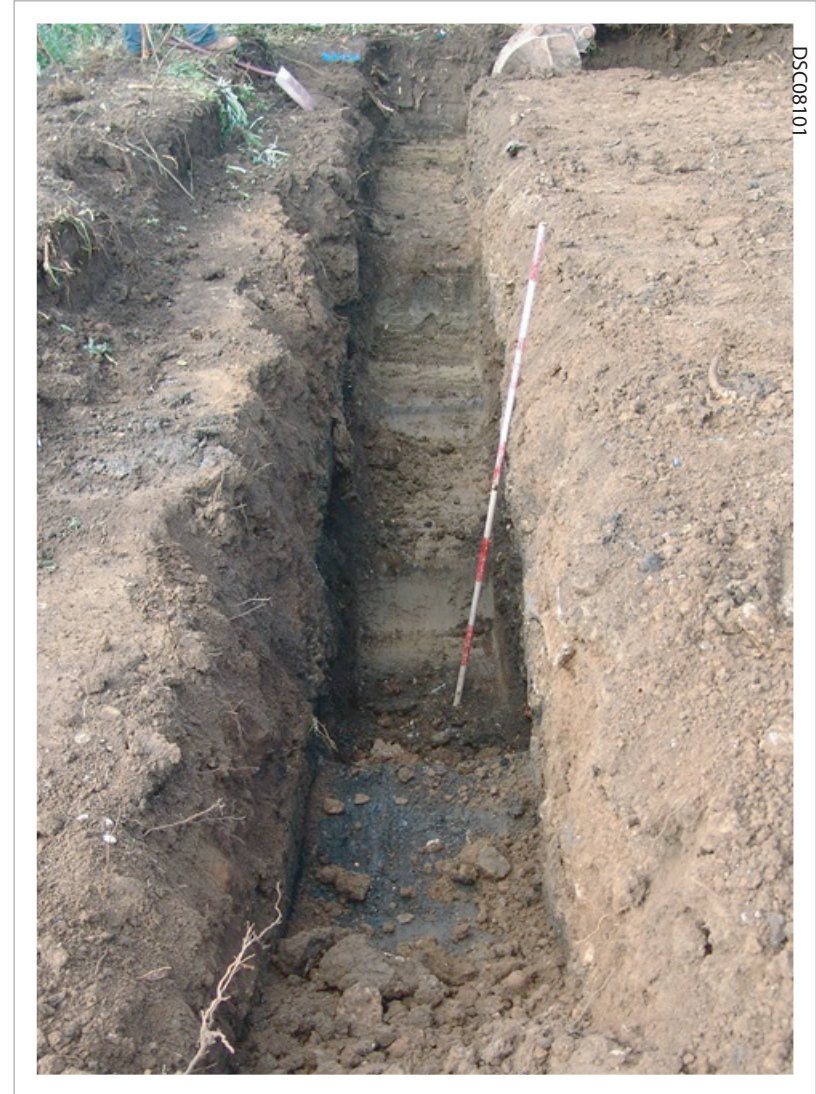
DSC08101

As the excavation continued westerly, the depth of the clay deposit decreased from 1.9 at 7m from the western end to 1.1m at 4m from the western end to 700mm, 2.5m from the western end.

PL06 shows the decrease as a set of 3 'step ups' to accommodate the rise in suitable building surface.

Plate 06: Centre to western end of trench 1 completed showing stepped cut required to reach clay [107] Showing [103] [104] [106]

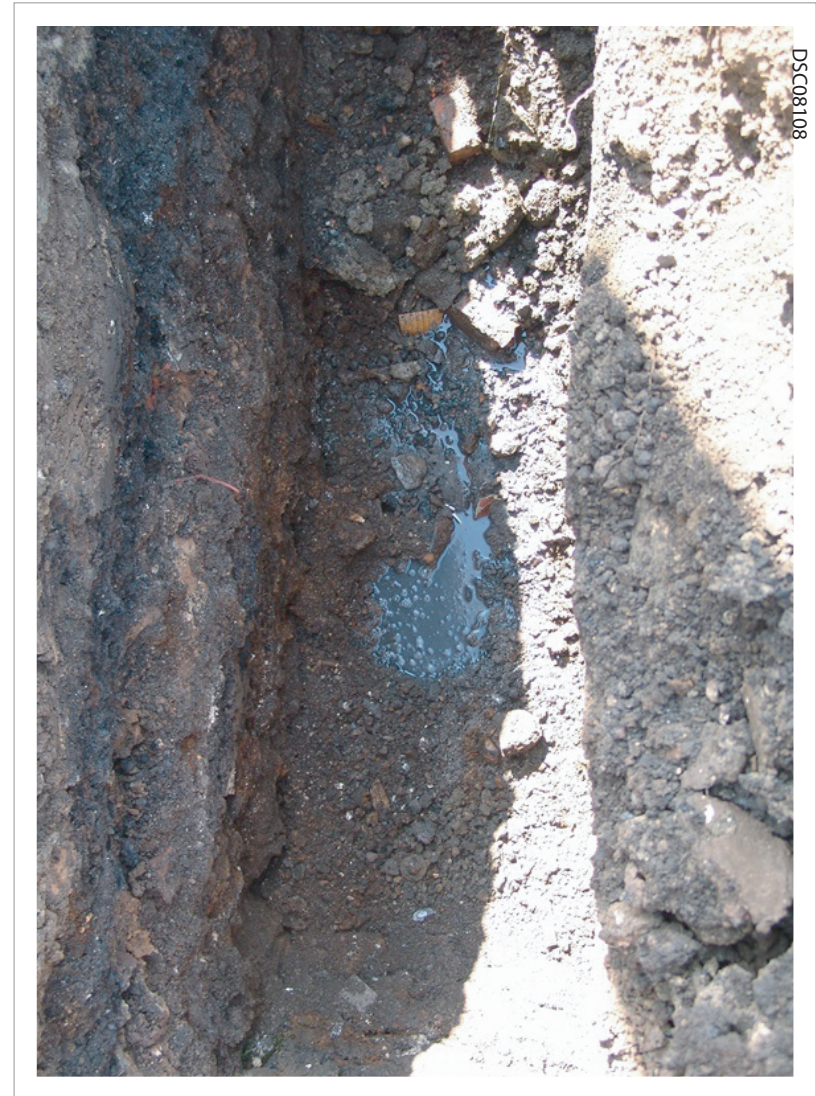
DSC08108

The instability of the deposit was further exacerbated when an unrecorded salt glazed foul pipe was fractured depositing sewage into the bottom of the trench, PL08.

Plate 08: Trench 3 at ≤ 3 m back fill [106] active waste pipe broken at 1.2m

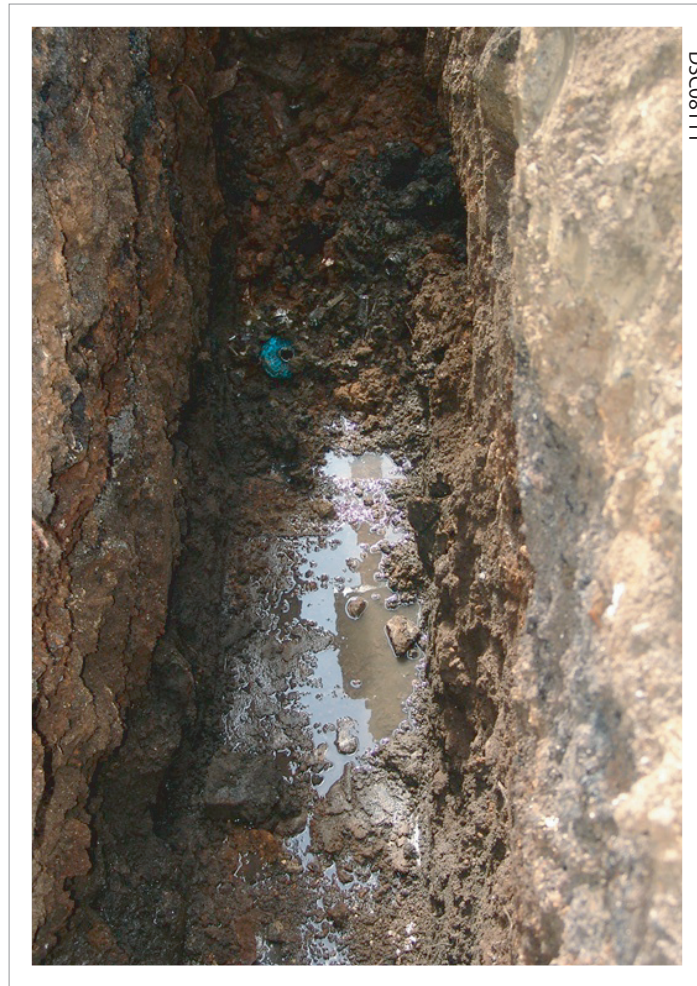
DSC08111

The ensuing wet mix continued to undermine the trench edges as excavation continued PL09, causing inevitable collapses, PL10 & PL11.

Plate 09: Trench 3 Southern end, being excavated

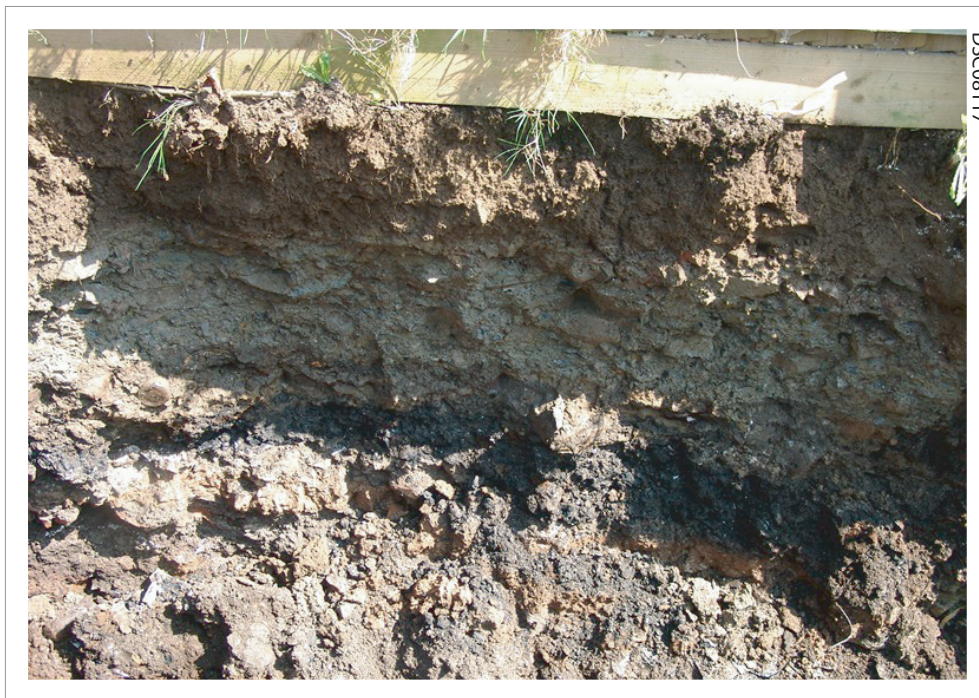
DSC08117

At this point excavation was stopped in order to deal with the unstable trenches due to the fact that the collapses were starting to undermine the boundary fence, PL10 & PL11.

Plate 10: Trench 3, eastern face showing second collapse undermining boundary fence

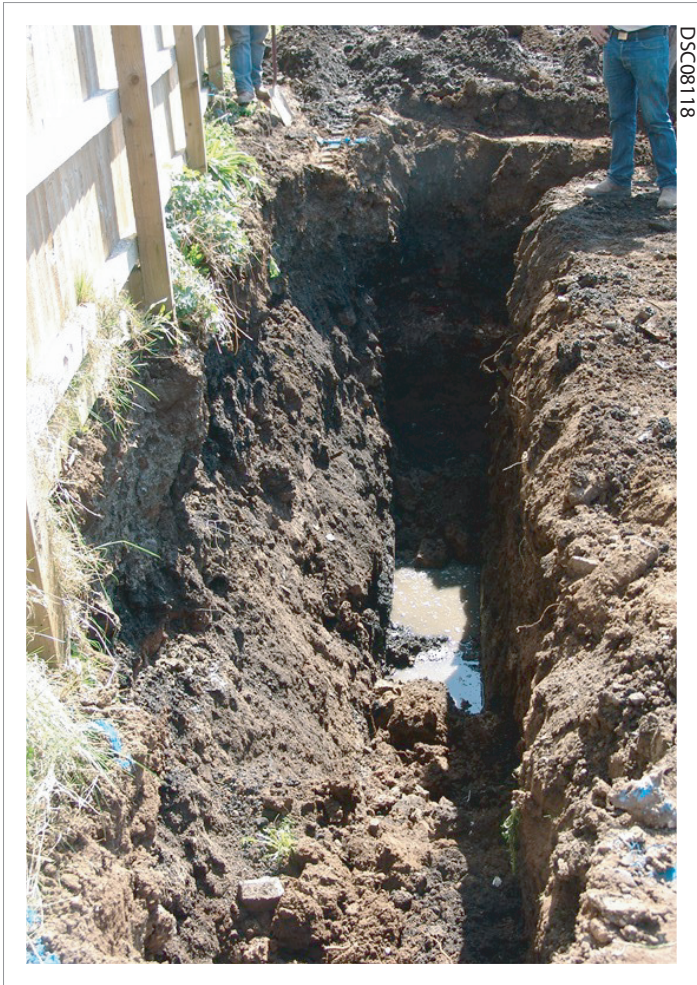
Plate 11: Trench 3, eastern face showing second collapse undermining boundary fence

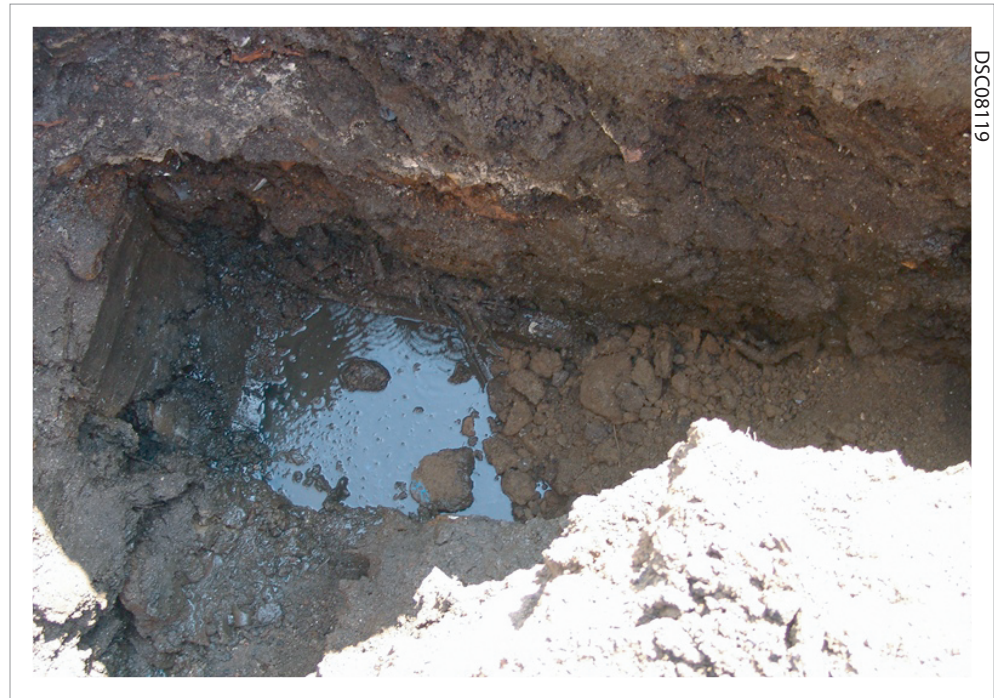
Eventually, trenches 3 & 1 were joined together, reaching a depth of approximately 3m at which [107] was reached PL12.

Plate 12: Trench 1 and 3 corner at 3m.

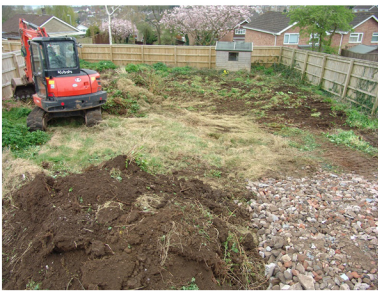
DSC08086.jpg

Cover Photograph: DSCO8086. *Initial vegetation stripping*

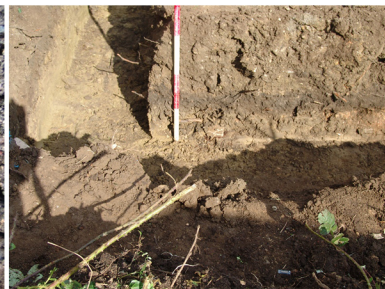
DSC08104.jpg

DSC08104	14/04/2015	DSC F828	3264x2448	V	Trench 1 and trench 2, sequence [102] over [107]	
DSC08105	14/04/2015	DSC F828	3264x2448	V	Trench 1 at 2.5m from west edge. sequence [102] [103] [104] [105] [106] [107]	
DSC08106	14/04/2015	DSC F828	3264x2448	W	Centre of trench 1, northern face step 3 3.7m from western edge. [104] [105] [106] [107]	
DSC08107	14/04/2015	DSC F828	3264x2448	E	Centre of trench 1, northern face step 3 3.7m from western edge. [105] [106] [107]	
DSC08108	14/04/2015	DSC F828	2448x3264	V	Trench 3 at ≤3m back fill [106] active waste pipe broken at 1.2m	PL08
DSC08109	14/04/2015	DSC F828	2448x3264	V	Trench 3 northern end, possible bedrock at base.	
DSC08110	14/04/2015	DSC F828	2448x3264	V	Trench 3 Southern end, possible bedrock at base.	
DSC08111	14/04/2015	DSC F828	2448x3264	S	Trench 3 Southern end, being excavated	PL09
DSC08112	14/04/2015	DSC F828	2448x3264	V	Trench 3 collapse	PL04
DSC08113	14/04/2015	DSC F828	3264x2448	E	Trench 3 collapse

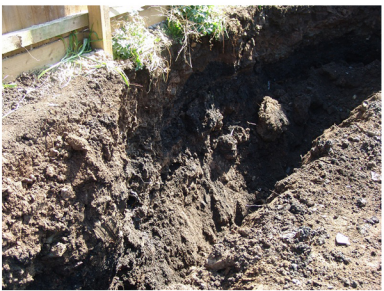
DSC08113.jpg

Excavation of the footings began on the second day concluding with extensive and continuous collapse along trench 3, which was completed and measured at 3m of unstable ground; the condition of which was exacerbated by the ingress of water, both foul and ground.

Plate 04: Trench 3 collapse

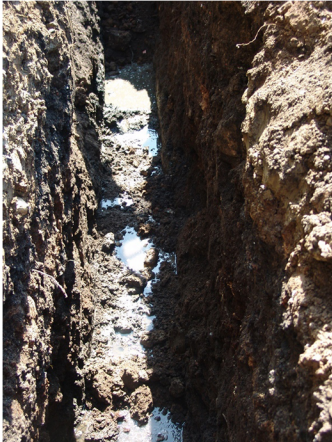
DSC08114.jpg

Excavation of the eastern end of trench 1 was left until after trench 3 was completed, due to working space commitments at the site; eventually clay [107] was found at just over 3m at 11.5m from the western end of the trench.

DSC08114	14/04/2015	DSC F828	2448x3264	E	Trench 1 eastern end	PL07
DSC08115	14/04/2015	DSC F828	2448x3264	V	Trench 3 trench 1 corner. Base at 3m in [106] with active water ingress	
DSC08116	14/04/2015	DSC F828	2448x3264	N	Trench 3, northern corner with second collapse	PL05
DSC08117	14/04/2015	DSC F828	3264x2448	E	Trench 3, eastern face showing second collapse undermining boundary fence	PL10
DSC08118	14/04/2015	DSC F828	2448x3264	SE	Trench 3, eastern face showing second collapse undermining boundary fence	PL11
DSC08119	14/04/2015	DSC F828	3264x2448	V	Trench 1 and 3 corner at 3m.	PL12
SM00001	13/04/2015	SM N9005	4128x3222	SE	Initial vegetation stripping	
SM00002	14/04/2015	SM N9005	3264x2448	SE	Trench 3 at ≤3m back fill [106] active waste pipe broken at 1.2m	
SM00003	14/04/2015	SM N9005	3264x2448	SE	Trench 3, eastern face showing second collapse at time of occurrence
