CPAT Report No. 1635

Rhosgoch Mill, Powys

Archaeological Watching Brief

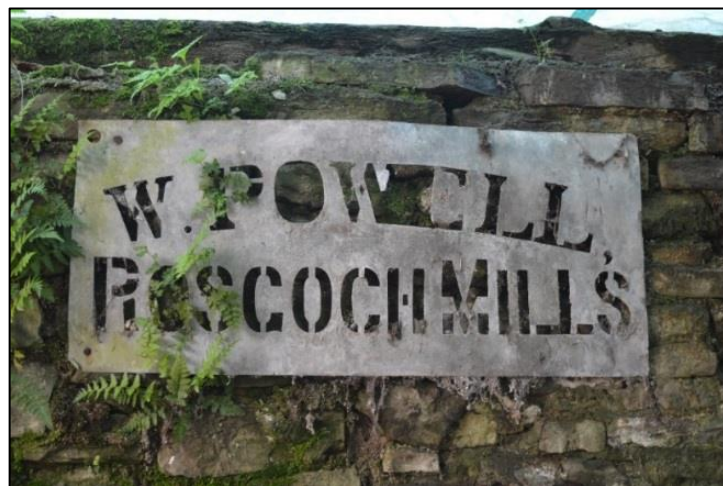
- 2.4. It is evident from this and information provided by the client that the mill has belonged to the Powell family from the late 18th century until the present day. A stencil for W. Powell is affixed to the inside of the mill (Fig. 4).

Fig. 4: The Powell stencil. CPAT 4343-0083

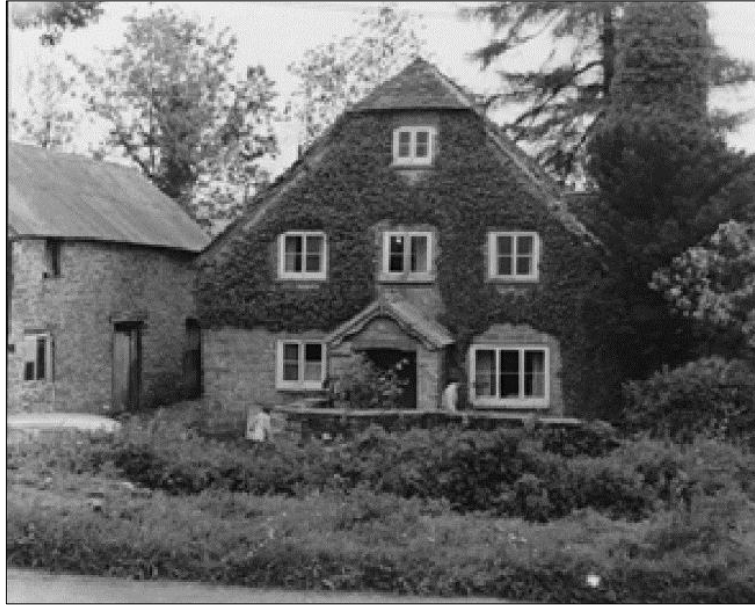
Fig. 6: Photograph taken in the 1950s showing the north-west elevation of the mill and adjoining barn

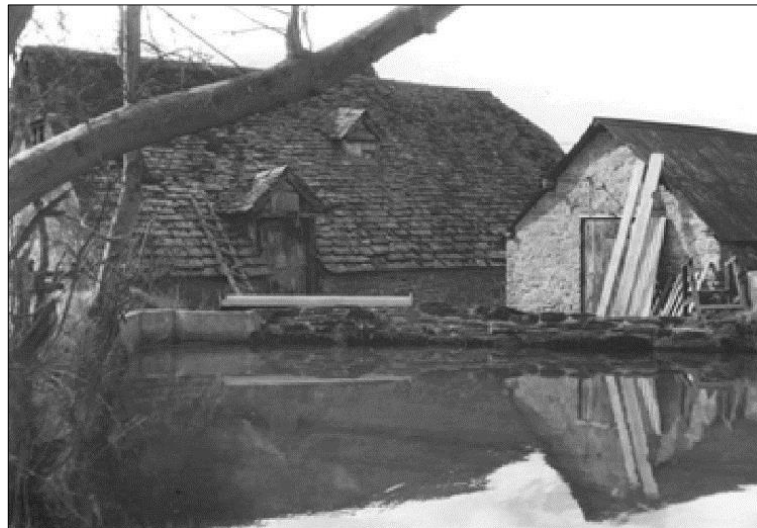
Fig. 7: Photograph taken in the 1950s showing the view across the mill pond, towards the mill

- 2.6. The earliest accurate depiction of the mill is the 1889 Ordnance Survey 25" map, although the detail is clearer on the 2nd edition map of 1904 (Fig. 5). This shows the combined mill and mill house, with a pond to the north, together with a tail race and bypass leat.
- 2.7. The mill remained in operation until the 1960s, with the client remembering it having still been in use in 1967. This makes it one of the last watermills in use in the county; it is shown in two photographs from the 1950s provided by the client (Figs 6 and 7).

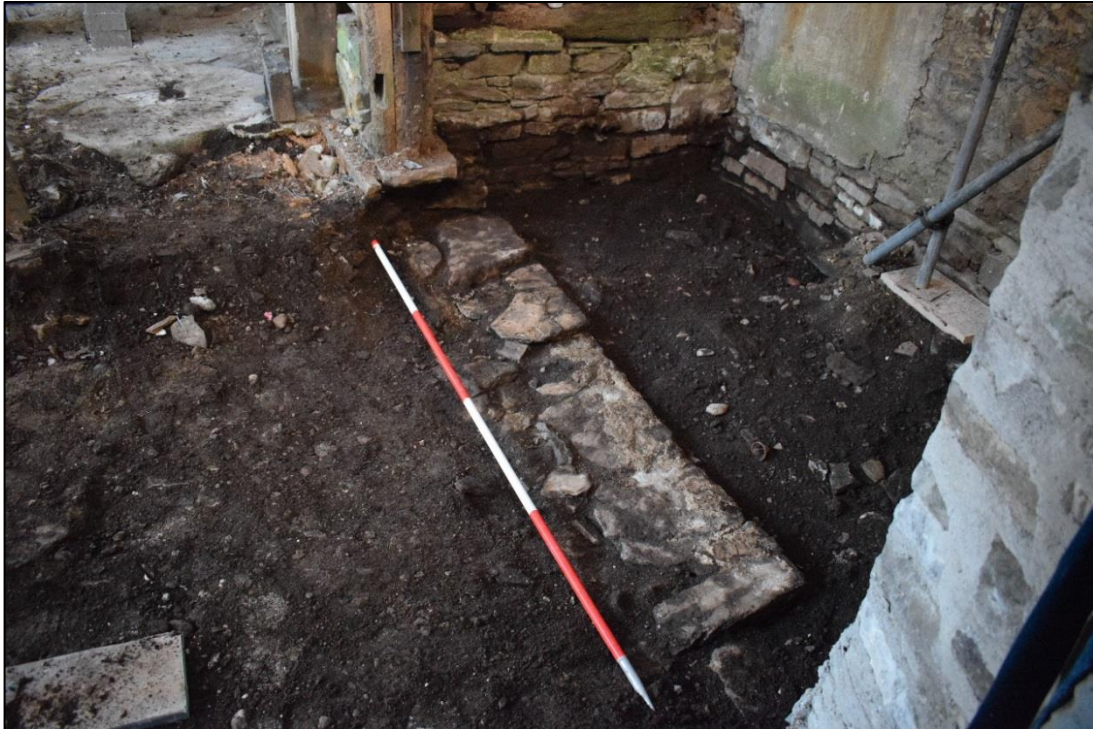
Fig. 9: The section of walling which defined the extension to the gearing pit, from the west. CPAT 4580-0001

- 3.4. Of more significance was a section of walling (Fig. 9), approximately 2.1m in length and 0.5m wide, that was discovered under the floor at the south-east end of the former kitchen. This demonstrated that the existing gearing pit in the mill building originally extended further to the south-west to occupy almost the full width of the building, but had later been reduced in size, the redundant part being levelled and infilled with loose silt and stones. This indicates that there was once an additional gearing mechanism in this area, most likely used to operate further milling machinery. The stub wall which defines the south-west side of the current gearing pit is therefore a later insertion, as is the vertical post next to it that was placed to support the end of the beam that forms the main support for the mill machinery and stones on the first floor; this beam is likely to have run across the entire width of the building and was clearly cut when the gearing pit was reduced in size. There is a blocked opening at ground-floor level in the south-east wall, the timber lintels for which survive internally and externally, and it seems likely this relates to the machinery that had been removed from the gearing pit; whether this has any implications for changes to the size and location of the water wheel is not known.

- 3.5. It is worth noting that the gearing pit wall does not quite extend as far as the south-west wall of the mill and this implies that the building was widened at some point.

This is supported by the presence of a masonry joint in the south-east wall of the mill which demonstrates that the south-west wall of the mill is a later addition, though whether this dates to the last refurbishment of the mill in 1867 or some earlier alterations cannot be determined. The yellowish sandy lime mortar in the gearing pit wall seemed to be different to that used in the main building.

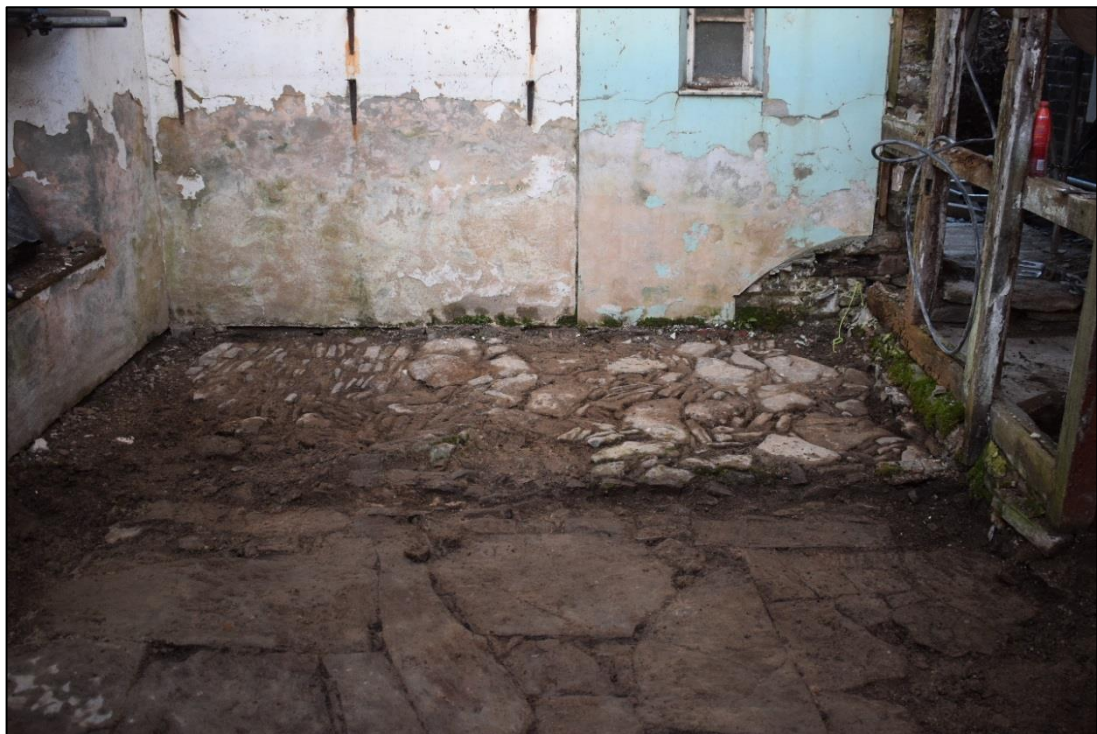
Fig. 10: The cobbled flooring of the dairy, from the south-west. CPAT 4580-0014

- 3.7. The slab flooring was removed in advance of the watching brief and this demonstrated that the cobbling was confined to the dairy (Fig 10), and had a rather more regular surface than had been appreciated in the small area seen in the assessment. It was perhaps significant that the cobbling did not extend across the full length of the dairy, and terminated between 0.3m and 0.8m from the north-west wall of the building. As with the wall in the former kitchen, this could be evidence that the flooring related to a slightly smaller and earlier structure, though it was not possible to be sure with the limited evidence that was revealed.
- 3.8. Once the cobbling had been photographed and recorded, a section was removed down to the level required to prepare the ground for the new floor. This revealed an underlying layer of stone and gravel, all of local origin, which provided the base for

the flooring. Whether this material represents the natural subsoil or an imported levelling deposit could not be determined. However, the depth of made ground within the mill suggests that there may originally have been a height difference of at least 0.5m between the two parts of the building.

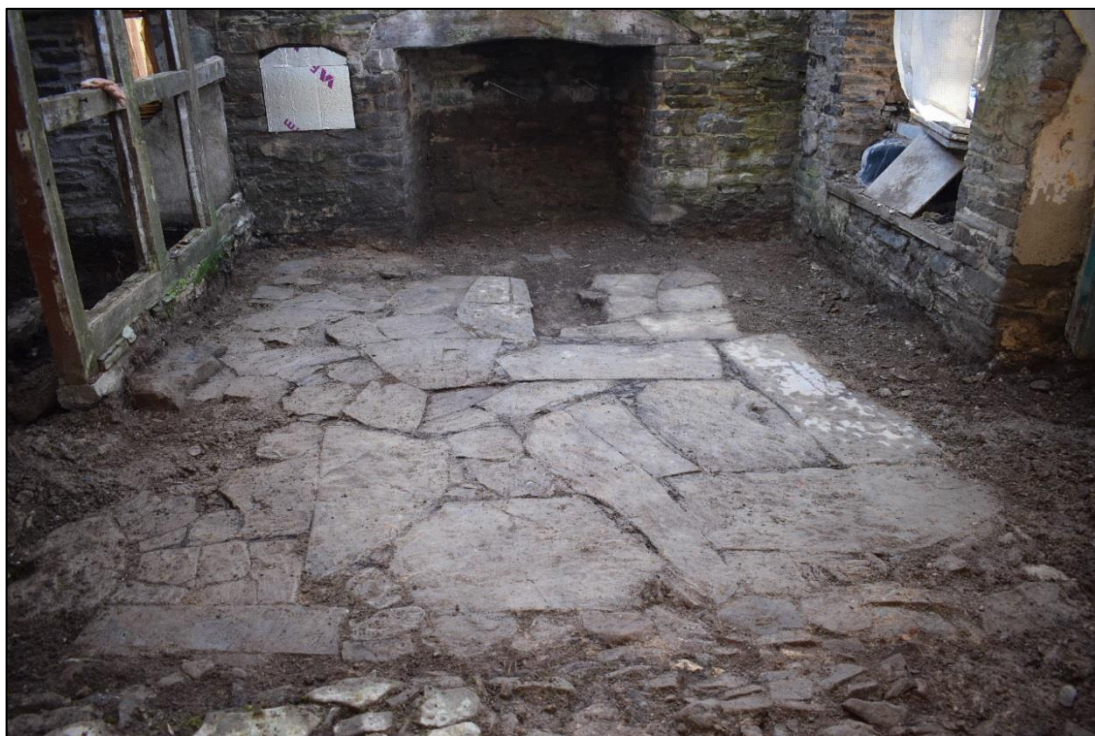
- 3.9. In the parlour section of the mill house and the adjoining passageway, a layer of about 0.1m of loose small stone was removed during the watching brief, below which a thin layer of yellowish clay was identified. This was removed to reveal a second layer of stone slab flooring (Fig. 11) which also did not extend as far as the north-west wall, terminating between 0.6m and 0.9m from it. The gaps between the stones contained the same humic material that had been seen in the dairy, so that although the floor was different in composition, the likelihood is that it was broadly contemporary. Again, it could be related to an earlier building.

Fig. 11: The stone slab floor in the parlour and main passage leading to the mill, which lies to the left of the image. CPAT 4580-0009.

- 3.10. A small area of slabs was removed and this revealed the same material as had been found beneath the dairy; the same thoughts regarding its origin as those expressed in para 3.8 apply.

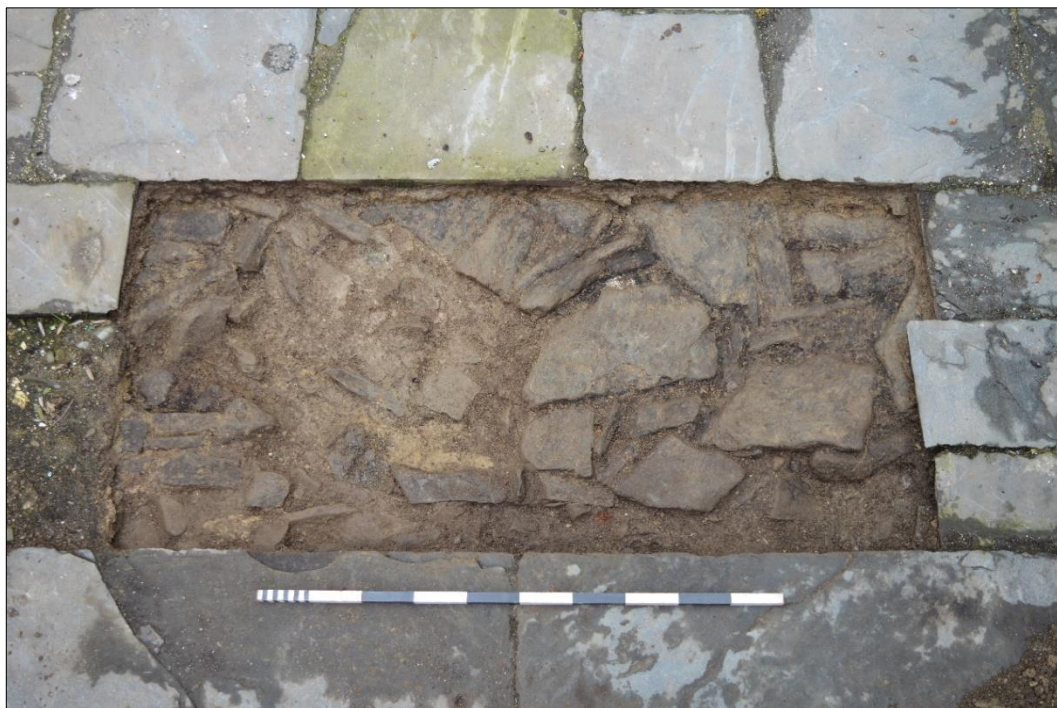
The stone surface revealed beneath the stone slab floor. Photo CPAT 4343-0108
