**The Tudor Mansion,
Neath Abbey,
Neath, Swansea, Glamorgan
(Phase 1).**

Standing Building Investigation & Recording
and Watching Brief

HRSWales
Report No: 188

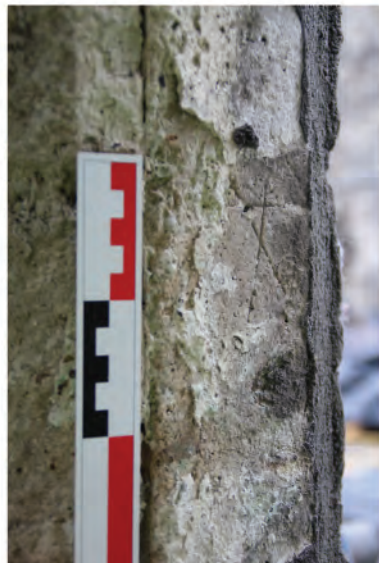
Plate 70. Apotropaic mark in mullion in late Tudor window (8) in west wall. Looking eastwards.

- 6.21 Close examination of one of the mullions of the first floor window (8) revealed the presence of two apotropaic marks or protection marks (9), each consisting of three intersecting straight lines cut into the mullion. These marks are generally believed to be representative of either the Virgin Mary or else represent the Holy Trinity. Being carved into the stonework, probably by one of the stonemasons working on the site in the late 16th century, these marks were thought to offer protection from Witches entering the house. A further protection mark was also noted on one of the window jambs at the far north east end of the east wall.

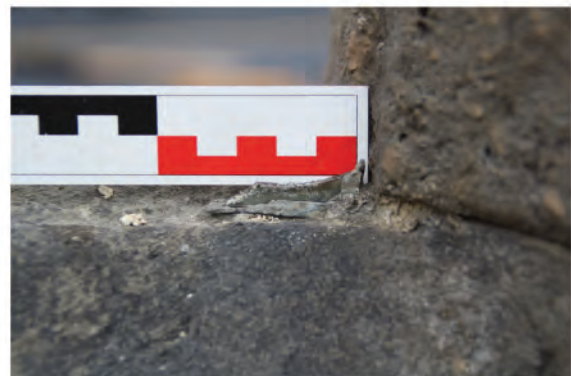
Plate 71. Fragment of lead and glass found in base mullion of late Tudor window in first floor of west wall (8). Looking eastwards.

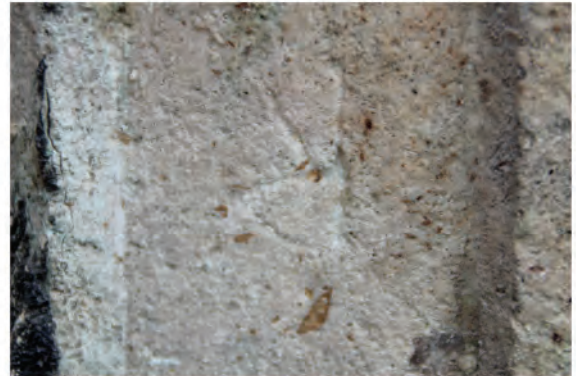
Plate 73: Detail shot showing mason's mark of an inverted letter 'R'. Found in side jamb of large oriel window (6). Looking southwest.

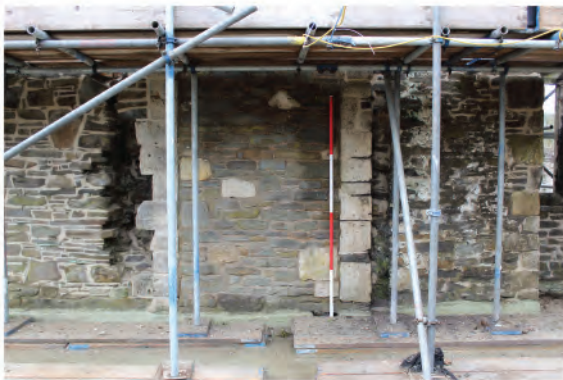
Plate 74: Remains of blocked 15th century doorway (33) in west wall from internal side. Looking west.

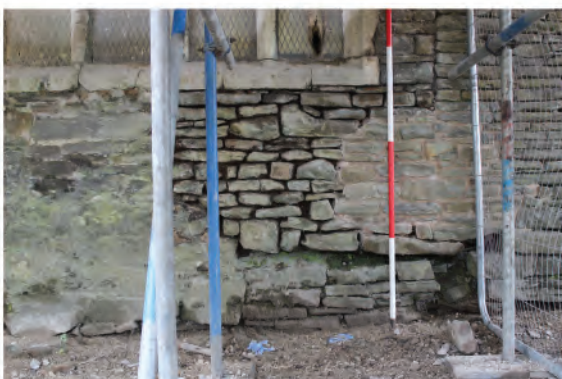
Plate 114. View of area of repair below late Tudor window in east wall (104). Looking west.

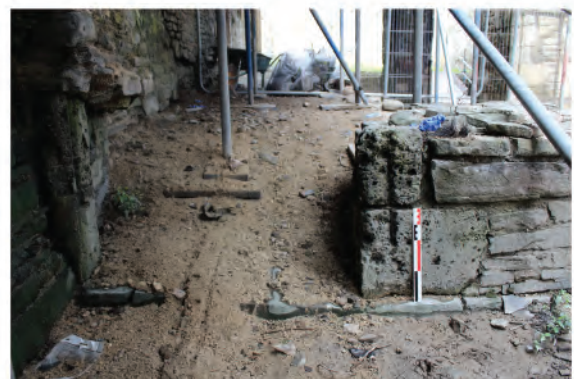
Plate 114. View of former opening in lateral cross wall at foot of east wall at base of buttress. Note moulded base orders. Looking north.

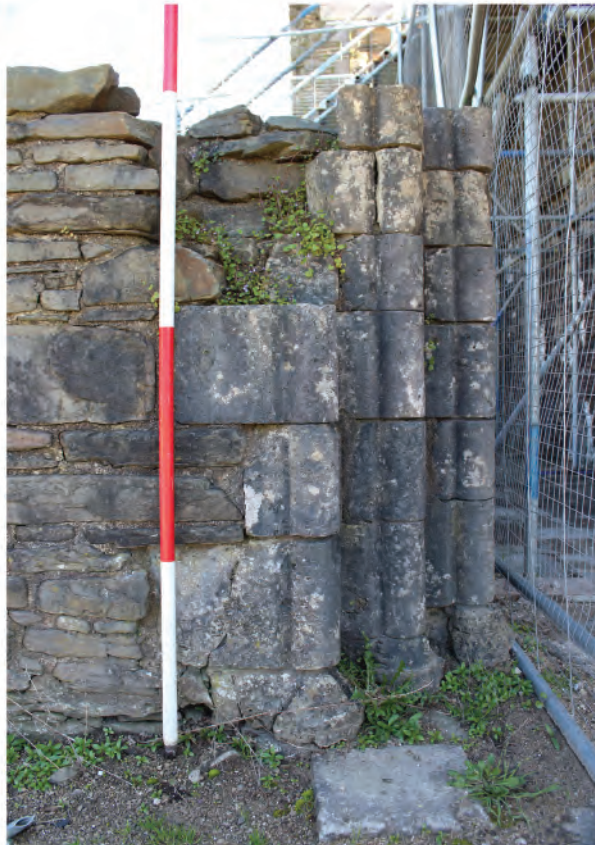
Plate 155. Detail shot of remains of moulded side jambs (15) of Slype passage at north end of west wall. Looking east.

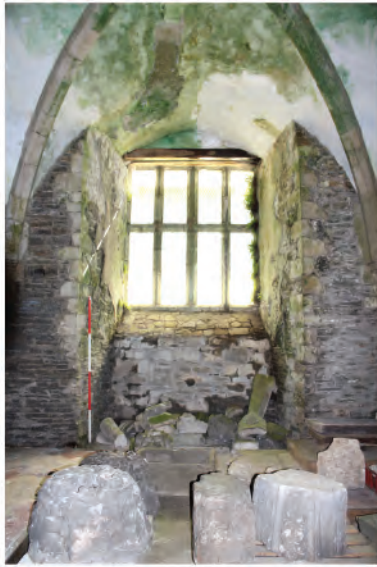
Plate 260. East window of South wall in undercroft prior to lintel replacement. Looking south

The watching brief during the removal and replacement of rotten oak timbers above the windows in the south wall revealed that once the timber s had been removed, it became apparent that the exposed stonework in the back wall above the square headed window and below the lintel had recently been rebuilt in modern times as the mortar used was a modern grey cement. The plaster covering this stonework was a mixture of lime and cement.

- 14). Replace existing rotten timbers with new timbers above the windows in the south wall of the Monks Day Room.

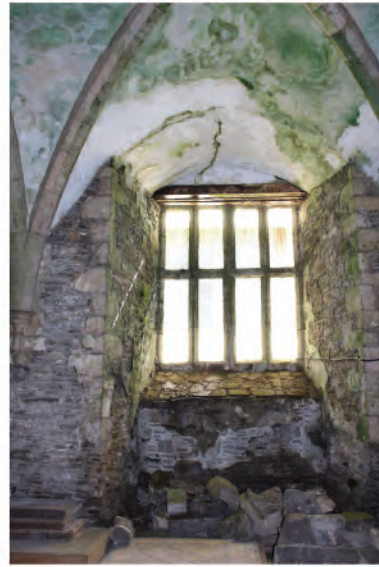
Plate 261. West window of South wall in undercroft prior to lintel replacement. Looking south

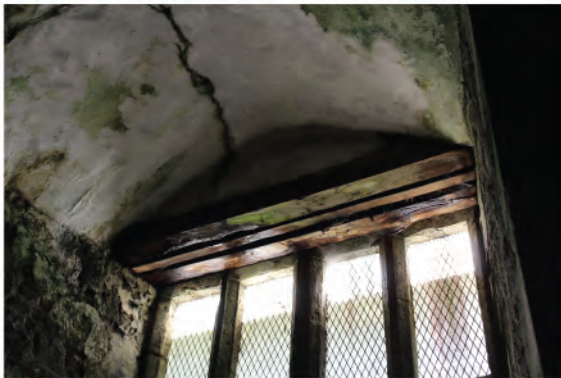
Plate 262. Timber lintels in east window prior to removal. Looking southeast.

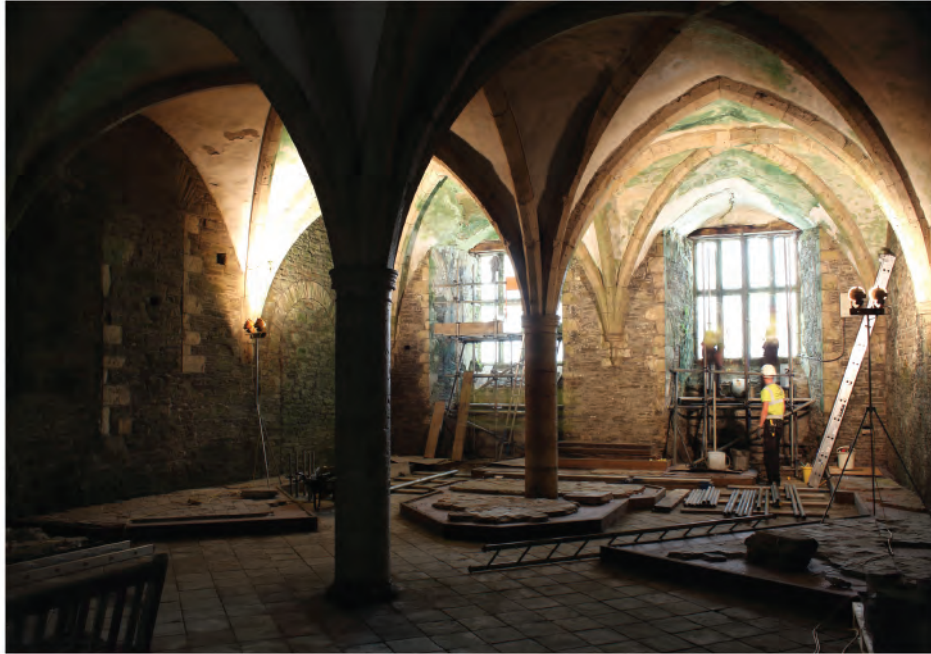
Plate 266. Working shot during timber lintel removal in undercroft. Looking south.
