CPAT Report No. 1267

St Beuno's Church, Llanycil, Gwynedd

Archaeological Watching Brief

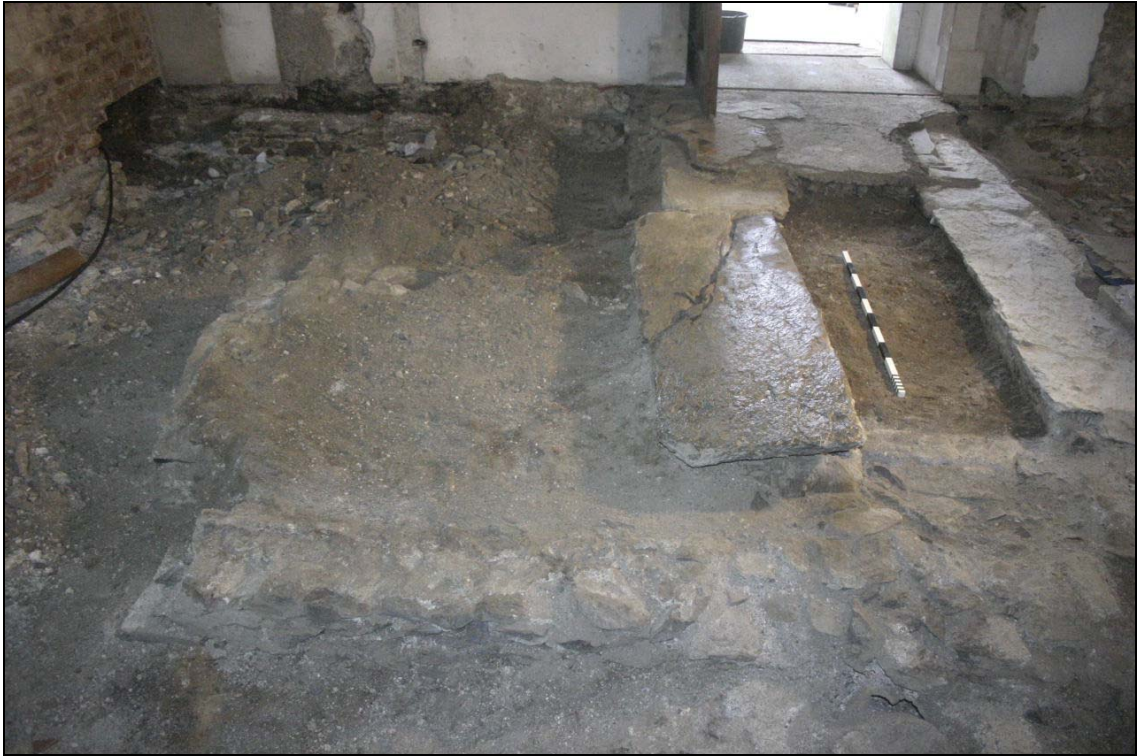
Fig. 3 The re-used grave slabs in the nave as a levelling foundation. 1m scale. Photo CPAT 3805-0003

- 3.3 Further clearance in the church entrance revealed that the grave slab was part of a levelling foundation for the tiled floor surface of the 19th-century church. This foundation comprised four long stone slabs aligned north-south towards the entrance of the church, with a shorter overlying slab at right angles at the entrance itself (see Fig. 3). The two long slabs to the west, including that already described in para. 2.2 above, both carried late 17th-century dates. The second memorial slab measured 1.5m in length, 0.56m in width and 0.8m in thickness and was adjacent to the entrance. Its inscription was less clear, with F IANY 10 1673 being visible, presumably including an abbreviated form of January. The U in the month is represented by a V and has been run together with the Y by the engraver.

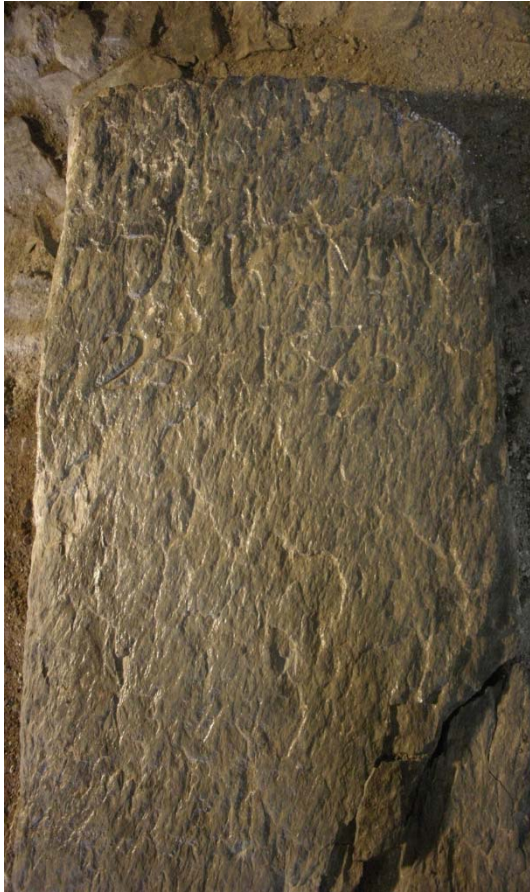
- 3.2 Ground works to reduce the surface levels in the nave had commenced prior the provision of archaeological monitoring. The removal of the tiled floor immediately inside the entrance to the church and the adjacent space where the font had been positioned revealed a 17th-century grave slab measuring 1.8m in length, 0.6m in width and up to 0.08m in thickness, placed 0.1m below the tiles. Once the grave slab was cleaned it was seen to have an inscription of EMK MAY 23 1675 with the initials E and M being only partially visible.

Fig. 6 Grave memorial slab engraved EMK
MAY 23 1675. Photo CPAT 3805-0009

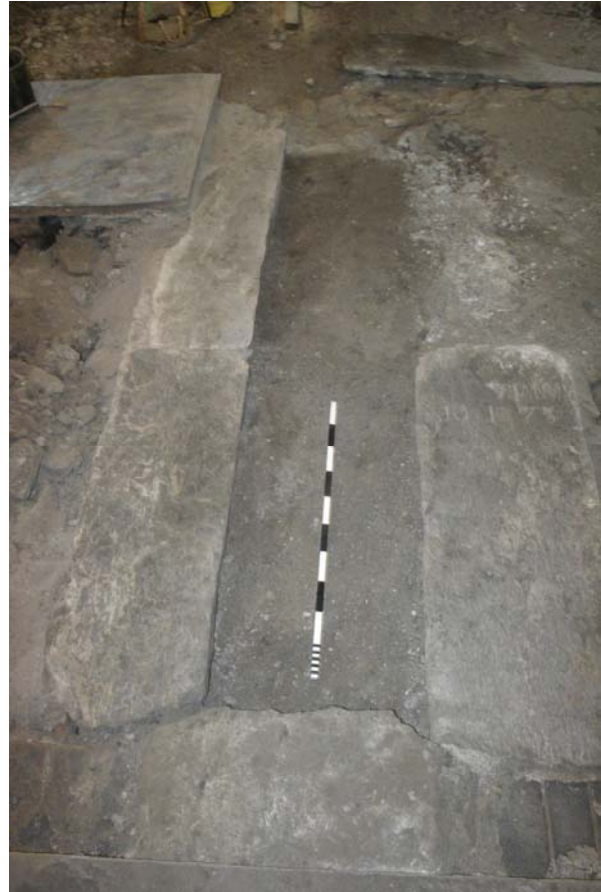
3.5 The stone slabs were laid on a bed of stone rubble and white mortar, within a make-up deposit (01) of mid-grey-brown sandy silt containing mortar fragments, a sherd of Buckley-type pottery and a few pieces of disarticulated human bone. This deposit extended for 2.0m from north to south and 3.0m from east to west and were contained

Fig. 7 Stone slab floor foundation at the
entrance to the nave with one grave slab
removed (and the photo scale introduced) to
reveal the rubble make-up, viewed from the
north. Photo CPAT 3805-0012

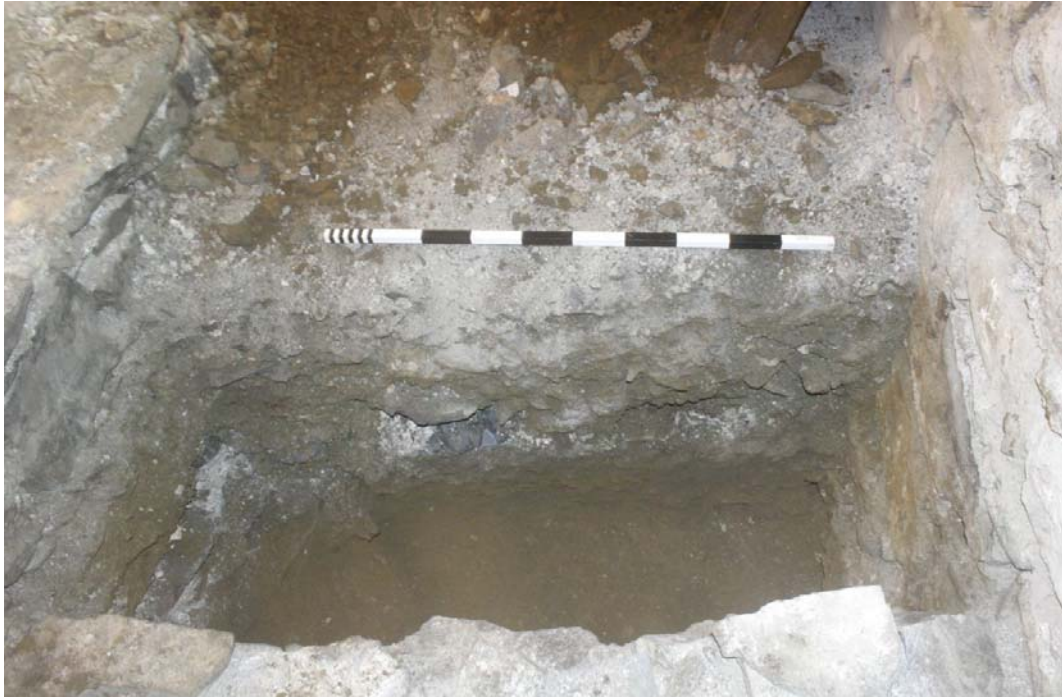
- 3.8 Sondage 2 was located directly by the south wall of the chancel, adjacent to the rood screen. It measured 1.65m in length from north-west to south-east and was 0.8m in total depth. The upper layer comprised 0.5m of mortared shale rubble make-up (o2) derived from the 19th- century building works, which overlay a compact 100mm-thick layer of roof slate and white plaster, with some of the latter exhibiting a smooth finished surface from the earlier church's internal decoration. Below this layer brown loam (o3) containing frequent fragments of disarticulated human bone was removed to a depth of 200mm; this was comparable with (11) in sondage 1 and was interpreted as 'church earth', probably derived from one or more graves.

Fig. 8 Sondage 2 showing 19th-century make-up and demolition deposits below, viewed from the west. Photo CPAT 3805-0020

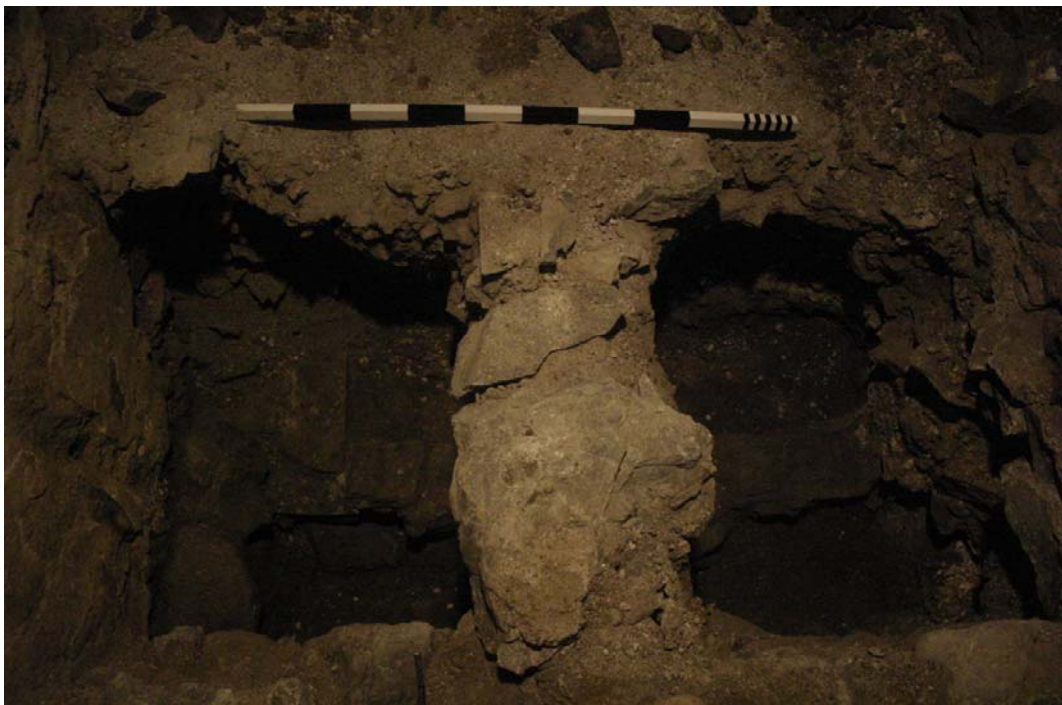
- 3.9 Sondage 3 was located by the north wall of the chancel, adjacent to the rood screen, and measured 1.6m in length, north-west to south-east, and was 0.95m in depth. Beneath the supports of the 19th-century suspended floor was rubble make-up (o5) 0.6m thick containing roof slate and mortar. This overlay a layer (o6) of roof slate rubble, medieval stone fragments and white plaster, some of which showed a smooth finished surface with an ochre wash from the earlier church's internal decoration. Below was brown loam (o7),

Fig. 9 Sondage 3 with the stone feature, possibly a coffin rim, just visible in the base of the trench, viewed from the west. The traverse 'wall' crossing the sondage is a 19th-century feature. Photo CPAT 3805-0028

- 3.10 At the base of the sondage was a structure (o8) built of roughly finished stone about 150mm in thickness which extended beyond the limits of the sondage. At one end this stone 'rim' turned and extended for 0.4m. Possibly this was a lidless coffin or some comparable grave structure. The north wall of the chancel was exposed in the sondage, with a white mortar skim over the rough shale fabric resting on pitted weathered and smoothed boulders, with a brown clay bonding and the base of the wall. This was almost certainly the foundation of the earlier church, re-used by the Victorian builders.

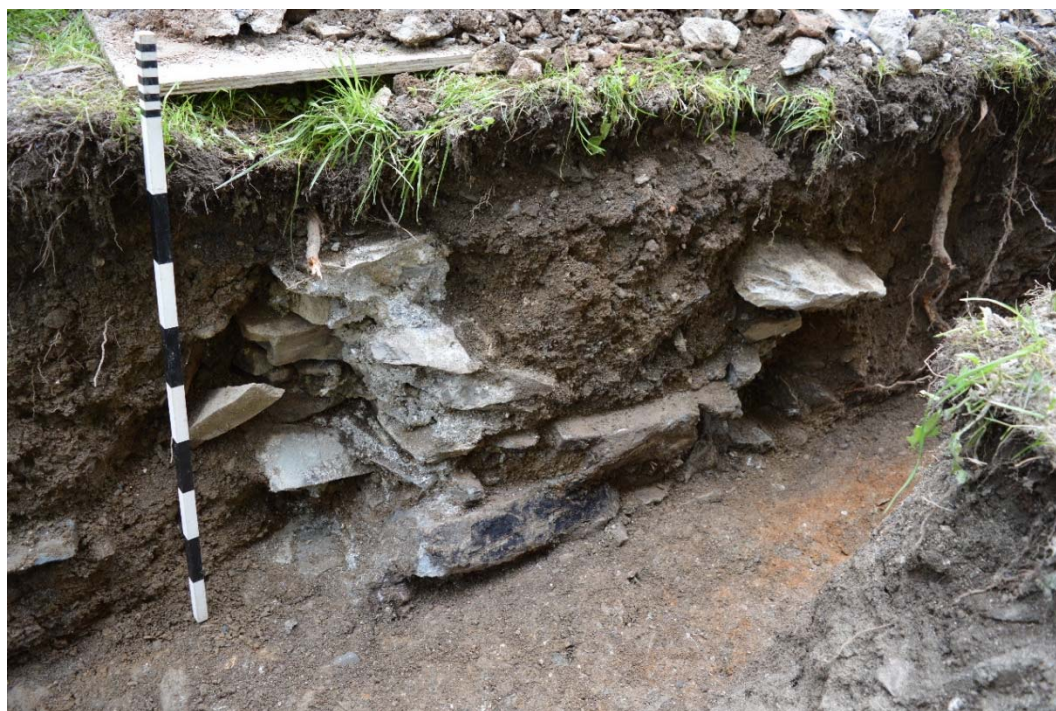
Fig. 12 Structure (45) exposed in the east facing section of the cable trench outside the west wall of the church. Photo CPAT 3843-0020

- 3.14 In the trench and nearly opposite the centre of the west wall of the church was structure (45) below 200mm of topsoil. Irregular limestone blocks were bonded with white mortar to a height of 0.8m and the feature was 1.4m wide externally from north to south; it had a base – not fully exposed – of large stone blocks up to 0.5m in length, some displaying a slightly sooty residue. The remains of this east to west-oriented structure with regularly faced sides on the north and south, might suggest a stone-lined grave but it was infilled with something very similar to the trench backfill (29) and appeared to be constructed with the similar materials to the 19th-century highlighting at least a possibility that it was not a burial feature but had some more mundane function. The

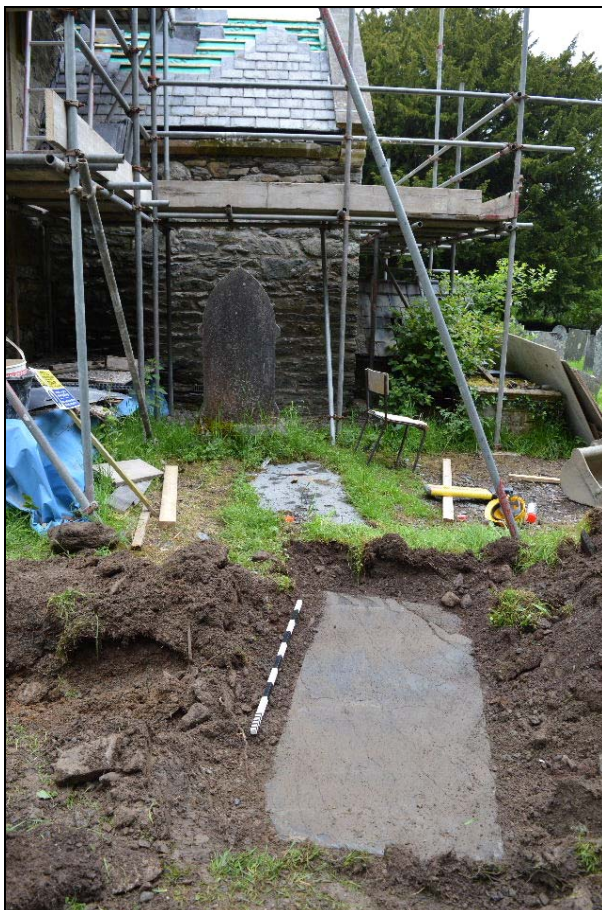
- 3.15 South of the south-western corner of the nave a slate memorial slab (48) lay 100mm below the ground surface, sloping downwards towards the south-west. It was 1.8m in length, 0.76m in width and 0.15m in thickness. One face of the slab was bevelled and this, together with the absence of an inscription, suggests it was once the lid of a chest tomb, comparable with other examples still surviving in the churchyard. The stoneware drain ran below this slab indicating that it must have been disturbed during the earlier works.

Fig. 13 Featureless slate slab (48), perhaps from a chest tomb, viewed from the west.
Photo CPAT 3843-0011

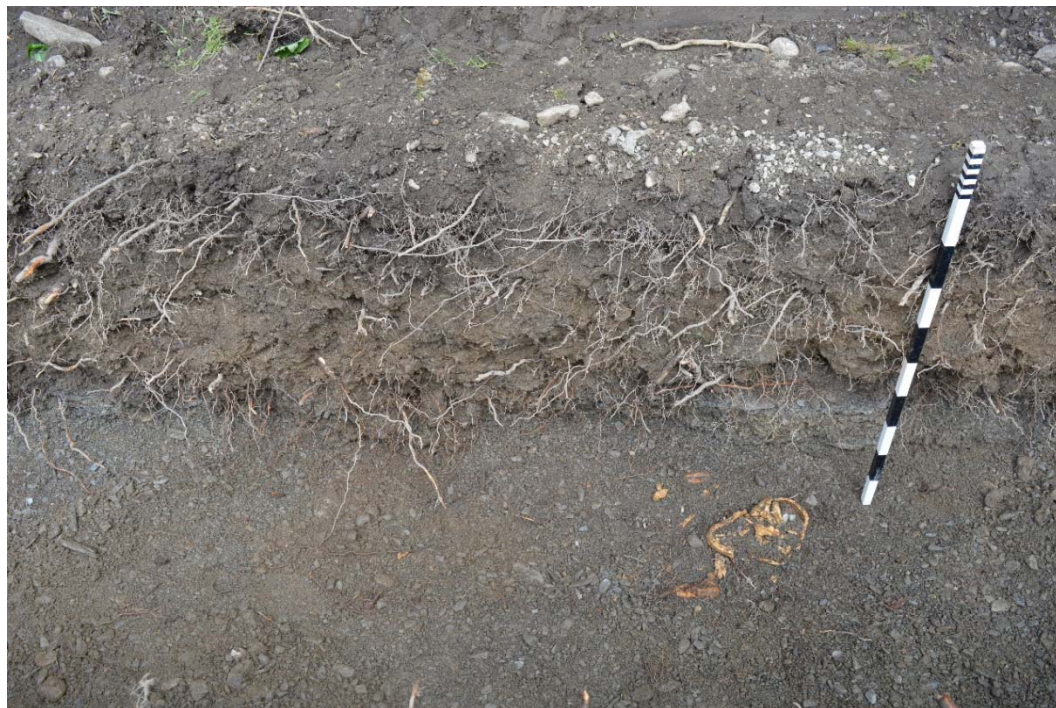
- 3.20 Near the western end of the southern service trench at 1.00m below the ground surface were the skull and shoulders of an articulated skeleton (42) oriented east to west, the associated grave cut being partially evident in the north-facing section of the trench. The grave fill was grey-brown clayey loam that became increasingly shale-rich towards the base, this material not surprisingly being very similar in character to the surrounding layers through which it was cut. Small fragments of 18th-century pottery were recovered from the light cleaning around the skeletal remains, from which it can be inferred that this grave was from the 18th century or later. The skeleton appeared to be that of an adult

Fig. 15 The partial cranium and upper skeleton revealed in grave 42, viewed from the north. Photo CPAT 3843-0016

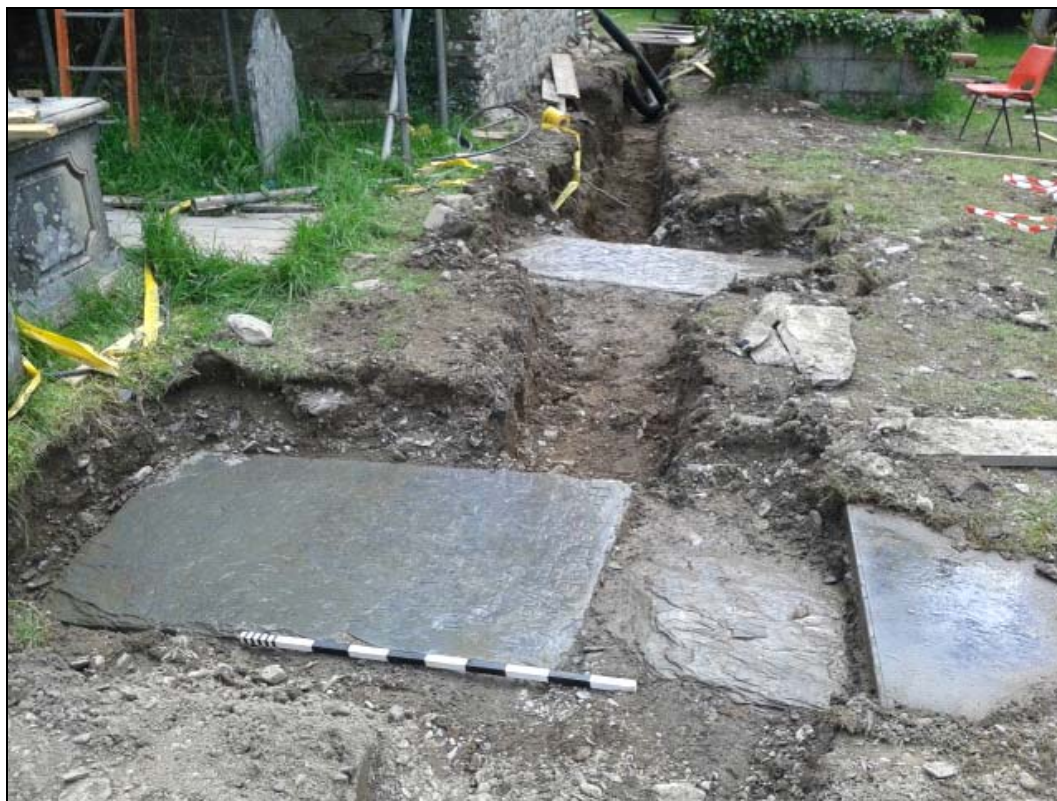
- 3.22 Two inscribed memorial slabs were encountered near the north-west corner of the nave, 100mm to 300mm below the ground surface. The earliest and closest to the church was (46), a slate memorial slab 1.7m in length, 0.77m in width and 0.08m in thickness, aligned north-east to south-west and slightly sloping downwards to the south-west. The inscription read:
HERE LYETH THE BODY OF IOHN EVAN OF CLANLLAVAR WHO WAS
INTERREDY 27 OF FEBR: AN DO¹¹ 1689

Fig. 16. Grave slabs 46 and 47, with a slab running beneath, viewed from the north.
Photo CPAT 3843-0026

- 3.23 A second memorial (47) lay 2.5m to the north of the first. It measured 1.6m in length, 0.79m in width and was 0.1m thick; aligned roughly east to west, it sloped downwards to the north-east. It was inscribed:
- Here Lyeth the Body of Roderick Thomas. Who died March 22^d 1762 Aged 70 In hopes of a Joyful Resurrection Here also Lyeth Interrd the Body of Elenor the wife of Rodrick Thomas who departed this Life the 24th of August 1768 Aged 71
- 3.24 Immediately to the west of (47) was a slate slab that appeared to run under a ledger that was still exposed to view in the churchyard and inscribed and dated to 1804. Slabs (46) and (47) were carefully lifted with straps and laid between other graves of the churchyard. Subsequently they were erected in an upright position in the side of the trench running along the south side of the churchyard boundary.

Fig. 17 Grave slabs 46 and 47

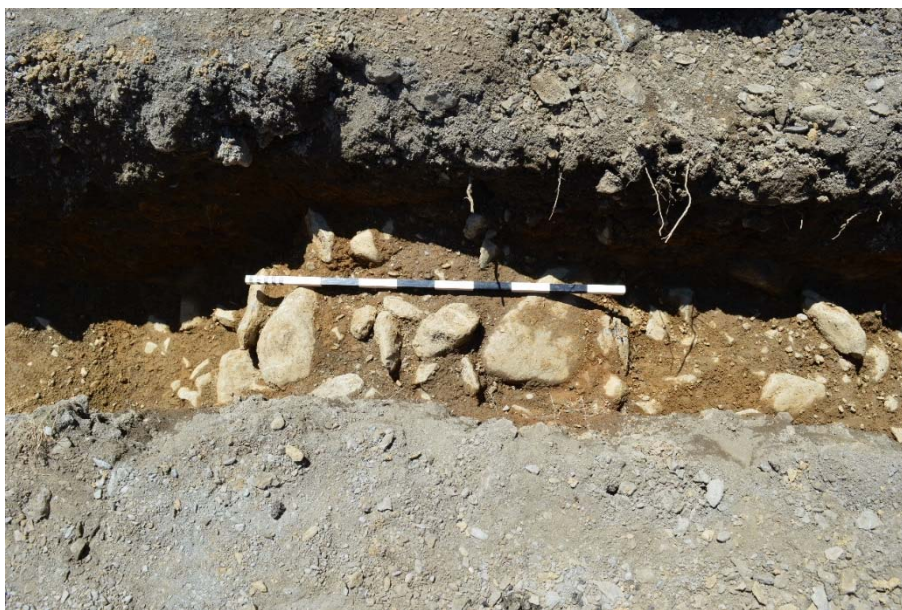
- 3.26 Two metres to the west of and parallel with grave (49) were the remains of a wall (50) at 0.5m below the present ground surface. The structure was aligned north-east to south-west, and constructed of large cobbles, bonded with grey clay and orange silt. The wall was 1.3m in width at the base and 0.9m at the top, and was 0.4m in height. There was nothing that could help to date the structure. Extending to the west of the

Fig. 18 Wall remains (50) and associated rubble (51), viewed from the south-west.
Photo CPAT 3843-0043

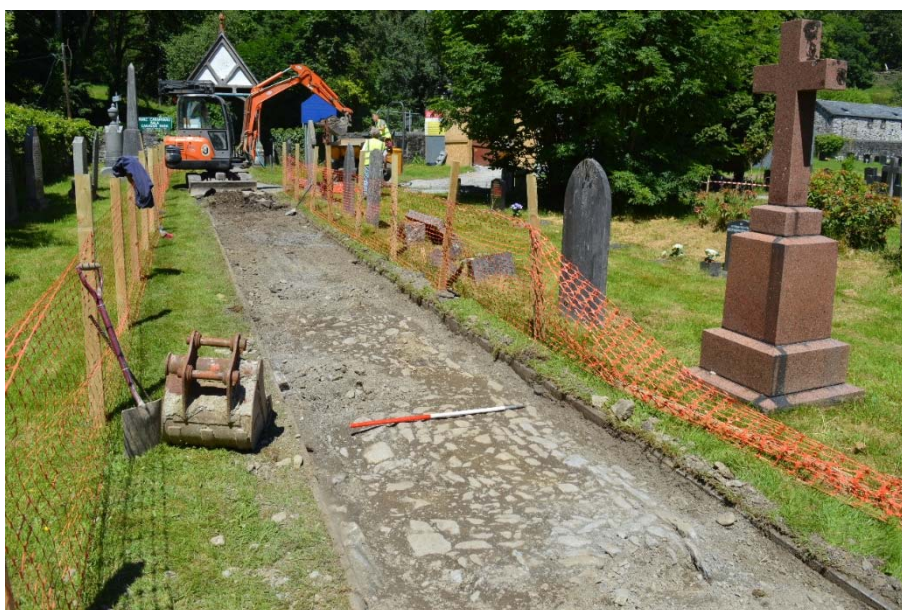
Fig. 19 Cobbled path (52) viewed from the south-east
CPAT 3843-0039

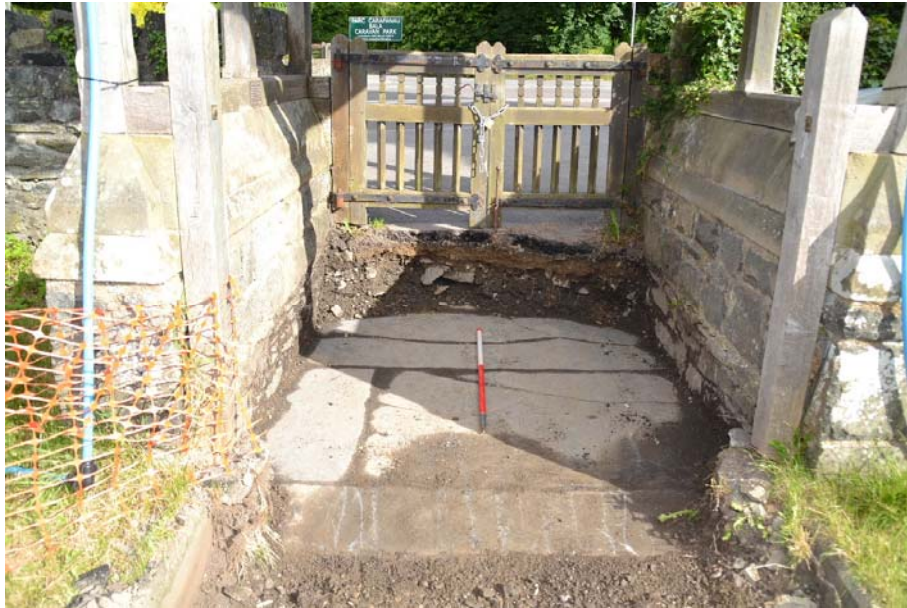
Fig. 20 Slate flag stone and beam footing of cemetery lychgate.
Photo CPAT 3881-0005.

- 3.27 The excavation of the service trench through the lychgate exposed an earlier footing and surface (55) which consisted of a rectangular stone, 600mm thick by 600mm wide and likely to be part of a foundation. In the centre of the lychgate was a slate flagstone surface less than 0.8m below the modern tarmac pathway. Removal of the slate flagstones revealed red sandy gravel used to create a level surface (part of (55)), and approximately 150mm below the slate footings lay the rough stone capping of an earlier culvert. The culvert beneath was 600mm deep with rough stone walls (of small stones less than 0.15m long) and a flagstone base. Up to 90% (in depth) of the culvert was filled up with a dark organic silty sand containing organic residues, small fragments of bone (not retained)

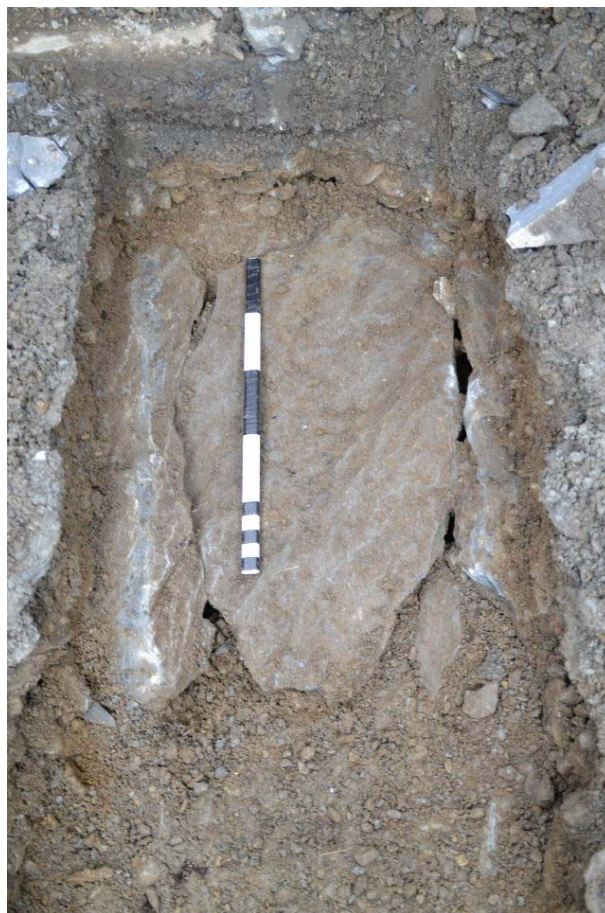
Fig. 21 Stone culvert capping (56) below the lychgate footing. Photo CPAT 3881-0008.

Fig. 22 Plan and section of the culvert (56) beneath the lychgate

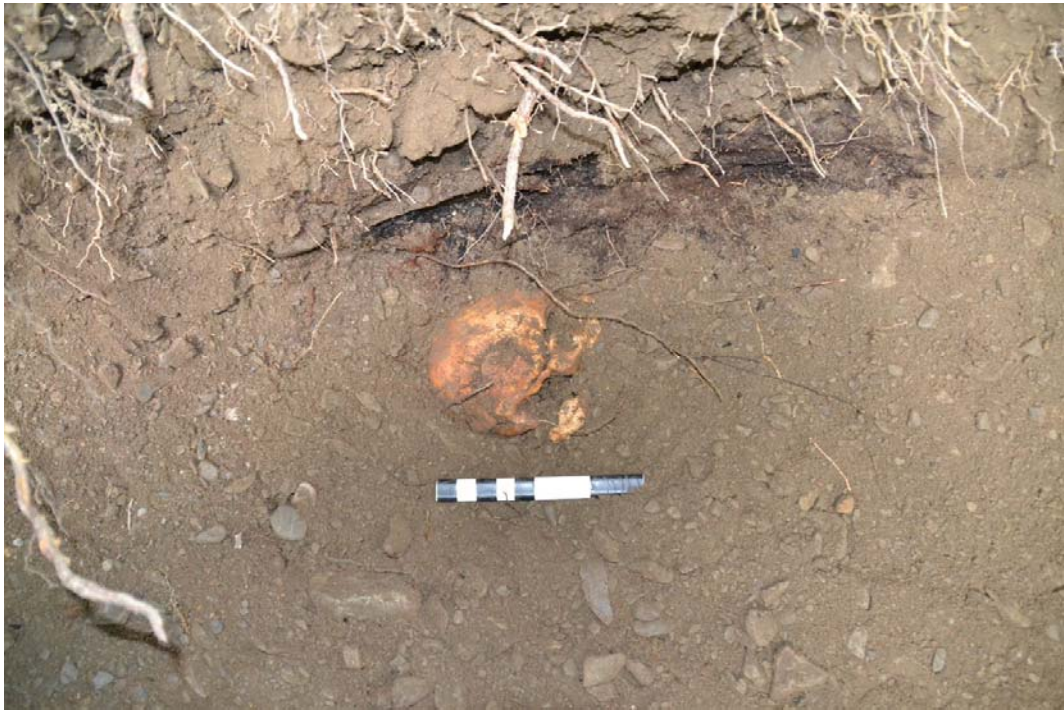
Fig. 23 West end of grave 63 with skull, wooden coffin remains and copper alloy plates.
Photo CPAT 3881-0022.

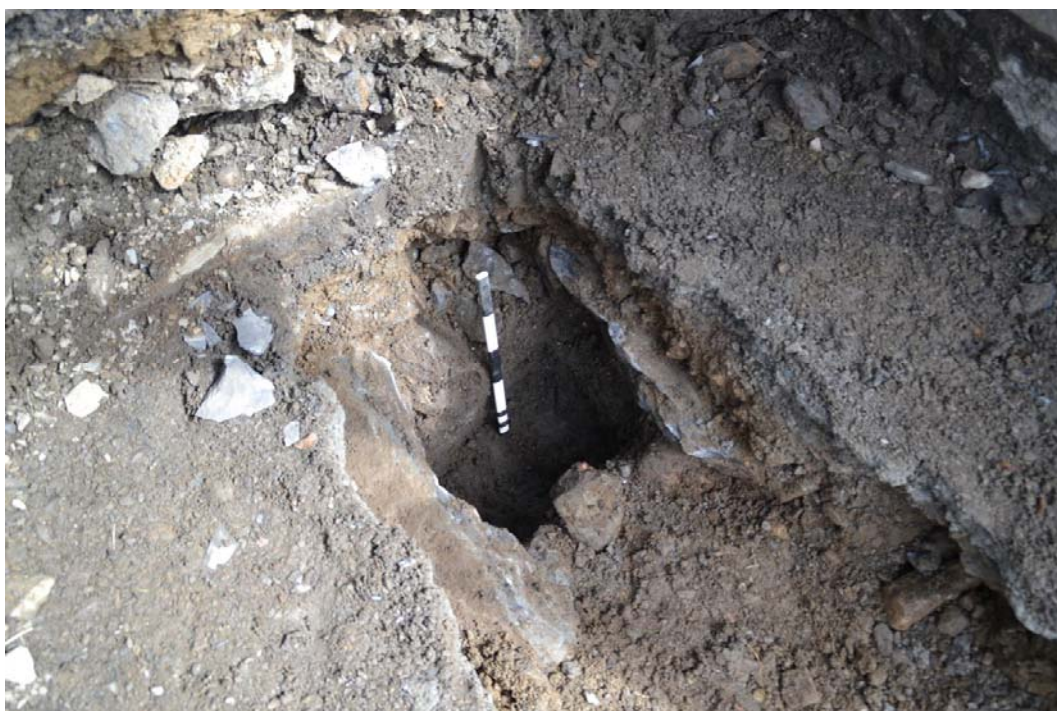
Fig. 26 Lime-bonded stone wall footing (64); the earlier line of the churchyard wall.
Photo CPAT 3880-0011.

- 3.31 At the point where the service trench crossed from the old cemetery into the modern cemetery, the footings (64) of what can be assumed to be the former boundary wall of the churchyard became visible at a depth of 200mm below the present surface. The wall appears to run below the present day pathway that now separates the old churchyard from the new cemetery, with the ancient yew trees just inside it. The wall itself was 800mm wide and consisted of large sub-angular stones bonded with a now degraded lime mortar, the makeup and dimensions of the footings matching that of the upstanding rough stone wall that forms the southern and western extent of the churchyard. The soils on the eastern side of the wall were a great contrast to the western soils within the churchyard; within what appeared to be a shallow, sloped cut for the wall, a spread of organic material, silt and orange clay had been deposited which contained fragments of modern glass, plastic and an early 1900s corked bottle.

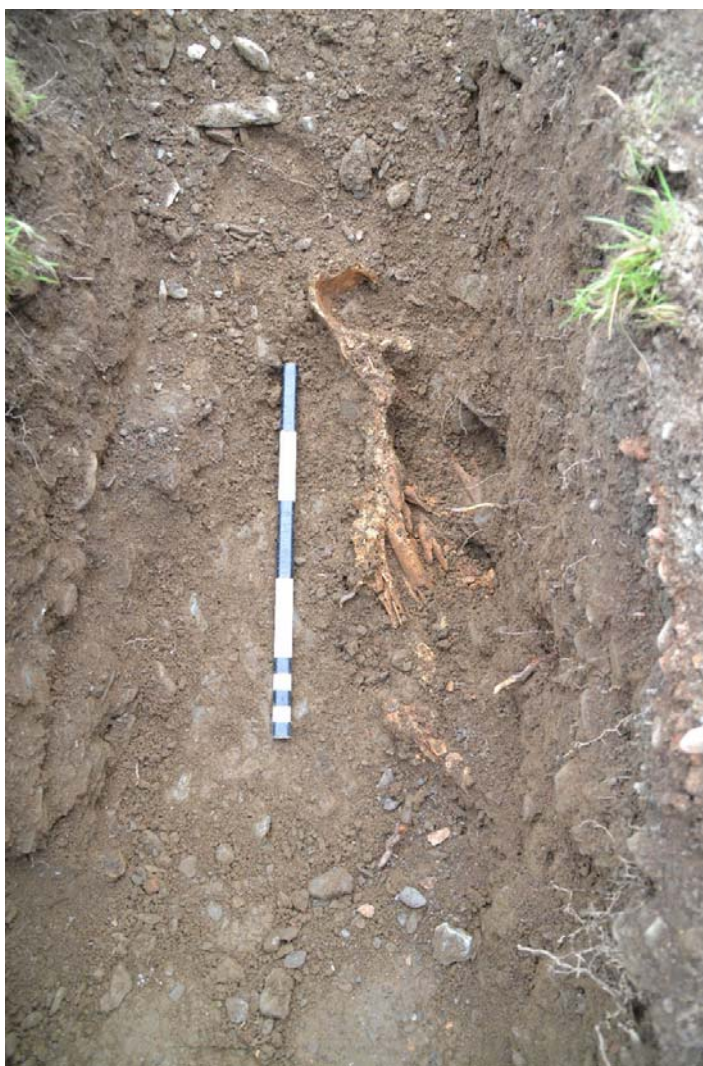
Fig. 27 Shallow grave with remains of child burial (65). Photo CPAT 3882-0008.

- 3.33 The excavation of the service trench running close to the north-west face of the church uncovered several graves and grave markers. The upper layer within the trench consisted of a fine orange gravel from a former pathway over typical churchyard soil which contained a scatter of disturbed human bone. Approximately 2.5m from the church wall and 6m east of the porch was a shallow grave, 450mm below the present surface. At first this seemed to be a jumble of bone in a pit, but further inspection revealed a probable child burial (65) lying in an unusual position, the body orientated east to west with the head to the east, and one leg lifted with the knee by its chest. Coffin nails were present and appeared to be *in situ* beside the burial. The identifiable bones consisted of the skull, two humeri, two femurs, a partially exposed pelvis, the degraded remains of the spinal column and a spread of long-bone fragments. The grave had been badly disturbed during the construction of the earlier pathway, which had displaced parts of the skull and the long bones. The bones appear to be those of an older child, possibly in the age range of 9-13. After excavation and recording was completed, the grave was carefully covered with geotextile sheeting and reburied with fine soil and chipboard planks to protect the exposed bone from the laying of pipes.

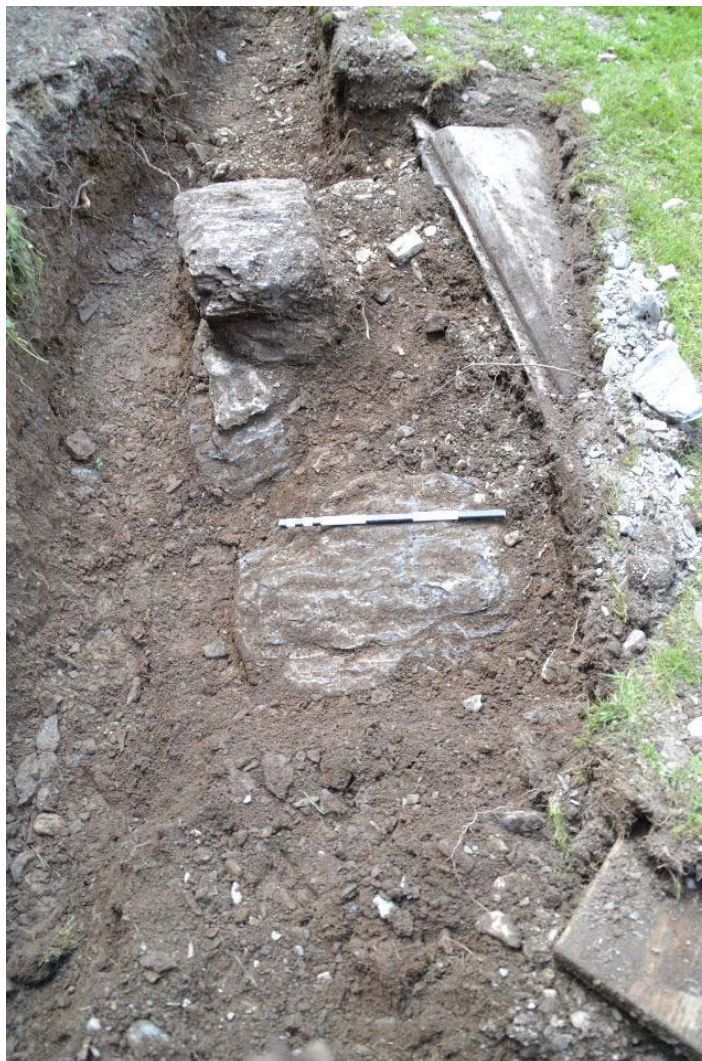
Fig.28 Buried elements of a chest tomb (67), near the north-east corner of the church building. Photo CPAT 3882-0012

- 3.35 No more than one metre from the north-east corner of the church, the remnants of a probable chest tomb (67) lay about 50mm below the present ground surface. What was probably the tomb's rectangular rubble footing was still *in situ*, but to the north its finely carved lid had been upturned to the side. Orientated east to west, the rubble stone base measured 1.6m in length and 650mm in width. The chest tomb was in close proximity to the main concentration of chest tombs in the churchyard which dated to the mid to late 1800s. The tomb's position was underneath the gravel pathway, but it can be no more than speculation that the tomb was flattened in order to allow a clear line for the pathway.

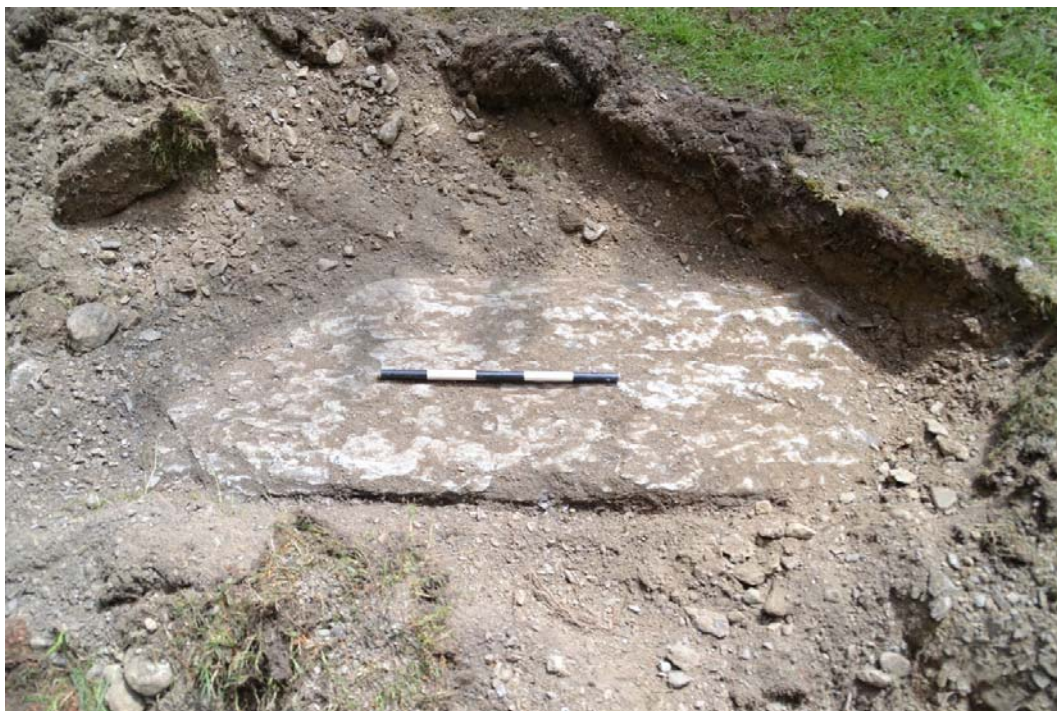
Fig.29 Buried stone slab (68), north east corner of church building.
Photo CPAT 3882-0019

- 3.36 Near the tree line to the east of the church an unmarked slab (68) was uncovered 300mm below the modern ground surface. A roughly dressed rectangular slab, it was orientated east to west. The slab measured 1.6m in length, 600mm in width and had a thickness of 100mm. There was no visible markings on either side of the stone. When lifted there was no visible grave cut below the slab, but the trench depth reached only 400mm. The grave marker, assuming this is what it was, lay close to some of the oldest marked graves in the churchyard, dating to the late 1700s.
