Watching Brief

WB1/05

Llanfair Old Barn,

Powys

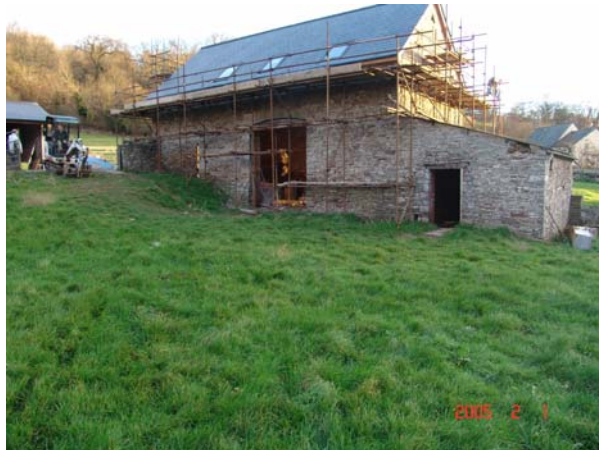
The barn itself which looks for the most part a 19th century build has some evidence of having re-used earlier architectural elements such as can be seen in (Plate 1) which shows the south windows in the background.

The second (Plate 1) shows the south end of the barn interior prior to levelling work. Again a great deal of building debris obscured the floor but it is possible to see the two edges of the raised ground connecting the east and west doorways.
