CPAT Report No 1216

Dolgarrog to Pentir Overhead Powerline, Gwynedd

Archaeological watching brief at tower AD27

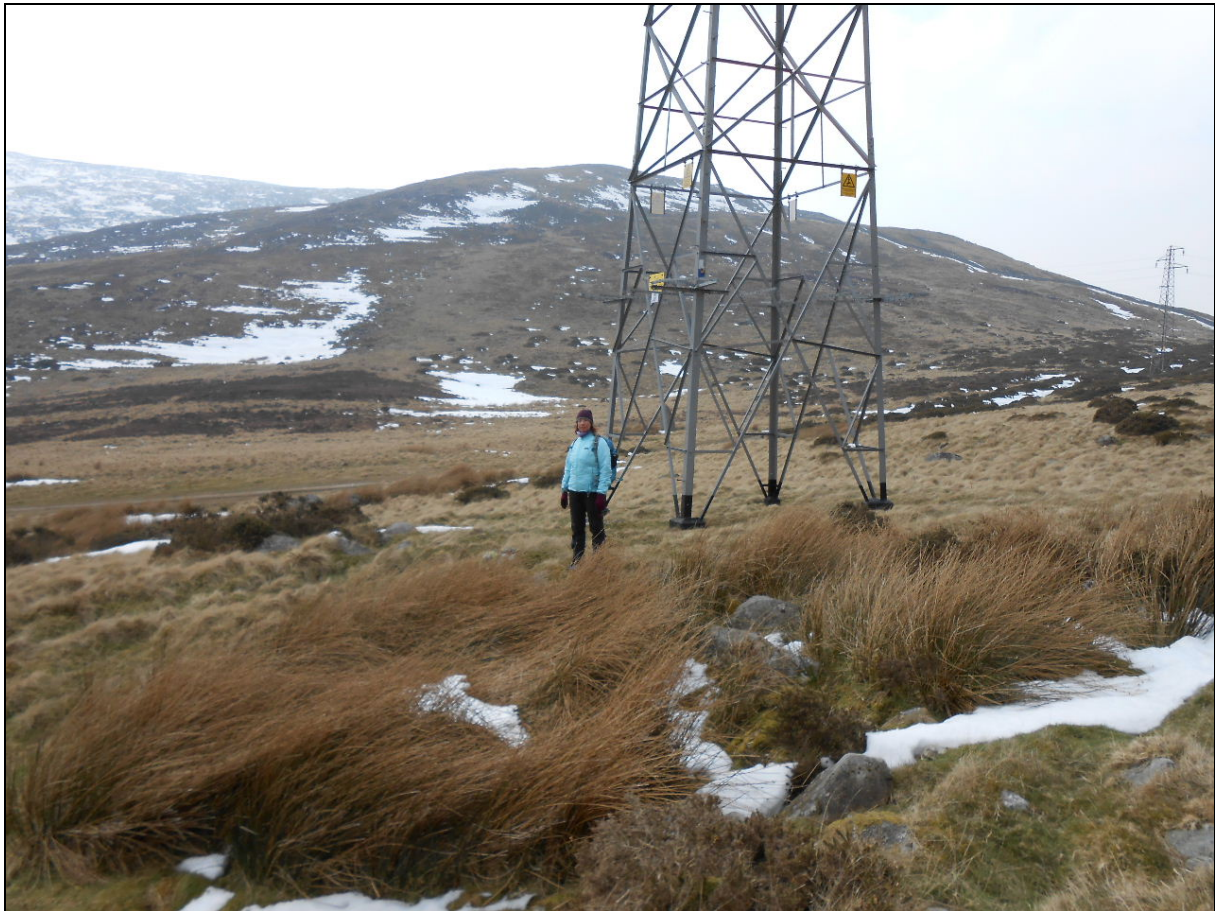
Fig. 2 Tower AD27 viewed from the north-east showing the curving line of boulders defining the enclosure (PRN 4702) on the eastern side of tower AD27

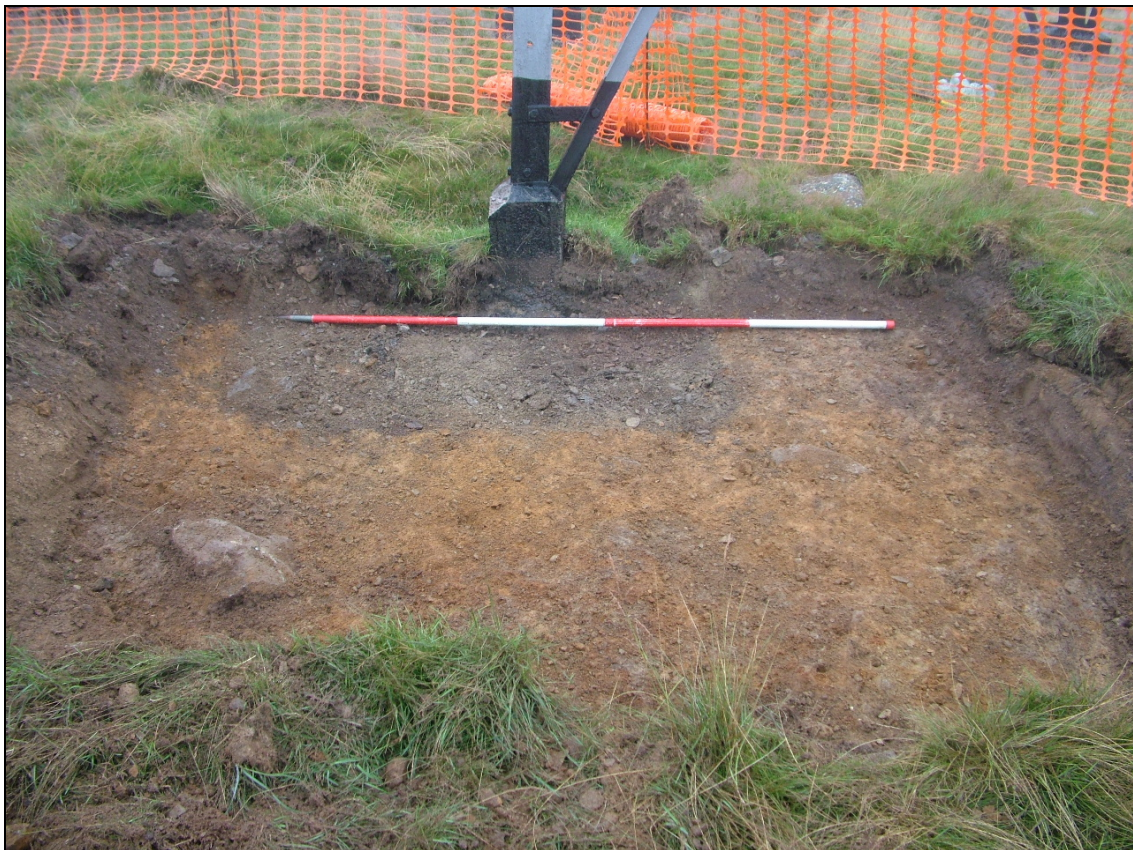
Fig. 3 View of the test excavation area with the west leg of tower AD27 behind; the backfill of the foundation excavation is clearly visible. Photo CPAT 3656-0025

- 2.4 Removal of the modern turf, including brown silty topsoil (1), up to 60mm thick, revealed a layer of redeposited natural subsoil, comprising orange and grey stony silt and some isolated patches of peat (2), up to 120mm in overall thickness, which was derived from the foundation pits at the time when the tower was erected. Layer 2 sealed a deposit of peat, a very dark grey layer (3), up to 70mm thick. The removal of layer 2 also exposed the extent of the tower foundation (6), cutting through the peat deposit and measuring 1.6m north-west/south-east by at

least 0.8m north-east/south-west; it was filled by material (7) which was of identical composition to layer 2. All of the above layers were removed by machine.

- 2.5 The removal of the peat deposit exposed a mid to light grey clay silt (4), up to 80mm in thickness, which was probably the natural subsoil. This layer was removed by hand down to an orange stony silt (5) to ascertain whether it contained any significant material, but no such material was observed. Observation of the test excavation revealed that the orange silt graded to grey stony silt with increasing depth.
- 2.6 No archaeological deposits, features or artefacts were observed during the watching brief.
