ARCHAEOLOGICAL

The Mill, Llandewi Skirrid

Watching brief

Planning Application No: DC/2010/00436.

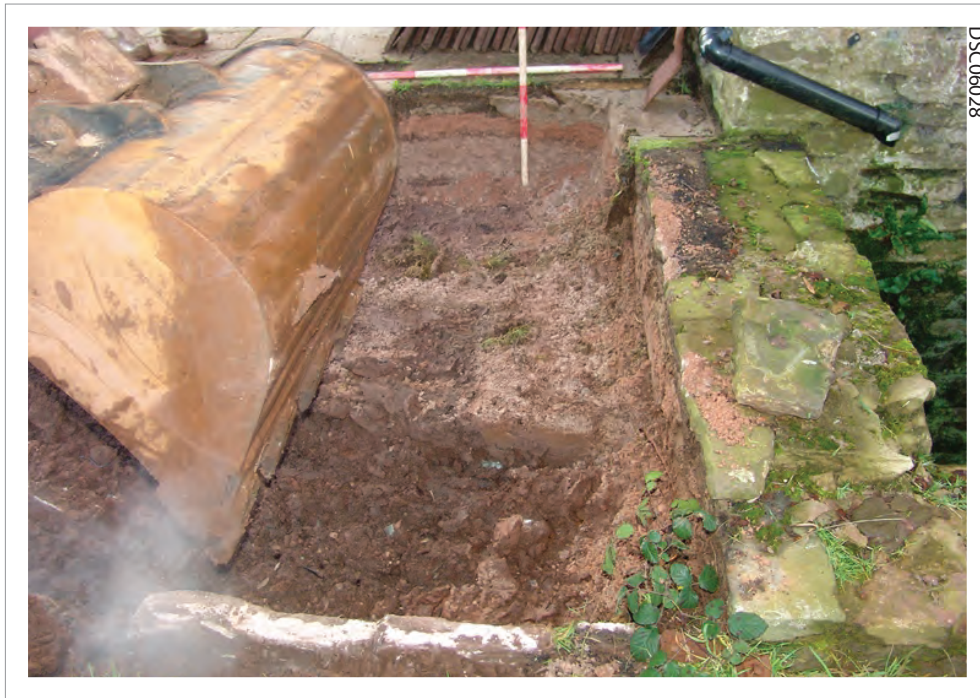
Plate 01: Removal of soil to east of wheel pit

The excavation was limited to the east edge of the wheel pit where after the patio slabs [100] were lifted, the digger's bucket cut through sand bedding [101] and gravel [102], Plate 01, before reaching a disturbed deposit of

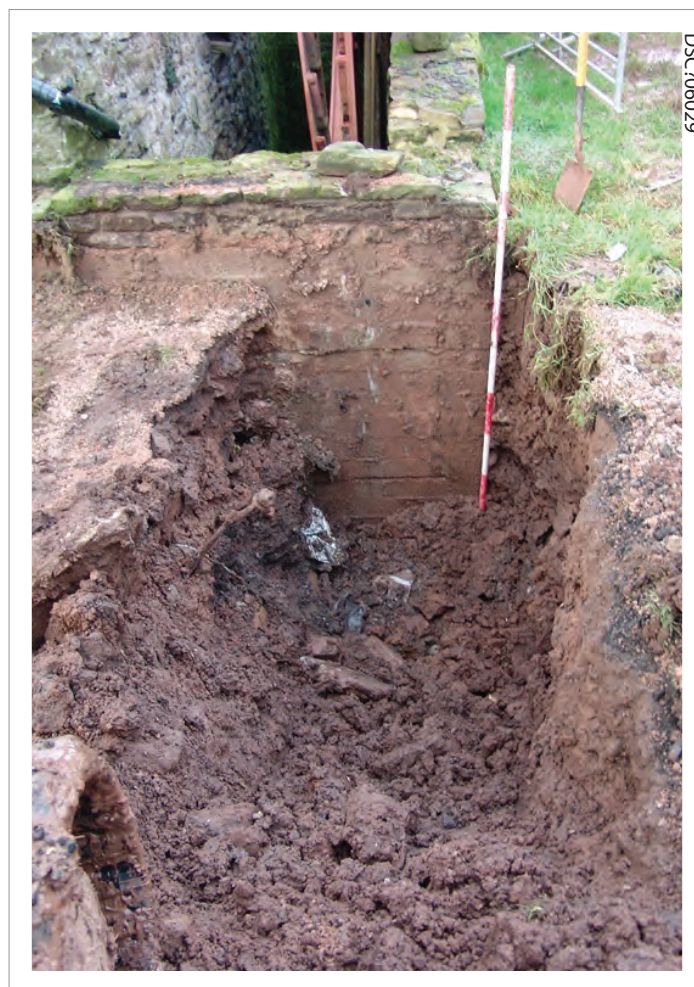
Plate 02: Removal of land for access to wheel pit

red sandy clay [103] with an assortment of landfill rubbish ranging from plastic bags to metal shopping baskets, Plate 02.

Obviously, the wall shown at the back of the Plate 02 is of the same date.

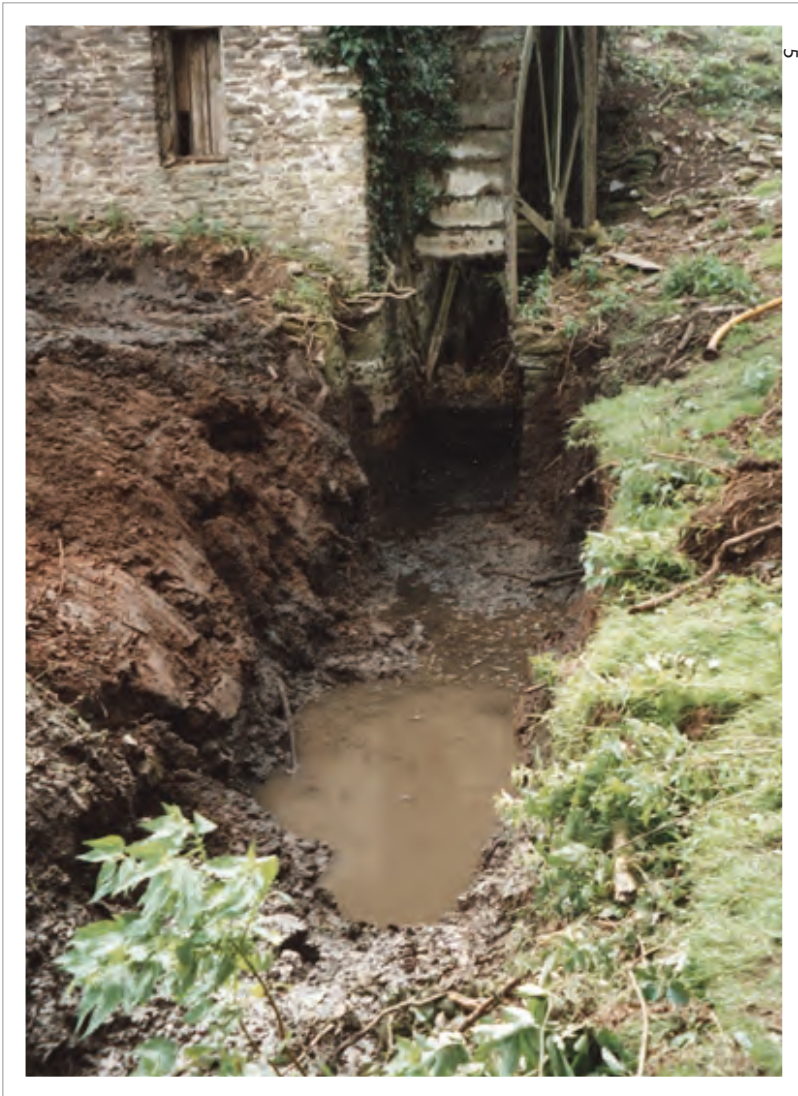
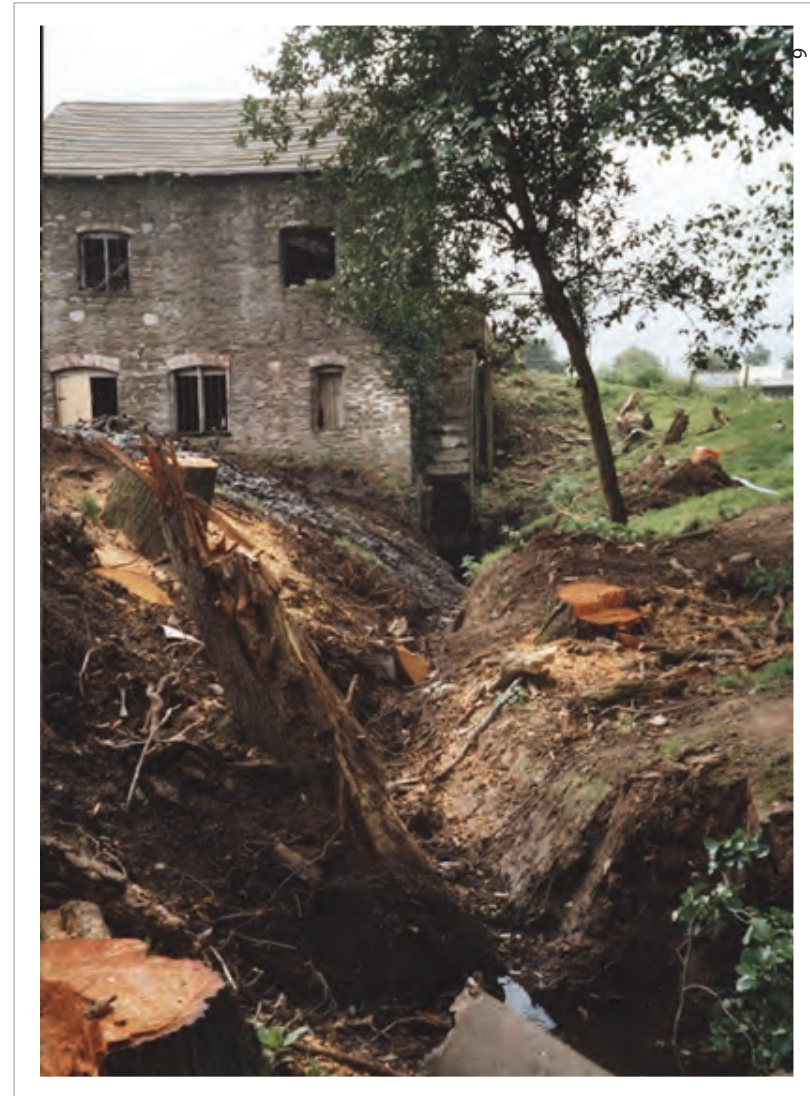
The landfill dates from the earlier work in 2002 by the present owner during consolidation work Plates 03 & 04 also included in the Building Survey: APAC Ltd DC/2010/00436.

Plate 03: Wheel race 2002

Plate 04: Wheel race 2002

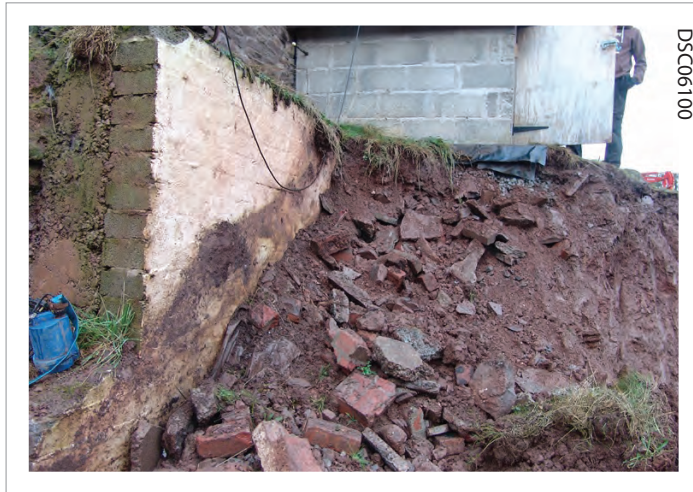
The pond was filled in during the later part of the 20th century and the bank against the west end of the mill was partially excavated during the 2002 in order to erect a retaining wall, Plates 05, 06 & 07).

The landfill [105] shown in the Plates 05, 06 & 07, was imported (*pers com*, Mr Jones), confirmed by the presence of various embossed bricks amongst the fill: PONTYPOOL BRICK CO, STAR NEWPORT, LITTLE MILL PONTYPOOL AND HOLT.

Plate 05: Detail of landfill

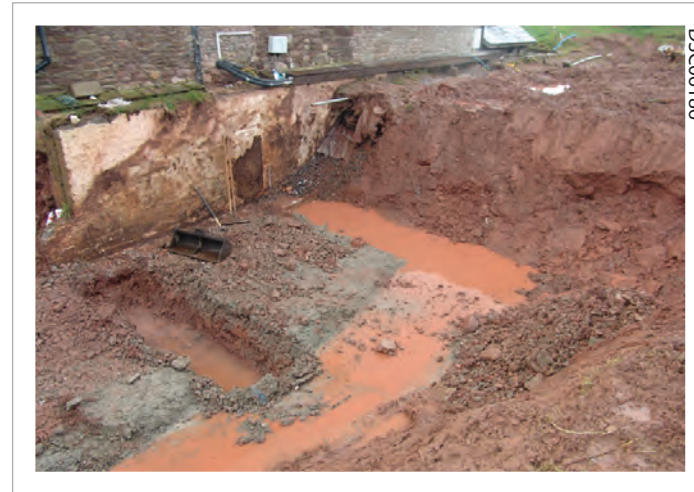
Plate 06: Overview of trenches 1,2 & 7 showing excavation to rear retaining wall, Fill evident top centre

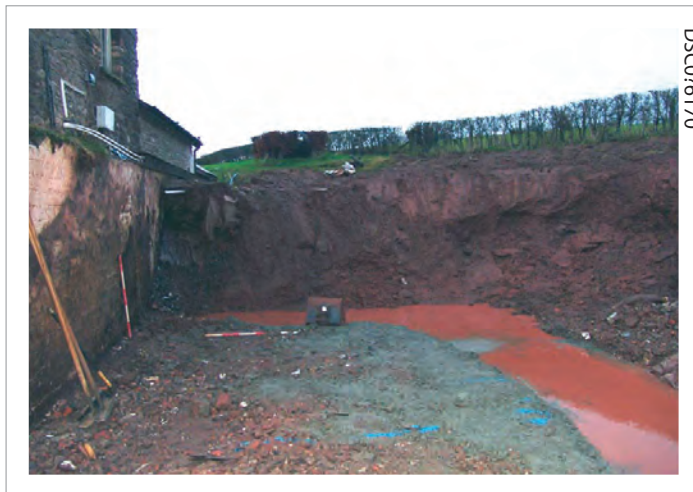
Plate 07: West retaining wall with footings 1 & 2

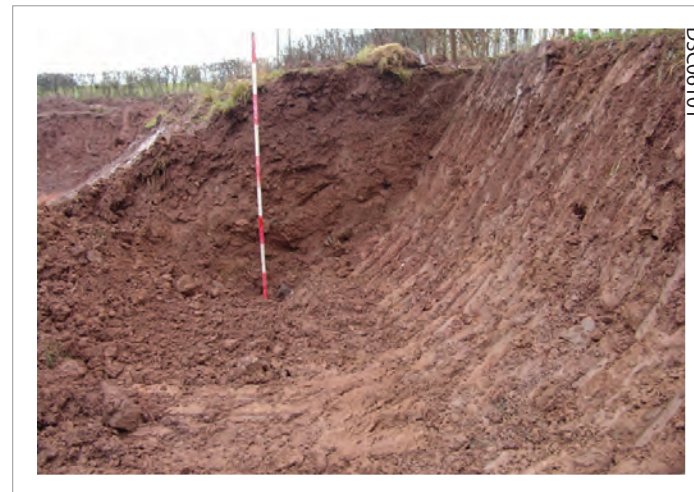
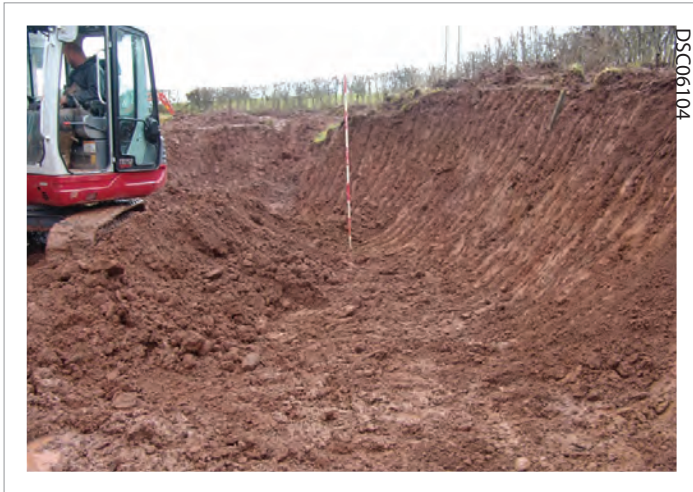
The undisturbed part of the bank had grass cover over a 160mm layer of orange/brown sandy soil [107] with occasional rounded stones Plate 08 & 09.

This overlay a 600mm layer of slightly darker sandy soil [108] with few stones before reaching, a more orange sandy clay with outcroppings of flat angular sandstone bedding [109].

Plate 08: Extent of bank removal

Plate 09: Extent of bank removal, final

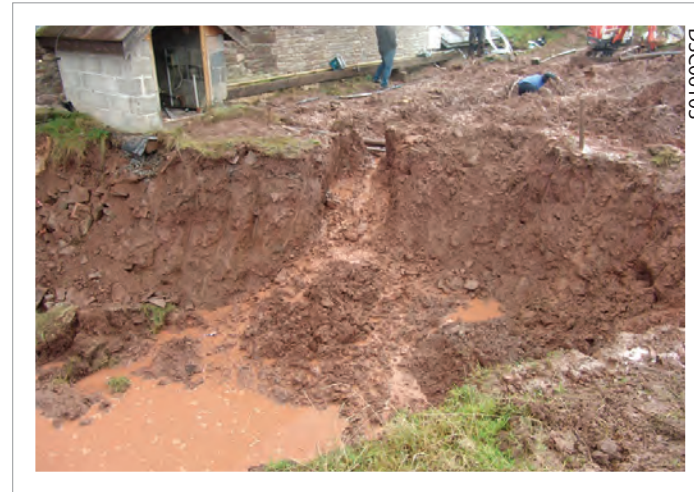
The excavation of trenches 1-5 was undertaken in increasingly worsening weather where there was a danger of the bank collapsing which rendered any in-depth recording hazardous, Plate 10.

Plate 10: Overview of bank removal

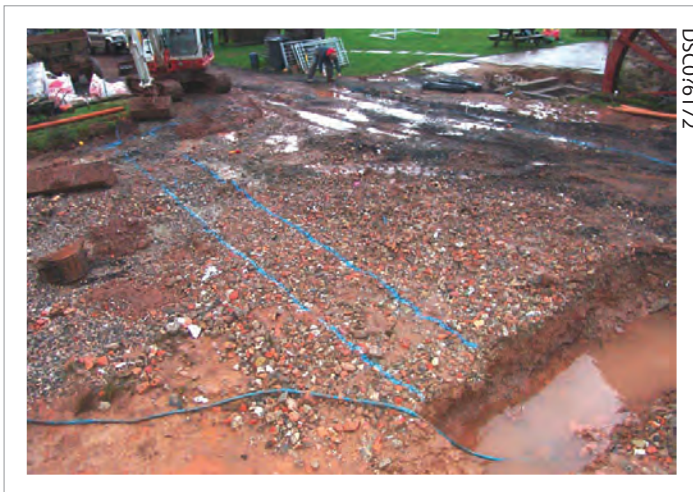
In order for the concrete to be poured, it was necessary to firm up the ground surface with imported crushed rubble, Plate 11, adding a new layer of deposit.

Plate 11: Trench 6 with 7 prepared

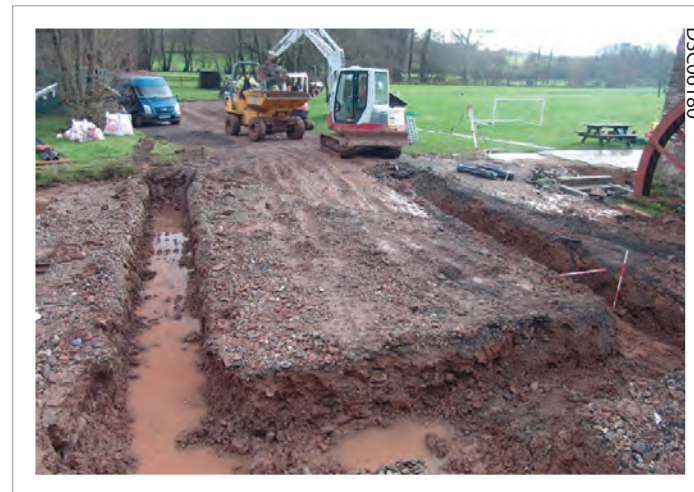
The final trenches 6 – 11 Plate 12, were dug in the order shown in fig 02, a sequence dictated by access for the mechanical digger.

All of the trenches had a fill consistent with [109] although the corner of trenches 6 & 8 reached a lower layer of orange clay/sand [110].

Plate 12: Overview of trench positions
6, 8 & 10
