CPAT Report No. 1450

Cadwgan Hall, Bersham

Heritage Impact Assessment

Client name: Dylan Roberts Cyf
 CPAT Project No: 2154
 Project Name: Cadwgan Hall, Bersham: Heritage Impact Assessment
 Grid Reference: SJ 2988 4875
 County/LPA: Wrexham
 CPAT Report No: 1450
 Event PRN: 140135
 Report status: Final
 Confidential: Yes

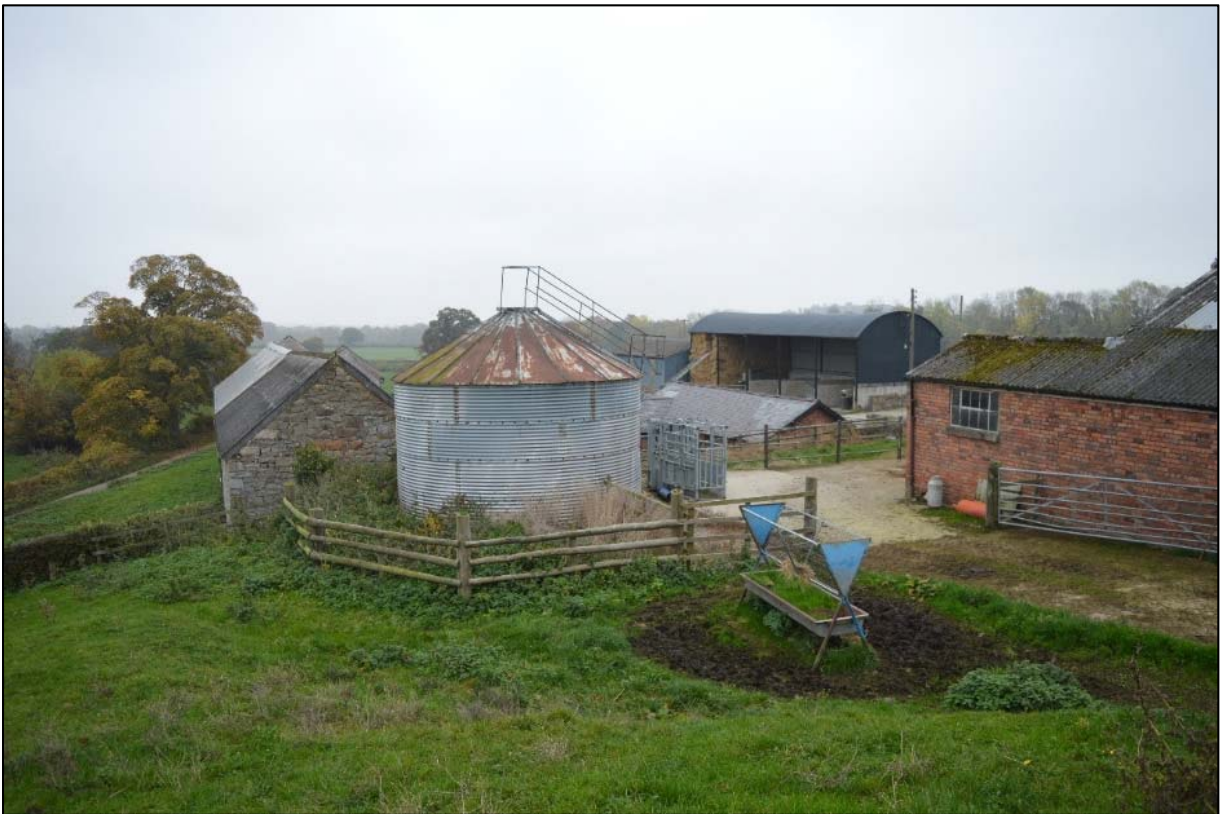
Cover photo: The feed silo located on the site of the proposed development, viewed from the top of the Cadwgan Hall Mound to its west (CPAT 4245-0007)

- 1.2. The site is currently occupied by a disused feed silo and it is proposed that this be demolished and its concrete foundation broken up and removed. The erection of the new building is expected to involve the excavation of the ground below the concrete foundation and the construction of a steel framed structure (see Fig. 2). The lower part of the walls will be of reinforced concrete, with the roof and upper part of the walls covered in profiled sheet metal.

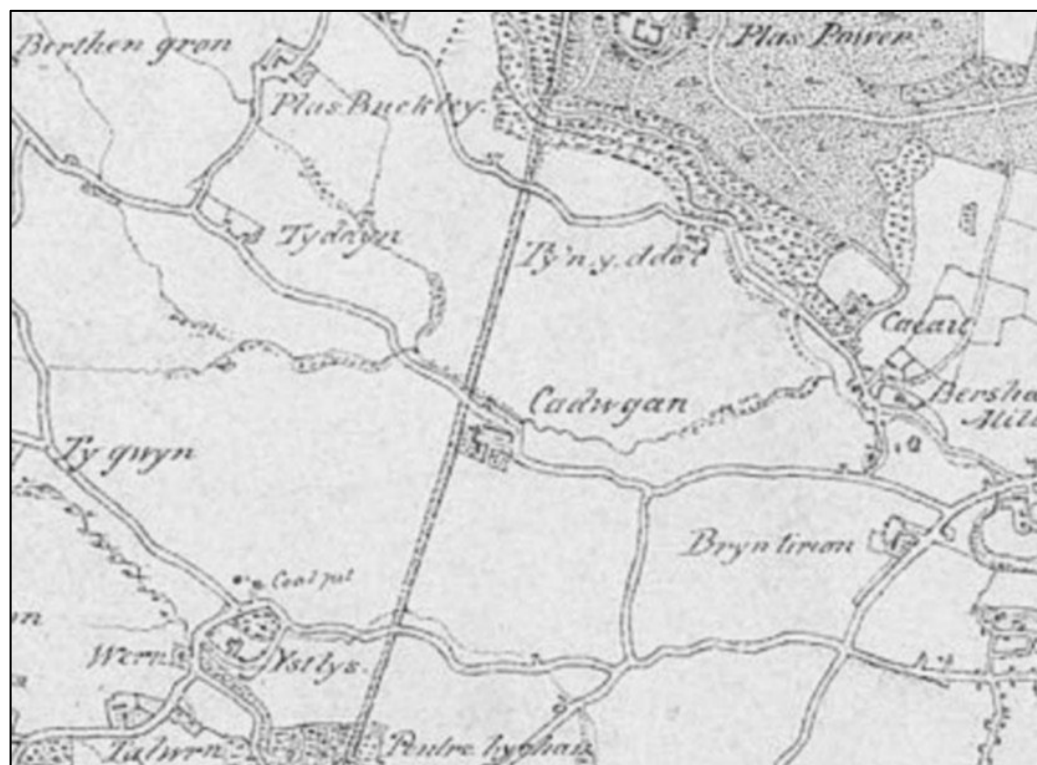
Fig. 3: Extract from the 1835 Ordnance Surveyors' Drawing (No 340g), showing the line of Offa's Dyke passing Cadwgan Hall

Apart from a small number of places where the dyke has been cut by later transport links, much of the dyke in this locality remains as an upstanding earthwork and its good condition has led to its designation as a scheduled ancient monument (SAM No DE132). The dyke was sufficiently distinct in 1835 to have been mapped by the Ordnance Survey and it is significant that it formed the boundary between two of the townships in the parish of Wrexham when the Tithe Survey was compiled in 1839.

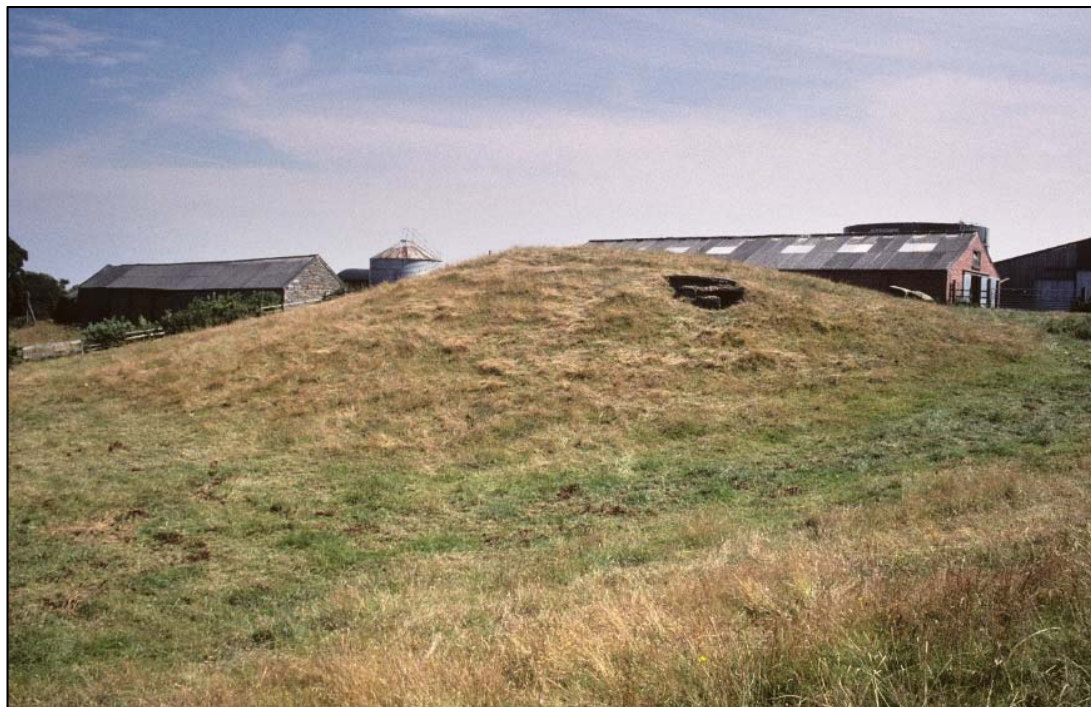
Fig. 5: Cadwgan Hall Mound (SAM DE 131), from the north-west. The remains of the air raid shelter set into the mound are also visible (CPAT CS99-034-0034)

- 4.3. Immediately to the east of the dyke at Cadwgan Hall is a large earthen mound (SAM DE131) which has been variously considered to represent a prehistoric round barrow, a mound associated with the dyke and a medieval motte. It was allegedly the site of an excavation in 1797 (<http://rhostyllen.info/historic%20buildings.html>), which revealed the skeleton of a large horse and four suits of armour complete with helmets. Current thinking tends towards a preference for this being a motte, and if so then it is significant that it lies in close proximity to Cadwgan Hall, which is known have been the site of a medieval dwelling. The mound was damaged by excavations for an air raid shelter in the Second World War; the entrance to this is blocked to prevent access by stock but the walls seem to have been made of stone with a corrugated iron roof capped with a concrete slab.

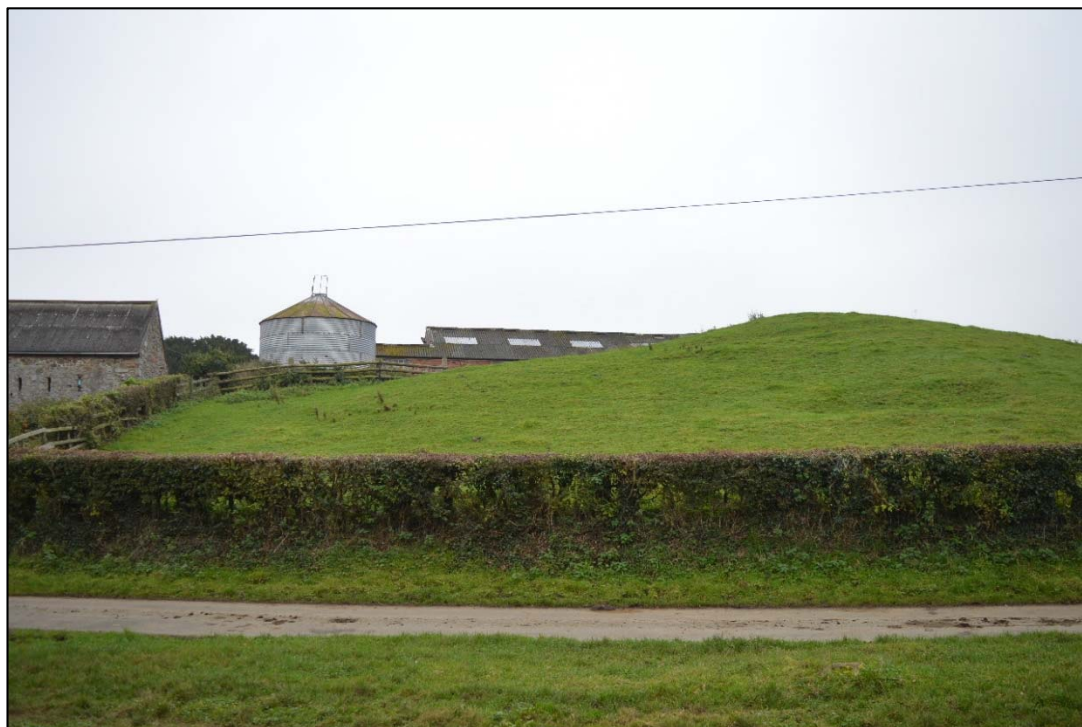
Fig. 8: The Cadwgan Hall Mound from the north, showing the existing feed silo (CPAT 4245-0015)

- 5.5. The mound is a prominent sub-circular earthwork lying immediately to the east of Offa's Dyke. The edge of the scheduled area abuts the proposed development on its west and north sides. A minor road passes to the north of the scheduled area in an

east/west direction and effectively provides the only location from which the site can be appreciated. The main views from it are to the north and west, over Offa's Dyke, and it is these areas which provide its setting; in contrast, the views to the east and south are dominated by the existing farm buildings at Cadwgan Hall which effectively shield it from view. Given that there is an existing metal feed silo on the site and this will be replaced by the implement store, which is believed to be of a similar height, it is not envisaged that the development will be significantly more intrusive on the views to and from the monument. The potential visual impact is therefore considered to be no more than **negligible** and its significance **slight**.

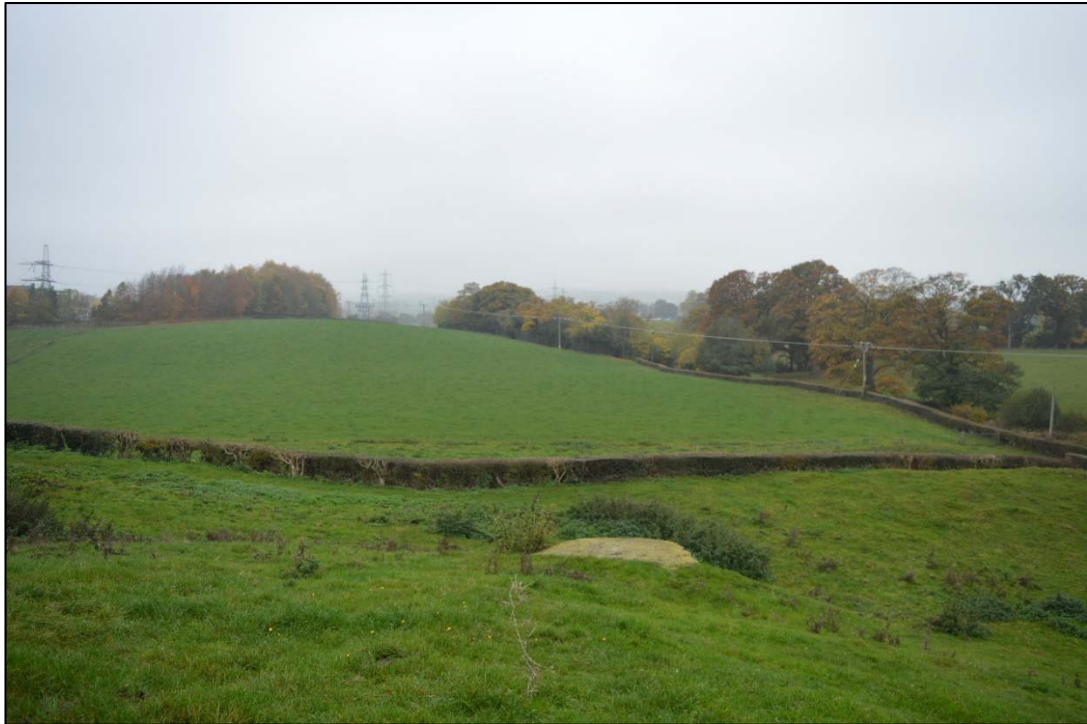
Fig. 9: The route of Offa's Dyke, shown by the hedge in the foreground, from the top of the Cadwgan Hall Mound to the south-east (CPAT 4245-0009)

- 5.6. The dyke runs on a north/south alignment immediately to the west of the farm and in this immediate locality a footpath follows its western side, while the scheduled area is separated from the proposed development by the area of SAM DE 131. There is little trace of a ditch, and it survives as an earthwork scarp facing west. The section of dyke adjacent to Cadwgan Hall is not particularly distinctive in comparison to the dyke as it continues north beyond the minor road and stream which cut it and pass the entrance to Cadwgan Hall. The dyke is probably best appreciated by members of the public from the footpath which follows it and the public road, although the best view is from the top of the Cadwgan Hall Mound, where its route north can be more readily appreciated. The views from the dyke are rather restricted by a combination of hedgerows and trees, although the buildings of Cadwgan Hall can be seen in the background of the view towards the Cadwgan Hall Mound. Again, given that there is an existing metal feed silo on the site and this will be replaced by the implement store, which is believed to be of a similar height, also that the dyke is partially masked

by the Cadwgan Hall Mound, it is not envisaged that the development will be significantly more intrusive on the views to and from the monument. The potential visual impact is therefore considered to be no more than **negligible** and its significance **slight**.

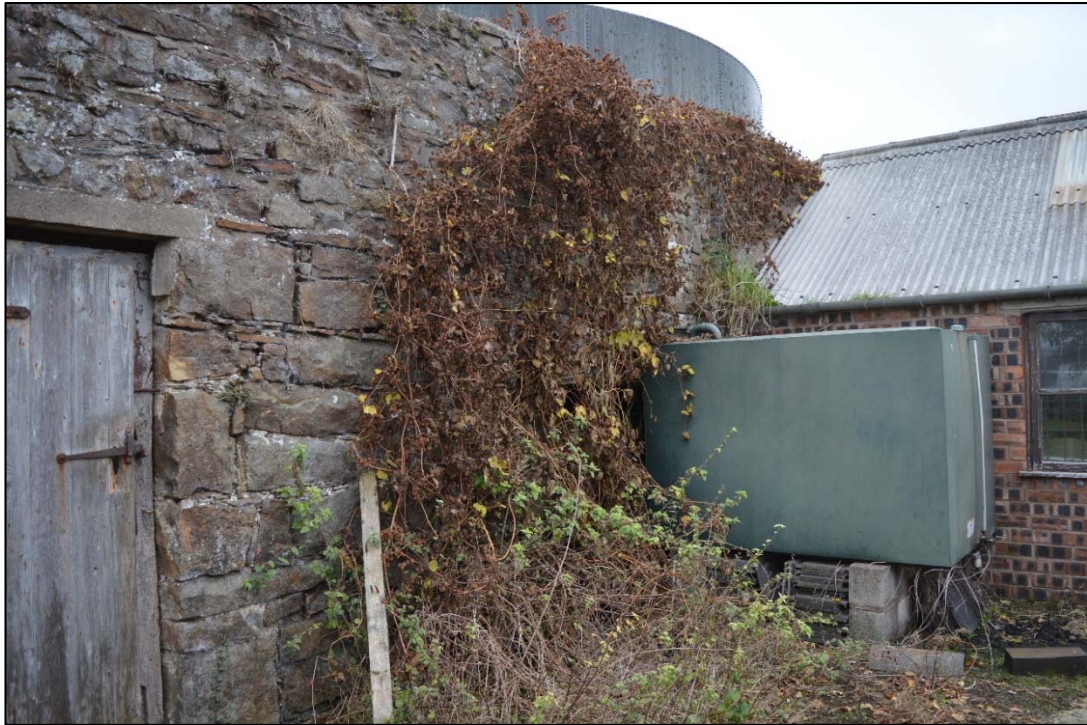
Fig. 10: The surviving section of wall belonging to the medieval Cadwgan Hall, from the south-east (CPAT 4245-0024)

- 5.7. The only surviving portion of the medieval building is a section of wall which is now largely hidden by farm buildings that have been built against and around it. It is not visible from the proposed development, owing to an intervening milking parlour, and the potential visual impact is therefore considered to be **no change** and its significance **neutral**.

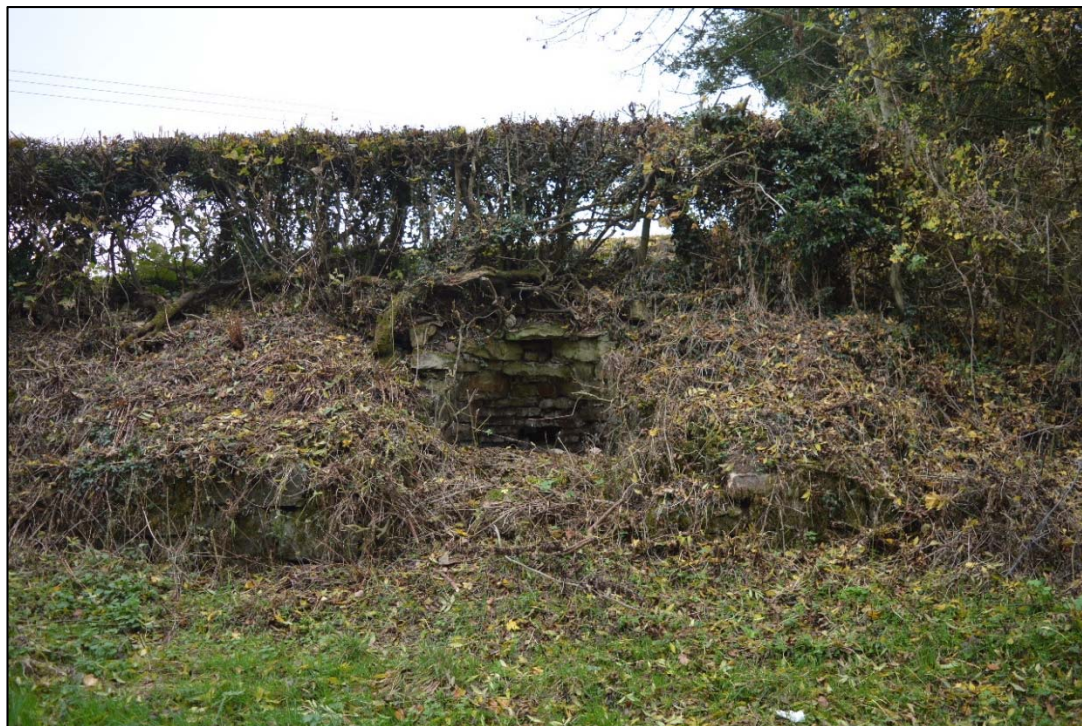
Fig. 11: The Cadwgan Hall limekiln, viewed from the road to its north (CPAT 4245-0013)

- 5.8. The lower portion of the limekiln survives along the southern side of the minor road that passes Cadwgan Hall but the only part that would have been originally visible when it was in operation has been levelled and forms part of the adjoining field, the surviving remains face away from Cadwgan Hall and are not visible from the development location. The potential visual impact is therefore considered to be **no change** and its significance **neutral**.

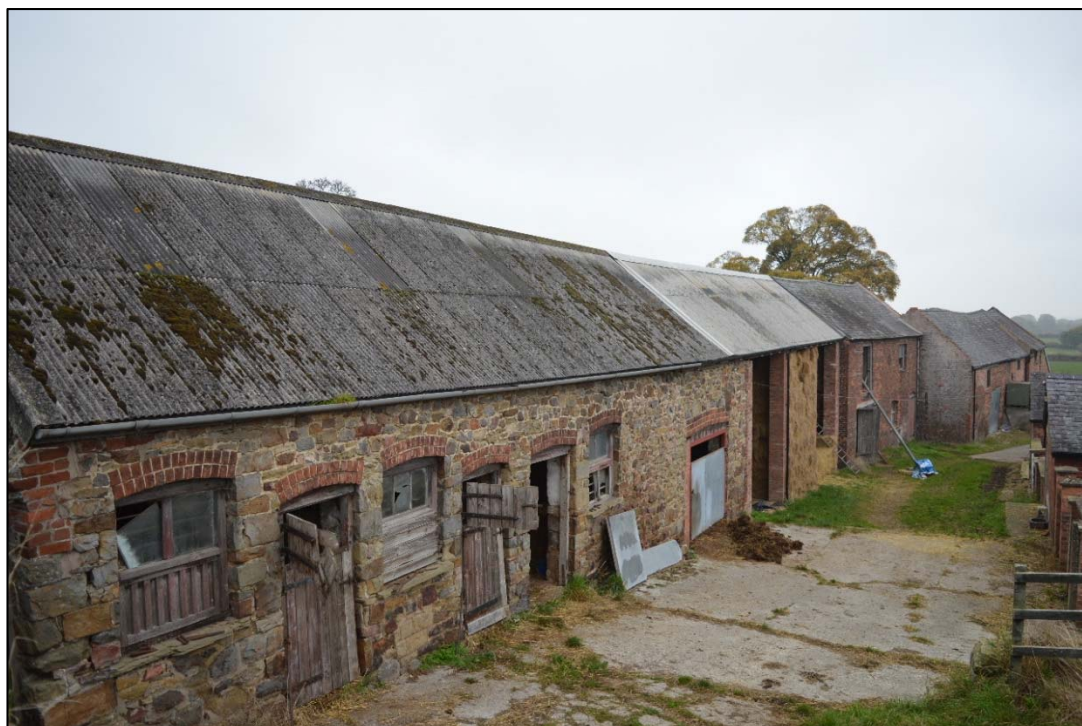
Fig. 12: The main historic range of farm buildings on the north side of the farmyard, from the west-south-west (CPAT 4245-0003)

- 5.11. While many of the farm buildings and particularly the farmhouse are relatively modern in date, some of those on the north side of the farmyard date from at least the early 18th century, and possibly earlier. The development plot itself was the site of a building, probably built in the first half of the 19th century but subsequently demolished. While the development and the farm buildings will clearly be intervisible, the fact that the development plot is currently occupied by a metal feed silo which is of markedly different character suggests that the new building is unlikely to be detrimental to the views from and to the historic buildings as they can currently be appreciated. The potential visual impact is therefore considered to be **no change** and its significance **neutral**.
