CPAT Report No. 1492

St Gwendoline's Church, Llyswen

Archaeological Watching Brief

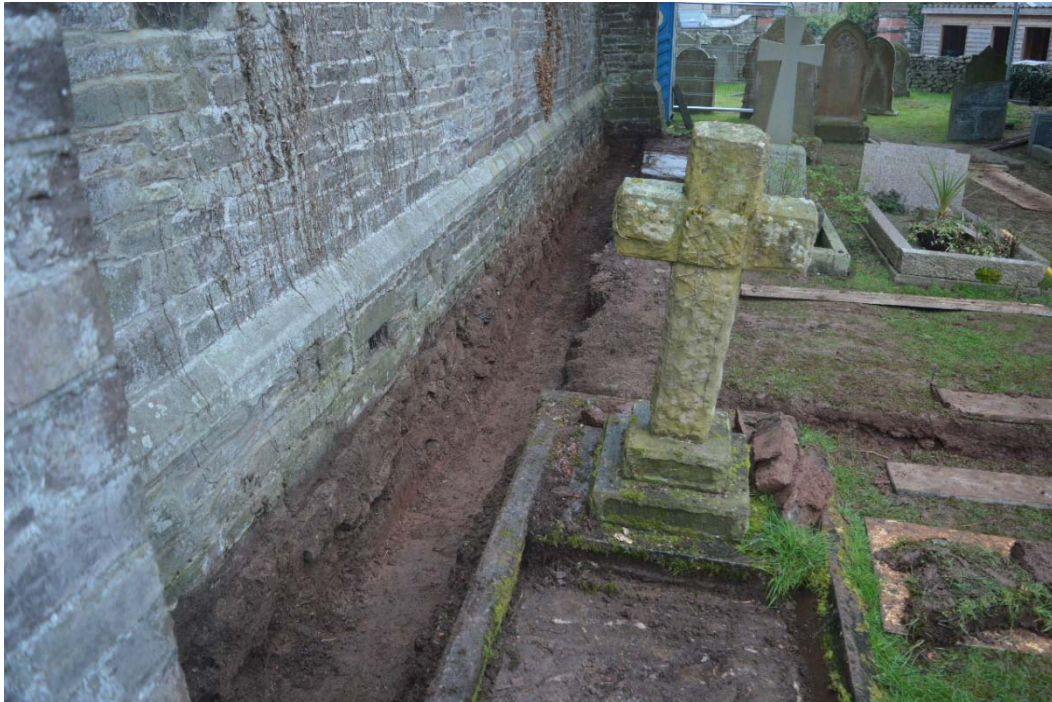
Fig. 3 Trench section along the north side of the nave CPAT 4308-0008

- 4.2. The topsoil (01) comprised a soft clayey silt, 0.12m thick, and overlying a moderately compacted reddish sandy silt (02) extending to a thickness of 0.65m. Three features were revealed cutting (02). The eastern ends of two graves (03 and 05), still visibly mounded, were exposed within the trench, although the maximum depth of excavation at this point was above the level at which the inhumations had been buried. At the north extent of Trench 1, a soakaway pit measuring approximately 1m × 1m was excavated to a depth of 1m, disturbing a charnel pit (07). Natural soils were attained at the base of the soakaway.

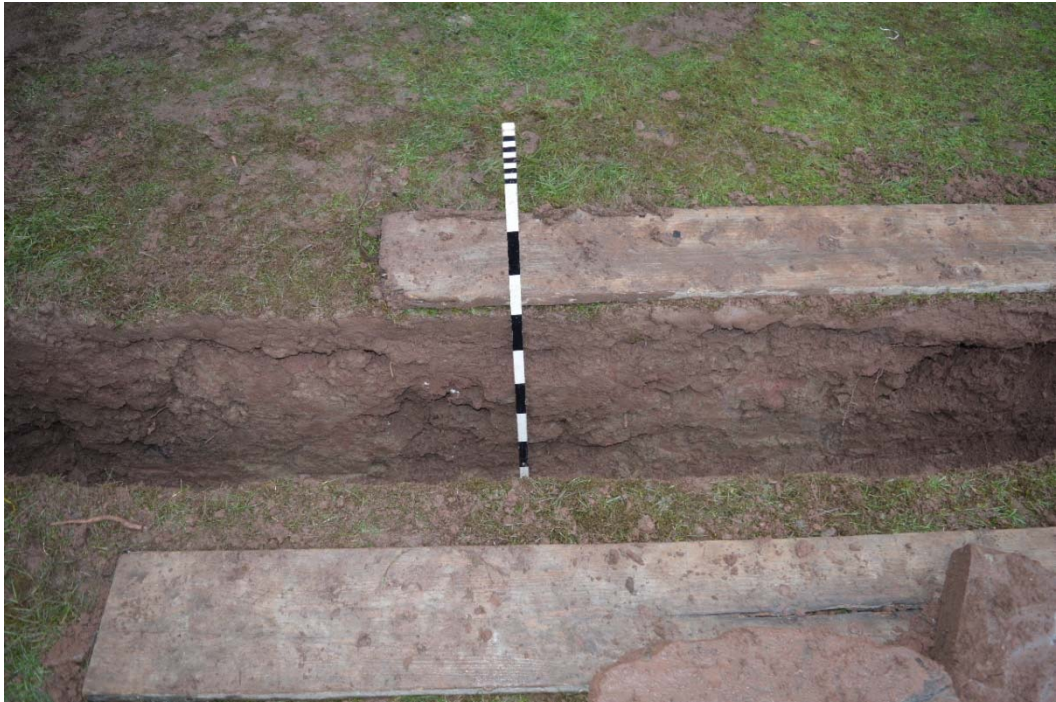
Fig. 4 Grave cuts [05] and [07] in section. Photo CPAT 4308-0004

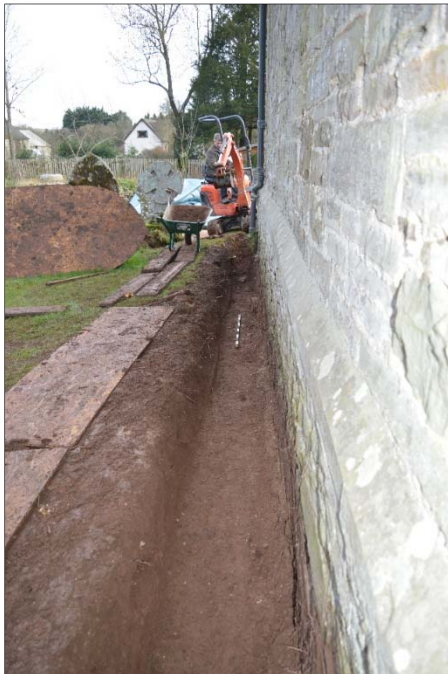
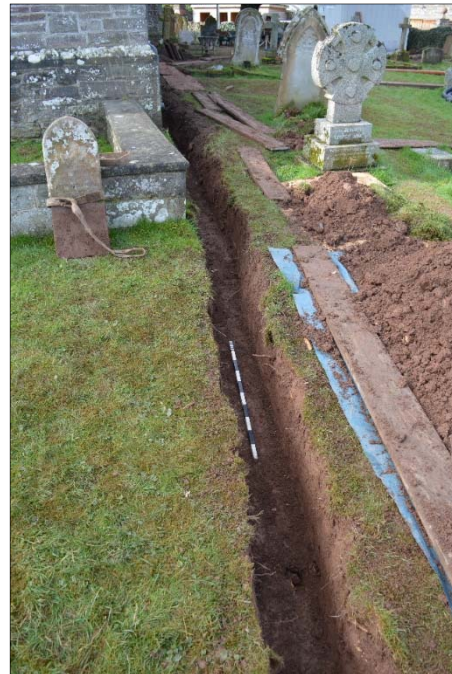
Fig. 5 Trench 2 from the west CPAT 4308-0017 Fig. 6 Trench 2 from the east CPAT 4308-0018

- 4.4. The topsoil (09) was a continuation of that in Trench 1 (01). Underlying this was a red sandy silt (010), a continuation of (02), containing large amounts of building rubble, possibly from the 1860s church restoration, and large quantities of charnel. A modern

drain (011) truncated the north side of the trench. The soakaway pit, excavated on the east wall disturbed a large pit (13), backfilled with stone rubble (014), probably a having resulted from the removal of a tree.
