St. Deiniol's Church, Church Lane, Hawarden, Flintshire CH5 3LT.

July 2018
V 1.0

Archaeological Watching Brief
Project Code: A0146.1
Report no. 0173

Archaeological Watching Brief

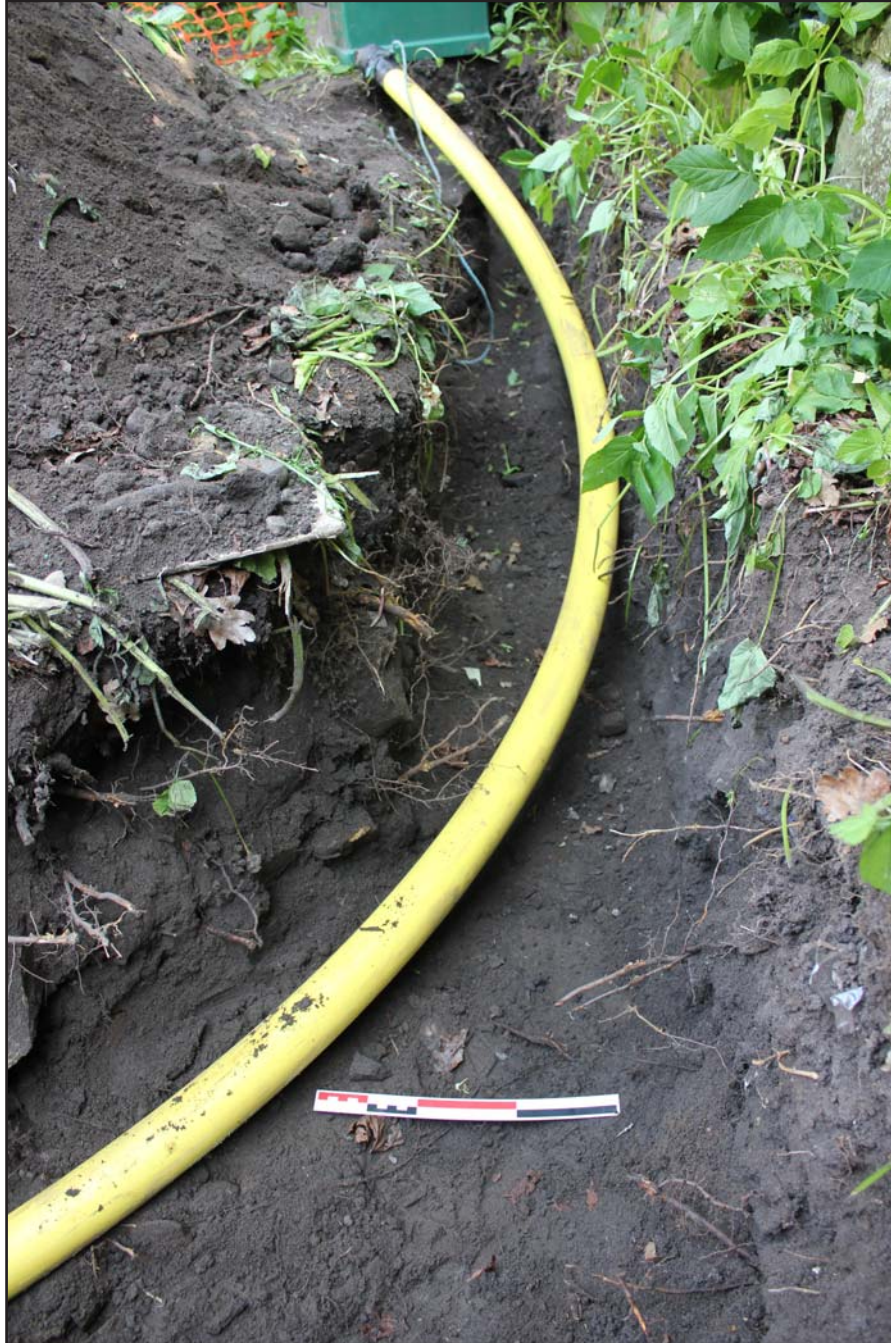
Plate 01: Trench A (east-west section) post excavation, from the west. Scale 0.3m.

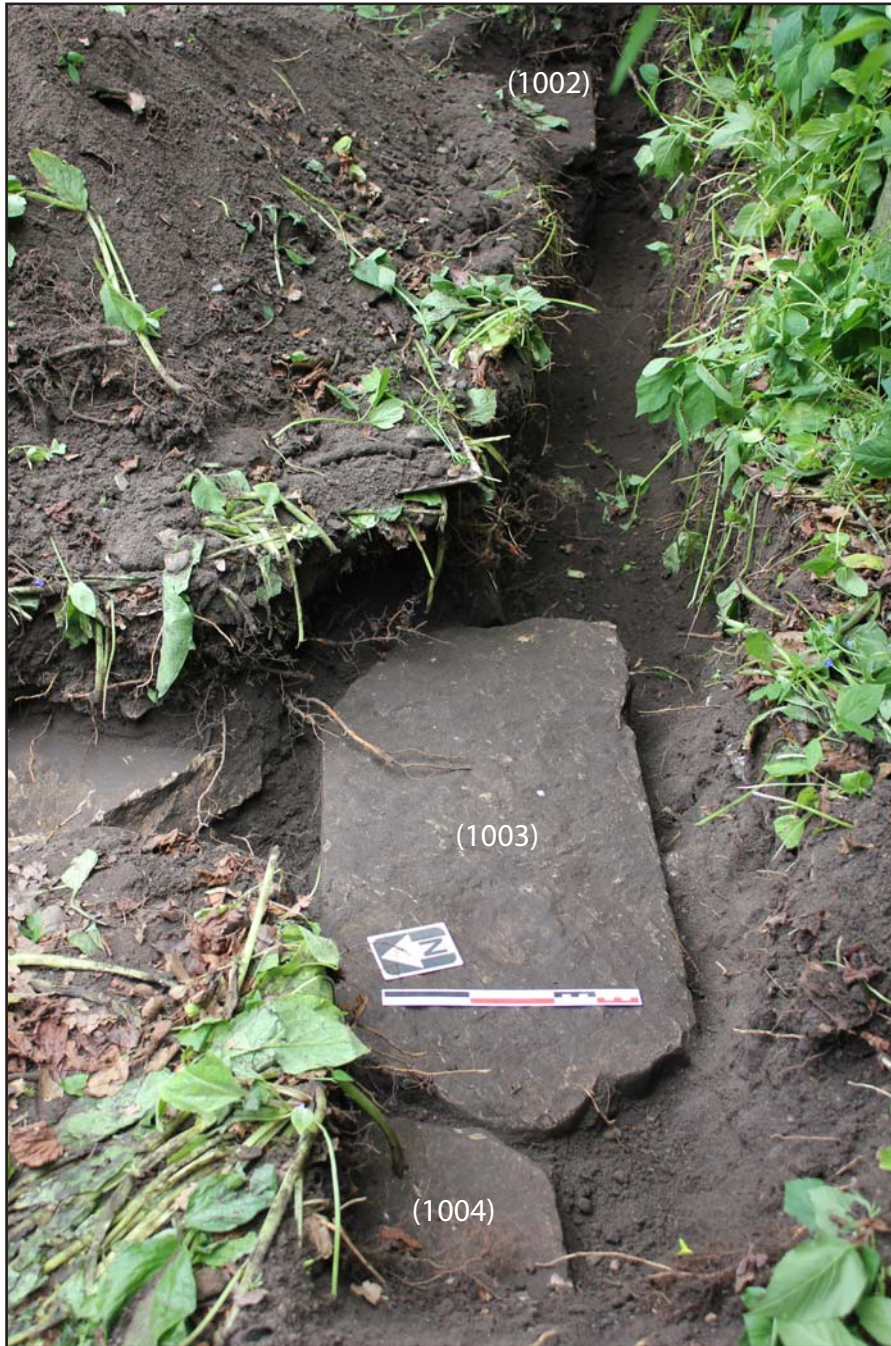
Plate 02: Trench A (east-west section) showing grave markers (1002) (1003) and (1004), from the west. Scale 0.3m.

At the southern end of the scheme within trench A three relocated grave-markers (1002) (1003) (1004) were found laid flat against the southern boundary wall. Two of these required moving and their inscriptions were recorded. The third was only partially visible and was retained in-situ. Further to the north in trench A an in-situ upright grave-marker stub (1005) was found which was removed and recorded. Further to the north again the edge of a sandstone vault (1006) was uncovered as well as the edge of a red-brick vault (1007), both of which were recorded and retained in-situ.

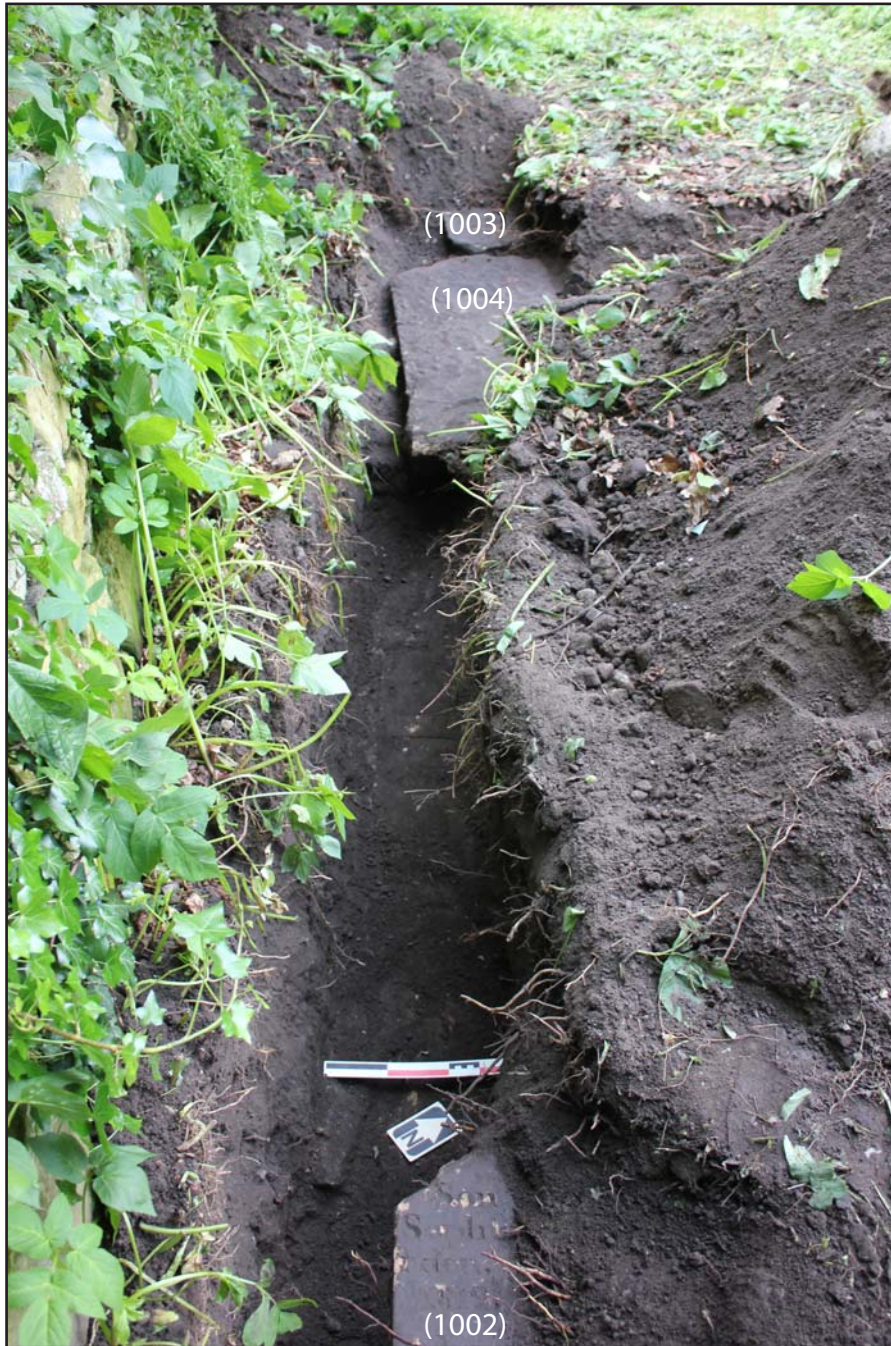
Plate 03: Trench A (east-west section) showing grave markers (1002) (1003) and (1004), from the east. Scale 0.3m.

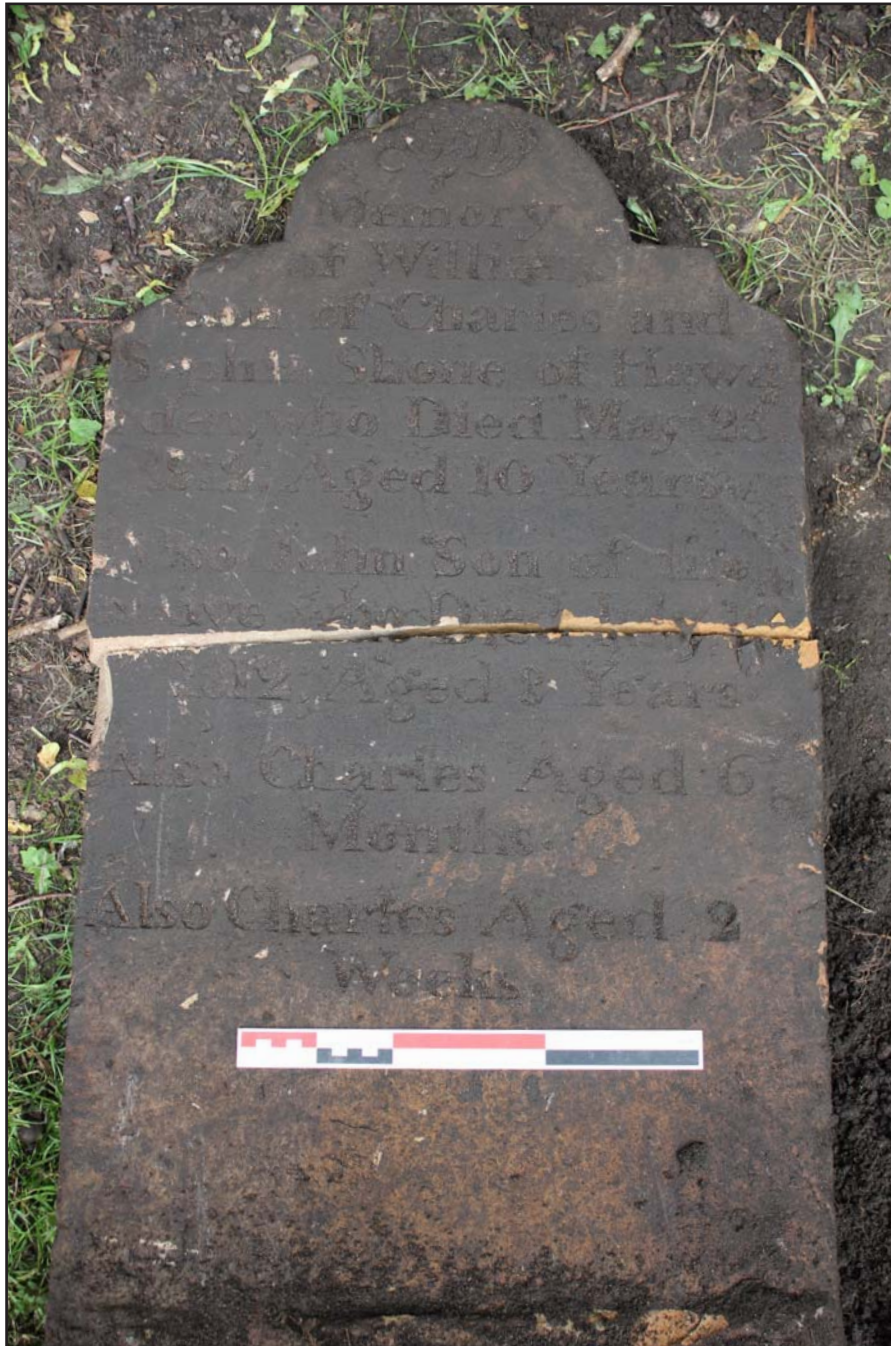
At the eastern end of trench 1 and partially beneath the new gas meter box, a flat sandstone grave marker (1002) (plate 04) was uncovered at 0.2m below ground level (BGL) (75.37m OD). This marker measured 0.82m in length by 0.5m in width by 0.05m in depth, orientated east to west, with rounded shoulders and top at the west end. Due to the location of the grave marker within trench A it required lifting so that the new gas pipe could be laid, and as such its upward face was found to carry the following inscription:

Plate 04: Grave marker (1002) recovered from trench A (east-west section). Scale 0.3m.

Grave marker (1002) is likely to have been relocated from elsewhere within the churchyard and laid flat within the position it was found and against the outer churchyard wall. Upon conclusion of the works the marker was relocated close to where it was found, and placed upright against the churchyard boundary wall.

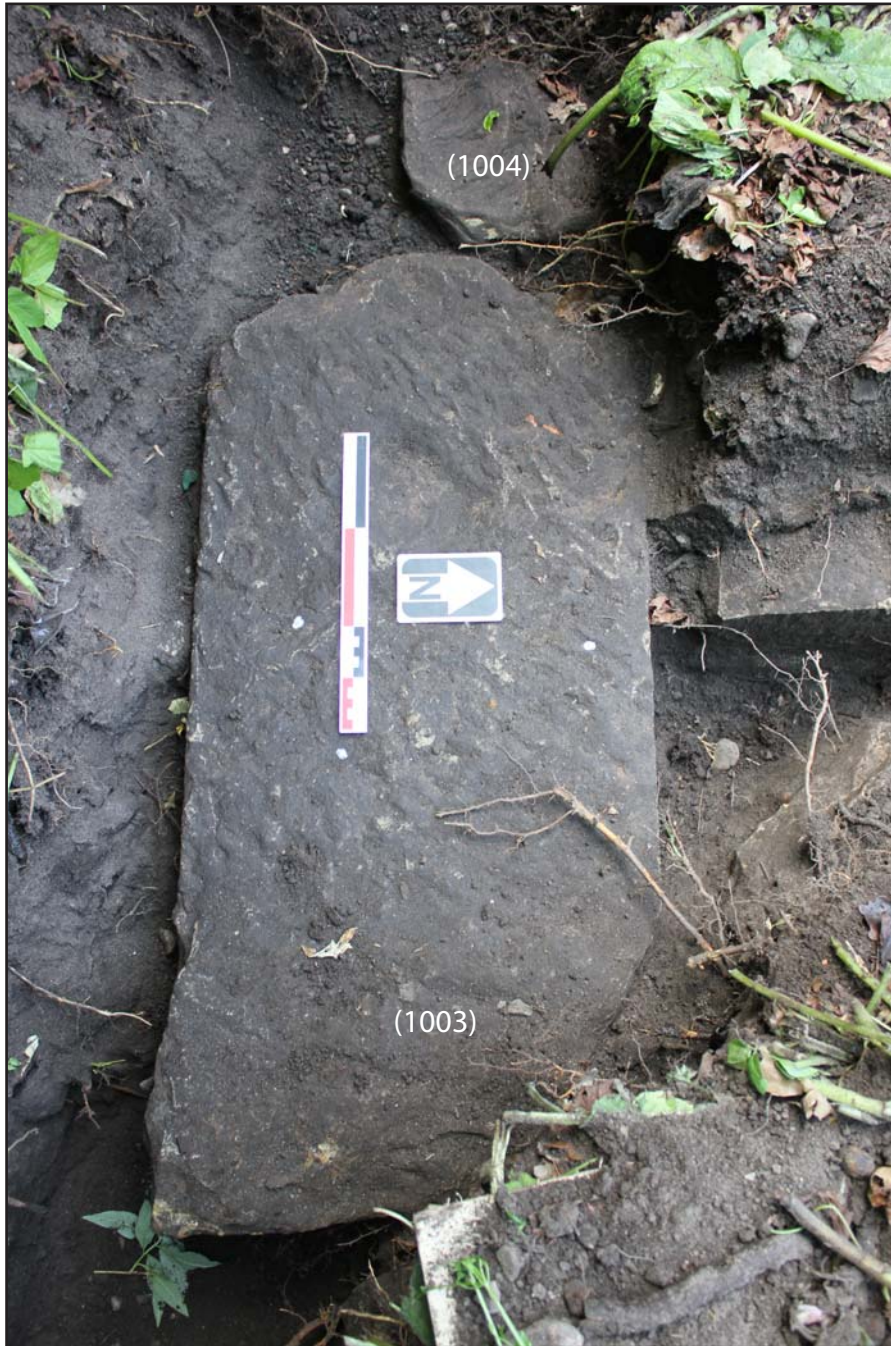
Plate 05: Trench A (east-west section) showing grave markers (1003) and (1004), from the east.
Scale 0.3m.

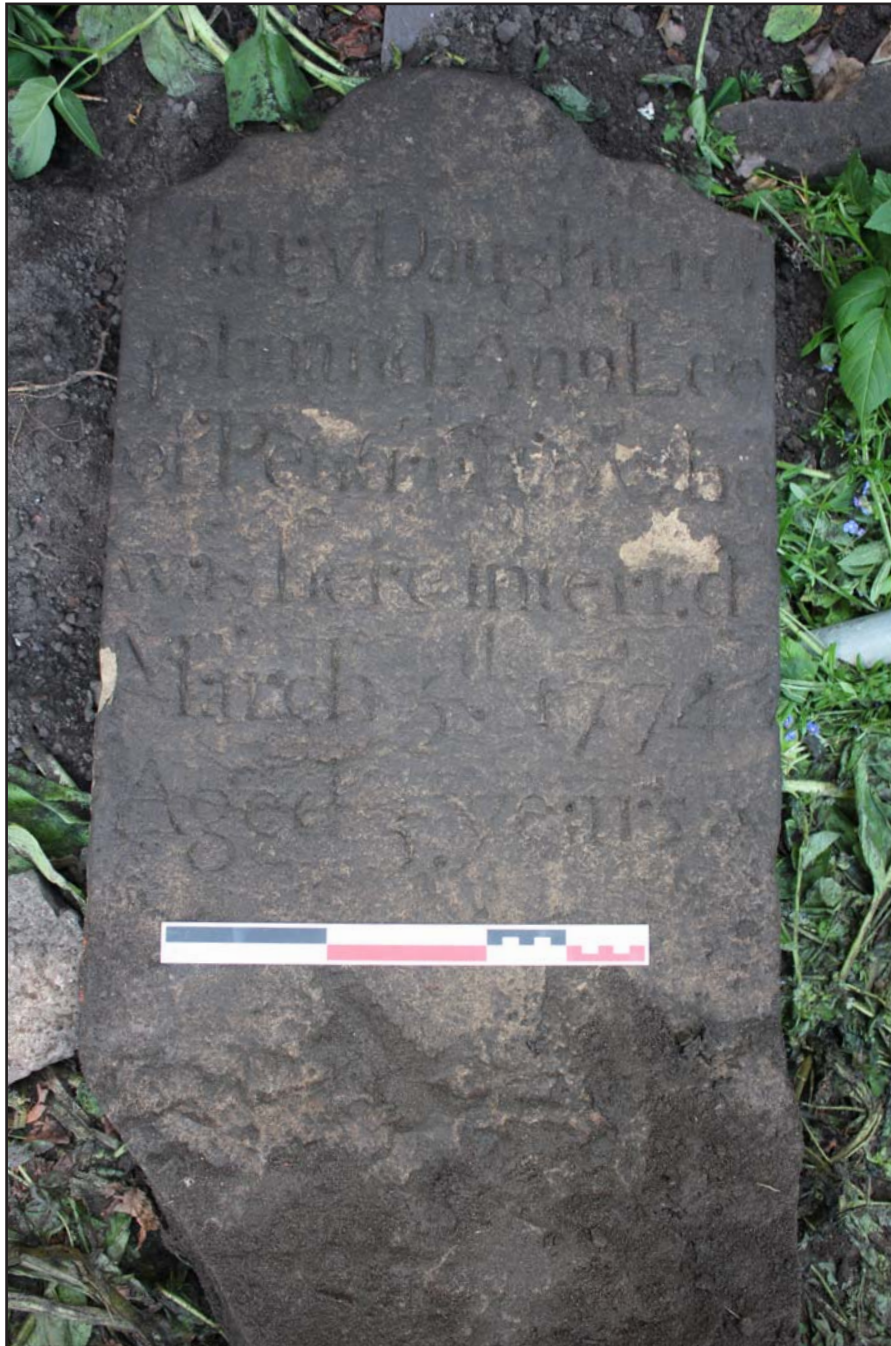
Plate 06: Grave marker (1003) recovered from trench A (east-west section). Scale 0.3m.

Grave marker (1003) is likely to have been relocated from elsewhere within the churchyard and laid flat within the position it was found and against the outer churchyard wall. Upon conclusion of the works the marker was relocated close to where it was found, and placed upright against the churchyard boundary wall.

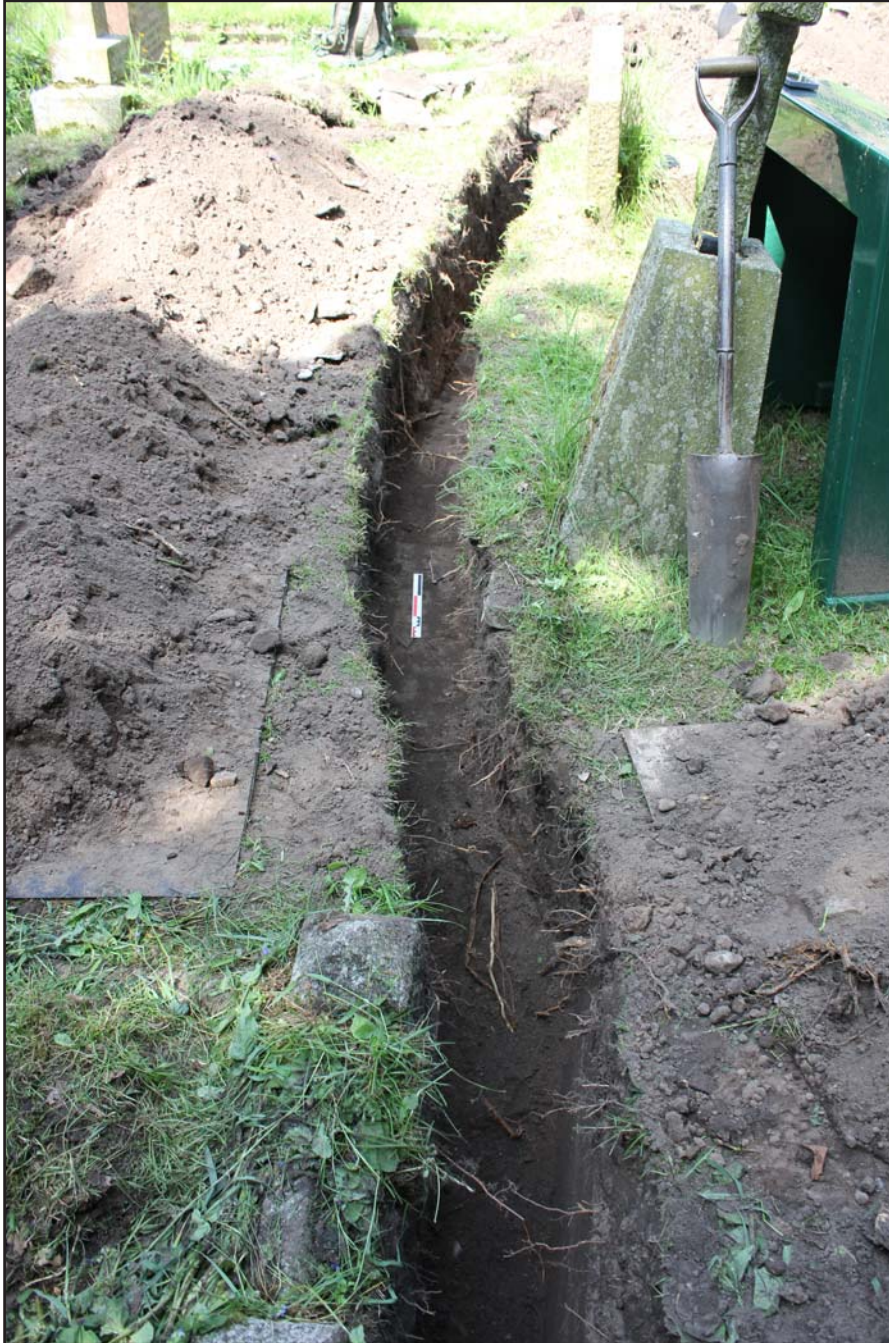
Plate 07: Trench A (north-south section) post excavation, from the south. Scale 0.3m.

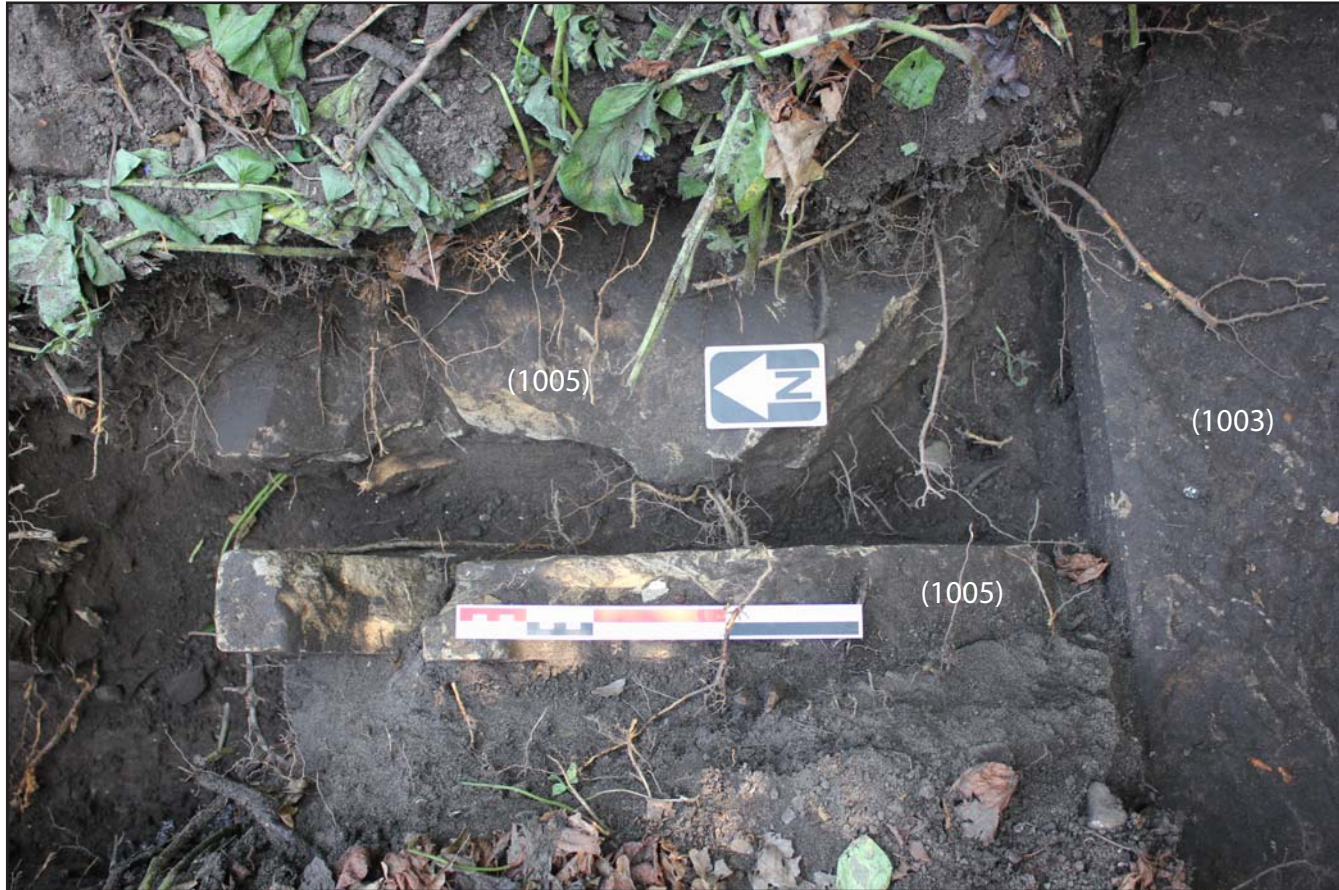
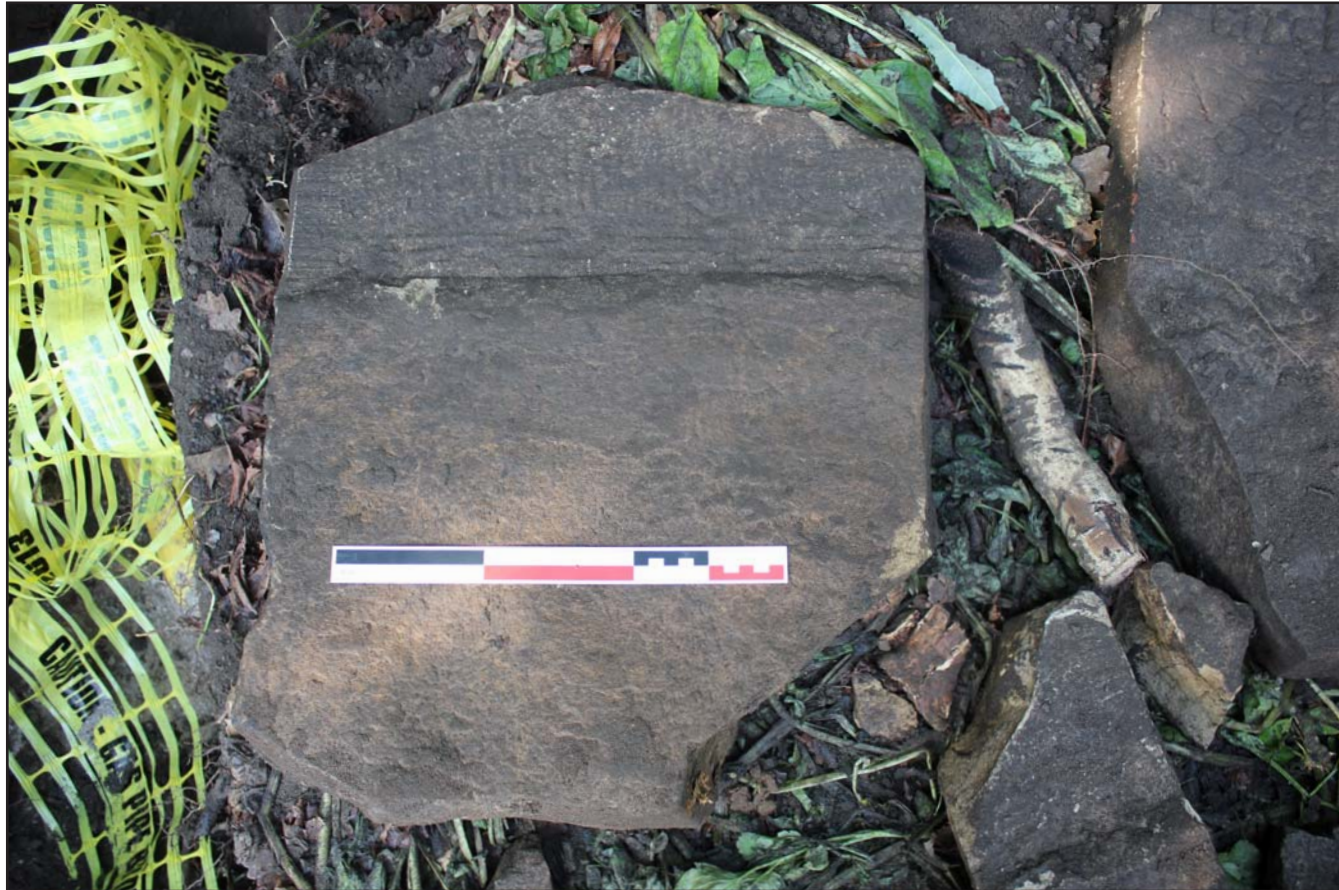
At the southern end of trench A (north-south section) and to the immediate north of grave marker (1003), an in-situ upright stump of a sandstone grave marker (1005) Plates 08 and 09) was uncovered at 0.15m BGL. This measured 0.68m in length by 0.24m in width by 0.08m in depth, with the broken remnants of the upper part of the stone lying flat to the immediate east and continuing into the eastern limit of excavation. The marker was lifted as part of the excavation works and was found to carry the remnants of an inscription but which was too illegible to transcribe.

Plate 08: Grave marker (1005) within trench A (north-south section), from the west. Scale 0.3m.

Plate 09: Grave marker (1005) recovered from trench A (north-south section). Scale 0.3m.

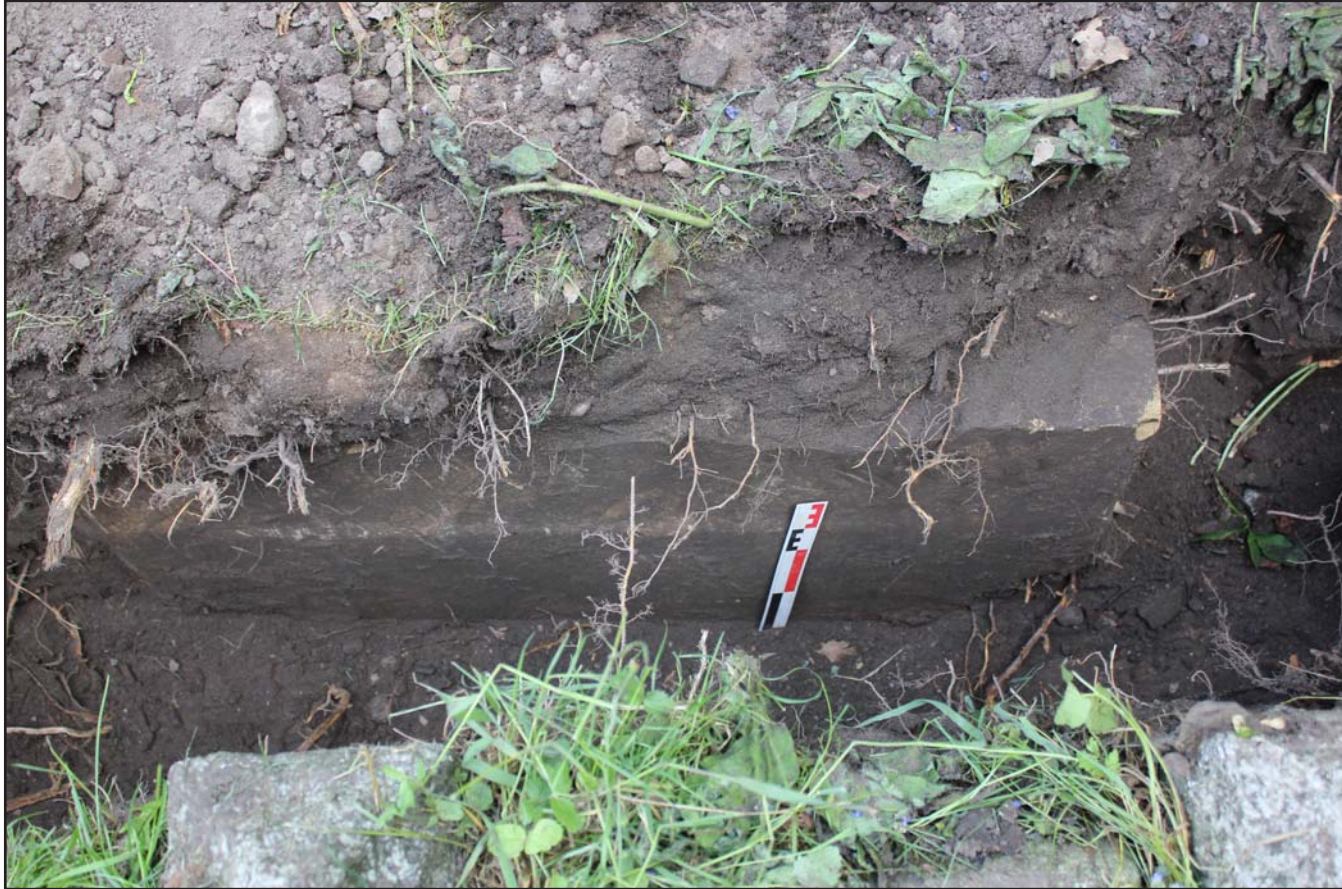
Located 0.32m to the north of marker (1005) the western end of an upright sandstone slab (1006) (plate 10) was uncovered lying 0.22m BGL. This measured >0.16m in length by 0.86m in width by >0.43m in depth, orientated east to west, and continued into the eastern limit of excavation as well as beyond the trench depth limit. It was constructed from a single slab of sandstone and appeared to be part of a sandstone burial vault. This feature was of unknown age and was retained in-situ.

Plate 10: Sandstone vault (1006) within trench A (north-south section), from the west. Scale 0.3m.

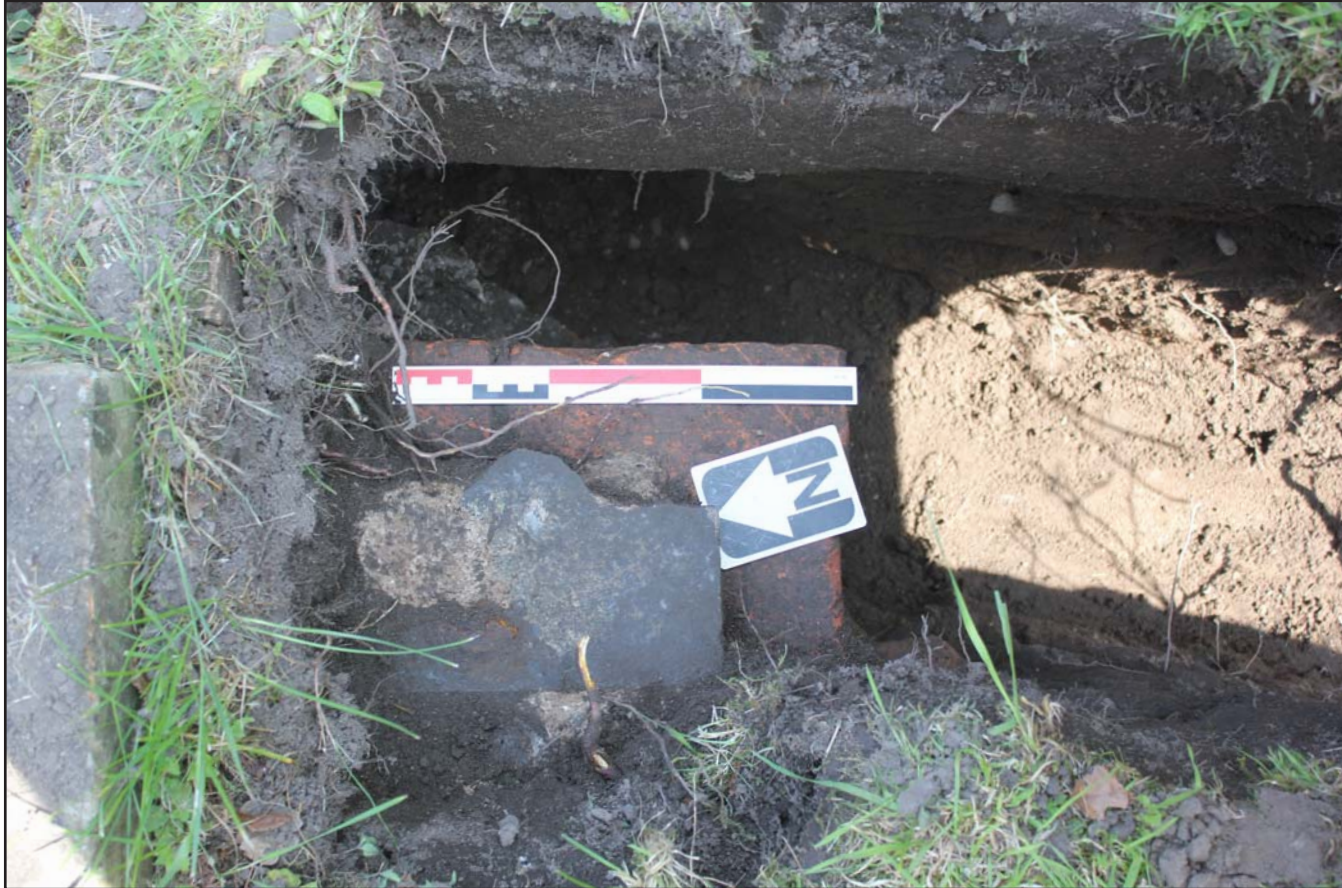
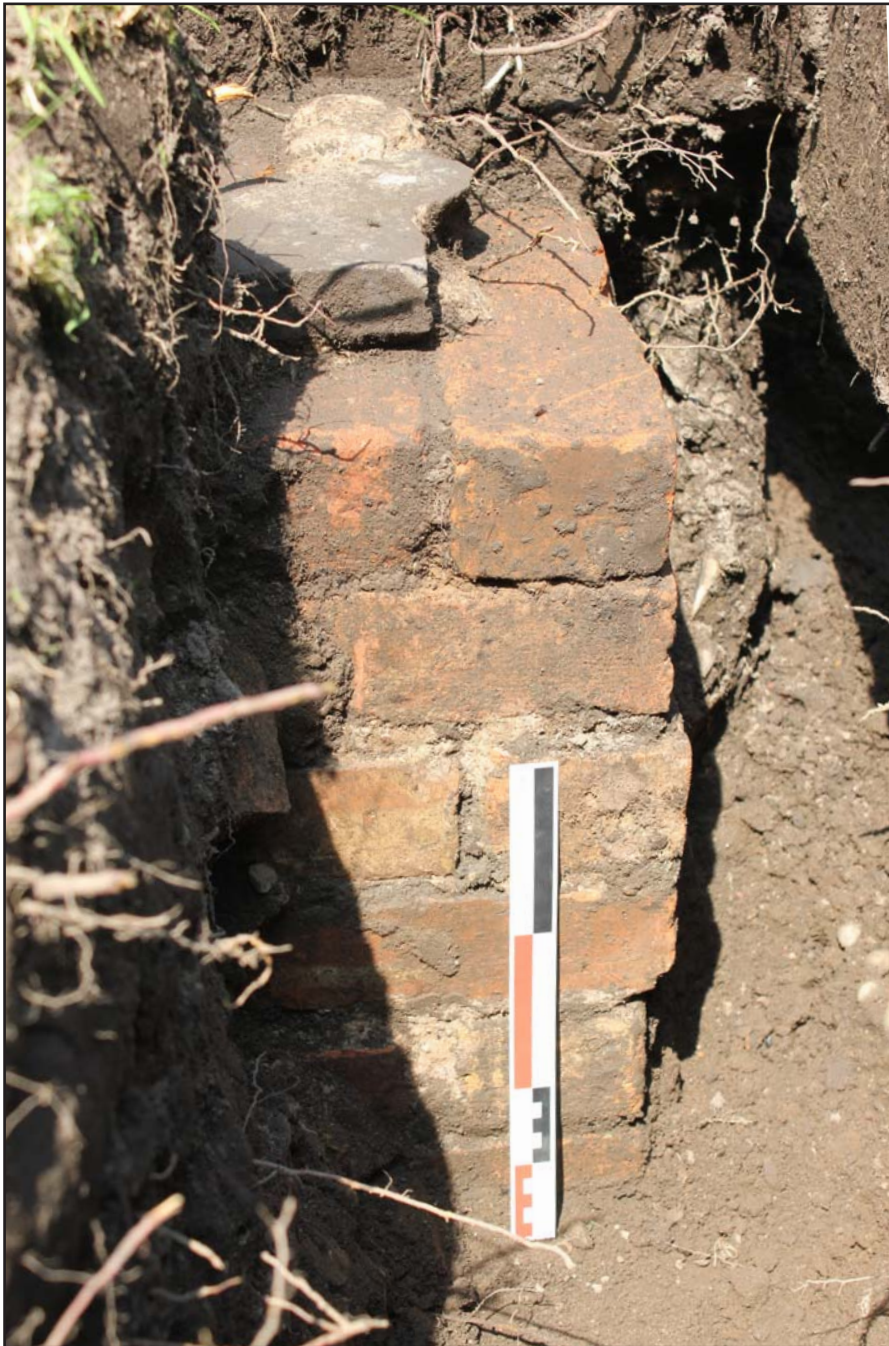
At the northern end of trench A (east-west section) the south-eastern corner of a red-brick burial vault (1007) (plates 11 and 12) was encountered within the trench at 0.18m BGL (75.11m OD). This vault measured >0.3m in length by >0.35m in width by >0.52m in depth, orientated east to west, and continued into the northern and western limits of excavation, as well as beyond the trench depth limit. It was constructed from unfrogged red-brick bonded by mortar using bricks measuring 0.23m in length by 0.1m in width by 0.075m in depth, and standing to at least six courses in height. A flat slab of sandstone appeared to function as a capstone and also continued into the northern and western limits of excavation. The vault is of unknown age but is of a form commonly seen within the Victorian period. This feature was retained in-situ.

Plate 11: Burial vault (1007) within trench A (north-south section), from the west. Scale 0.3m.

Plate 12: Burial vault (1007) elevation within trench A (north-south section), from the south. Scale 0.3m.

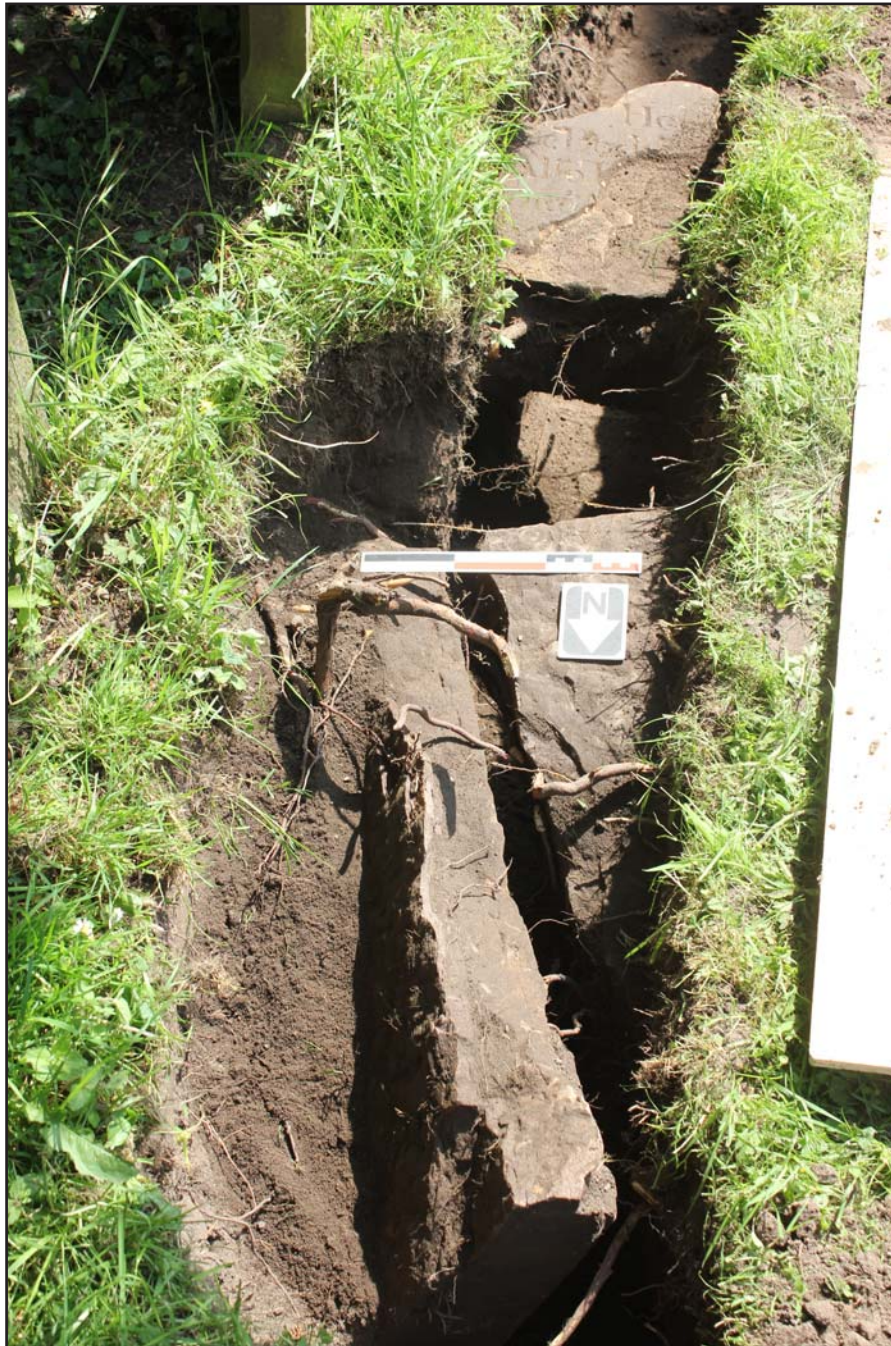
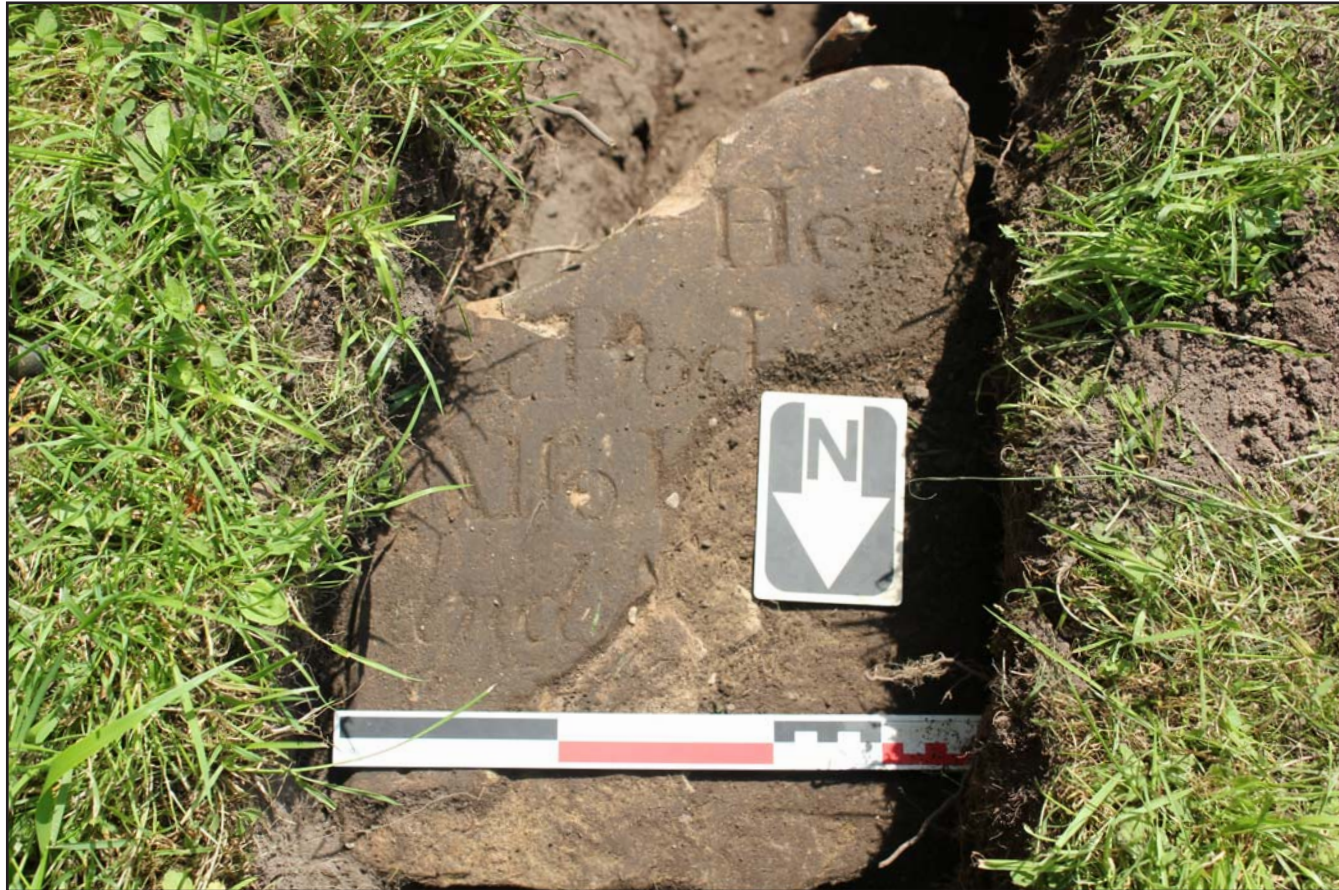
Towards the centre of the trench three broken fragments of sandstone grave marker (1008) (plates 17 and 18) were uncovered at 0.25m BGL (76.05m OD). These fragments were all from the same marker but were not in-situ, most likely having been reburied once they had broken apart. They measured >0.63m in length by >0.23m in width by 0.1m in depth; 0.88m in length by >0.58m in width by 0.12m in depth; and 0.44m in length by >0.3m in width by 0.08m in depth. The southernmost fragment carried an inscription but which was illegible. These fragments were suspended mid-way up the trench due to continuing into the eastern and western limits of excavation, and were retained in-situ.

Plate 17: Grave marker fragments (1008) within trench C, from the north. Scale 0.3m.

Plate 18: Grave marker fragments (1008) showing inscription, from the north. Scale 0.3m.

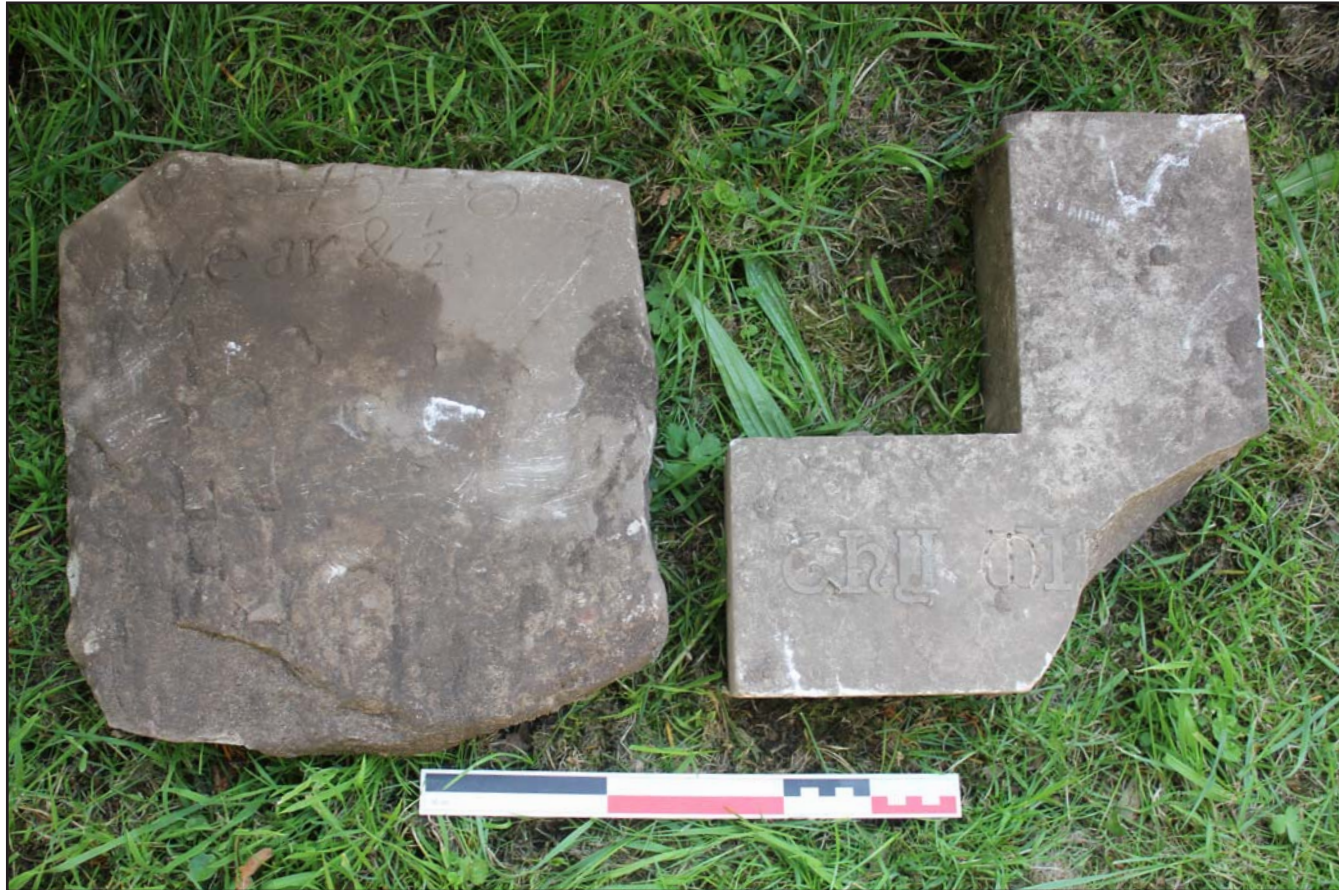
Plate 19: Grave marker fragments recovered from deposit (1001) in trench C. Scale 0.3m.

Within trench C several fragments of broken grave-marker were recovered from the general graveyard deposit (1001).

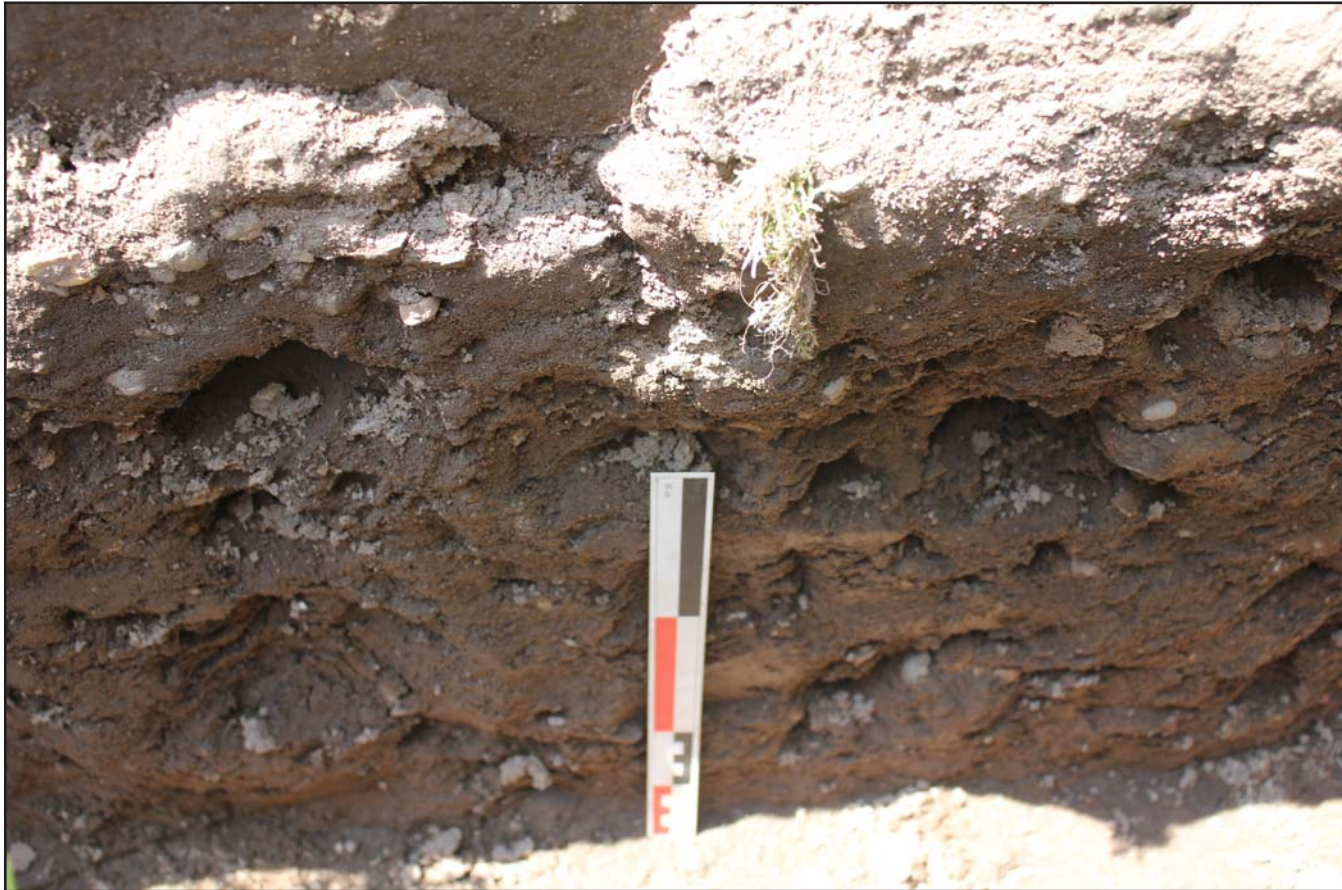
There were no archaeological features uncovered within the trench limits.

Plate 22: Trench D west facing section, from the west. Scale 0.3m.

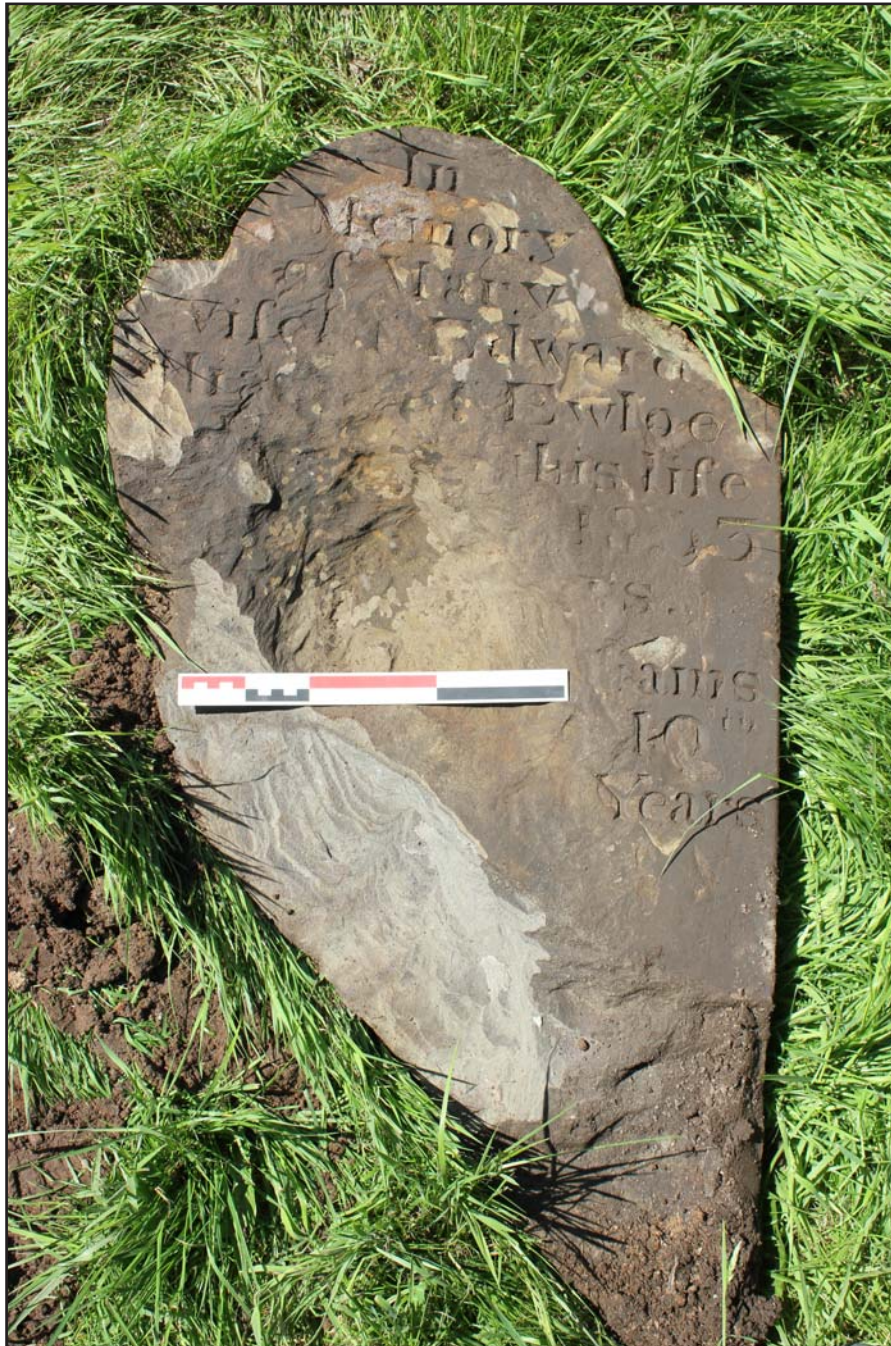
Plate 25: Grave marker recovered from pathway (1009) within trench E. Scale 0.3m.

At the northern side of the Church within trench E the remnants of a former pathway (1009) of laid York stone was uncovered directly beneath the existing flagstones and included a reused upturned inscribed grave-marker which was recorded. Further to the east within trench G a probable coal chute and drain inspection chamber (1010) of unfrosted red-brick was uncovered and recorded. Further to the east again and approximately 1.5m west of the scheme terminus a chamfered sandstone block (1011) was uncovered running north-south with laid York stone to the immediate east and west. The sandstone block retained a cut notch for former iron railings and it is likely that this was a grave-marker / monument pre-dating the Vestry extension of 1910 which lies very close to it.
