St. Deiniol's Church, Church Lane, Hawarden, Flintshire CH5 3LT.

July 2018
V 1.0

Archaeological Watching Brief
Project Code: A0146.1
Report no. 0173

Archaeological Watching Brief

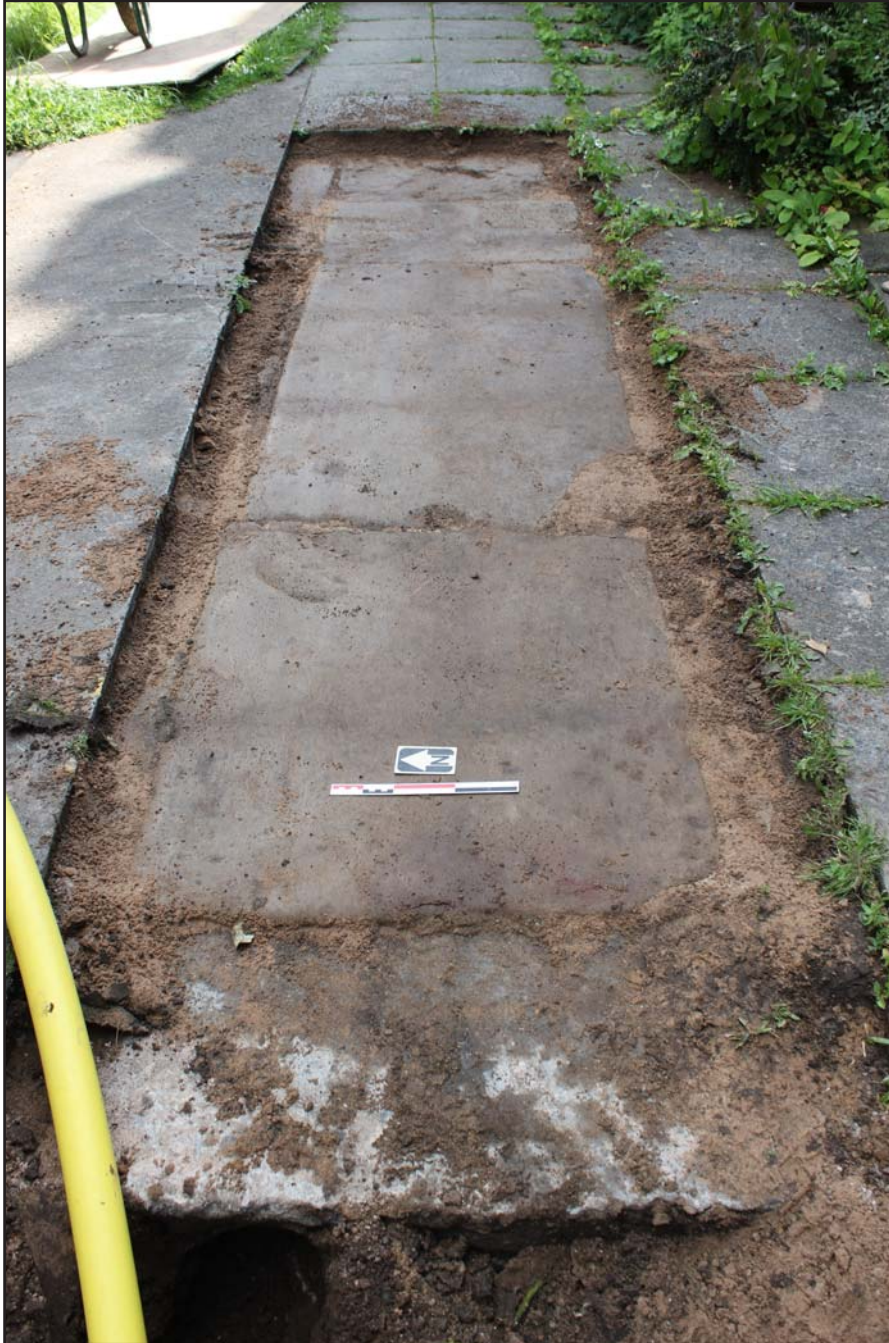
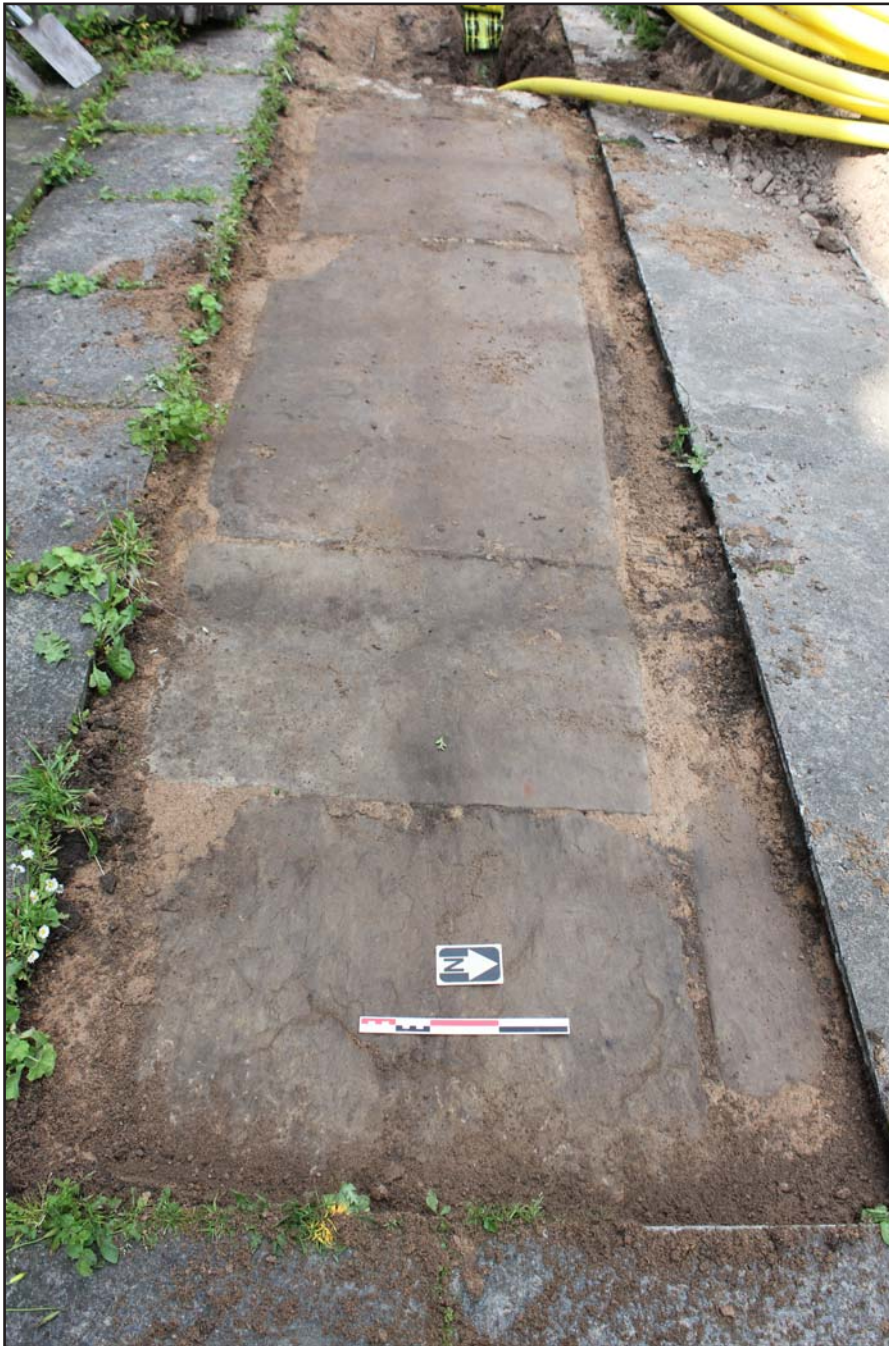
Within trench E, F and G at the northern side of the Church the watching brief uncovered the remains of a former pathway constructed from large flat York stone slabs. Within this pathway a relocated grave-marker was found.

Plate 26: Former stone pathway (1009) at the location of trench F, from the west. Scale 0.3m.

Plate 27: Former stone pathway (1009) at the location of trench F, from the east. Scale 0.3m.

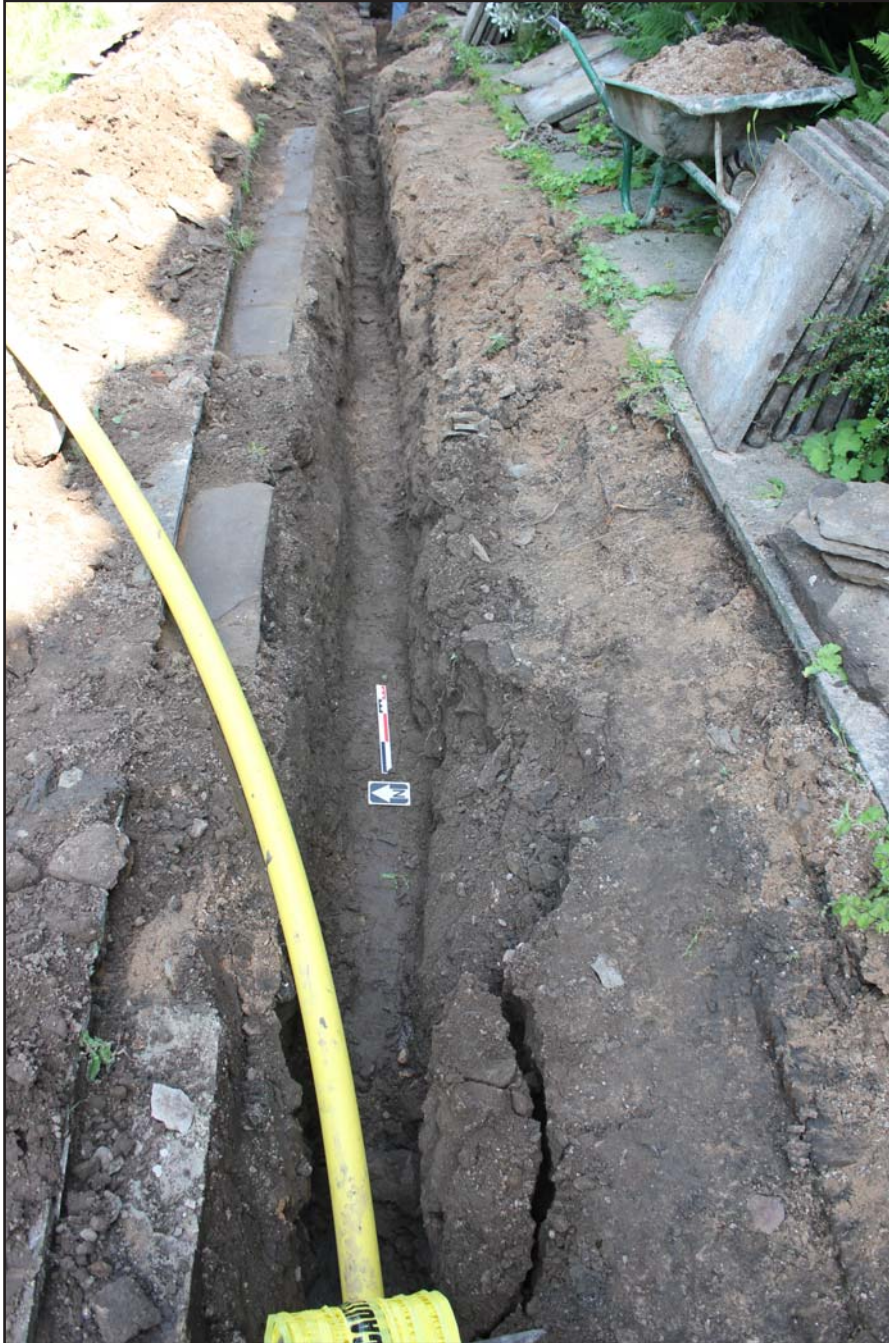
Plate 29: Trench G showing remnants of (1009), from the west. Scale 0.3m.

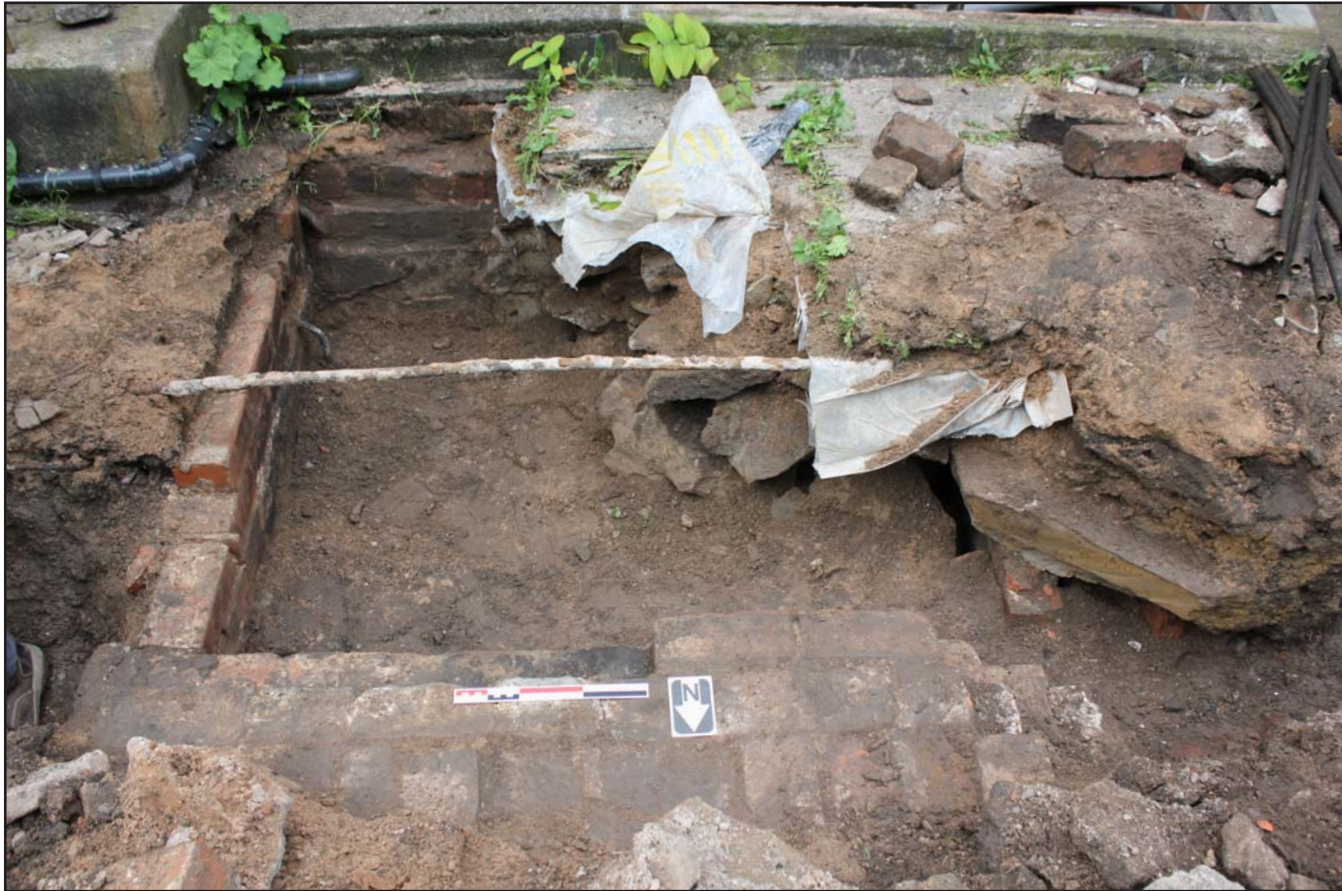
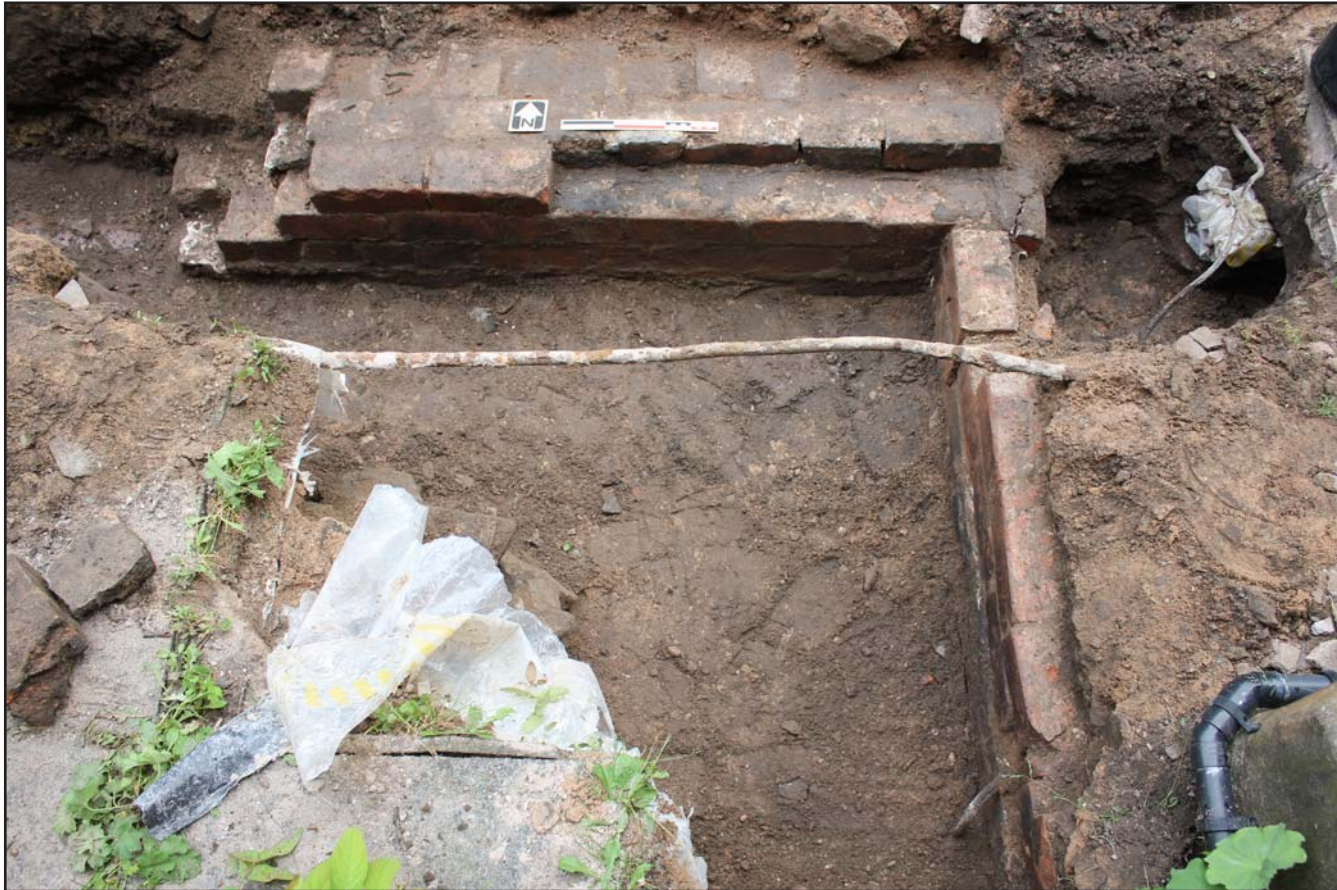
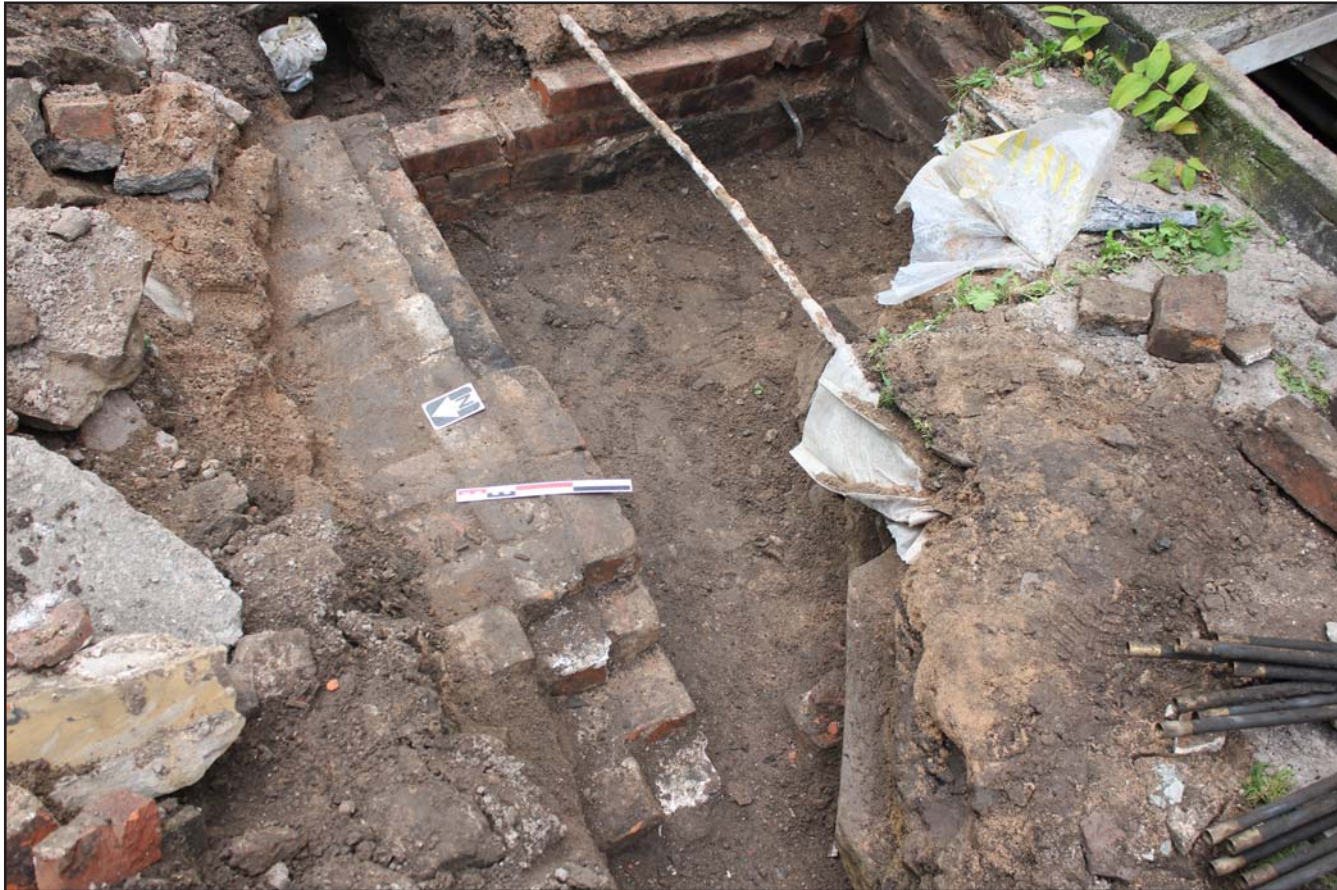
At the eastern end of trench G an infilled red-brick coal chute and inspection chamber was found immediately adjacent to the boiler room.

Plate 30: Red-brick coal chute (1010) within trench G, from the north. Scale 0.3m.

Plate 31: Red-brick coal chute (1010) within trench G, from the south. Scale 0.3m.

Plate 32: Red-brick coal chute (1010) within trench G, from the northwest. Scale 0.3m.

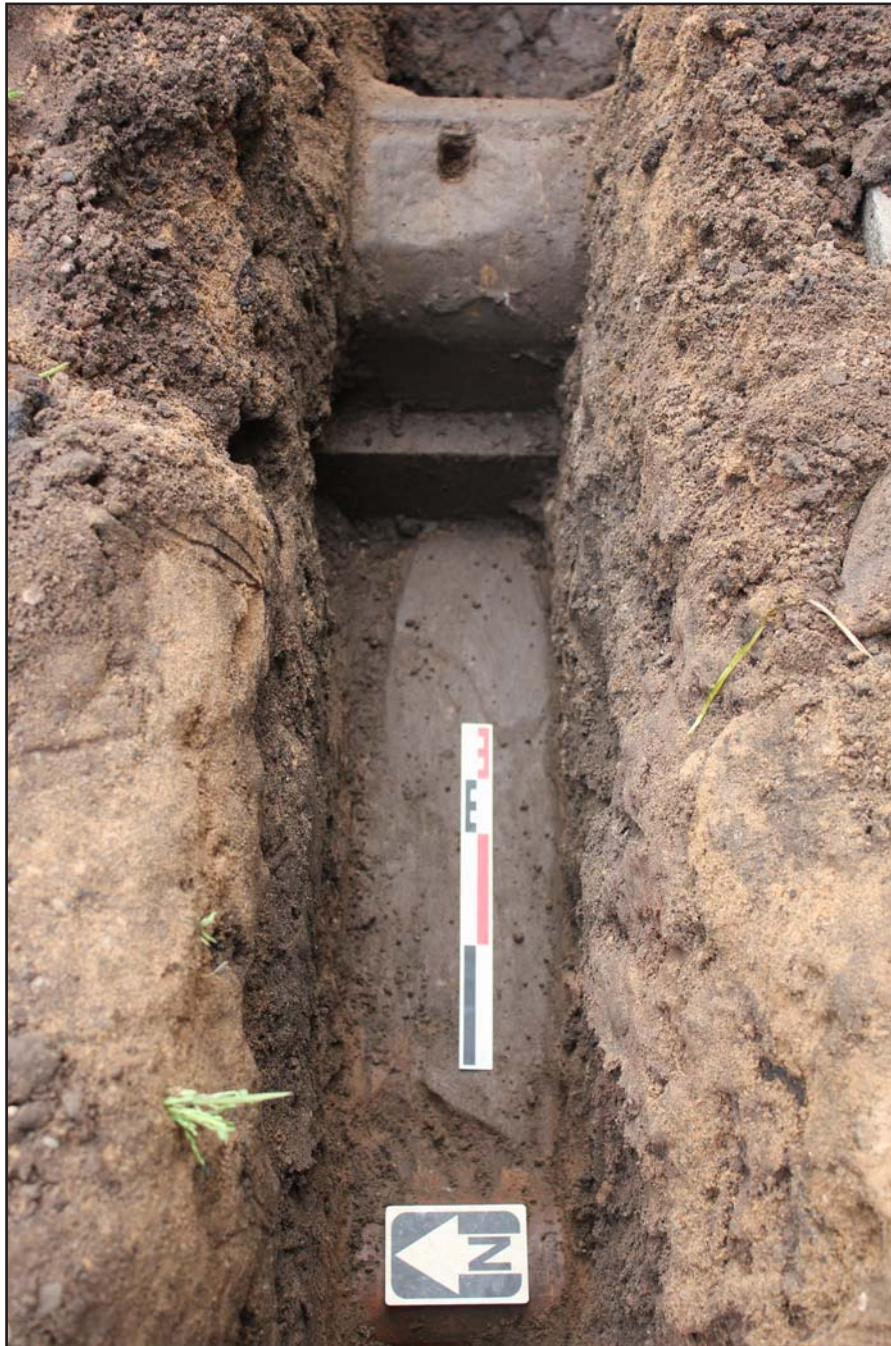
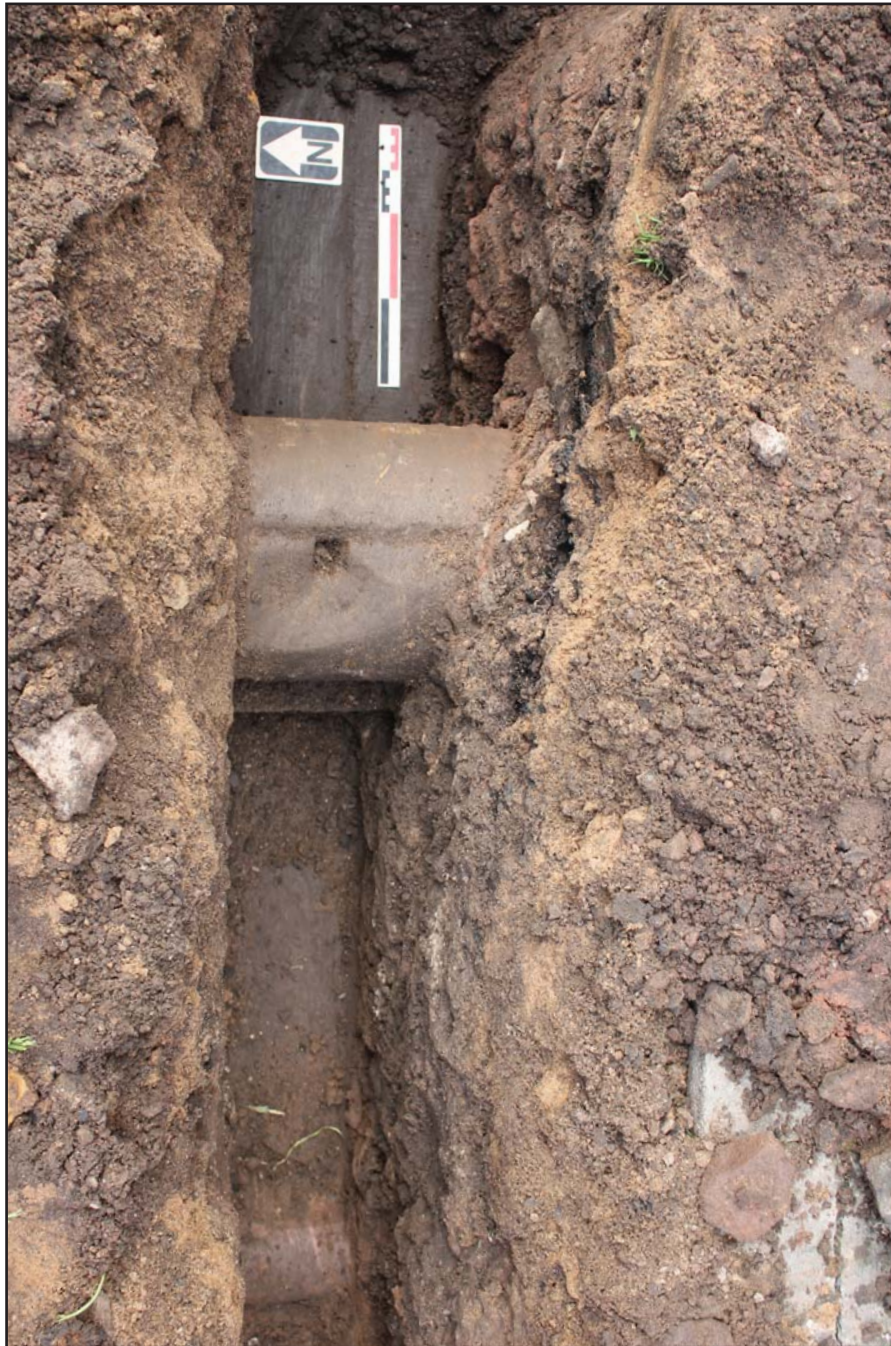
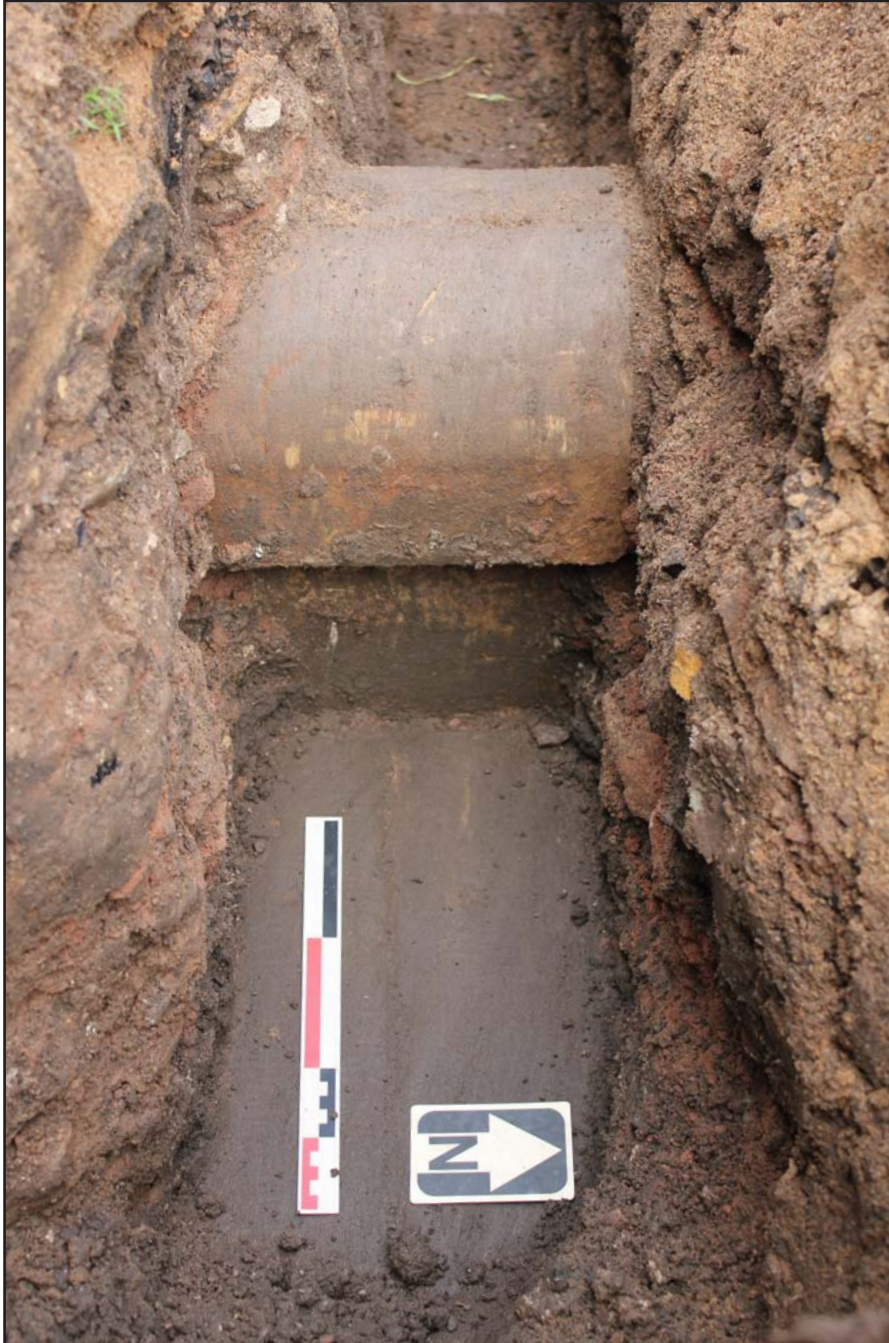
At the eastern end of trench H an in-situ sandstone and York stone grave monument was found that almost certainly predates the construction of the Vestry in 1910.

At the eastern end of the trench two blocks of chamfered sandstone (1011) (plates 34-36), one atop the other, were uncovered at 0.3m BGL (75.05m OD). These measured >0.3m in length by 0.26m in width by >0.4m in depth, orientated north to south and continuing into both the southern and northern limits of excavation. In addition three flat York stone slabs had been laid to the immediate east and west (2 x east, 1 x west) and were butting up against the north-south sandstone blocks. This formed a feature measuring >0.3m in length by >1.3m in width by >0.4m in depth but continuing into the north, south and eastern limits of excavation. Within the top of the uppermost sandstone block there was a square socket measuring 0.04m in length and width which had almost certainly once contained part of an iron railing. It is probable that this feature was part of a burial monument with raised sandstone curb with iron railings. Moreover the close proximity of the Vestry, located 1.5m to the southeast, suggests that this feature predates its construction in 1910, most likely having been an above-ground monument of Victorian date.

Plate 34: Monument (1011) in trench H, from the west. Scale 0.3m.

Plate 35: Monument (1011) in trench H, from the west. Scale 0.3m.

Plate 36: Monument (1011) in trench H, from the east. Scale 0.3m.
