CPAT Report No. 1818

Lower Woodhouse Farm, Knighton, Powys

Historic Building Survey

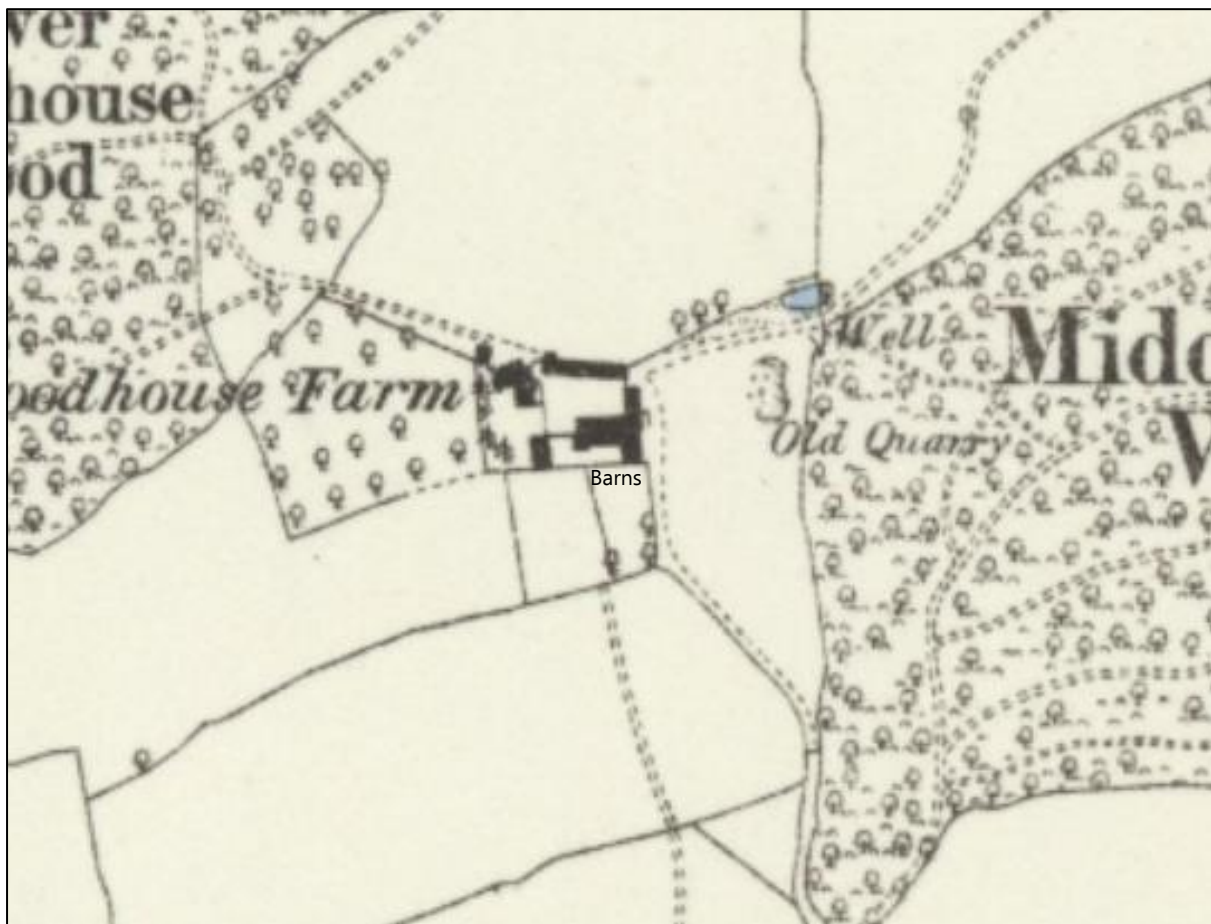
Fig. 2 Extract from the Ordnance Survey 6" map of 1889

- 2.1. Lower Woodhouse Farm is recorded on the 1839 Tithe Map for Knighton. The house was constructed during the 16th and 17th century and is Grade II listed (9036). The original farm yard extends to the east of the house and includes a six bay barn constructed in the 17th or early 18th century, which is listed in its own right (9037). The other buildings at the farm including the cart shed and cowshed are listed under curtilage. The farm was subsequently extended to the south with the construction of a number of buildings around a separate yard during the mid-19th century, with the surveyed barns to the south-east (Fig. 2).

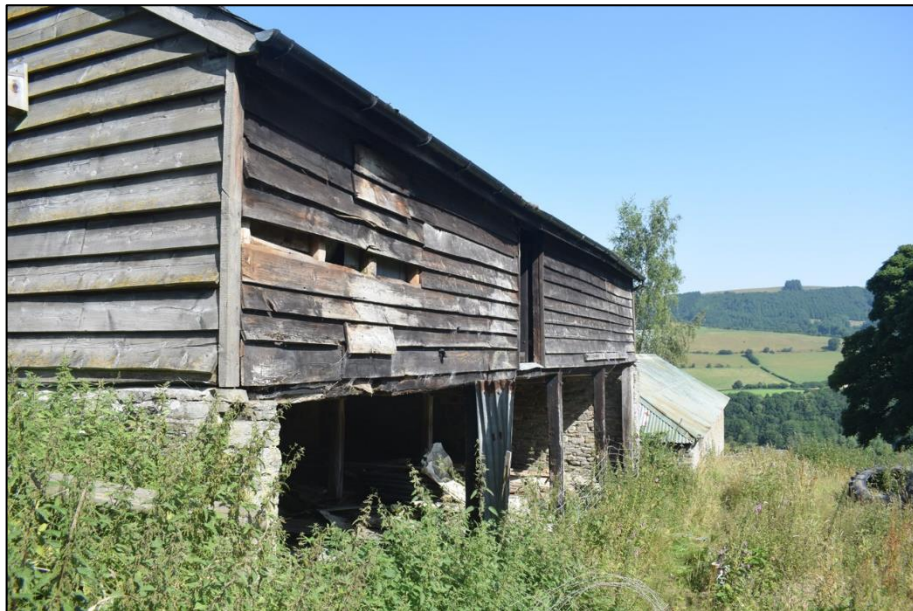
Fig. 3 Cart shed, viewed from the south Photo CPAT 4942-018

- 3.4. The eastern range was oriented north-south and measured 12m by 6.8m. It comprised an open fronted cart shed, with four bays accessed from the east (Fig. 3). The south elevation of the building was cut into the hillslope. A granary or seed store was located above the cart shed, accessed via steps on the south gable end (Fig. 4) and a doorway or window on the upper east elevation (Fig. 3). The lower walls on the north, south and west elevation were constructed from grey uncoursed lime mortared sandstone (Figs. 5 & 6). The upper floor was constructed in wood, with timber cladding on the walls. No flooring material was evident in the cart shed, which may have been bare earth, whilst the flooring in the granary had been replaced with modern plywood. The roof frame was constructed from machine cut softwood and comprised compound trusses on either gable end and king post intermediate trusses (Figs. 7 & 8). There was evidence of subsequent strengthening having been carried out, in the form of hand-made collars connecting the principal rafters and rather insubstantial looking posts supporting each of the tie beams. The roof was intact and boarded on the inside with slates externally. The slates had been treated with a bituminous solution to further improve weather resistance.

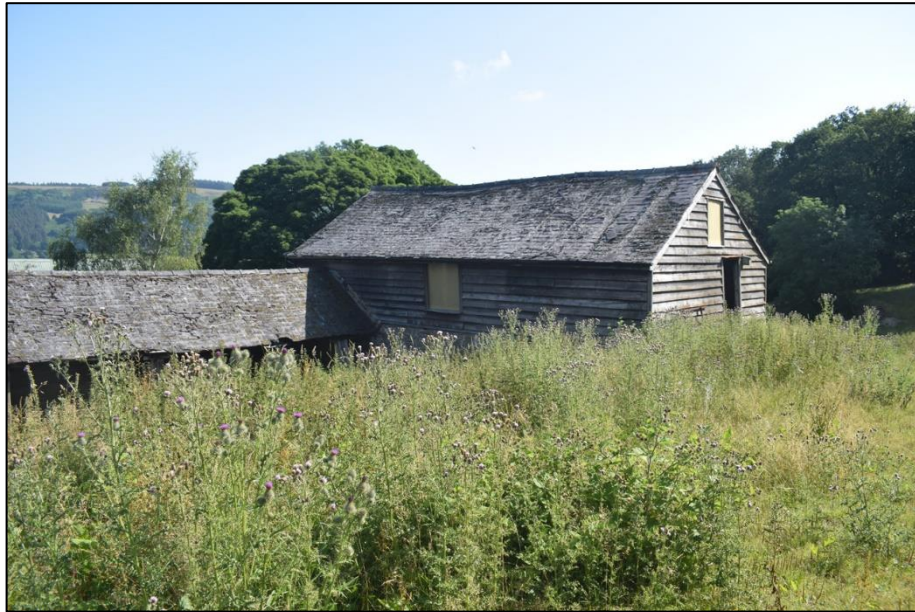
Fig. 4 Cart shed, viewed from the south-west Photo CPAT 4942-005

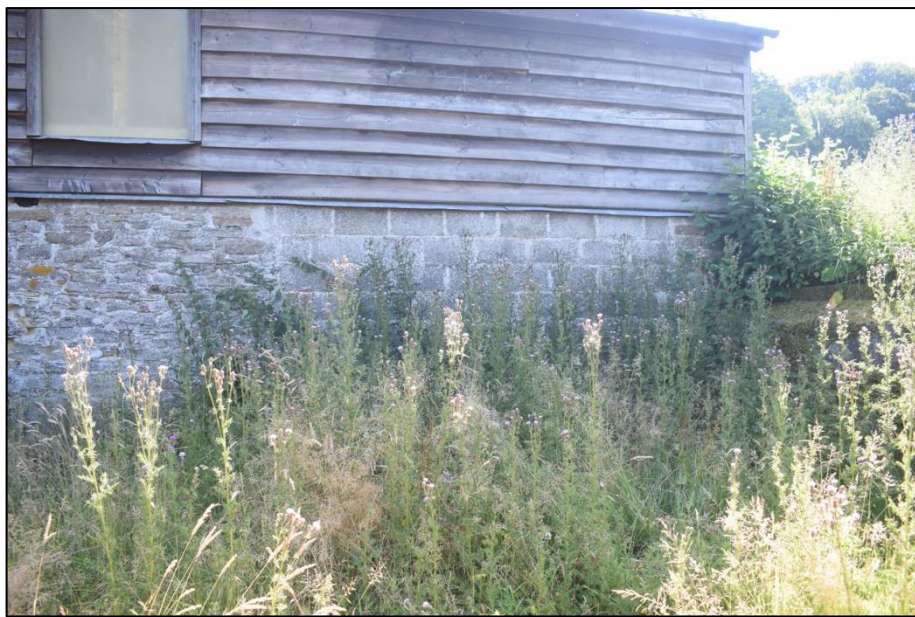
Fig. 5 Cart shed, viewed from the west showing wall section rebuilt in blockwork Photo CPAT 4942-017

- 3.5. Alterations to the original fabric of the cart shed were quite minor, and comprised a section of the west elevation rebuilt in blockwork (Fig. 5), a later doorway which had been added to access the cowshed from the cart shed and then later infilled with blockwork (Fig. 6). It was noted that several of the bays within the cart shed had been fitted with gate hinges and may have functioned as a covered animal shelter, for calving or lambing for example.

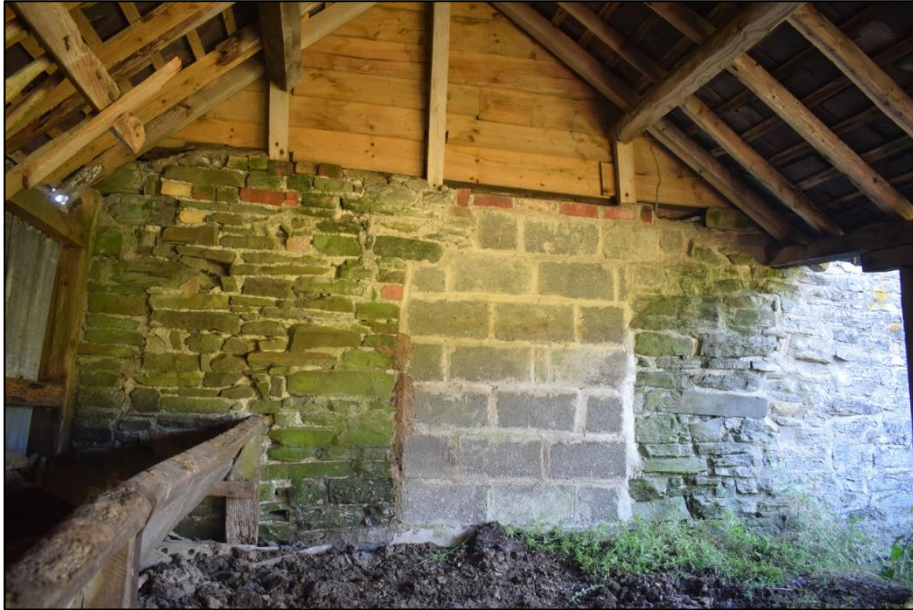
Fig. 6 Cart shed, viewed from the west showing infilled later doorway into cowshed Photo CPAT 4942-015

- 3.8. The cowshed seems to have been in use for a considerable period of time, the feed troughs and hay feeds are intact and still in position. It is notable that there was at one time a doorway linking the cowshed and cart shed, and that there was provision for stock gates to keep animals in the cartshed, suggesting that its purpose had changed over time, perhaps as arable farming diminished in importance and stock rearing became the primary enterprise. The granary may subsequently have functioned as a hayloft, as the high level doorway on the east elevation implies, which would have been a pragmatic reuse of an otherwise redundant building.

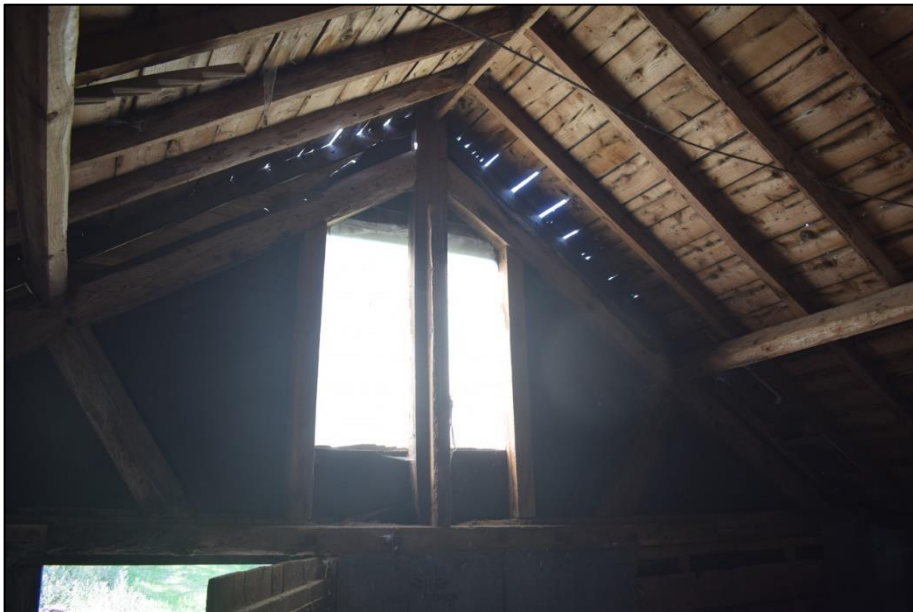
Fig. 7 Compound truss on south gable end of cart shed Photo CPAT 4942-033

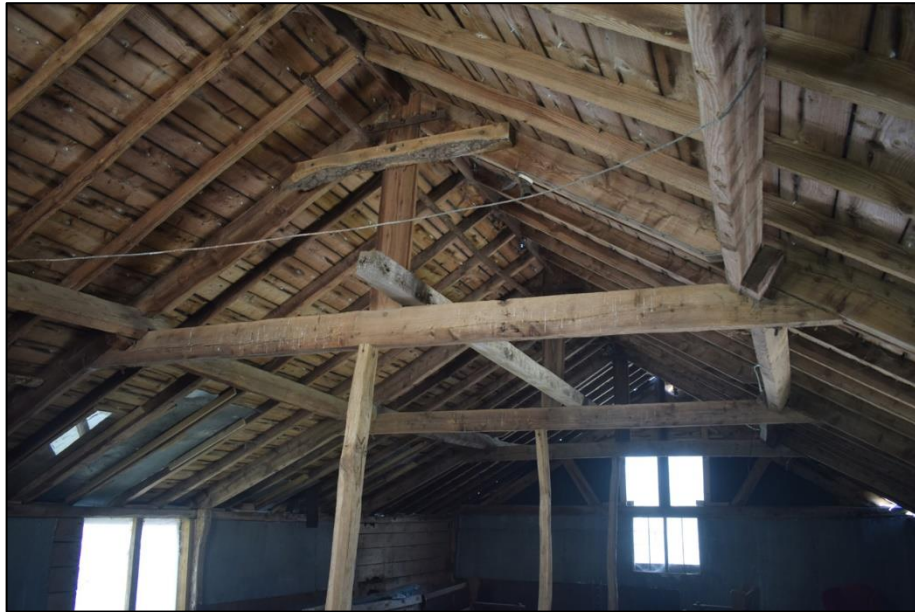
Fig. 8 Intermediate king post roof truss within the cart shed Photo CPAT 4942-029

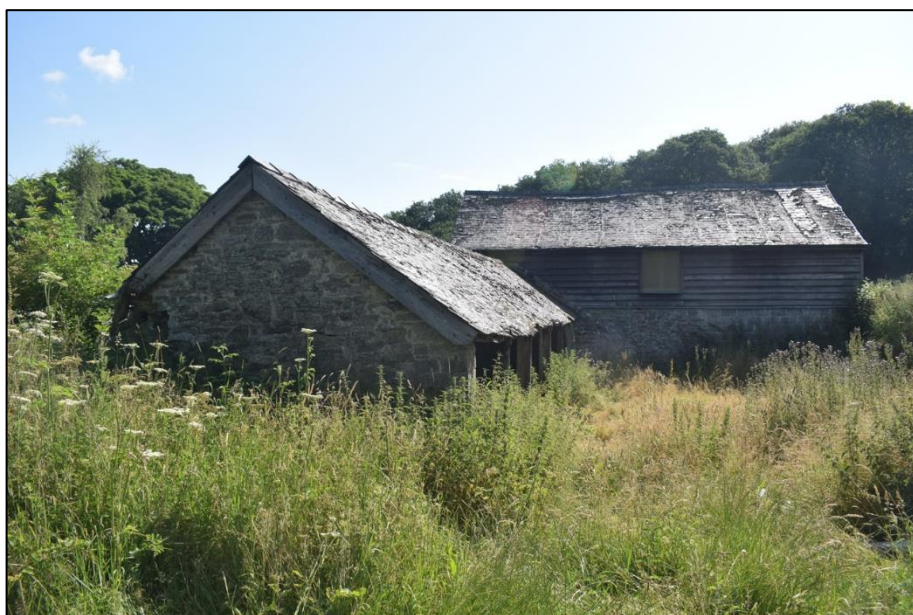
Fig. 9 Cowshed (foreground) viewed from the west Photo CPAT 4942-001

- 3.6. The cowshed was oriented east-west, measured approximately 15m by 4m, and faced into a yard on the south side, which had been cut into the hill slope and retained by a stone revetment wall. The west gable end (Fig. 9) and a short section of the north wall were constructed of a grey sandstone similar to that used to construct the cart shed. The south of the cartshed was open. Most of the north elevation of the cowshed had been sheathed in tin, but may have originally been clad in timber. A feed trough and hay feeders ran the length of the north elevation (Fig. 10). The roof framing was machine cut softwood with over and under roof purlins and no ridge beam supported by queen post type trusses (Figs. 10 & 11). The interior of the roof structure was weather proofed with planking in the vicinity of the hay feeders. The external roofing material was slate covered with bituminous weather proofing.

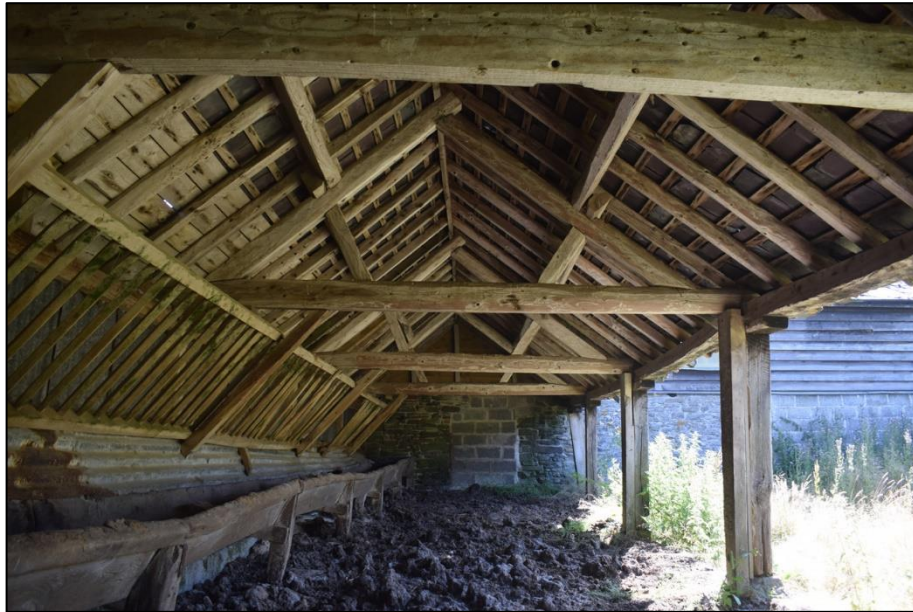
Fig. 10 Interior of the cowshed viewed from the west Photo CPAT 4942-007

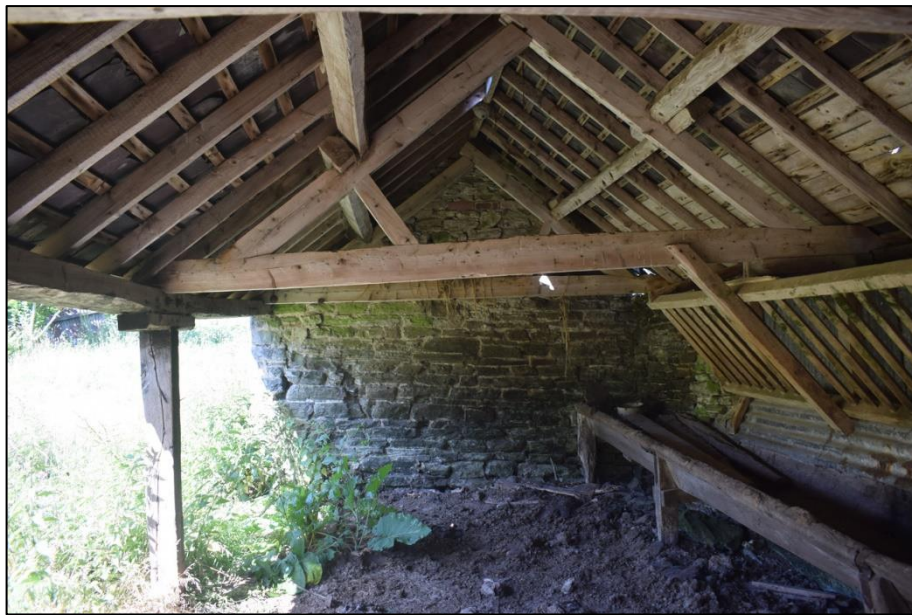
Fig. 11 West gable end of the cowshed Photo CPAT 4935-013

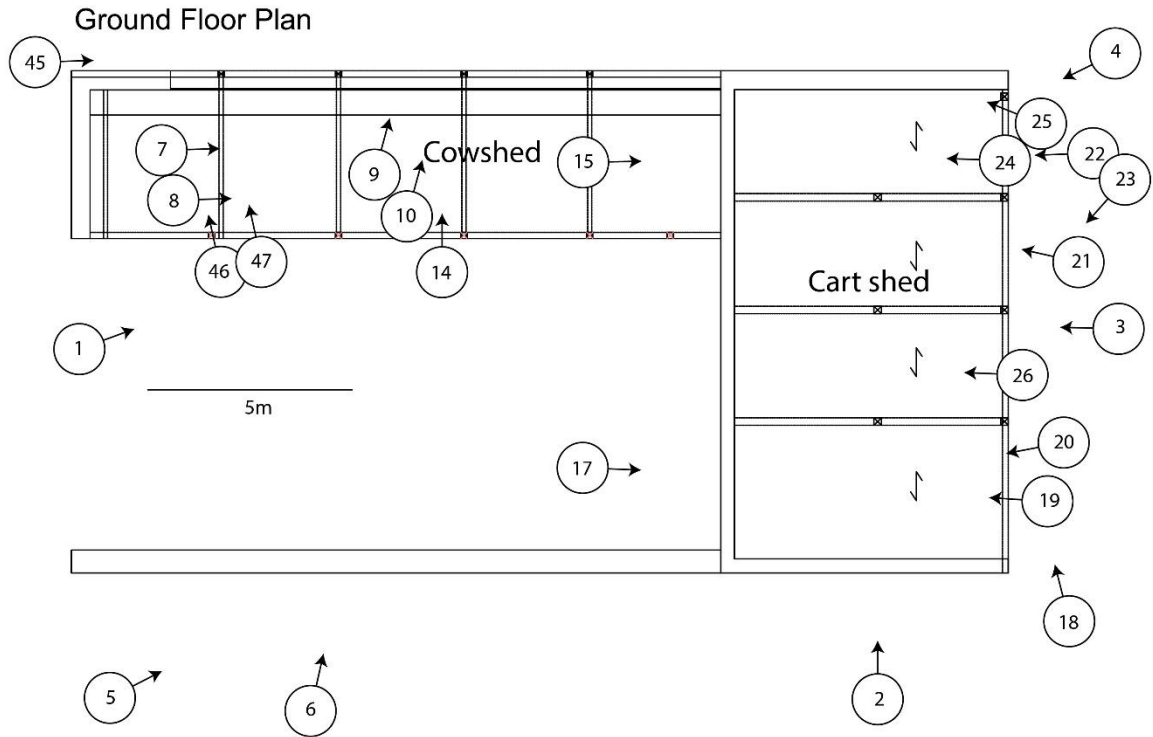
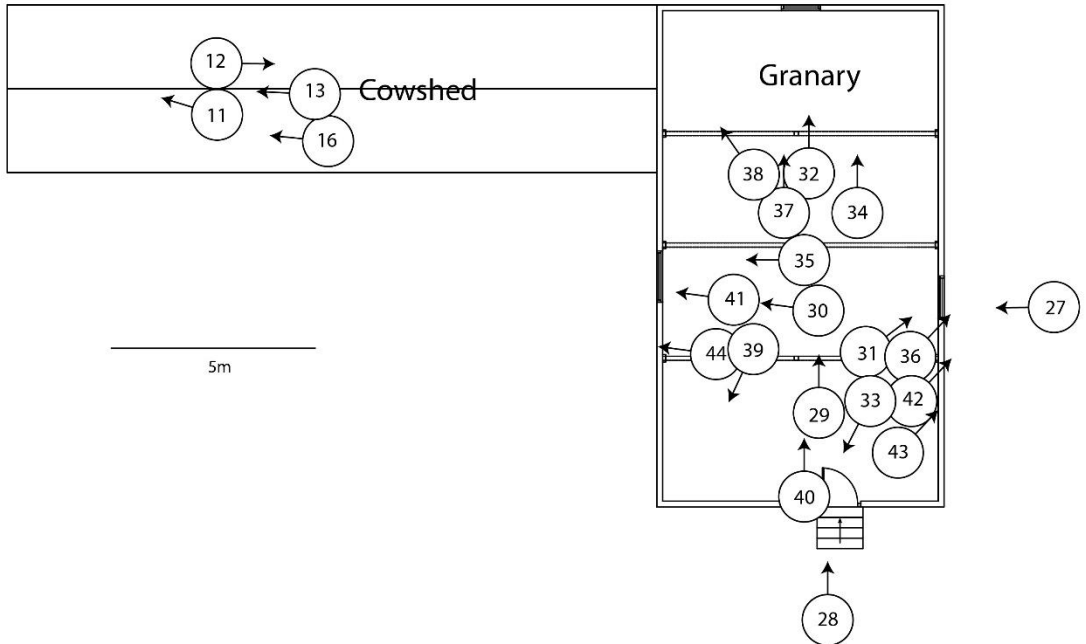
Fig. 12 Photographic location plan

First Floor Plan

- 3.2. Plans of the buildings and the location and direction of photographs are shown in Figure 12. A full set of photographs are reproduced as contact prints in Figures 13 and 14.
- 3.3. The barns comprised two connected buildings forming an L shape around a sunken yard area.
