PE544 CARN BRIW ROUND CAIRN SCHEDULED MONUMENT:
RECONSOLIDATION WORK OF CAIRN

Prepared on behalf of the Pembrokeshire Coast National Authority by Tomos Jones, Community Archaeologist.

03 October 2022

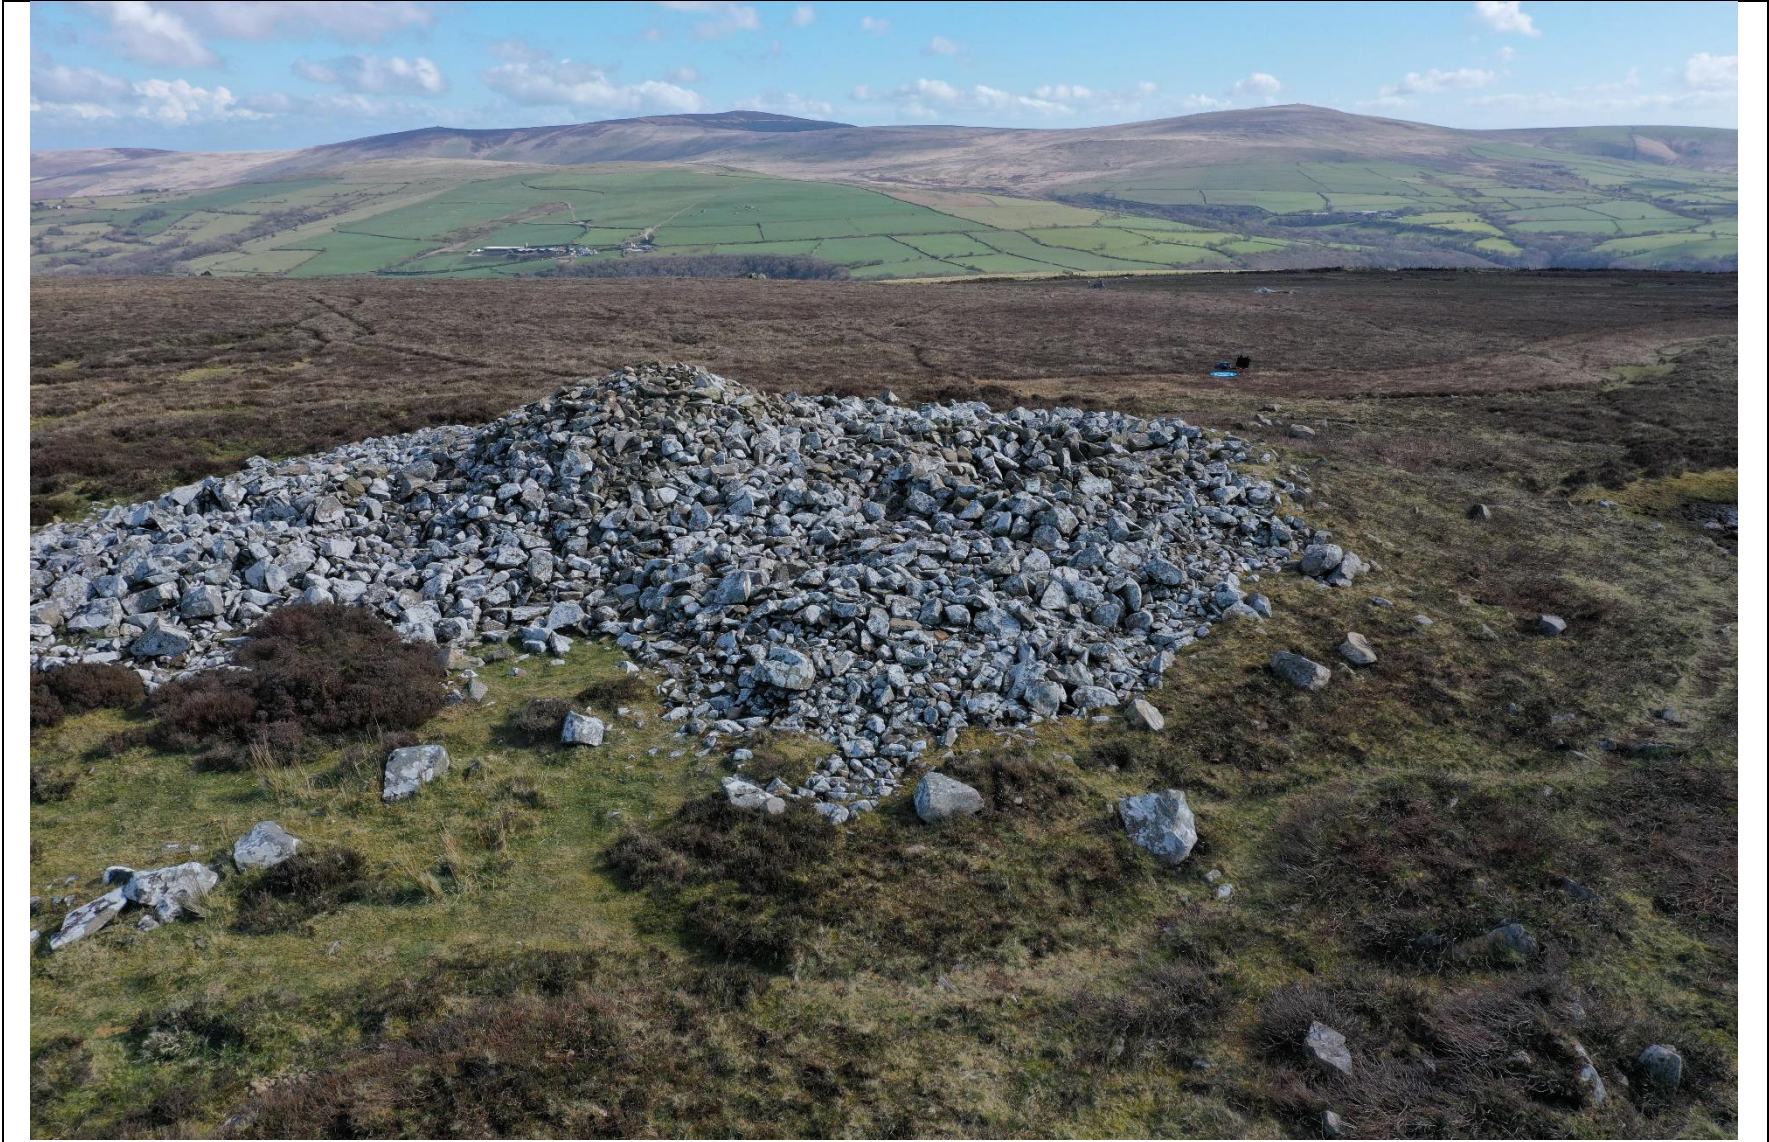
Figure 3. Monument towards south after reconsolidation work.

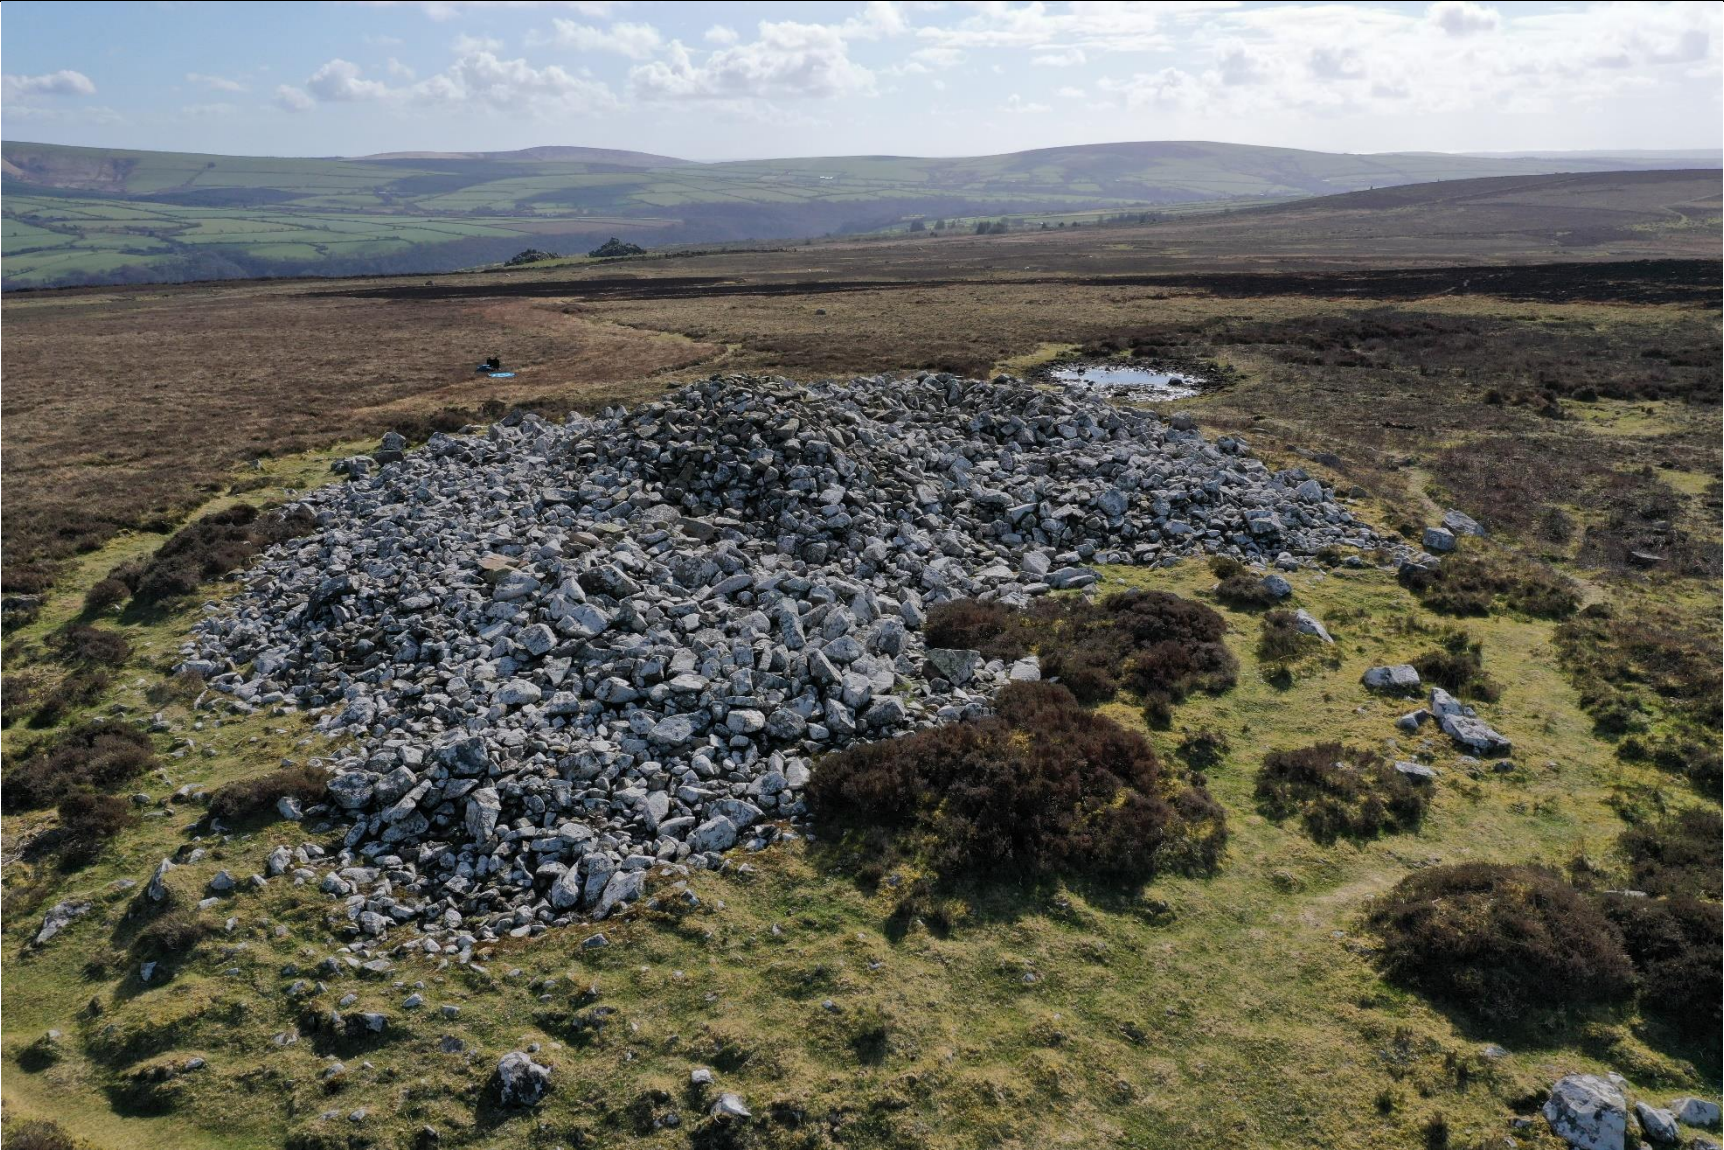
Figure 5. Monument towards west after reconsolidation work.

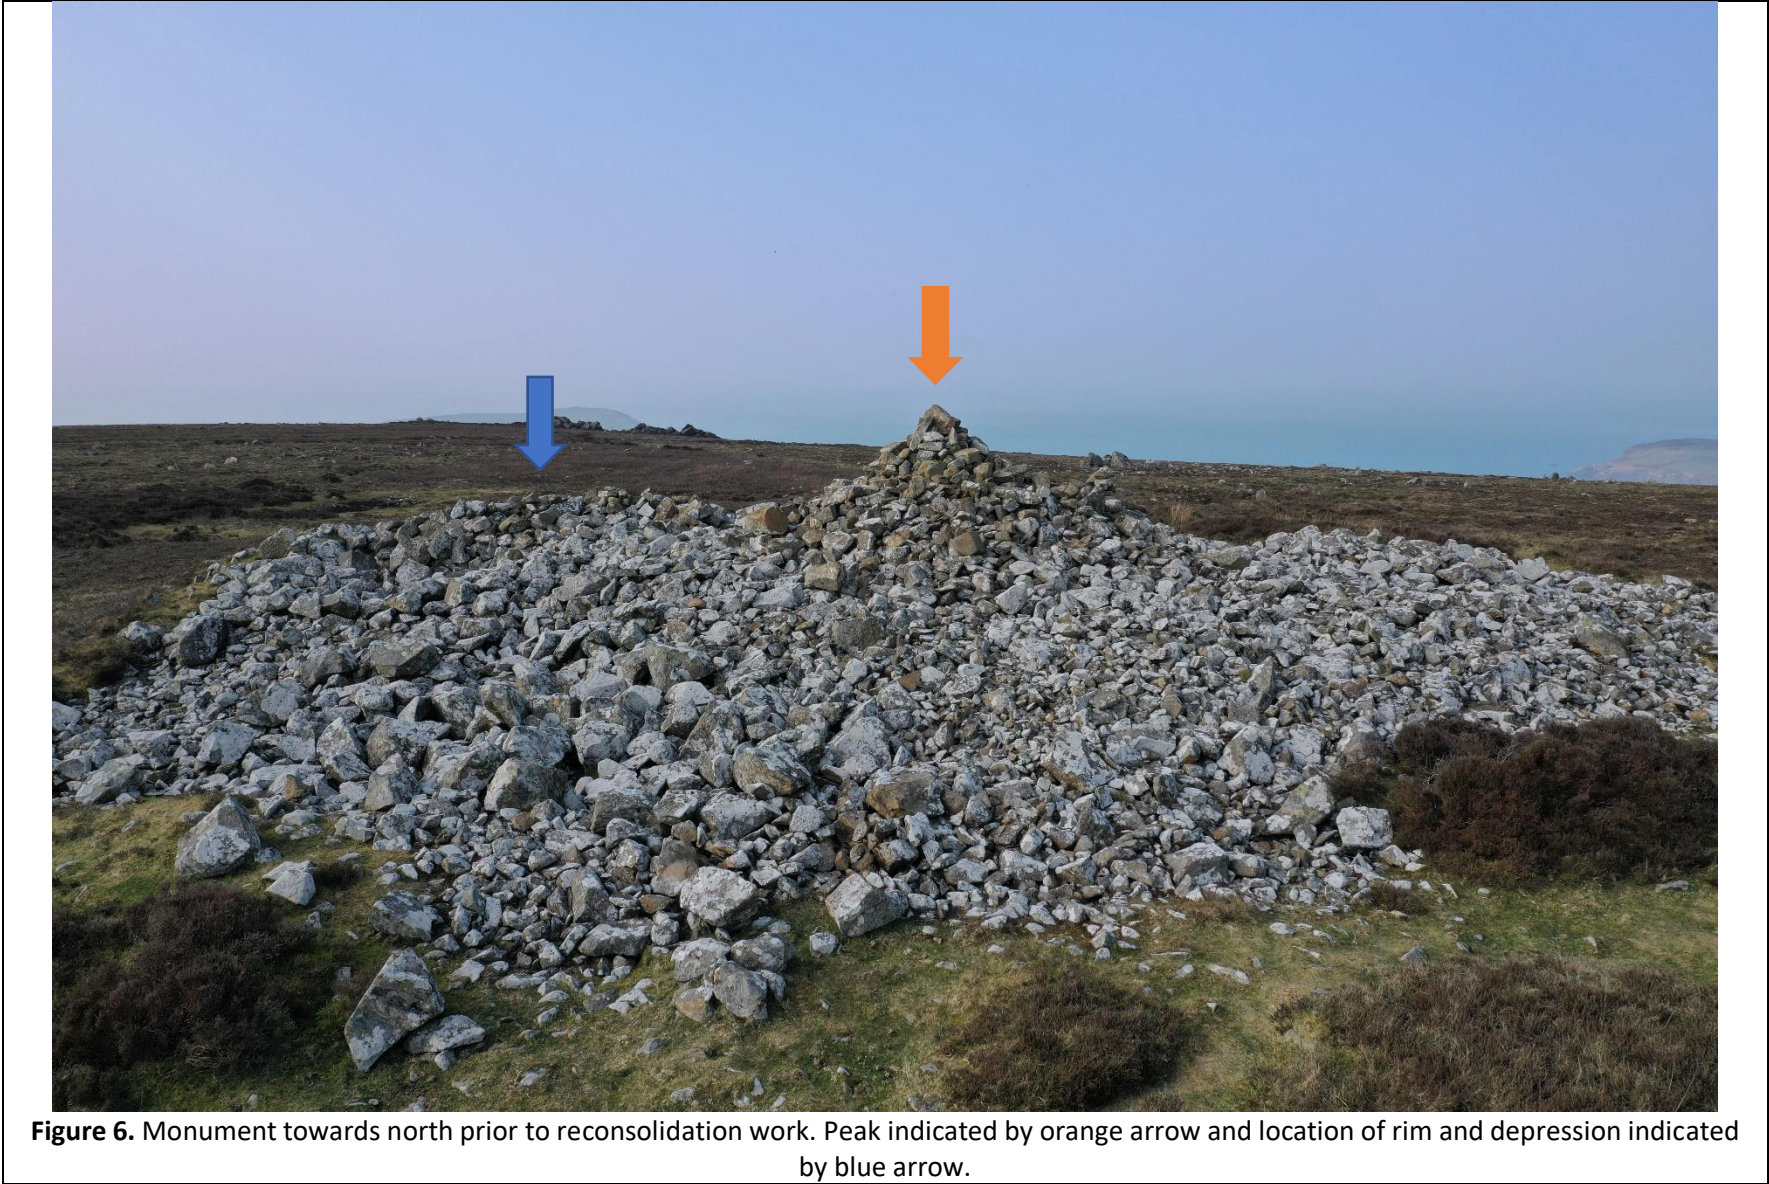
Figure 6. Monument towards north prior to reconsolidation work. Peak indicated by orange arrow and location of rim and depression indicated by blue arrow.

- In relation to the peak of the cairn (see section 3), stones were carefully removed to reduce the height of the peak. It is likely that disturbance had been ongoing for a significant amount of time in this area, as such only a degree of reduction took place. Once the height had been reduced, stones with lichen were placed at the surface facing upwards. This meant the cairn looked less disturbed, this will hopefully discourage or at the very least limit future disturbance. Stones removed from the peak were redistributed across the cairn with lichen side of stones facing upwards.

- In relation to the rim and depression on the southern side of the cairn (see section 3), stones composing the rim were carefully removed. The stones were then placed in the depression. Stones with lichen on their surface were placed on top. This meant the surface looked less disturbed, hopefully discouraging or at the very least limiting future disturbance.
- A general walk over the cairn surface took place to identify stones that had been disturbed, indicated by the absence of lichen on the surface of stones. Any identified disturbed stones were turned over, so that lichens were facing towards the sky (see example in figures 14 and 15).
- Photographs showing before and after are provided in section 3.

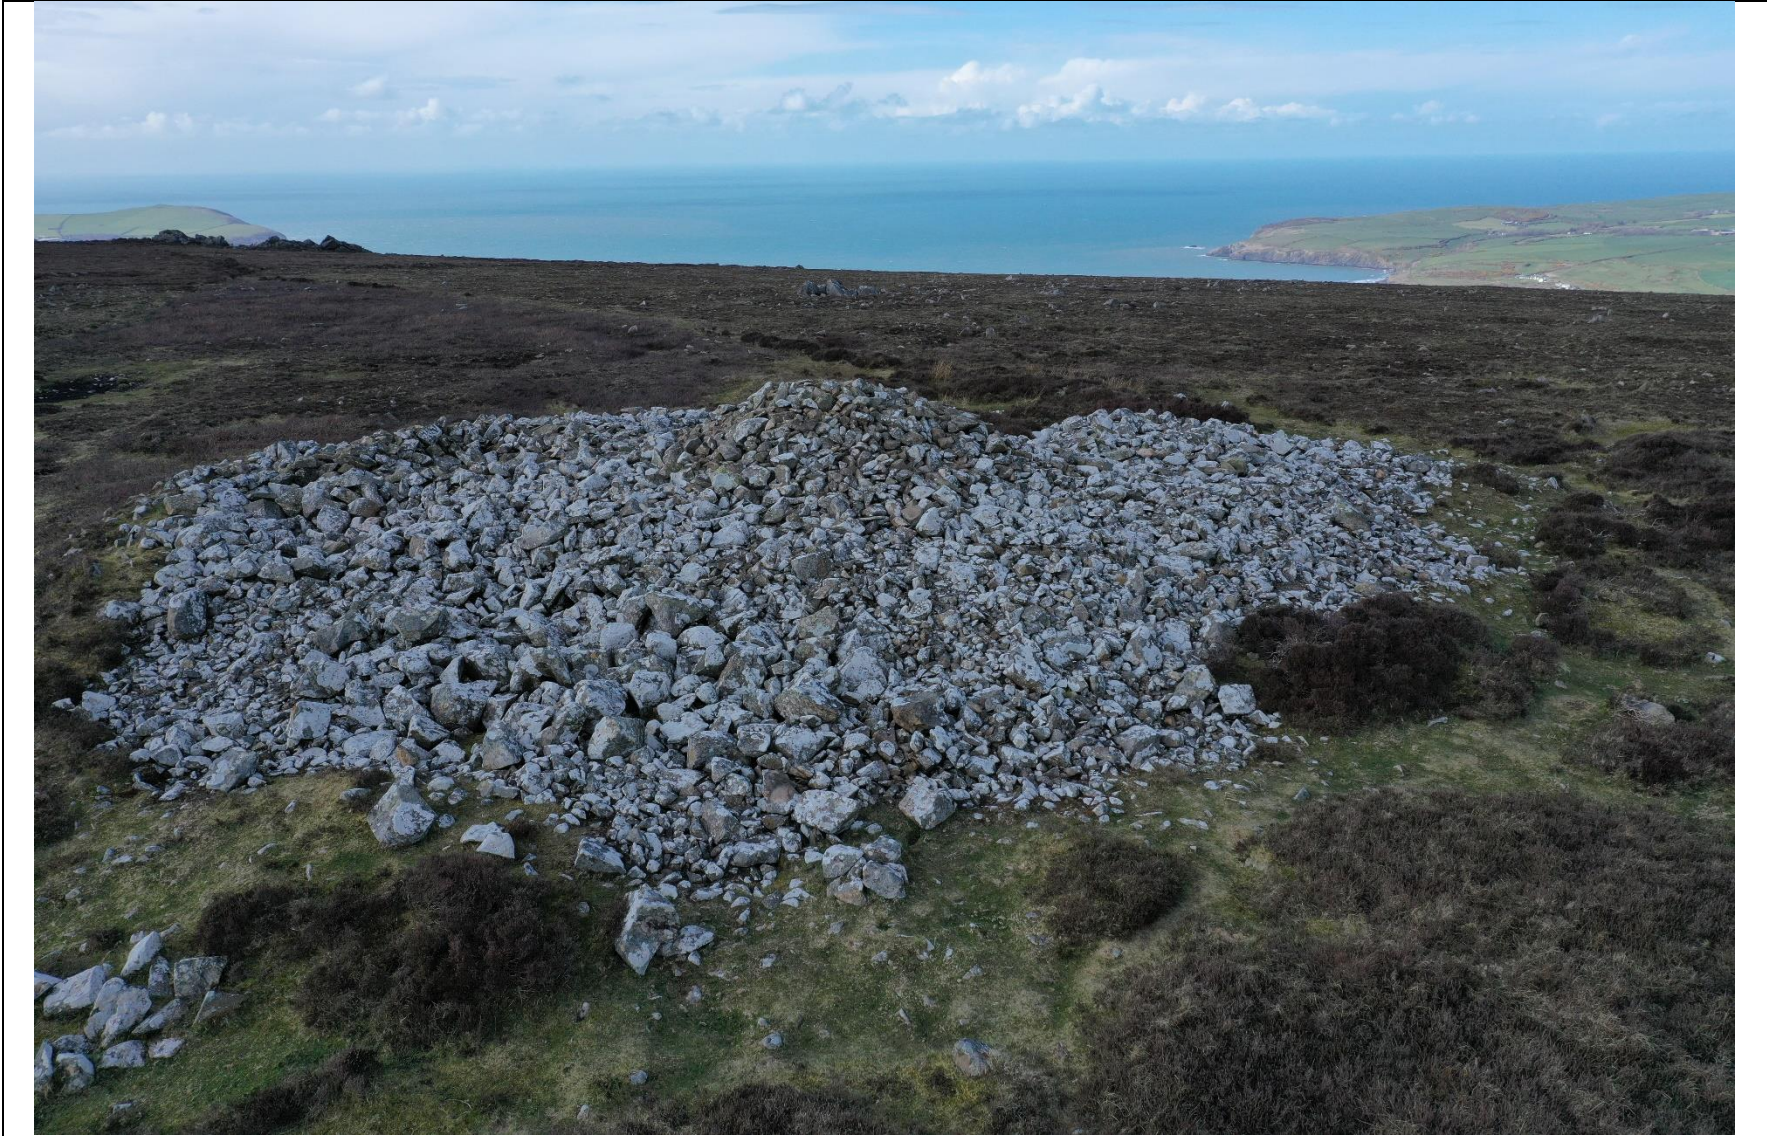
Figure 7. Monument towards north after reconsolidation work.

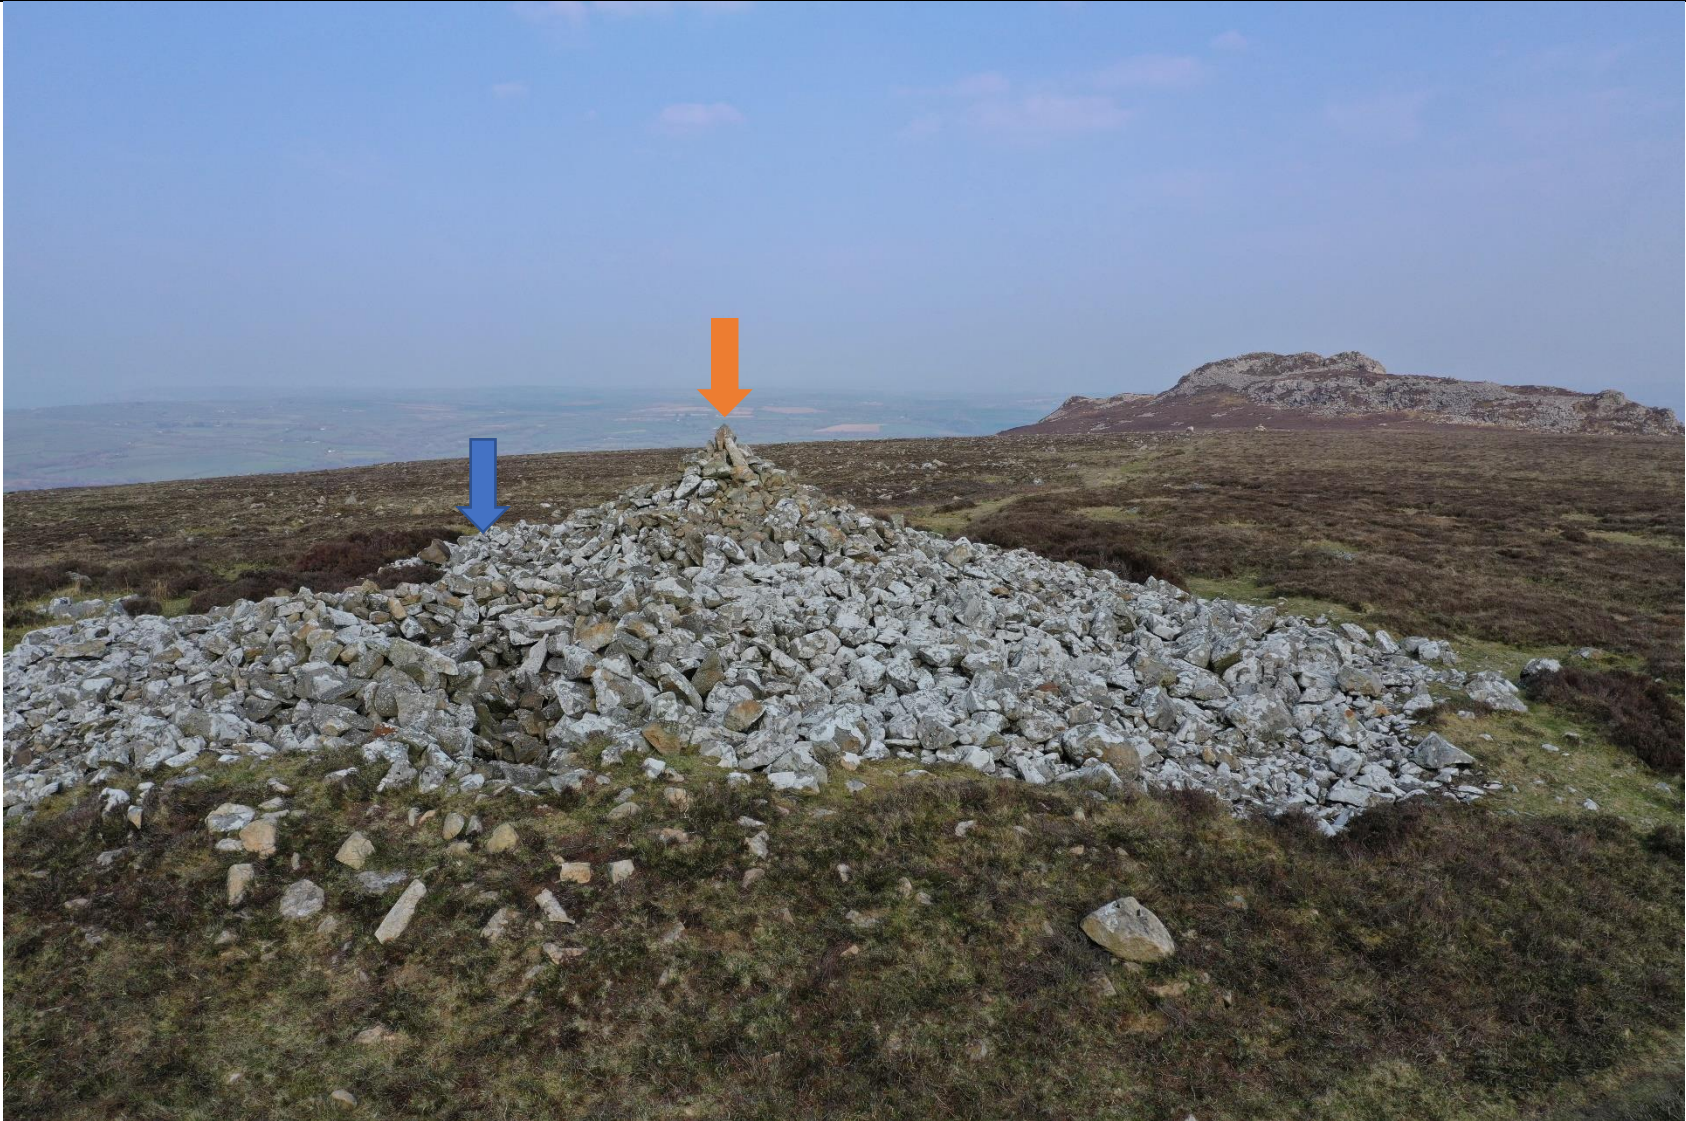
Figure 8. Monument towards east prior to reconsolidation work. Peak indicated by orange arrow and location of rim and depression indicated by blue arrow.

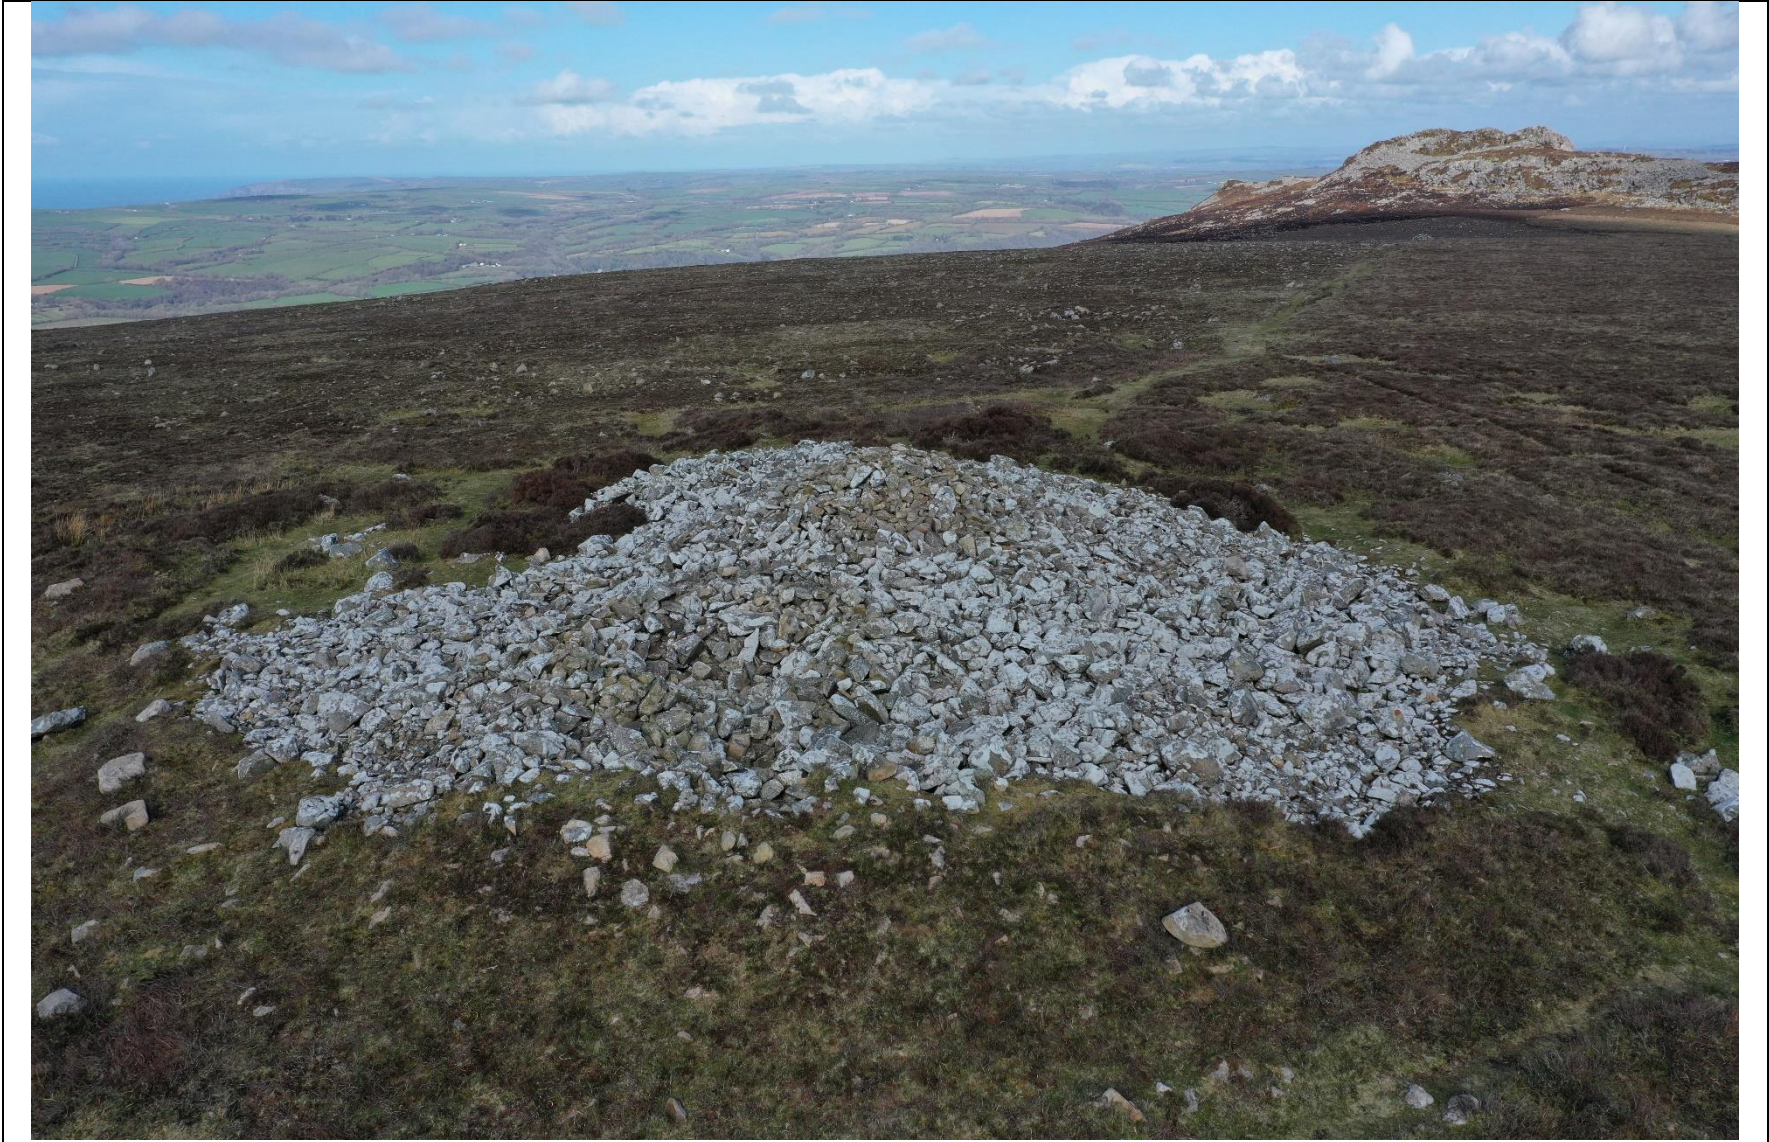
Figure 9. Monument towards north after reconsolidation work.

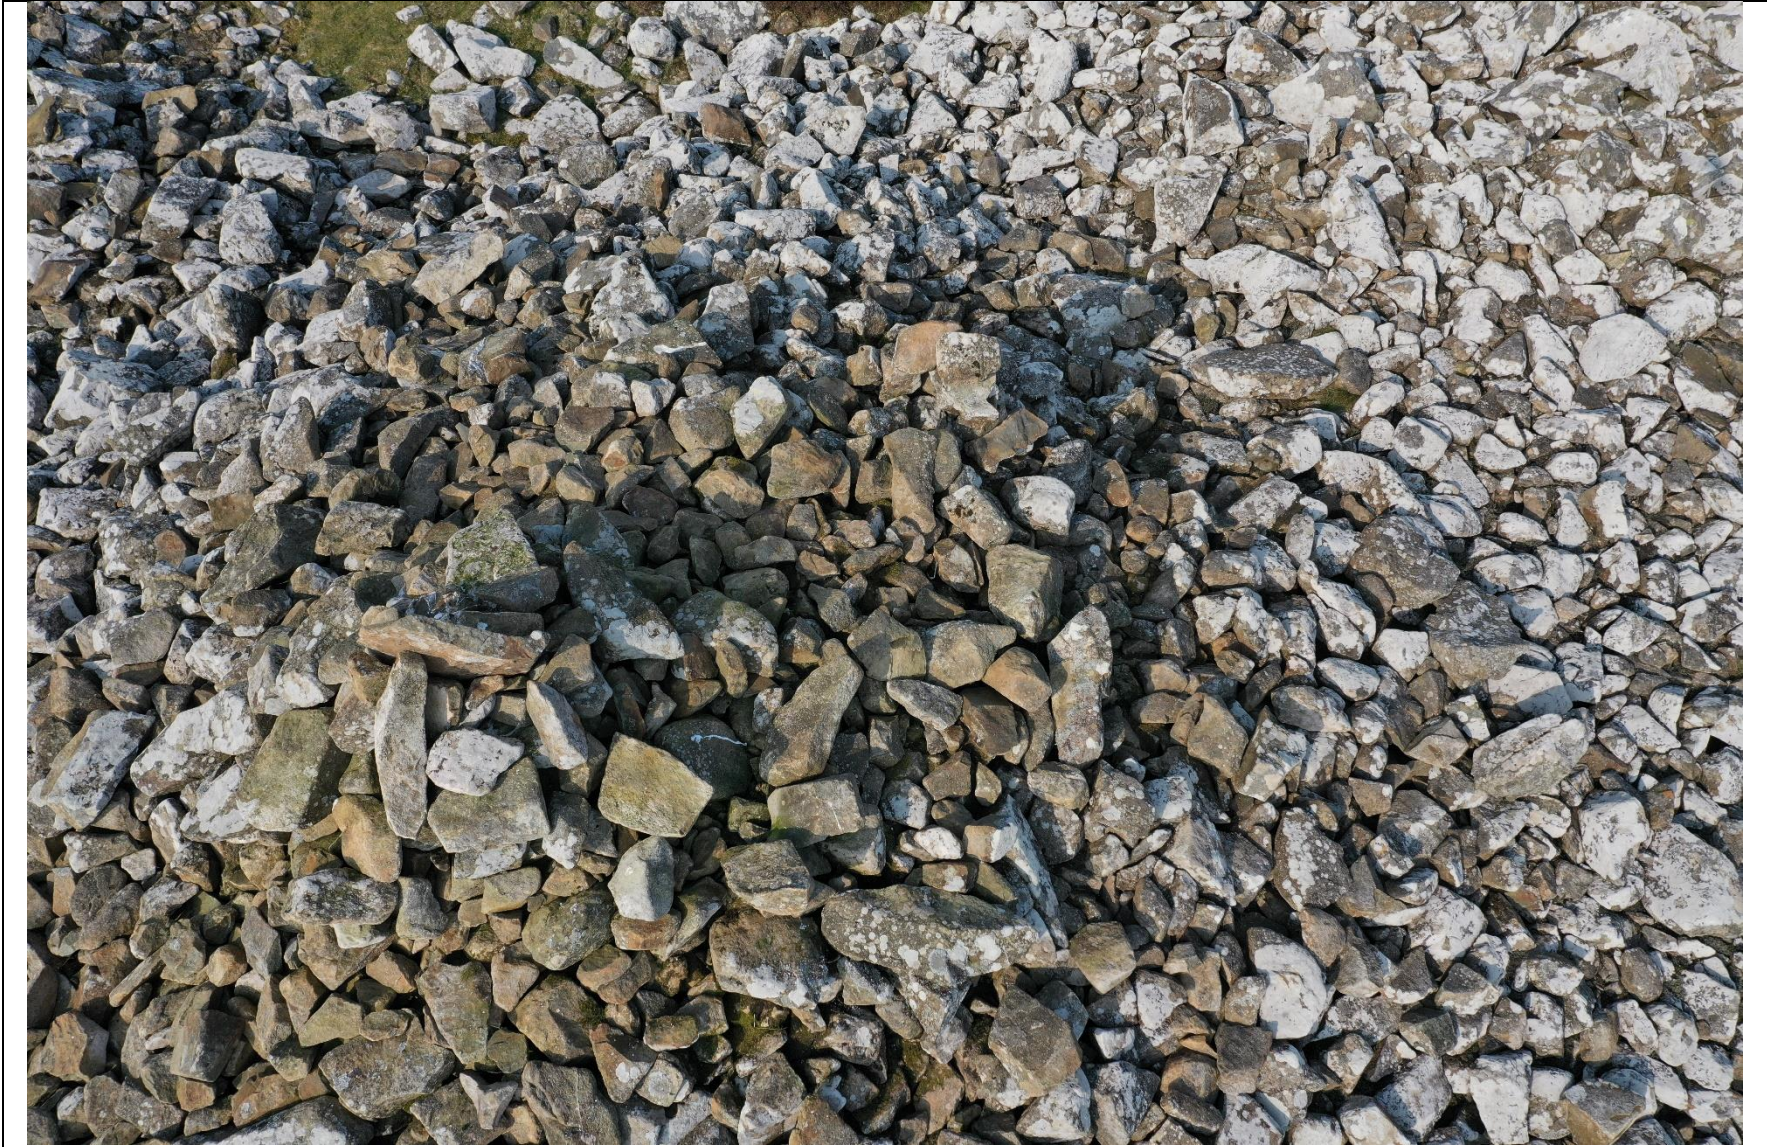
Figure 10. Aerial view of peak prior to reconsolidation work.

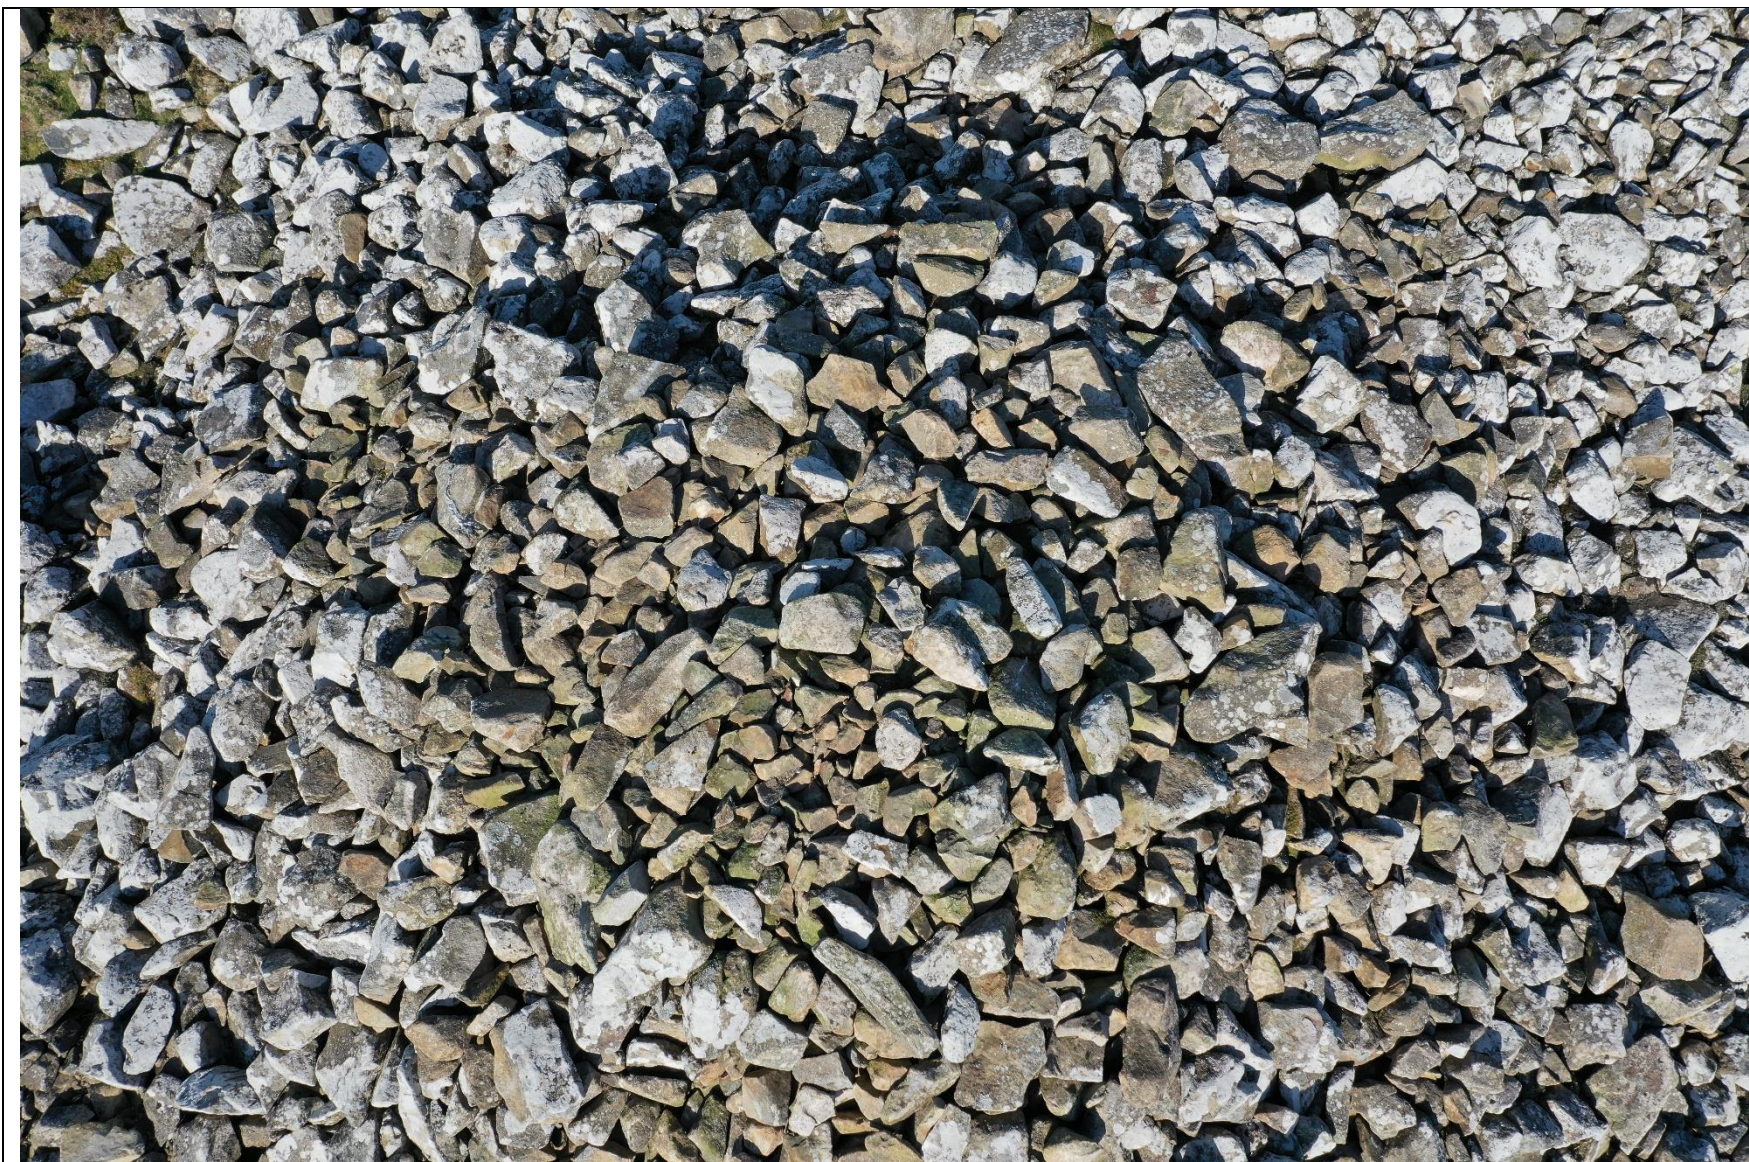
Figure 11. Aerial view of peak after reconsolidation work.

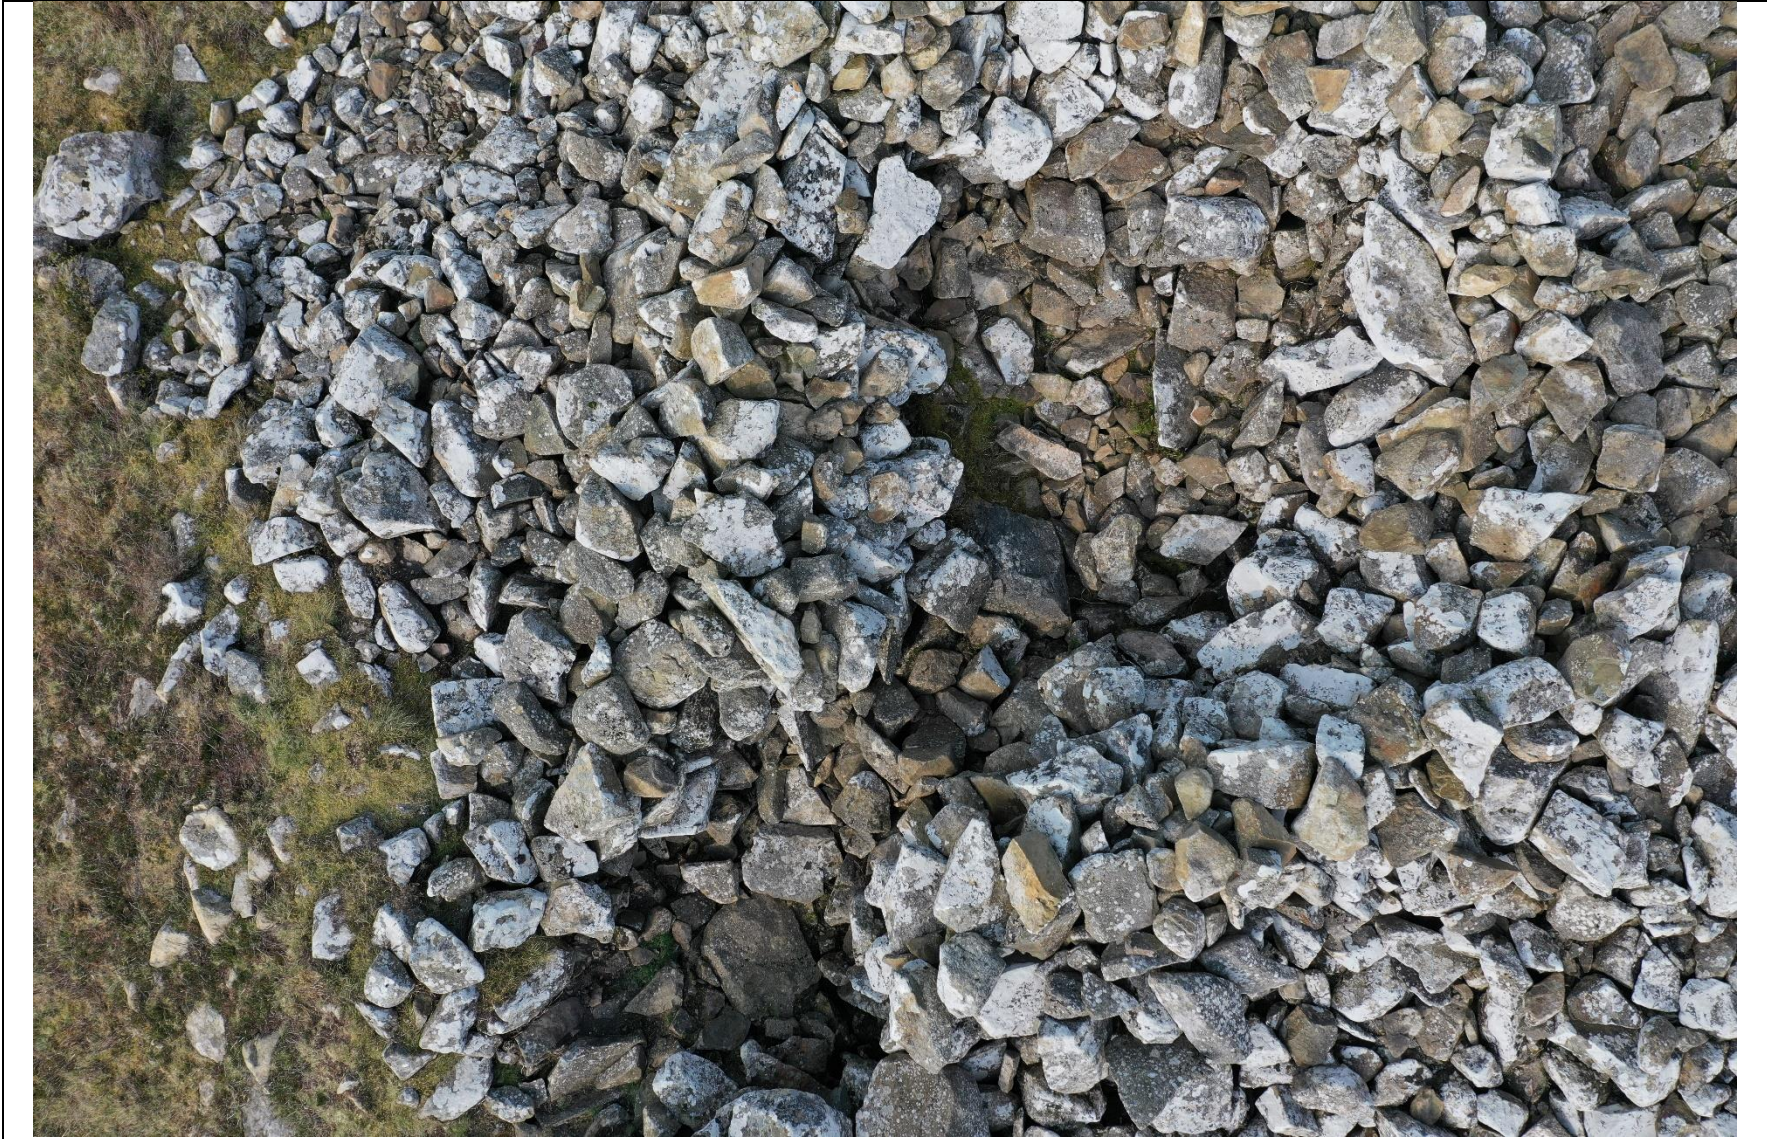
Figure 12. Aerial view of rim and depression prior to reconsolidation work.

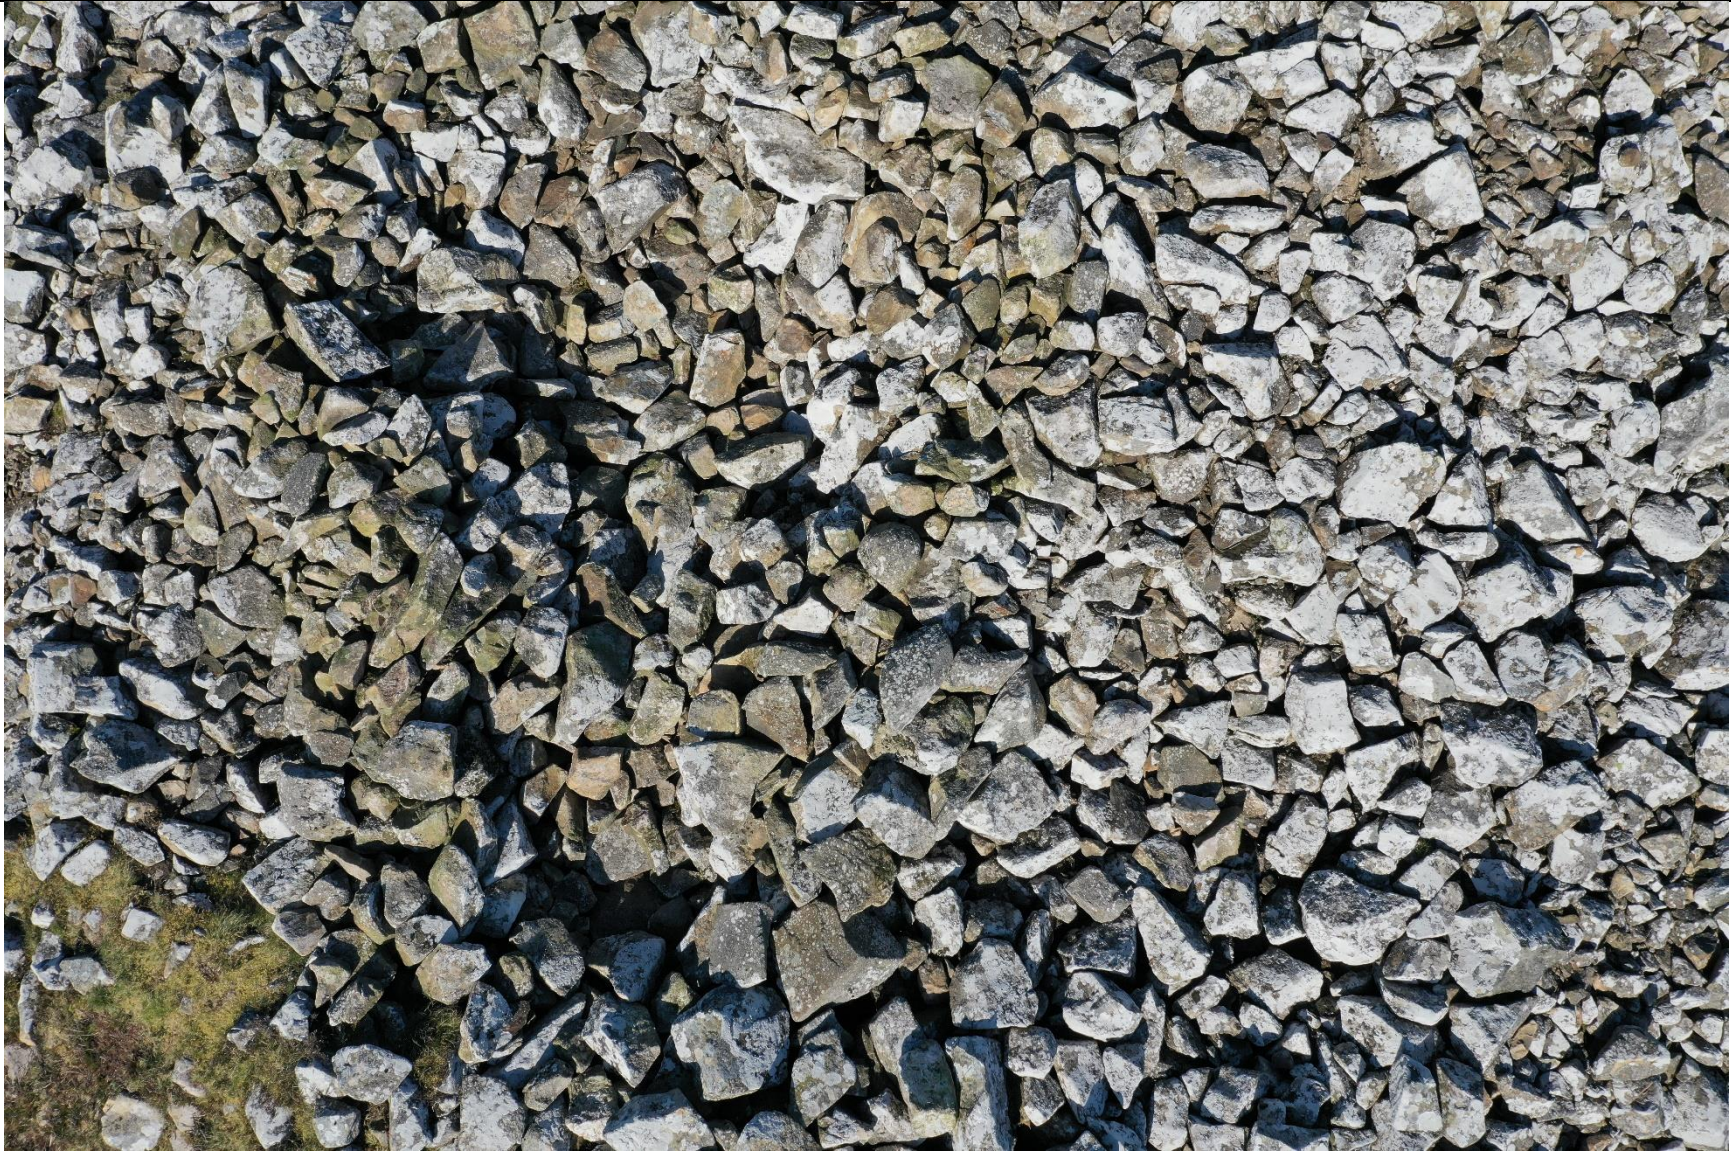
Figure 13. Aerial view of rim and depression after reconsolidation work.

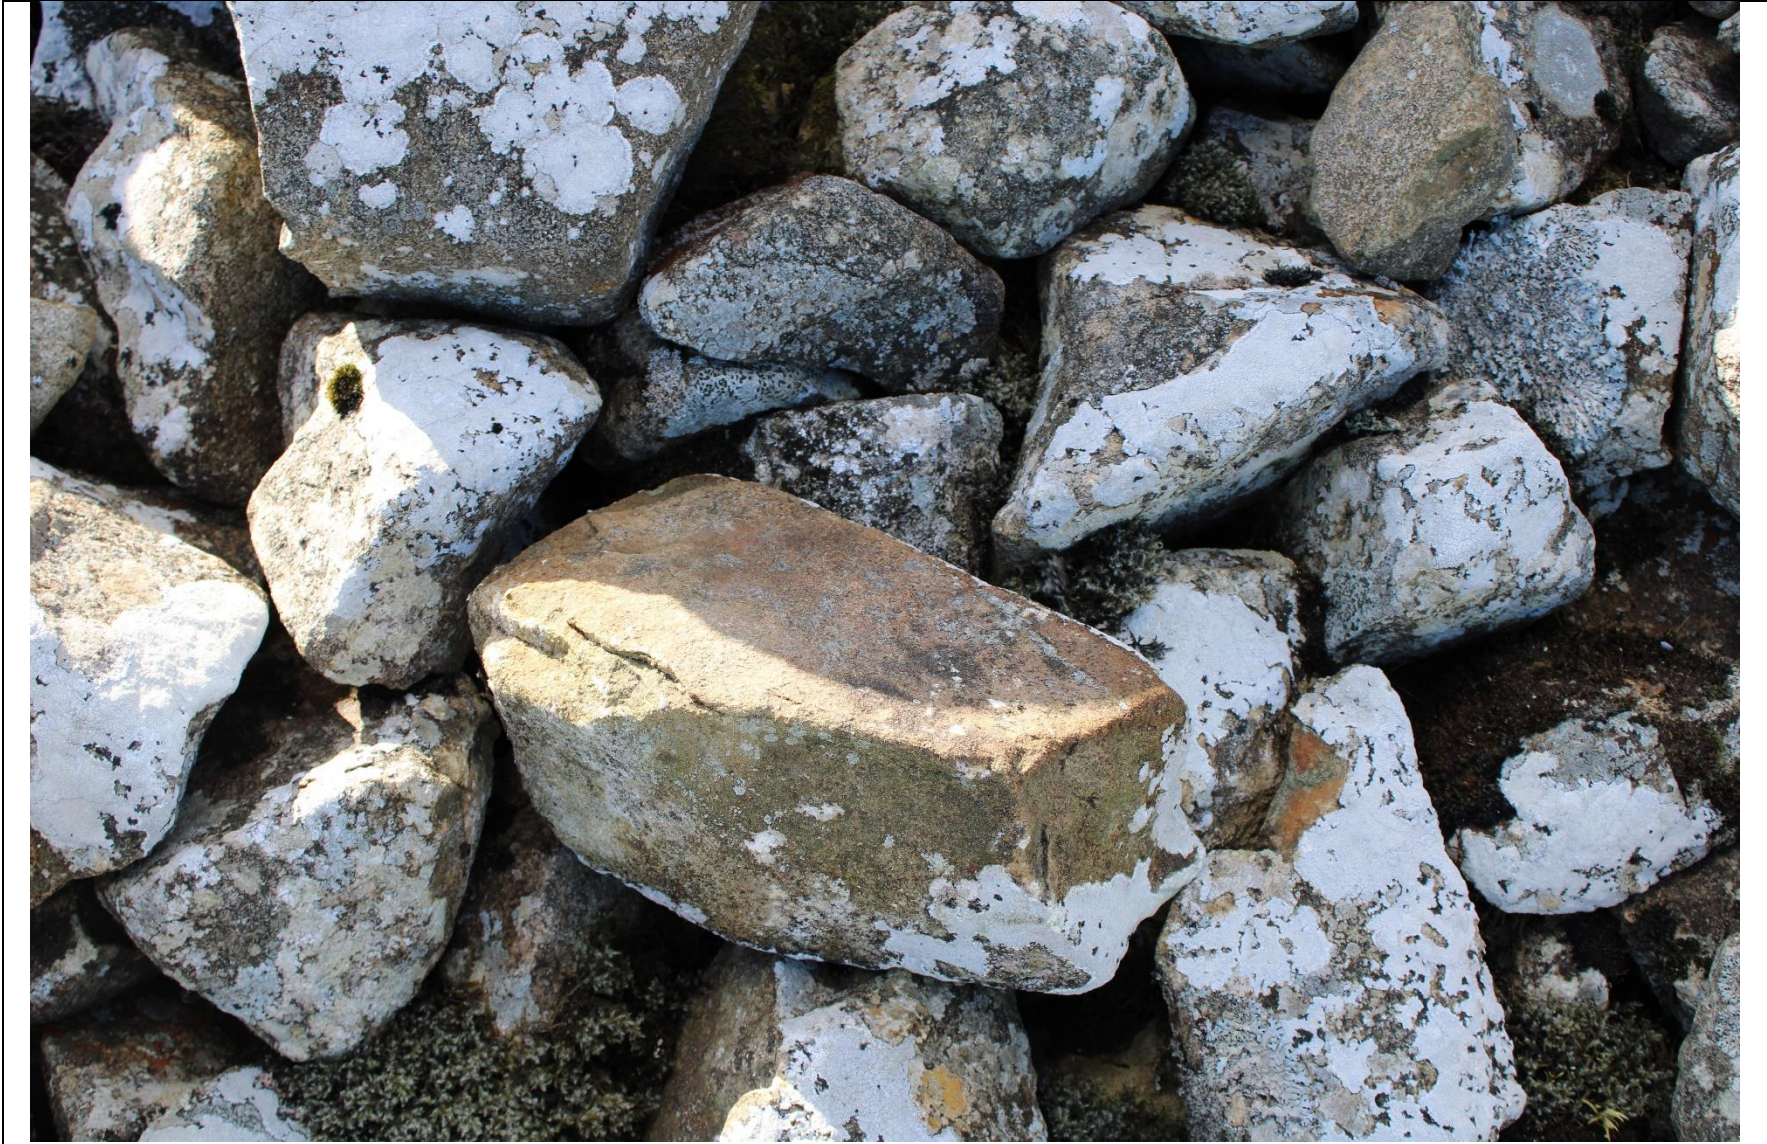
Figure 14. Photo showing example of disturbed stone with lichen facing downwards.
