PE544 CARN BRIW ROUND CAIRN SCHEDULED MONUMENT:
RECONSOLIDATION WORK OF CAIRN

Prepared on behalf of the Pembrokeshire Coast National Authority by Tomos Jones, Community Archaeologist.

03 October 2022

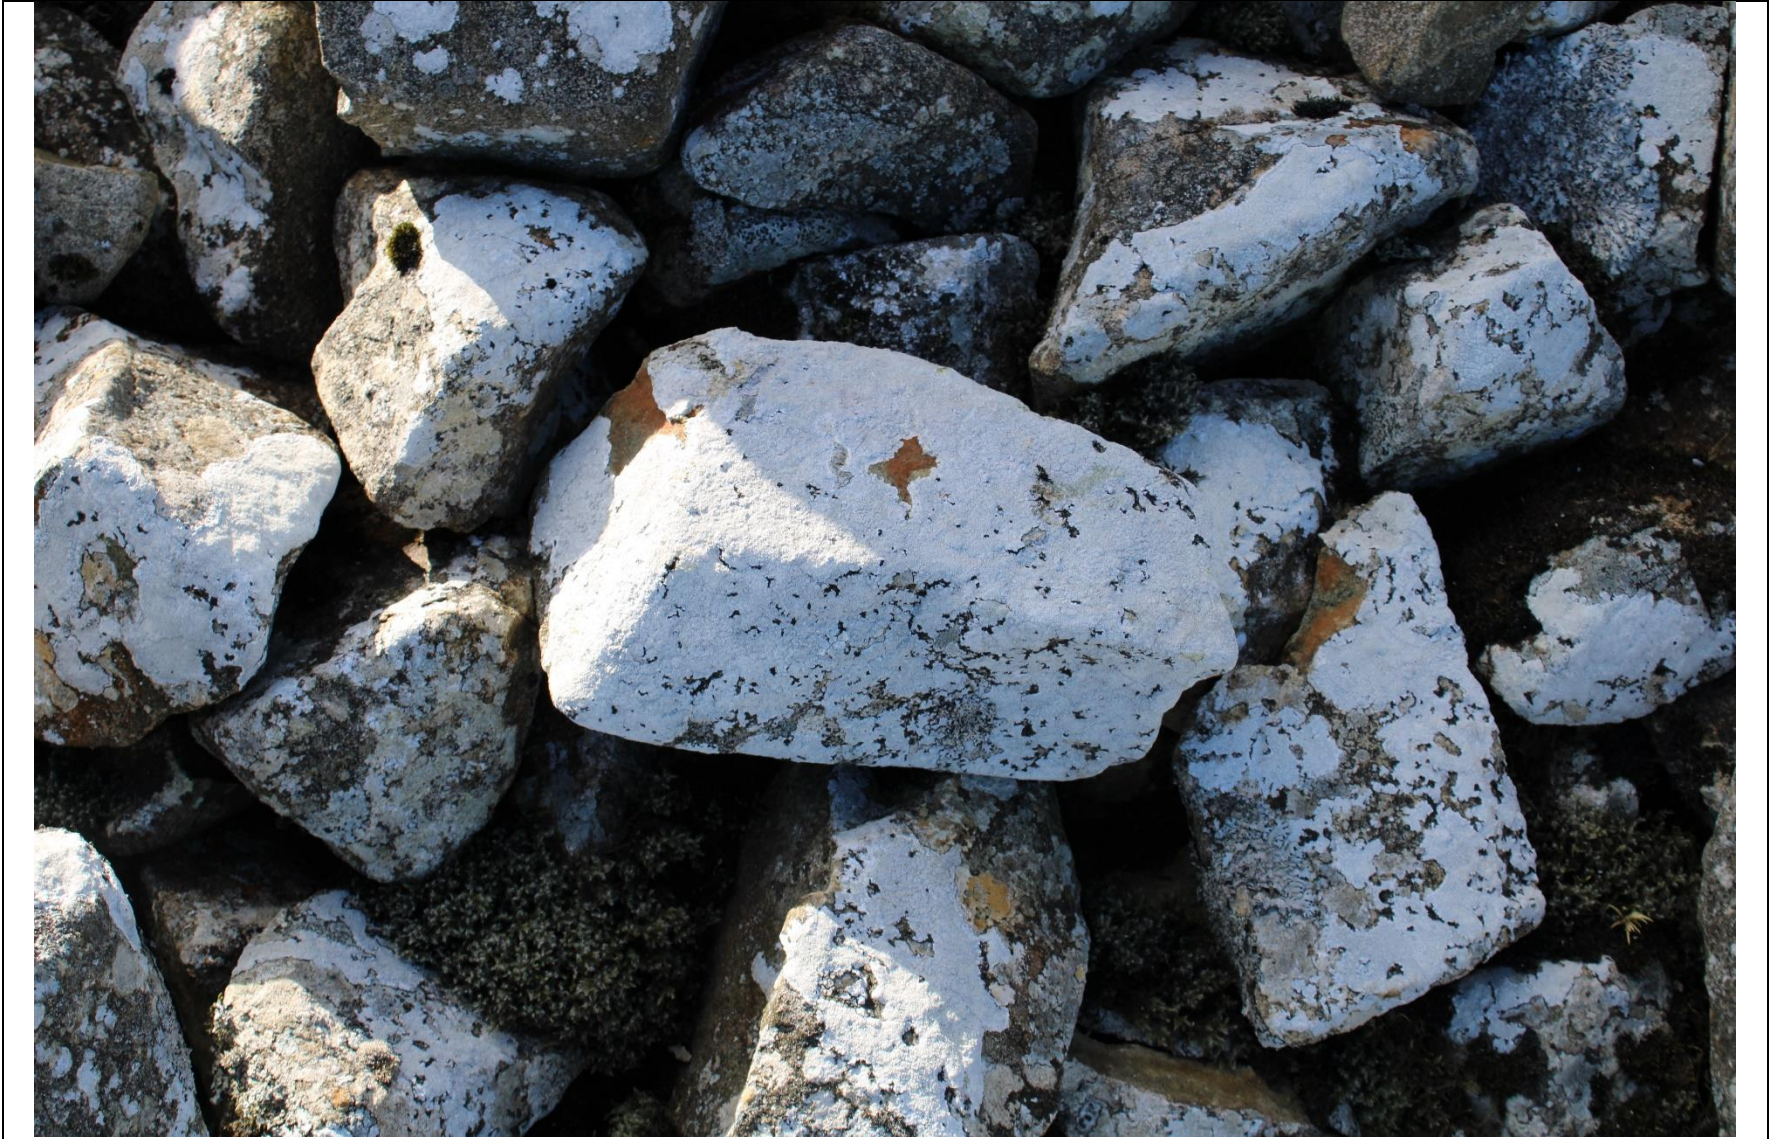
Figure 15. Photo of same disturbed stone in figure 14 turned over so that lichen is correctly facing the sky.

- In relation to the rim and depression on the southern side of the cairn (see section 3), stones composing the rim were carefully removed. The stones were then placed in the depression. Stones with lichen on their surface were placed on top. This meant the surface looked less disturbed, hopefully discouraging or at the very least limiting future disturbance.
- A general walk over the cairn surface took place to identify stones that had been disturbed, indicated by the absence of lichen on the surface of stones. Any identified disturbed stones were turned over, so that lichens were facing towards the sky (see example in figures 14 and 15).
- Photographs showing before and after are provided in section 3.

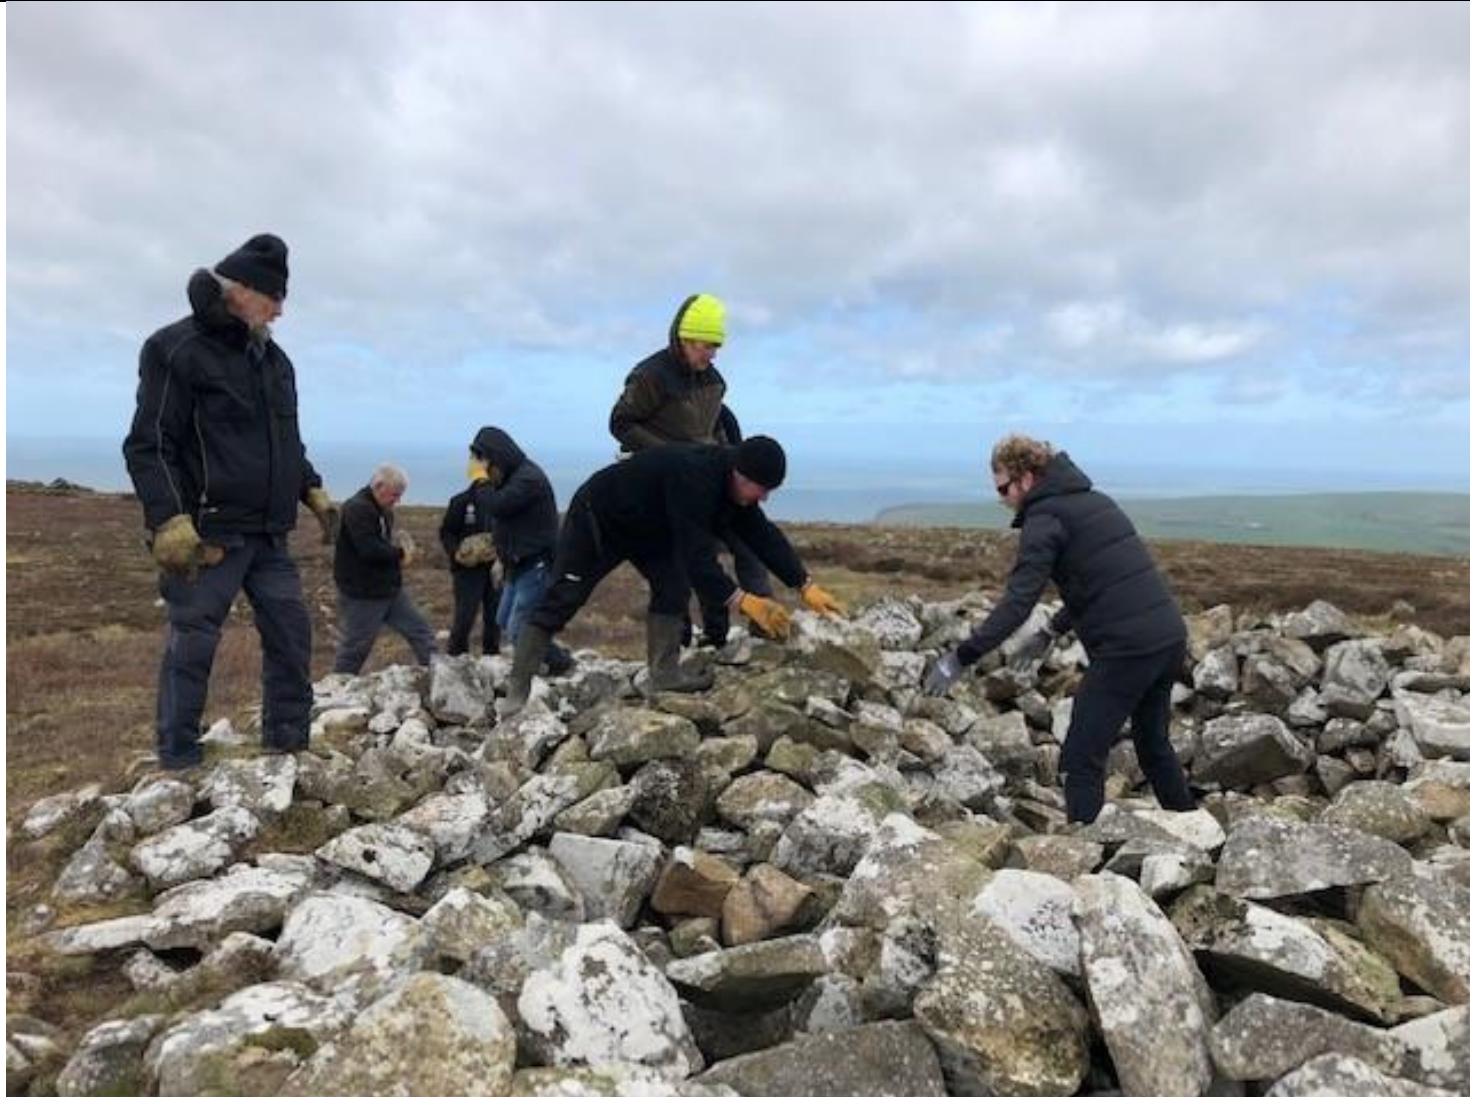
Figure 16. Photo showing the community archaeologist with group of volunteers rearranging stones to minimise the impact of disturbance.

The proposed work was carried out on behalf of the National Park Authority by the community archaeologist with the help of an area ranger and also a group of volunteers on 07 April 2022. The following approach was undertaken:
