## Archaeological Watching Brief Report:

### Caerphilly Castle Moat Banks

January 2023

Prepared for Cadw

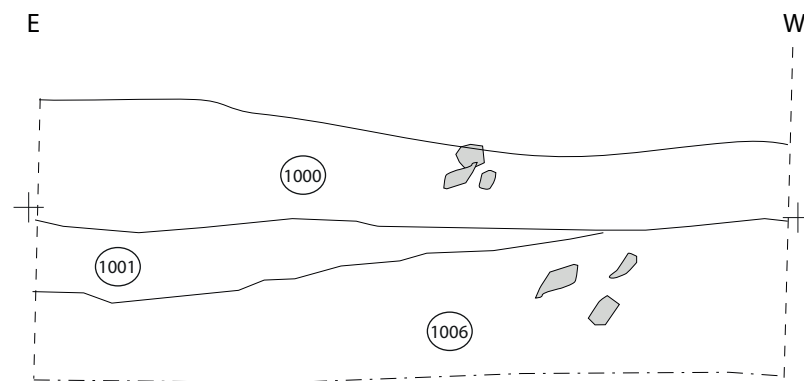
North Facing Representative section within Area 1W

Figure 3:  
Representative sections within  
Area 1

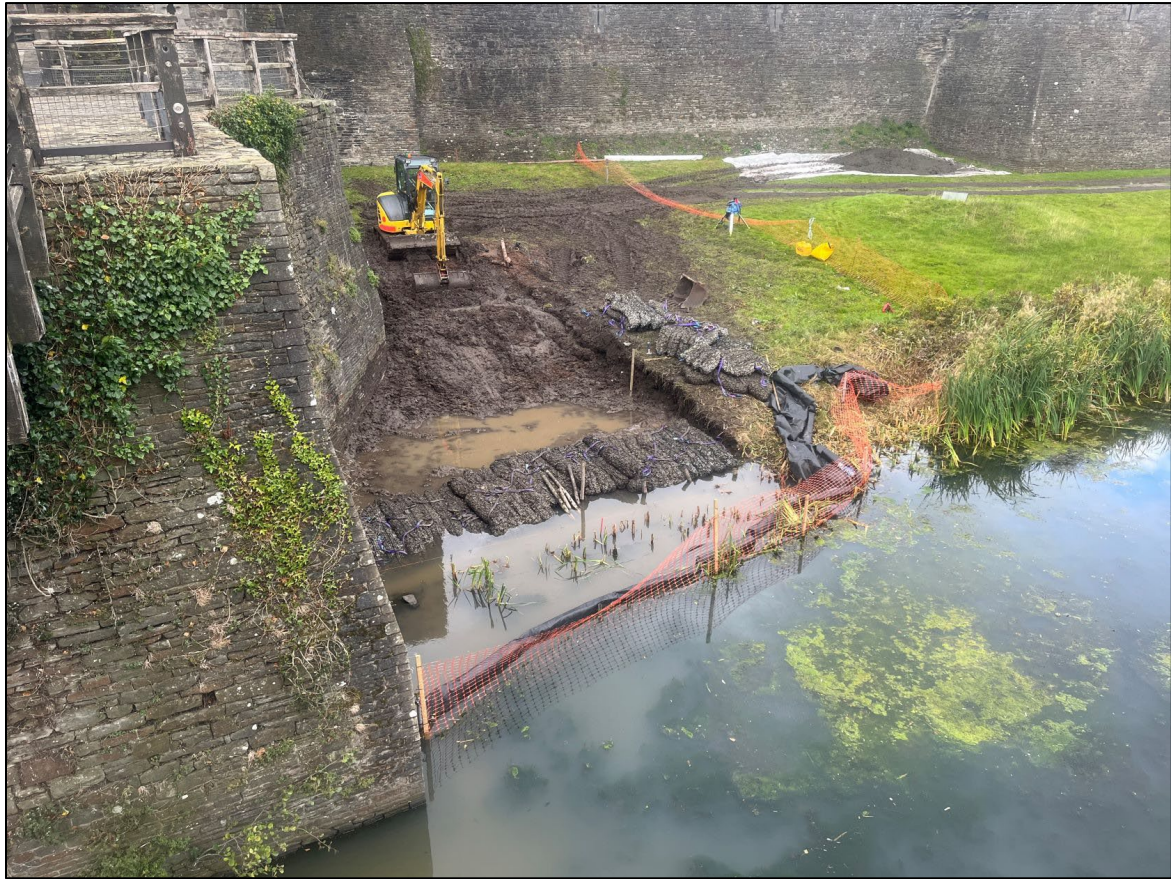
- 4.2.1. Area 1 West comprised a sub-rectangular area with an irregular southern edge bordering the eastern outer entrance bridge piers and the Outer Castle Curtain walls. The area measured 17m north to south by 28m east to west and was excavated to an average depth of 0.63m from the current ground level. The topography of Area 1W sloped down towards the east and the moat, relatively flat towards the west end and increasing in gradient towards the moat (plate 1). The area had been previously disturbed by the excavation of evaluation Trench 1 and by the installation of a large number of power cables. These were disconnected and removed, further disturbing the layers within Area 1W. For a fuller stratigraphic account of the undisturbed archaeological deposits see *Glass, 2022*; Trench 1.

*Plate 1: Area 1W, eastern end, view to northwest.*

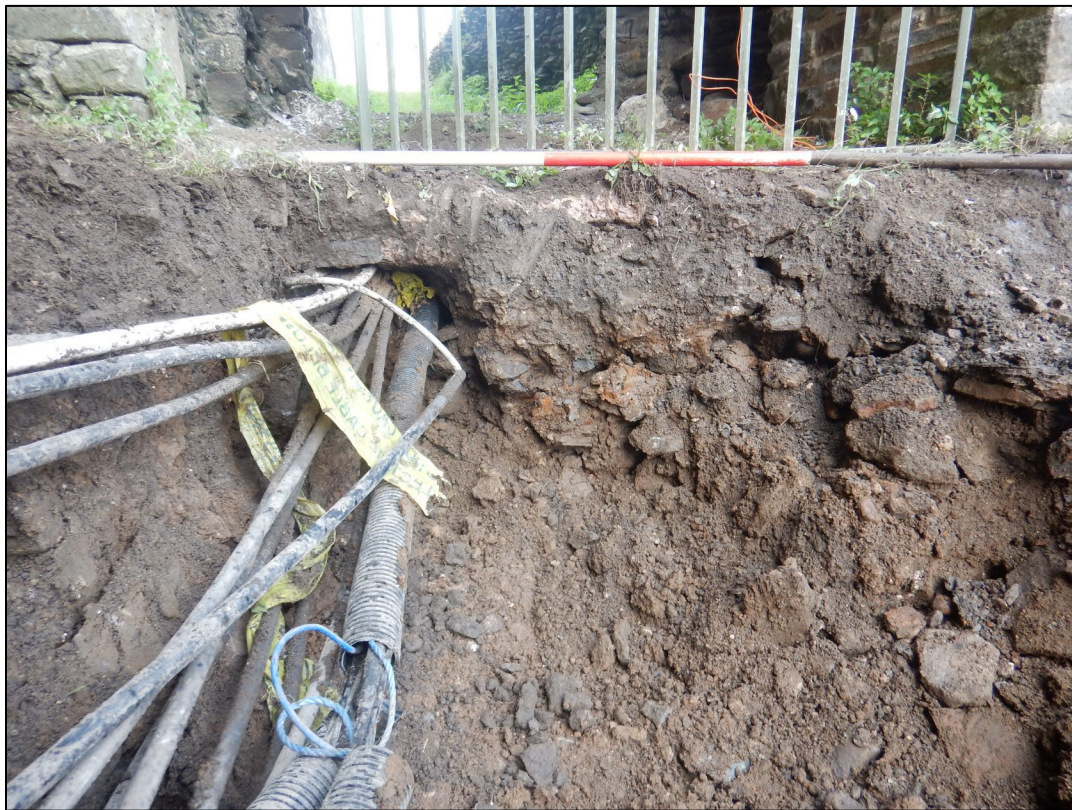
- 4.2.2. The basal deposit encountered during the watching brief in Area 1W was a firmly compacted mid brown and yellow clay containing occasional small to large angular and sub-angular stones (1002). This deposit was recorded in the western up-slope part of Area 1W at a depth of 0.35m and in the eastern down-slope part at 0.42m. This layer is interpreted as the natural geology and appeared to be overlain by foundations

for the outer curtain wall and gate (plate 2). The foundations for the eastern castle entrance bridge were also exposed at the southern end of Area 1W (plate 3)

*Plate 2: Area 1W, East Facing Section, context (1002) and modern electrical services, view to west. 1m scale.*

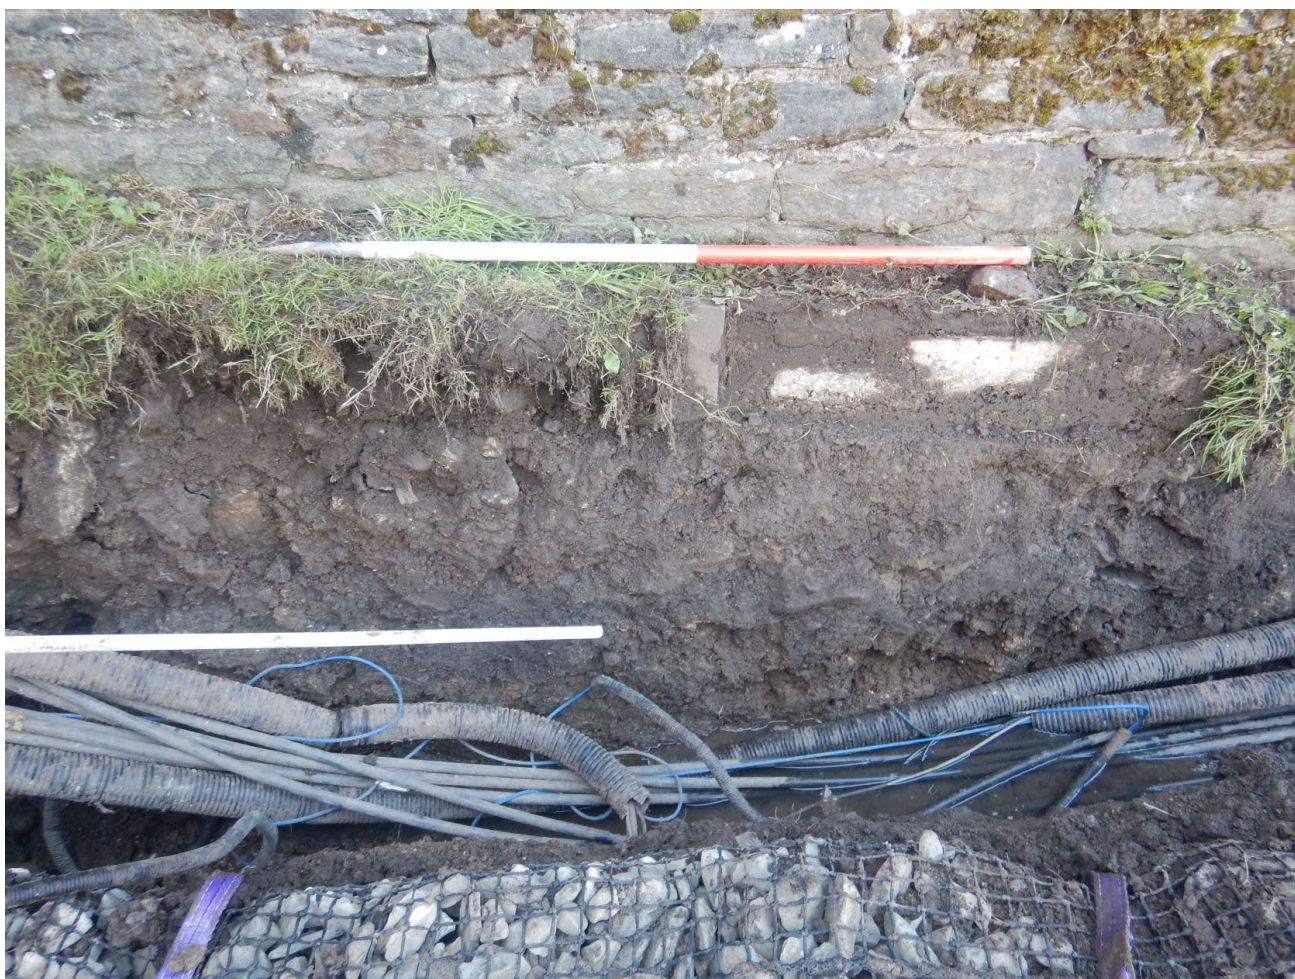
*Plate 3: Area 1W, North Facing Section, showing foundations of bridge pier view to south. 1m scale.*

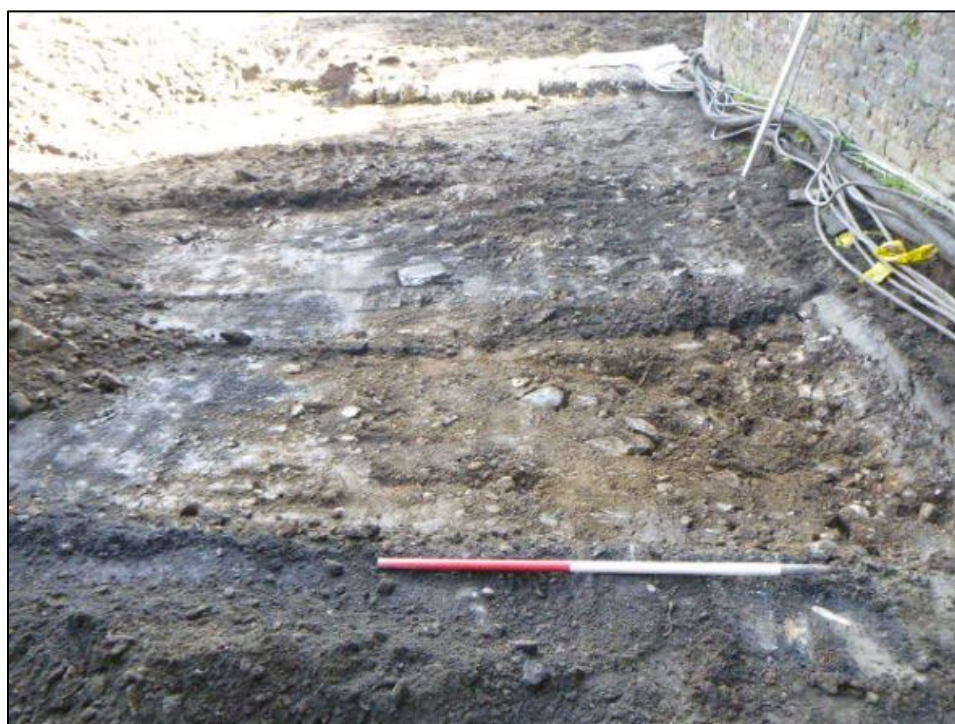
- 4.2.3. Located at the southwest corner of Area 1W, adjacent to the curtain wall gateway was a cut [1003] for a stone path (1006). The cut was linear, aligned approximately east-west, shallow (approx. 0.2m deep) with vertical sides and measured approximately 8m long by 2.9m wide (north-south). The fill (1006) contained rounded and sub-angular limestone of varied sizes (plate 3). These were bonded with mid greyish-brown silty clay containing inclusions of coarse sand, mortar and charcoal flecks (plate 4). This is equivalent to path (108) recorded in the earlier evaluation (Glass, 2022). A re-deposited subsoil layer (1004) was also recorded above the natural (1002) on the north side of Area 1W. This layer comprised a compact deposit of mixed mid yellowish-grey, mid brownish-yellow, mid brownish-red and black silty sand with pockets of clay or coarse sands with frequent stone. This layer is interpreted as a made ground deposit composed of mixed stone, mortar and sands deliberately dumped to create a raised solid level for the western bank of the eastern moat and is equivalent to layer (107) recorded in the earlier evaluation (Glass, 2022). Its stratigraphic relationship with path (1006) was not clear.

*Plate 4: Area 1W, Deposit (1006), view to east. 1m scale.*

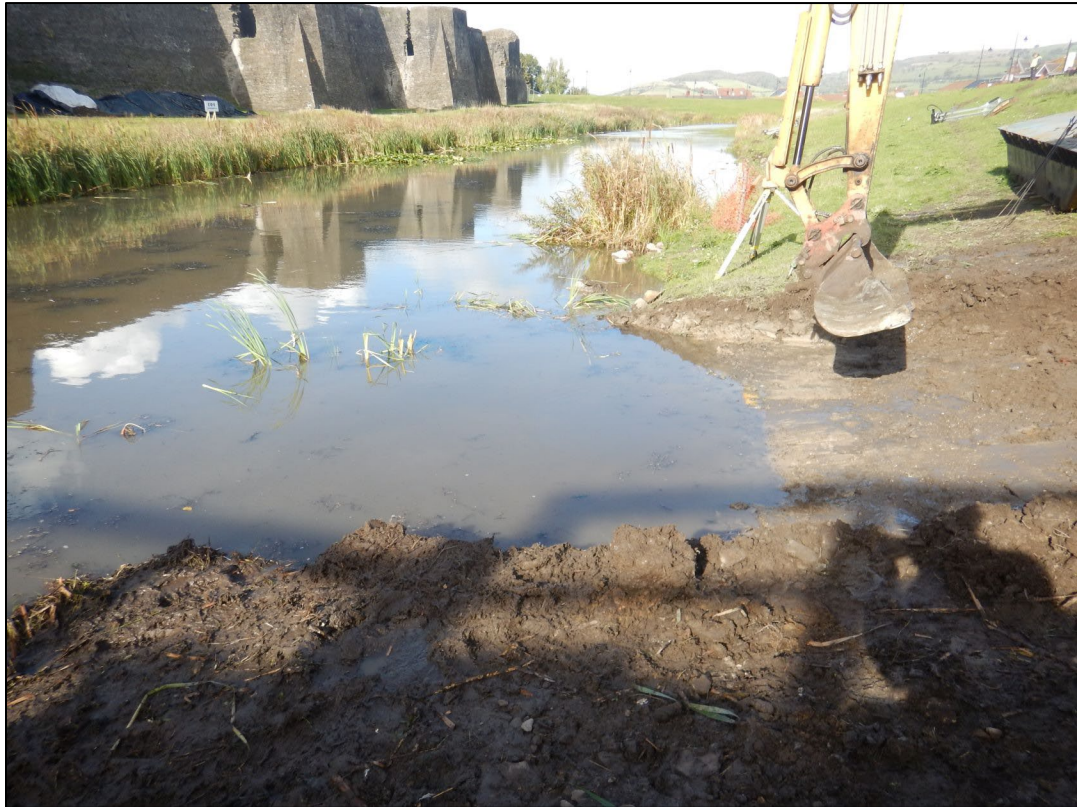
- 4.3.1 Area 1 East was approximately rectangular in plan and occupied the moderately sloping eastern moat bank. The eastern portion of the area rose steeply to the south towards the bridge entry walls creating a steep incline. The area measured 17m north to south and 12m east to west with a curved southeast corner where the footpath joins to the entrance bridge. Up-slope the area was excavated to a maximum depth of 0.50m and downslope to 0.63m (plate 5). The area contained three redeposited soil layers and there were no archaeological features observed.

*Plate 5: Area 1 E, view to north.*

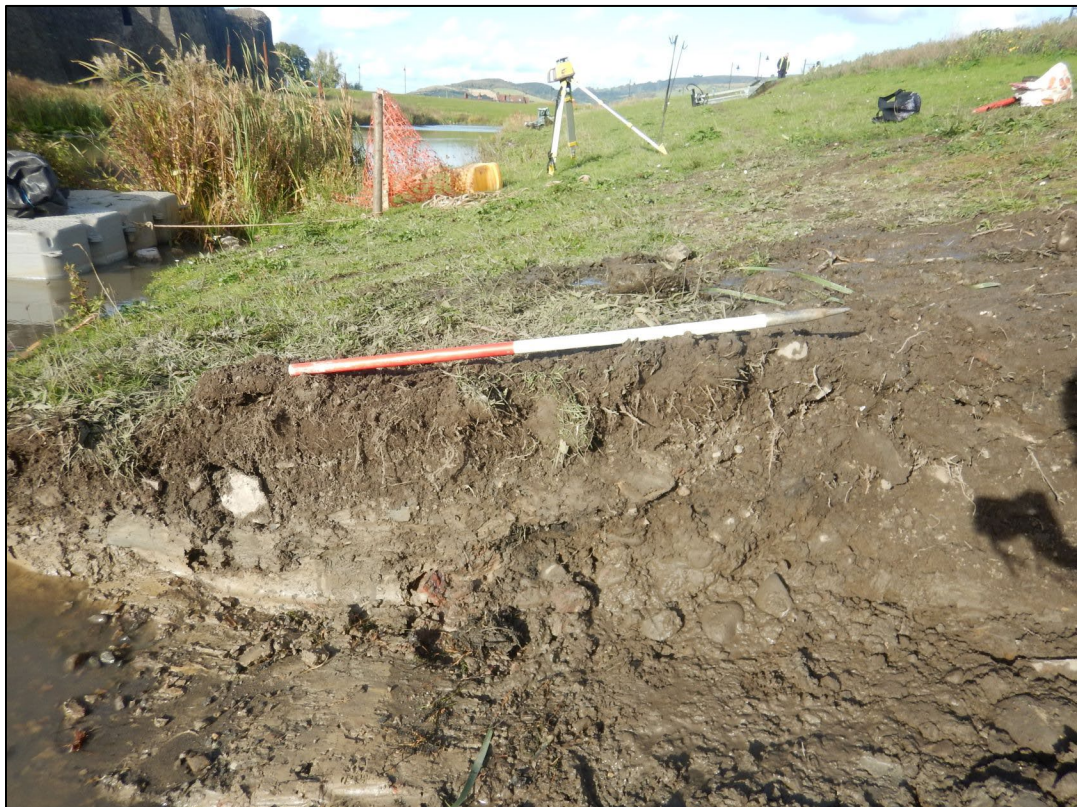
- 4.3.2. The basal deposit, recorded at a depth of 0.63m at the western end of the area, was layer (2002). This comprised a deposit related to the build-up and re-profiling of the bank during the mid-20<sup>th</sup> century (plates 5 and 6) and is equivalent to layer (202) recorded during the earlier evaluation (Glass, 2022). The soil comprised a mixture of dark grey silt, grey sand and grey-brown clay containing CBM, glass and brick fragments. Directly above (2002) was a re-deposited subsoil (2001) measuring 0.45m thick and consisting of mottled dark brown silty sand mixed with grey clay, large

*Plate 6: Area 1 E, South Facing Section, view to north. 1m scale.*

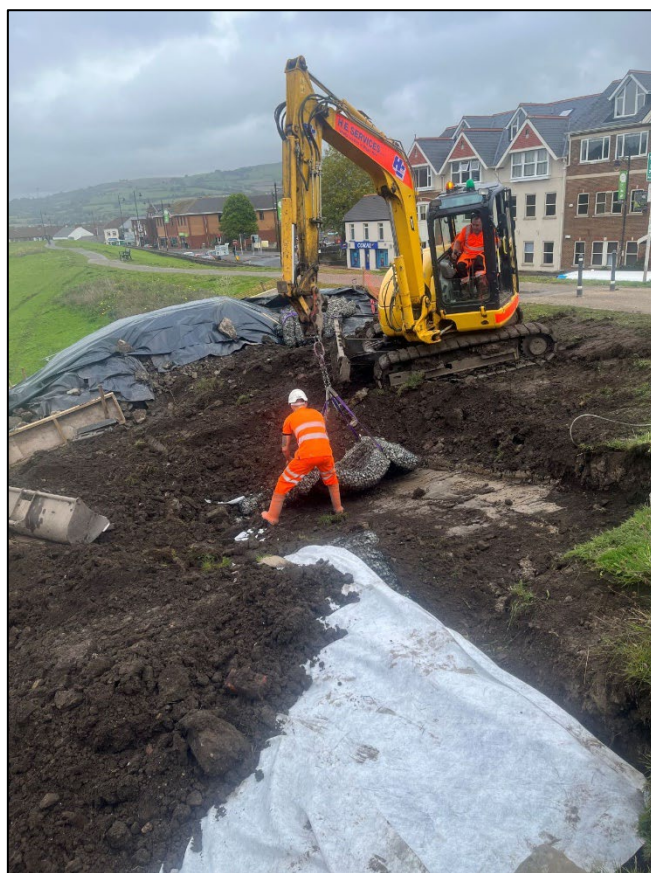
*Plate 6: Area 1 E, working shot: laying of pre-filled rock mattress. View to northeast.*

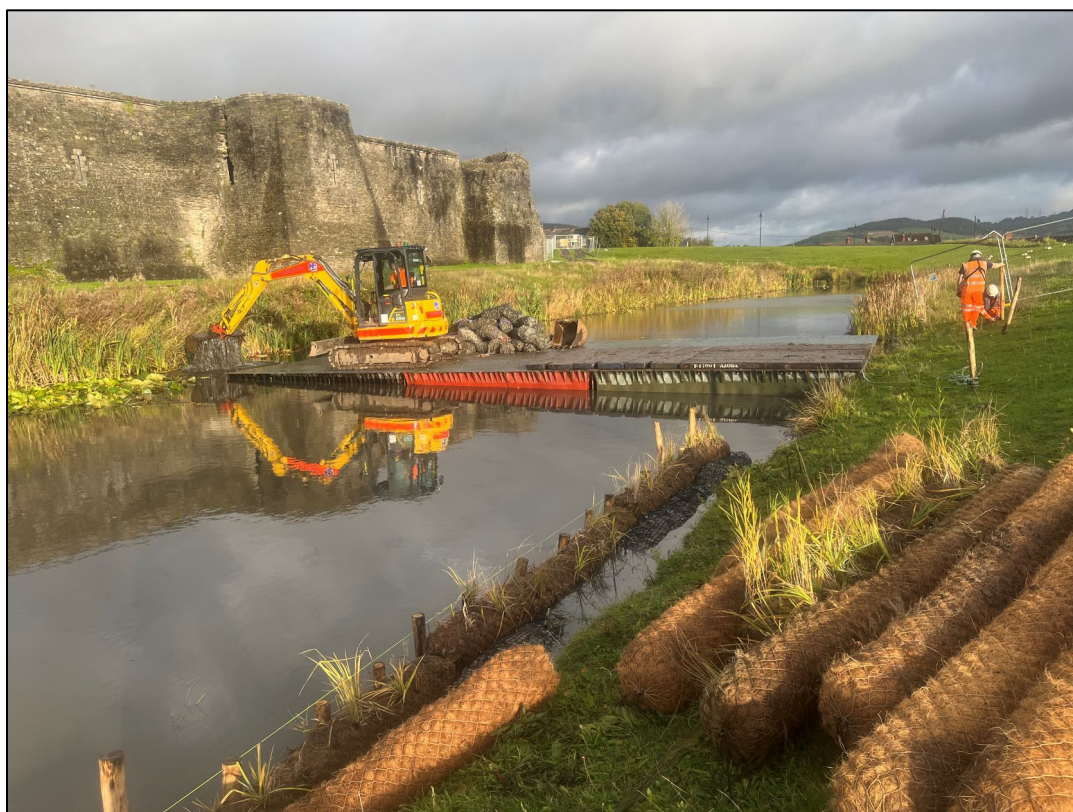
- 4.4.1. Area 2 comprised a long thin strip of ground running north from the northwest corner of Area 1E and bordering the down-slope edge of the eastern bank of the moat along the water line for the installation of coir rolls (plate 8). For safety reasons, monitoring of the soil deposits took place from the bank while the machine bucket contents were deposited on a pontoon floating in the moat.
- 4.4.2. A single soil deposit (3000) was recorded in Area 2, below the topsoil and the waterline. It comprised a loose waterlogged layer of dark grey and brown decaying organic debris and silty clayey sand. The soil contained small to large stone, whole and fragments of brick and broken pieces of plastic and cat tail reeds. Separation of soil horizons was impossible due to submergence. There were no archaeological features observed.

*Plate 7: Area 2, laying of coir rolls. View to north.*

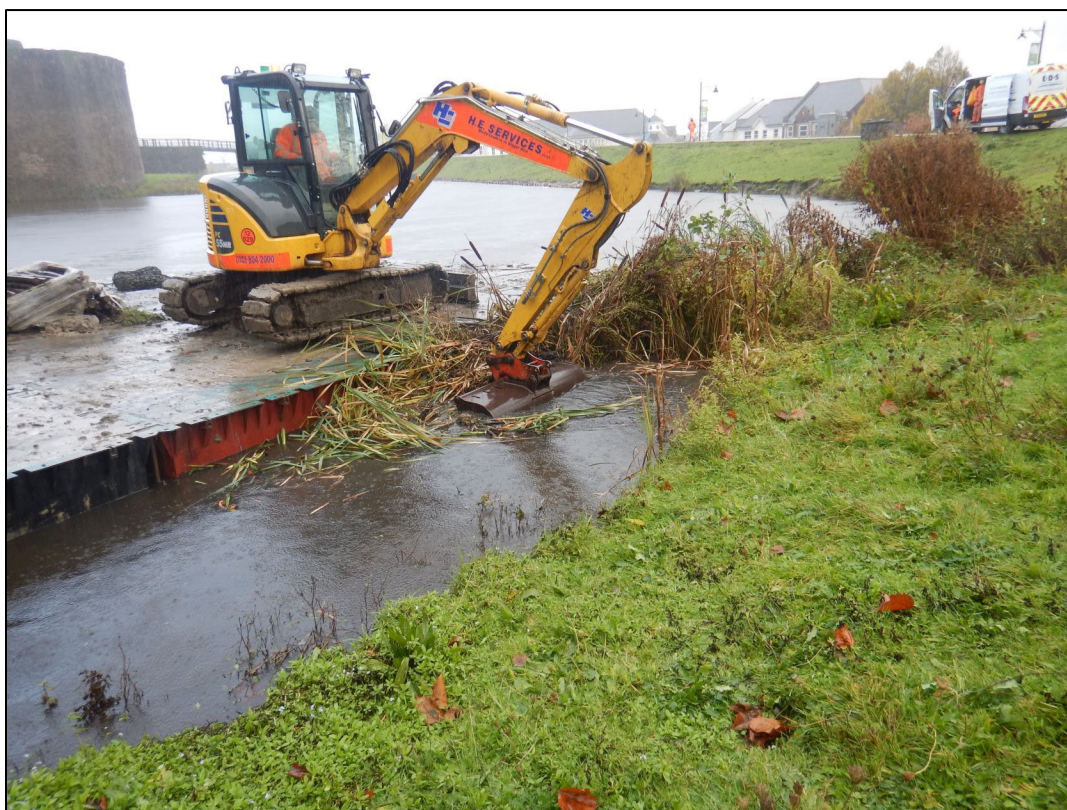
- 4.5.1. Area 3 comprised a long thin strip of ground bordering the eastern edge of the eastern bank of the moat, south of the eastern castle entrance bridge for the installation of coir rolls (plates 9-11). Again, for safety reasons, it was necessary to observe the soil deposits dredged up from below the water line from the bank while the machine bucket contents were deposited on a pontoon floating in the moat.

*Plate 8: Area 3, south end, removal of reeds in advance of excavation. View to the northeast.*

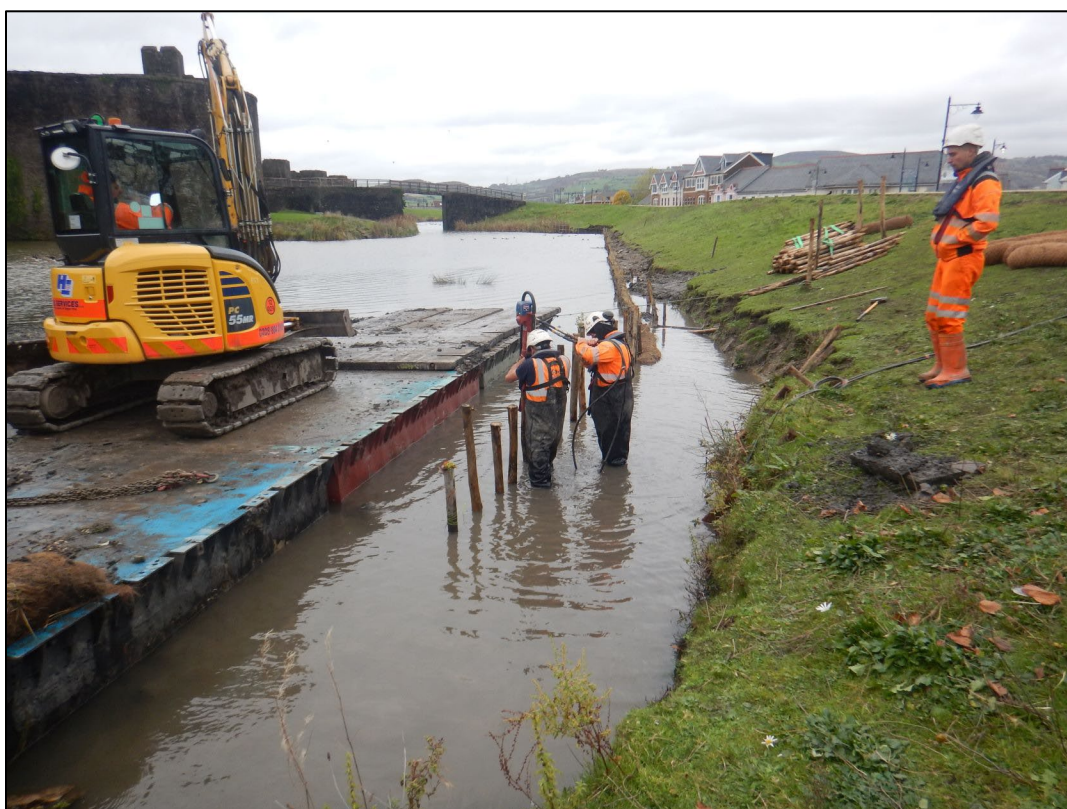
*Plate 9: Area 3, south end. Driving stakes ready to receive coir rolls. View to northeast.*

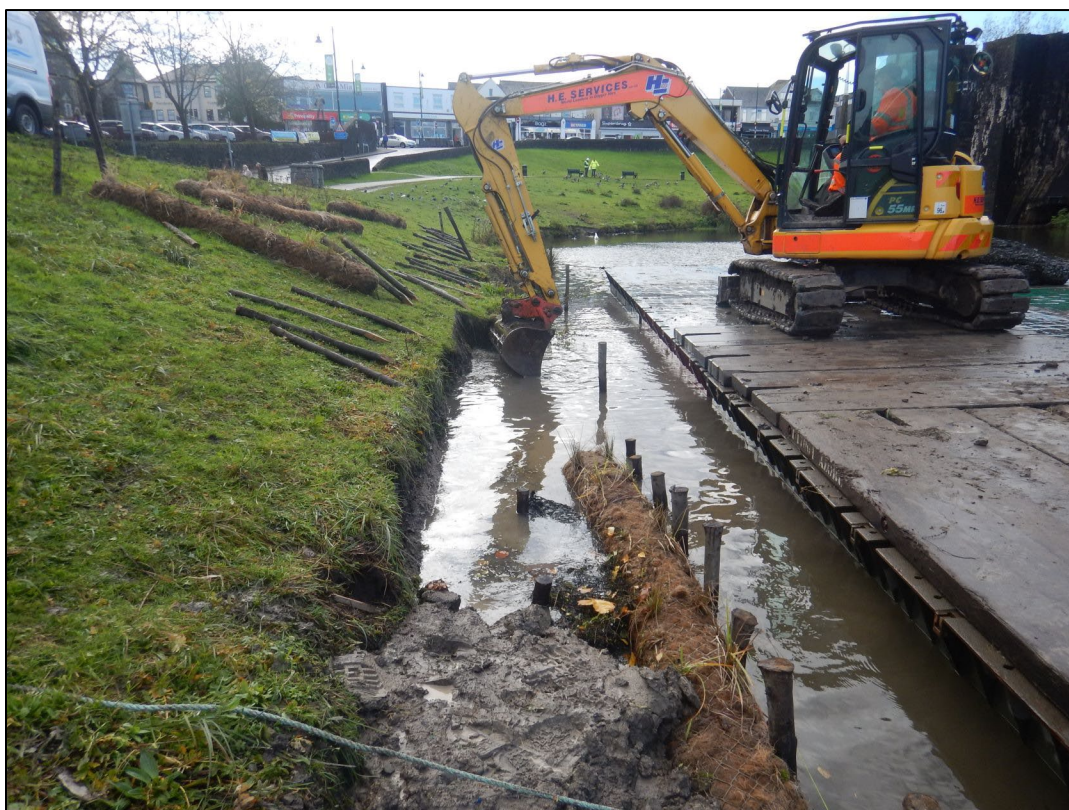
- 4.5.2. A single soil deposit (4000) was recorded in Area 3, below the topsoil and the waterline. The fill consisted of loose, waterlogged dark grey and brown decaying organic debris and silty clayey sand. The soil contained small to large stones, whole brick and brick fragments, modern rubbish and cat tail reeds.

*Plate 11: Area 3, north end, excavation of bank. View to south.*

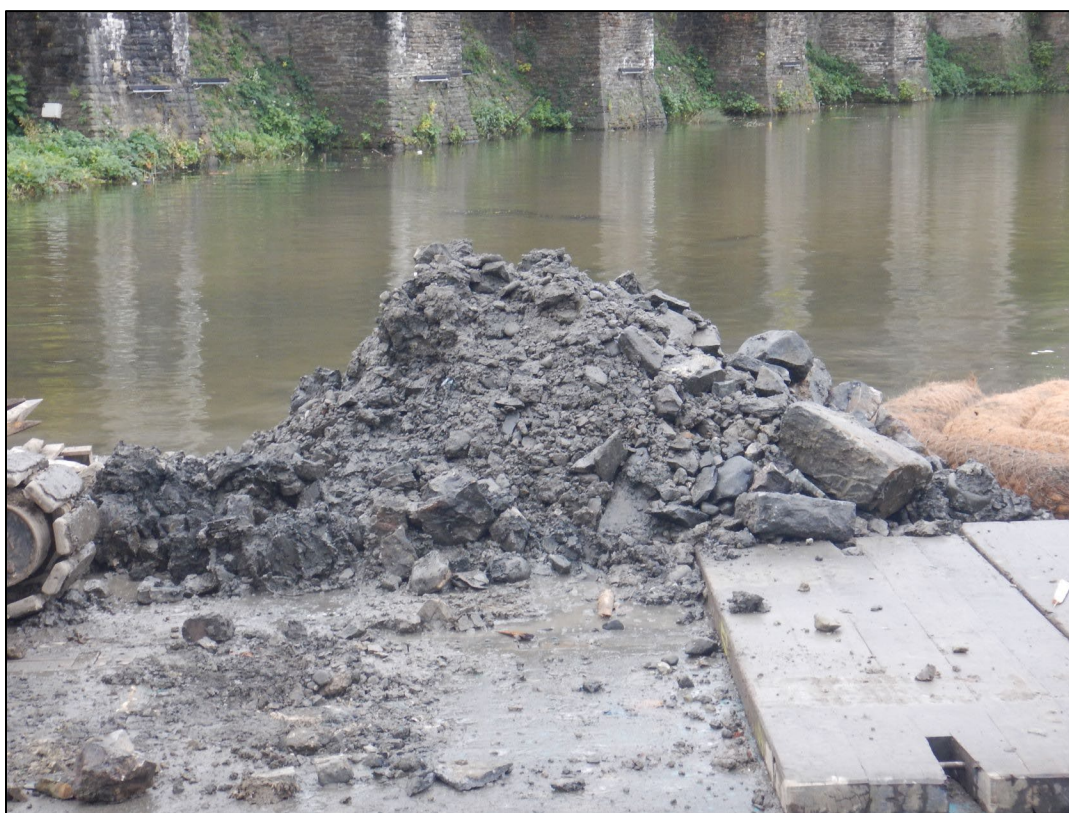
- 4.5.3 Towards the southeastern end of Area 3, close to the south end of the massive wall of the south dam, with its battery of projecting buttresses; deposit (4000) was observed to contain a higher level of large stone rubble (plate 12). This is interpreted as demolition rubble from former 19th and 20th century buildings fronting on to Castle Street recorded on historic maps. These buildings appear to have been demolished between 1920 and 1937 and the rubble then incorporated into modern landforms during the moat re-profiling works of the mid-20th century. Close to the south dam wall, the stone base of a building corner (4001) was glimpsed submerged below the water line. It was not possible to record it in any further detail and its interpretation remains uncertain. However, its location corresponds approximately with that of

buildings recorded on historic maps from 1841 but removed between 1920 and 1937 (Platt, 2021; Figures 6-11).

*Plate 12: Area 3, south end. Demolition rubble (4001) derived from 19<sup>th</sup> century buildings dredged up from the moat bank. View to northwest.*

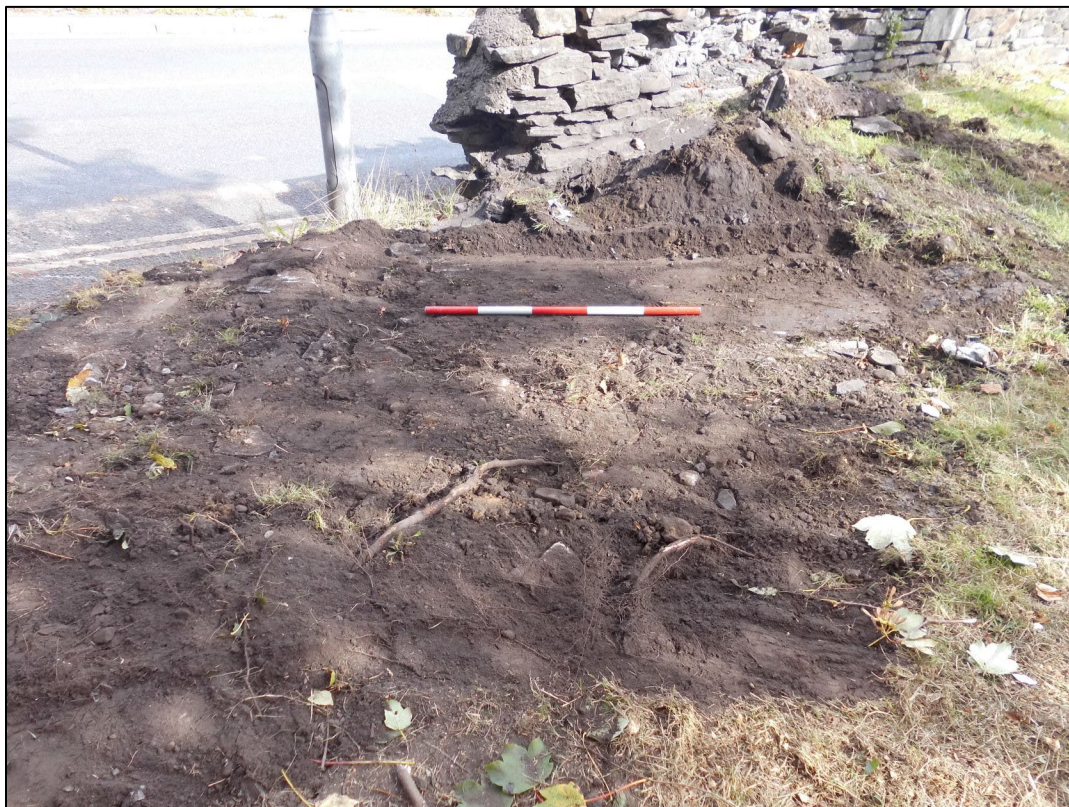
*Plate 10: Nantgarw Road gate excavations, view to northeast. 1m scale.*

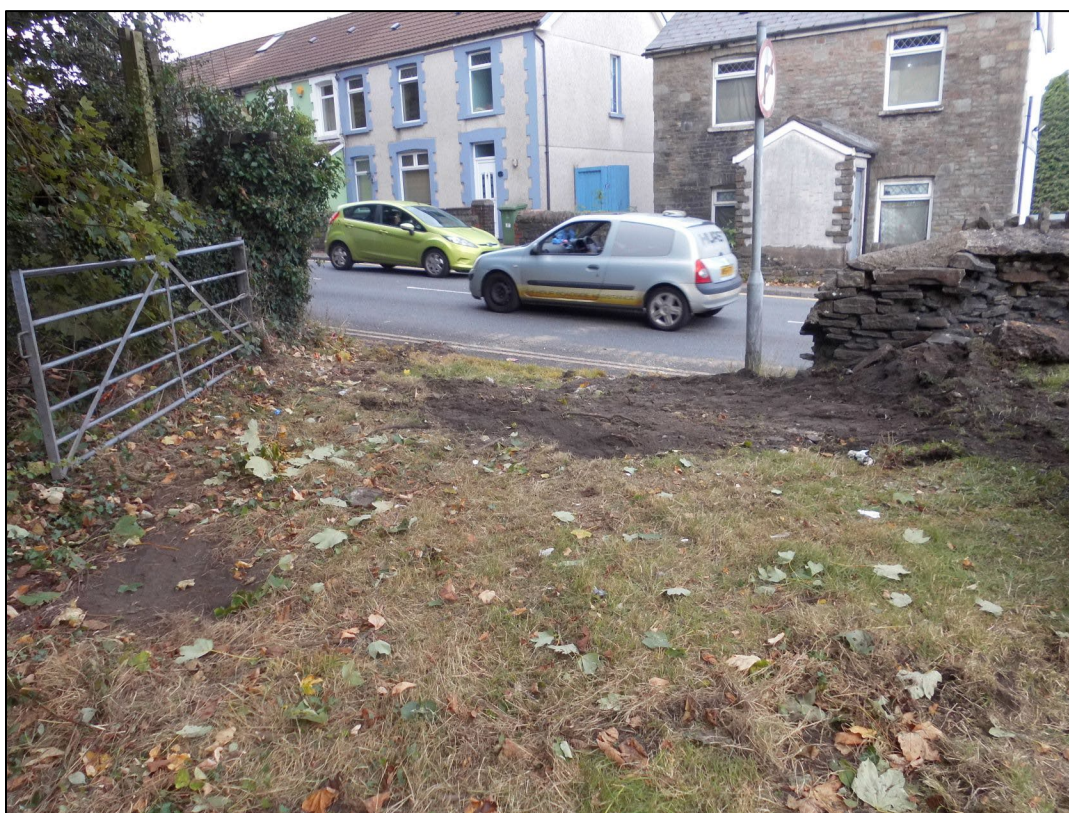
*Plate 11: Nantgarw Road gate excavations, view to northwest.*

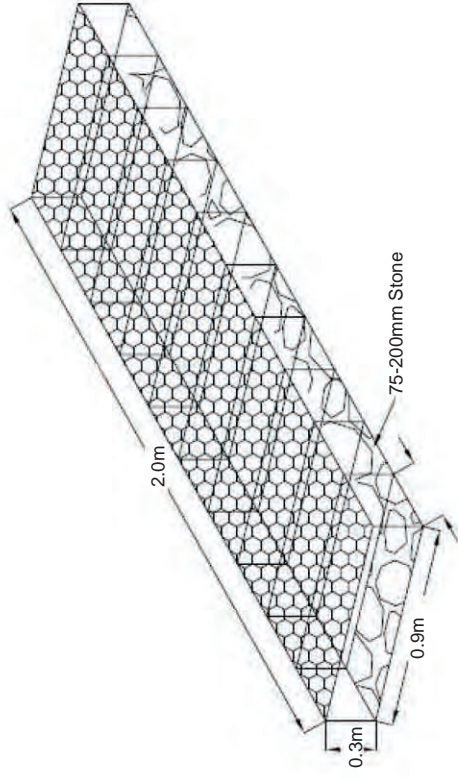
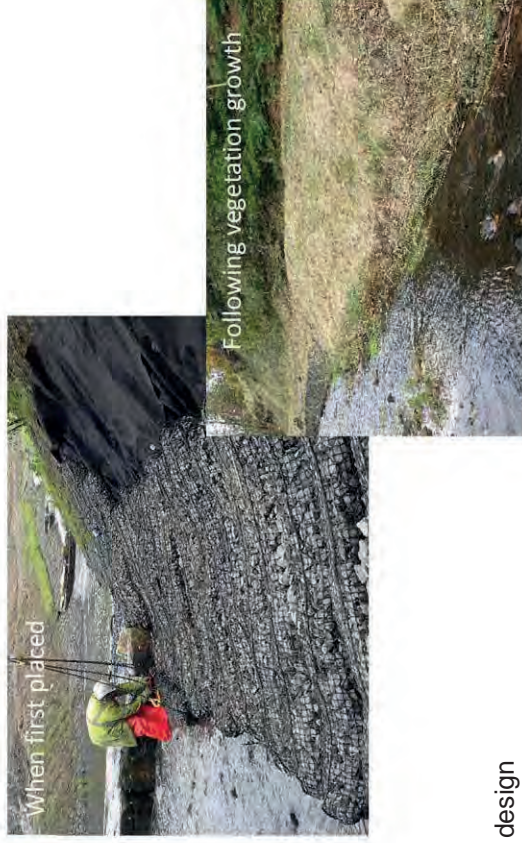
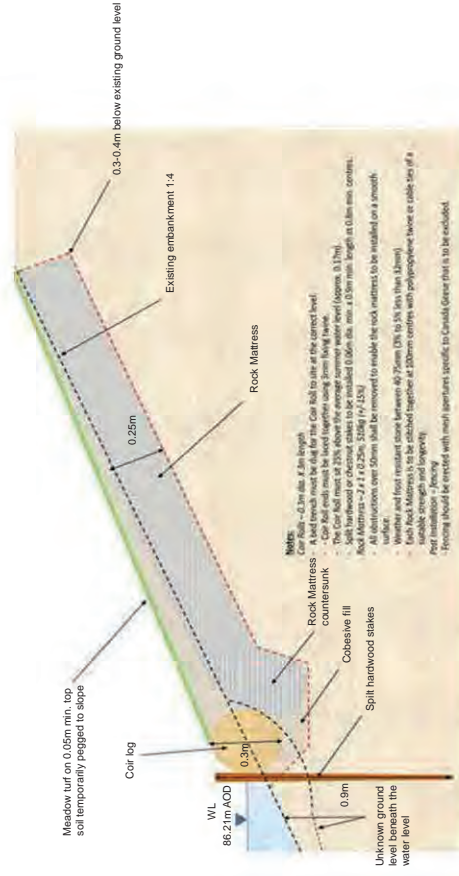
Figure 3: Proposed remedial Option 1a (Area 1) pre-filled rock mattress (After Platt, 2021, Fig 26)

Typical design

Detail for rock and coil log

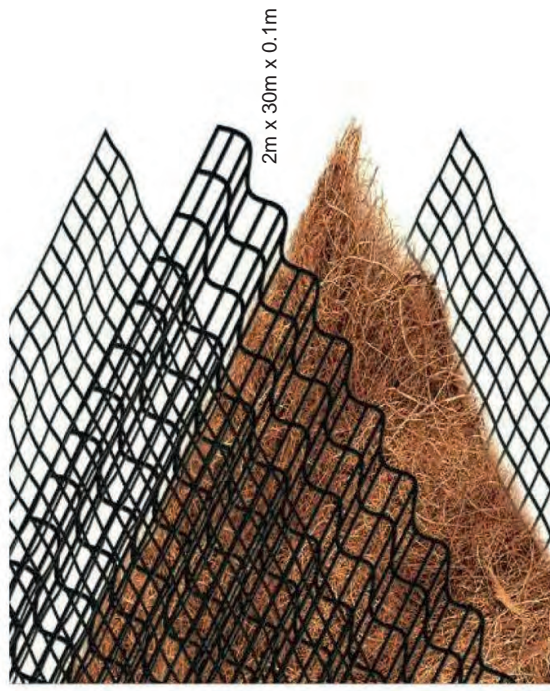
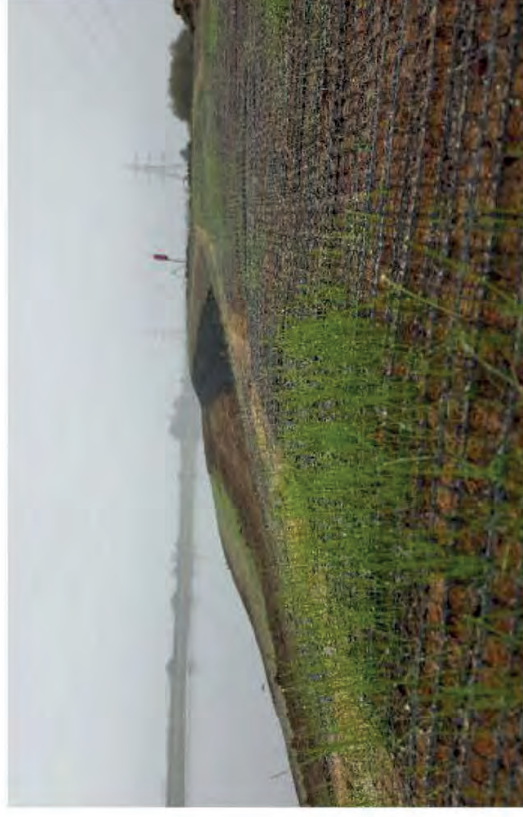
Figure 4: Proposed remedial Option 1b (Area 1) turf-re-inforced mats  
(After Platt, 2021, Fig 27)

Typical design

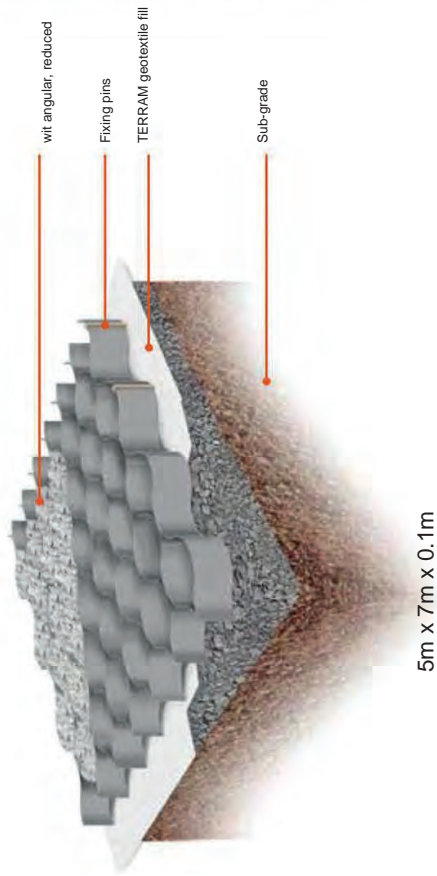
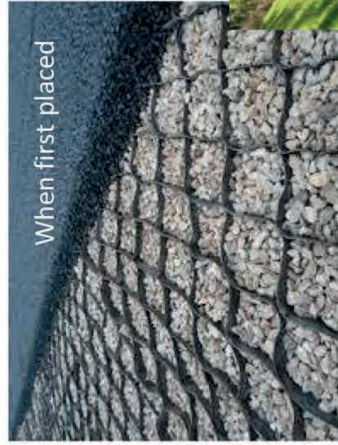
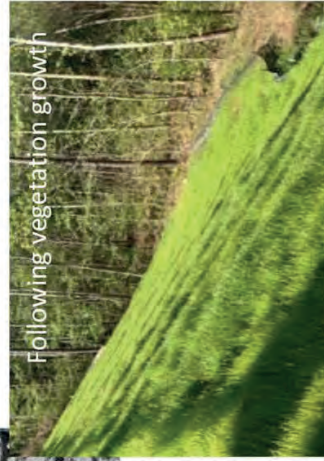
Figure 5: Proposed remedial Option 1c (Area 1) geocell system (After Platt, 2021, Fig 28)

Typical design

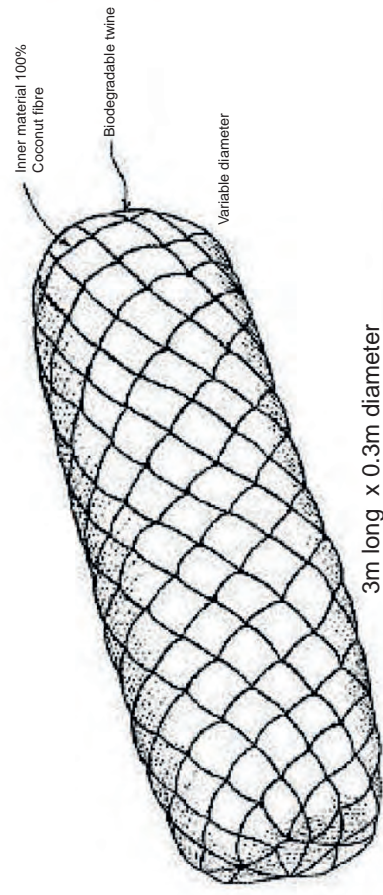
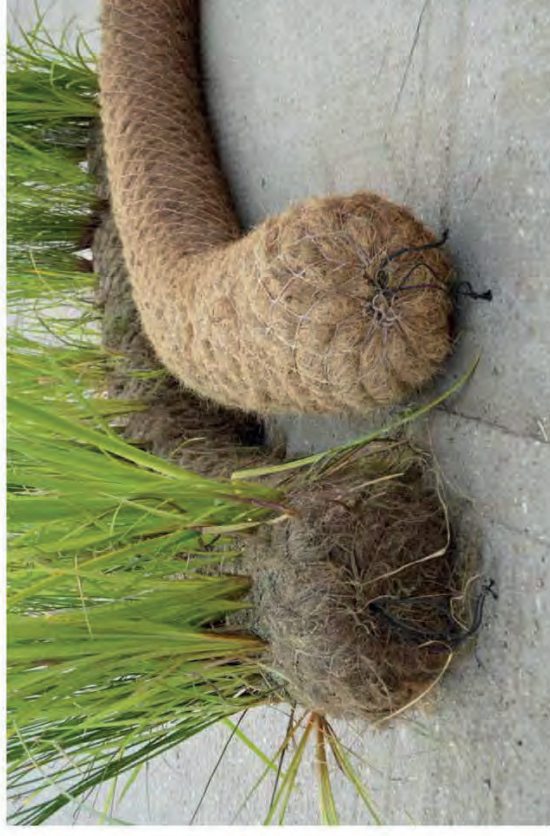
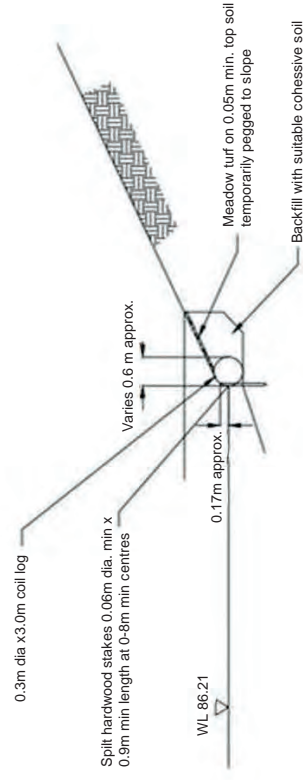
Figure 6: Proposed remedial Option 1d (Area 1), Option 2a (Area 2) and Option 3b (Area 3) coir rolls (After Platt, 2021, Fig 29)

Typical design

Typical detail for coir log stabilisation
