**Coal Tip Remediation at the Site of the Former British  
Ironworks, Talywain  
Aberyschan, Torfaen  
Desk-based Assessment**

Morgan, R. 2022. *Coal Tip Remediation at the Site of the Former British Ironworks, Talywain, Abersychan Torfaen: Desk-based Assessment*. Black Mountains Archaeology Report No **251**.

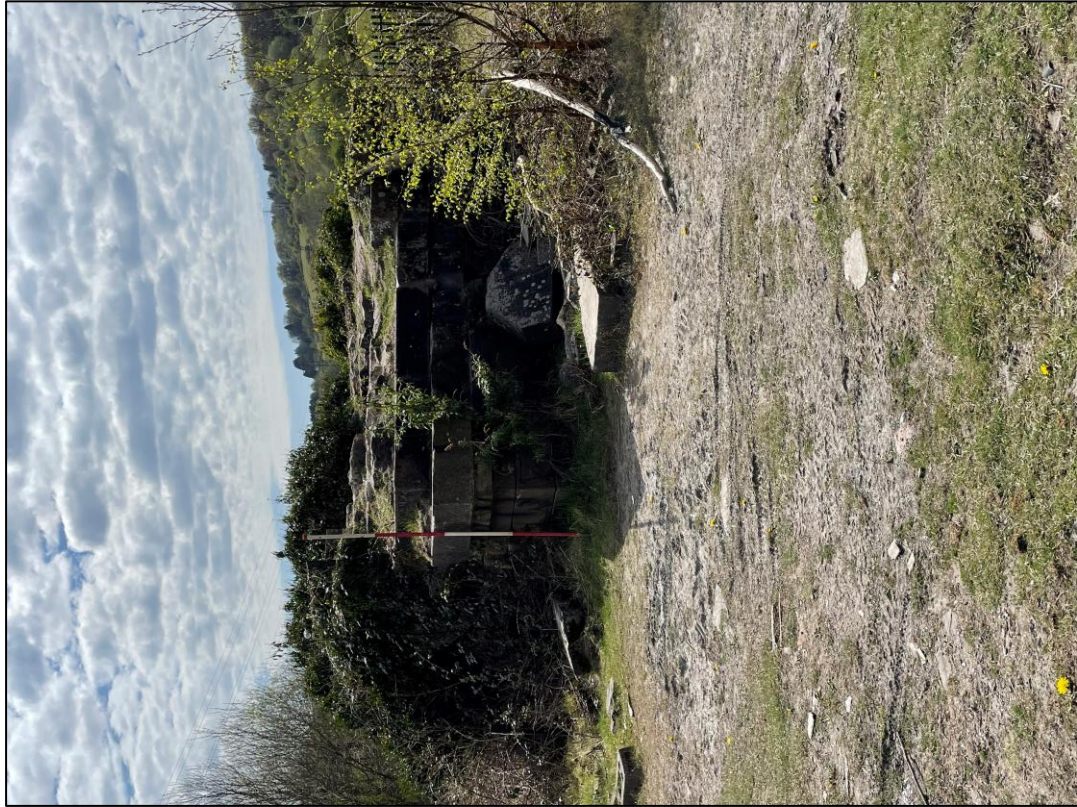
Plate 1. Photograph of British Ironworks Chimney Base (ID9) (view south)

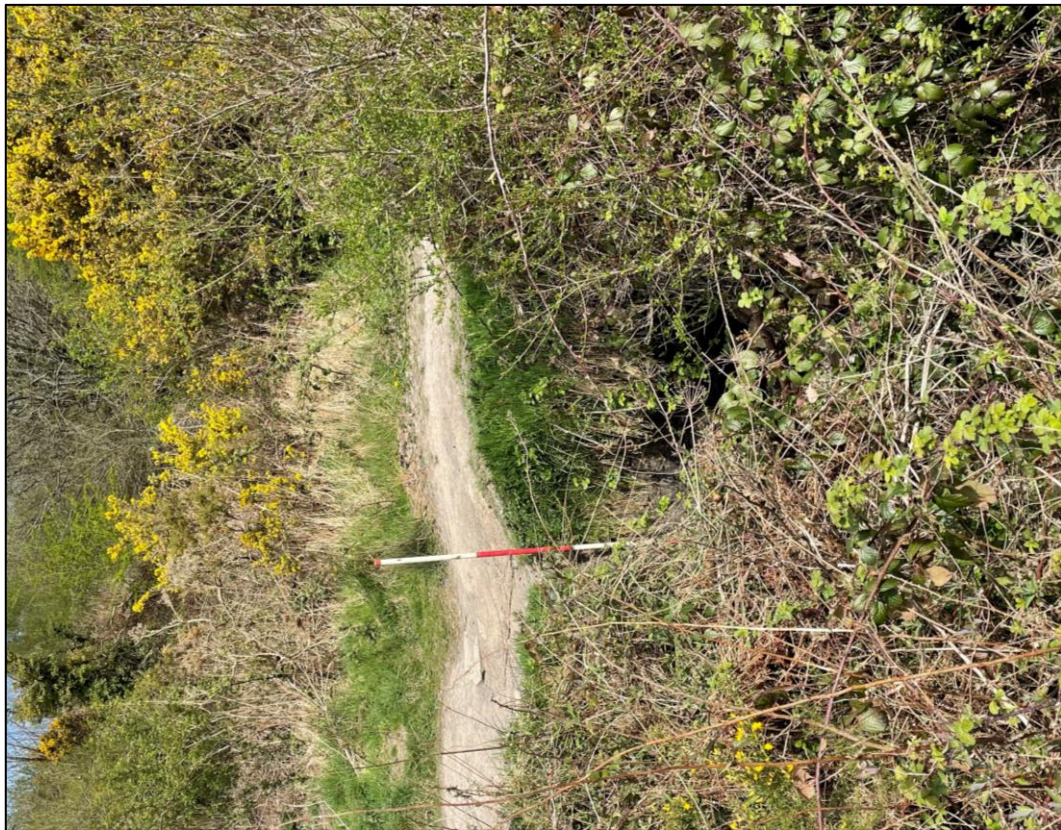
Plate 2. Photograph of British Ironworks Reservoir Sluice III (ID42) (view north)

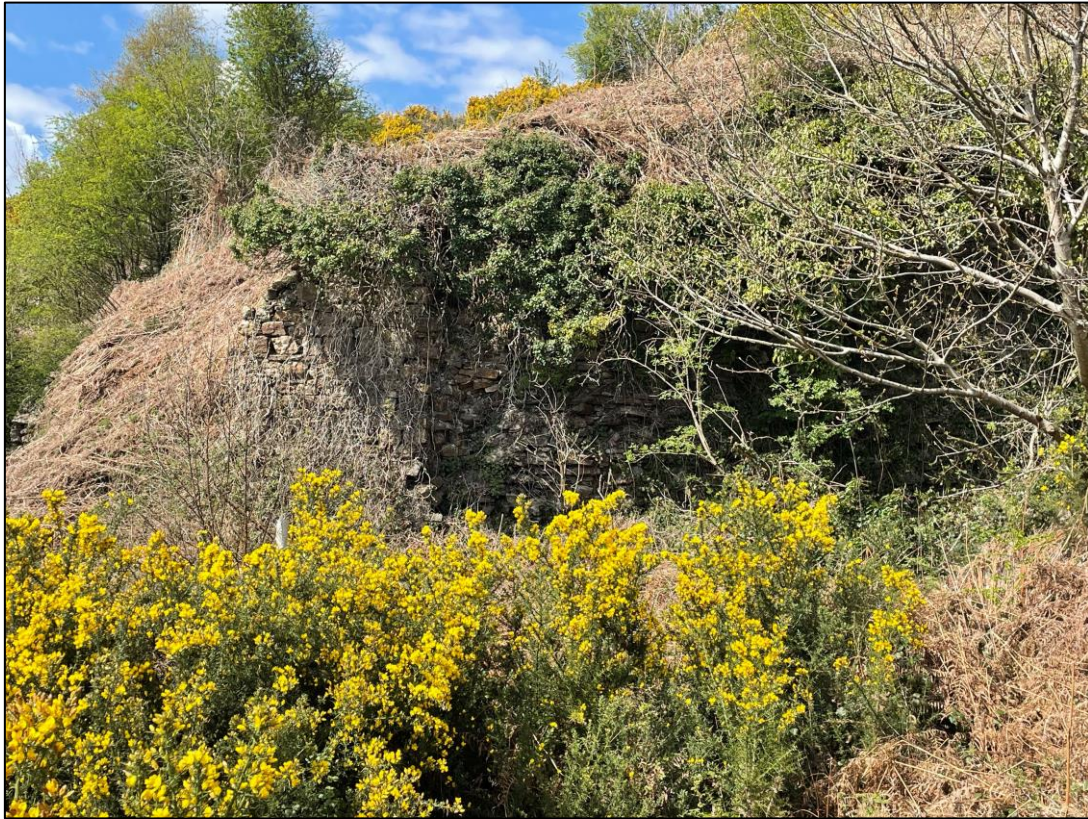
**Plate 3. Aerial photograph of visible elements of British Ironworks Blast Furnaces (ID50) (view northwest)**

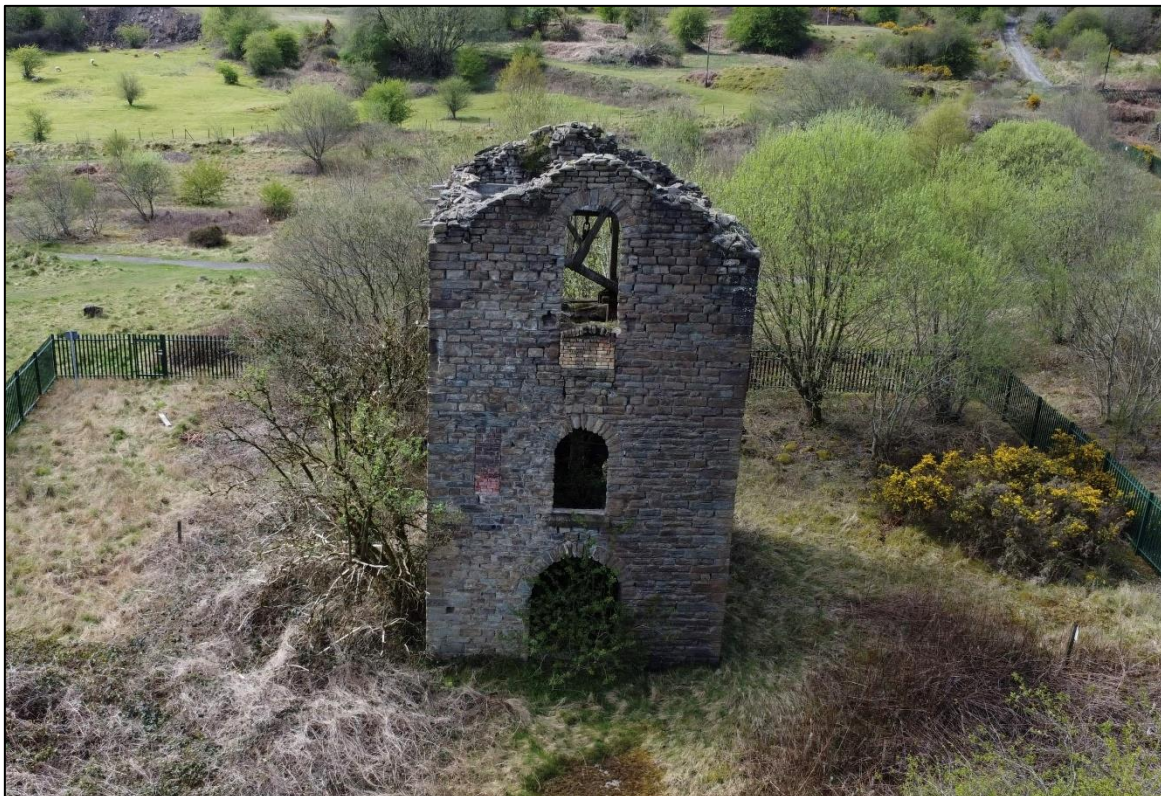
**Plate 4. Aerial photograph of British Colliery Pumping Engine House (ID1) (view southwest)**

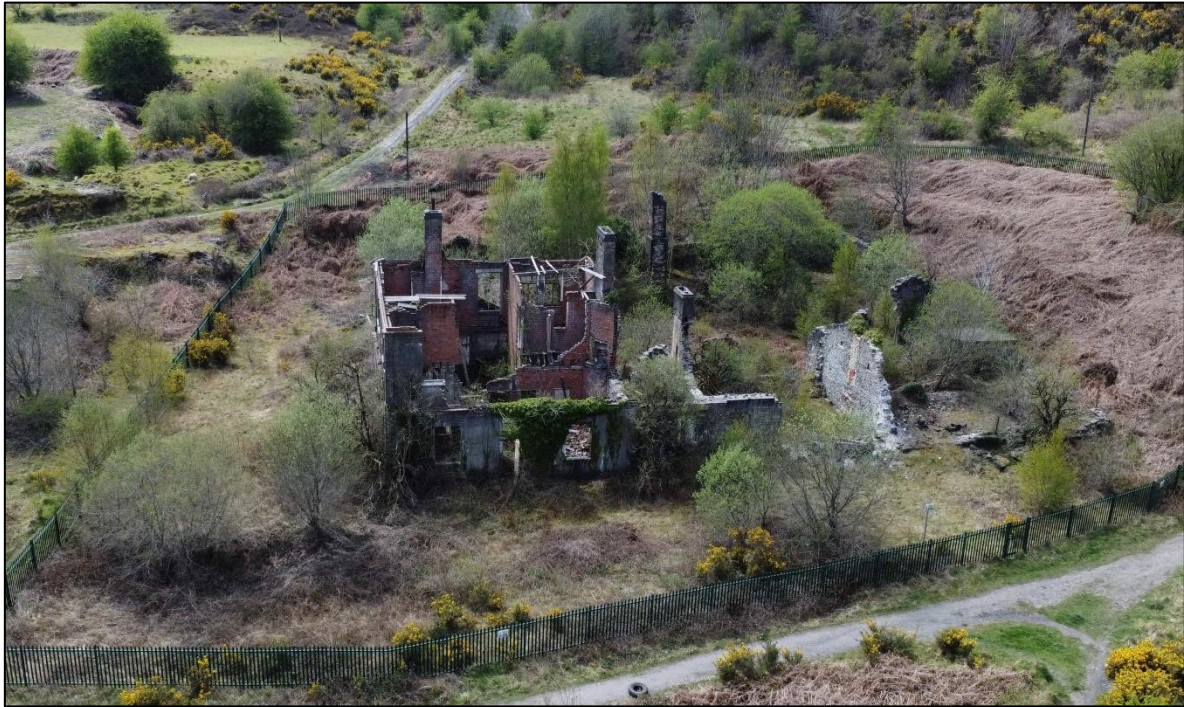
Plate 5. Aerial photograph of British Ironworks Office and Foundry Quadrangle (ID54) (view south)

- The Grade II\* Listed Former British Ironworks Office and Foundry Quadrangle (LB14870) to the south (Plate 5 and 6), which comprises a series of buildings that were constructed from sandstone masonry walls and roofs comprising slate tiles. The precise date during which these buildings were erected is unknown, although in consideration of the architectural design of the right-hand pavilion, a construction date between the 1820s and 1830s may be suggested.

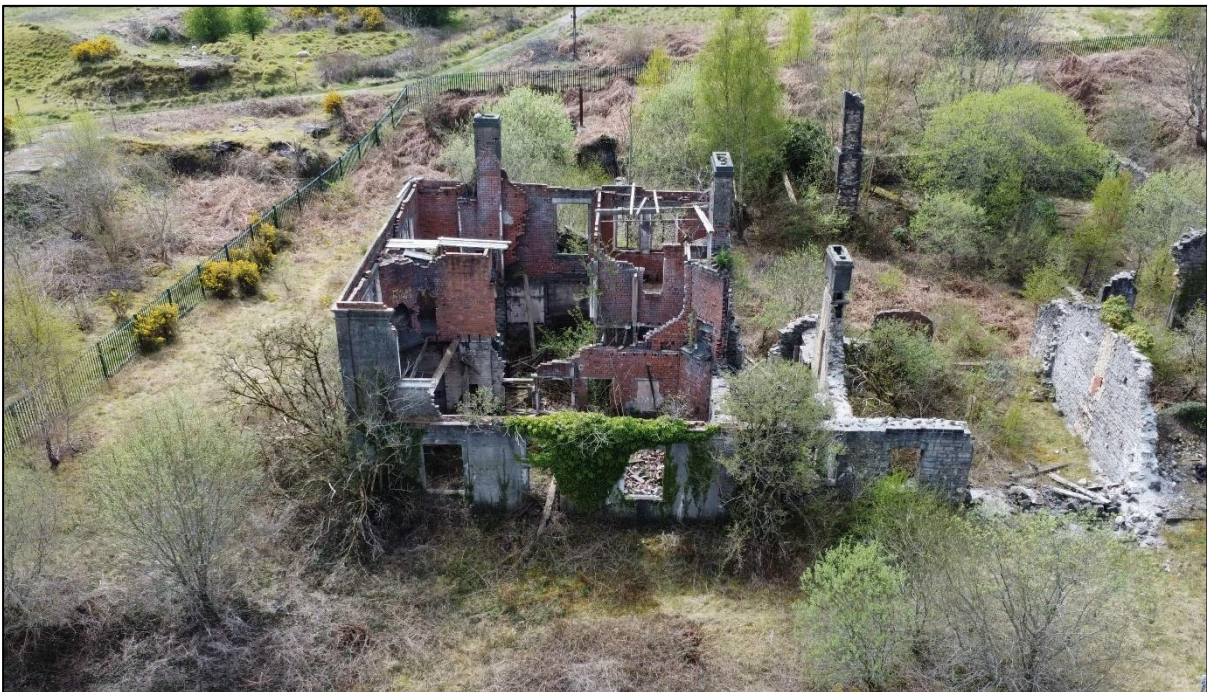
Plate 6. Detailed aerial photograph of British Ironworks Office and Foundry Quadrangle (ID54) (view south)

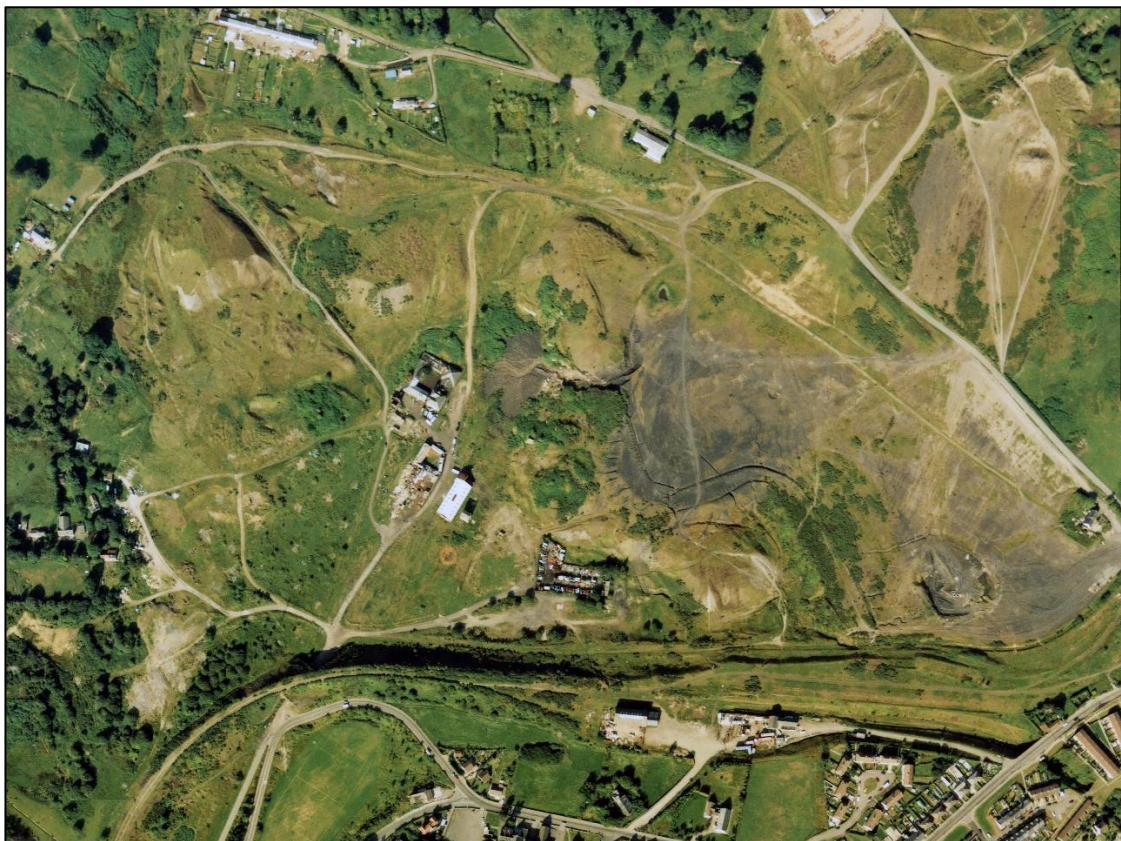
Plate 8. 1991 aerial photograph of site of former British Ironworks (copyright Air Photo Wales)

3.6.2 The 1991 aerial photograph of the local area (Plate 8) reveals the development area to be largely unchanged, with the exception of the former site of the worker housing and brickyard, which is now being used as a car scrap yard. The 1995 aerial photograph appears to indicate that the development area is in much the same condition as it is today, with the two spoil tips having been flattened off. The car scrap yard is, however, still visible, which is no longer present today.
