The Significance of a Former Glasshouse, at Gelligemlyn, Ganllwyd, Dolgellau, LL40 2HH

Report by: Trysor

January 2020

Trysor Project No. 2019/696
GAT HER Event PRN: 45780

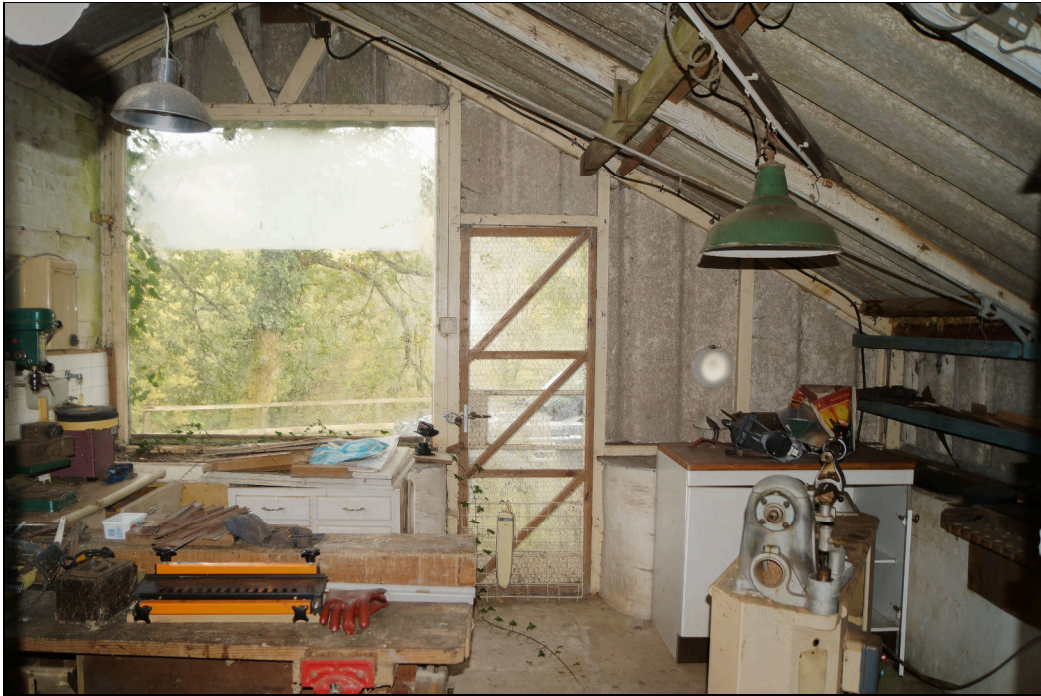
Plate 1: GGN2019_001 - A view of the workshop at the eastern end of the building. Looking east.

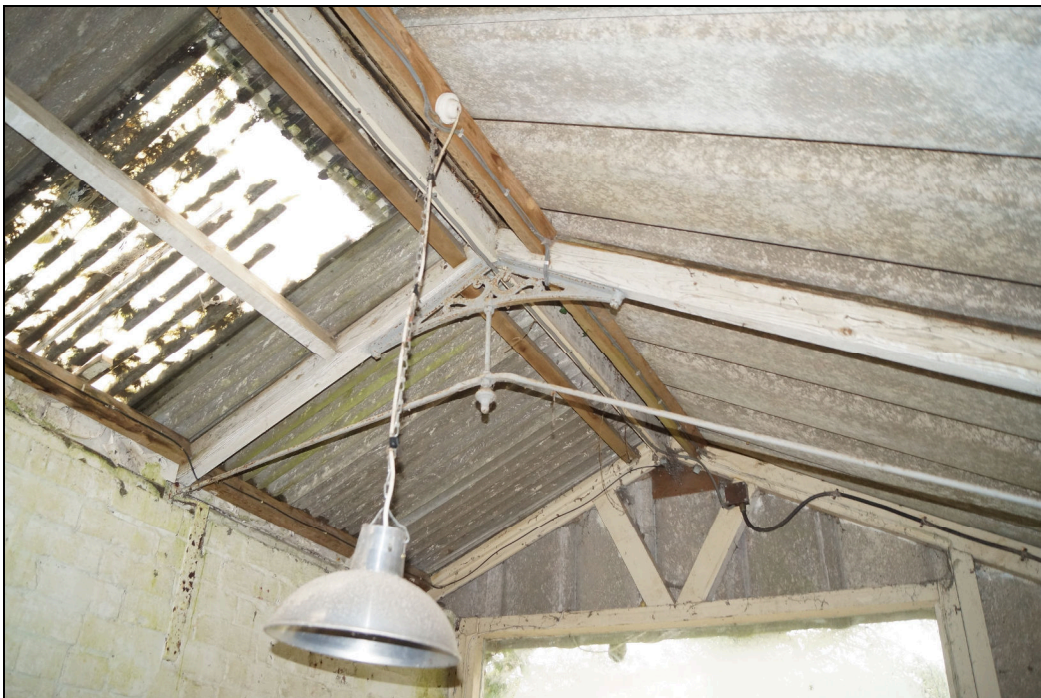
Plate 2: GGN2019_002 - A view of the metal brackets and struts at the apex of the roof in the workshop, which are original and form the roof structure of the glasshouse. Looking east-northeast.

5.2 There would be a high, direct, physical impact to the building but historical features, such as the metal brackets of the original glasshouse, would be retained and refurbishing and repurposing the building will undoubtedly save it from further decay and loss.

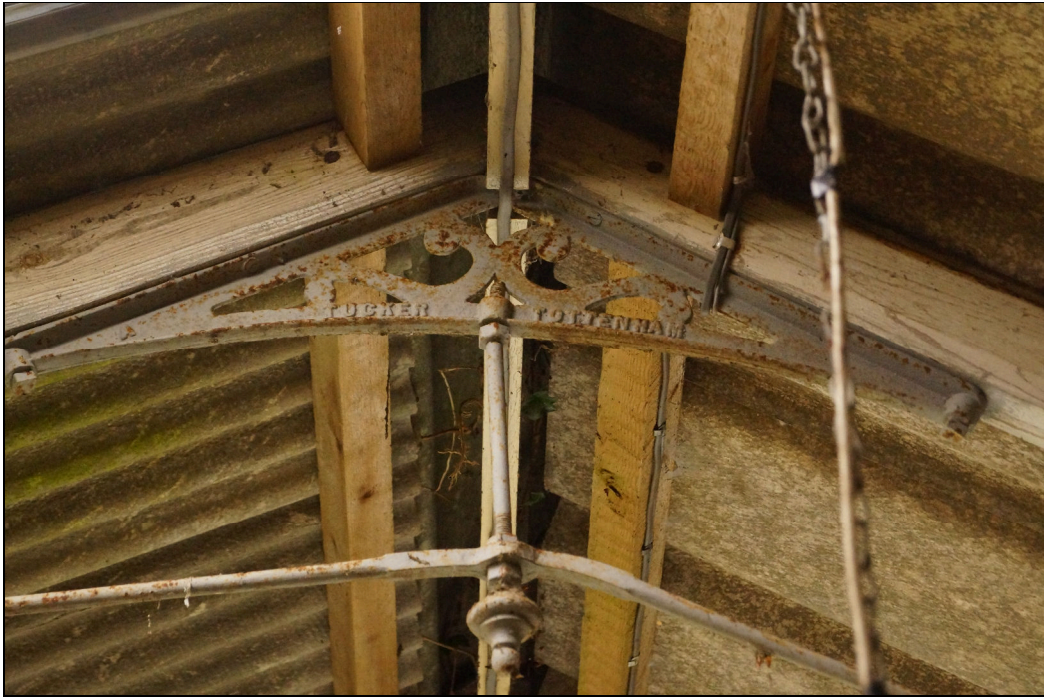
Plate 3: GGN2019_003 – A closer view of the roof brackets in the workshop showing the “Tucker Tottenham” stamp of the specialist glasshouse manufacturer who designed and supplied the structure. Looking east.

4.2.11 The purpose-built glasshouse and potting shed was also added around this time. It was purchased from the glasshouse specialist manufacturers W. Duncan Tucker of Tottenham and assembled on site. The manufacturers stamp is still visible on the metal frame of the roof. The former glasshouse still stands on higher ground to the west of the walled garden, although the glass was replaced by asbestos cladding during the mid-20th century. This was probably the glasshouse referred to in a newspaper report of 1922, when the Head Gardener of Gelligemlyn discovered a drunken intruder had smashed a window to gain entry and had set a fire inside the building to keep warm (Western Mail, 24 January, 1922).

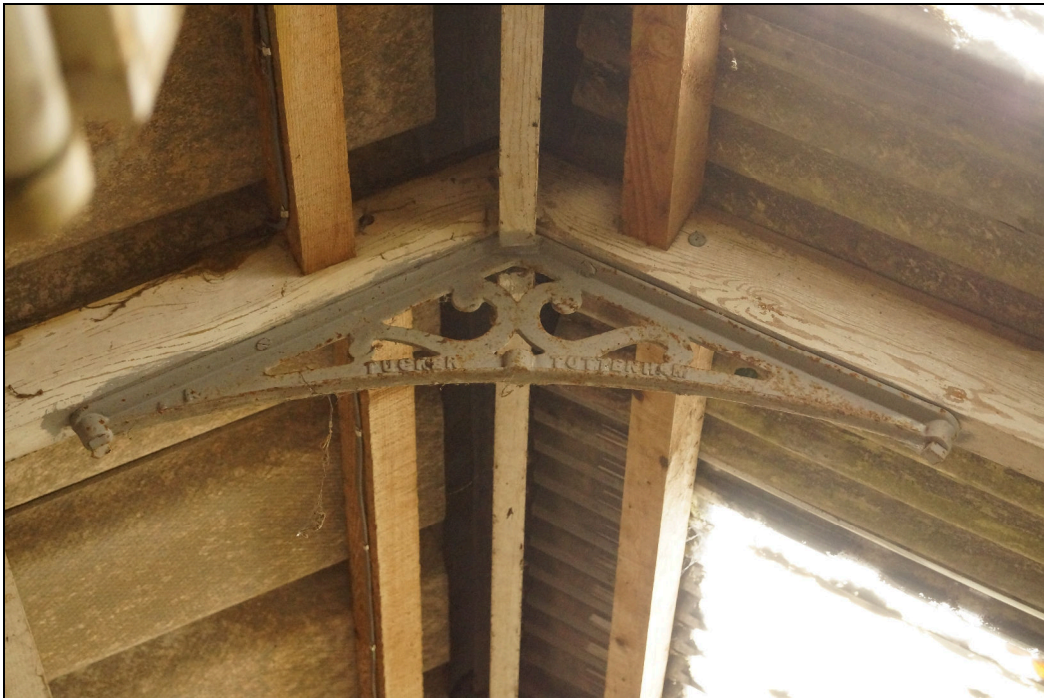
Plate 4: GGN2019_004 – A view of the roof brackets in the western part of the building showing the manufacturers stamp. Looking west.

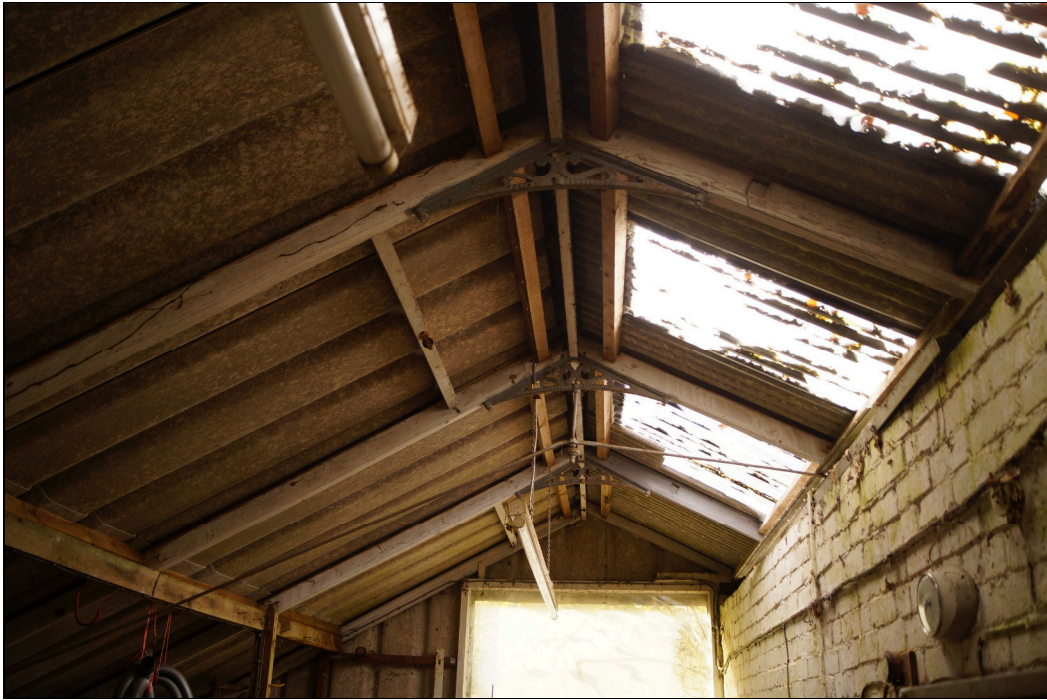
Plate 5: GGN2019_005 – A view of the roof and metal brackets in the western part of the building. Looking west.

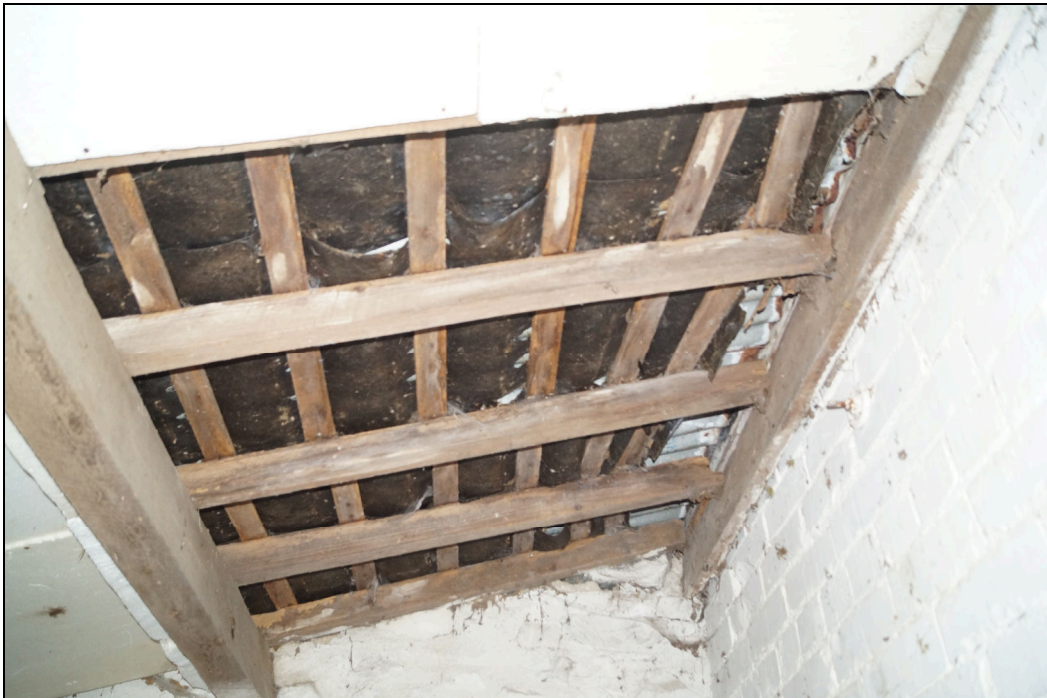
Plate 6: GGN2019_006 – A view through the ceiling showing part of the original slate roof inside the "stable" at the northern side of the building. This may originally been the potting shed. Looking east.

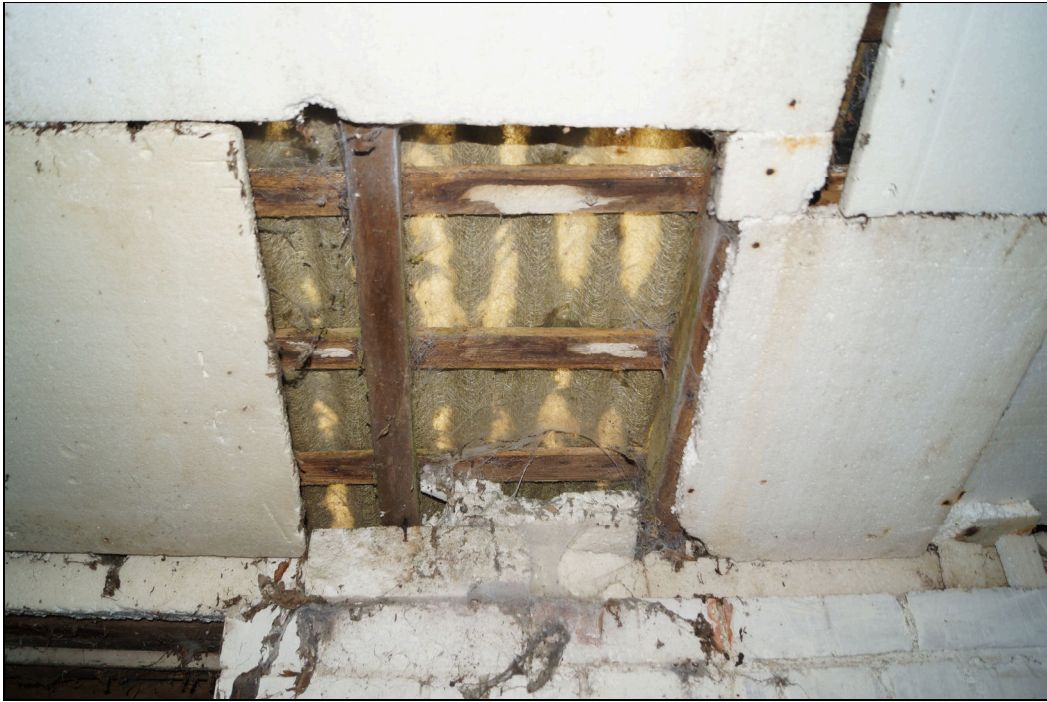
Plate 7: GGN2019_007 – A view through the ceiling showing the underside of the corrugated asbestos sheeting on the roof of the "stable" along the northern side of the building. Looking south.

7.6 During the later 20th century the glasshouse was converted for use as a workshop and stable. The glass roof was replaced with corrugated asbestos sheeting and some of the floors concreted. The walls of the original structure remain in good condition and the original profile and pitch of the roof seems to have been retained.

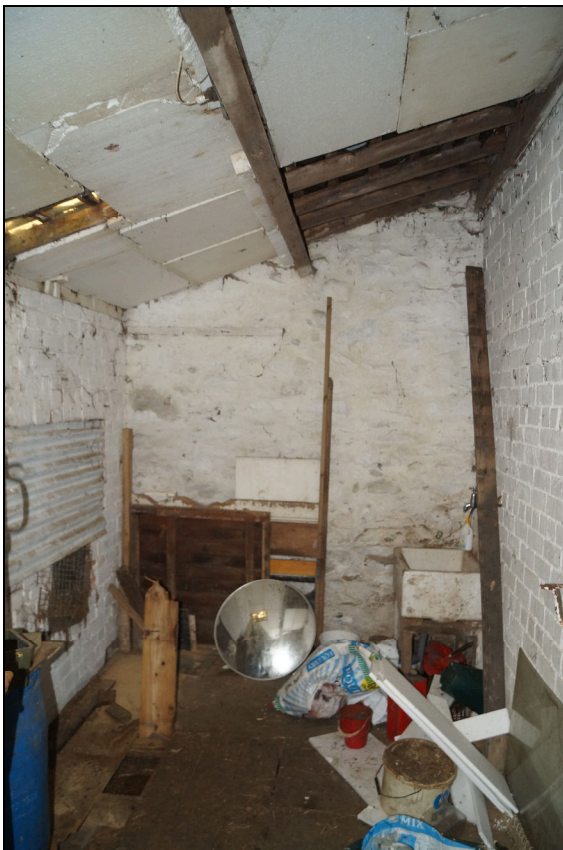
Plate 8: GGN2019_008 – A view of the inside of the "stable" which was probably the potting shed attached to the northern side of the building when it was in use as a glasshouse. The original stone floor appears to be in place. Looking east.

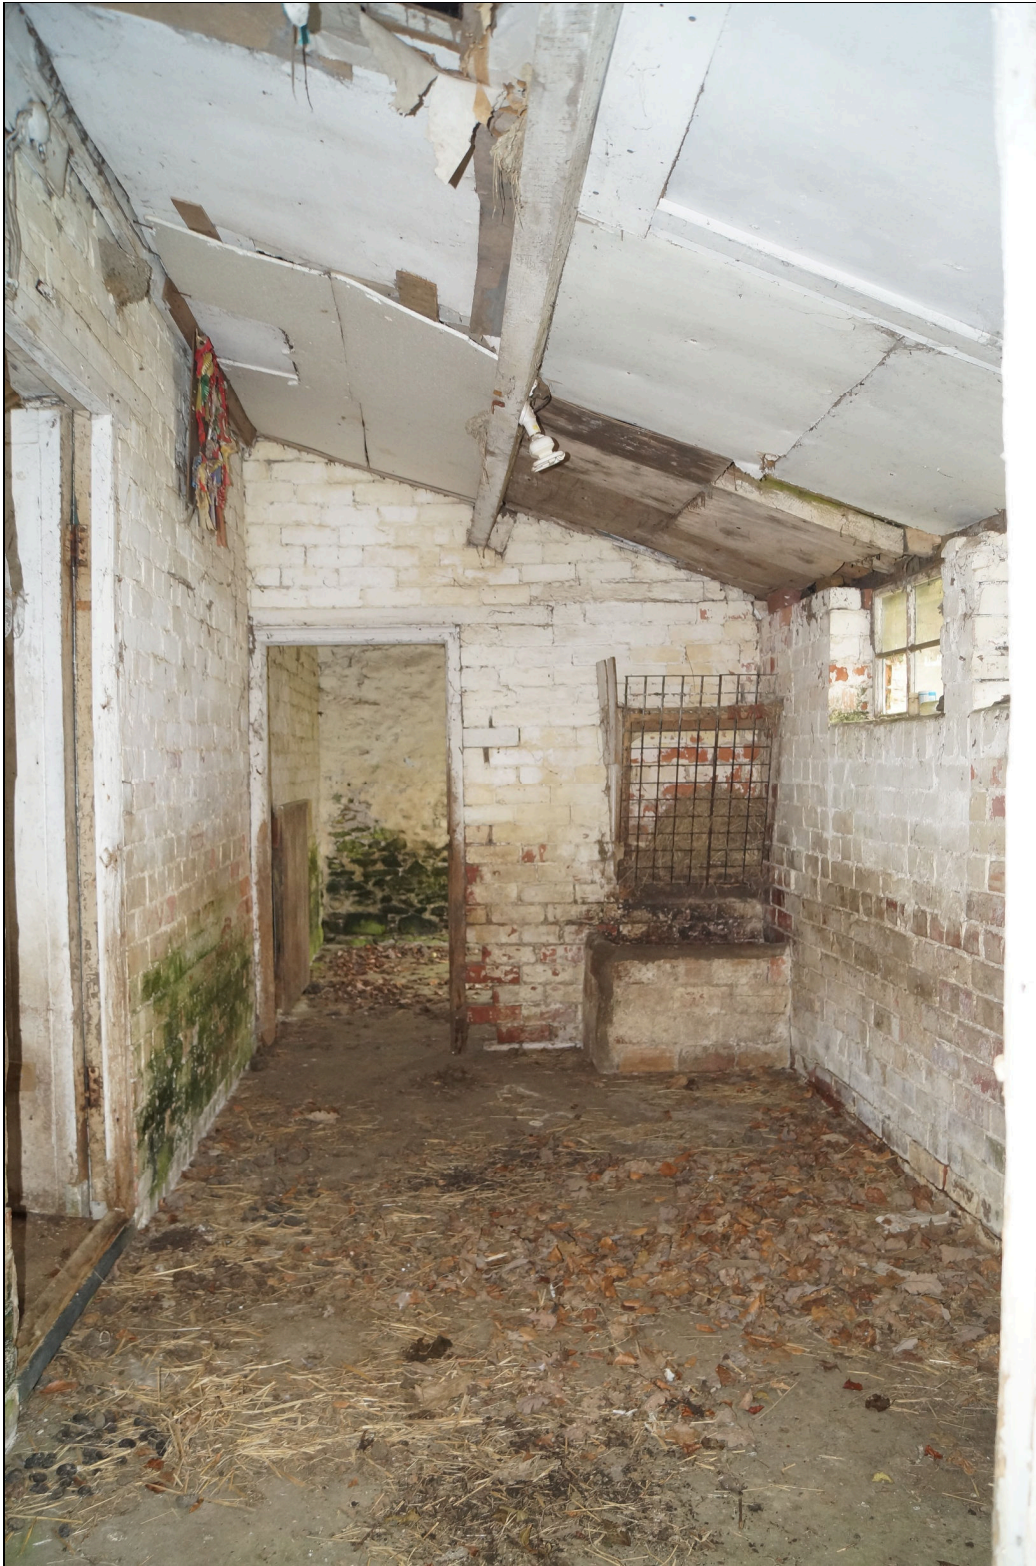
Plate 9: GGN2019_009 – A view of the inside of the "stable". The feeder to the right of centre has been added in after the building had ceased being used as a glasshouse and potting shed and the stable had been created inside its northern section. Looking west.

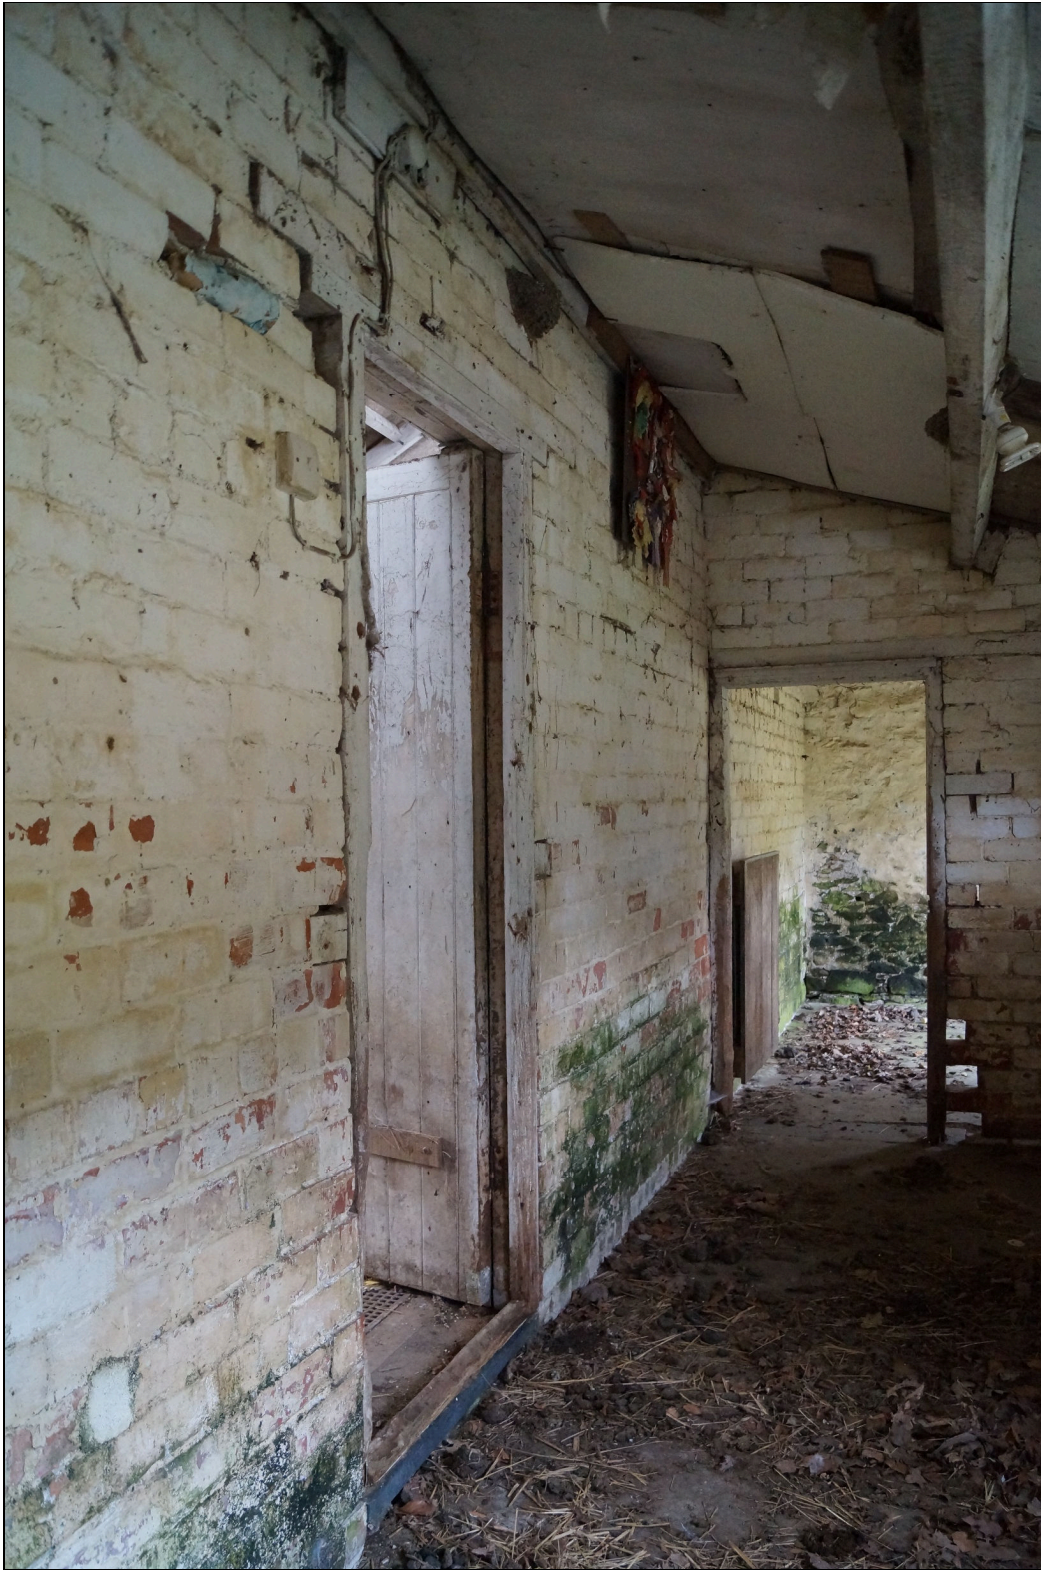
Plate 10: GGN2019_010 – A view inside the "stable" showing the door into the former glasshouse, left of centre. Original drain covers seem to be in place in the floor inside the door. Looking west-southwest.

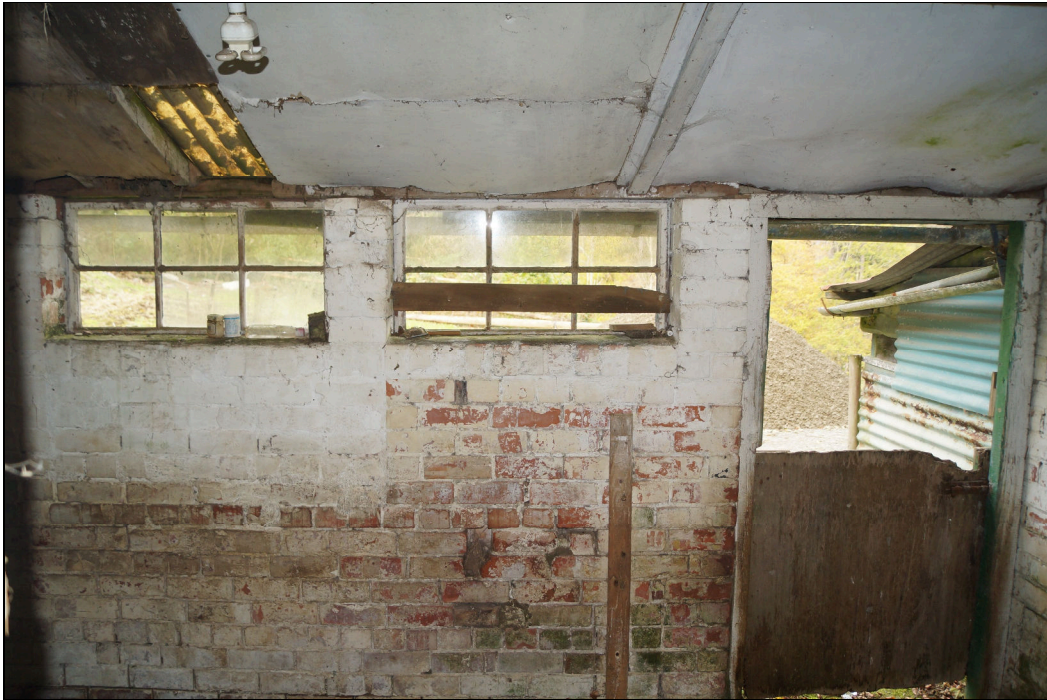
Plate 11: GGN2019_011 – A view of the northern lateral wall of the "stable". The metal-framed windows and brick walling appear to be original elements in the Edwardian potting shed. There is a later extension visible through the door to the right. Looking north.

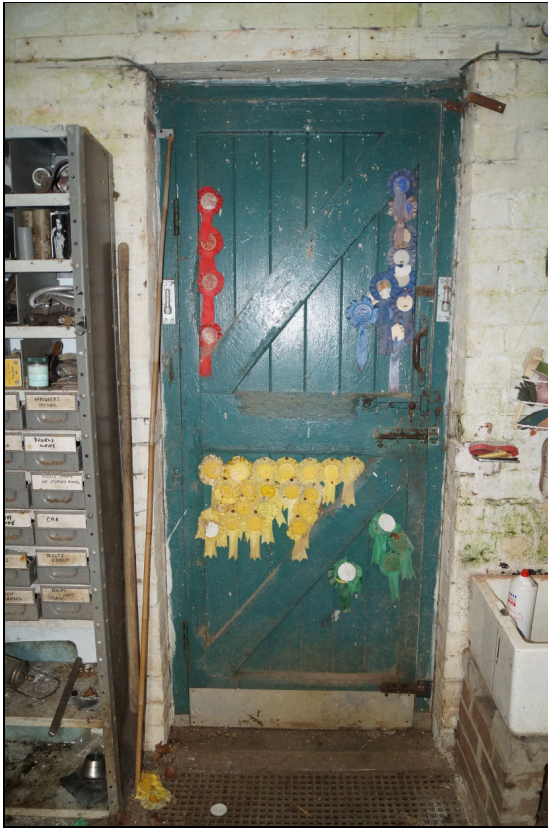
Plate 12: GGN2019_012 – A view of the doorway connecting the former glasshouse with the former potting shed to its northern side, the latter being used as stable in modern times as evidenced by the rosettes hung on the door. Looking north.

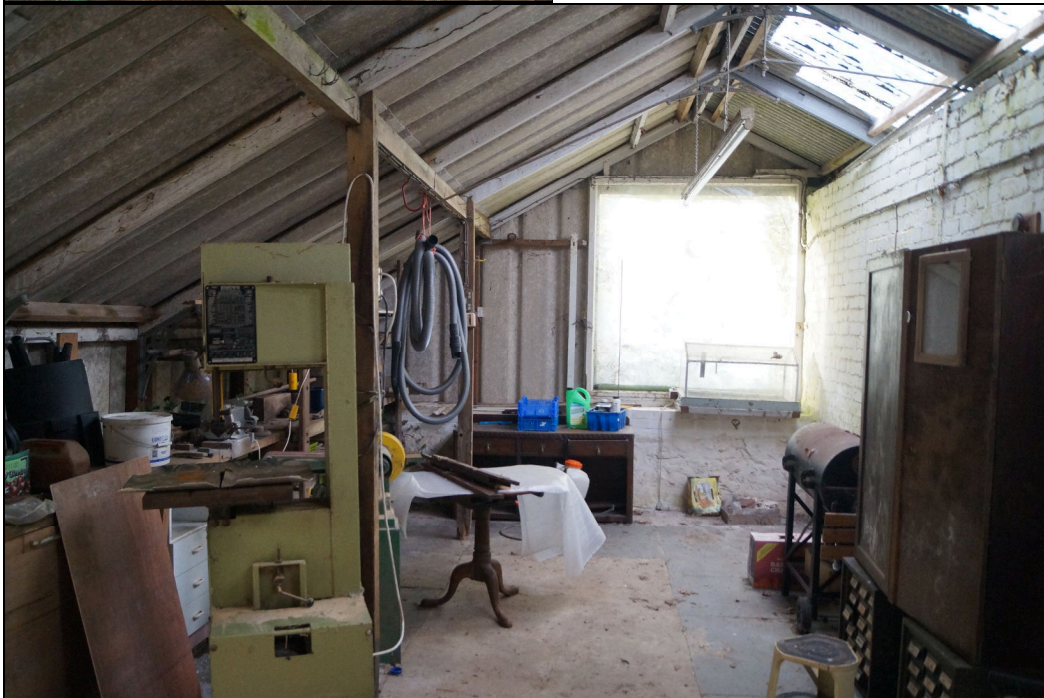
Plate 13: GGN2019_013 – A view inside the western part of the building. Note the original stone slabs around the side of the room and a concrete slab in the centre. The concrete may infill a former water tank or soil bed associated with the original use of the building as a glasshouse. Looking west.

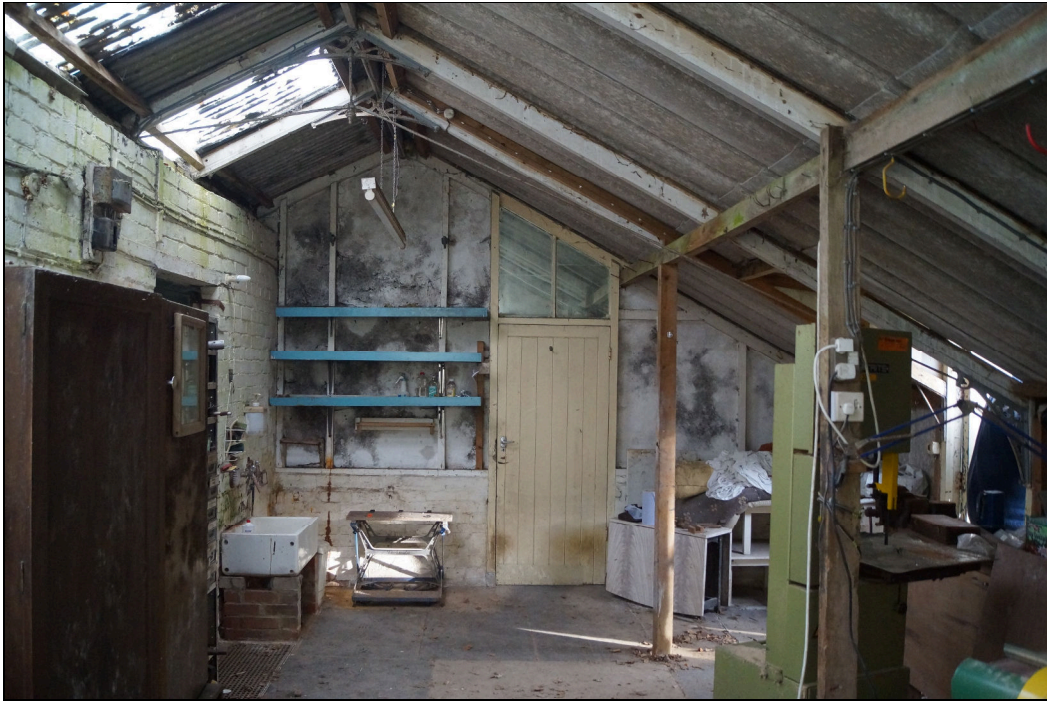
Plate 14: GGN2019_014 – A view inside the western part of the building. Note the original stone slabs around the side of the room and a concrete slab in the centre. The concrete may infill a former water tank or soil bed associated with the original use of the building as a glasshouse. Looking east.

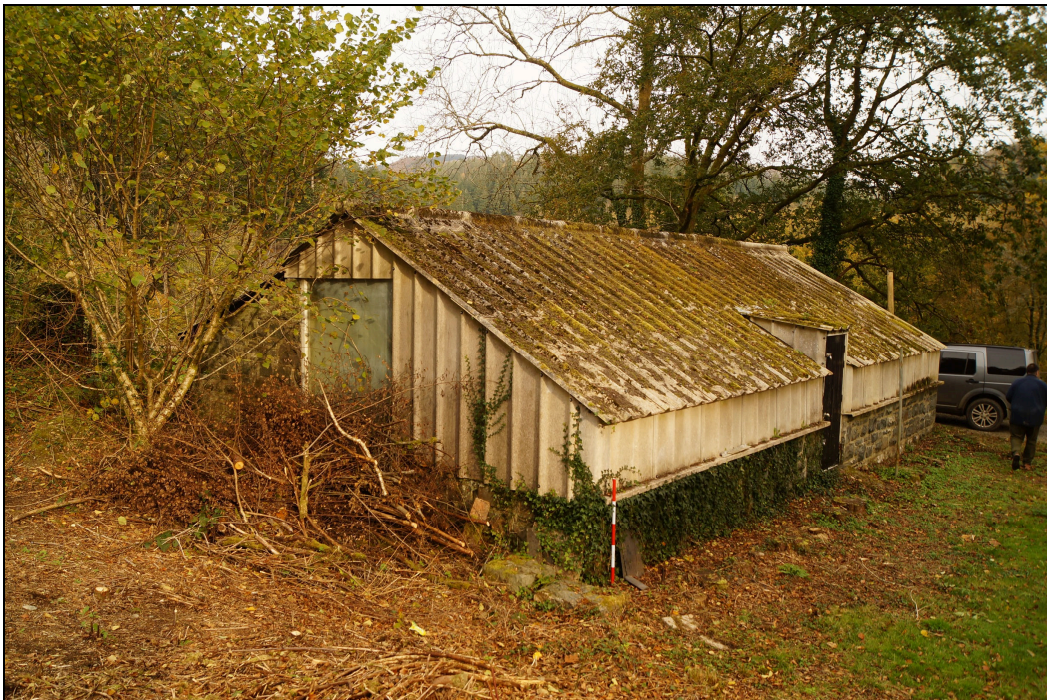
Plate 15: GGN2019_015 – An external view of the building. The corrugated asbestos sheeting seems to have replaced the original glass roof and walls over the front (south) side of the building. Looking northeast.

4.3.3 The building survives largely intact, although somewhat decayed and now without the glass roof and sides which would have once characterised the southern section of the building. It is of interest that the timbers and metal stays and brackets supplied by Tuckers remain in place, whilst the stones for the base of the southern section and presumably the bricks of the northern section would have been locally sourced. These details give an indication of the processes involved in ordering a horticultural building from a distant supplier and adapting them to local circumstances.

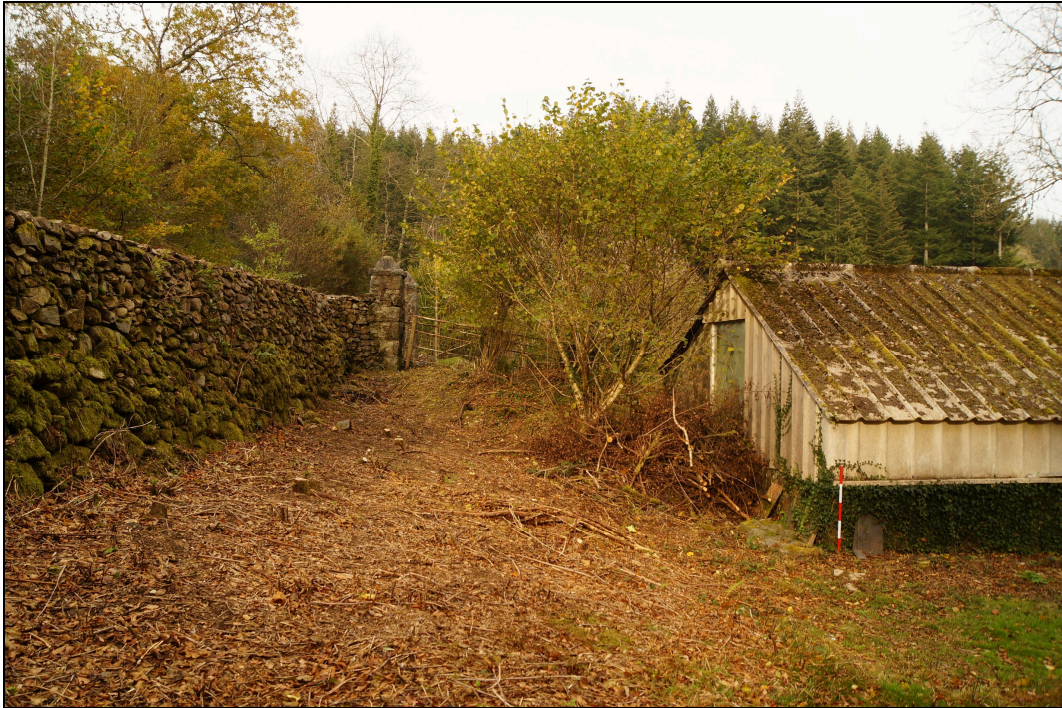
Plate 16: GGN2019_016 – An external view of the western end of the building., showing the gap between the building and the stone wall which marked the western boundary of the gardens of Gelligemlyn, outside which the main Dolgellau road passes. Looking northeast.

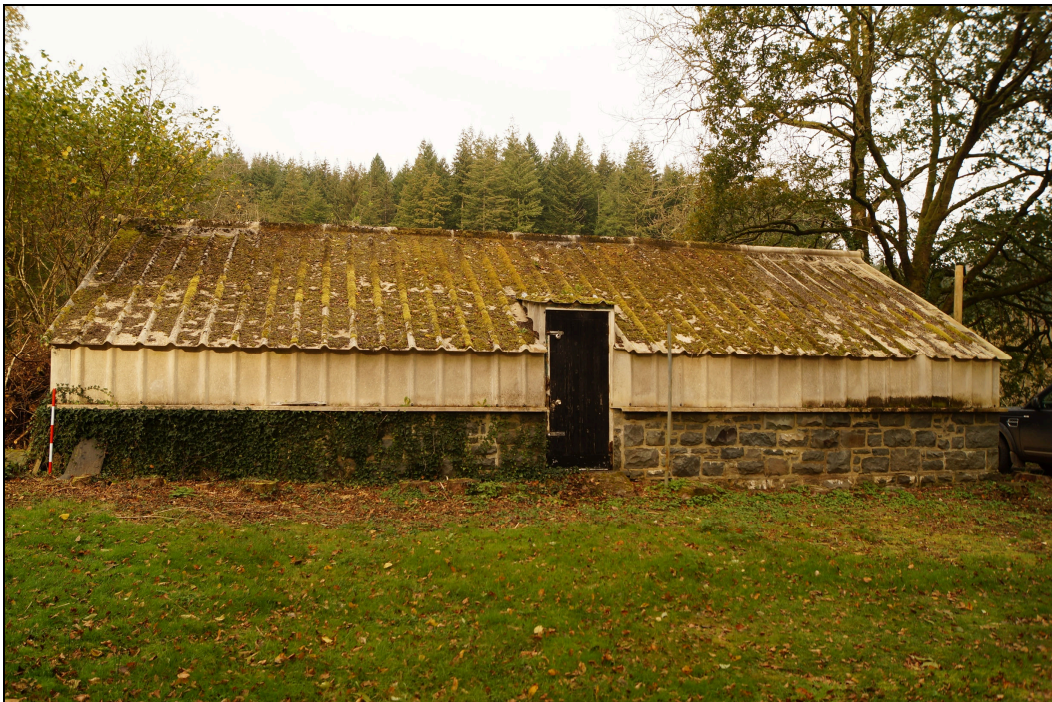
Plate 17: GGN2019_017 – An external view of the building. Looking north.

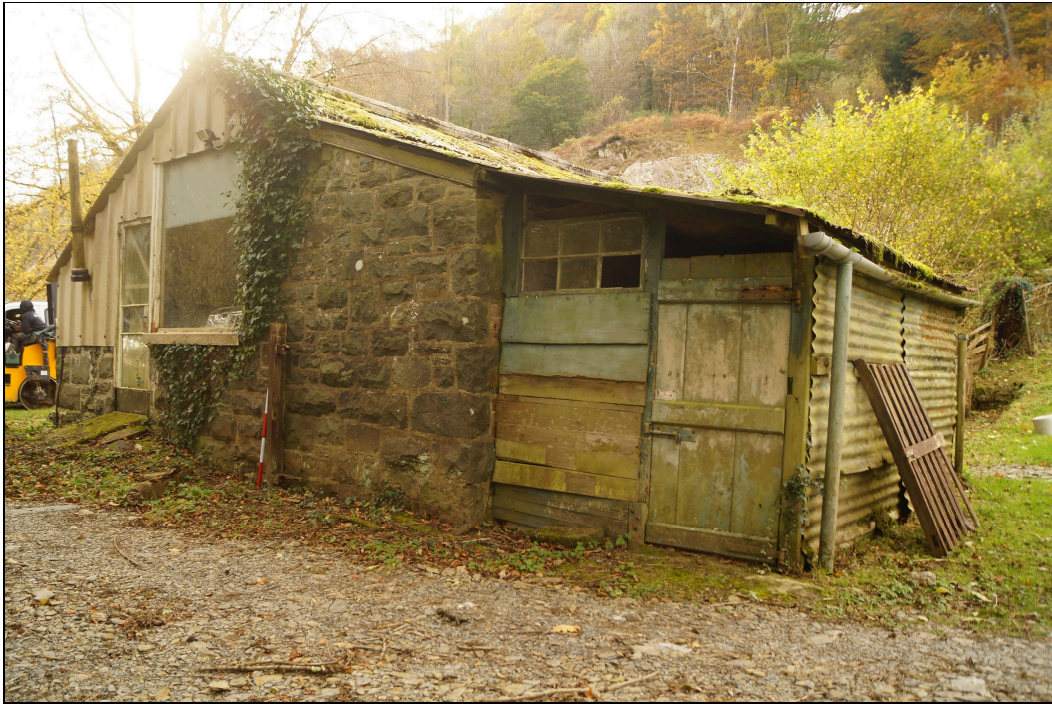
Plate 18: GGN2019_018 – An external view of the building. The crude extension seen right of centre does not appear to be part of the original glasshouse and potting shed. It first appears on an aerial photograph of 1962 (Central Register of Aerial Photography for Wales, 6208 RAF58_5165/F22/0100), being absent from aerial photographs dating to the 1940s. Looking southwest.

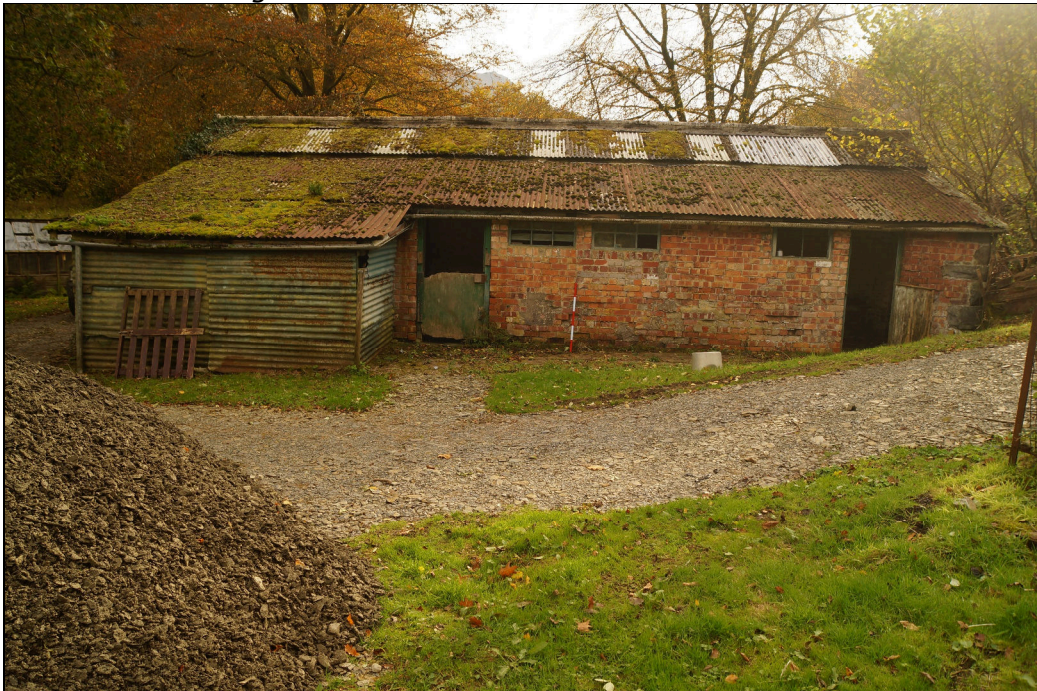
Plate 19: GGN2019_019 – An external view of the building. The redbrick part of the building is likely to have been the potting shed, with the

glasshouse beyond it forming the main part of the structure. Looking south.

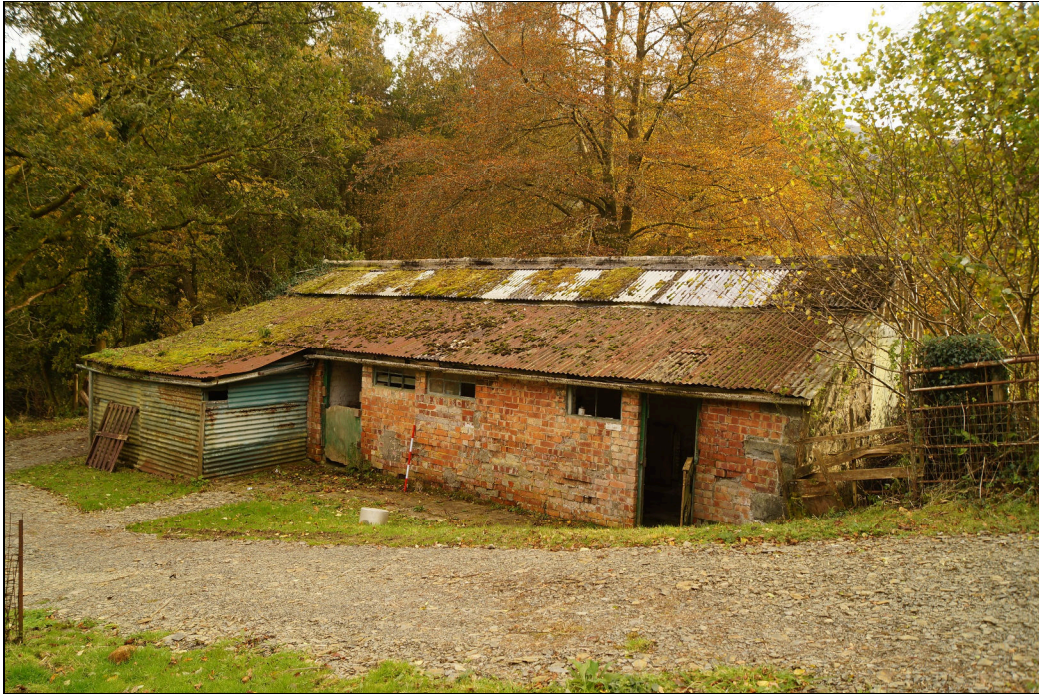
Plate 20: GGN2019_020 – An external view of the building. Looking southeast.

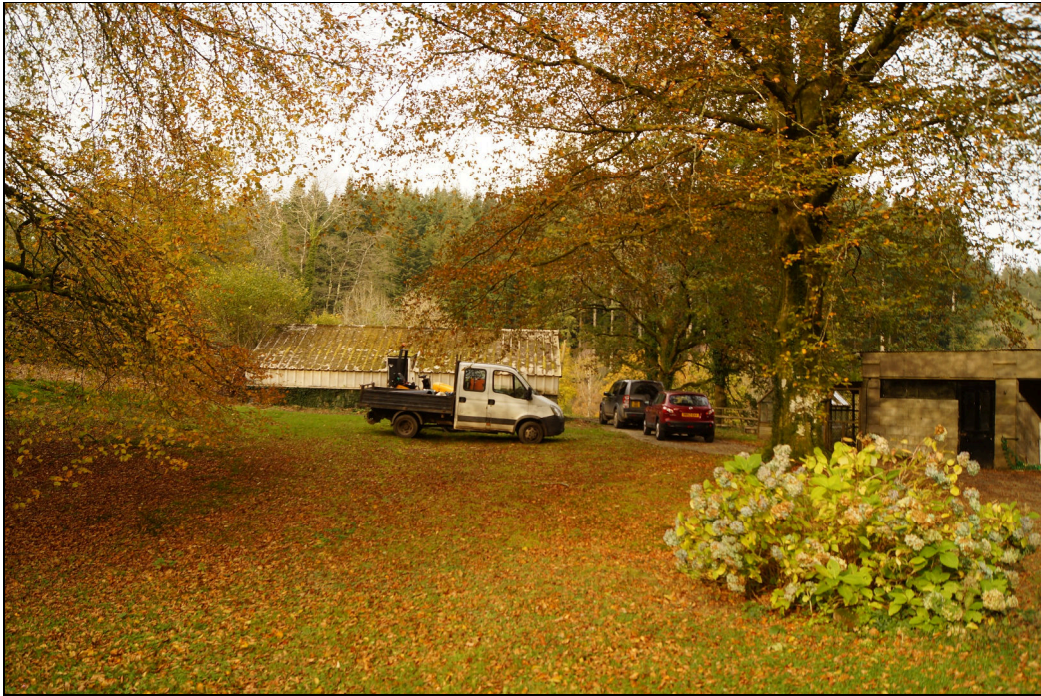
Plate 25: GGN2019_025 – A view of the former glasshouse, seen beyond the white truck left of centre. The setting of the building is quite secluded and apart from the house at Gelligemlyn. Looking north.

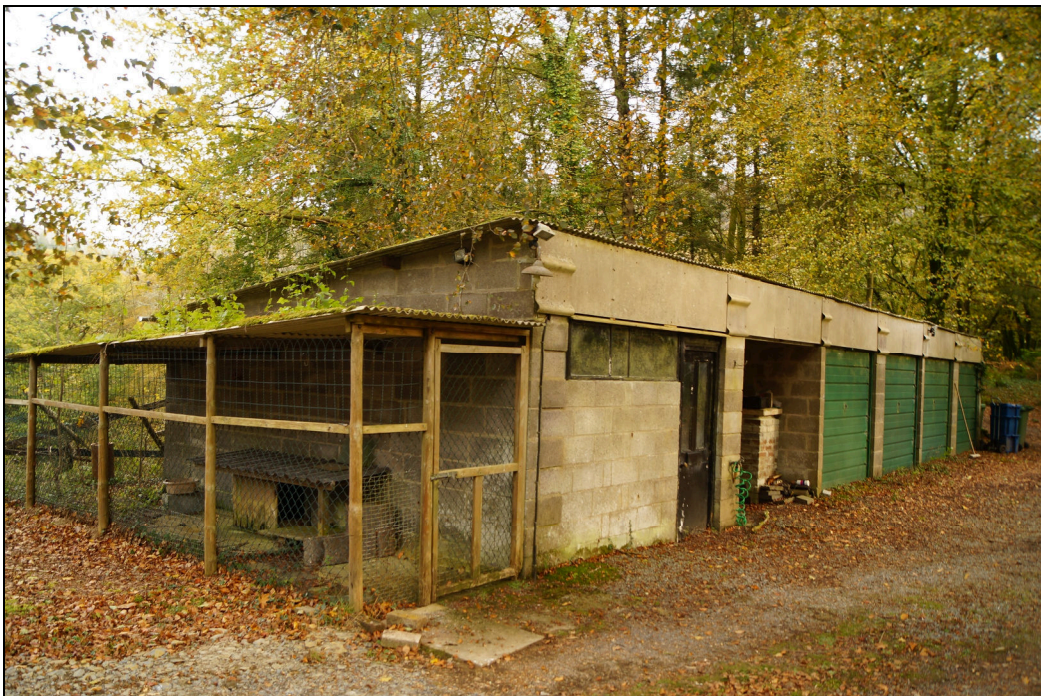
Plate 26: GGN2019_026 – A view of the later 20th century garage range, which has no historical association with the former glasshouse. It does not appear on an aerial photograph of 1962 (Central Register of Aerial Photography for Wales, 6208 RAF58_5165/F22/0100) but is shown on an

aerial photograph dating to 1971 (Central Register of Aerial Photography for Wales, 7179 OS71_283/0472). Looking southeast.

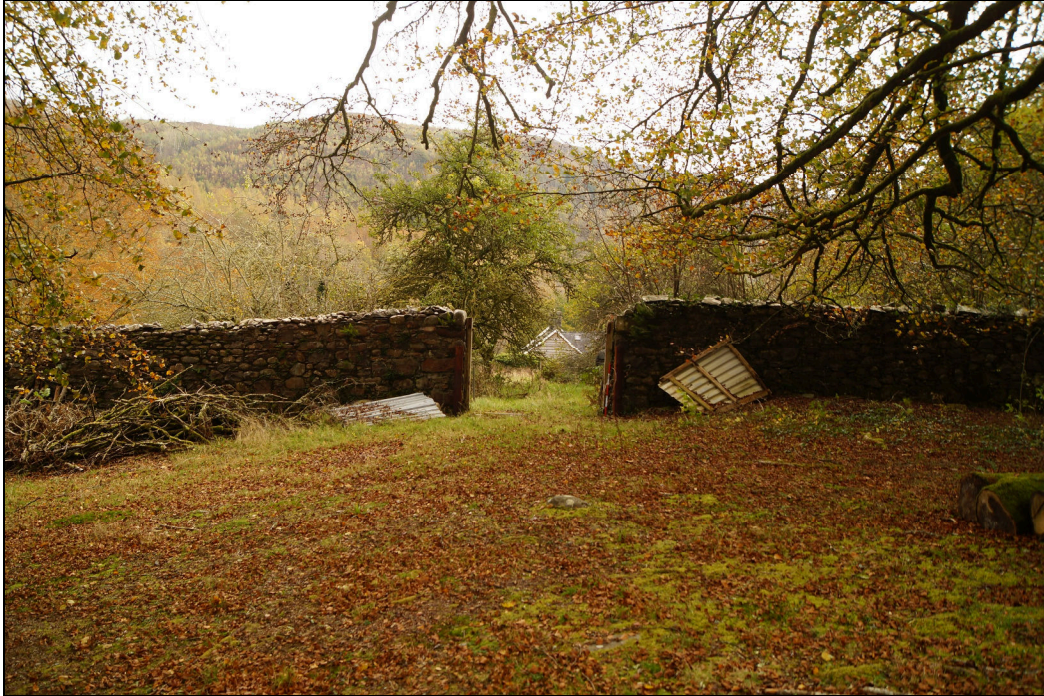
Plate 27: GGN2019_027 – A view into the walled garden at Gelligemlyn. The building visible through the entrance is Hen Gelligemlyn, which was the farmhouse present before the mansion was built in 1880. This entrance is not visible on historic aerial photographs dating to the 1940s and 1960s and may be a relatively recent modification. Looking south-southeast.

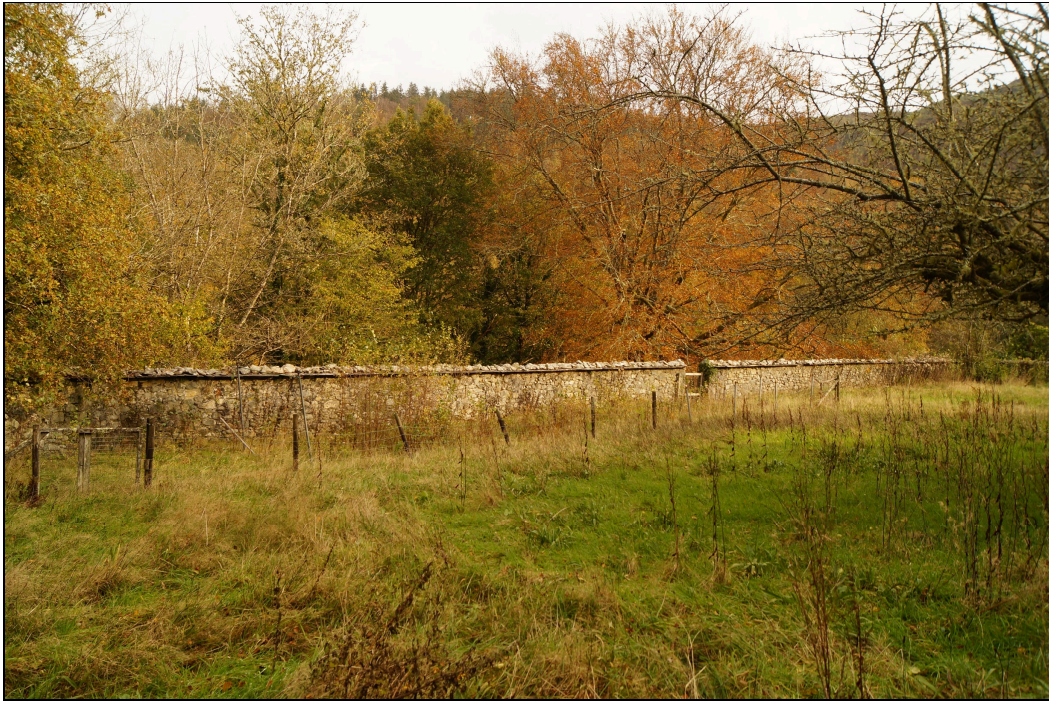
Plate 30: GGN2019_030 – A view of the well-preserved wall along the eastern side of the walled garden, beyond which the Afon Mawddach flows. Looking southeast.

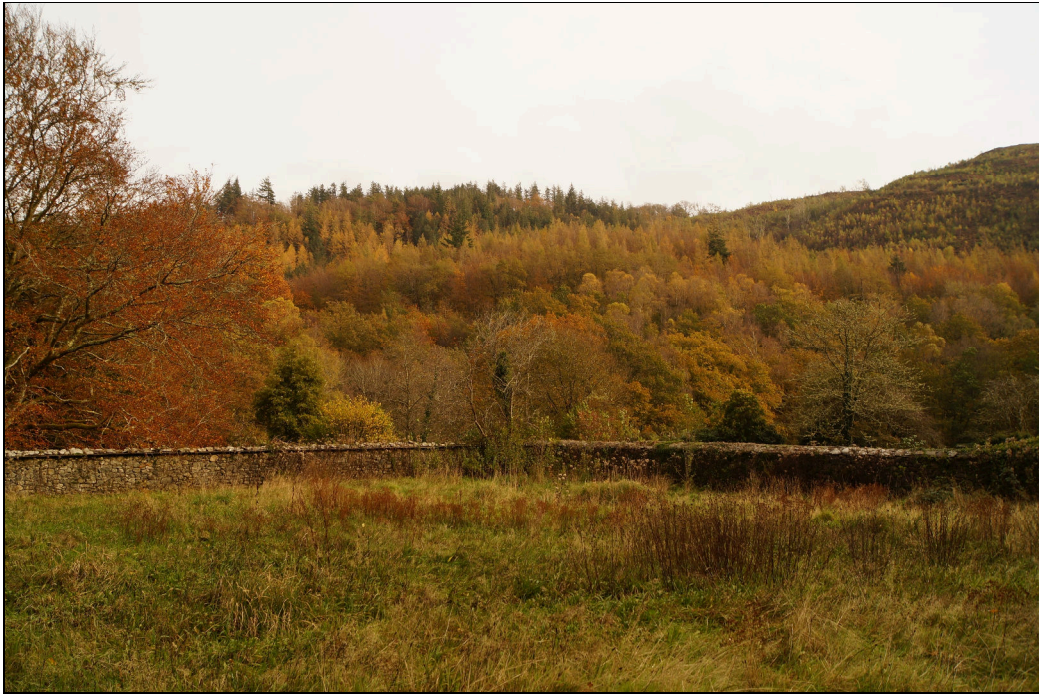
Plate 32: GGN2019_032 – a view of the northeastern corner of the walled garden taken from inside the garden. Looking north-northeast.

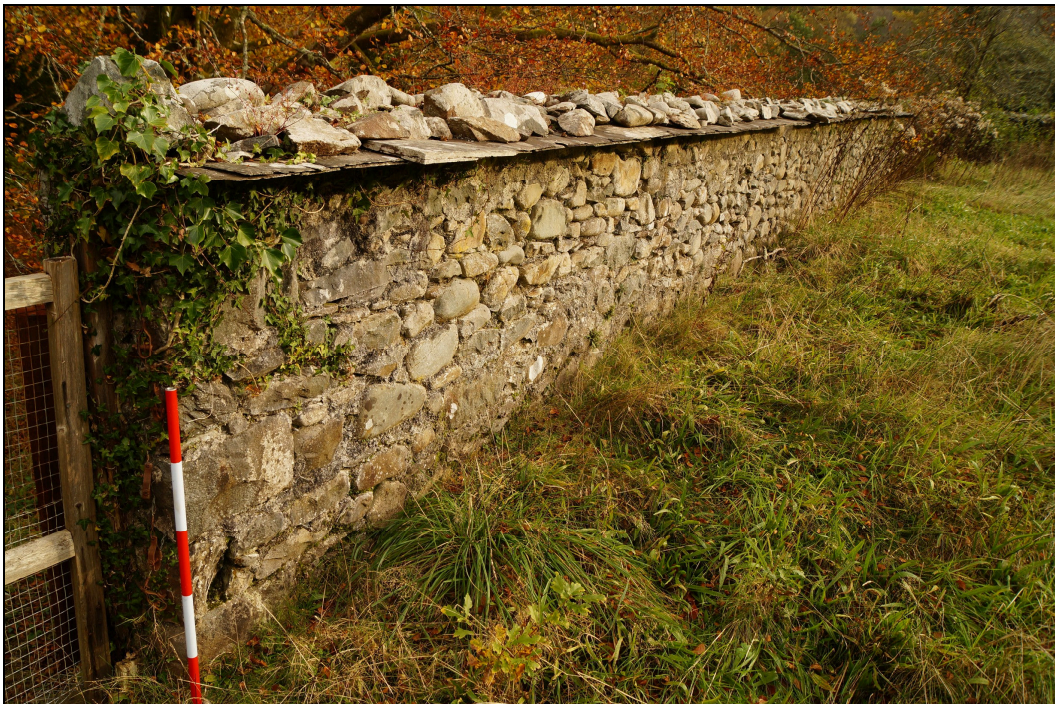
Plate 33: GGN2019_033 – a more detailed view of the eastern wall of the walled garden, showing the quality of its built and the slate copings still in situ. Looking southeast.

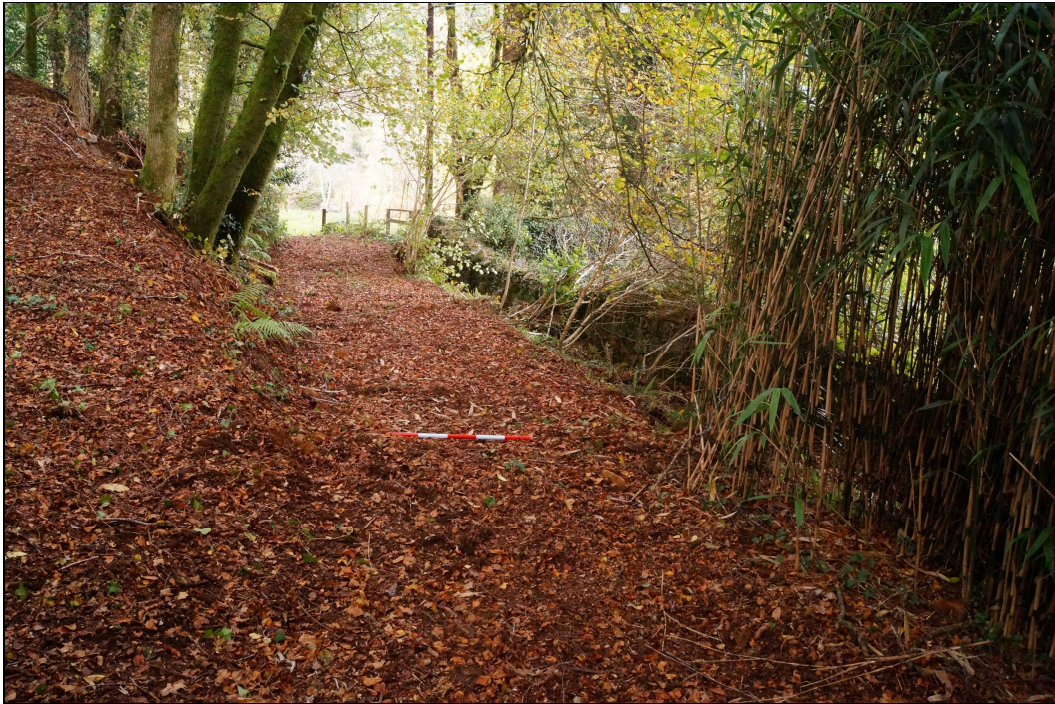
Plate 34: GGN2019_034 – a series of trackways run from the walled garden through the wooded area to its western side. These appear to be original and the branch at the far left of this image connects the walled garden to the former glasshouse and potting shed.
