## **Carey Baptist Chapel, Bridgend Road, Aberkenfig**

Standing Building Recording

Report No: 1343

Date: **May 2015**

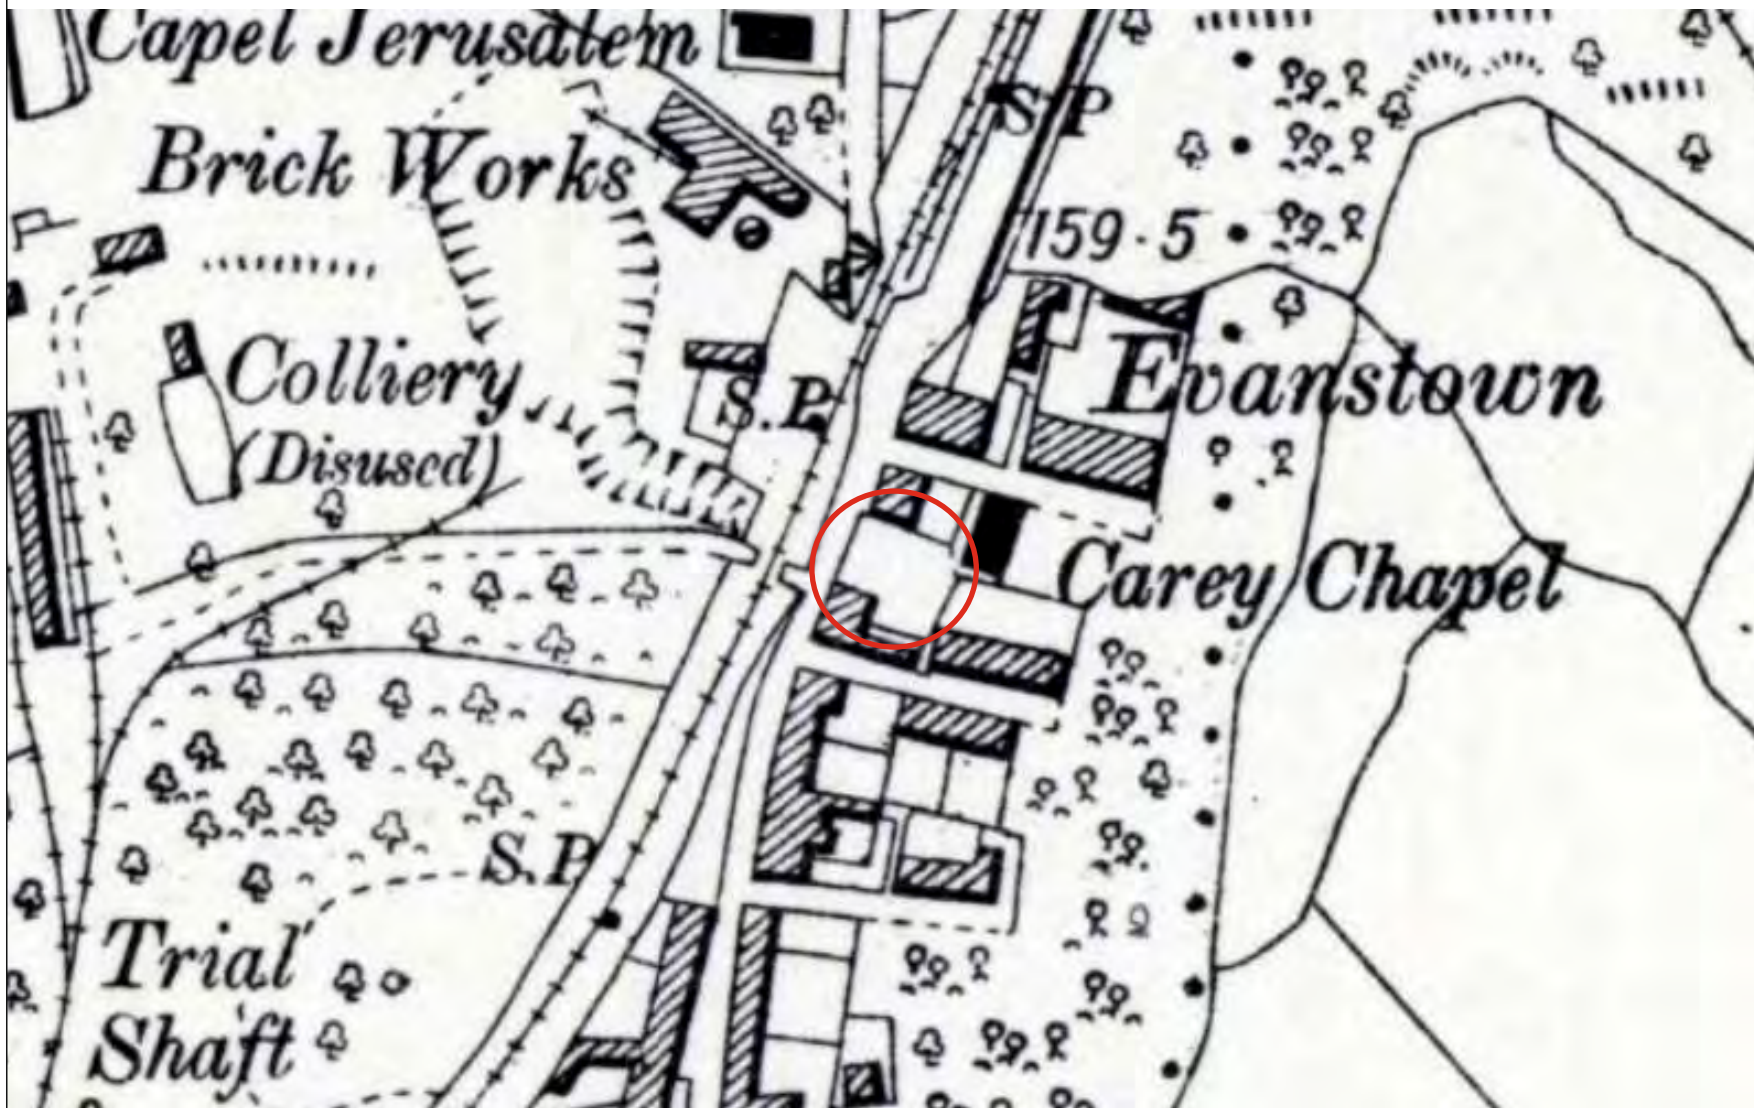
Fig 2: 1897 OS Edition  
1:2500

The 1897 Edition Ordnance Survey (OS) map 1:2500 (Figure 2) shows the absence of the present Carey Baptist Chapel structure, however adjacent and east of the current site is Carey Chapel. A rectangular structure orientated north to south located on Oak Street. This would appear to be the Iron Chapel cited in the Glamorgan Gazette.

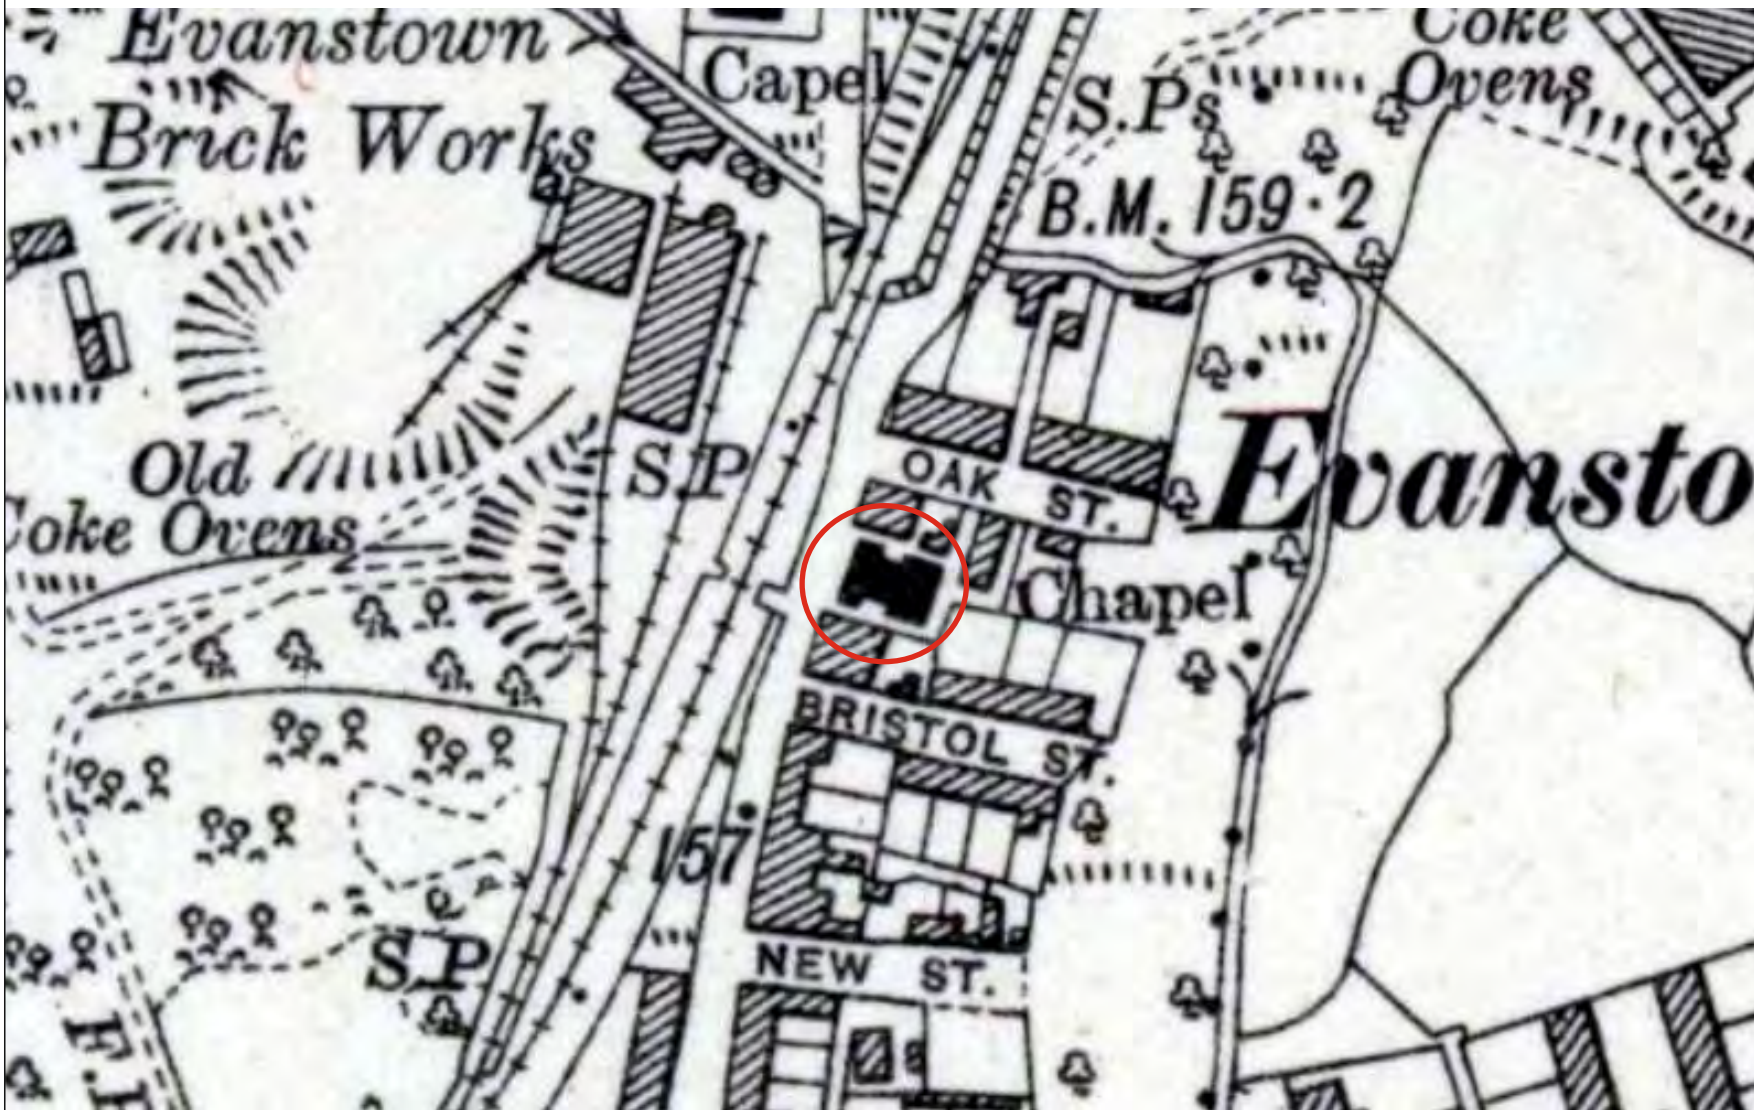
Fig 3: 1914 OS Edition  
1:2500

The 1914 Edition OS map 1:2500 (Figure 3) shows the Carey Baptist Chapel now present. The Chapel is orientated east to west with the north and south transepts protruding out at the far eastern end and the vestibule at the far western end also protrudes out either side to a similar size as the transepts.

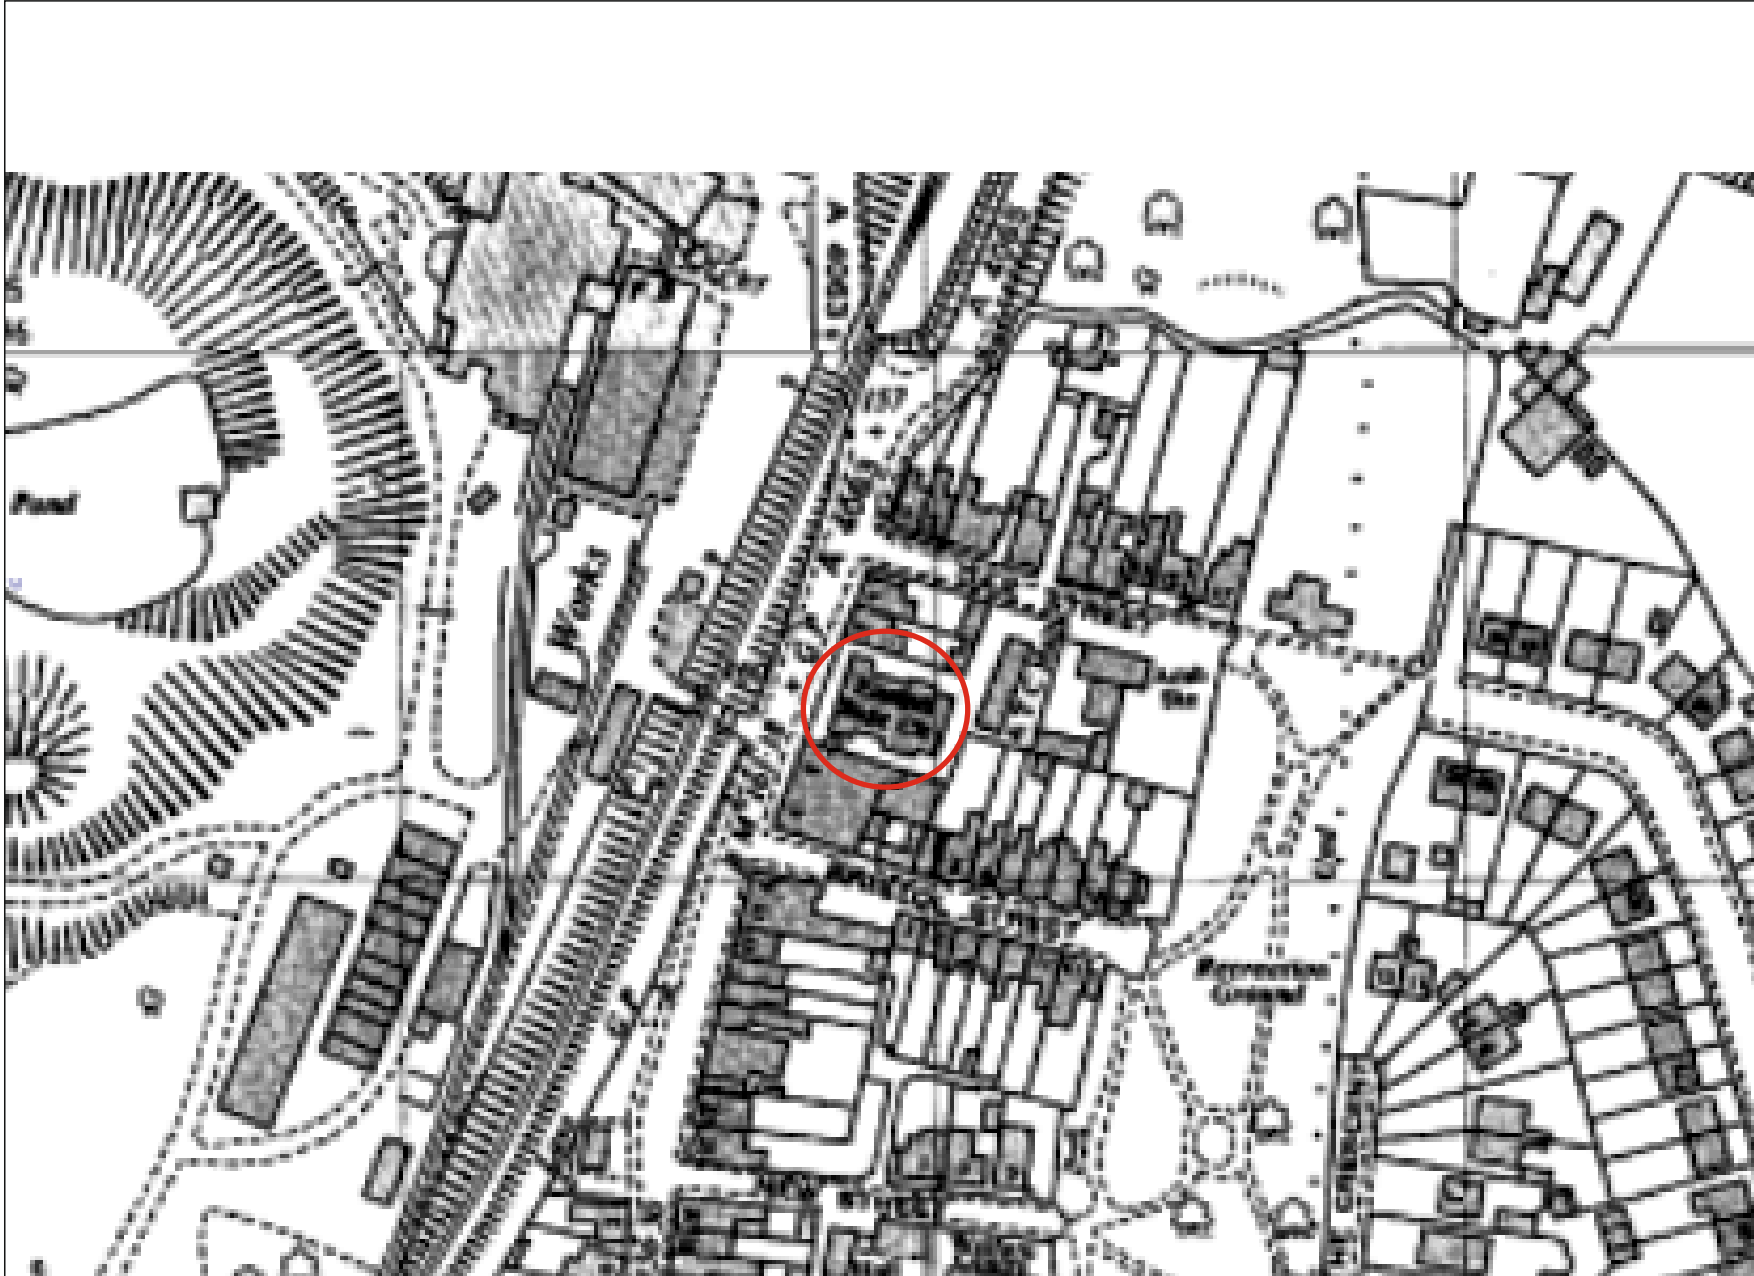
Fig 5: 1964 OS Edition  
1:2500

The 1942 Edition OS map 1:2500 (Figure 4) shows no changes to the building, however the 1964 Edition OS map 1:2500 appears to show the Chapel in more detail than previously

recorded, with the eastern end, past the transepts now showing as slightly indented, forming a typical cruciform shape in plan with extended vestibule at western end.

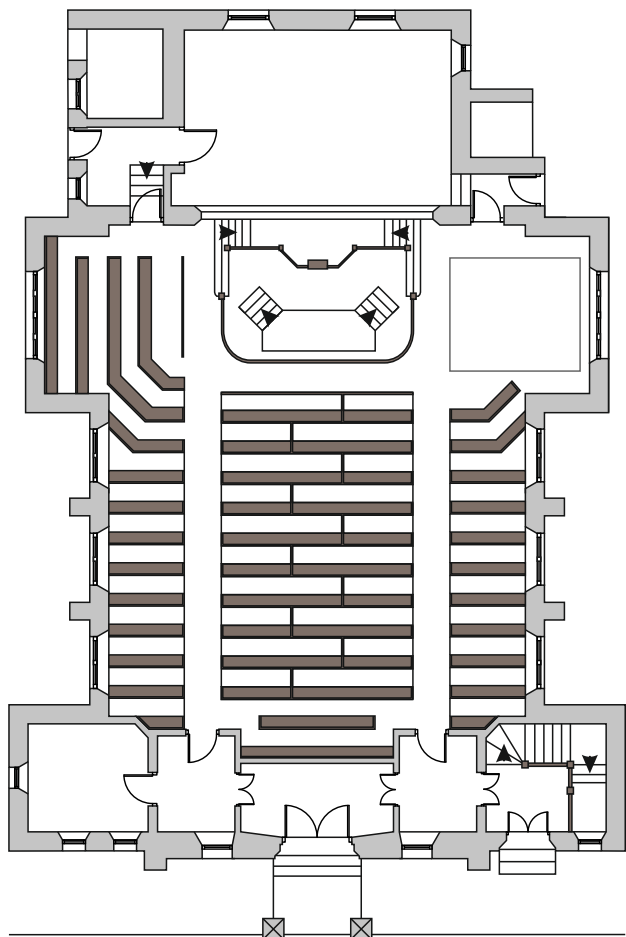
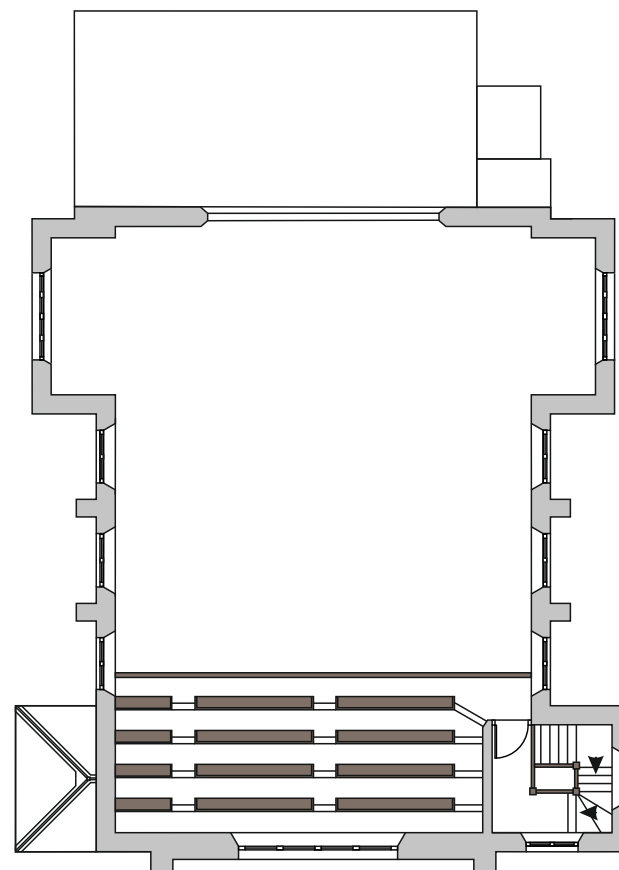
Fig 6: Plan of First and Second Floors

Figure 6 shows the existing ground and first floor plan of Carey Baptist Chapel. Figures 7 and 8 show the existing elevations of the building. Figure 9 shows the location and direction from which the photographic plates were taken. The number after each red arrow corresponds to the plate on which the photograph appears.

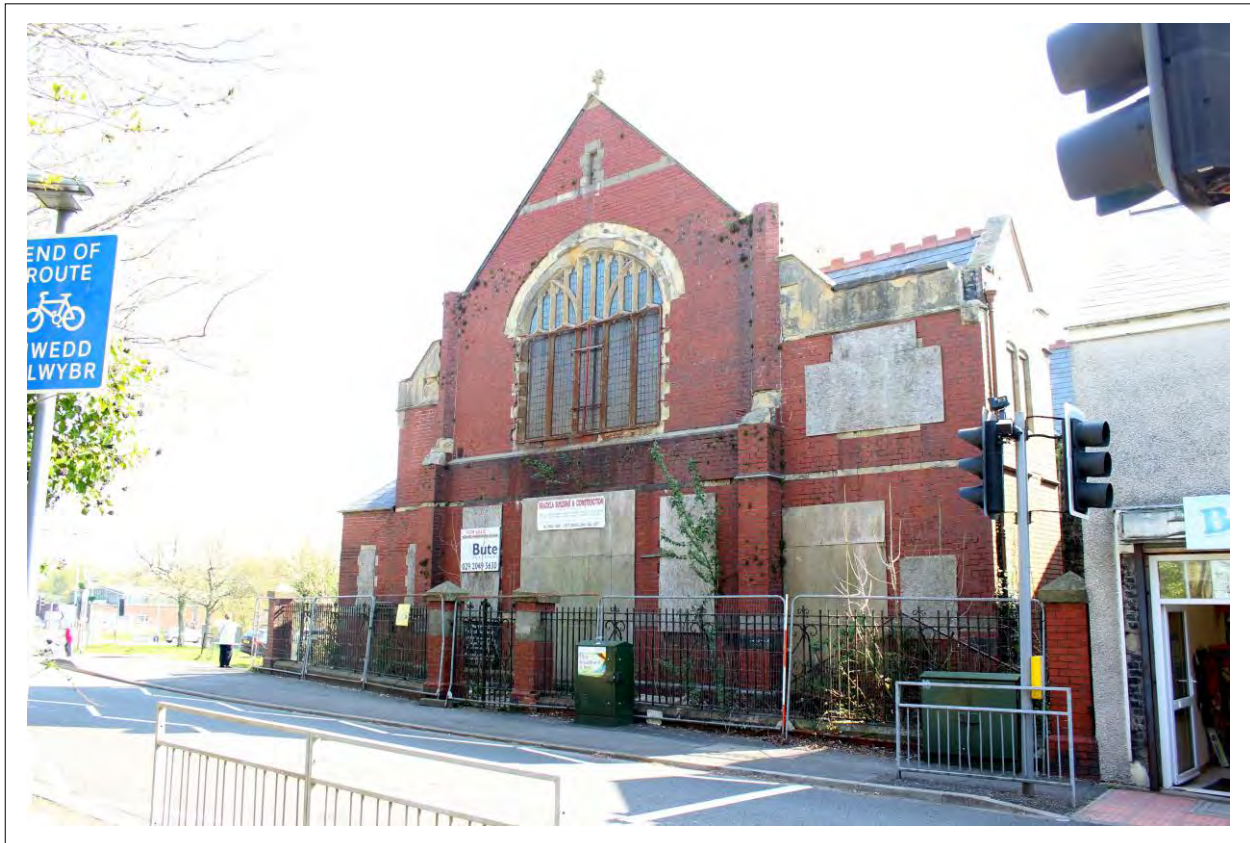
The building is cross gabled (Plate 1 and 9), formed by the transepts and the southern wing of the vestibule, the north wing of the vestibule has a hipped construction (Plate 5 and 6). The vestry is a pent roofed construction (Plate 9). The eastern gable end has overhanging wooden eaves painted brown, the rest are flush with the buildings' stone work. Purple slate tiles cover the roof with orangey brown angled ceramic ridge plates alternating with angled crested ridge plates covering the main building and cross gables (Plate 4, 6 and 9).

The western elevation is mostly symmetrical in design (Plate 1). The main central bay holds the doorway which is constructed of a carved stone two-centred arch with double wooden doors, flanked by windows featuring two-centred stone arches with stain glass. Framing the central bay are square brick towers/buttresses, which extend half way up the building to a chamfered horizontal decorative stone band. The upper section of the towers are octagonal extending up to the bottom of the gable. A large two centred arched stain glass window is located in the first floor, constructed with carved stone and decorated with tracery panels (Plate 2). The lower panels feature trefoil cusped lancets with flowing ogee arched centres which lead onto the smaller upper panels featuring further plain trefoil cusped lancets and blind panel work on the cusps and spandrels. Above the window is a plain stone band and a rectangular blind window. A top of the apex of the roof sits a stone carved cross of cercelée or anchored design.

Plate 1: Western elevation

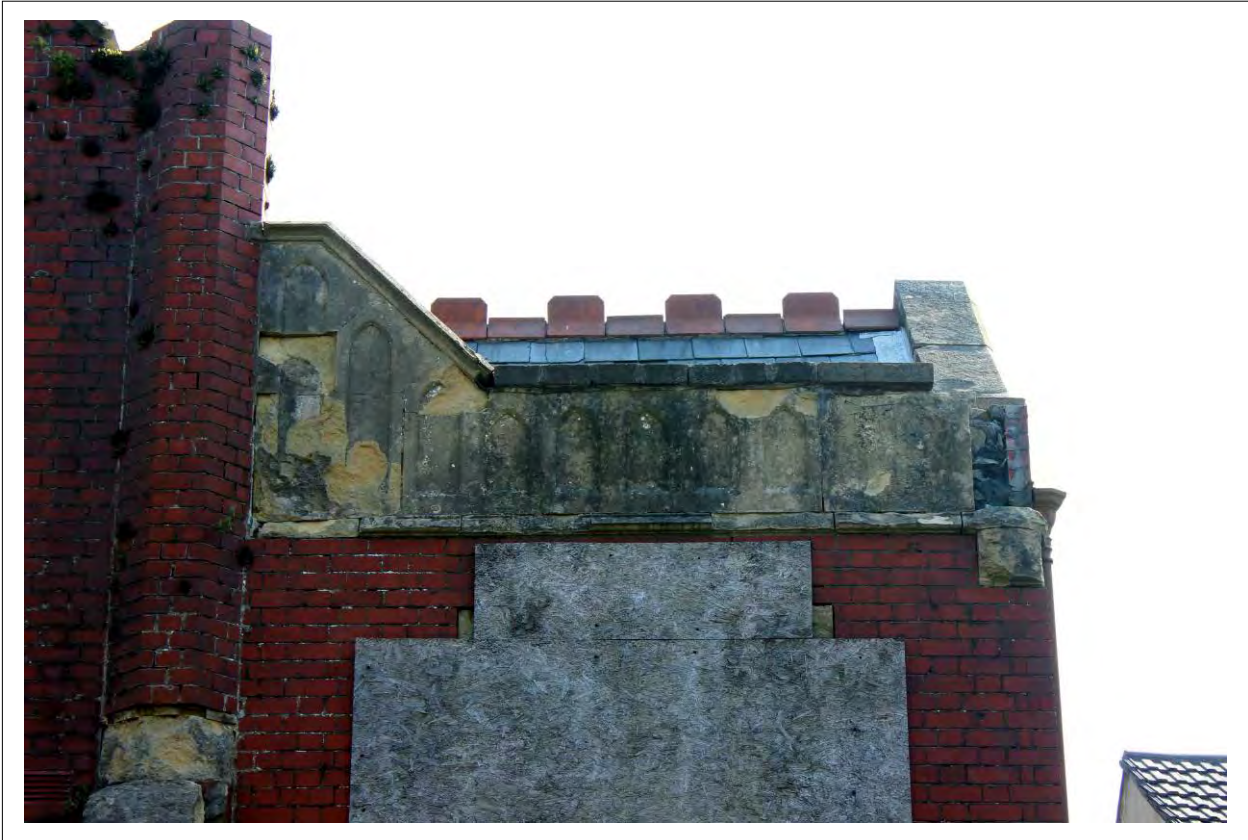
design supports a protruding parapet adorned with blind lancets which extends towards the centre and increases in height where the line of the central gable roof would extend through (Plate 1 and 4). The parapet is topped with a saddleback coping with cyma reversa moulding. The same design is featured in the northern bay but less width (Plate 3). Two separated depressed stone arches with stained glass are located in the ground floor.

Plate 4: Western elevation parapet with blind lancets

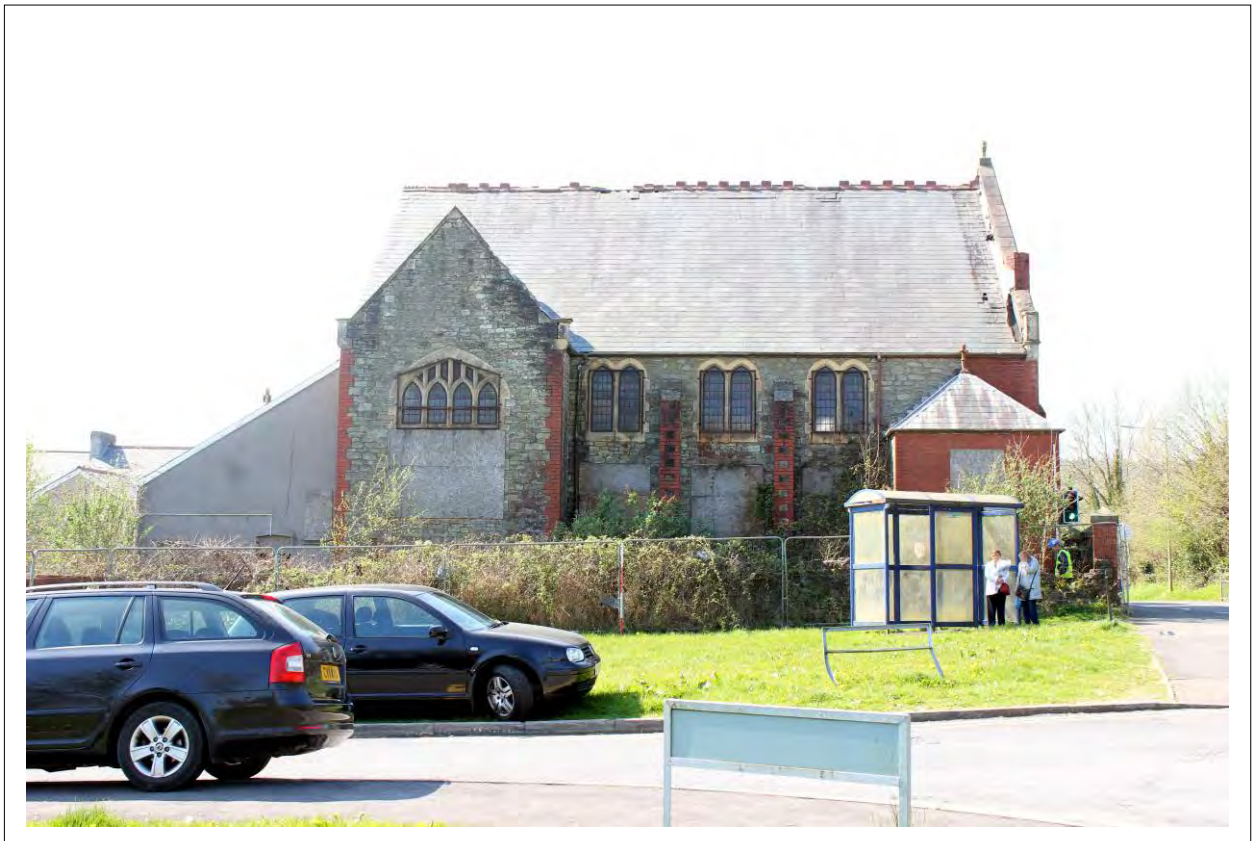
The central section of the northern elevation has three sets of double mullioned windows in the upper and lower floors, these are evenly spaced and separated by two square brick and stone buttresses (Plate 6). The upper floor windows are of plain lancet type and the lower are depressed arched with keystone removed, all with stained glass (Plate 7, 23-25). The western vestibule wing is rectangular with hipped roof topped with a decorative ridge plate. A single depressed arch window with stained glass features in its northern elevation. The Vestry is located at the eastern end of the chapel and is a pent roofed construction with rough concrete render (Plate 9). The Vestry was boarded and not accessible around the eastern or southern side, however the archive plans (of which there were several variations) suggests the doorways and windows were of brick surrounds. The main vestry doorway had a flanking window to its west and a second doorway which entered the boiler room to its east.

Plate 6: Northern elevation

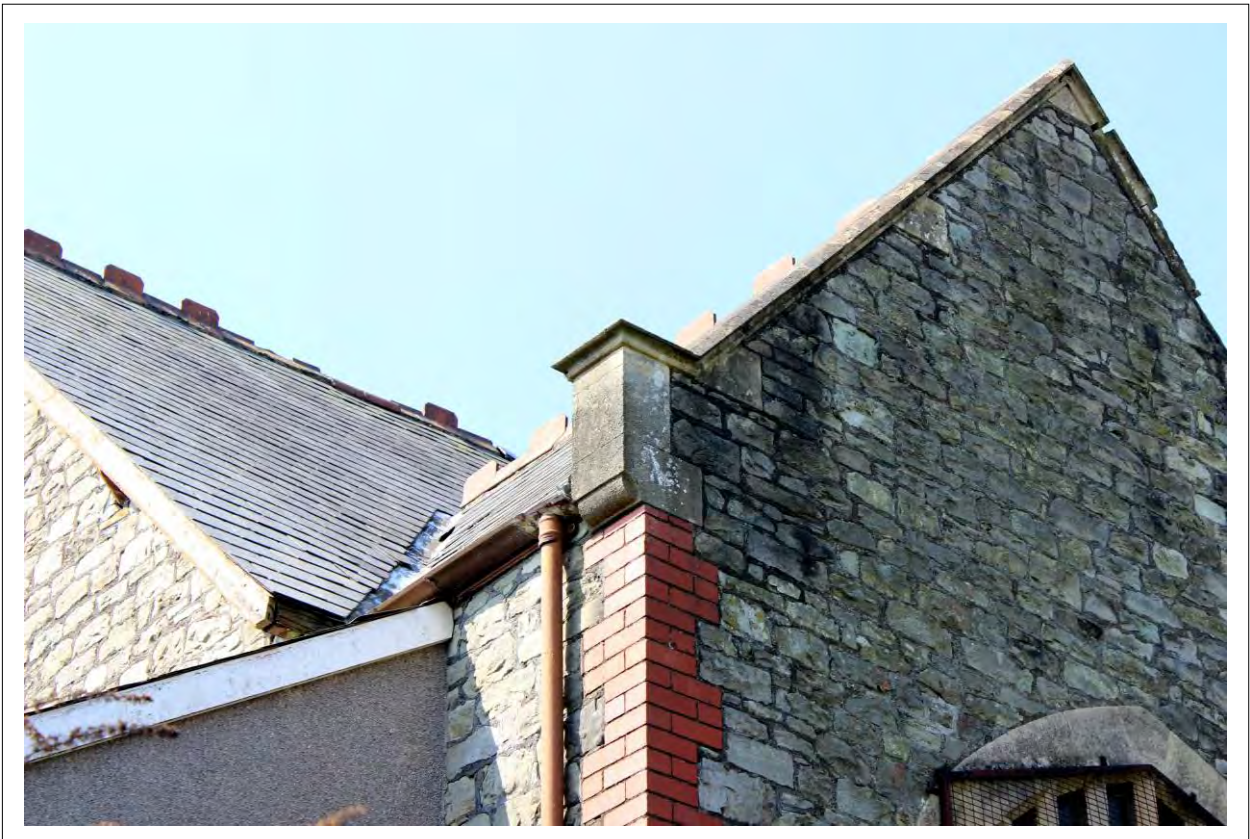
The northern elevation holds the north gabled transept at its eastern end, with stone carved corbels featuring ovolo decoration supporting protruding stone eaves with cyma reversa mouldings (Plate 8). Located centrally within the transept is a moderately sized two-centre arched stain glass window constructed with carved stone and decorated with tracery panels (Plate 6). The window features four rectangular larger panels along the bottom with a flat transom separating four equal sized lancet windows above. The upper section of the window is formed by the spandrels, which extend straight up forming the curve of the window (Plate 22).

Plate 8: Northern elevation closeup of ovolo corbel and mouldings

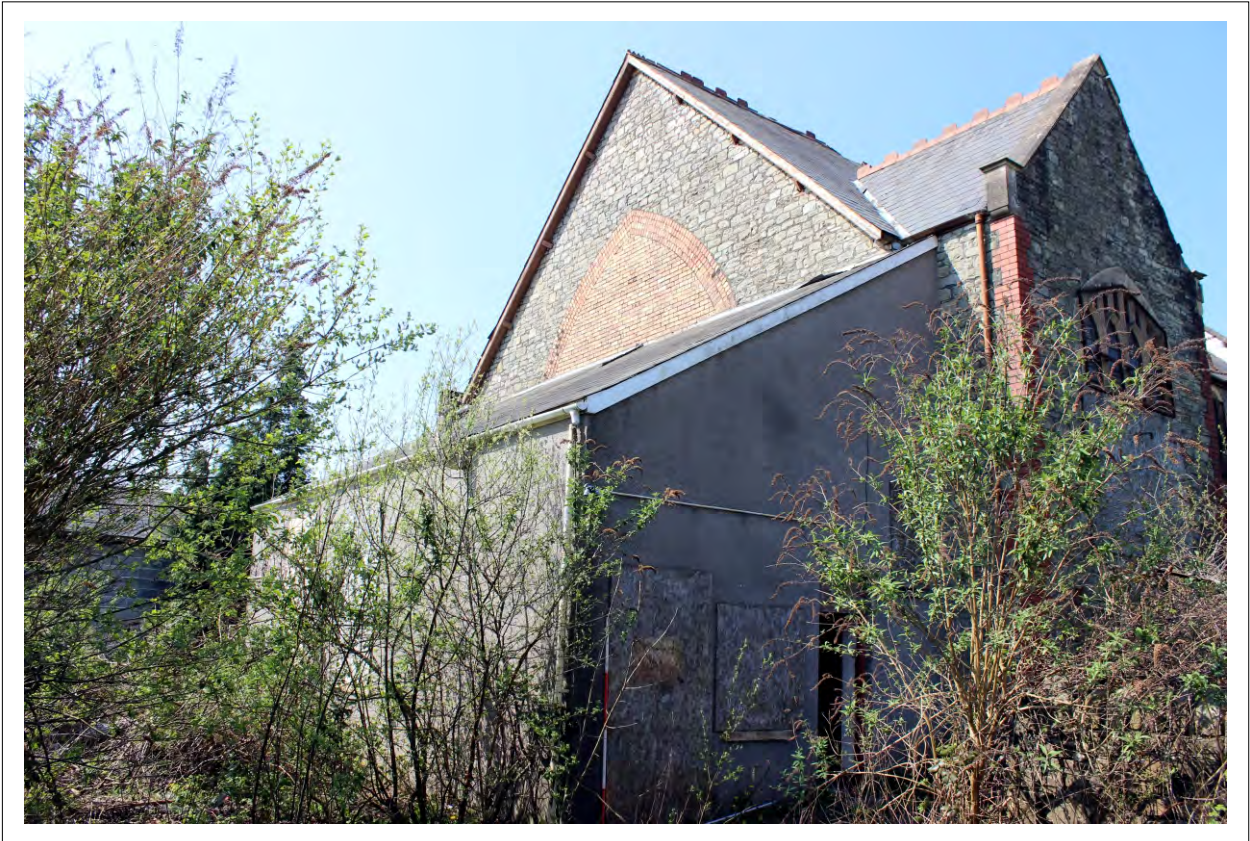
- . The addition of rough concrete render to the Vestry external walls. Plate 9.
- . The addition of a modern PA system. Plate 10.
- . The addition of a RAF commemorative stain glass window. Plate 27.
- . The addition of an Organ in circa 1932. Plate 28.

The building is cruciform in shape with extended wings on the vestibule, approximately 20m long by 16m wide. The building is orientated typically east to west and consists of ground and first floor. The walls are constructed of rough faced stone and lime mortar bonding brought to course with brick details on the corners (Plate 6). The fenestrations are formed from carved sandstone. The western frontage is constructed of red brick and lime mortar in a Flemish bond with carved stone forming the fenestrations (Plate 1). The Vestry has been rough cement rendered (Plate 9).

The eastern elevation is mostly taken up by the Vestry, which has two large horned sash windows of a six-over-six type located evenly spaced along the elevation. The gable of the chapel is visible above the pent roof and shows a four course stacked header bond, two centred orange brick arch, in filled with orange brick in a running bond (Plate 9).

Plate 9: Eastern elevation pent roofed vestry

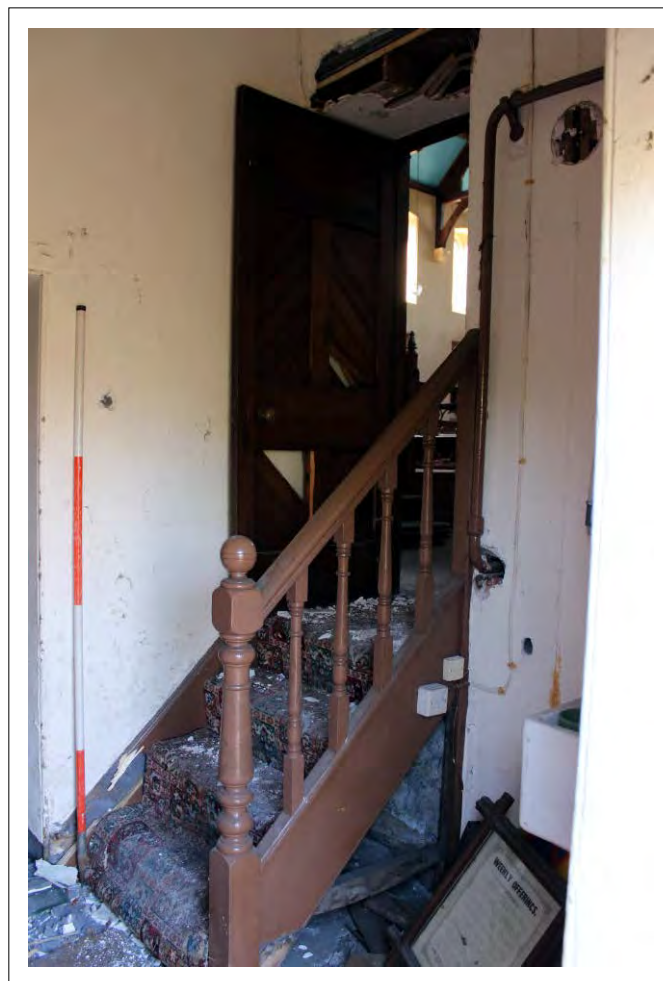
Plate 10: View from vestry doorway, south toward stairs leading into chapel

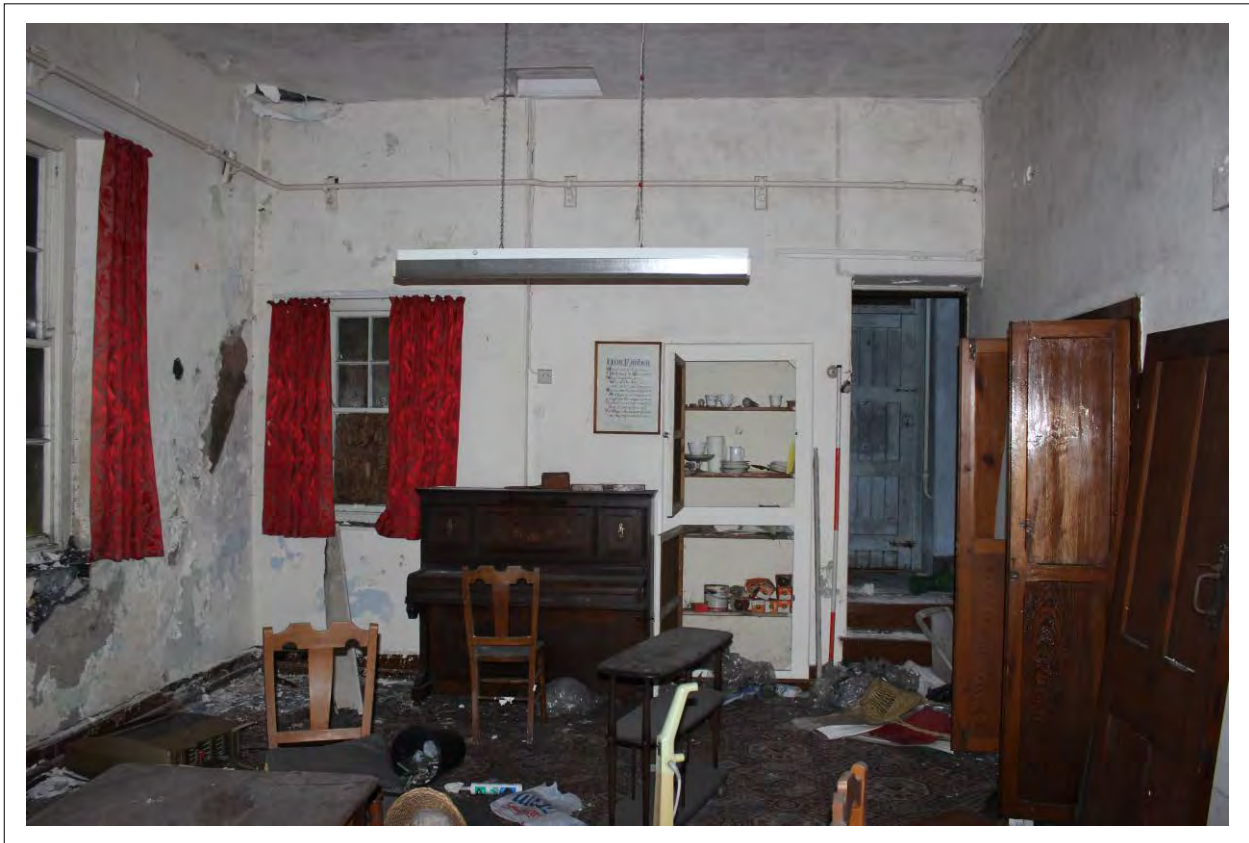
The Vestry was fairly plain with two horned sash windows in the eastern wall and a single in the southern wall (Plate 11 and 13), the room had small corridors which led onto doorways at the southern and northern ends. These corridors also had doorways in the western walls which led into the chapel (Plate 10). Built in cupboards were located along the western wall with a single adjacent to the window in the east (Plate 11 and 12).

Plate 11: View south showing vestry

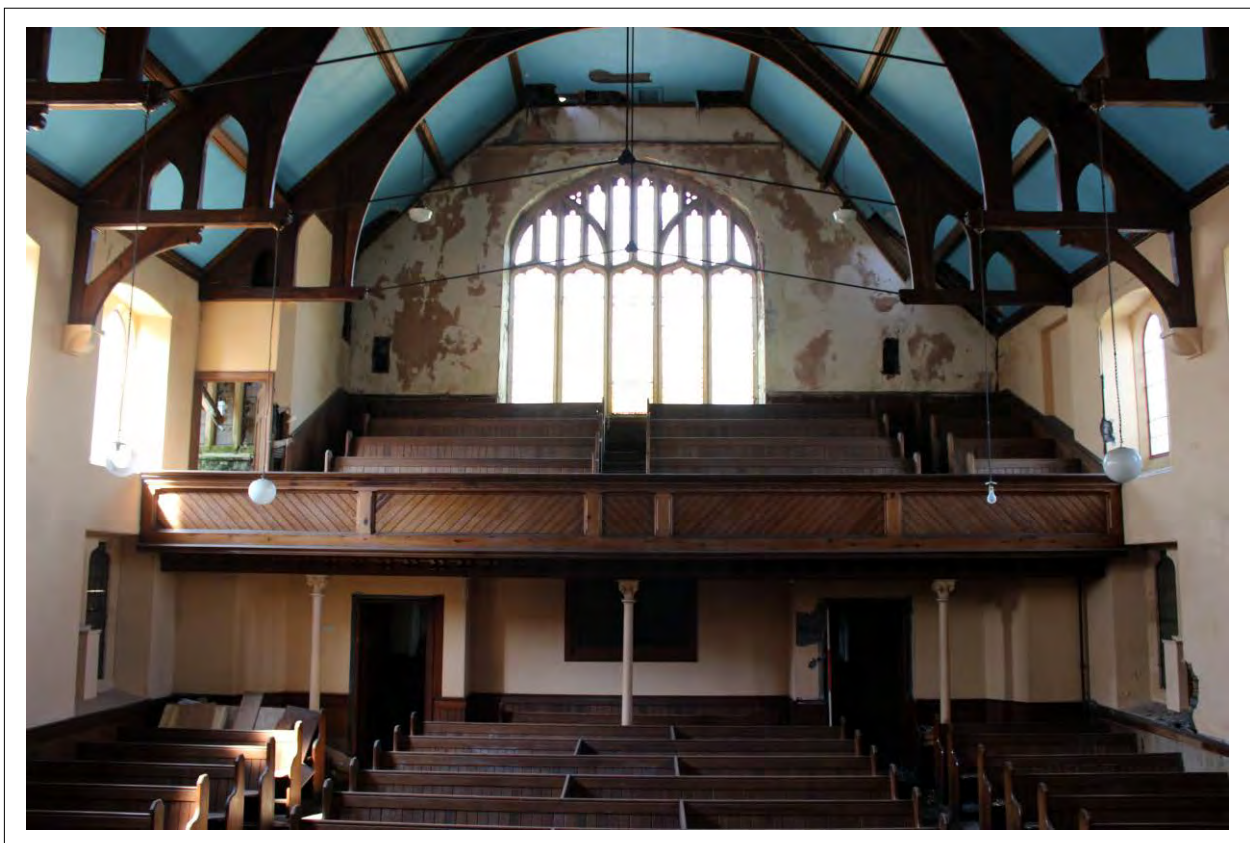
The balcony, which was inaccessible, was supported by iron columns, with capitols featuring foliate and rose decorations (Plate 18 and 19). The balcony itself was constructed of timber with the sides partially timber clad and the pews laid out straight on a tiered platform with the main stained glass window visible to the rear (Plate 14 and 15).

Plate 14: View west showing church from pulpit

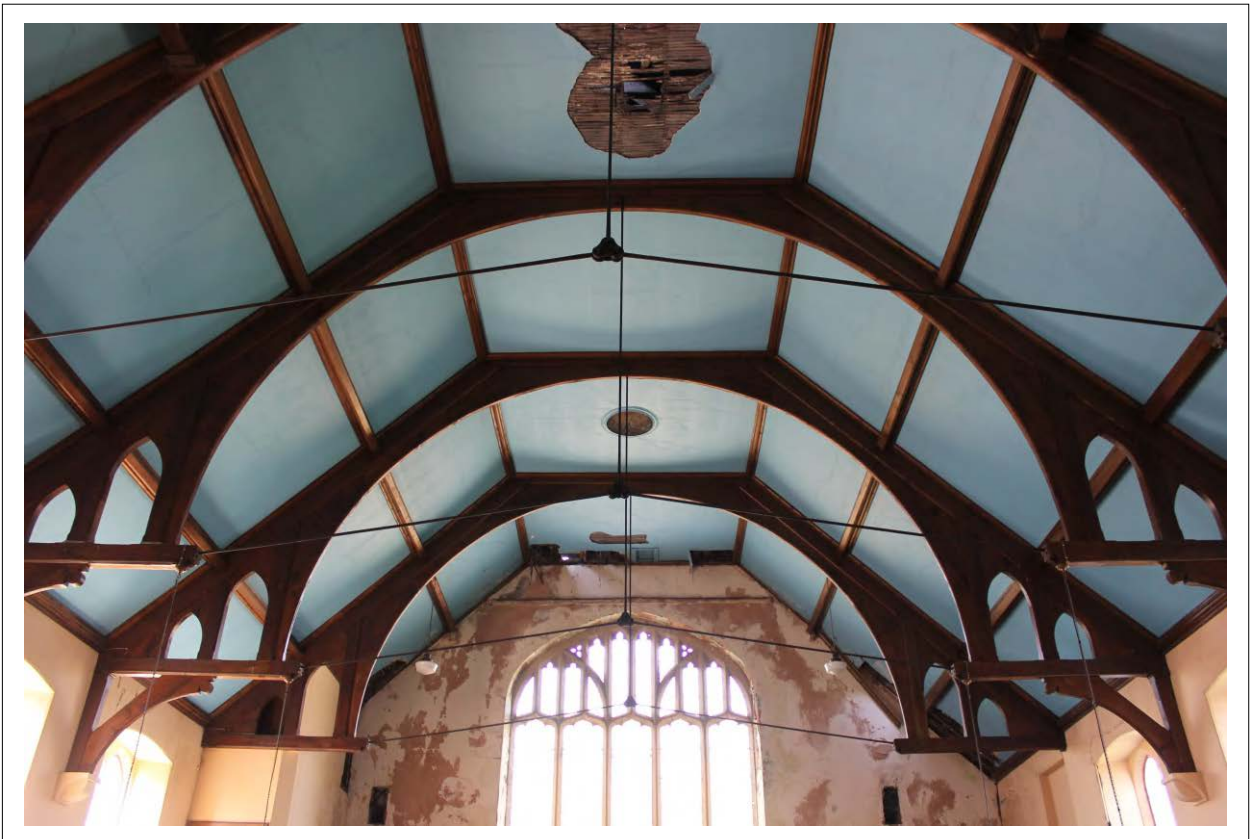
The roof supports were visible and were a hammer beam roof truss construction sat on lofted stone corbels carved with an ovolo design (Plate 16 and 17). The trusses featured open lancets with the main beam and brace having a carved torus design at the ends. The purlins between the arched ribs were left open.

Plate 16: View west showing hammer beam roof truss

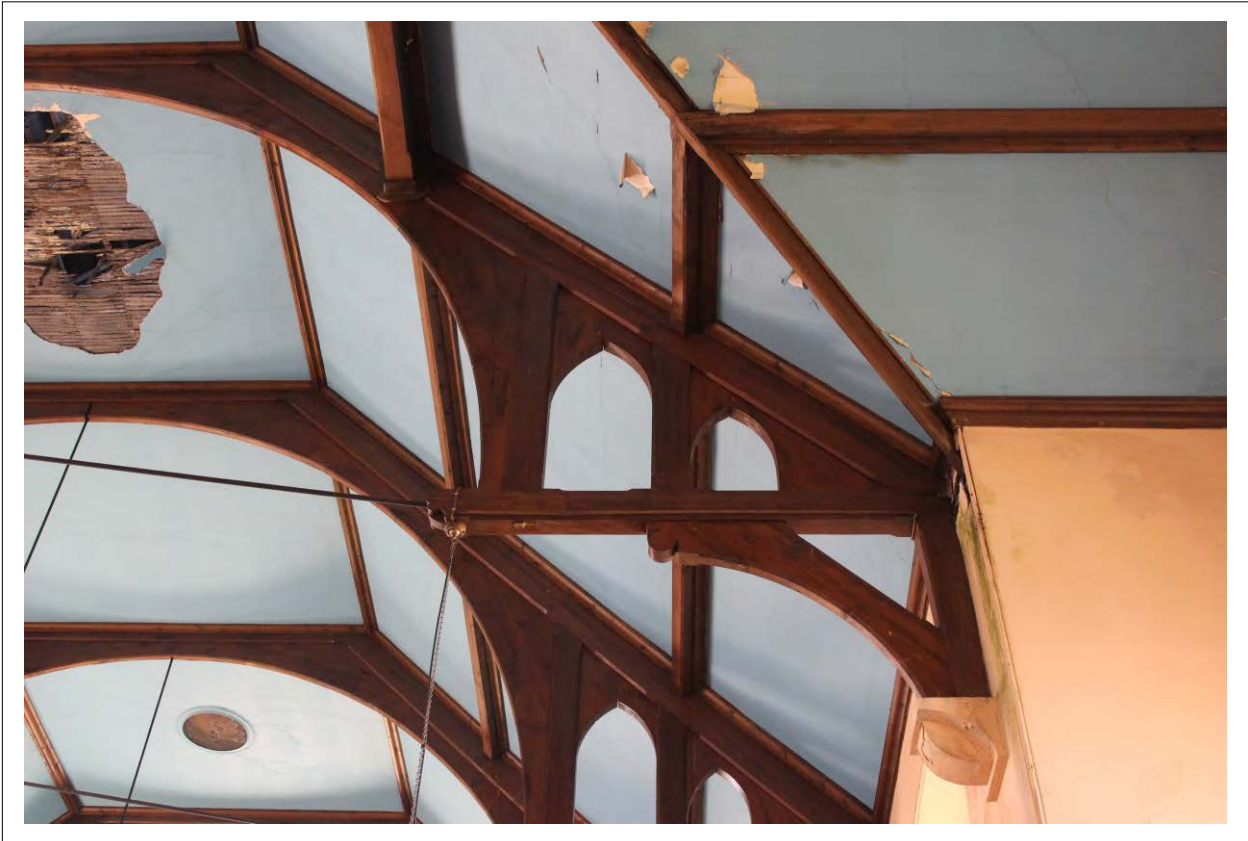
Plate 17: View west showing closeup of hammer beam roof truss and corbel

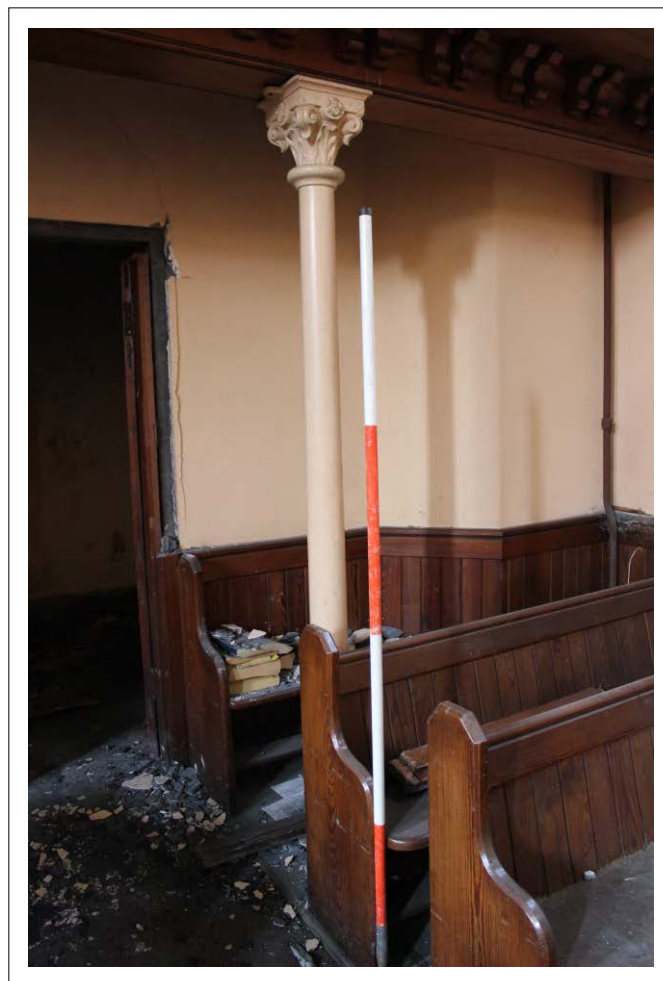
Plate 18: View west showing detail of columns

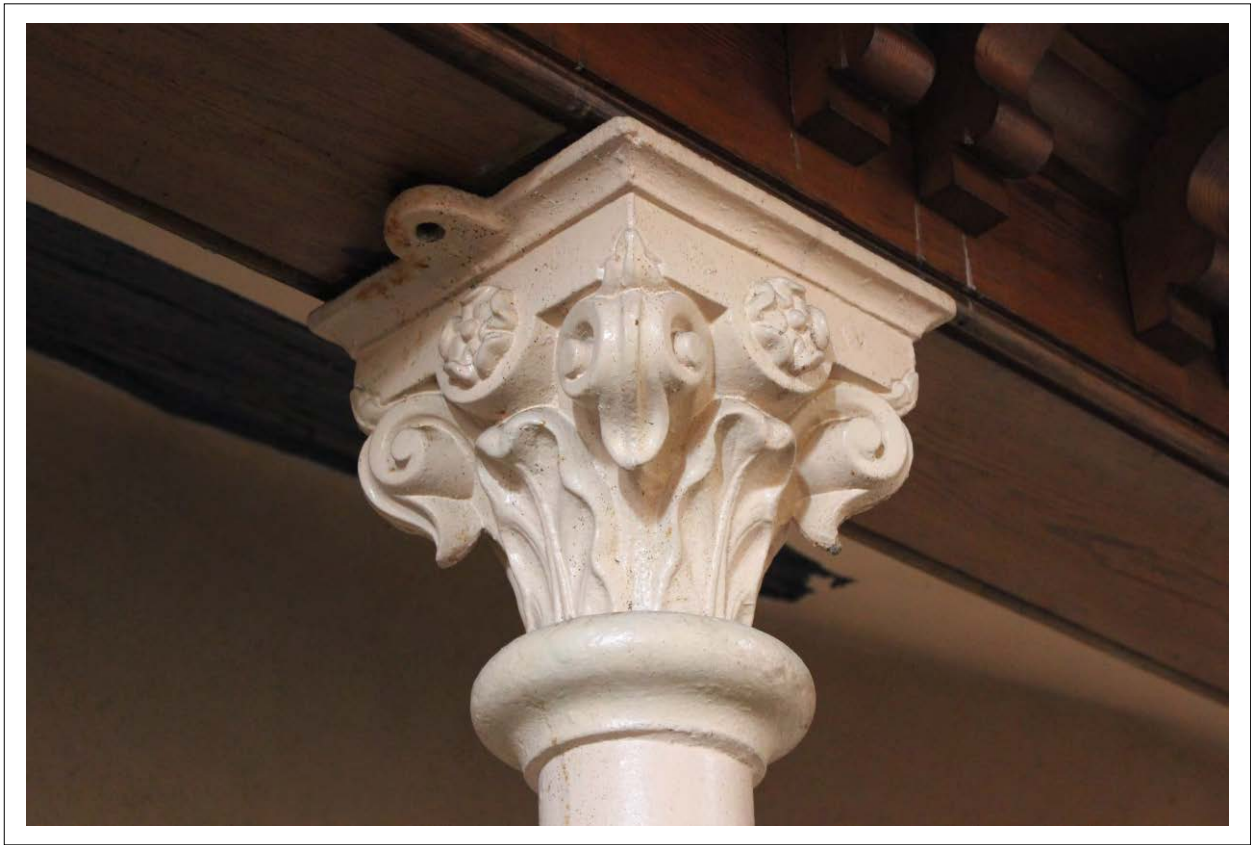
Plate 19: Column capital detail

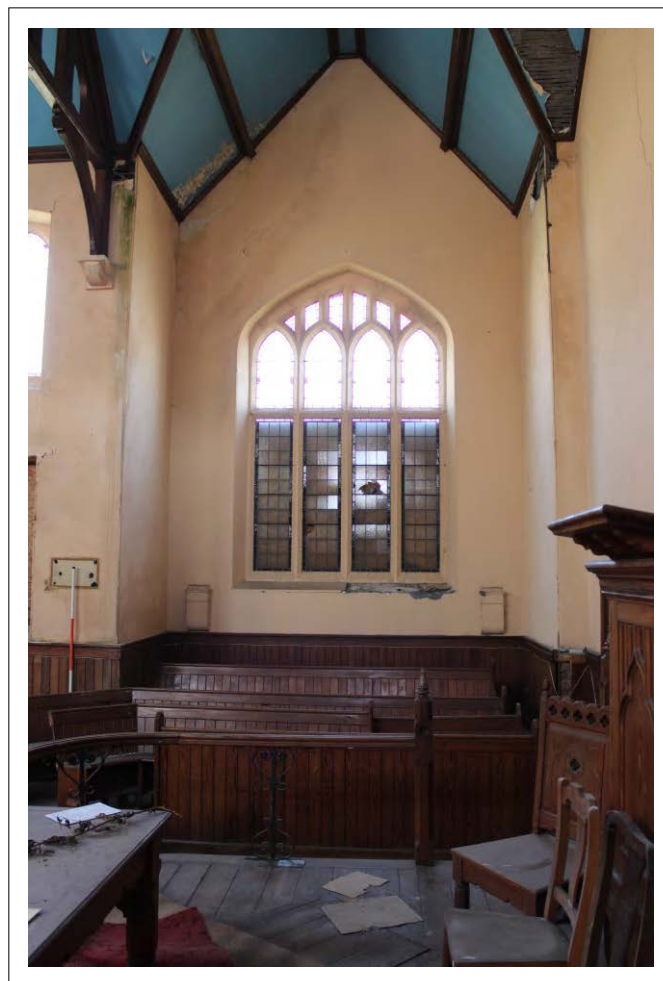
Plate 22: View north showing stain glass window

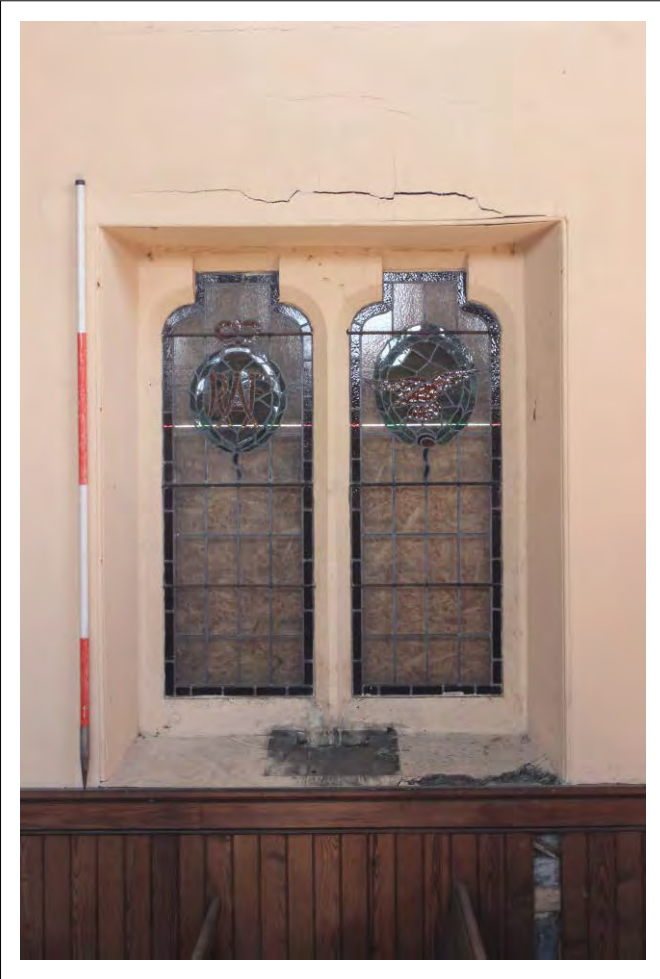
The chapel is laid out in a symmetrical fashion. The pulpit is located centrally at the far eastern end on top of a rectangular chancel/stage with rounded corners (Plate 29 and 30). The southern transept houses the organ which appears to be a later addition of circa 1935 (Plate 28), with the northern transept containing further pews with the first three rows laid out octagonally so as to face the stage. The rest of the pews extend back through the nave and aisles either side in straight lines (Plate 14). The three upper and lower stained glass windows are visible either side of the northern transept window, with the southern transept window partially obscured by the organ (Plate 21-26). The windows all appear to be the same design with the only difference being a later (presumably Second World War) addition of a RAF commemorative stained glass motif, inserted in the central lower window on the south side (Plate 27).

Plate 27: View of RAF commemorative stained glass window
