## **Carey Baptist Chapel, Bridgend Road, Aberkenfig**

Standing Building Recording

Report No: 1343

Date: **May 2015**

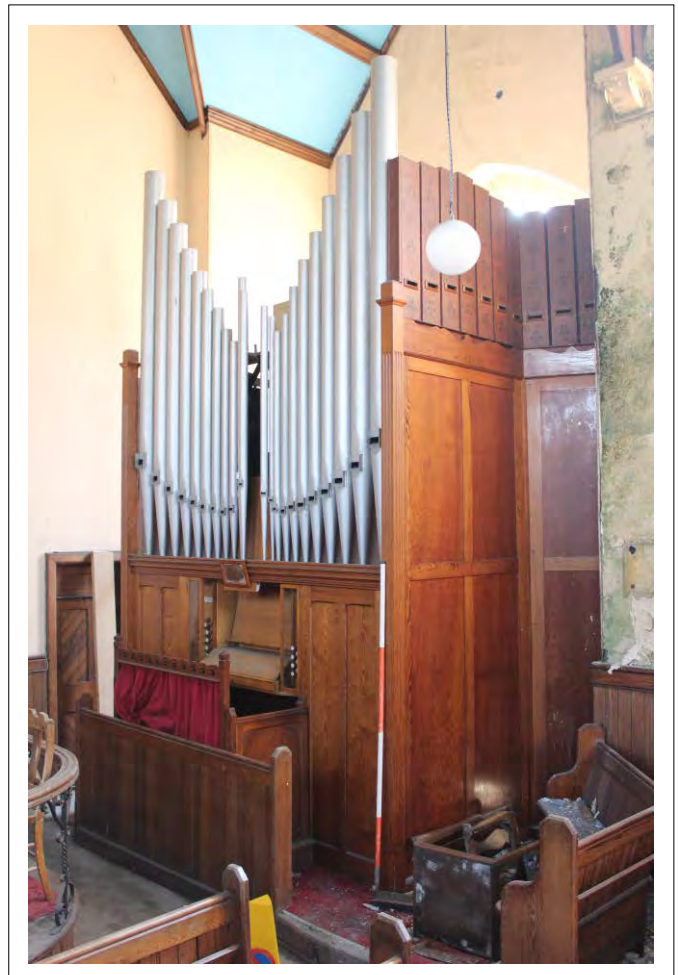
- . The addition of rough concrete render to the Vestry external walls. Plate 9.
- . The addition of a modern PA system. Plate 10.
- . The addition of a RAF commemorative stain glass window. Plate 27.
- . The addition of an Organ in circa 1932. Plate 28.

The chapel is laid out in a symmetrical fashion. The pulpit is located centrally at the far eastern end on top of a rectangular chancel/stage with rounded corners (Plate 29 and 30). The southern transept houses the organ which appears to be a later addition of circa 1935 (Plate 28), with the northern transept containing further pews with the first three rows laid out octagonally so as to face the stage. The rest of the pews extend back through the nave and aisles either side in straight lines (Plate 14). The three upper and lower stained glass windows are visible either side of the northern transept window, with the southern transept window partially obscured by the organ (Plate 21-26). The windows all appear to be the same design with the only difference being a later (presumably Second World War) addition of a RAF commemorative stained glass motif, inserted in the central lower window on the south side (Plate 27).

Plate 28: View south east showing organ

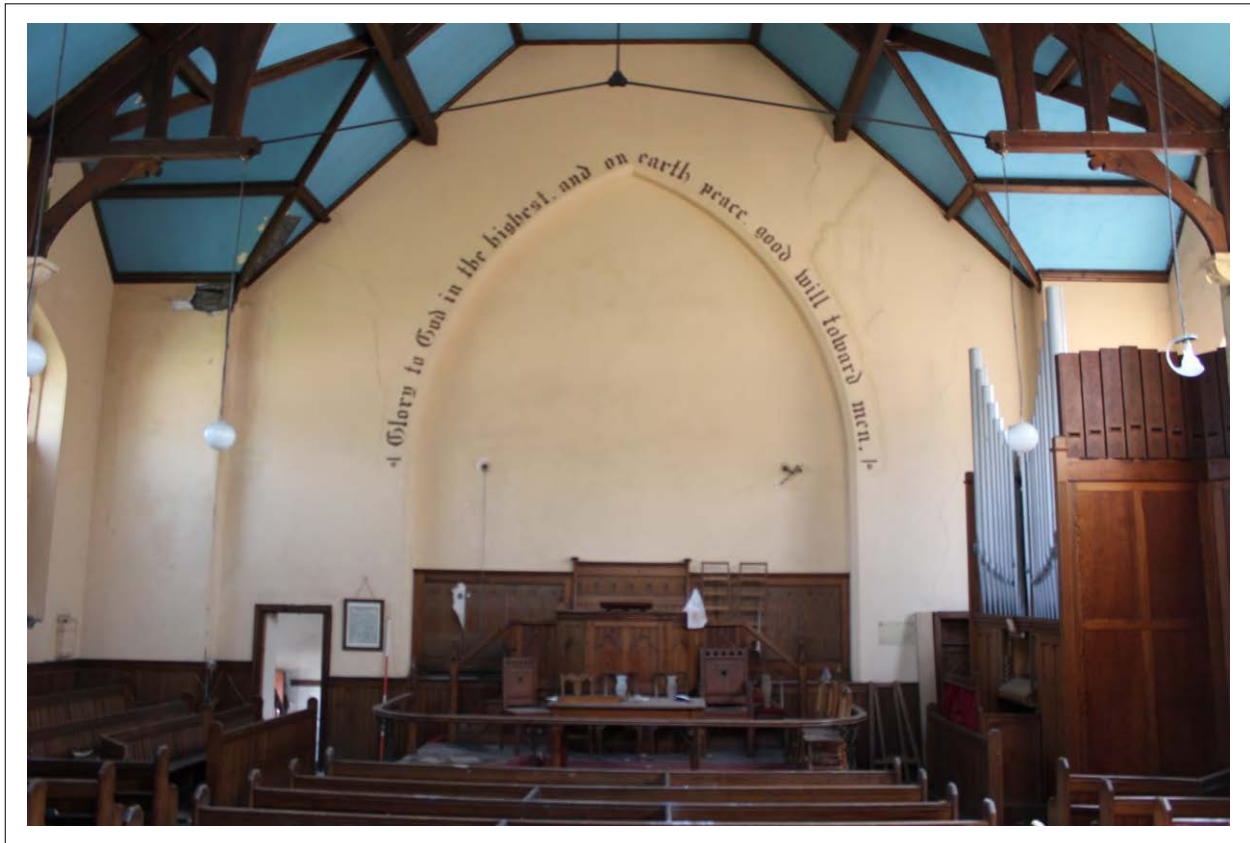
Plate 29: View east showing pulpit

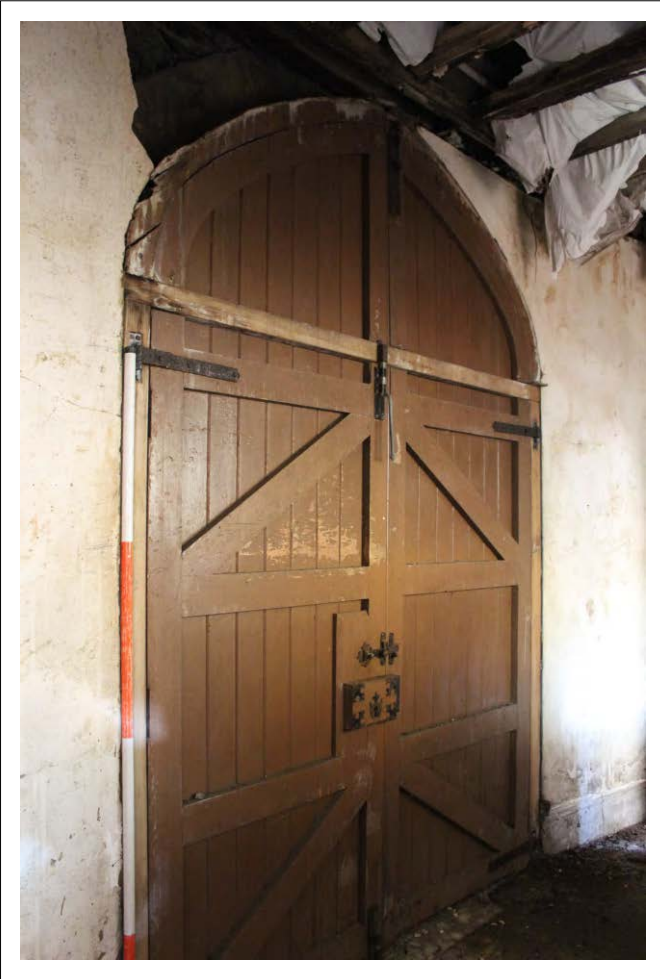
The main access to the building would have been gained through the double doors in the western elevation (Plate 39). The vestibule has a rectangular stained glass window directly opposite the doorway. Two double doors are located at either end of the vestibule entering small hallways which lead into the chapel (Plate 36). Each hallway has a two-centred arched window with stained glass, however the northern one had been removed and the southern window vandalised (Plate 37 and 38). The hallway to the north has a second doorway which leads into a timber clad room with two windows in the south wall and one in the west, these are rectangular stained glass windows fitted into a depressed arch opening (Plate 40 and 41). The southern hallway has a flight of stairs leading to the upper balcony (Plate 42). The room leading off the northern hallway and the stairs were both inaccessible due to safety constraints.

Plate 39: View west showing rear of main doorway
