**Bodidris Hall, Llandegla,
Denbighshire, LL11 3AL.
April 2016
V 2.0**

Archaeological Watching Brief
Project Code: A0057.1
Report no. 0081

Archaeological Watching Brief

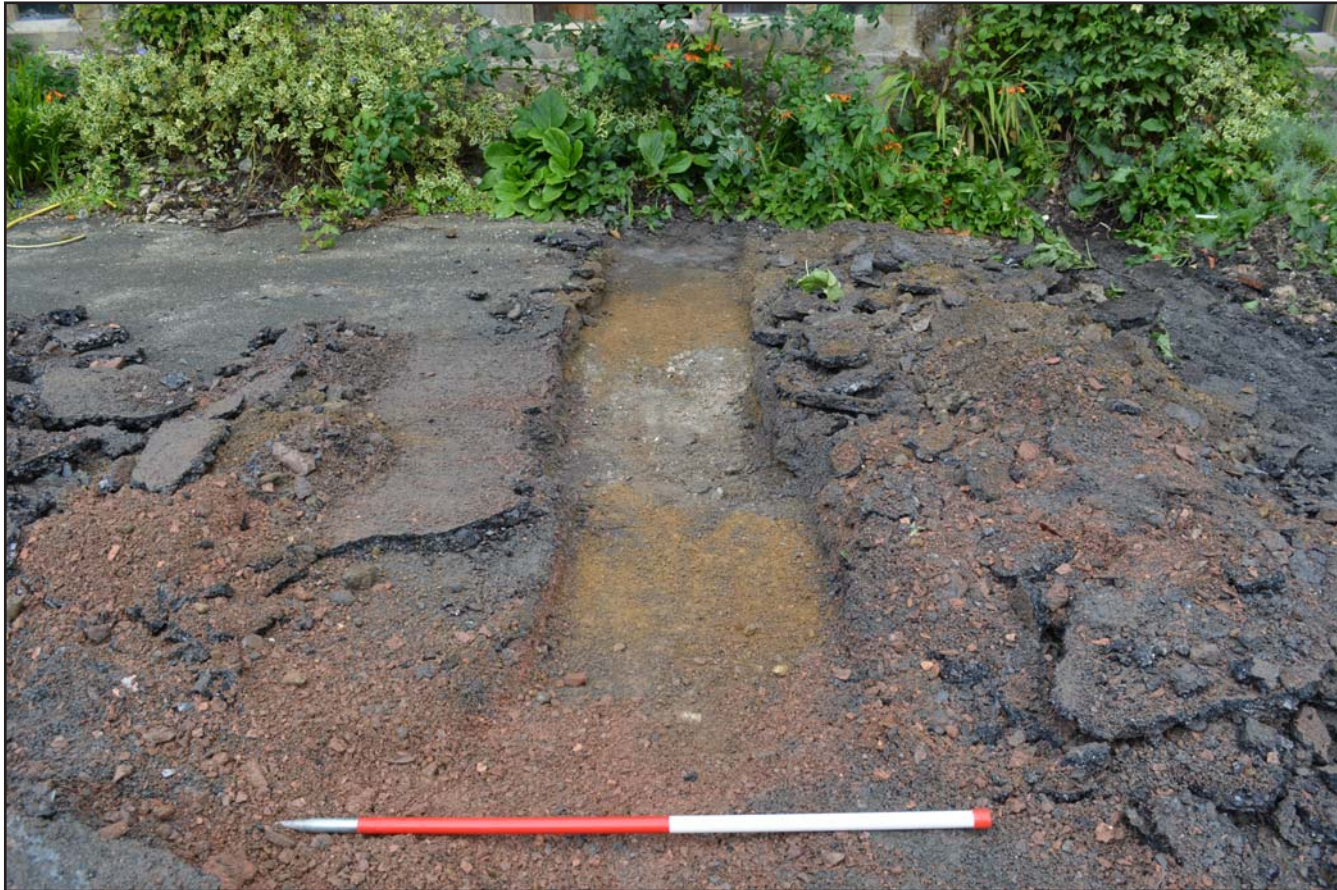
Connection C1 ran from the Hall wall in the northeast to the main drainage trench in the southwest, and measured 6.4m in length by 0.9m in width by 0.55m in depth. The trench was excavated through a 0.06m deep layer of tarmac and hardcore (01) which overlay a 0.05m deep deposit of fairly loose, mid orange-yellow coarse silt-sand (05) which most likely functioned as a levelling layer to the tarmac and may have been a continuation of deposit (02) seen in the northern gable connection trench. This overlay a 0.1m deep firm mid brown-grey stony-clay deposit (06) with frequent pebble and small stone inclusions thought to be a possible relict surface or perhaps a repair/replacement deposit of deposit (08 – see below). This had been cut by a modern drainage trench [07] on a roughly north-south alignment.

Plate 05: Drainage connection C1 showing levelling deposit (05) and cut of drain [07], from the southwest. Scale 1.0m.

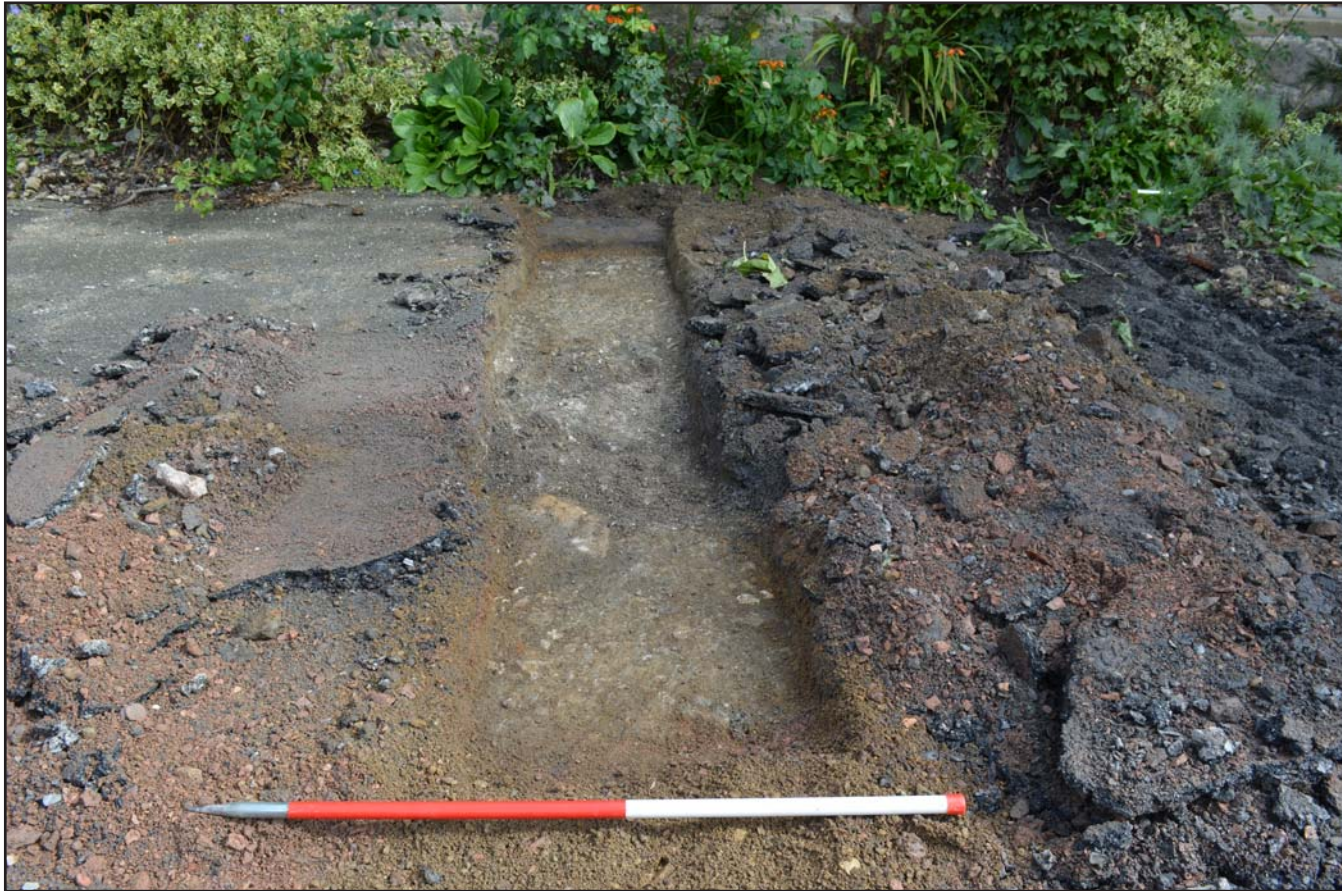
Against the southwest elevation of the Hall another modern drain was encountered, brick built and stone capped, presumably for rainwater. Below the compacted layer (06) was a >0.2m deep firm dark-grey clay-silt deposit with frequent cobbles measuring >0.2m in diameter (08). This deposit produced a post-medieval ceramic base sherd (SF1). Below this was a 0.2m deep stony layer (09), initially investigated as a surface but later found to be a fairly firm mottled brown-grey clay-silt deposit containing a small amount of domestic refuse including a sherd of post-medieval ceramic (SF2); an animal tooth (SF4); and a fragment of animal bone (SF5). Bedrock, again initially investigated as a surface, was found at the same level at this layer. Natural subsoil below this layer was yellow sandy clay.

Plate 06: Drainage connection C1 showing relict surface deposit (06) and cut of drain [07], from the southwest. Scale 1.0m.

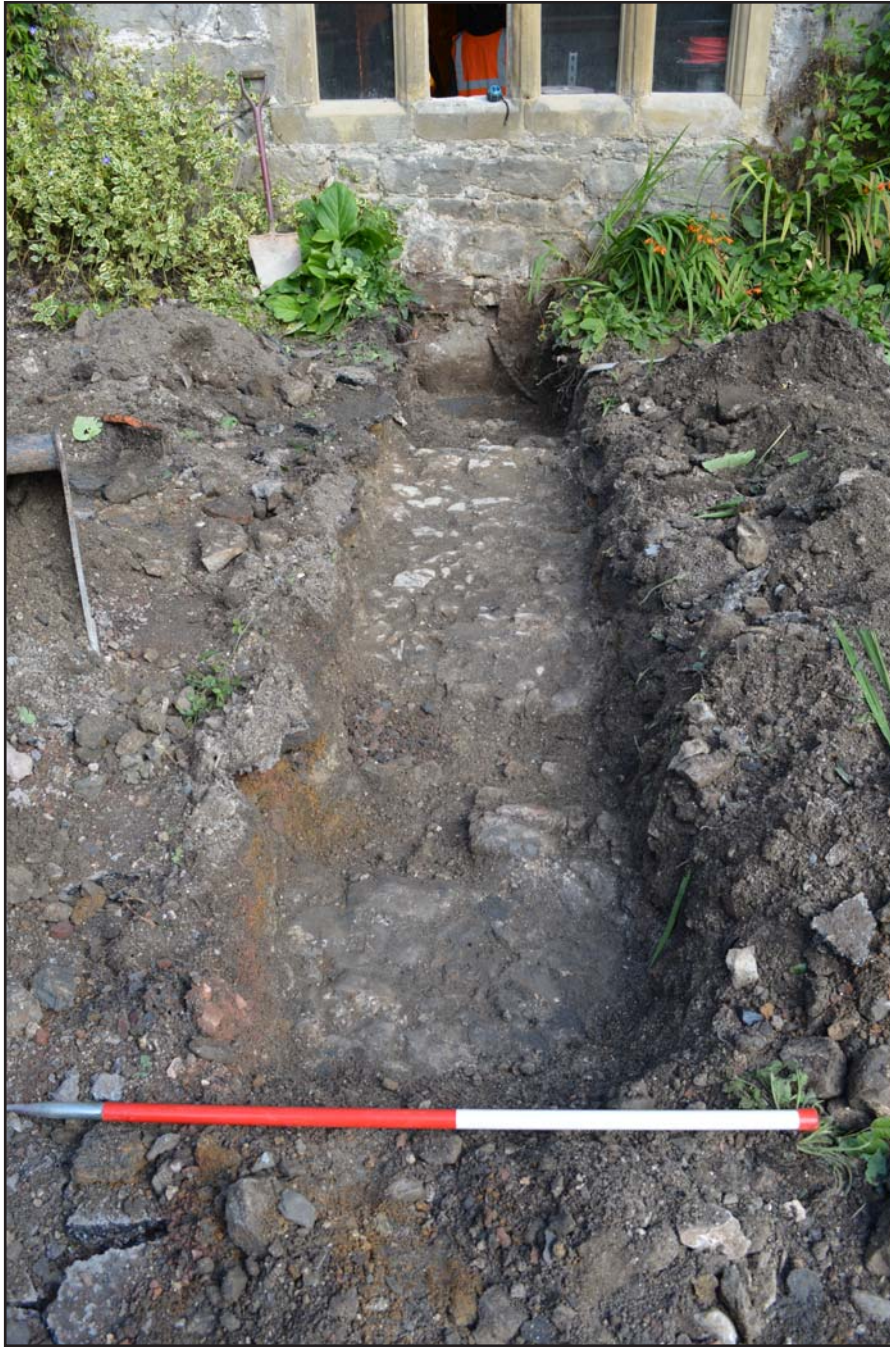
Plate 07: Drainage connection C1 showing cobble deposit (08), from the southwest. Scale 1.0m.

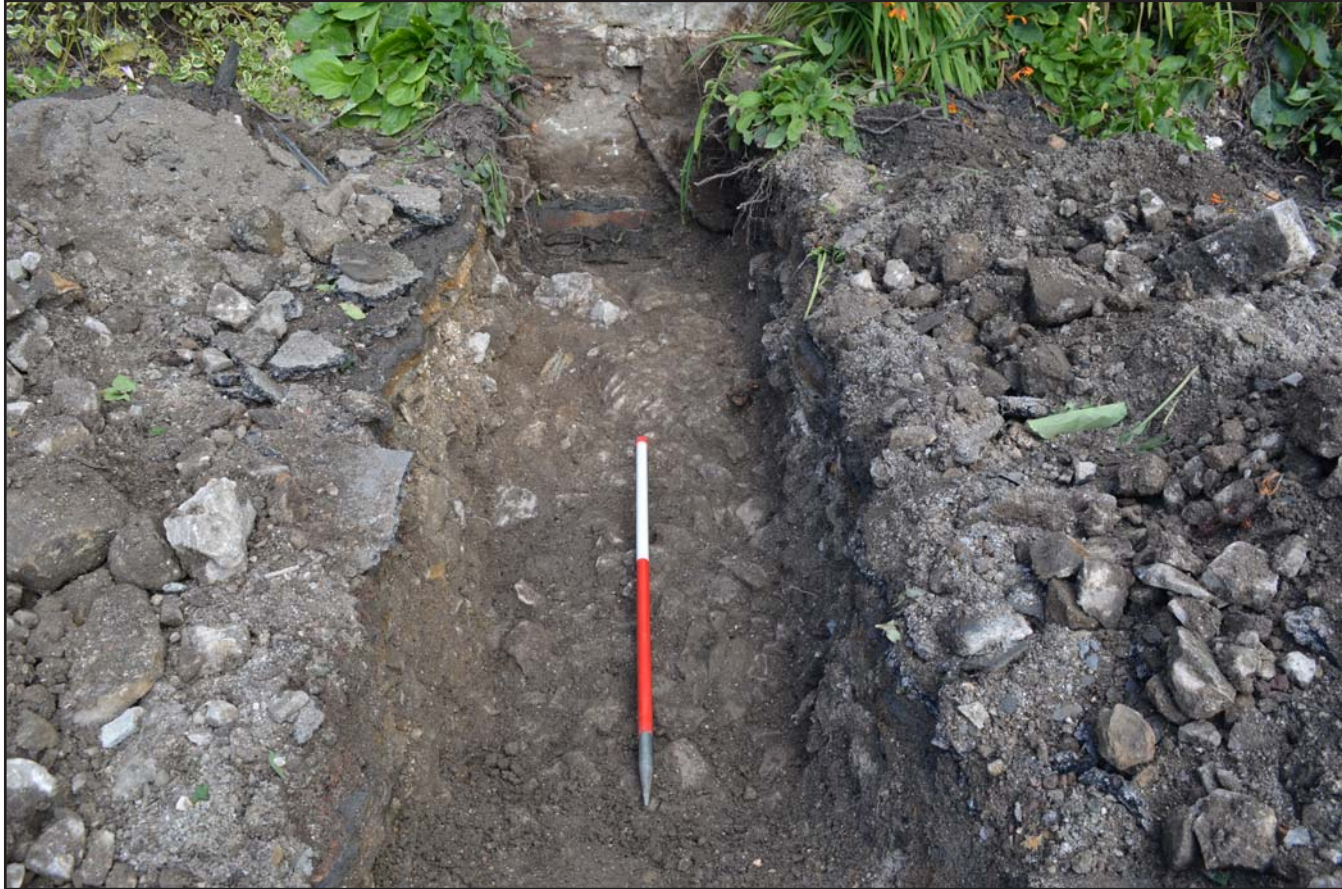
Plate 08: Drainage connection C1 showing mixed stony deposit (09) and natural glacial substrata, from the southwest. Scale 1.0m.

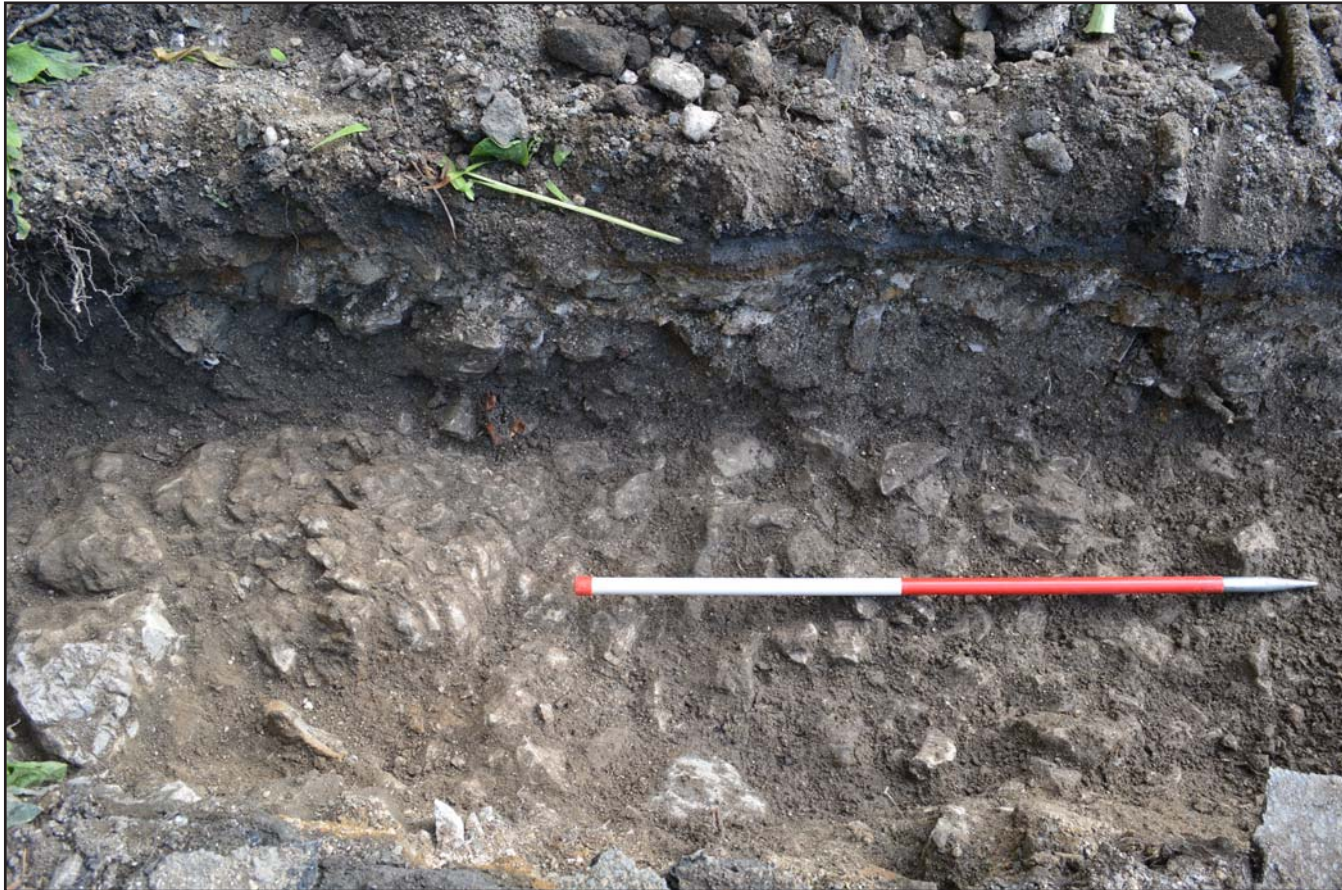
Plate 09: Section of drainage connection C1, from the northwest. Scale 1.0m.

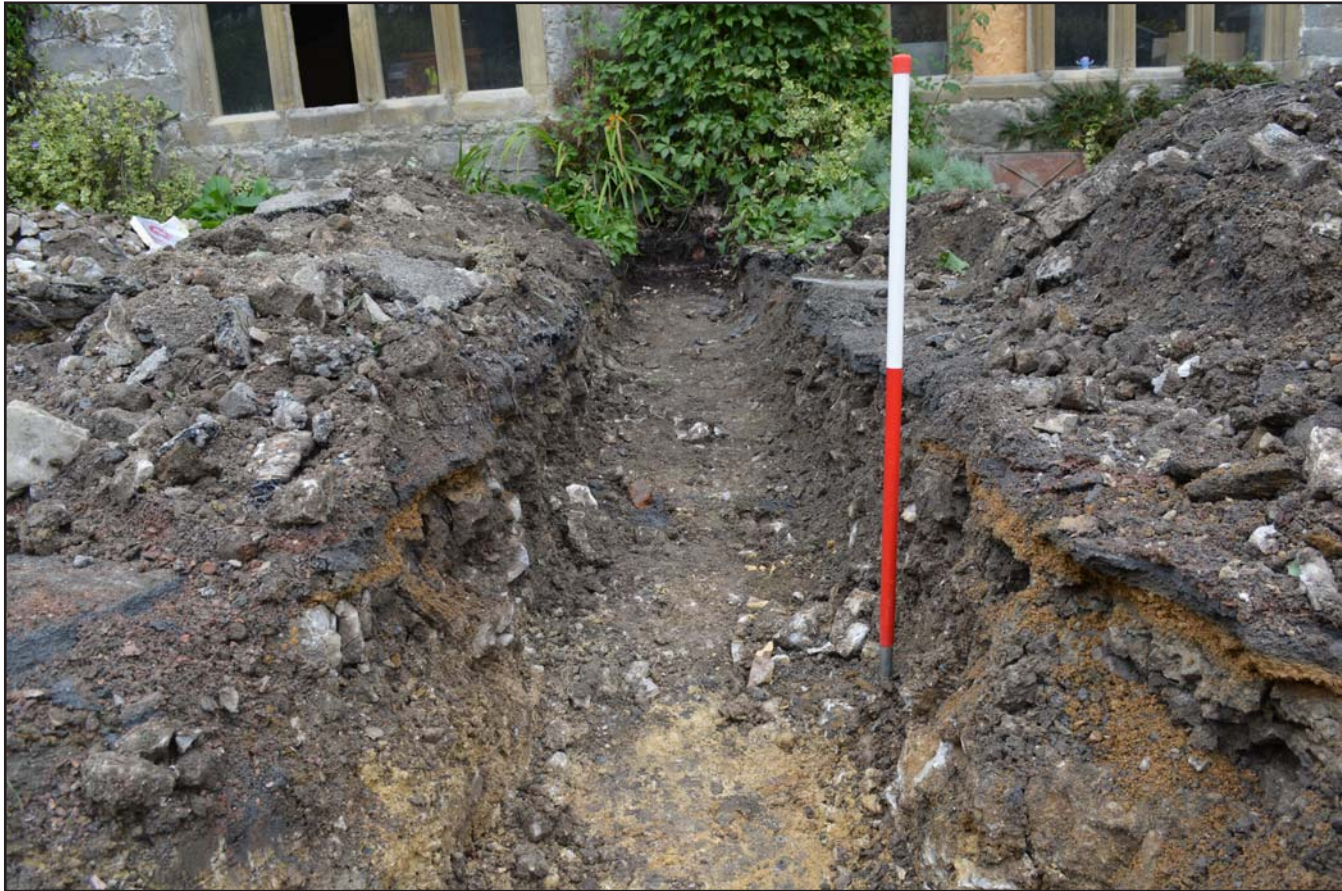
Both trenches were excavated through a 0.06m deep layer of tarmac and hardcore (01) which overlay a 0.05m deep deposit of fairly loose, mid orange-yellow coarse silt-sand (05) which most likely functioned as a levelling layer to the tarmac and may have been a continuation of deposit (02) seen in the northern gable connection trench. This deposit overlaid a brown-grey and orange mottled clay natural substrata.

Plate 10: Drainage connection C2, from the southwest. Scale 1.0m.

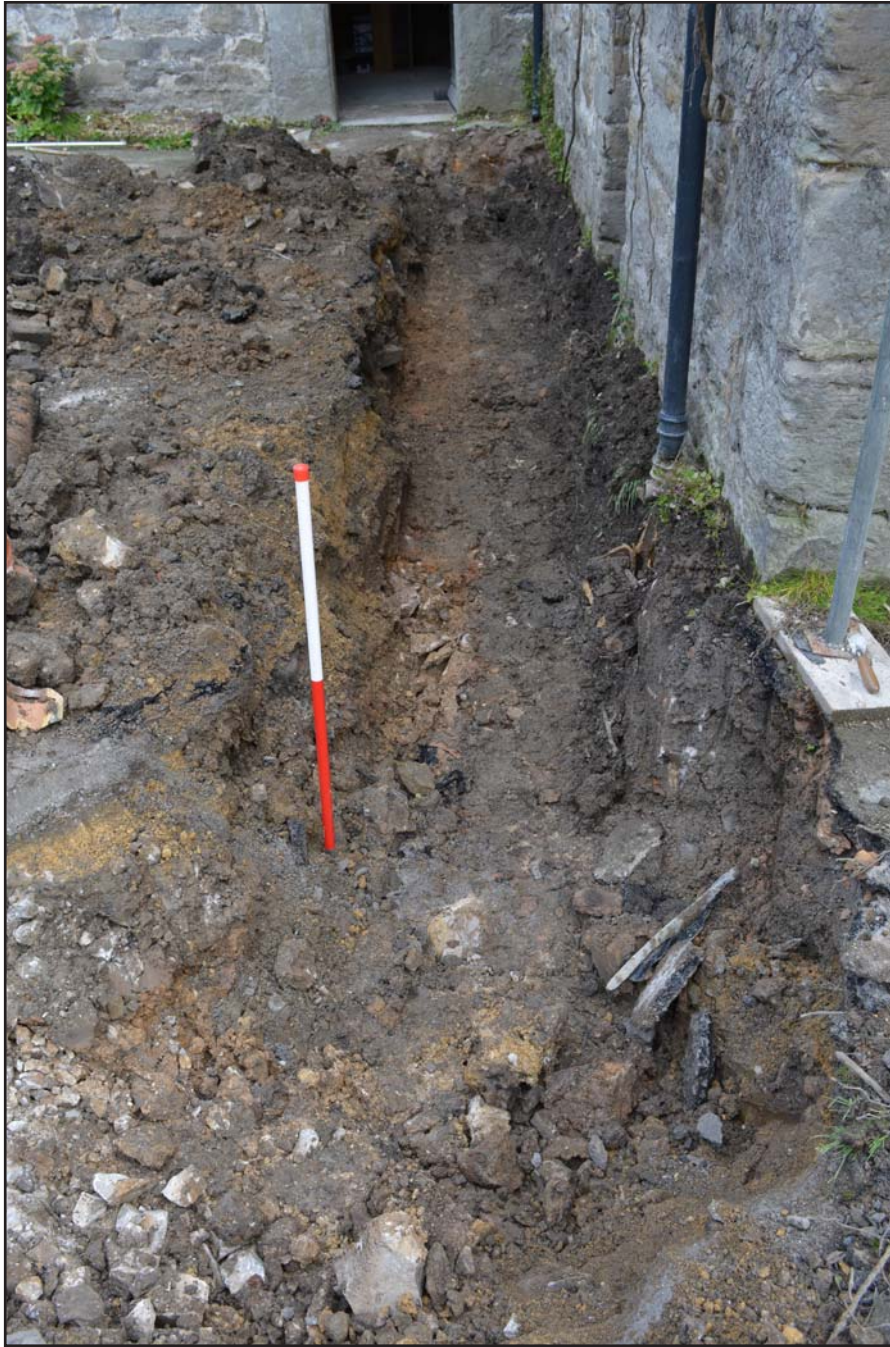
Plate 11: Drainage connection C3, from the southwest. Scale 1.0m.

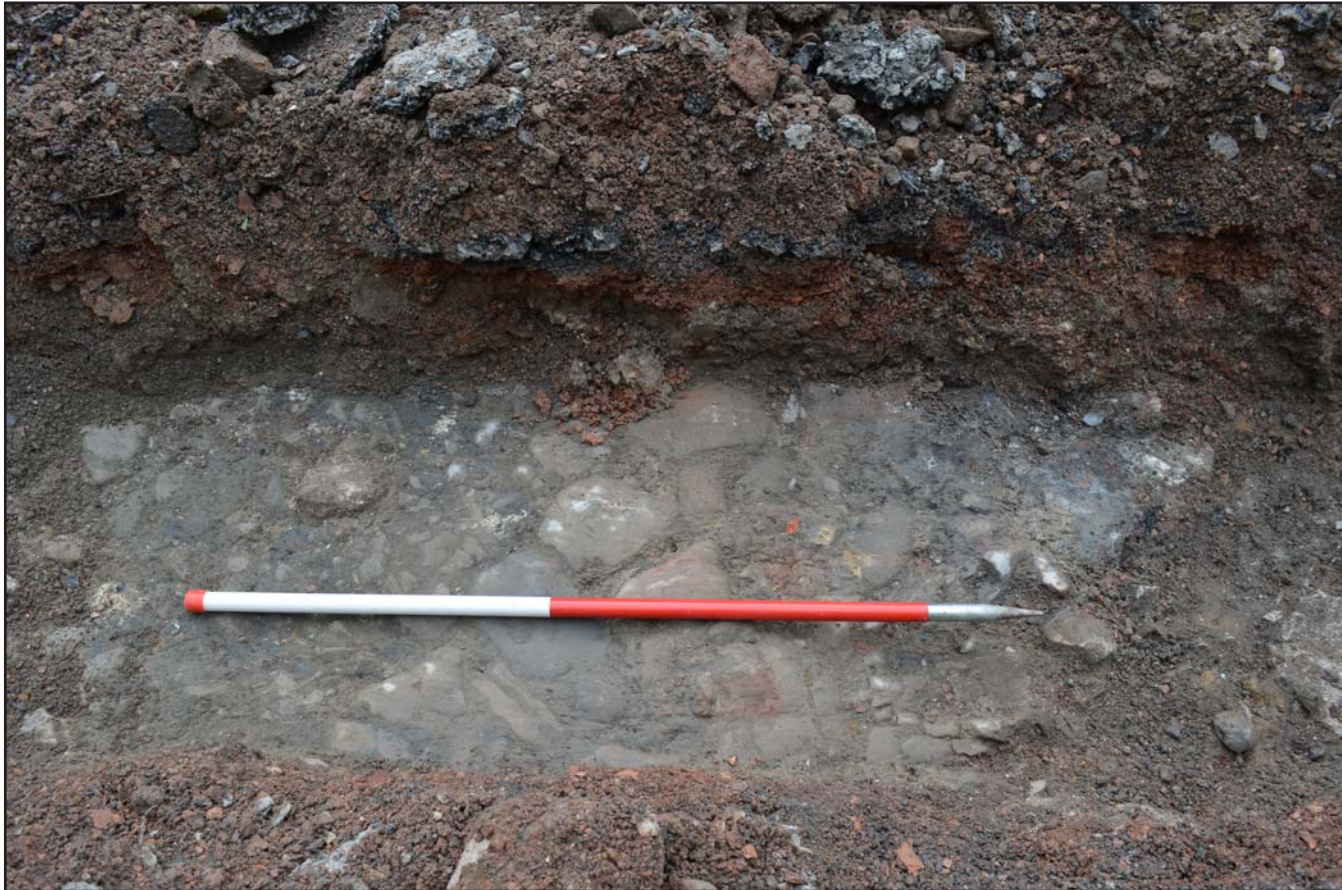
The main drain was excavated from north to south at the western end of the Hall, and measured 16.7m in length by 0.6m in width by a maximum of 0.92m in depth. At the northern end of the main drain the demolition deposit seen in the connection trench of moderately firm mottled grey and light-brown mixed demolition material (03) continued for approximately 3.0m. The cobble layer (06) found in Connection C1 was encountered approximately 5.0m to the south, and continued approximately 1.0m south of C1, at which point it petered out. Below the cobbles a layer of grey clay (10) produced a fragment of dark green-brown glazed pottery (SF3), probably early post-medieval in date. The layer also contained a pig tooth (SF6) and a fair amount of charcoal of which a bulk sample was collected. To the south of C1 the level of the natural subsoil raised dramatically and bedrock was encountered.

Plate 13: Main drain showing continuation of cobble deposit (08), from the east. Scale 1.0m.

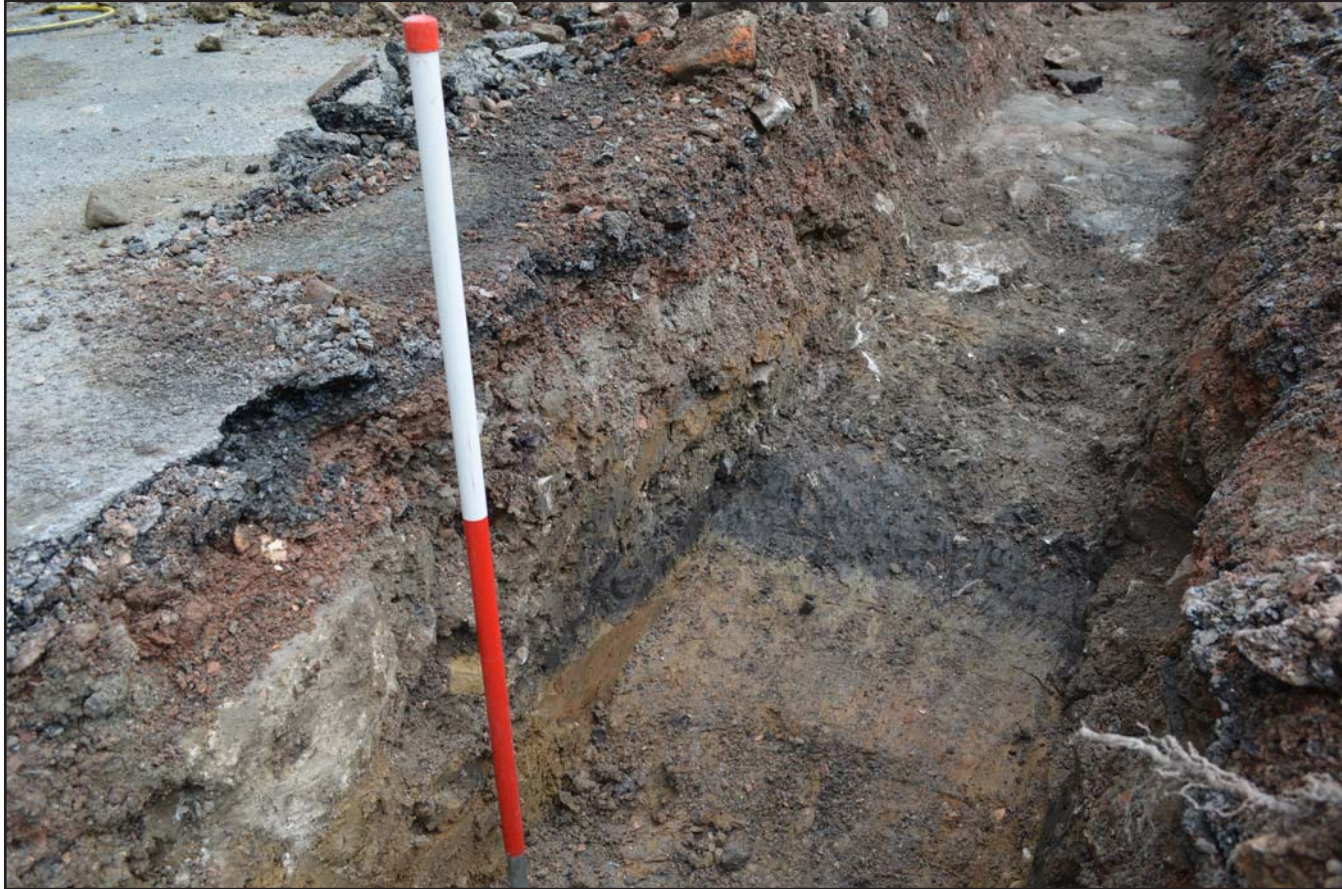
A single environmental bulk sample was taken from brown-grey charcoal-rich silt-clay deposit (10) found within the main drainage trench. This sample has been retained by Aeon Archaeology but has not been processed as the deposit yielded a post-medieval ceramic sherd.

Plate 14: Main drain showing dark brown-grey silt-clay deposit (10), from the northwest. Scale 1.0m.

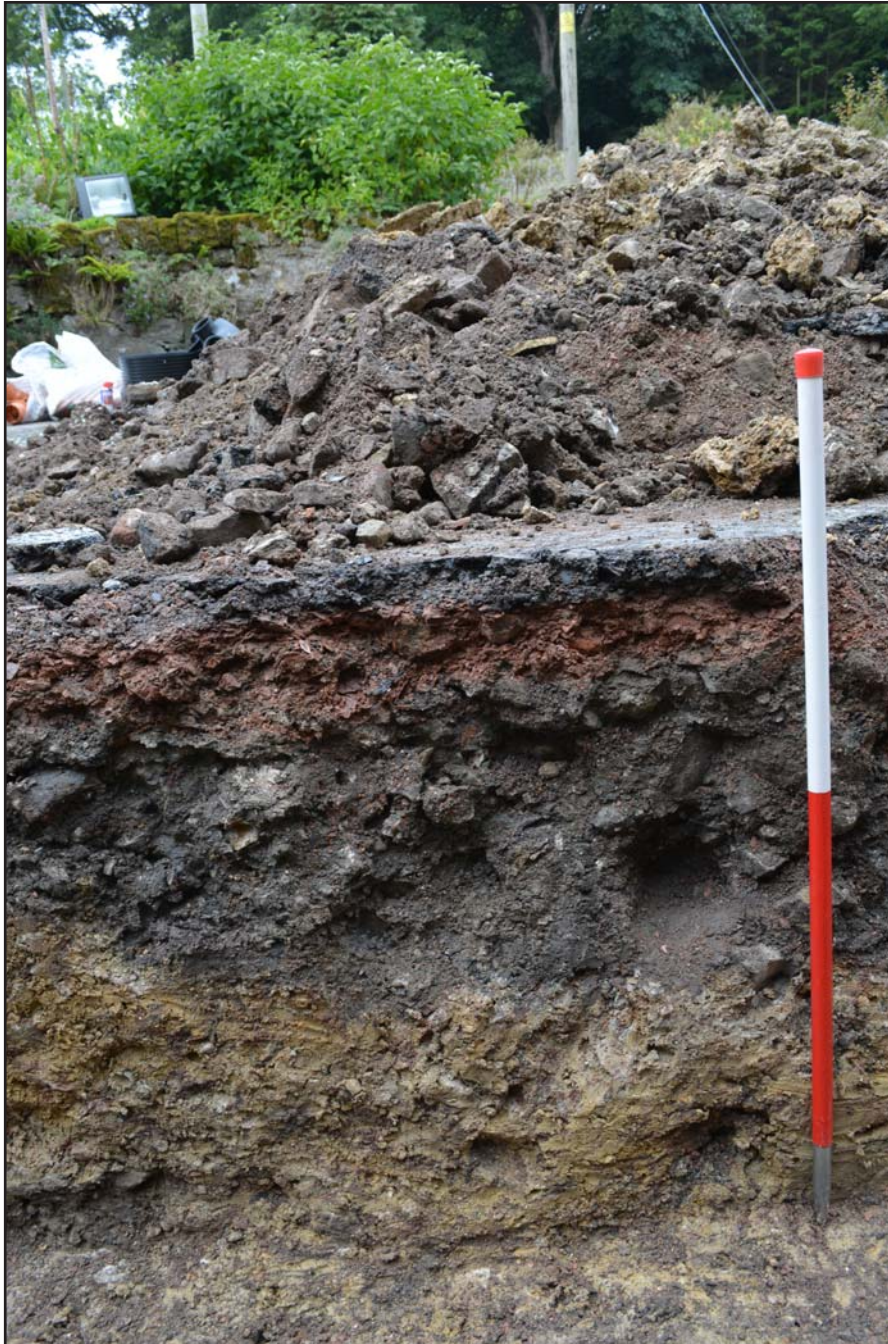
Plate 16: Section of main drain trench, from the east. Scale 1.0m.

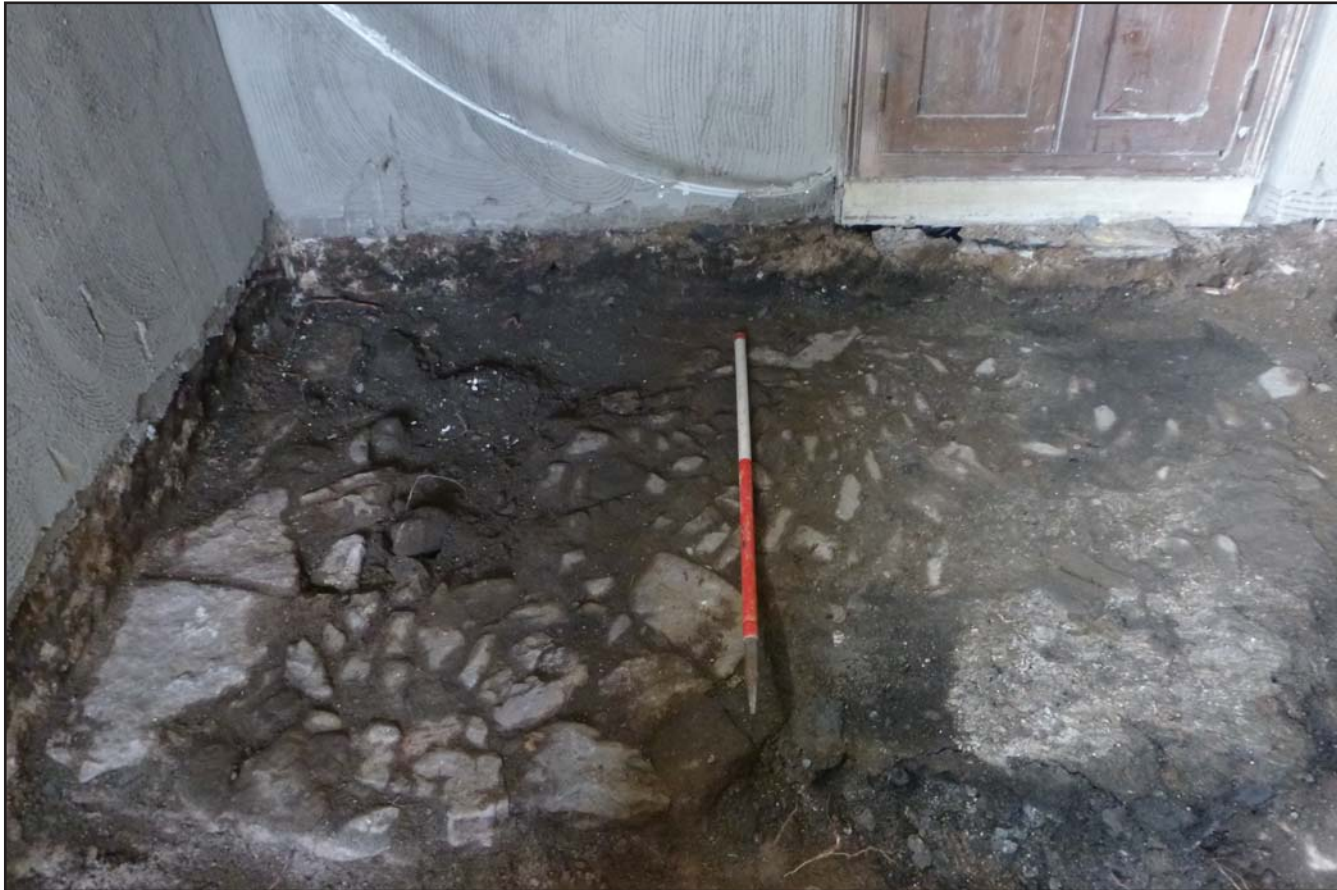
Plate 23: Lobby (G3) post-excavation showing cobbled surface (1002), from the southeast. Scale 1.0m.

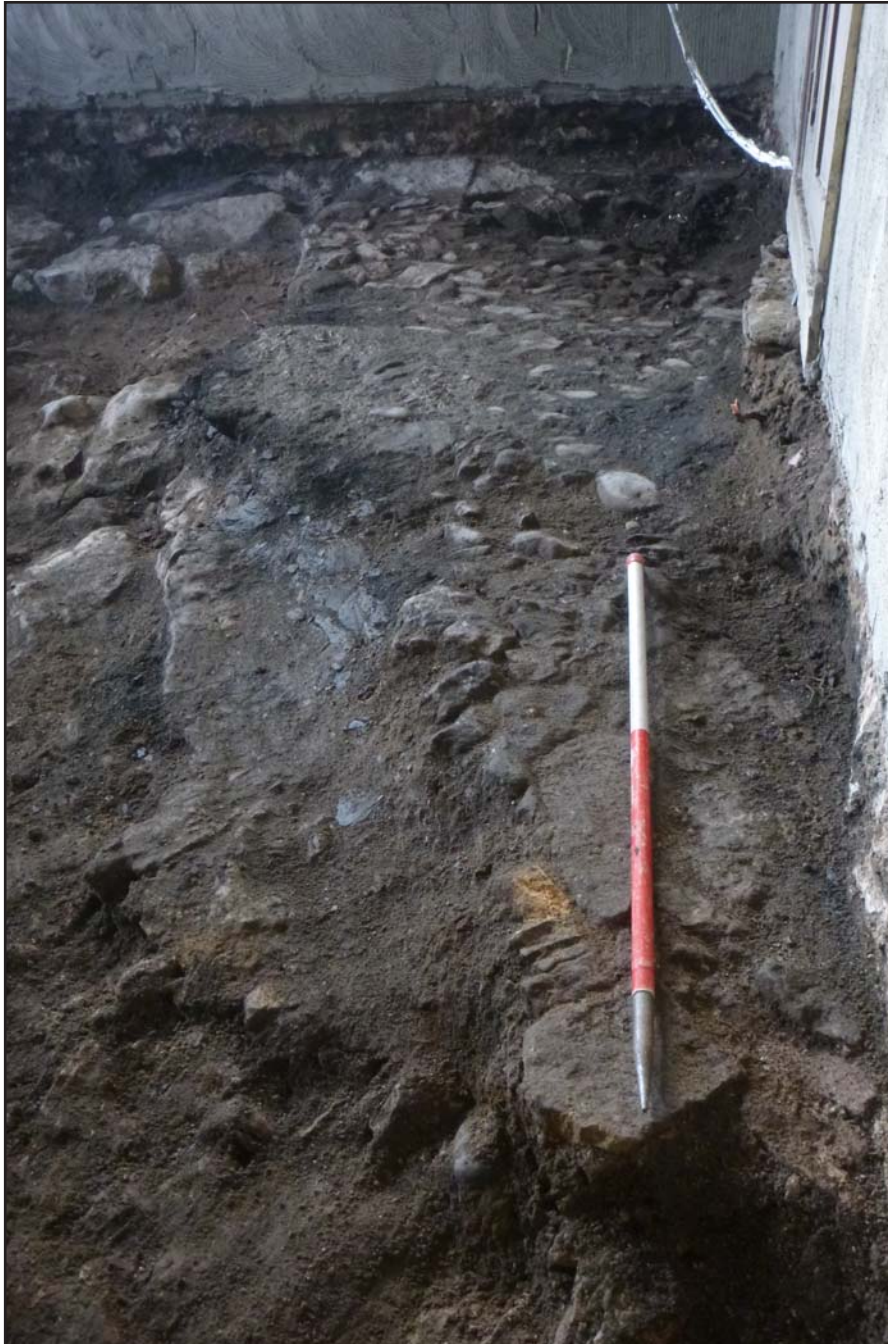
Plate 24: Lobby (G3) post-excavation showing cobbled surface (1002), from the northeast. Scale 1.0m.

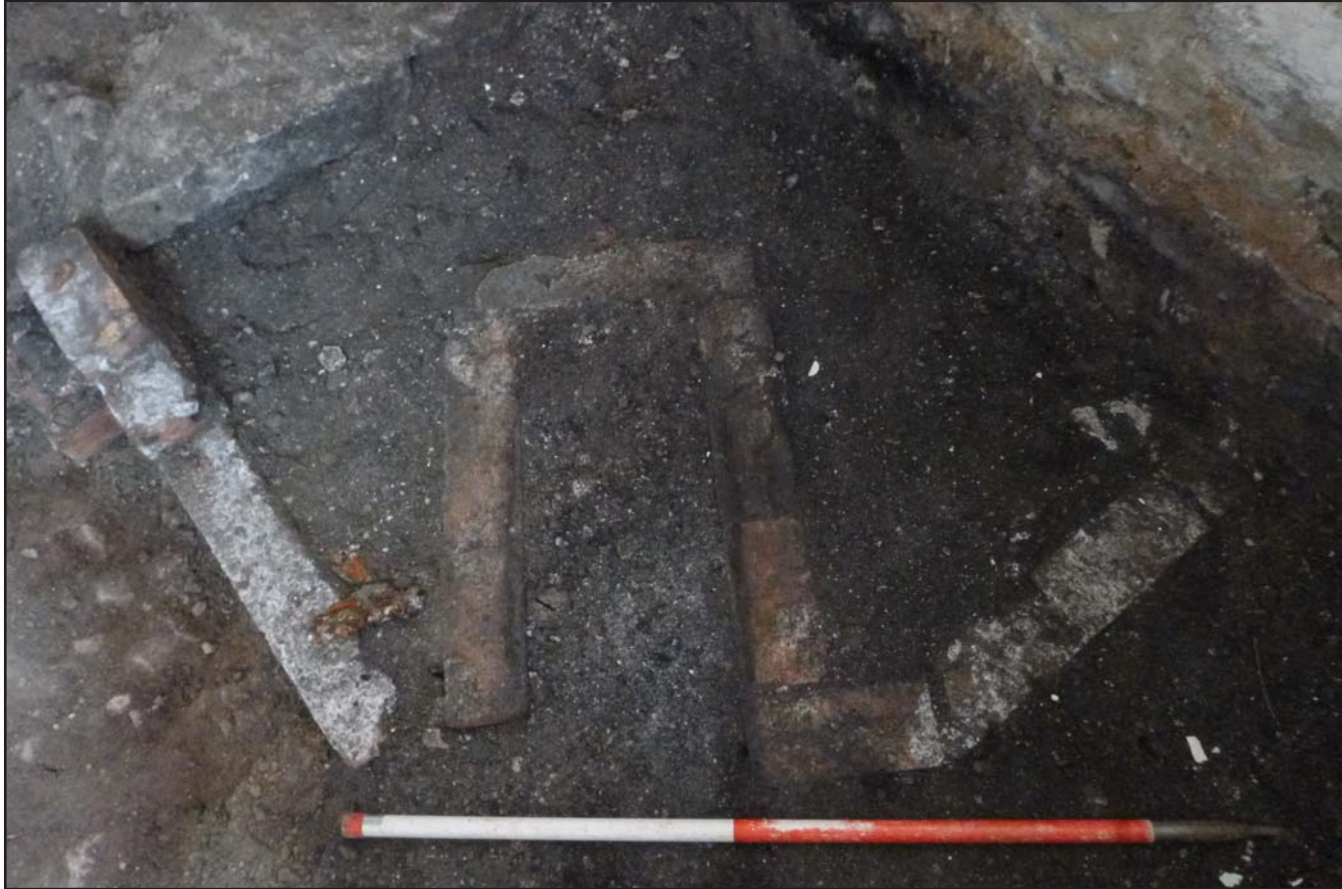
In the southern corner of the room a rectangular red-brick structure (1006) measuring 1.46m in length by 1.25m in width was encountered. The base of this feature was not reached due to the required depth limits having been achieved, however the structure was at least two courses in height and was constructed from unfrosted red-brick measuring 0.23m in length by 0.11m in width by 0.08m in height bonded by mortar. The central aperture measured 0.8m in length by 0.22m in width and was in-filled with a friable black-grey silt-sand with frequent ash inclusions (1008) suggesting that the structure had functioned as a hearth or smithy.

Plate 25: Lobby (G3) post-excavation showing hearth (1006), from the west. Scale 1.0m.

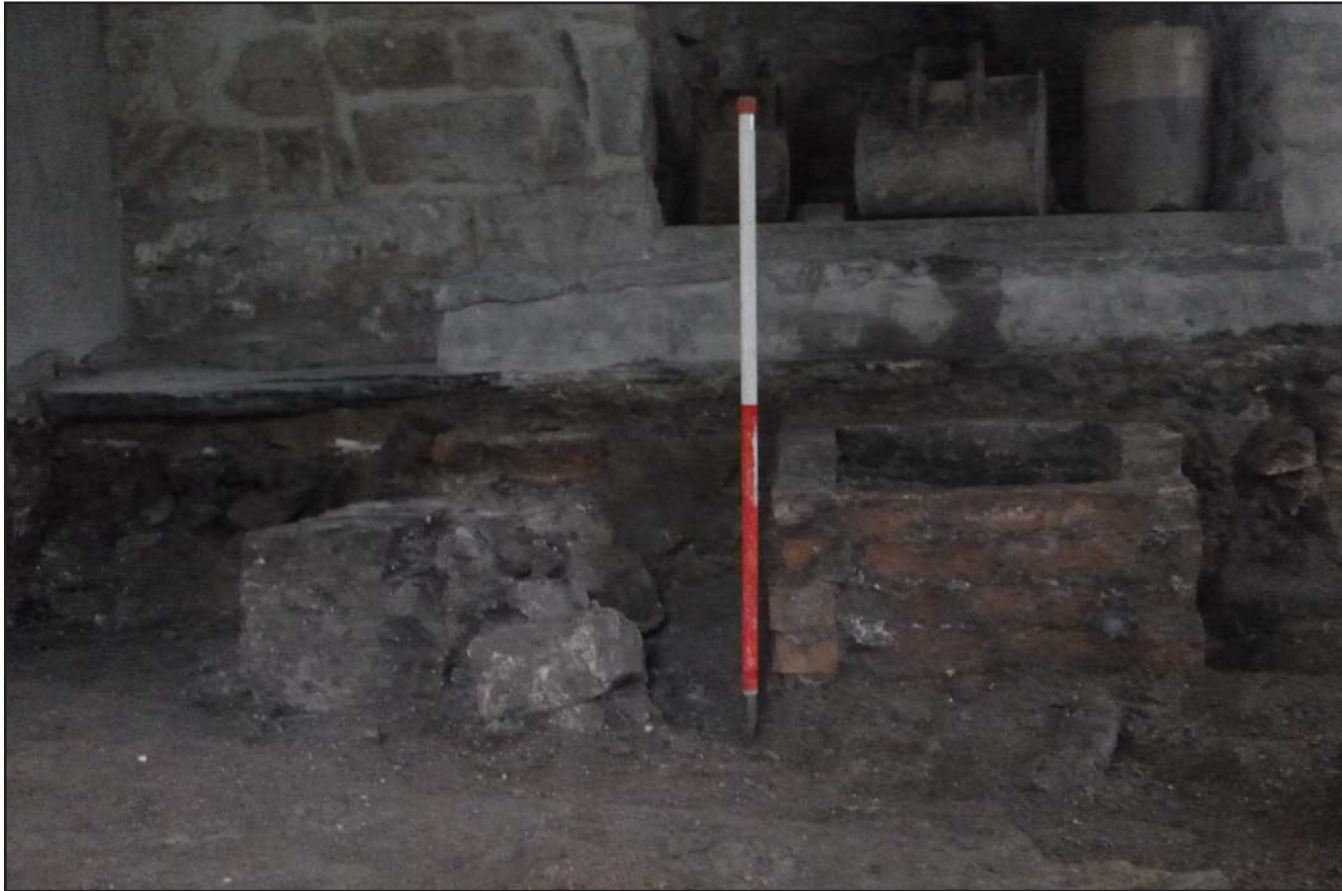
Plate 26: Lobby (G3) post-excavation showing hearth (1003) and wall (1005), from the northwest. Scale 1.0m.

The southernmost brick built hearth was found to butt up against an L-shaped sandstone rubble wall that appeared to be on the same alignment as a second sandstone wall to the north. The southernmost wall stratigraphically predated that of the red-brick hearth in the south, although the fact that the two sandstone walls appeared to respect the central hearth would suggest that a feature of similar purpose had been replaced by the brick hearth.

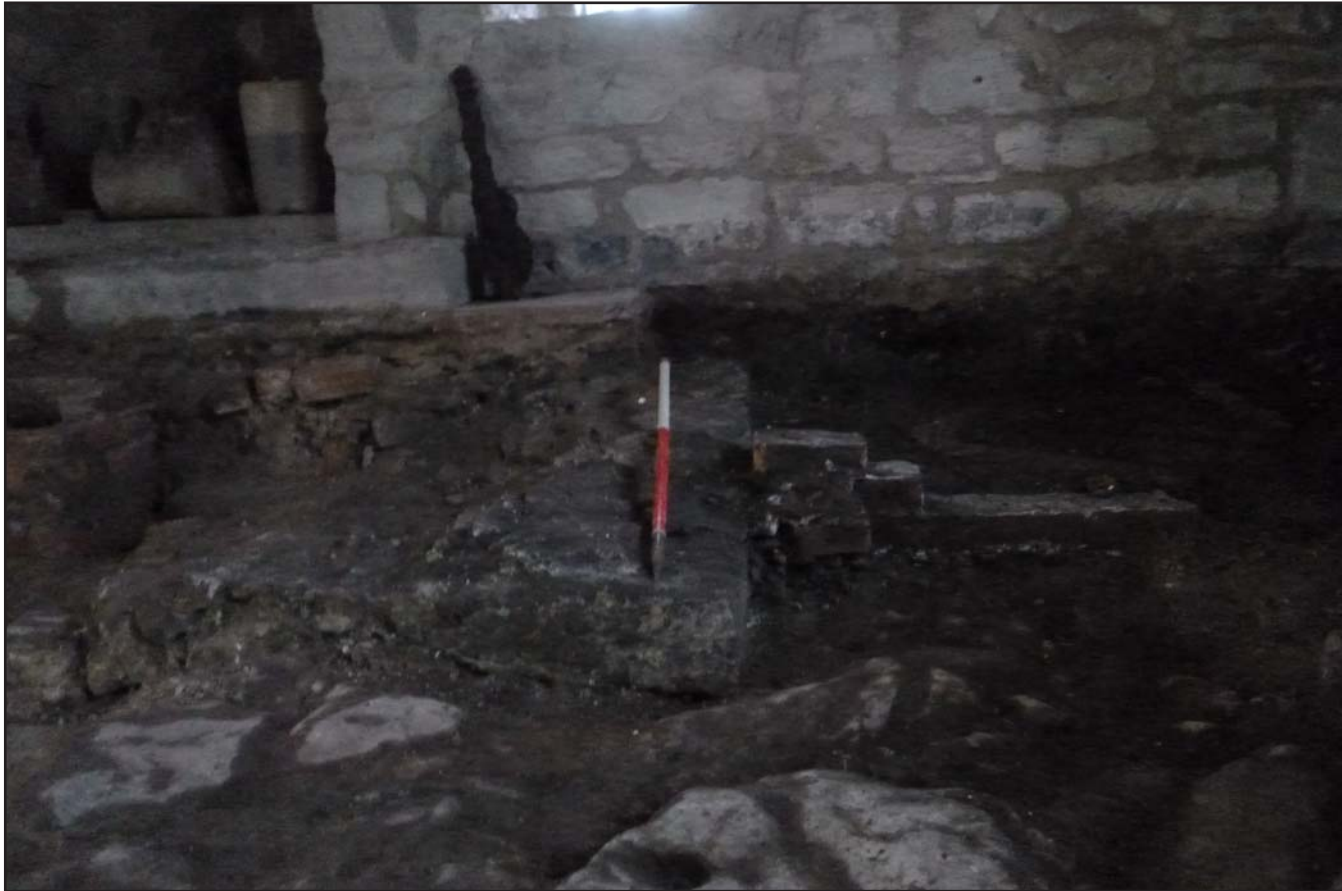
To the immediate north red-brick structure (1006) was found to butt up against an L-shaped wall constructed from sandstone rubble bonded by mortar (1004) measuring 1.74m in length by 0.55m in width. This structure was on the same alignment as a second wall of sandstone located at the northern end of the room (1005) which measured 0.78m in length by 0.64m in width and together surrounded a rectangular hearth constructed from red-brick (1003). This feature measured 0.74m in length by 0.54m in width orientated northeast to southwest and stood at least five courses in height, although the base had not been encountered. It had been constructed from wire-cut unfrosted bricks measuring 0.23m in length by 0.11m in width by 0.08m in height and bonded by mortar. The central aperture measured 0.54m in length by 0.3m in width and was in-filled with a friable black-grey silt-sand with frequent ash inclusions suggesting that the structure had functioned as a hearth or smithy.

Plate 27: Lobby (G3) post-excavation showing wall (1004), from the northwest. Scale 1.0m.

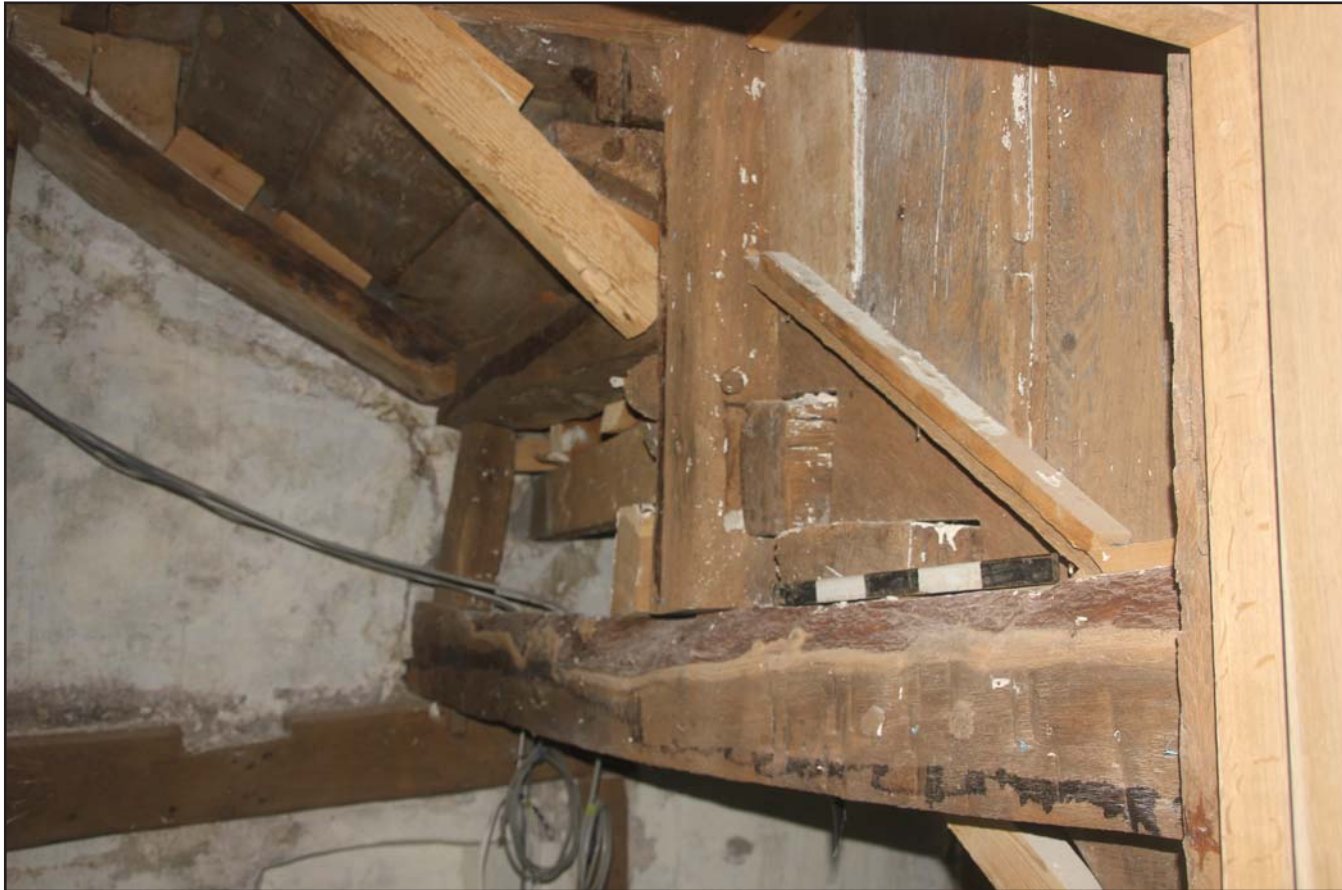
The wooden beams and wattle and daub panelling are almost certainly original to the staircase and appear to be in a good condition. An information plaque on the stair suggests a 16th Century date for the staircase and there is no reason to suspect that the framing and wattle and daub do not belong to this phase of construction.

Plate 28: Revealed timber framing in well of stair, from the west. Scale 0.5m.

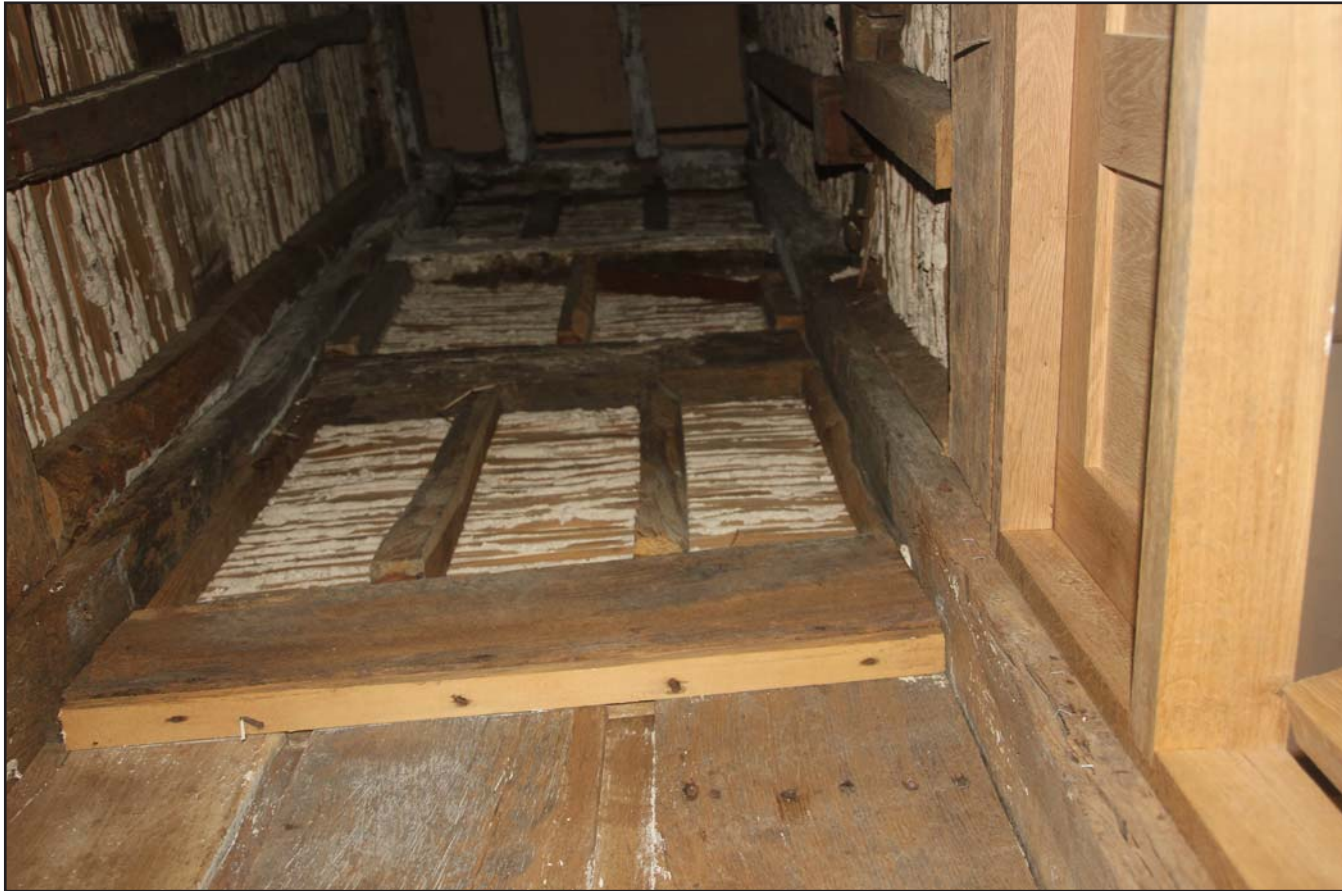
Plate 29: Revealed timber framing and wattle and daub walls in well of stair, from the northwest.
