**Bodidris Hall, Llandegla,
Denbighshire, LL11 3AL.
April 2016
V 2.0**

Archaeological Watching Brief
Project Code: A0057.1
Report no. 0081

Archaeological Watching Brief

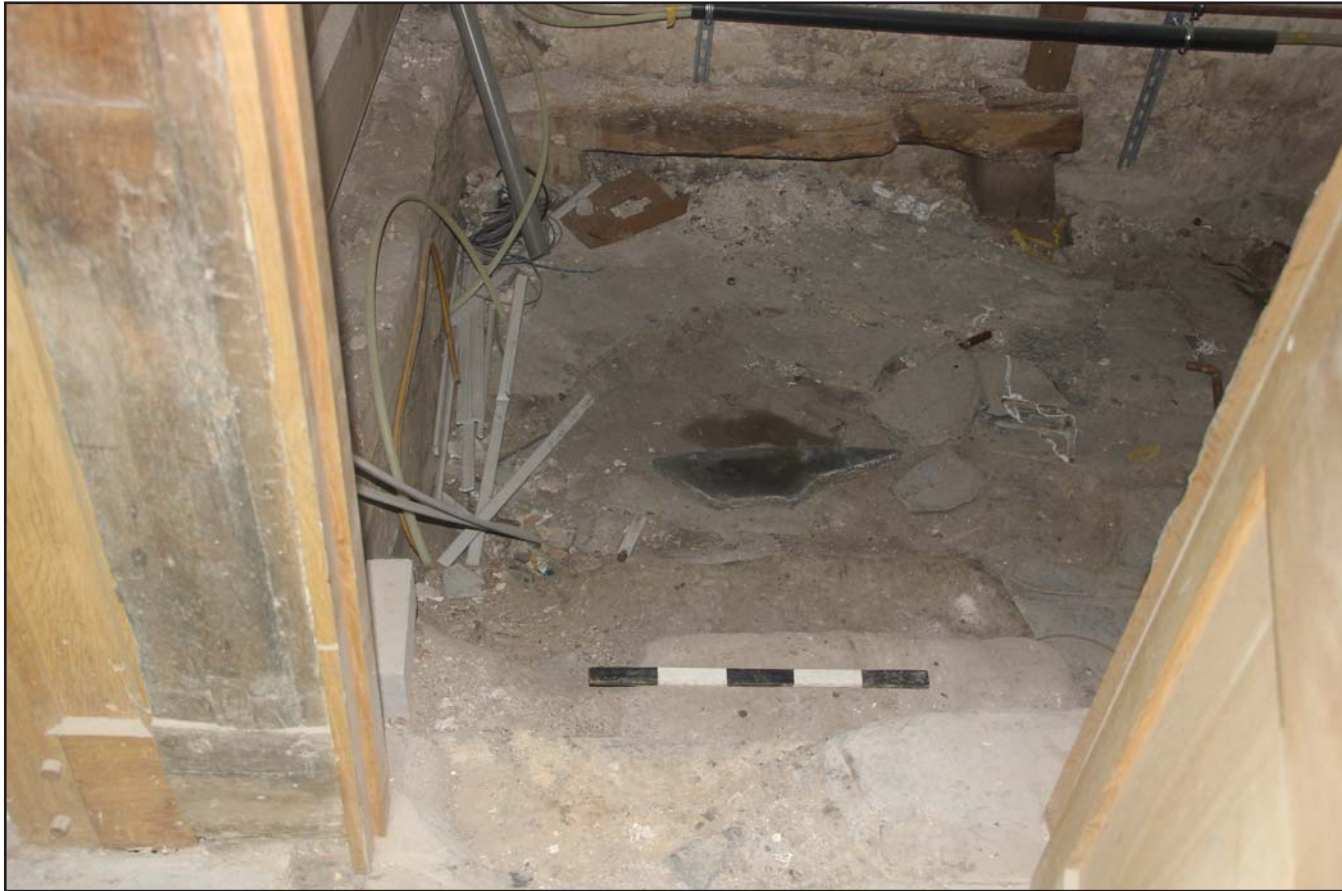
The three steps uncovered consisted of single slabs of light-grey stone measuring on average 1.1m in length by 0.3m in width by 0.2m in depth and alighting 0.6m in total between the entrance hall in the west and the stair well in the east. The upper and middle most steps had seen phases of repair with stone blocks averaging 0.2m in length by 0.1m in depth having been mortared in place.

Plate 30: Revealed stone steps in well of stair, from the west. Scale 0.5m.

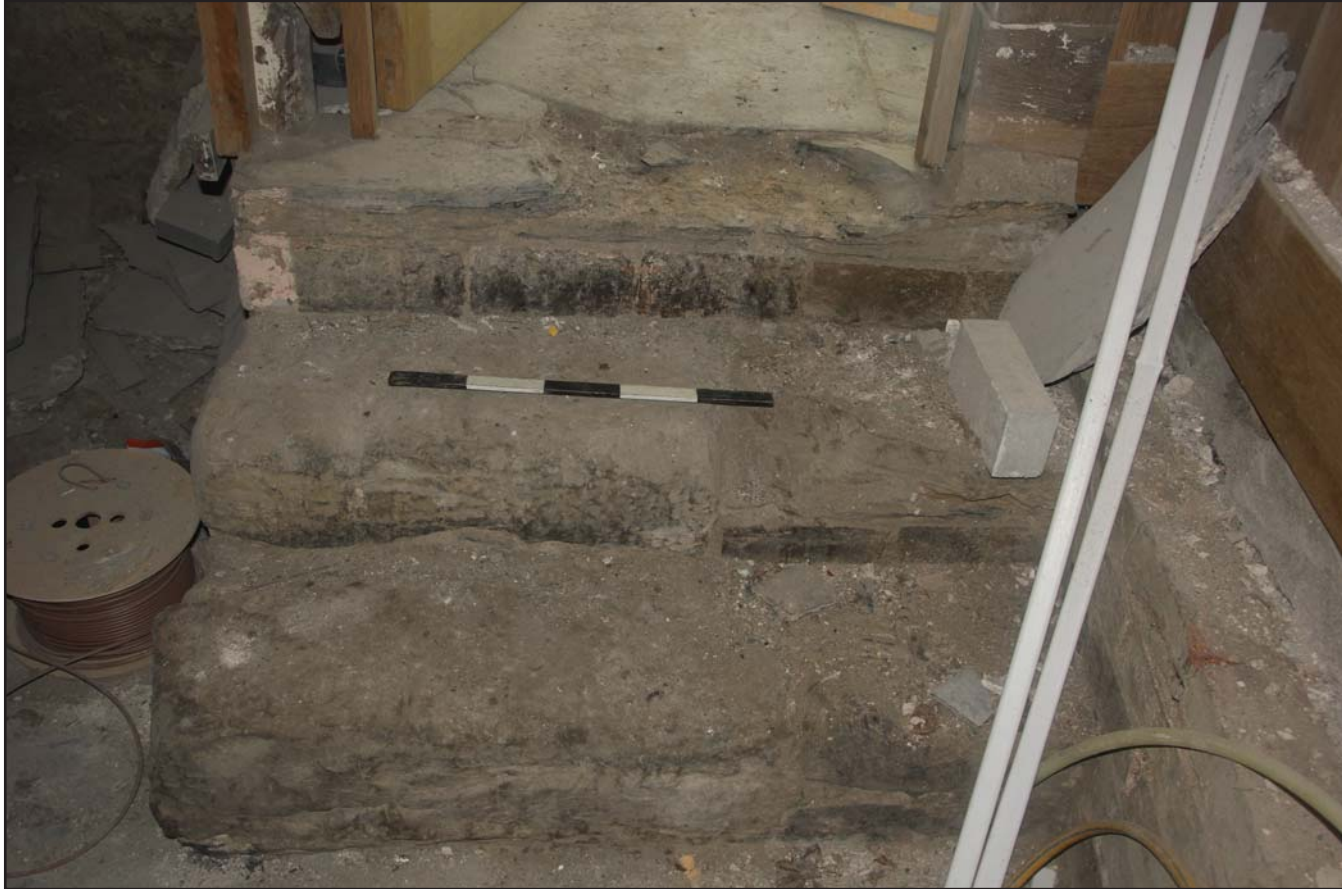
Plate 31: Revealed stone steps in well of stair, from the east. Scale 0.5m.

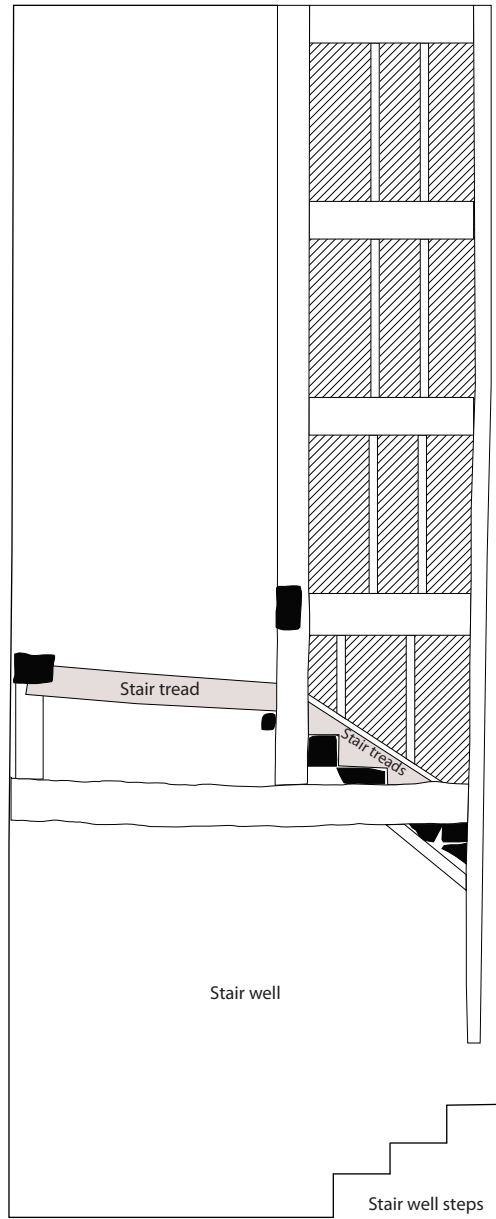
Figure 08: Elevation drawing of stair well showing timber framing and wattle and daub walls, from the northwest. Scale 1:40 at A4.

The steps and framing were photographed and an elevation drawing created and reproduced in figure 08.
