**20-36 Monnow Street
Monmouth
Monmouthshire**

Historic Building Recording

CA Project: 3978
CA Report: 13374

September 2013

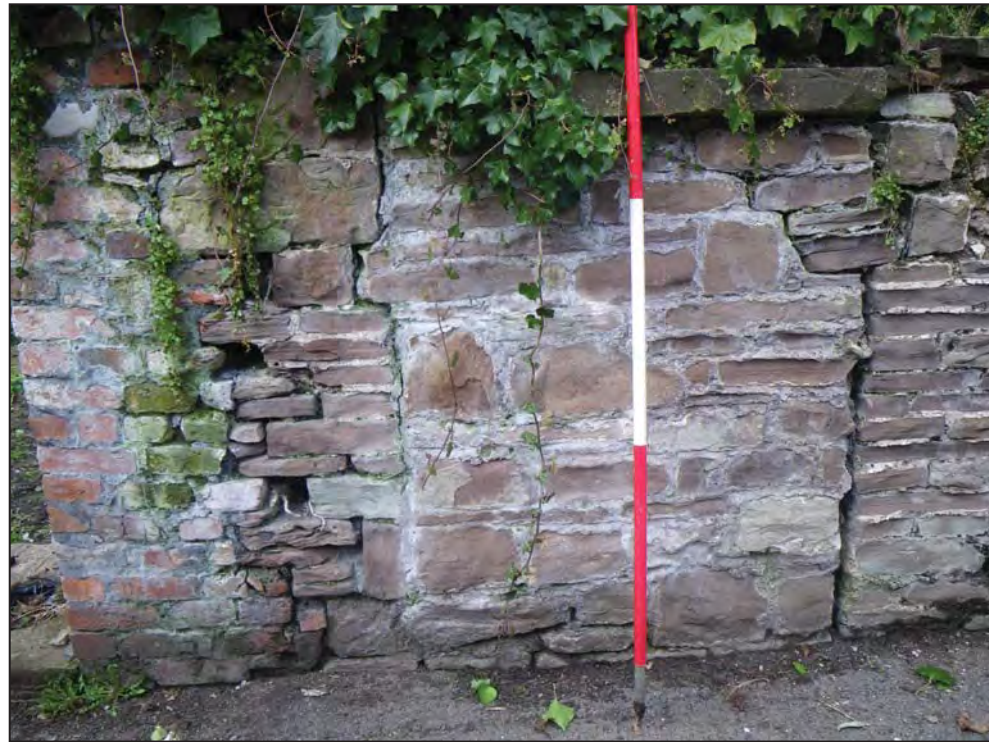
- 5 Structure 2 trapped between recent brick to the left and Structure 1 to right; blocked door and subsequent window sill behind scale (scale in 0.5m divisions)
- 6 Structure 1 at end of no. 32, looking north-west; various phases of masonry (cf Fig. 4) (scale 0.5m divisions)
- 7 The north end of Structure 1 at the end of no. 32, to the north-west, showing window jamb, end of Structure 3 (behind scale) and door and associated brick and concrete work into no. 30 (cf. Fig. 4) (scale 2m)
- 8 Structure 1 looking south, end wall of no. 30 in foreground (scale 2m)

- 2.4 The section of wall across the end of no. 32 included the eastern butt end of Structure 2, which is further described below. The presumed return of structure 2 to the south had been replaced by a modern brick gate post. Its return to the north was complex. Its lower part, up to about 0.9m, was built of thin, squared and regularly coursed local sandstone blocks of a fairly even thickness, set in a pale grey mortar. The upper part was made of larger blocks, more roughly cut, in a similar mortar. Both sections of this wall ended in a straight joint with the next section, built of large roughly squared blocks and some rubble. This was pointed in cement mortar. It was capped with a flat window sill, which on the southern side supported bricks forming a window jamb facing the north side of the upper part of the end of Structure 2 (Figs 4 and 5).

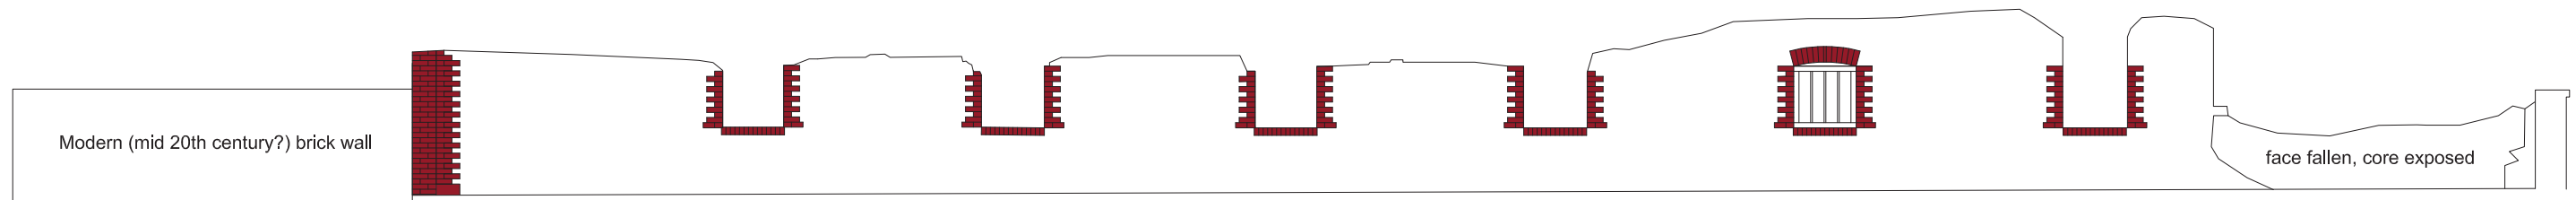
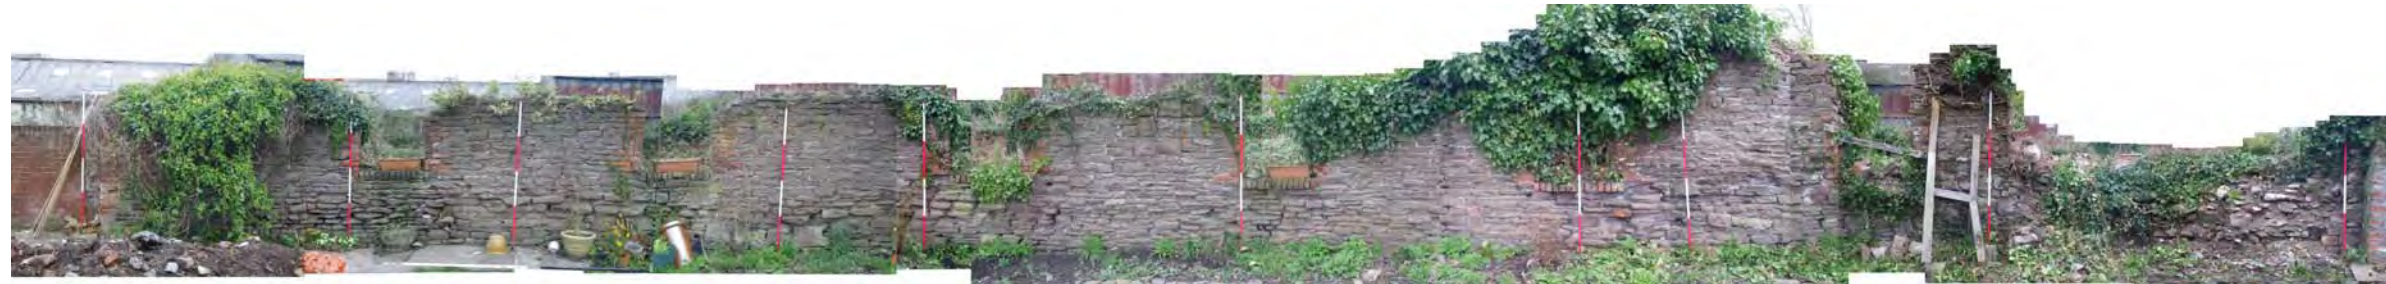
PROJECT NO.	3978	DATE	16-09-2013	FIGURE NO.
DRAWN BY	DJB	REVISION	00	9 & 10
APPROVED BY	PJM	SCALE@A3	1:100

FIGURE TITLE
 South elevation and Photo-montage of
 Structure 2

2.12 Running north-west/south-east for 21m, this formed the boundary between Nos 32 and 34 Monnow Street. Its north-east elevation was recorded by Graham Frecknall Architecture and Design, but the south-west side was drawn and a photomontage assembled by Cotswold Archaeology as it had been largely cleared of obstructions by time we visited (Fig. 9). Detail of the masonry is shown on the photomontage of the south-west side of this wall (Fig. 10).

2.13 The remain of six windows were noted with red bull-nosed brick jambs and bull-nosed bricks laid as a sill. The latter were a quarter inch larger in all dimensions. One window survived to its head, which was segmentally arched in brick. The spacing suggests the possibility of a seventh at the collapsed south-east end of the wall.

2.14 At the north-west end the wall ended in brick quoins. The corner was rebated and had traces of mortar as if to receive a post or pillar. A stone block at its base suggests a wall may have run south from here (Fig. 10).

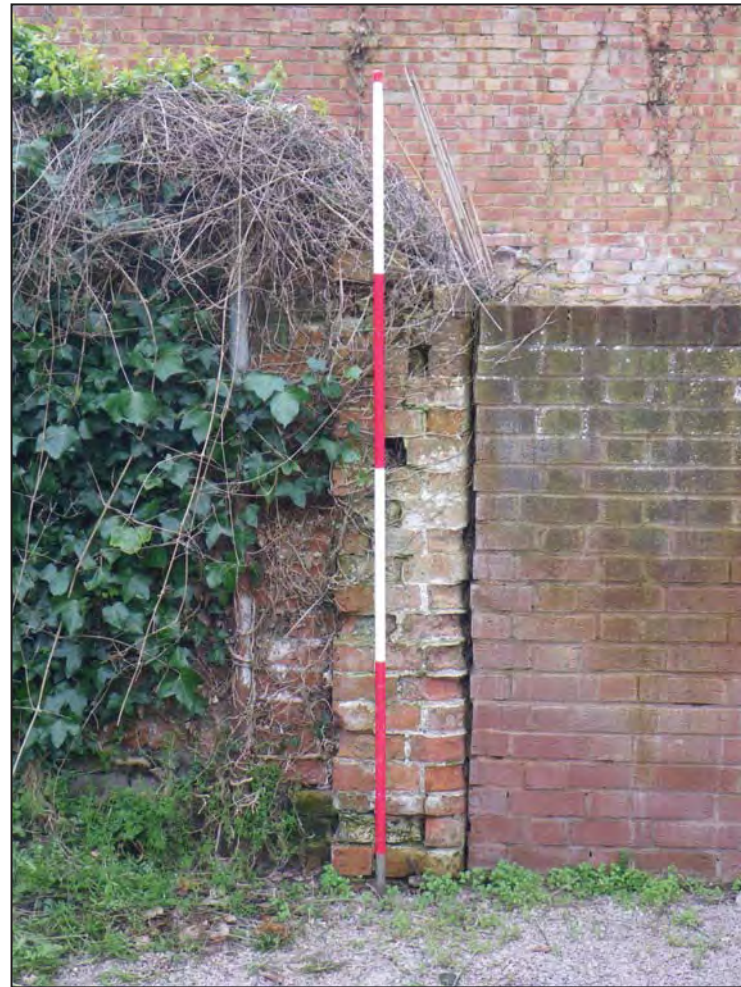
- 11 The north side of the brick respond/door jamb at the west end of Structure 2, looking south (scale 2m)
- 12 The footing at the east end of Structure 3, looking west, and the later low brick wall to its north (right) (scale 1m)
- 13 The south side of the east end of Structure 3 (scales 1m)
- 14 The junction of the brick section of Structure 3 with the stone west end

2.15 On the other (north-east) side of this quoin the bricks formed a respond or door jamb, with a rounded north corner (Fig. 11)

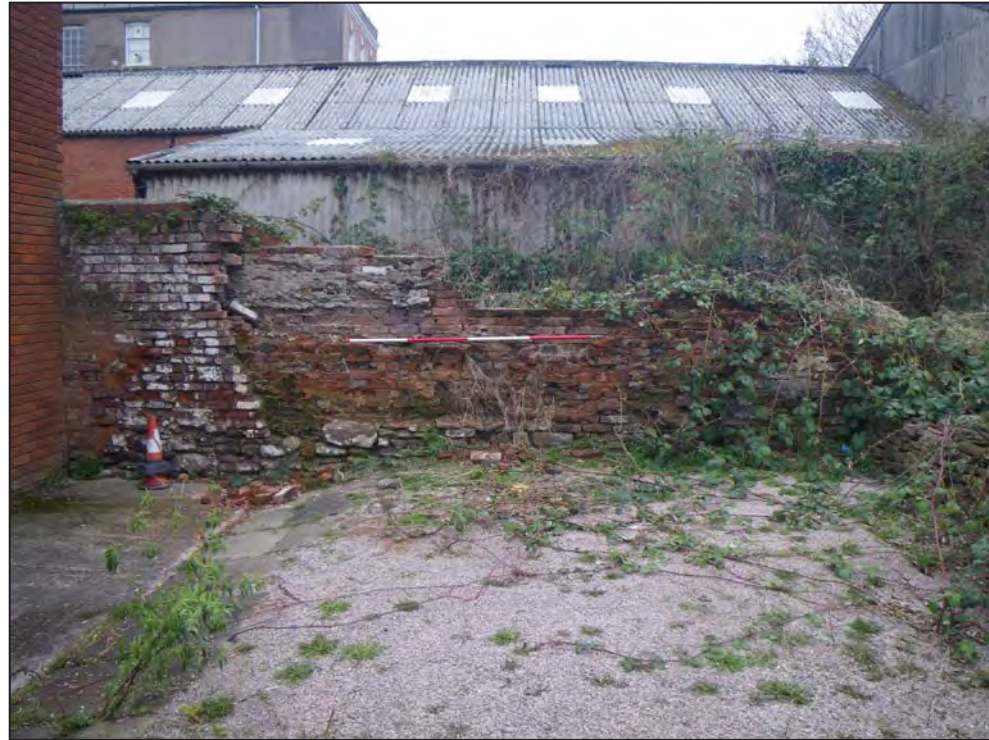
- 15 The stone basal courses and brick upper sections at the western end of Structure 3 (scale 2m)
- 16 The various brick walls on the stone basal courses of Structure 3, the west end looking north-west (scale 2m)
- 17 The stone footings under the bricks of Structure 3, near the east end, looking N (scale 0.3m)
- 18 The upstanding section of Structure 4, south side of no. 34, Monnow Street, looking south-west (scale 2m)

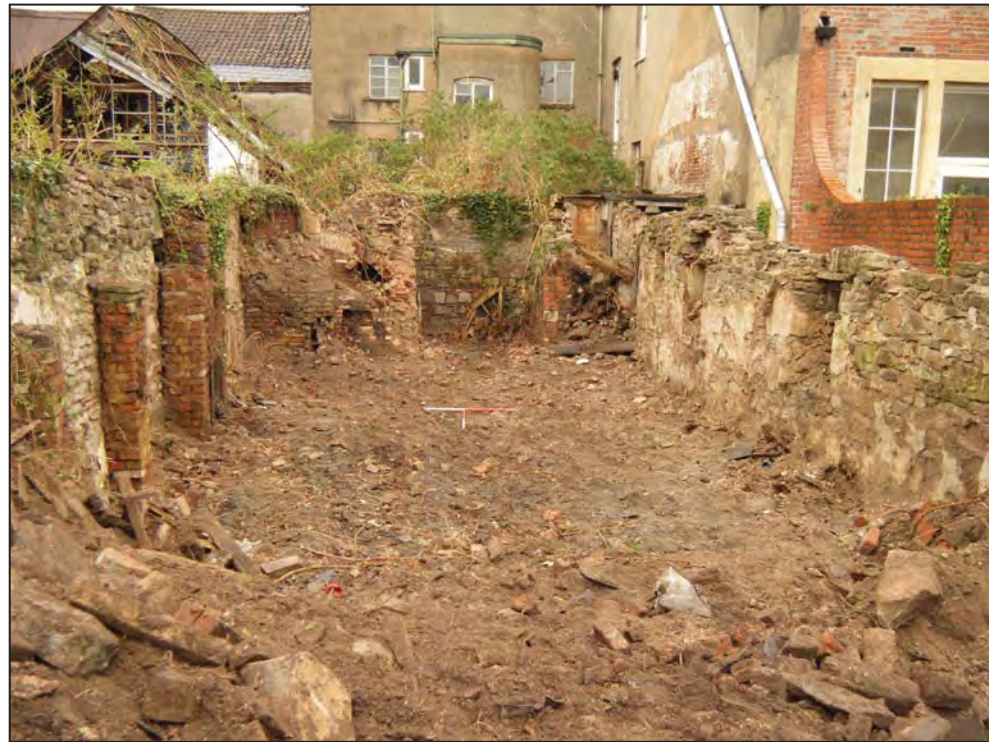
- 20 Structure 5 after clearance, looking north-west, no.20-22 Monnow Street at rear (scales 1m)
- 21 The tenement boundary wall forming the south-west side of Structure 5, looking from the site of the steel retail shed behind no. 24 across 22/20 (Structure 5) to 18. Note scar of gable of Structure 5 on side wall of 18
- 22 The small eroded stone-framed window in Structure 5 (scale 1m)
- 23 Stone-framed window of 16th to 17th-century date in the north-east wall of no. 22, seen from the rear yard of 20/22, Monnow Street (scale 0.5m divisions)

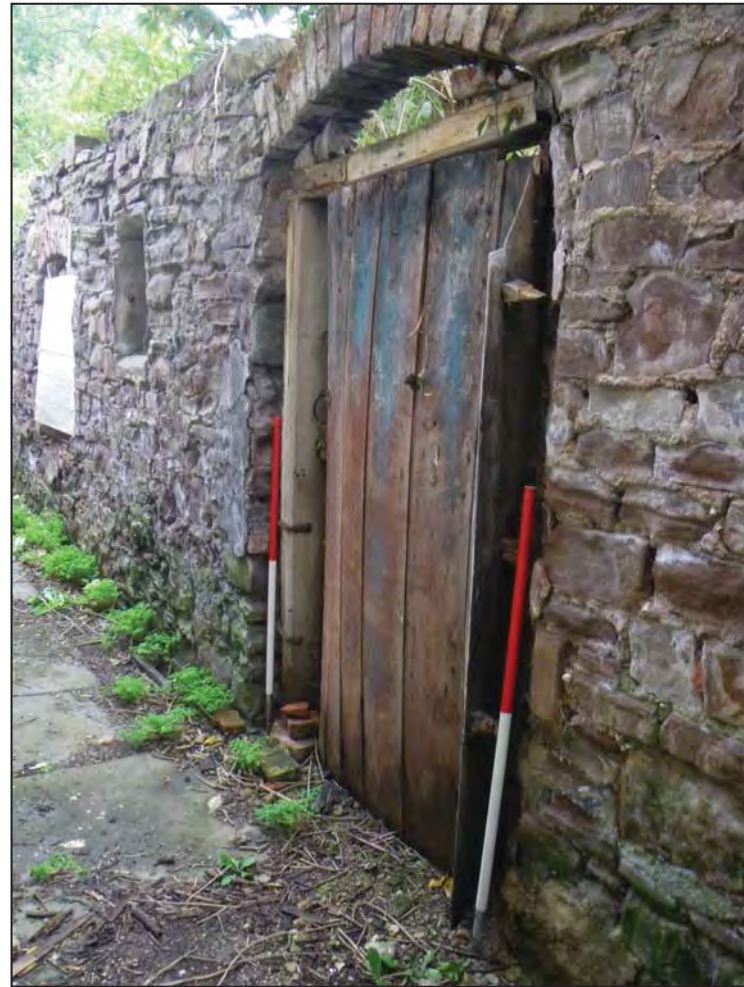
- 24 The north-west arched door and the adjacent windows in the north-east wall of Structure 5, looking east (scales 1m)
- 25 Brick piers at the south-east end of Structure 5, looking north-east before clearance (scales 1m)
- 26 The south-west wall of Structure 5, showing raising of wall, and addition of brick piers (and beam pockets above them) and two-storey stack, looking south-west (scales 1m)
- 27 The staircase enclosure of Structure 5 looking from the exterior southwards, brick rebuild to right and on top of far wall (scale 2m)

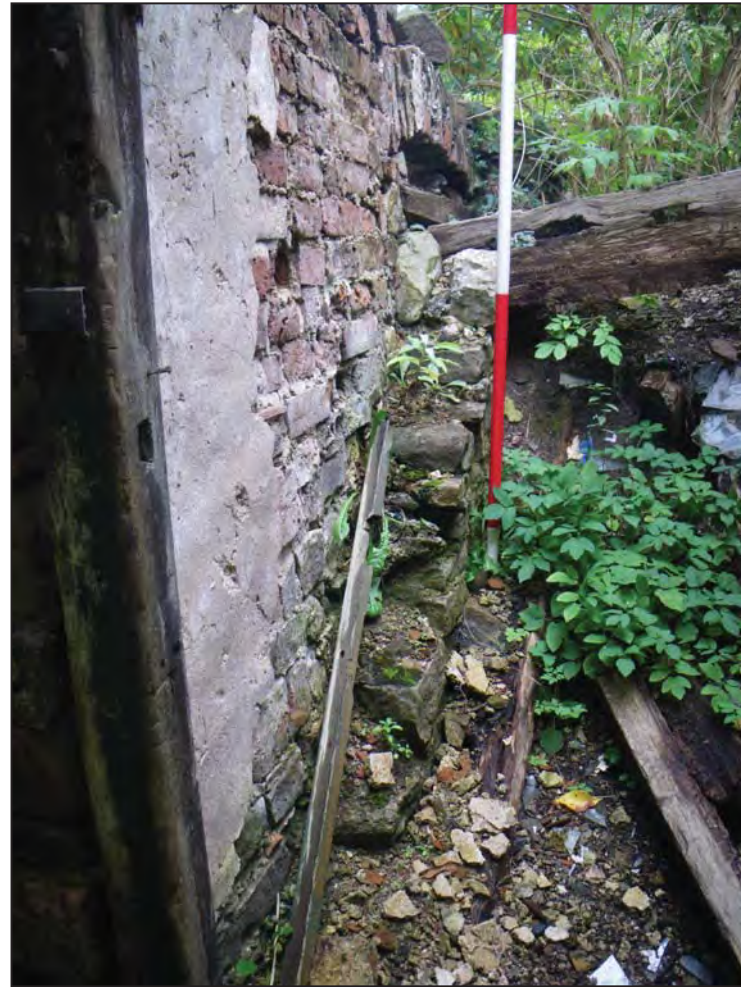
- 28 The staircase enclosure from the interior looking south-east showing cutaway of stone wall for steps and brick re-facing of adjacent wall (scale 0.5m divisions)
- 29 The north-western entrance to the covered passage under the upper floor of Structure 5, looking east (scale 2m)
- 30 The brick walls, piers and the ceiling beams of the covered passage in Structure 5
- 31 North-west elevation, the central door and the inserted window, looking east (scale 2m)

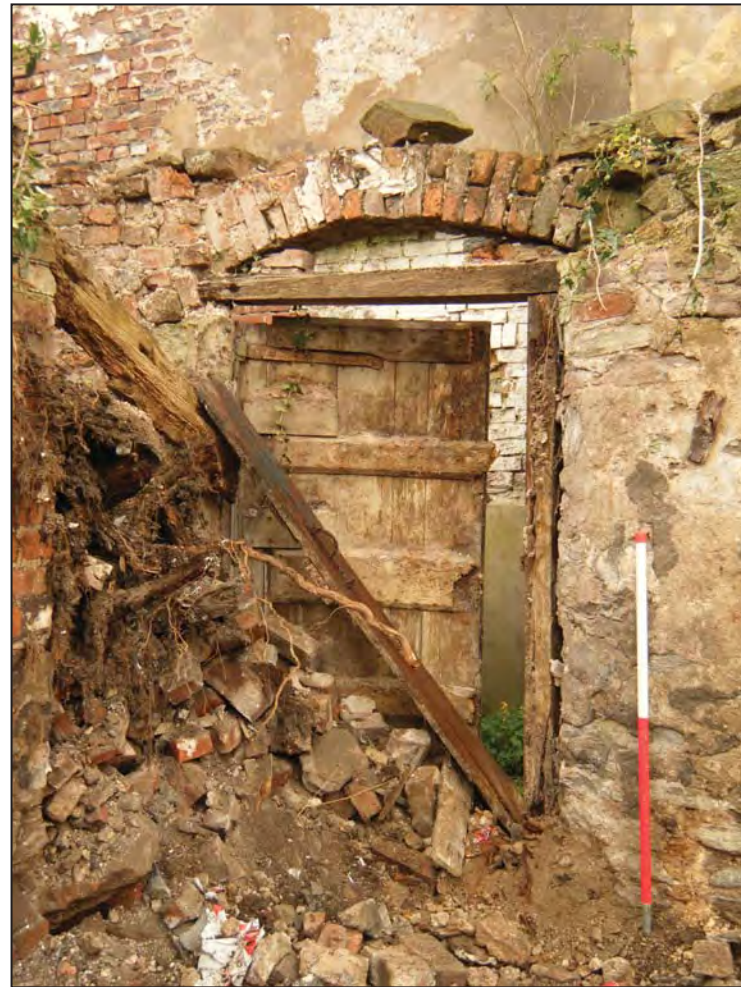
- 32 The door in the north-east elevation that was put out of commission by the stair, the interior, looking north (scale 1m)
- 33 The cluster of brick-built ovens etc. in Structure 5, looking west (scales 1m)
- 34 The shallow-apsed recess at the north-west end of the main room in Structure 5, looking north-west, stair to left, brick-vaulted oven to left (scales 1m)

the main alterations in brick. We have noted that the door at the north-west end next to the stair, while having an arched brick head, was put out of commission by, or at least must pre-date, the creation of the stair. This may mean that there were three recognisable phases: stone-built with small stone-framed window(s?); stone-built with new brick-arched windows and doors (both phases perhaps of one storey); and a largely brick and brick-and-rubble phase with a stair and a first floor. The ovens and fireplace belonged to this phase.

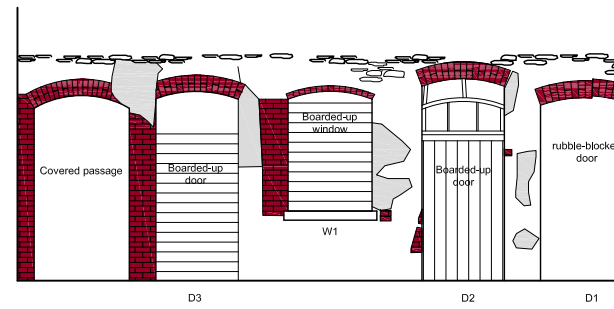
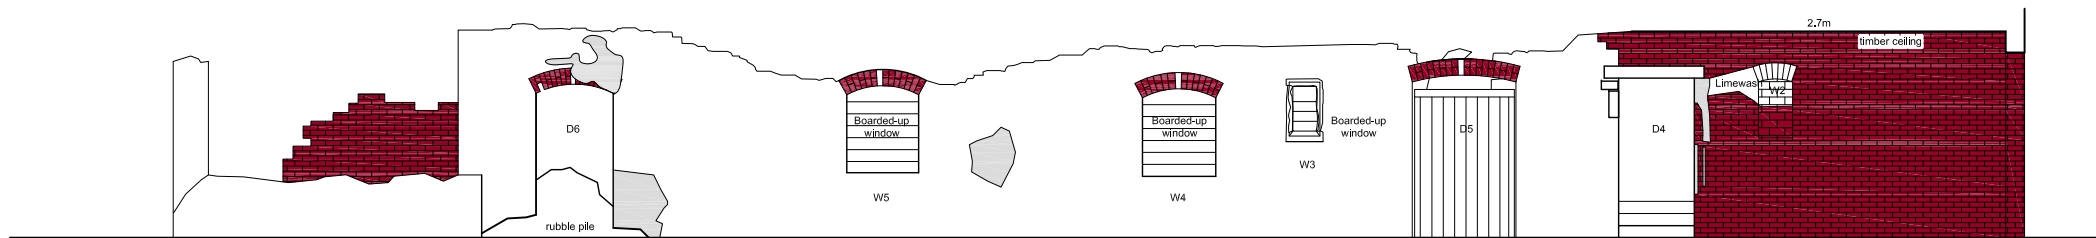
PROJECT NO.	3978	DATE	17-09-2013	FIGURE NO.
DRAWN BY	DJB	REVISION	00	35
APPROVED BY	LG	SCALE@A3	1:100

FIGURE TITLE
**The north-west and north-east elevations of
 Structure 5 (based on drawings supplied by
 Graham Frecknall Architecture and Design)**

- 2.29 On the north-east side were two windows with segmental arched brick heads (Fig. 35, W4 and W5), and a third that had a sandstone window frame, very heavily eroded and probably re-used (Figs 22 and 35, W3). Although rather small and damaged, this was obviously very similar to that in party wall of 22/24, probably of 16th or 17th-century date (Fig. 23).

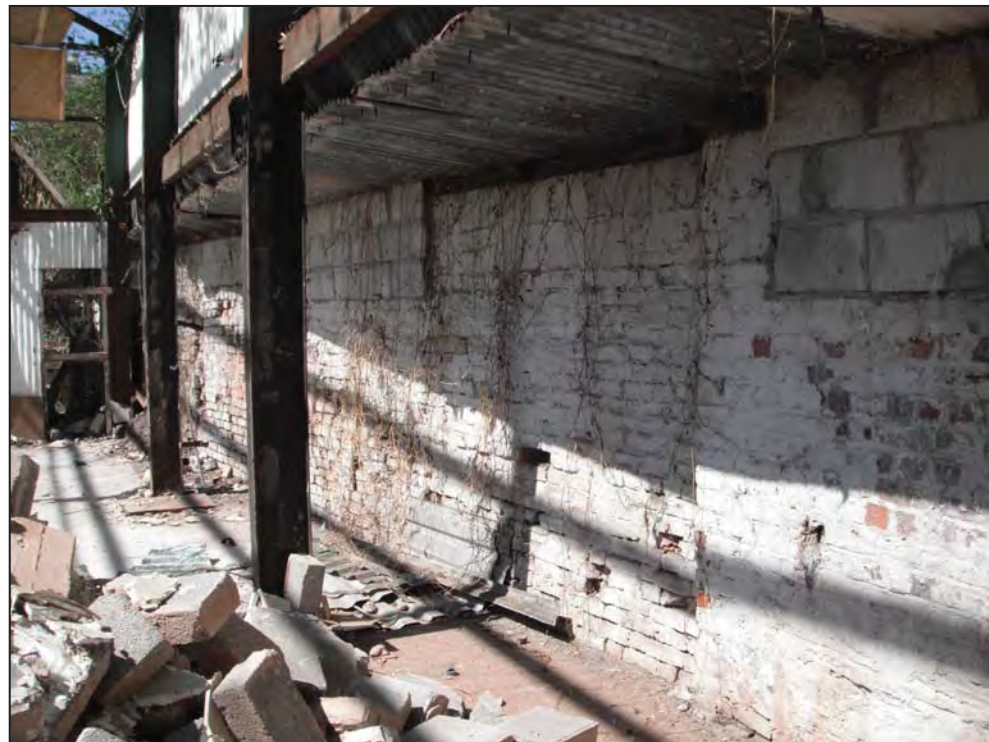
- 36 Structure 6, the boundary wall between 22 and 24 Monnow Street, showing the sequence from brick boundary wall to 20th century steel retail shed (stone base not visible in this photograph), looking north-west
- 37 Structure 7, the boundary between 24 and 30, Monnow Street, looking south at the kink in the wall, rough stone section nearest (scales 1m)
- 38 One of the two openings noted in Structure 7, looking south-west, note neat thin-coursed rangework, later repair to top left (scale 1m)
