Introduction and Overview of Chirk Home Farm and Associated Buildings.

Essentially a mid C18th designed model farm structure added onto an existing building (Johnson's Cottage) which was itself probably built about a century or so earlier. The Estate map of 1751 shows the whole structure completed and it is assumed to have been built shortly before this date. The layout is of a square of mainly single story buildings, except for Johnson's cottage and the low lofted area over the south range and part of the west range. This south range was the corn barn and threshing floor, entirely superseded by new mid – late C19th century advances in agricultural technology and re-utilised and rendered inoperable by additional buildings to its south. There is a yard at the centre with access by means of wide gap to the north and a vaulted archway at the east, probably the whole and its cobbled surface unaltered since use in conjunction with the threshing floor in the south range. The earliest part of the whole - Johnson's cottage is stone built as is the Stable at the NE. All the other buildings conform to a faux Elizabethan style of stone base up to the window top, topped by timber framed super

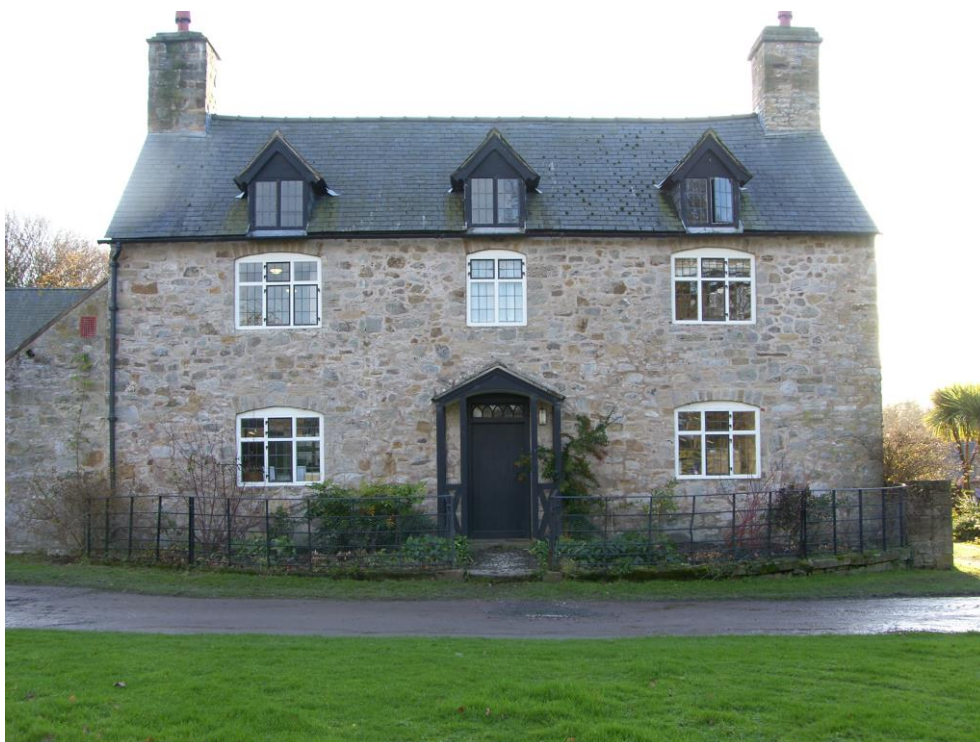
1 Johnson's cottage / PM **A** / Late C16th early C17th origins but massively altered with modernised interior.

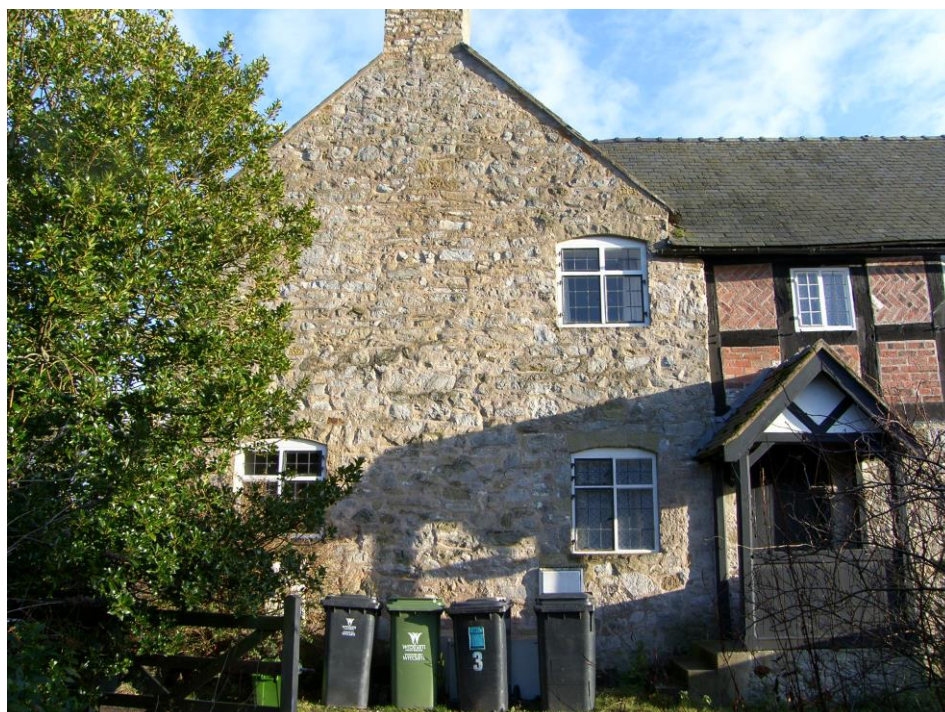
2 Johnson's cottage / PM **A** / largely unaltered facade.

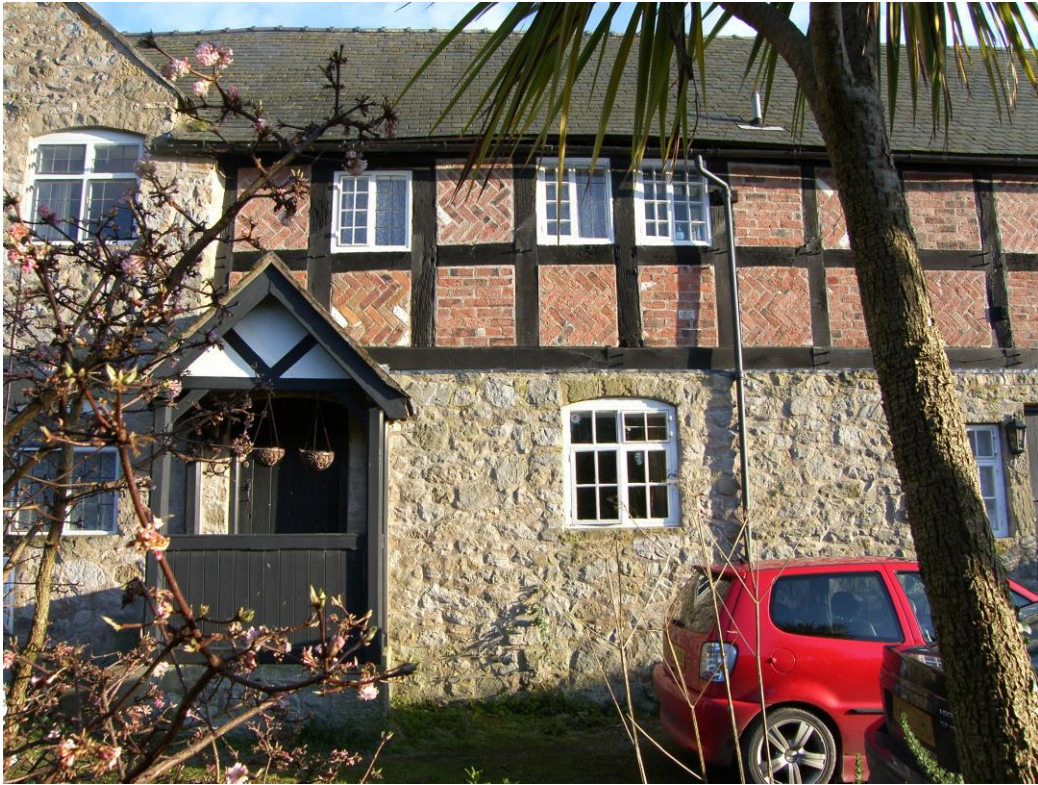
3 The Bothy / PM **C** early to mid C18th (pre 1751)

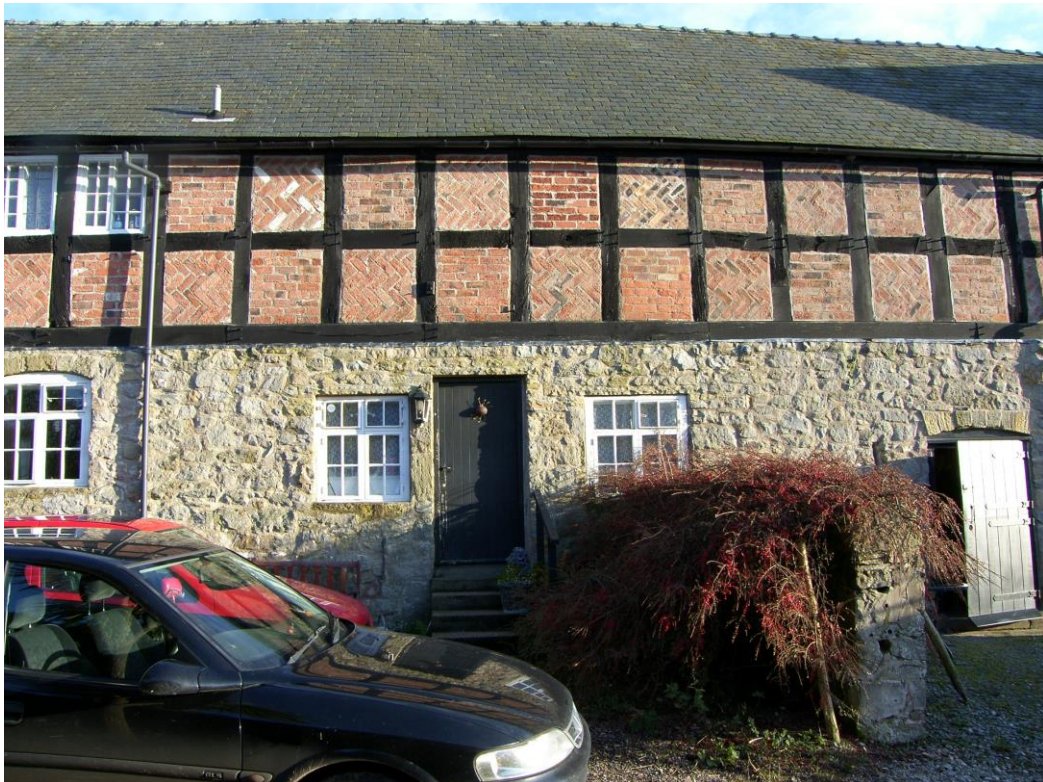
4 The Bothy to the left and entrance to Home Farm Cottage no. 3 / PM **C** early to mid C18th (pre 1751). Accommodation for farm workers probably created mid C19th.

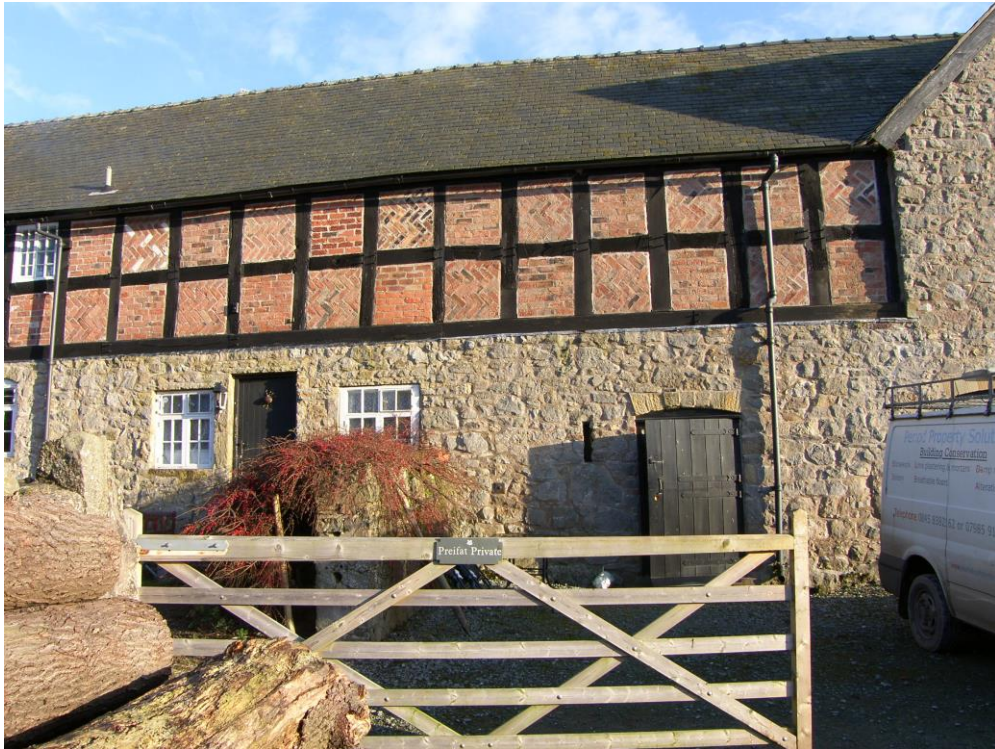
5 Home Farm Cottage No 3 (left), Cowhouse (right) PM **E** the cowhouse is lofted – see View 58 (below).

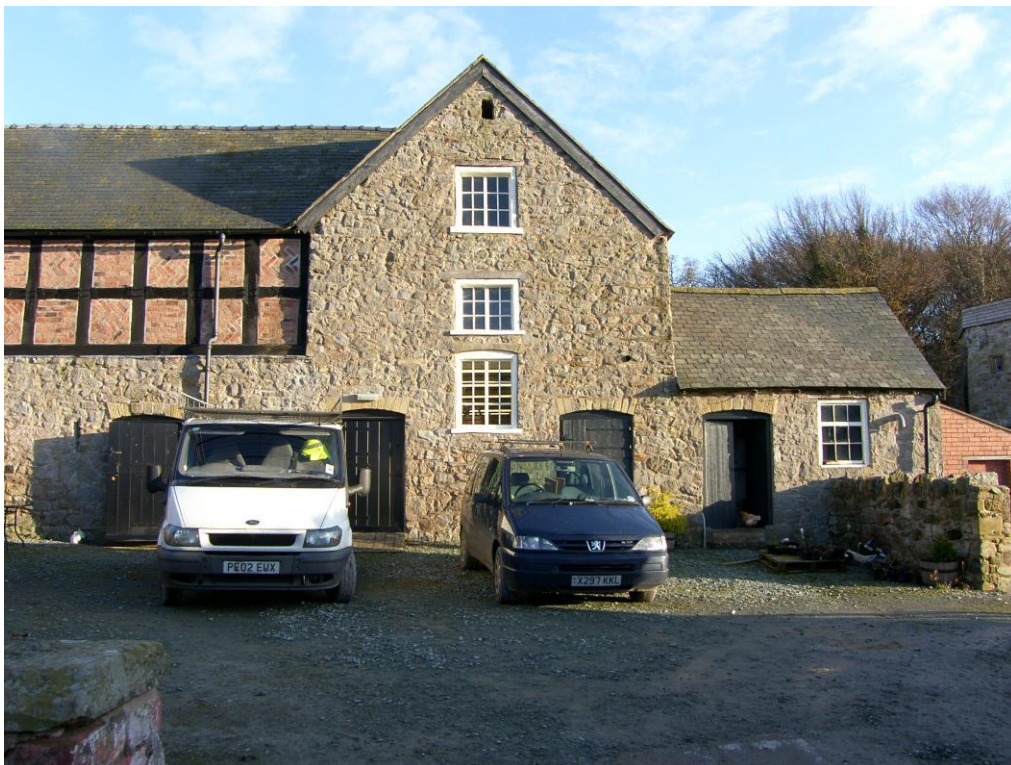
6 Former Cattle stalls now Exhibition Space cum presentation area. PM **F**, early / mid C18th, loft over – see view **59**

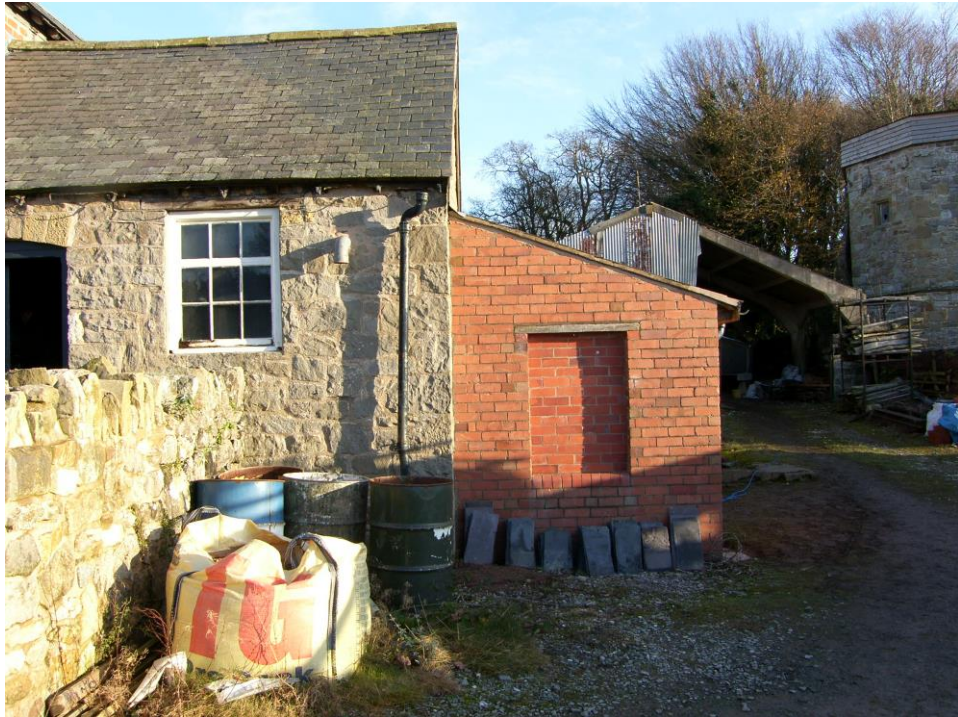
7 Tank Room (left) PM **S** / Pump Room (right) PM **T**. Tank room late C18th, Pump room late C19th.

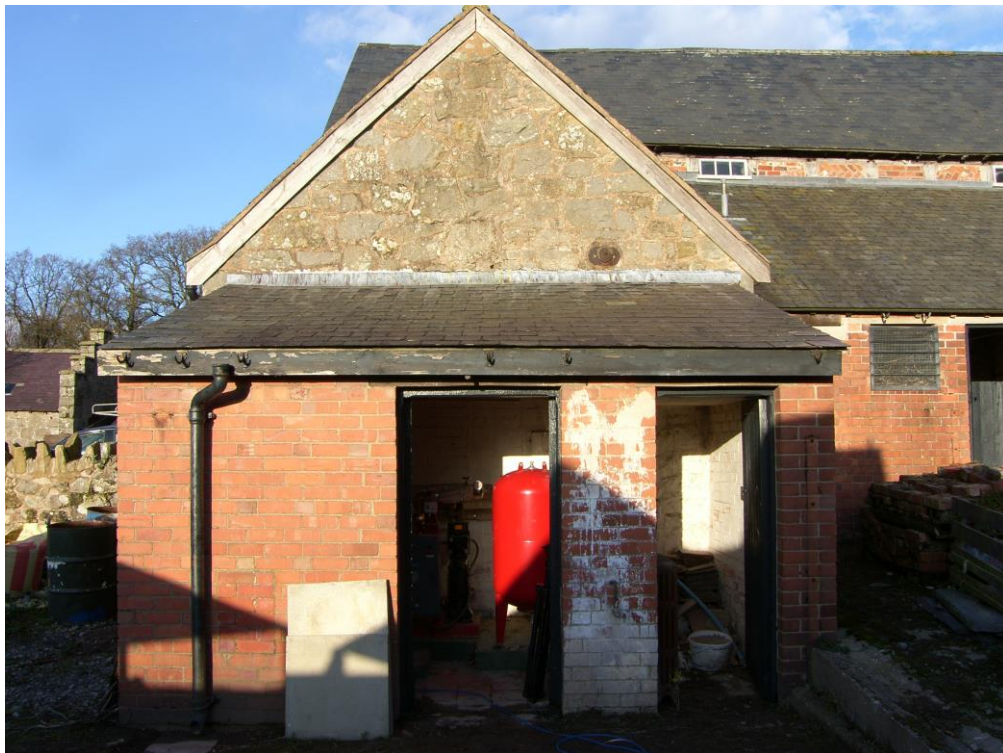
8 Pump Room (former) now used for storage. PM **T**, late C19th.

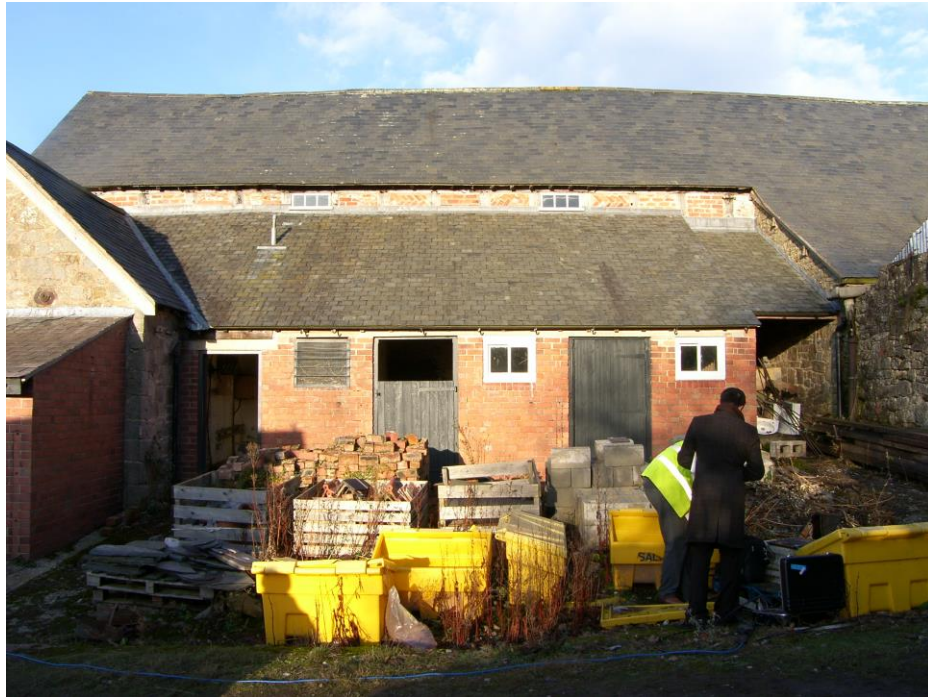
9 Former Calf sheds late C19th. Also the partially hidden rear of the Corn Barn and threshing floor - ?early-mid C18th. PM **R**. .

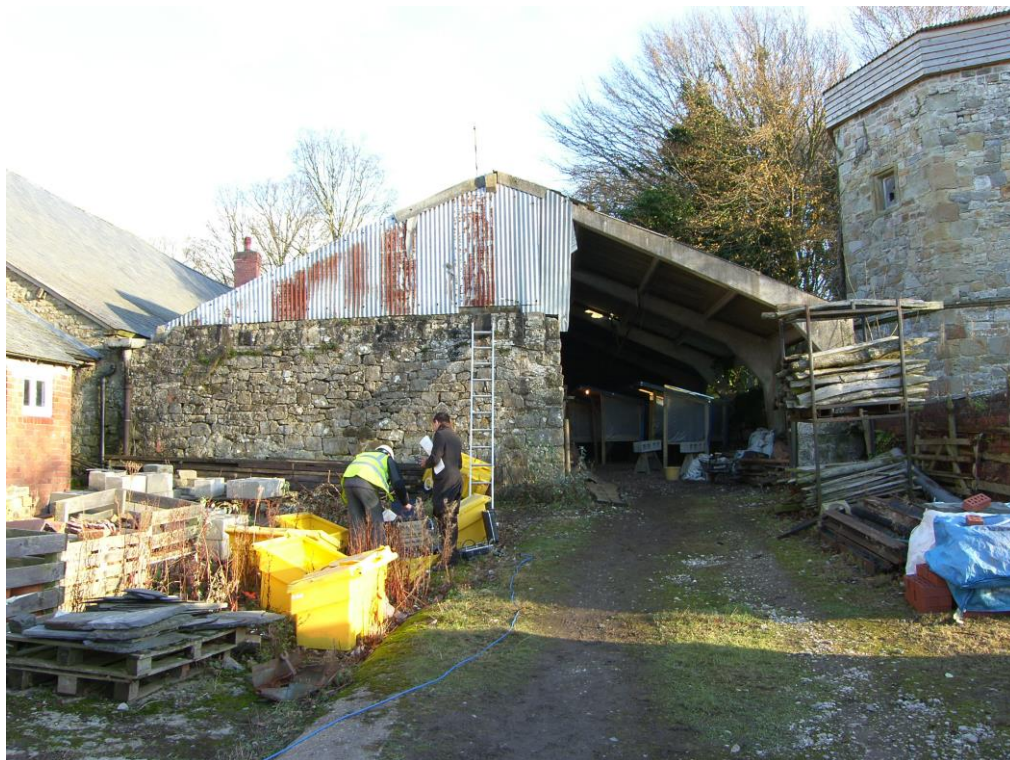
10 Portal Frame Building PM **Q** and Hammel **P** (obscured) within. Portal Frame Building 1960's, Hammel early to mid C19th.

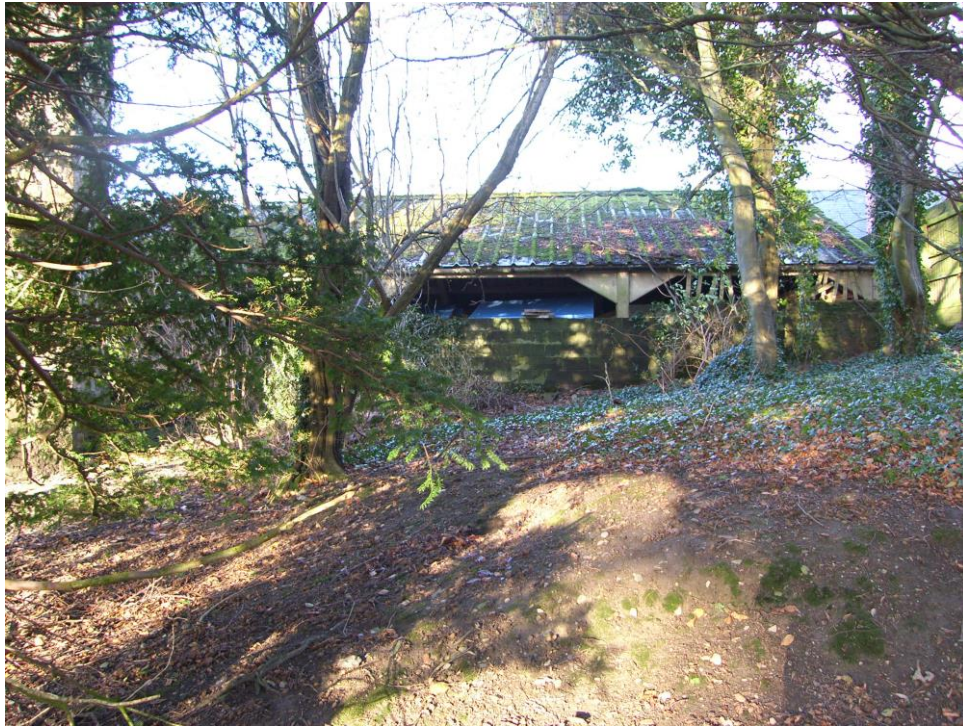
13 (alternate) Portal Frame Building PM **Q** and Hammel **P** (obscured) within. Portal Frame Building 1960's, Hammel early to mid C19th.

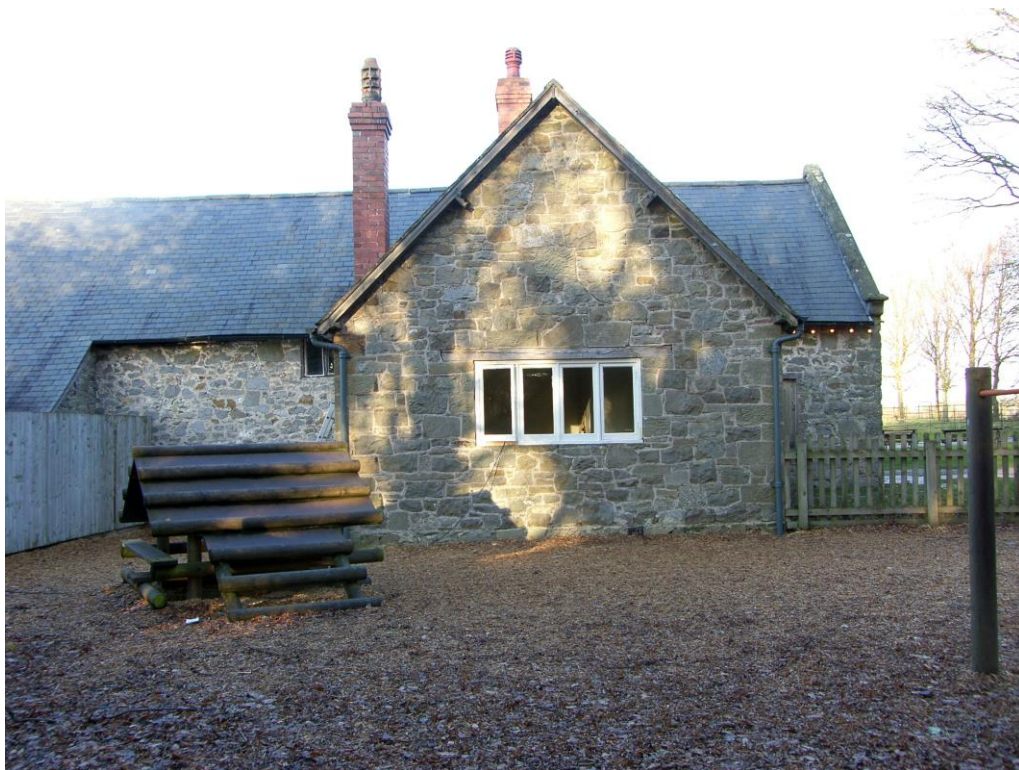
16 “Office” (early C20th) PM **O** with rear of former cartshed at left PM **M** and Farm Office at right PM **N** (both mid C18th).

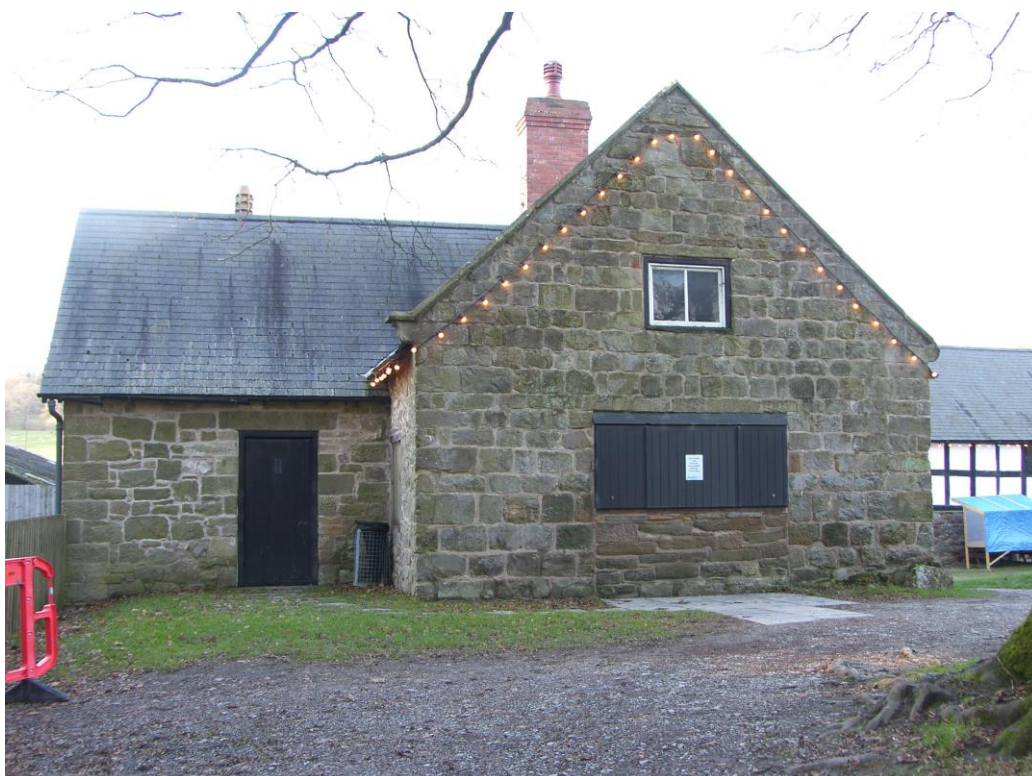
25 Farm Office gable end on PM **N** (mid C18th) with Farm Office to left.

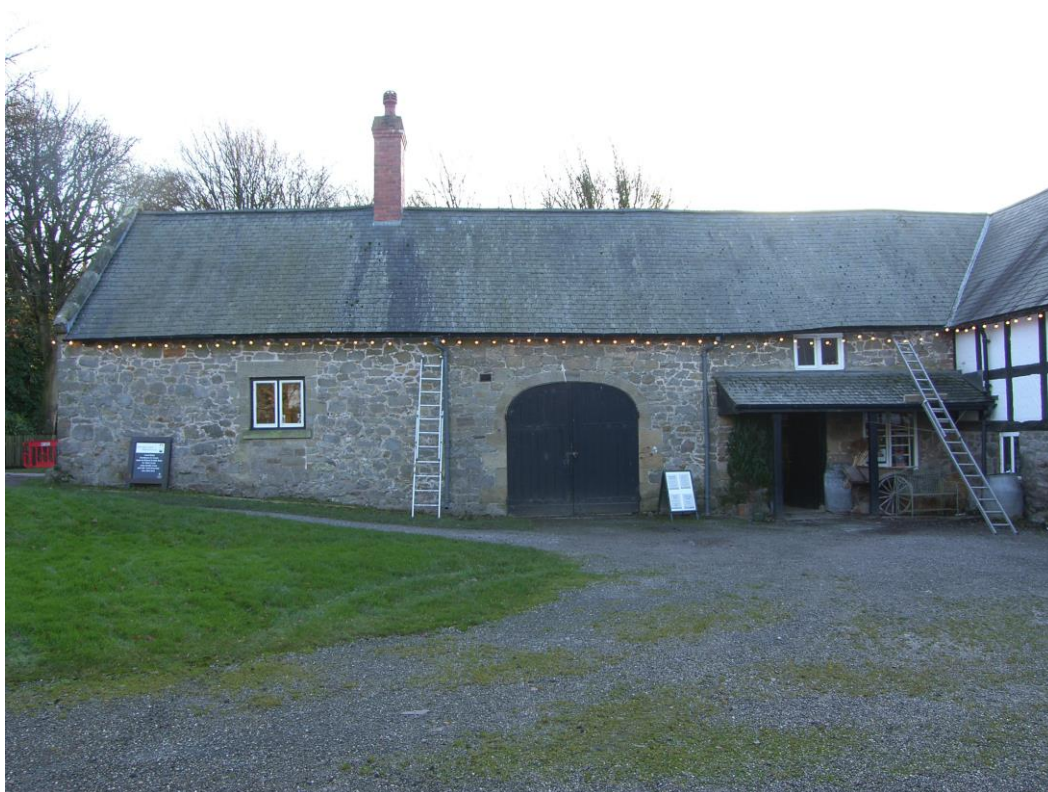
26 l – r Farm Office, former Cartshed (with doors), Dairy, (all mid C18th) PM **N M L**. Note window on left formerly larger (modified late C19th).

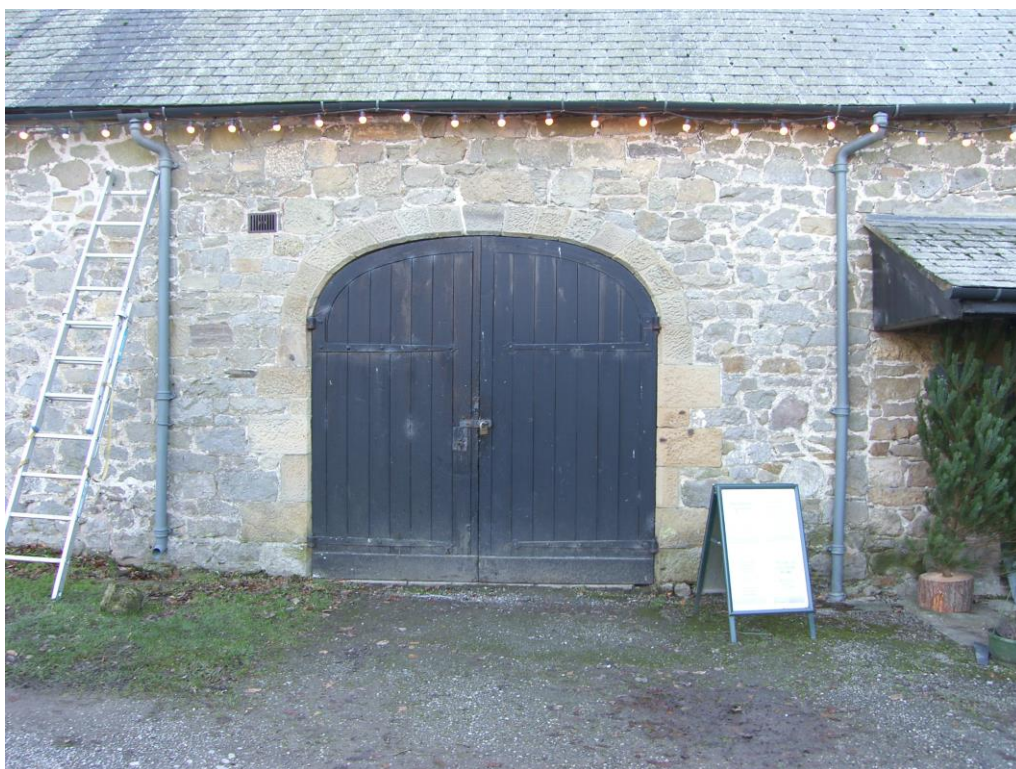
27 former Cartshed doors (detail) PM **M**

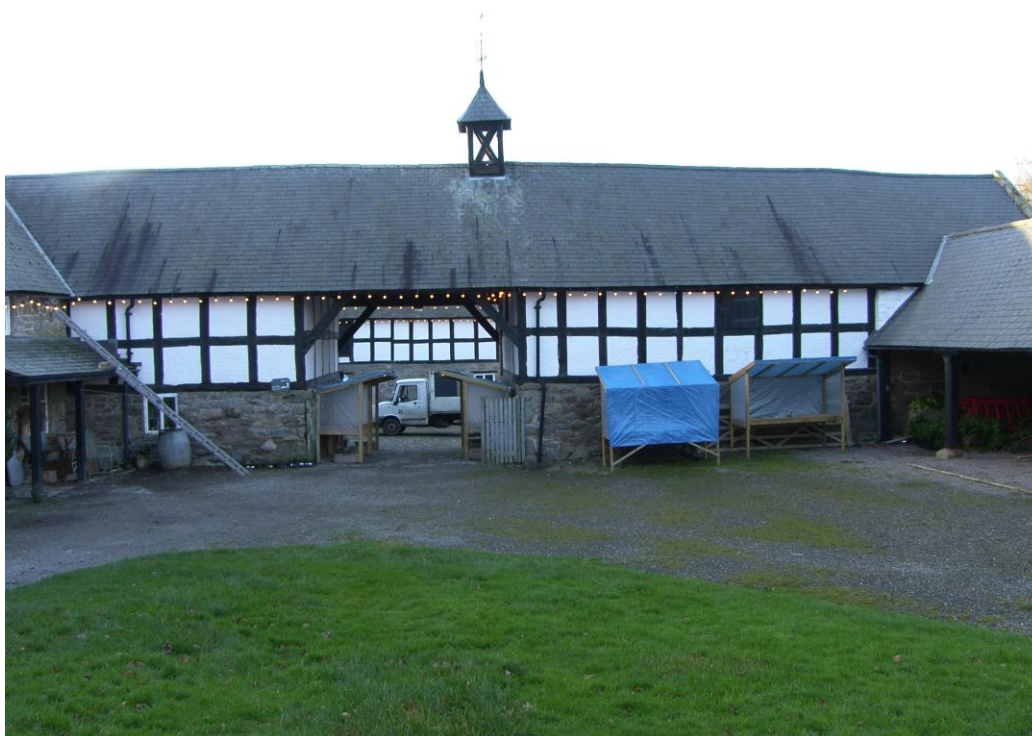
28 Lofted stable, early – mid C18th (left), covered passage (1771 date on timber) and lofted stable, late C18th (right). PM **H I**. NB C19th destroyed structure approx where the two timber stalls now stand.

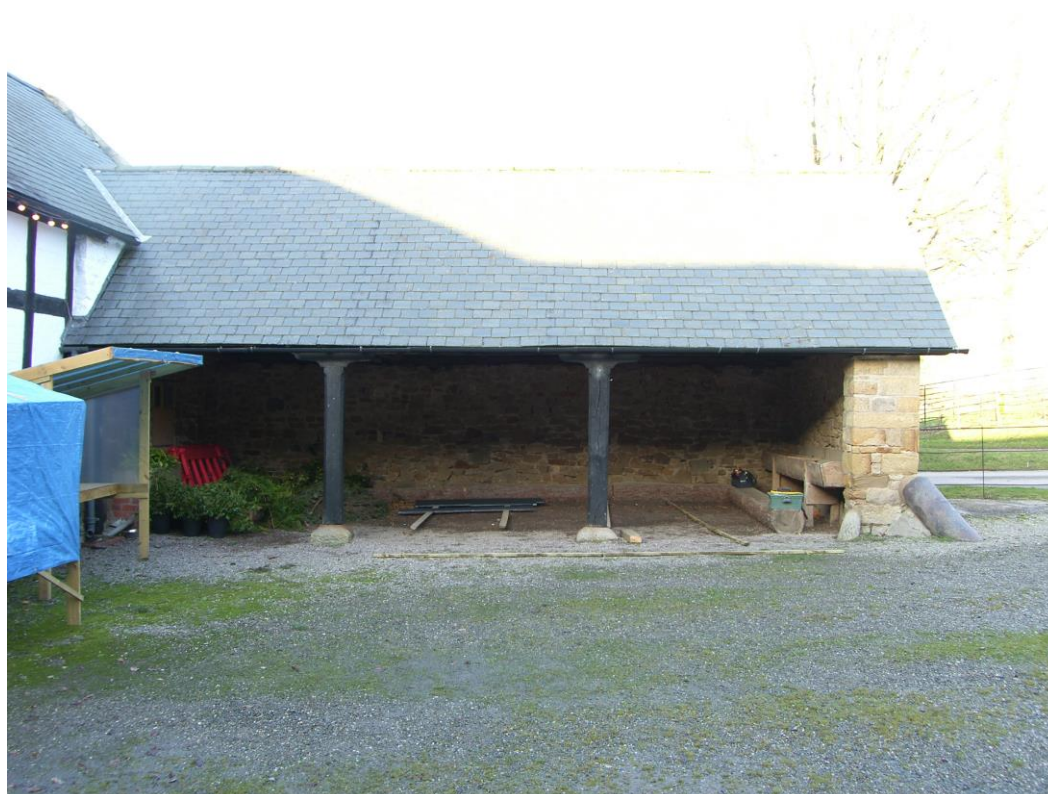
29 Open fronted Cart or Implement Shed – early C20th with feeding trough and cobbled floor. PM **K**

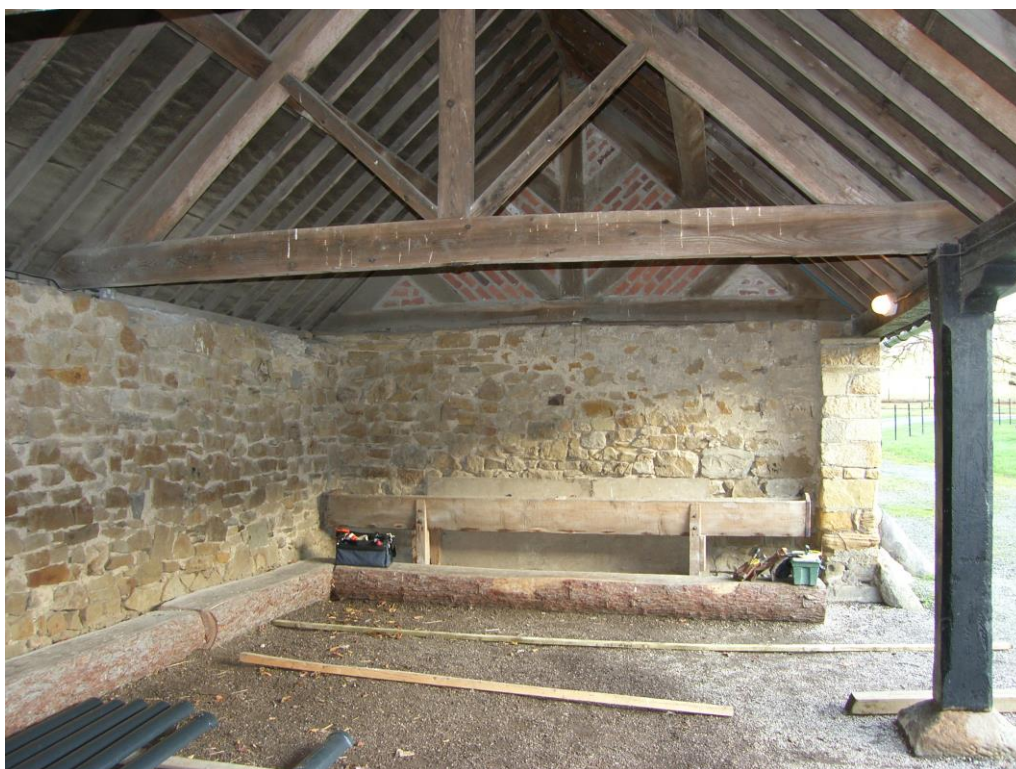
34 Cart or Implement Shed interior. PM **K**

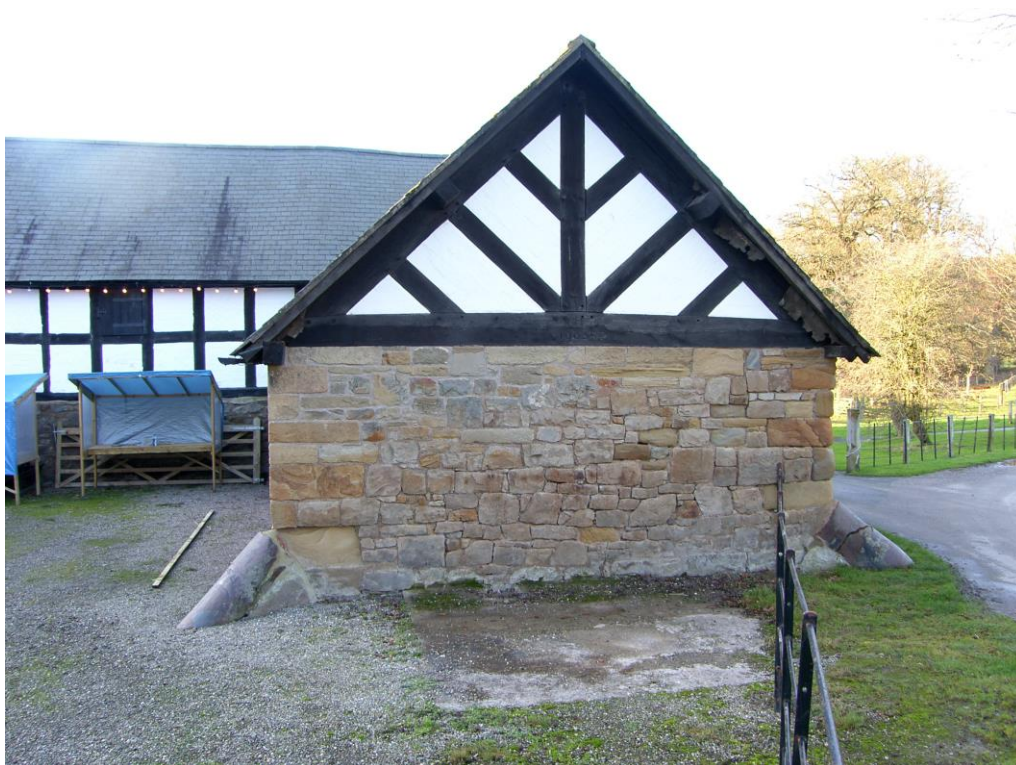
33 Open fronted Cart or Implement Shed – early C20th with feeding trough and cobbled floor. PM **K**. Note curious cylindrical corner reinforcement – purpose unclear.

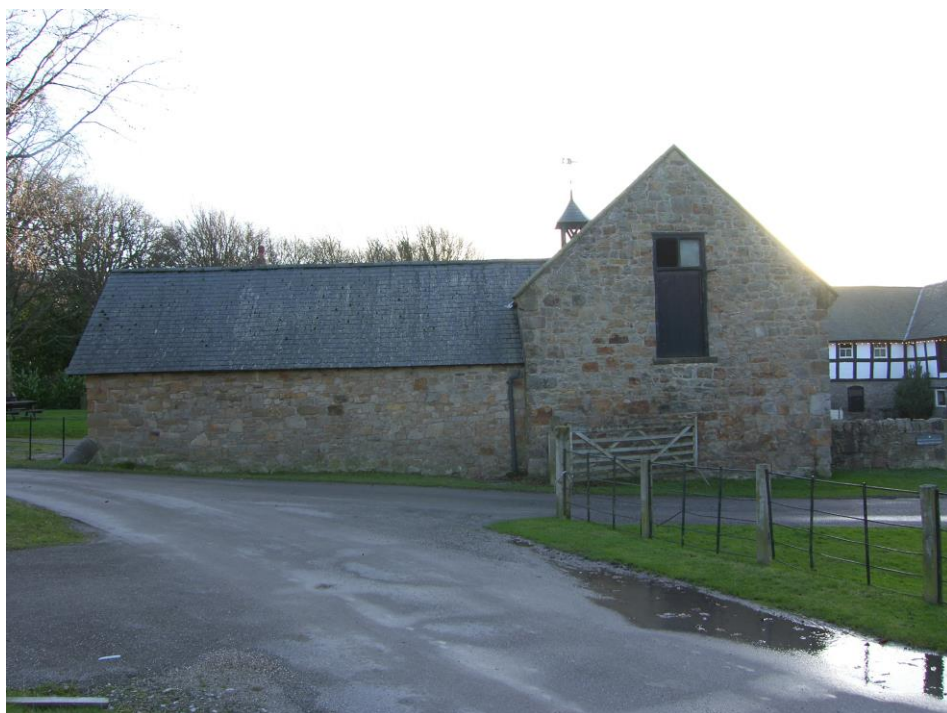
36 Open fronted Cart or Implement shed (left) Gable end of partial lofted Stable (right). PM **K J**

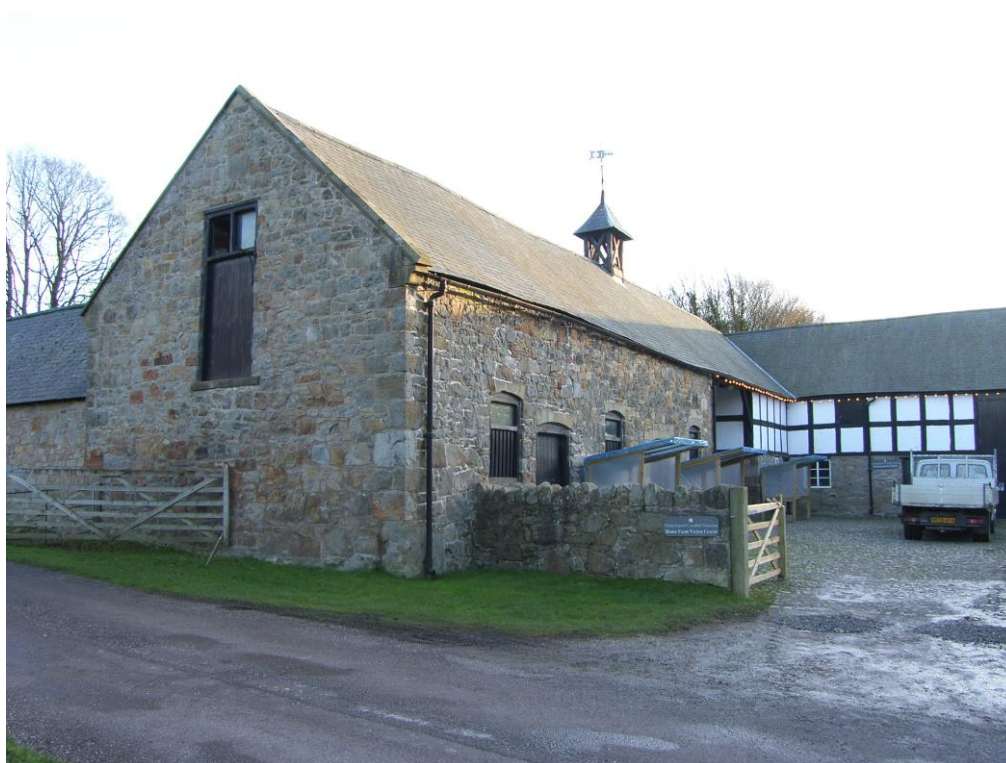
37 Oblique view of Stable, lofted with hay loading eye to upper floor storage area. ?late C18th. PM **J I**

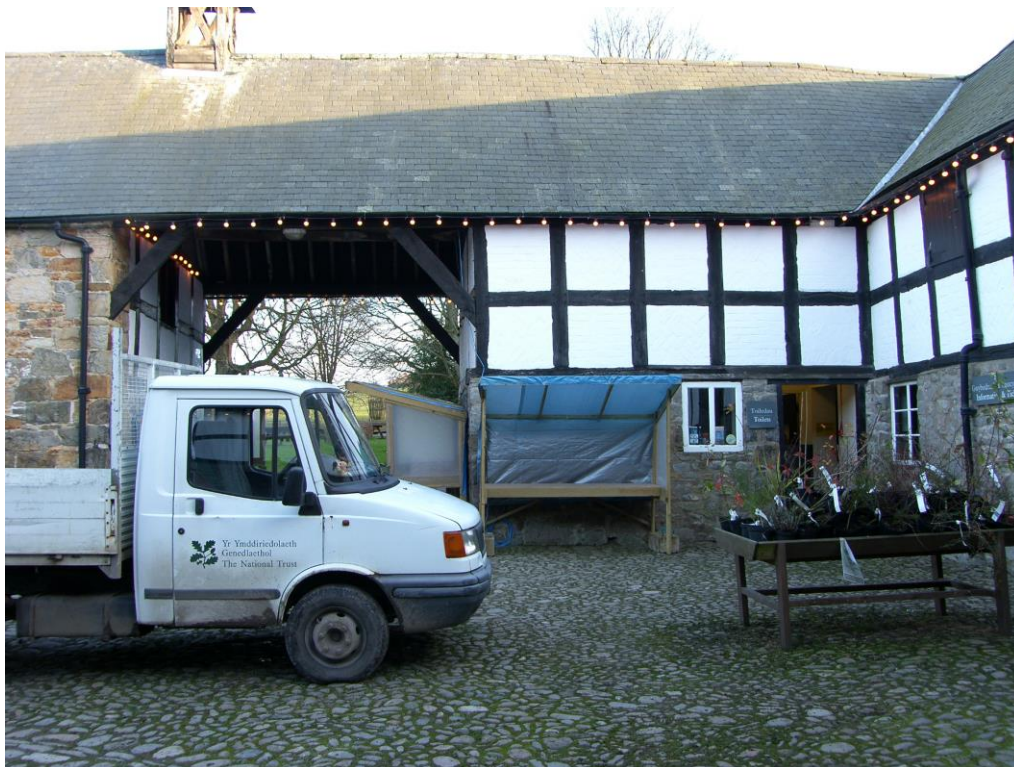
42 Covered Passage and Lofted Stable (now toilets) ?early-mid C18th. PM **H**

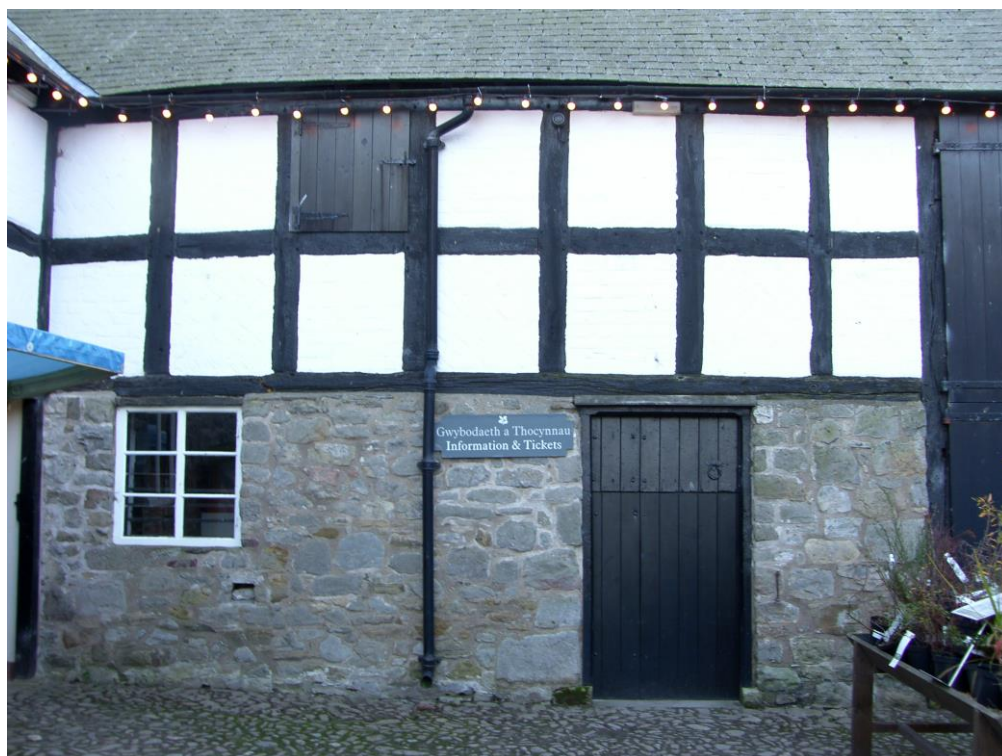
43 Corn Barn (east end of – converted into storage space) Inserted Loft (date uncertain) Building ?early-mid C18th. PM **G**

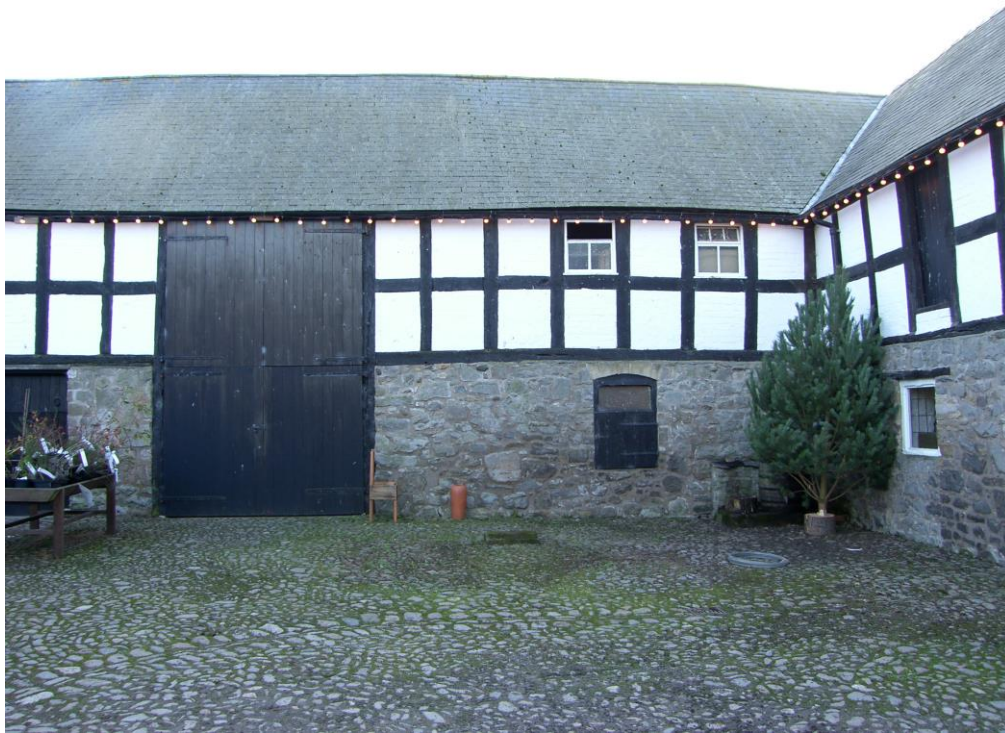
44 Corn barn showing the threshing floor area (hidden by doors) and part of the barn. Used as shop and exhibition / presentation space. Inserted Loft with sawn and chamfered roof trusses (splayed queen post style). PM ref **G F**

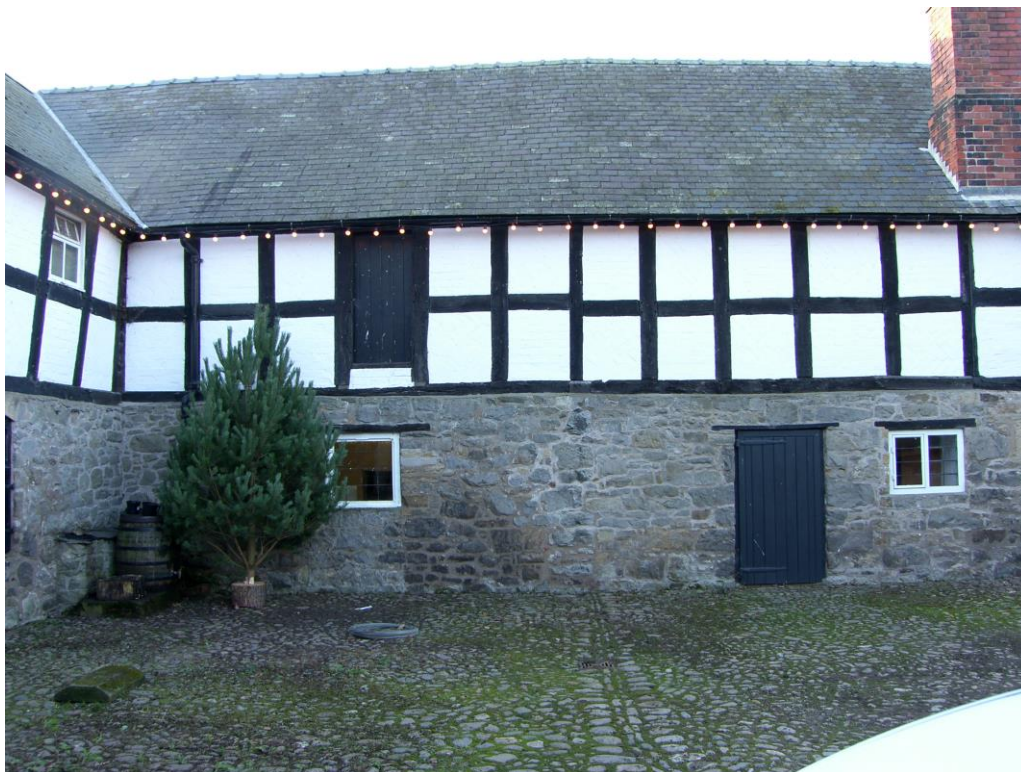
45 Lofted Cowhouse (left), former coal-shed and privy (right). early-mid C18th. PM **E D** Note blocked door between door and window (C19th modification)

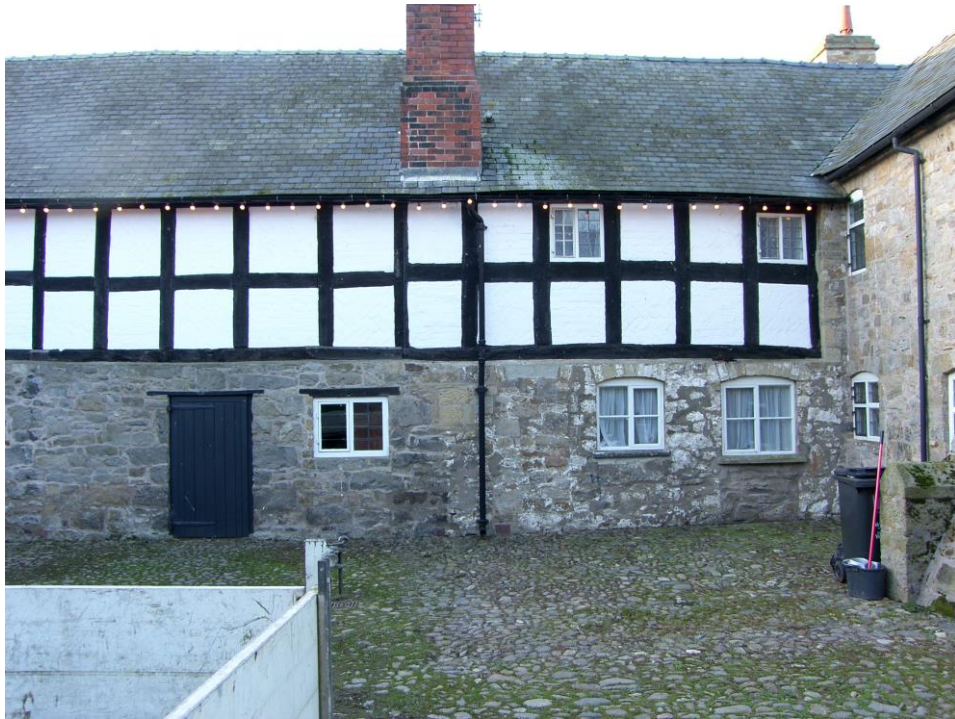
46 Part of the coal-shed (see previous) and the Bothy (right). Note break in masonry between the two. Both early-mid C18th – possible the Bothy was formerly an annexe of Johnson’s cottage before Home Farm complex was built. PM **D C**

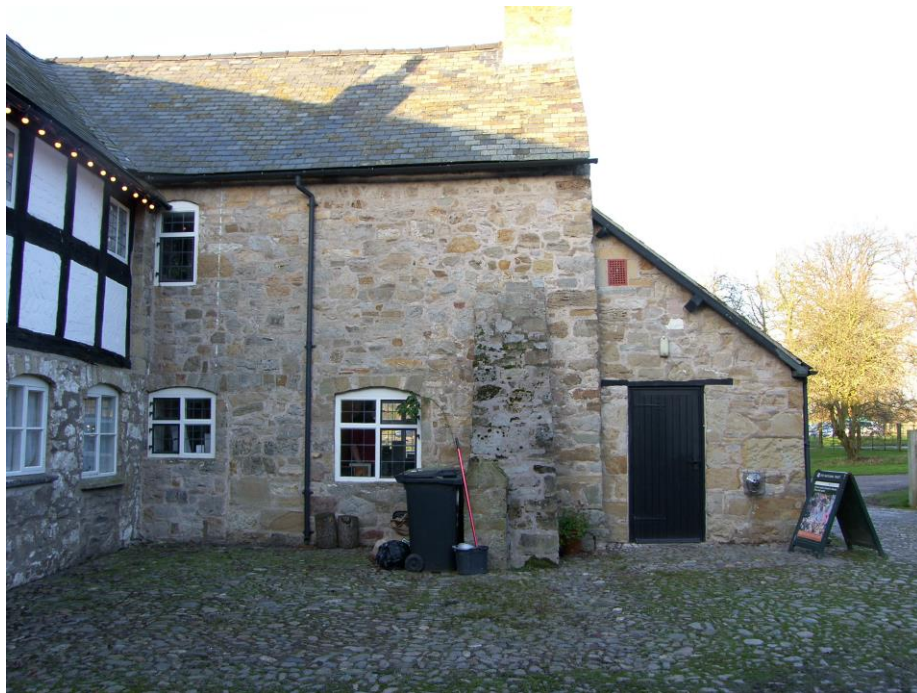
47 Rear of Johnson’s Cottage with part of The Both (left)). Late C16th – early C17th origin. Johnson’s Cottage has been completely modernised internally. PM **A**. Note the blocked door on left, probably a mid/late C19th change.

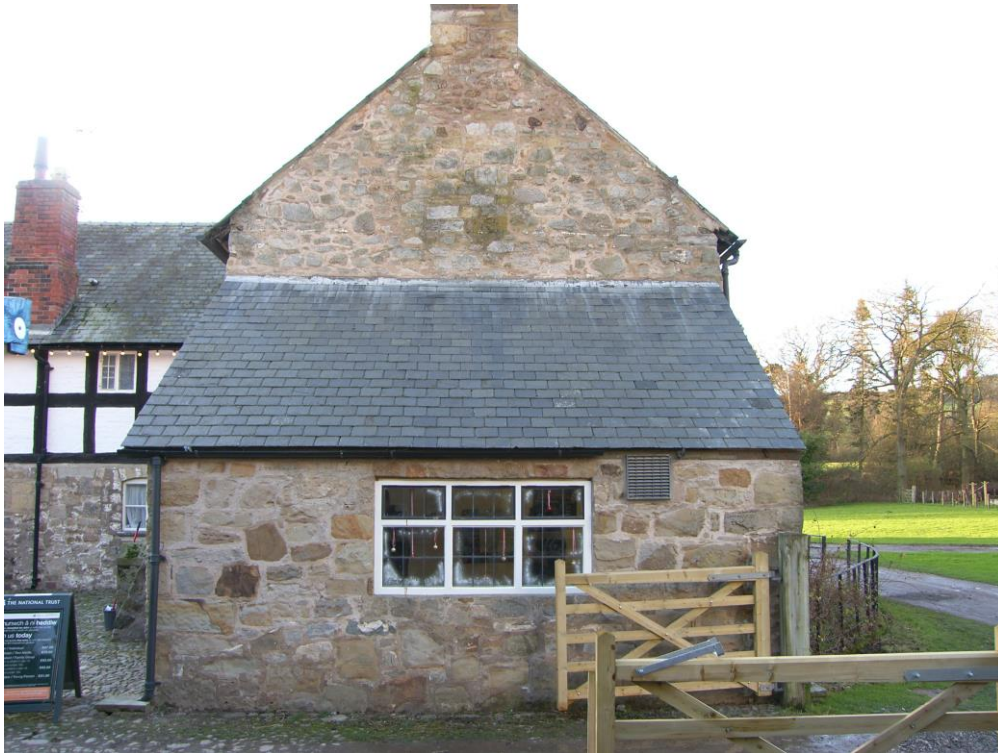
56 Johnson's Cottage, outshot with catslide roof, possibly a late addition, built at time of Open fronted Implement Shed PM K (see view 33 above). Early C20th. PM **A**

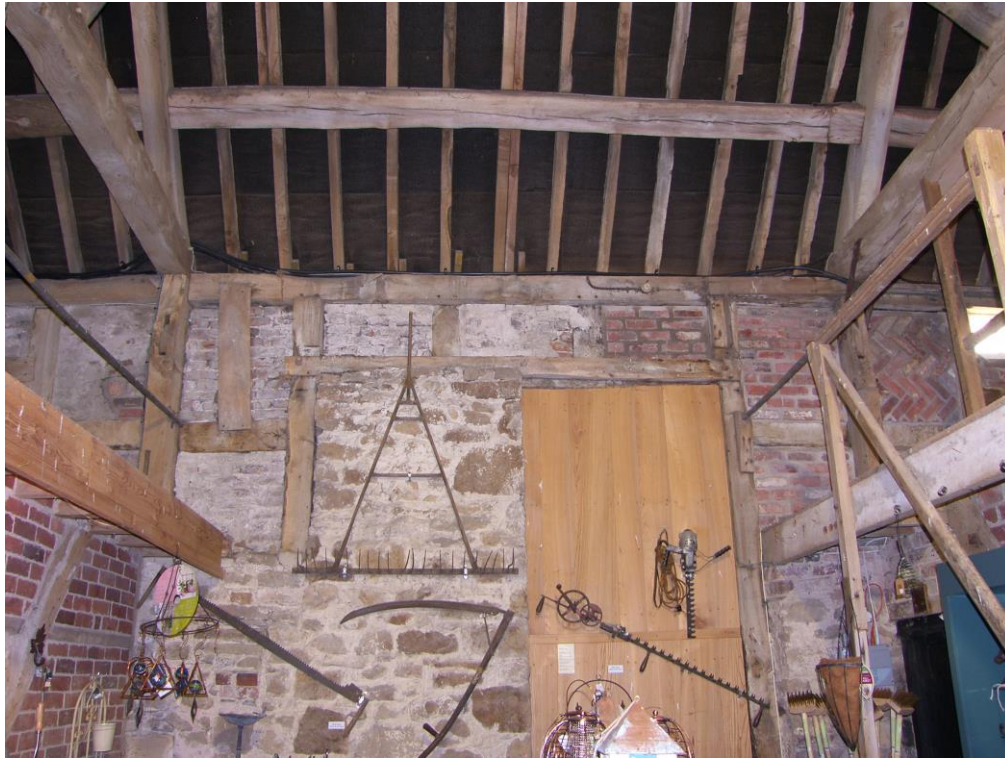
50 Corn Barn view looking South showing narrowed door, formerly open threshing area (see view **44**). PM **G**
