Introduction and Overview of Chirk Home Farm and Associated Buildings.

Essentially a mid C18th designed model farm structure added onto an existing building (Johnson's Cottage) which was itself probably built about a century or so earlier. The Estate map of 1751 shows the whole structure completed and it is assumed to have been built shortly before this date. The layout is of a square of mainly single story buildings, except for Johnson's cottage and the low lofted area over the south range and part of the west range. This south range was the corn barn and threshing floor, entirely superseded by new mid – late C19th century advances in agricultural technology and re-utilised and rendered inoperable by additional buildings to its south. There is a yard at the centre with access by means of wide gap to the north and a vaulted archway at the east, probably the whole and its cobbled surface unaltered since use in conjunction with the threshing floor in the south range. The earliest part of the whole - Johnson's cottage is stone built as is the Stable at the NE. All the other buildings conform to a faux Elizabethan style of stone base up to the window top, topped by timber framed super

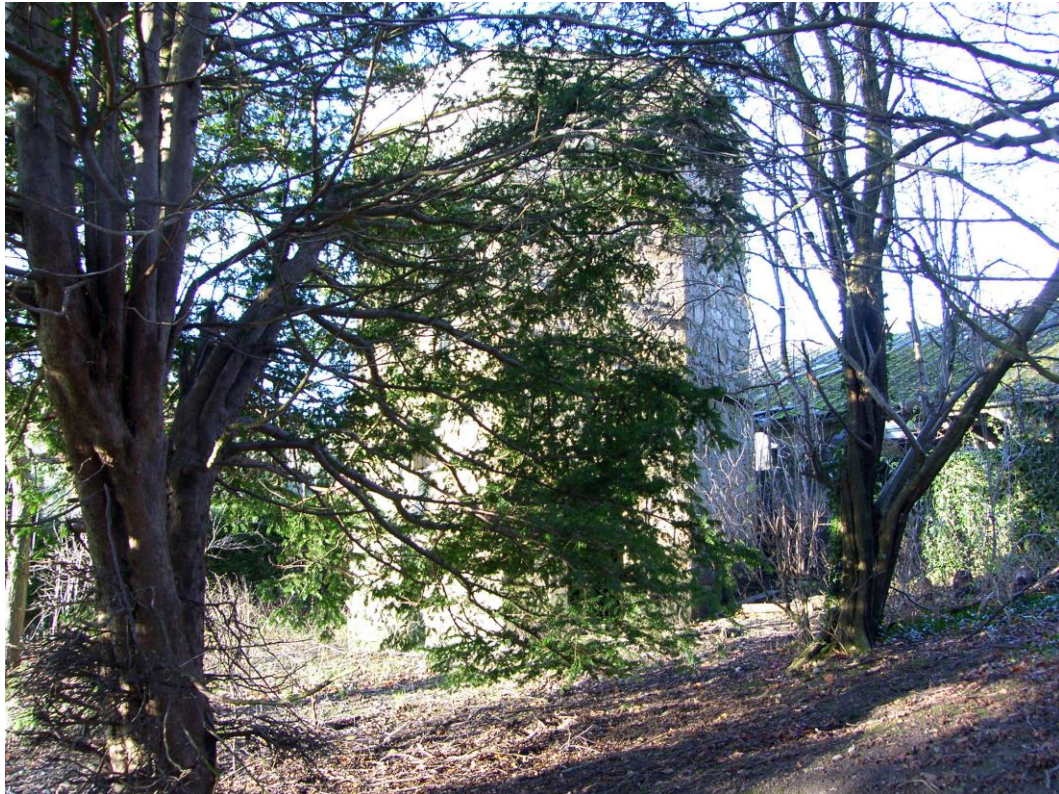
14 Dovecote. ?early 18th taken down and rebuilt present site 1765.

This fine structure is shown on one side of the formal garden in a drawing in a 1740 engraving by Thomas Badeslade. However for some reason it was demolished and rebuilt on its present site in the later C18th (1765). Octagonal in plan, 6.5m in diameter. Ashlar and rubble stone built with decorative ledge at one third height. There is stone moulding around the entrance and the “window” embrasures, The stone work part of the structure is about 8m high and was probably about 12m to the top the now vanished pagoda style roof. It is lined with brick and fitted out inside with brick ledges for the pigeons to nest on. The roof was probably removed in the 1960 when the site was derelict. The complete structure is shown on an aerial photograph of the mid—1950's (below). Surveyed in 1997 (see p31 above).
