HAFODYSBYTY, FFESTINIOG, GWYNEDD

Architectural Record

FINAL REPORT

January 2012

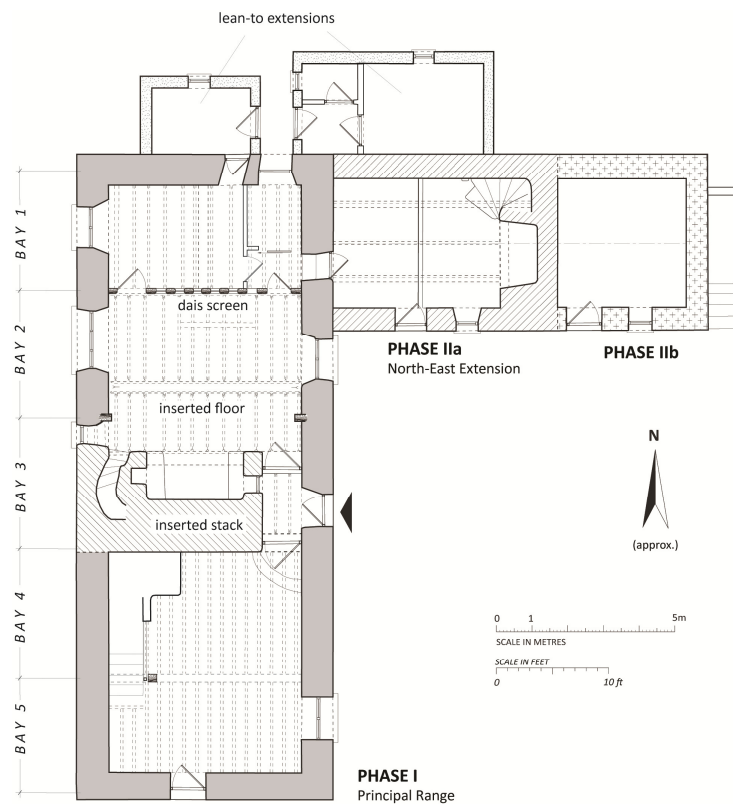
Hafodysbyty: Sketch plan showing principal features described in text

4.1.1 Hafodysbyty comprises two main, chronologically distinct elements; a principal range (Phase I, with modifications), aligned approximately north-south, with a secondary extension projecting eastwards from the north end of the east elevation, the latter probably of two phases (Phases IIa and IIb); two tertiary blocks are appended to the north elevation of the principal range and north-east extension (see sketch plan below).

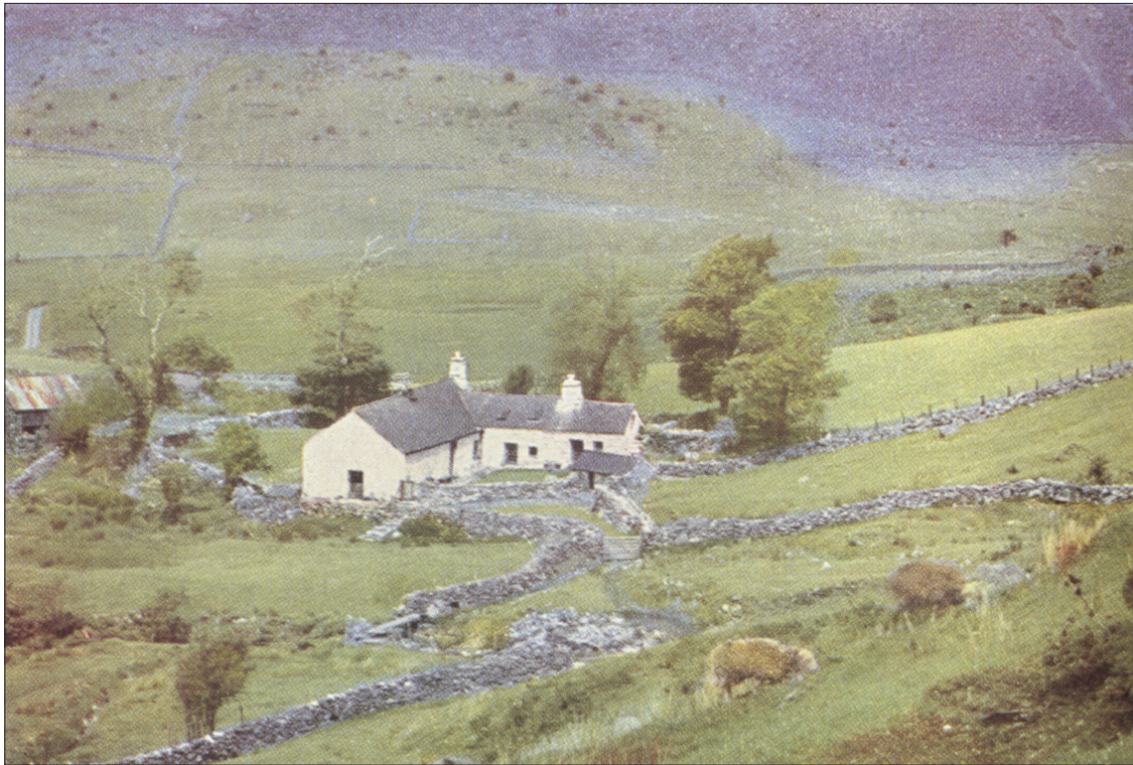
(a) View of Hafodysbyty from south (from North, Campbell and Scott, 1949. plate 34a).

4.2.2 The **south elevation** (Plate 3) presents a plain, stone-built gable end pierced by two simple openings. A narrow, pedestrian doorway to the centre of the ground floor is understood to be a 20th-century modification of a former, wider entranceway⁵ while at first floor level, a two-light casement is clearly also a recent introduction, being absent from historic photographs of the building (Figure 3).

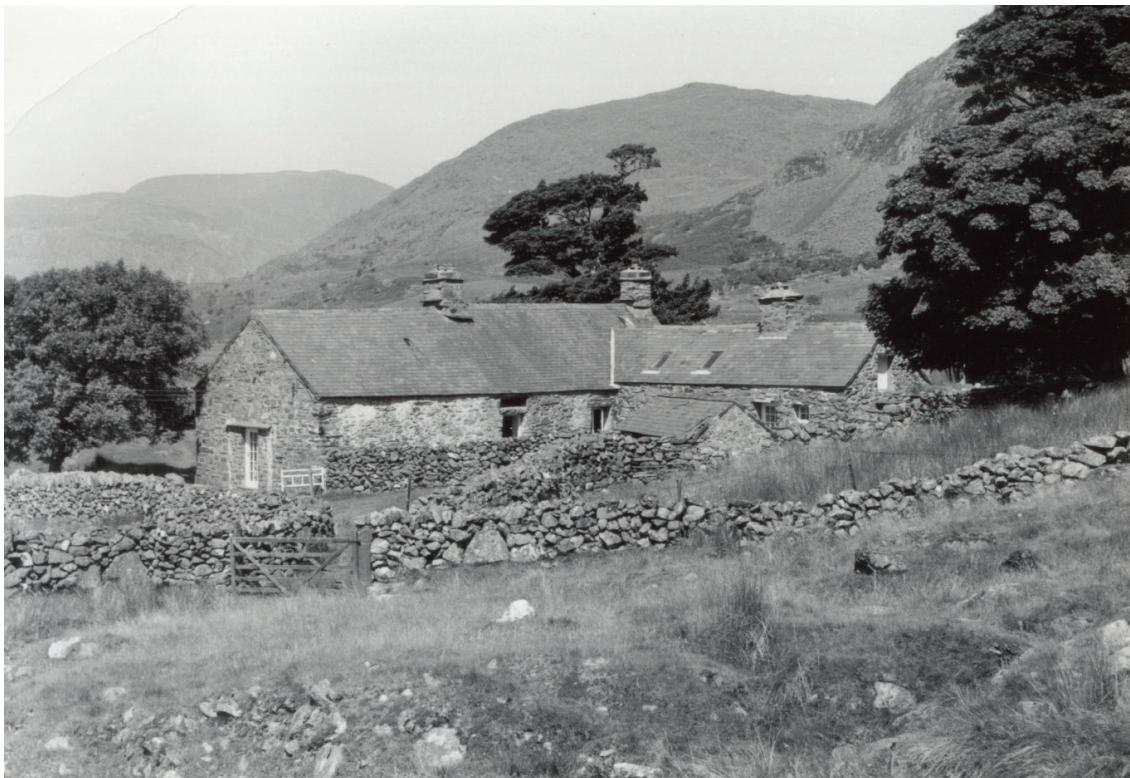
(b) View of Hafodysbyty from south-east with Ffestiniog Hills of Manod Mawr and Manod Bach in the background (undated original photograph courtesy Dr. Helen Ford).

⁵ Dr. H Ford, *pers. comm.* See also Figure 3b (undated photograph) where what appear to be former, wide-set jambs are visible.

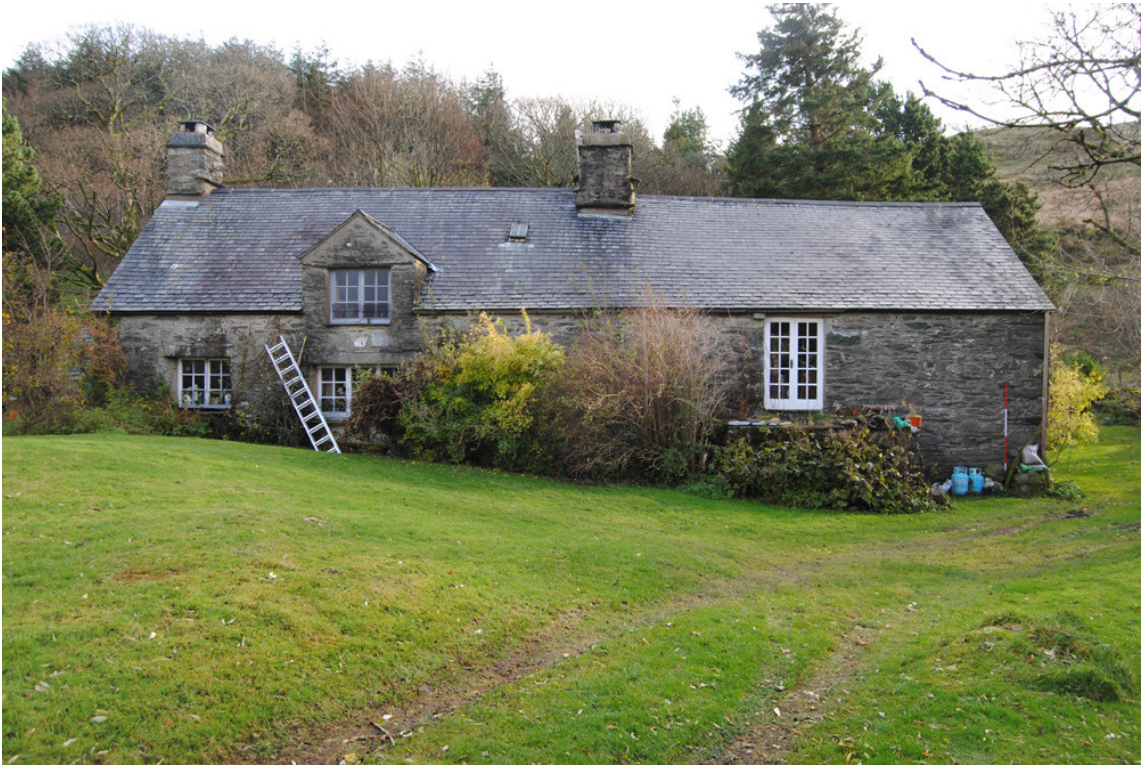
Plate 1: Primary range, east elevation.

4.2.1 The principal range is built on a rectangular plan with external measurements of 18.25m (60ft) north-south x 7.25m (c.24ft) east-west and standing c.5.8m (19ft) to the ridge. The **east elevation** (Plate 1) is stone-built of a single storey beneath a pitched roof, slate-clad and gabled to north and south, ridge stacks rising above the north gable and to the centre of the range. Fenestration comprises modern timber casements throughout, mainly of two-lights but with a wide, three-light window towards the north of the range, lighting [GF01] internally with a gabled dormer over (Plate 2), breaking the eaves line and lighting the upper room inserted over the original hall.⁴ A raised, wide opening housing glazed double doors is located centrally to the southern section of the range. The masonry of the southern section of the elevation appears distinct from that to the north though no clear 'straight-joint' was visible to clearly define a building break or evidence the insertion of the main stack into a pre-existing wall, though it should be noted that access to the central section of the elevation was hindered and visually obscured by vegetation at the time of survey (Plate 1).

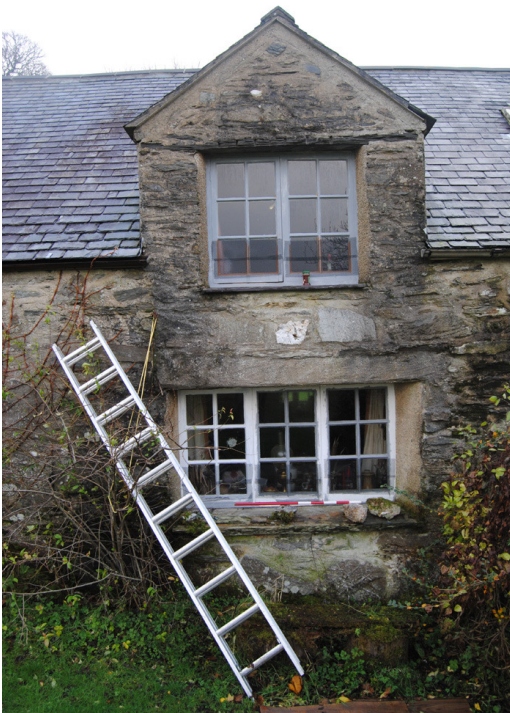
Plate 2: East elevation, dormer.

⁴ Though of a non-diagnostic appearance, and masked to an extent by the renewed fenestration, the introduction of the dormer window reasonably dates to the insertion of the upper floor within the former open hall in the (?early-17th century).

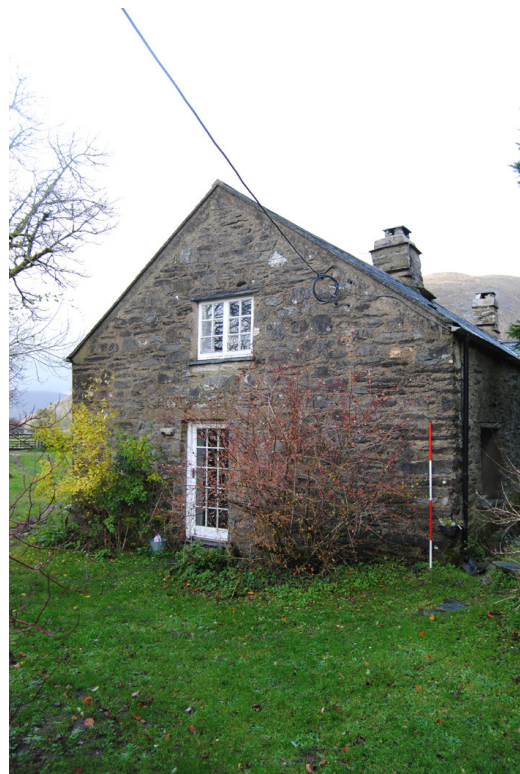
Plate 3: Primary range, south elevation.

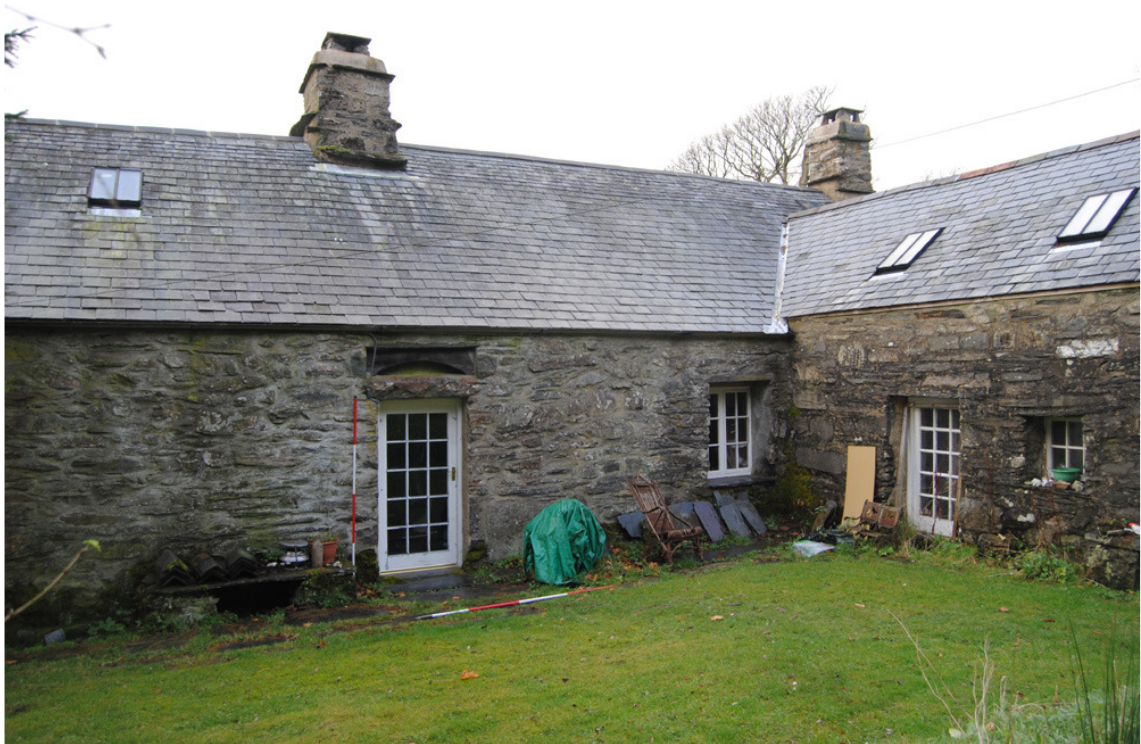
Plate 4: Primary range, west elevation.

4.2.3 The **west elevation** overlooks an enclosed yard area formed in the south-east angle of the two principal ranges (Plate 4). It is stone-built of a single storey beneath a slate-clad pitched roof, gabled to north and south. Ridge stacks rise above the north gable end and above the centre of the elevation, the latter stack aligning with the main entrance doorway. The northern end of the elevation is obscured by the Phase II north-east extension which abuts. To the south of the Phase II range are a two-light casement window and a simple pedestrian doorway housing a modern, multi-pane glazed door; a four-centred timber doorhead is incorporated into the stonework of the elevation above the flat stone lintel of the modern door (Plate 5), possibly representing a re-set original feature; an inscription (?in Greek) is understood to read 'Peace be upon this house'.⁶ The southern part of the range is lit by a further two-light casement, again a modern introduction post-dating a number of historic photographs (Figure 3) and most likely contemporary with the modified/new openings within the south gable-end.

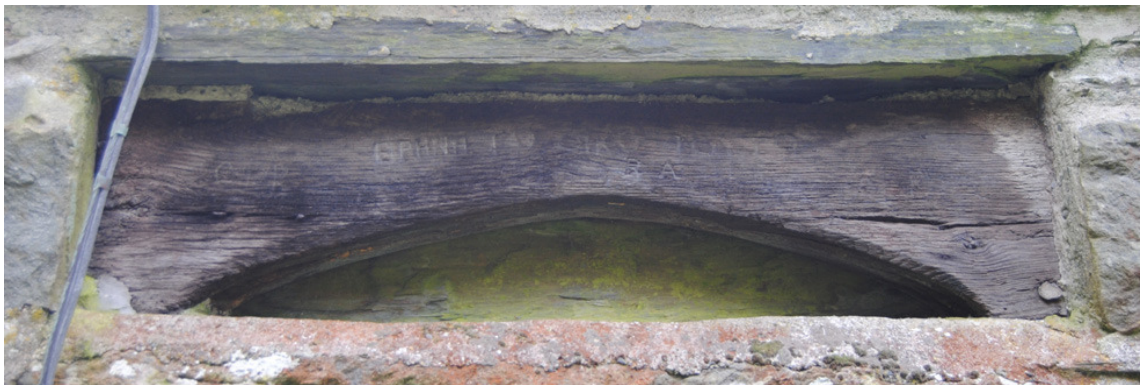
Plate 5: (?)Primary doorhead reset in masonry of west wall above current door

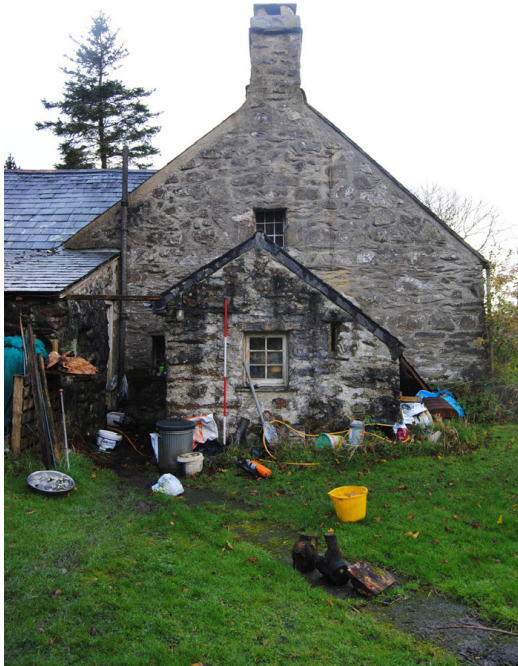
Plate 6: Primary range, north elevation.

4.2.4 The **north elevation** (Plate 6) presents a plain, stone-built gable, capped by a tall, square ridge stack, with a small 9-pane fixed light window located centrally to the upper floor; the ground floor is for the most part obscured by a tertiary, pent-roofed extension (Plate 7), though a pedestrian doorway to the eastern side opens to the interior of the range.

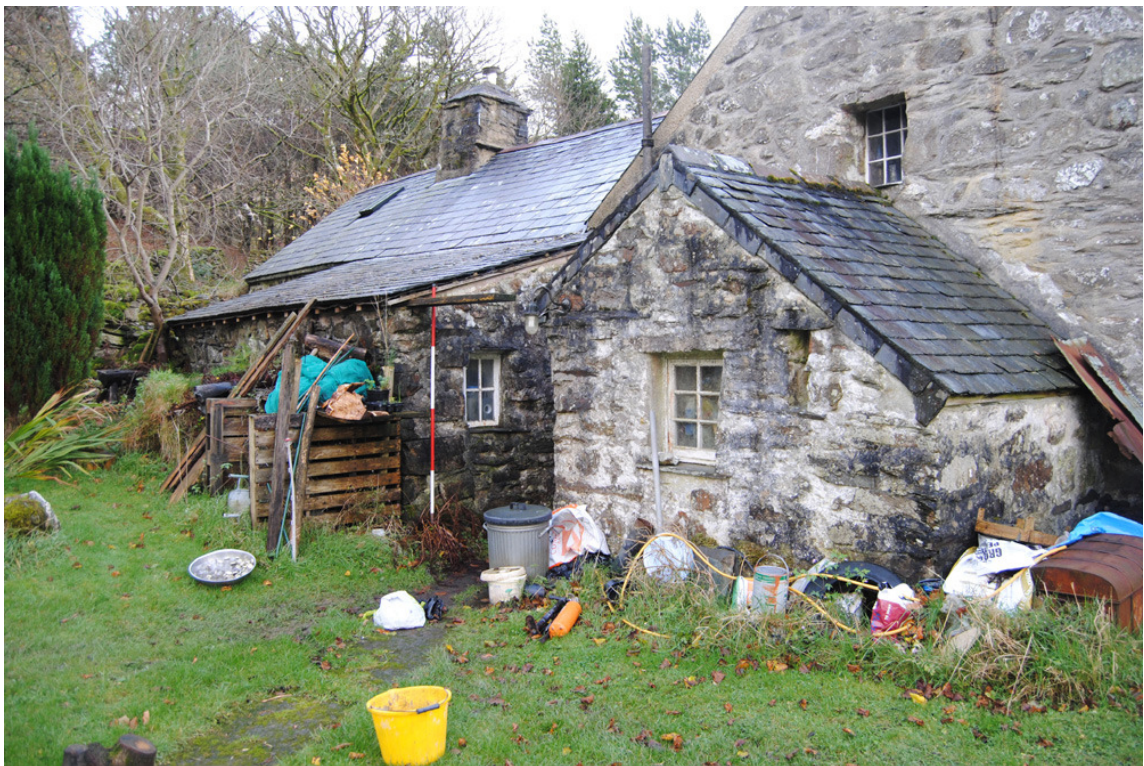
Plate 7: Single-storey extensions to north elevation of primary and north-east range.

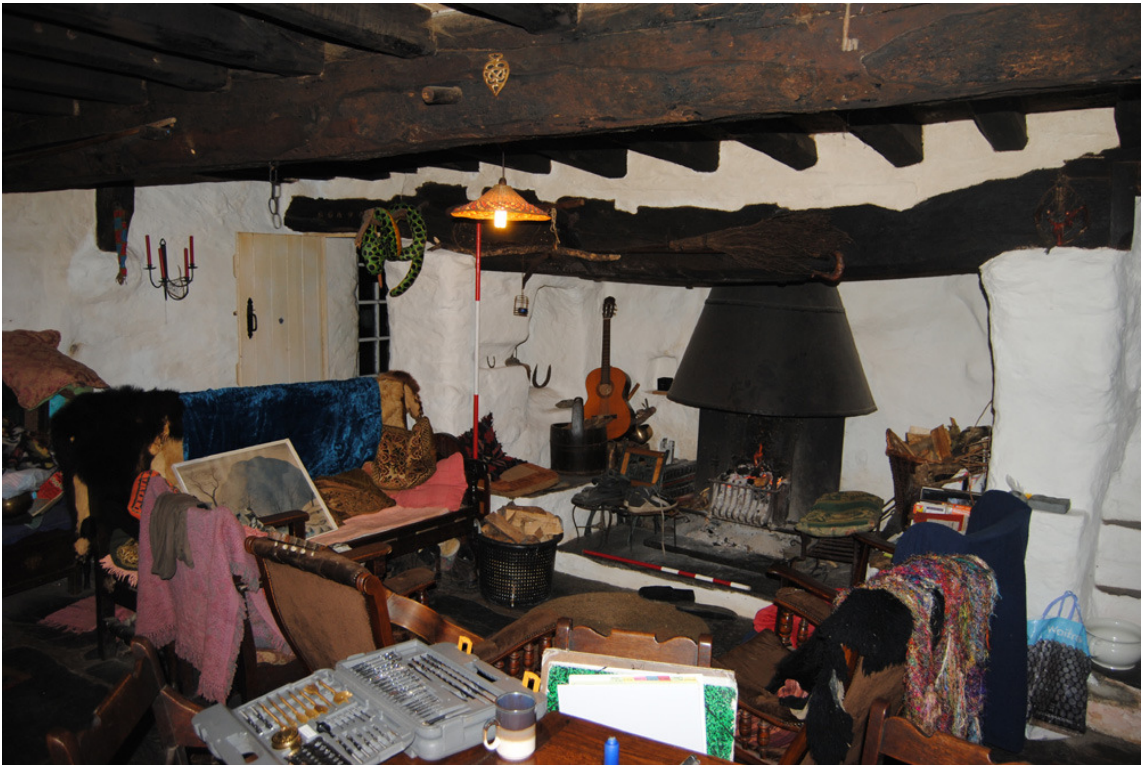
Plate 8: Room [GF01] looking south-east with inserted stack within Bay 3.

- 4.2.6 The interior of the house is accessed via a doorway within Bay 3 of the east wall, which opens onto a small lobby [GF05] formed to the east side of the inserted stone stack heating hall [GF01] and creating a classic 'lobby-entry' plan; doorways lead to north and south onto [GF01] and [GF06] respectively. To the north, principal room [GF01] (Plate 8) occupies Bay 2 and the northern part of Bay 3, representing approximately $\frac{2}{3}$ of the floor area of the primary open hall, subsequently ceiled to form an upper floor ([1F01]). The room is lit by modern casement windows within splayed reveals in the east and west walls and is heated by a wide fireplace to the south, a secondary insertion within the southern part of Bay 3. The fireplace recess is spanned by a substantial timber bresummer, plain-chamfered, and is furnished with a small window onto the entrance lobby in its eastern flanking wall and an arched alcove to the west. To the west of the fireplace, an integral stone winder-stair (Plates 9/10) rises to the inserted upper floor. The north wall of [GF01] is formed by a primary dais screen of post and panel construction (Figure 7; Plate 11) comprising seven plain-chamfered uprights of 11 x 3½ in. scantling, double-pegged to the top and single pegged to the cill. A pattern of horizontal peg alignments evident within the posts of the screen (highlighted in red on Figure 7) may relate to an original dais bench/canopy. Paired doorways with four-centred heads are located at the eastern and western ends of the screen, that to the west (**A**; Plate 12) being somewhat wider at 0.79m/31in. than that to the east (**B**; Plate 13) at 0.68m/ 27in., both opening onto Bay 1 to the north. The head beam of the dais screen is set immediately below the plain chamfered tie of cruck **C1** which is decorated with a number of painted heraldic panels and associated gothic lettering (Plate 14), not recorded in detail but understood to date from c.1941 when the house was used to station German prisoners of war.⁷ The inserted floor over [GF01] is carried by a single substantial transverse beam (11in. x 13in. deep) set slightly to the north of Cruck **C2**, the lower blades of which are visible to both east and west (Plates 16/17). The floor structure is formed of x 13 common joists, 4-5in. wide x 4½ in. deep, plain-chamfered with stepped run-outs, which are lodged over the tie of **C1** to the north (Plate 14), set into the stonework of the inserted stack to the south (Plate 8) and jointed to the central beam using bare-faced soffit tenons (Plate 15). A trimmed section of floor to the north side of Bay 2, against the dais partition, possibly represents the location of a former hatch or stair, though the latter interpretation would appear unusual given the stone winder-stair to the west of the fireplace, unless the upper room [1F01] was at some time sub-divided.

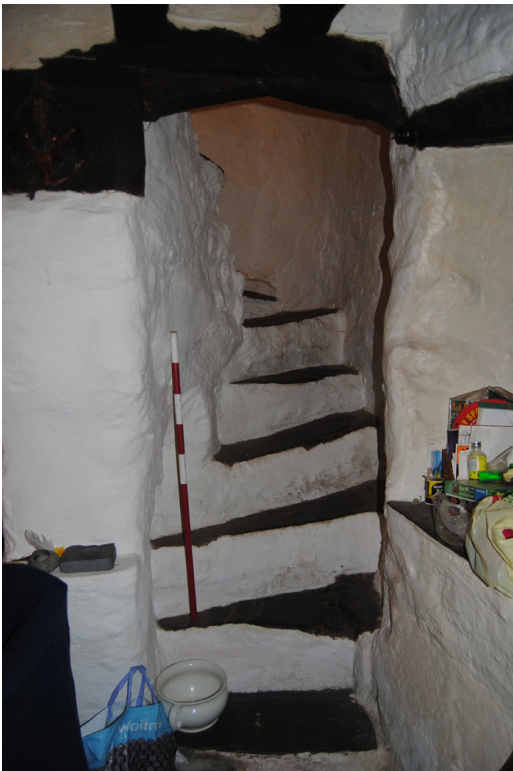
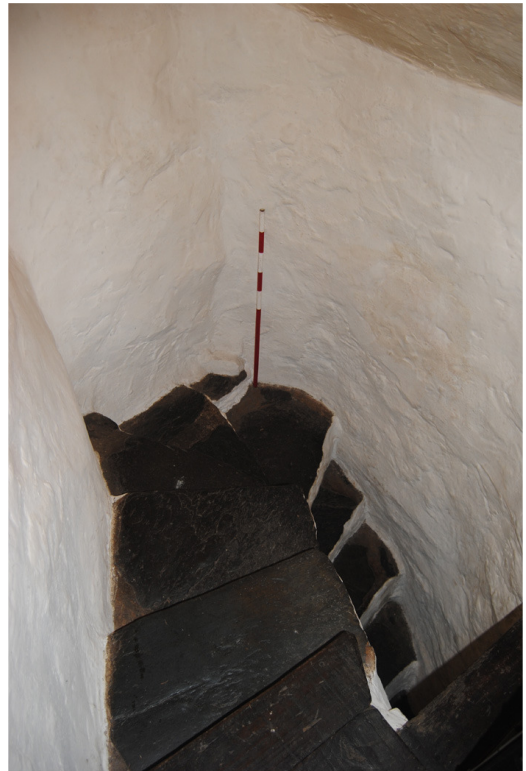
Plate 9: Winder stair to west of stack.

Plate 10: : Winder stair to west of stack (↓).

- 4.2.9 The principal means of access to the upper level remains the integral stone winder-stair (Plates 9/10) located to the west of the inserted stack within Bay 3 (Room [GF01]); a secondary stair rises within [GF06] to the inserted upper floor of the southern bays. The winder stair rises to Room [1F01], occupying the upper part of the former open hall (Plate 22); the room is lit by a two-light casement dormer window in the west wall, set within splayed reveals while the south wall comprises the upper part of the inserted stack, with a small cupboard to the east. The principal feature of note is the upper section of cruck **C2** (Figure 8; Plate 22) representing the central cruck of the former open hall, the status being reflected by the superior quality of the carpentry employed. The substantial blades (16 x 6in.) are connected by a high collar supported by curving arch-braces, the tenons of which engage long mortices in the soffit of the collar and inner edge of the cruck blades, all related joints here utilising unusual double, offset rows of pegs (Plate 23);⁹ pegs are driven through from the northern (upper) face and many project significantly to the south. Lower blades, arch-braces and collar are all plain chamfered to both north and south while the blades themselves display a distinctive cusp just above the level of the inserted floor (Plate 25). Above the level of the collar, double-pegged v-struts are also cusped forming a 'quatrefoil' to the apex (Plate 24), though the lower, flanking apertures do not form full trefoils, as might be expected, the collar and blades here being plain. Dendro sample [hsy01] from the western blade of **C2** produced a ring sequence of 72 but failed to date (see §.5, Table 1).

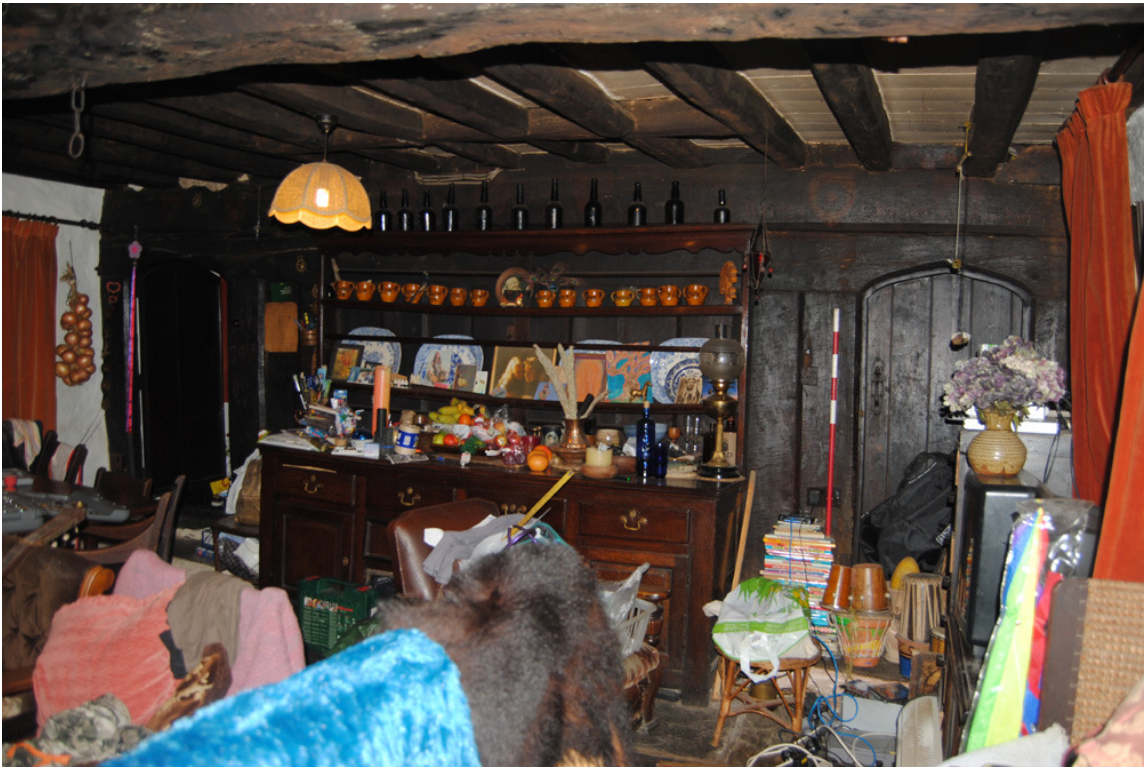
Plate 11: Primary dais screen to north side of [GF01] (Cruck C1)

- 4.2.7 To the north of [GF01], and accessed via the paired doors **A** and **B** within the dais screen, Bay 1 is currently subdivided by inserted walls of red-brick construction to form kitchen ([GF02]), bathroom ([GF04]) and lobby ([GF03]). The floor level of Bay 1 is raised in relation to Bay 2, reflecting the natural slope of the land but also reflecting the status of the former 'upper' end of the range. [GF02] (Plate 18) is lit by a two-light casement window in the west wall, set within played reveals, while [GF04] is lit by a single light window in the north wall; doorways within the north and east walls give onto the exterior and north-east extension respectively. The south wall of [GF01]/[GF03] is formed by the rear of the dais screen, described above; above the screen, the rear face of the tie of **C1** includes an unusual series of staggered sockets (Plate 19), 30 x 3cm (c.1ft x 1¼ in.), presumably related to a primary planked ceiling of a 'post and panel' form within the rooms of the inner bay.⁸ The common joists of the present floor (3 x 4in. scantling) are set somewhat higher, simply lodged over the tie of **C1** to the south and set into the masonry of the exterior gable to the north; a principal axial beam displays no evidence for a former partition beneath.

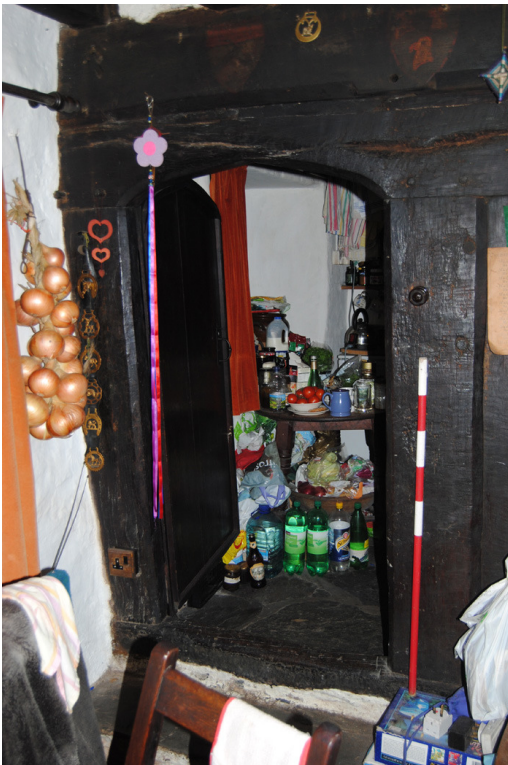
Plate 12: Door A to east end of dais screen.

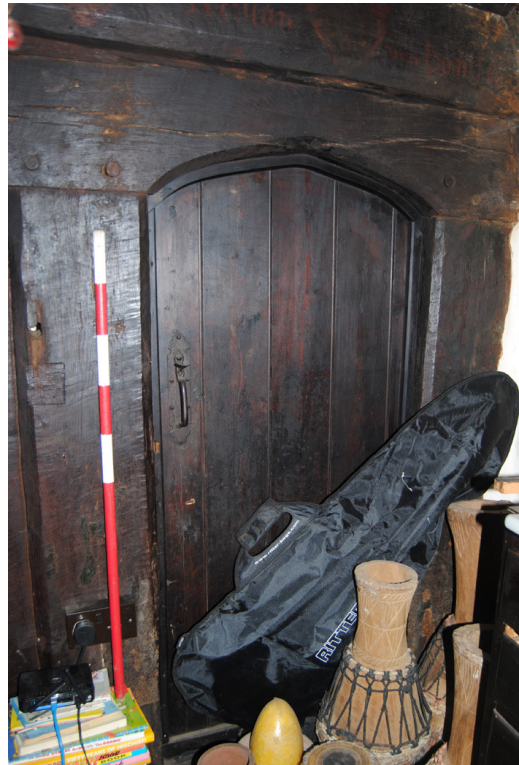
Plate 13: Door B to west end of dais screen.

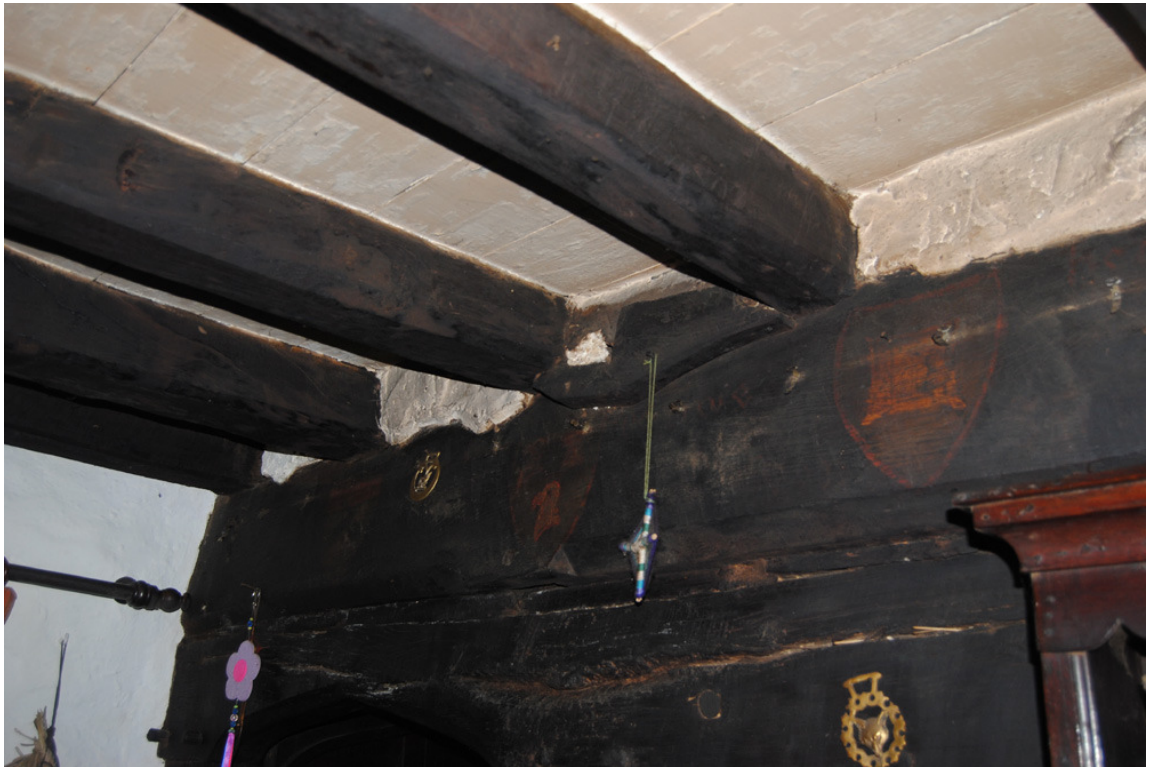
Plate 14: Joists of inserted floor rest upon tie of cruck **C1** (NB: heraldic panels of c.1941)

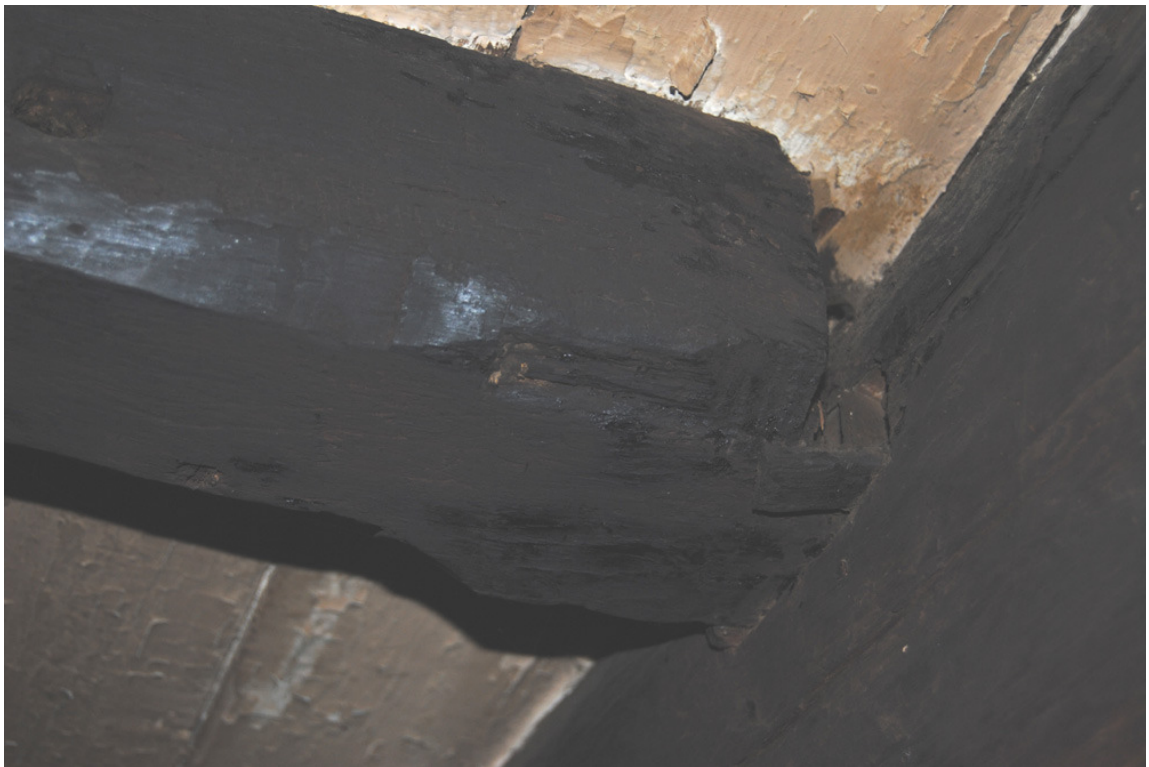
Plate 15: Common joist of inserted floor jointed to principal beam with bare-faced soffit tenon.

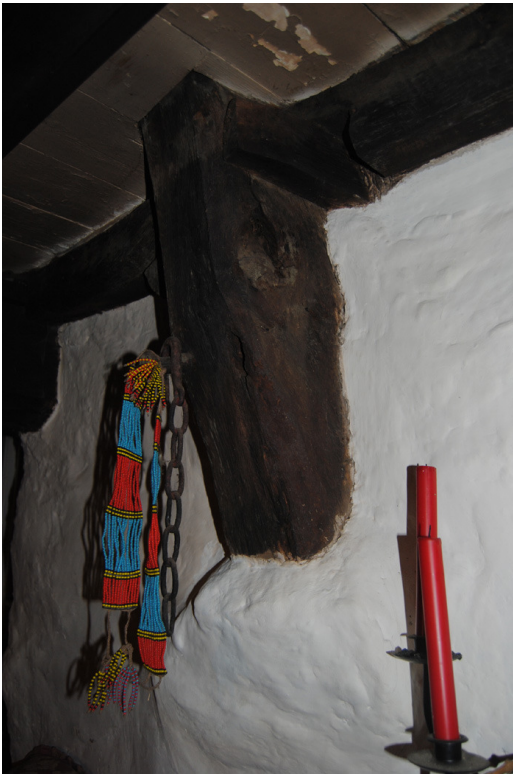
Plate 16: West foot of Cruck C2, note projecting

- 6.1.4 It is unclear whether the masonry walls of the house are primary or whether the building was originally furnished with timber-framed walls, being later encased in stone possibly at the time of the insertion of the principal stack. No clear evidence for primary wall framing survives, for example in the form of cruck spurs or any redundant joints/pegging related to the connection of wall framing and cruck frames, indeed the use of mortice and tenon joints for the collar and tie of a number of the crucks beyond the central arch-braced frame is of itself of note. Thus it may be that the masonry walls are original, at least in part, with the cruck blades themselves having originally been 'raised' slightly as opposed to being carried on a timber plate at ground level;¹⁴ cruck **C2** (E) in particular sits upon a projecting 'corbel' within the side wall (Plate 16).

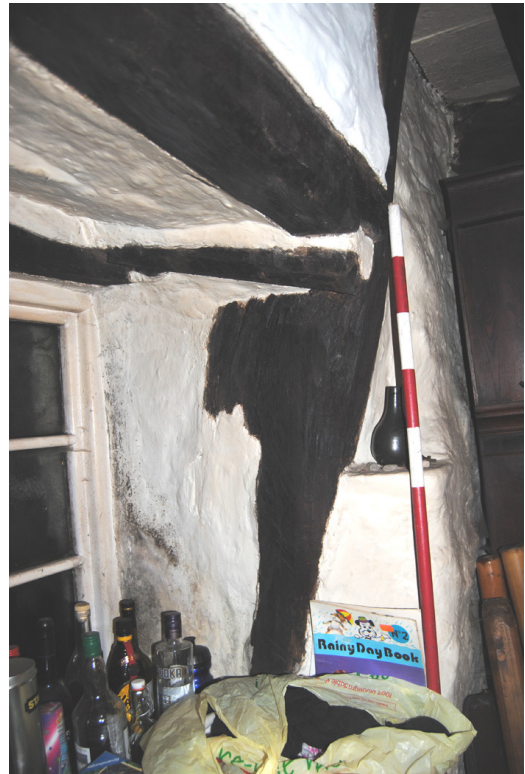
Plate 17: East foot of Cruck C2.

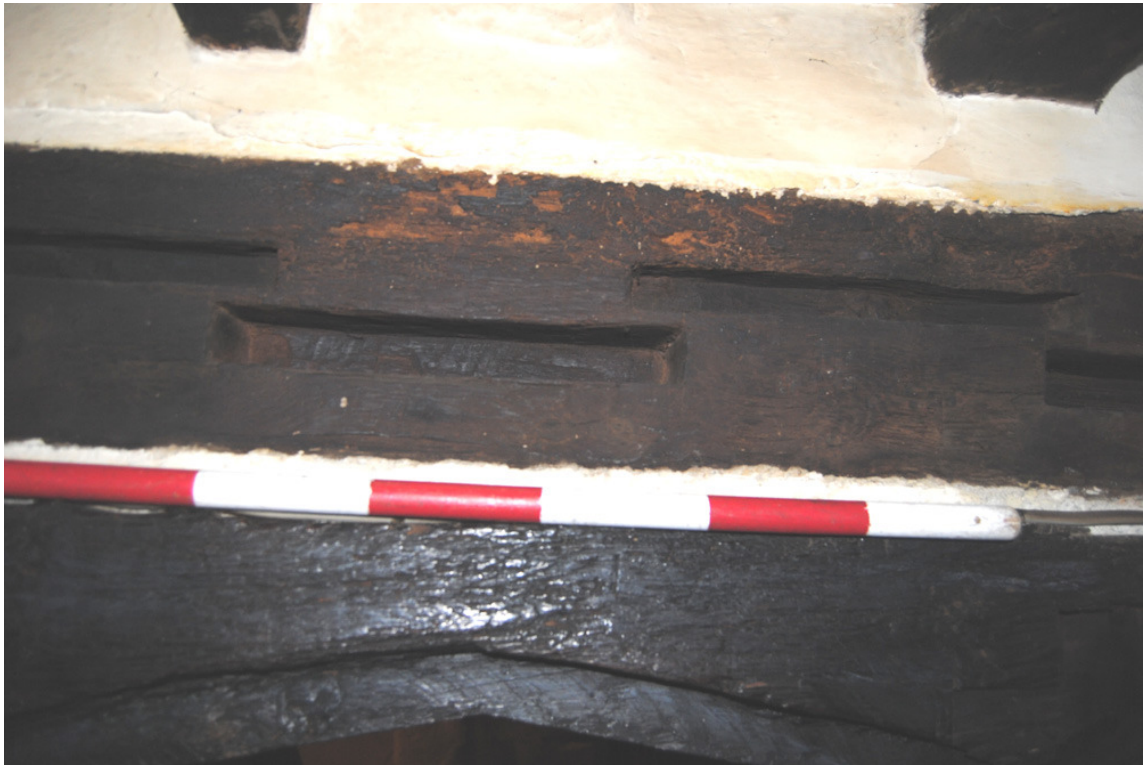
Plate 19: Staggered mortices for former 'post and panel' ceiling to north face of dais head-beam (= tie of C1).

storeyed in its primary form and the pattern of staggered mortices within the northern face of the Cruck **C1** tie indicates a former elaborate ceiling of 'post and panel' type. No evidence for the subdivision of the inner bay was recorded; in particular, the central longitudinal beam of Bay 1 retained no trace of a partition as would be the case if the bay had originally been divided to form two rooms of equal size.

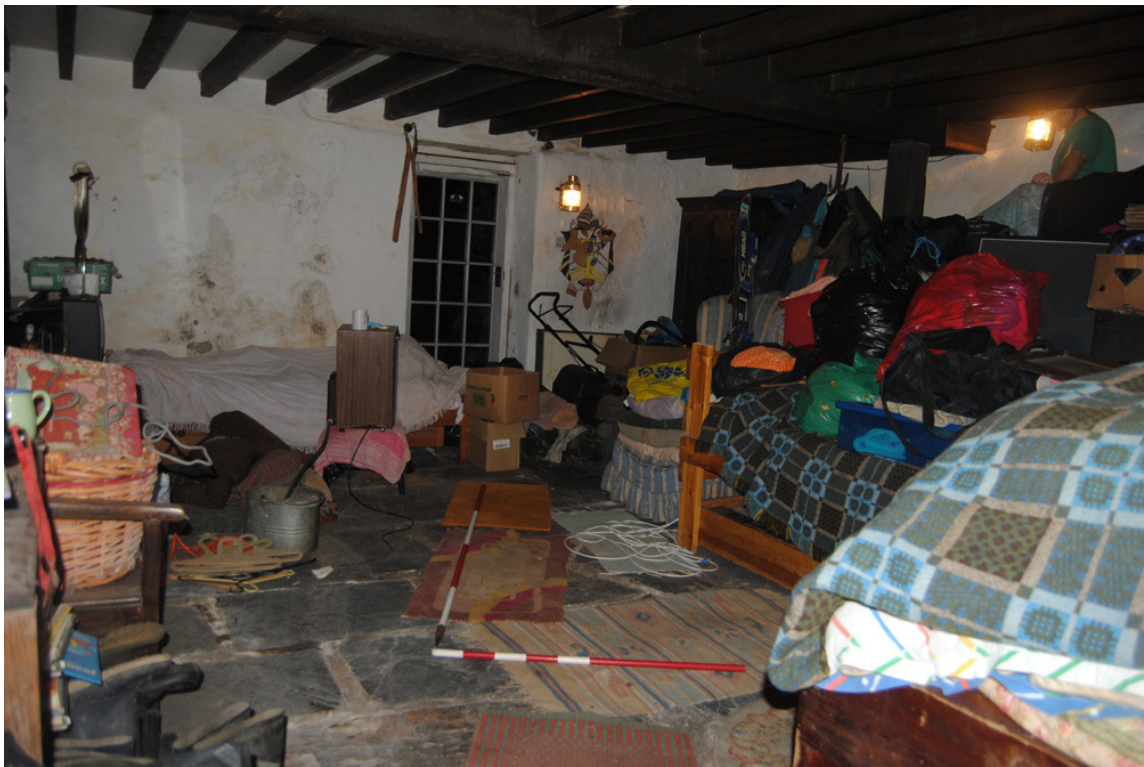
Plate 20: Room [GF06] (Bays 4/5) looking south-west.

- 4.2.8 To the south end of the range, [GF06] (Plate 20) occupies the full extent of Bays 4 and 5, and is accessed from lobby [GF05] via two steps down (Plate 21), the floor level of the lower end being set some 0.44m below that of the main house. The room is lit by a two-light casement (inserted) within the west wall and has a pedestrian doorway set centrally to the south wall; it is unheated and is ceiled over by an inserted floor, the upper level being accessed via a stair rising from south to north against the west wall and

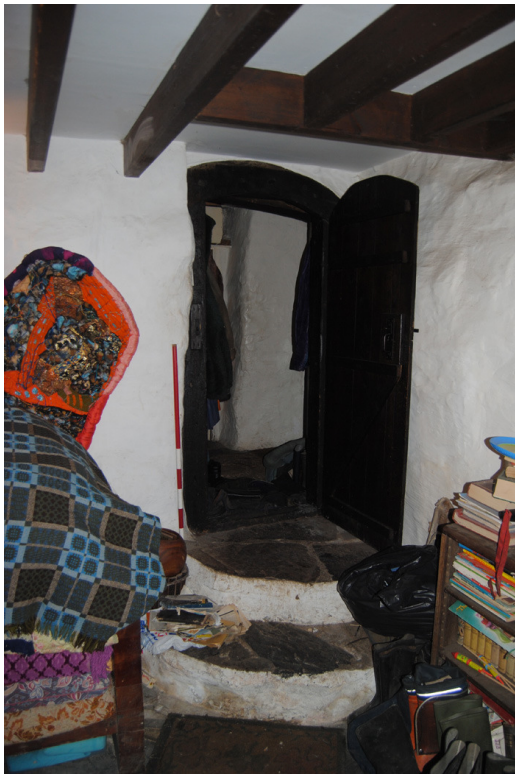
Plate 21: Steps down to Bay 4.

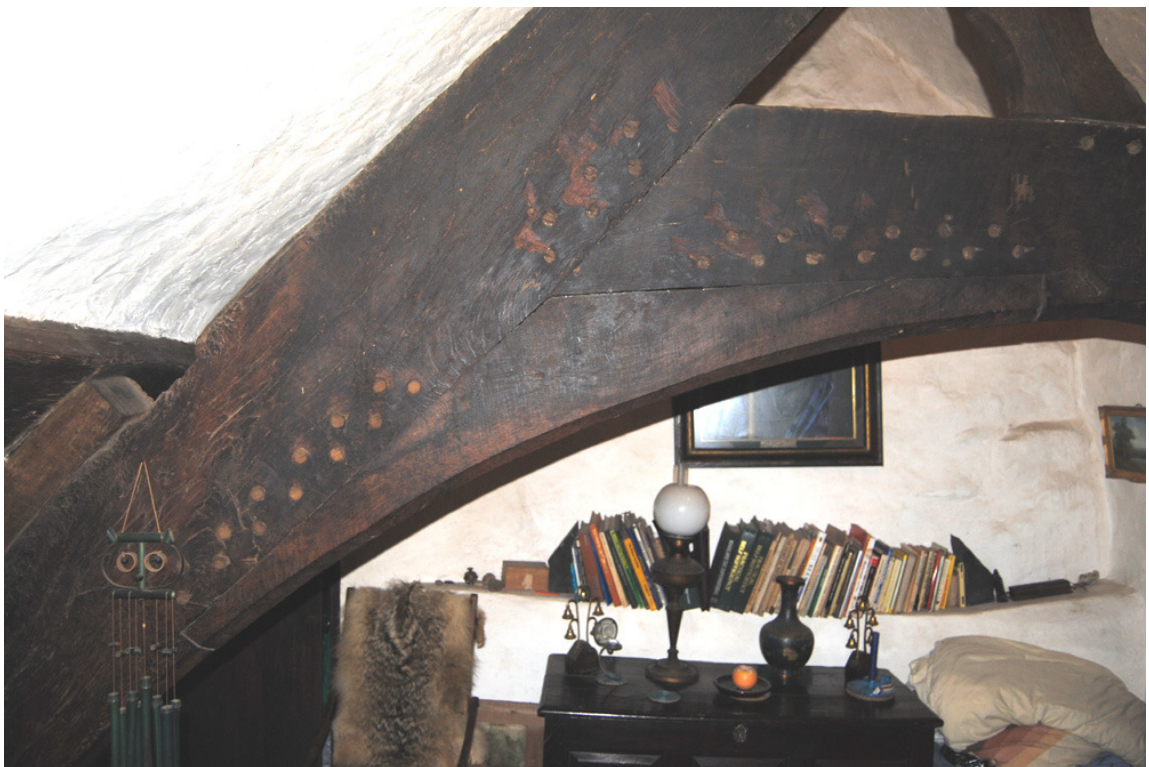
Plate 23: Cruck C2; detail of double-pegging of principal, collar and arch brace.

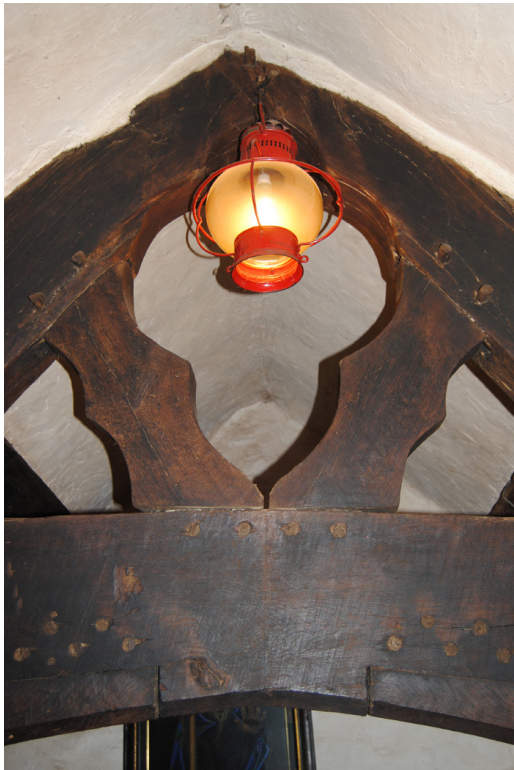
Plate 24: Cruck C2; cusping to v-struts.

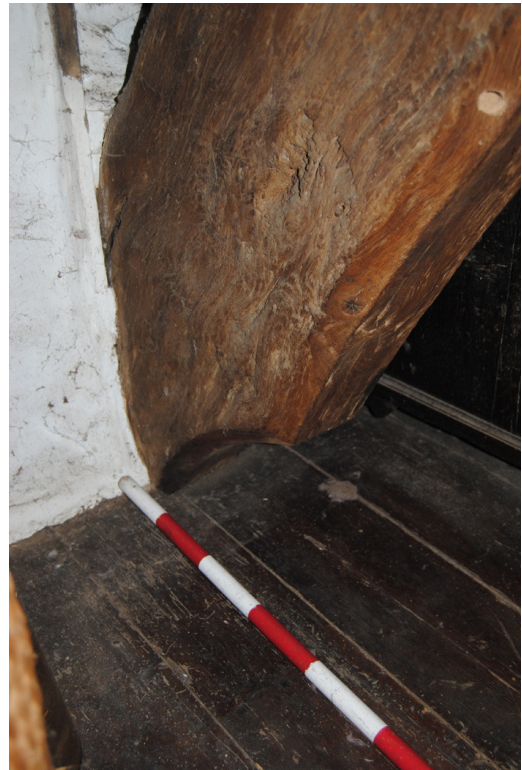
Plate 25: Cruck C2; cusping to western blade.

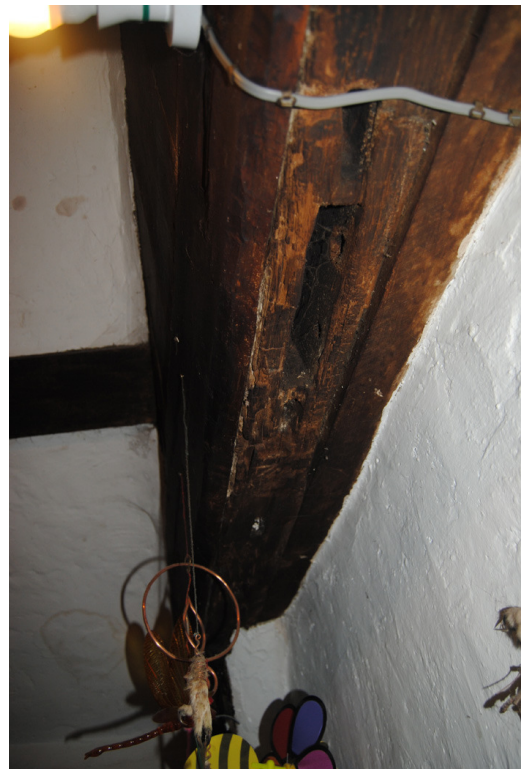
Plate 27: Mortices to collar soffit of C1.

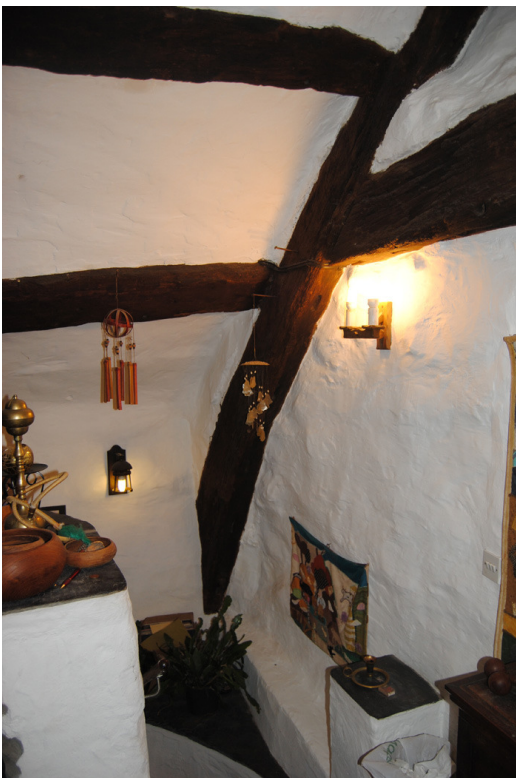
Plate 29: West blade of C3.

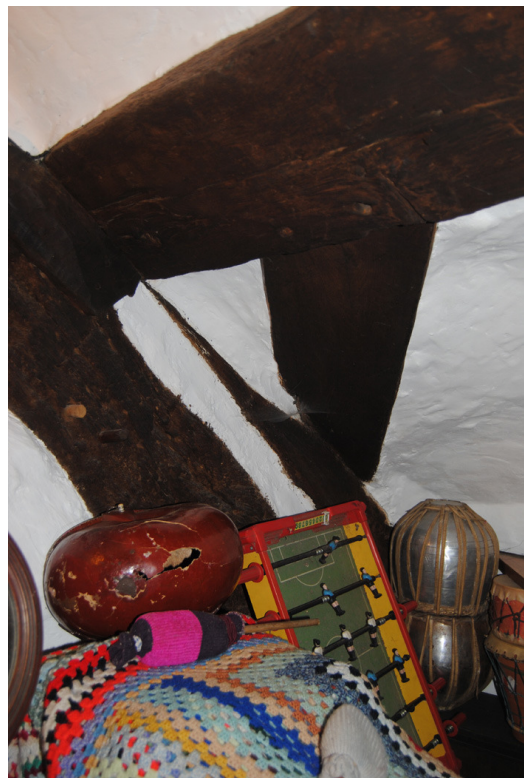
Plate 30: Surviving wind-brace at C3 (E).

survives *in-situ* to the lower purlin within Bay 4 (E), where it can be seen rising from a principal rafter (Plate 30). The apex detail is nowhere clearly exposed though a double-pegged bridled joint is evident at **C2** (Plate 24), presumably carrying a square-section ridge piece. Dendro sample [**hsy02**] from the lower purlin of Bay 2 (W) produced a felling date range of 1509-1537 (see §.5, table 1).

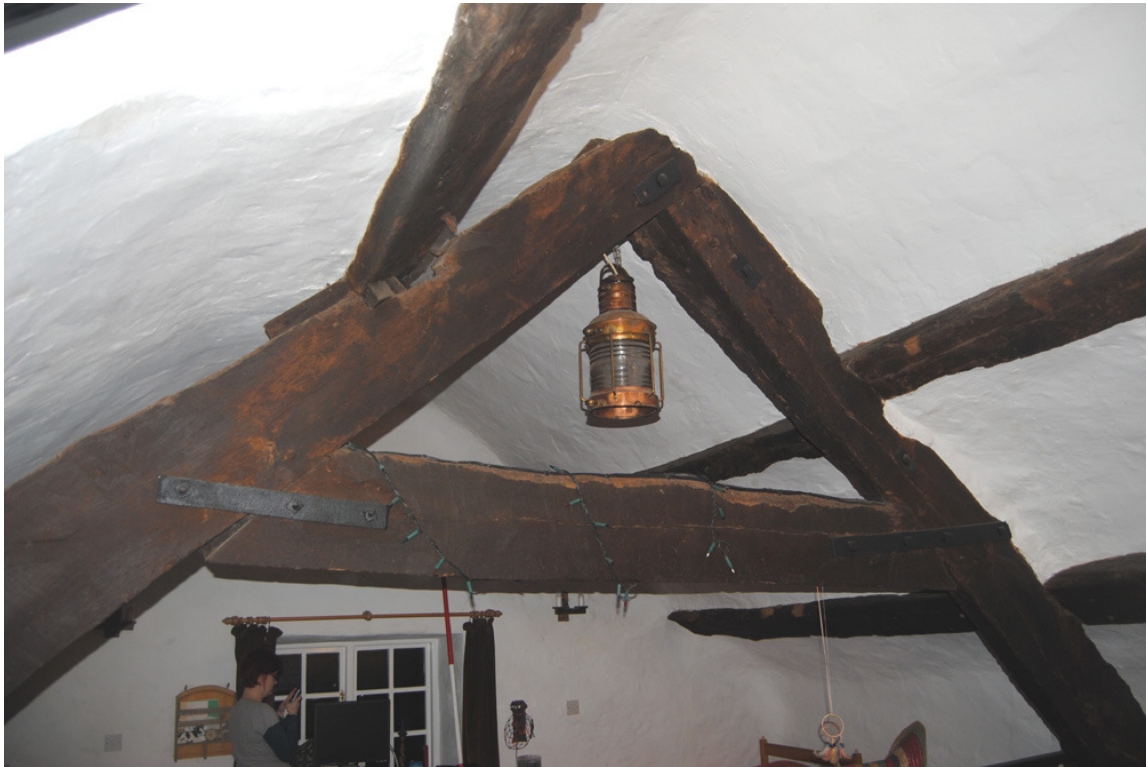
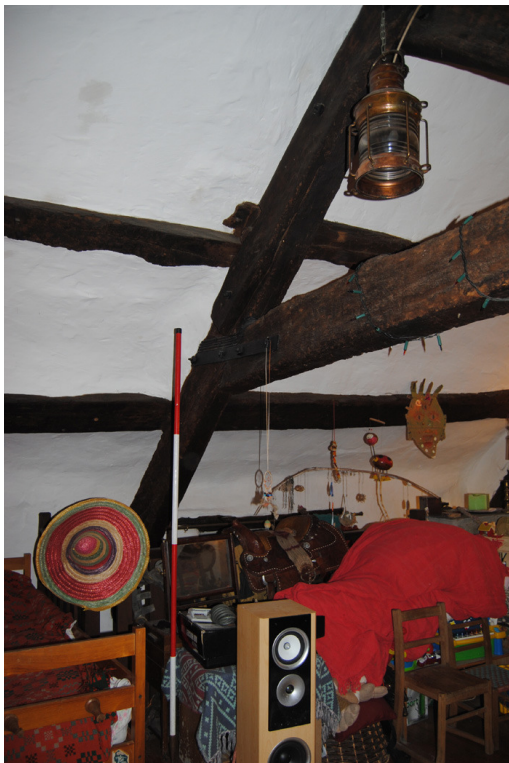
Plate 31: Room [1F03]; Cruck C4.

Plate 32: East blade of C4.

- 4.2.12 Cruck **C4** (Plates 31/2) is of simpler form, originally (and remaining) open. The collar is again jointed by mortice and tenon joints, triple pegged and here reinforced by iron straps to counteract spreading. Timbers of **C4** display signs of weathering, in particular to the southern face.
