HAFODYSBYTY, FFESTINIOG, GWYNEDD

Architectural Record

FINAL REPORT

January 2012

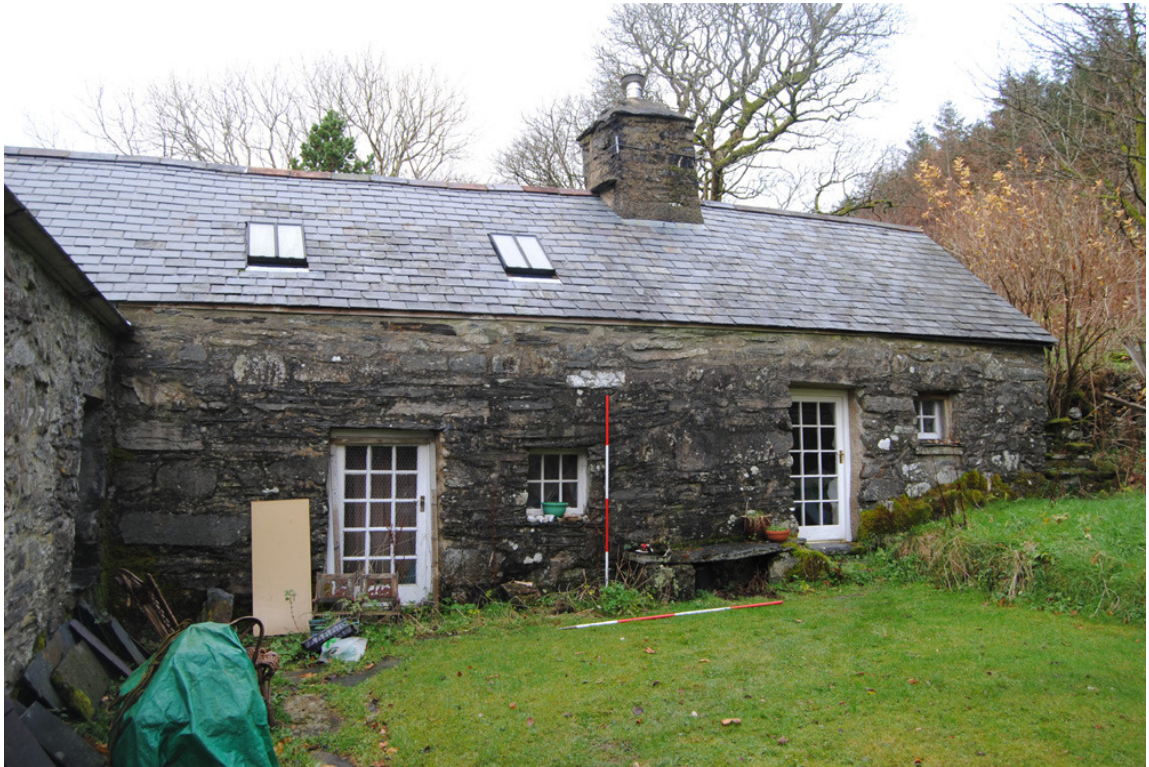
Plate 33: North-east extension; south elevation.

- 4.3.1 The north-east extension (Figure 11; Plate 33) is rectangular in plan, measuring 5m (16½ ft) north-south x 10.3m (c.34ft) east-west, aligned east-west and extending eastwards from the north end of the principal range which it abuts. It is stone-built of a high, single storey with pitched, slate-clad roof standing 4.5m (c.15ft) to ridge, gabled to the east; a large, square ridge stack rises off-centre towards the eastern end of the range, possibly defining a building break (Phase IIa/b; Figure 11a). The south elevation includes two pedestrian doorways and two small square window openings, each serving an interior room; the north elevation is blind.

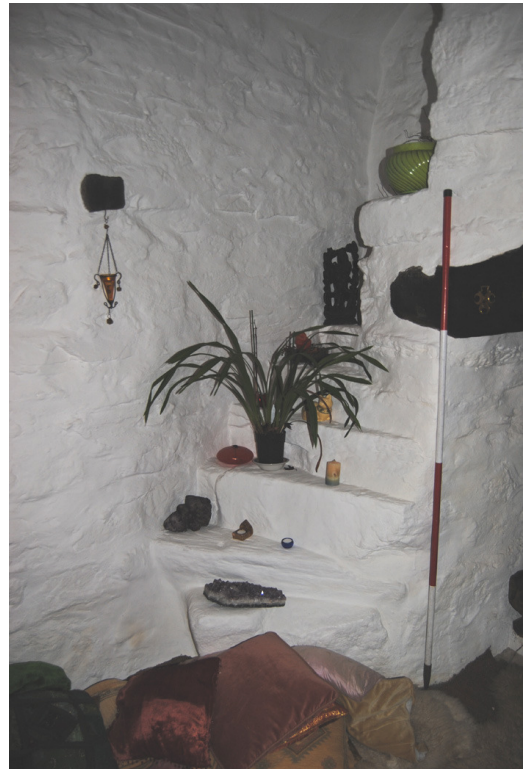
Plate 35: Stone winder stair to north of FP; note cut off joist of former first floor.

- 4.3.2 Internally, the range comprises two discrete elements, possibly of two phases. To the west, [**GF07**] is accessed from Bay 1 of the primary range; it constitutes a single, unencumbered space and, in its current state, is open to the roof (Plate 34). The east wall includes a substantial fireplace recess, spanned by a cambered timber bresummer, with an integral stone winder-stair rising to the north to the level of a former upper floor, further evidenced by a cut off joist within the north wall (Plate 35).

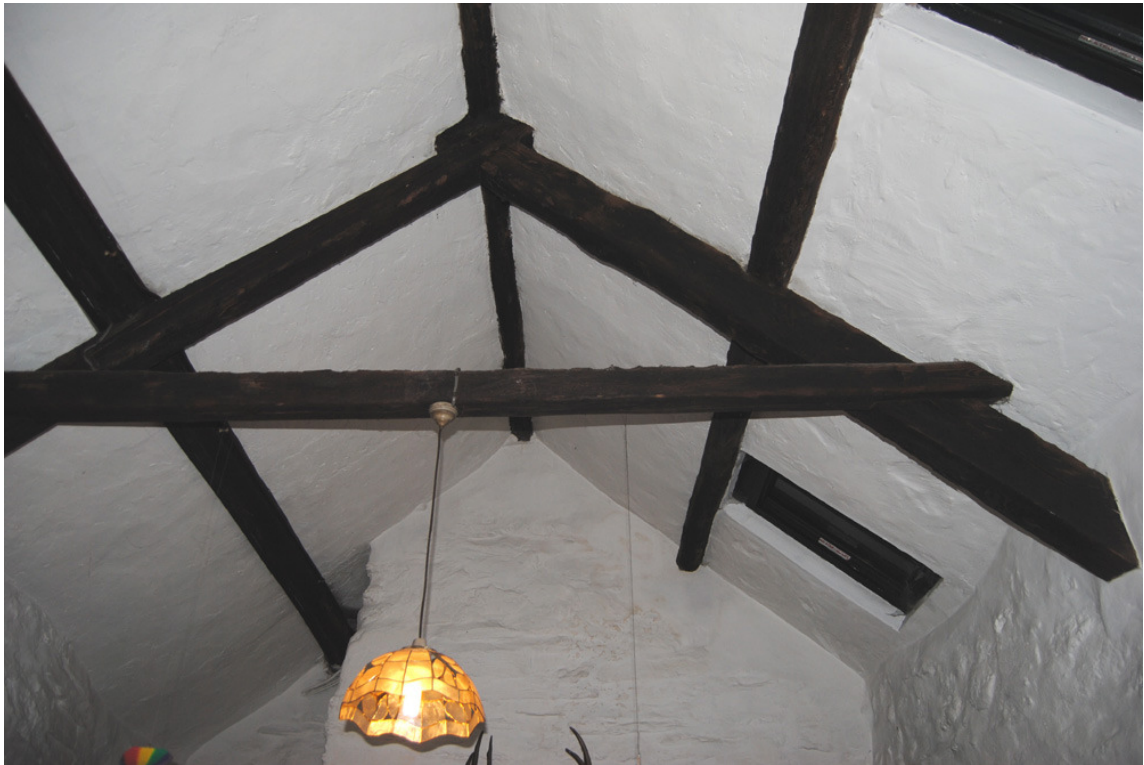
Plate 36: North-east extension roof structure.

- 4.3.3 The roof (Figure 11b; Plate 36) is of plain collar-beam form with a lapped collar, bolted to the principal rafters which cross at the apex to carry a square section ridge piece. The roof is supported on a single tier of side purlins.
