CASTELL PANT-Y-PHILLIP, SCLEDDAU, PEMBROKESHIRE: GEOPHYSICAL, TOPOGRAPHICAL AND PHOTGRAPHIC SURVEY

Prepared by Dyfed Archaeological Trust
for Cadw

RHIF YR ADRODDIAD / REPORT NO. 2017/10
RHIF Y DIGWYLLIAD / EVENT RECORD NO. 110326
CADW PROJECT NO. DAT A113

Mawrth 2017
March 2017

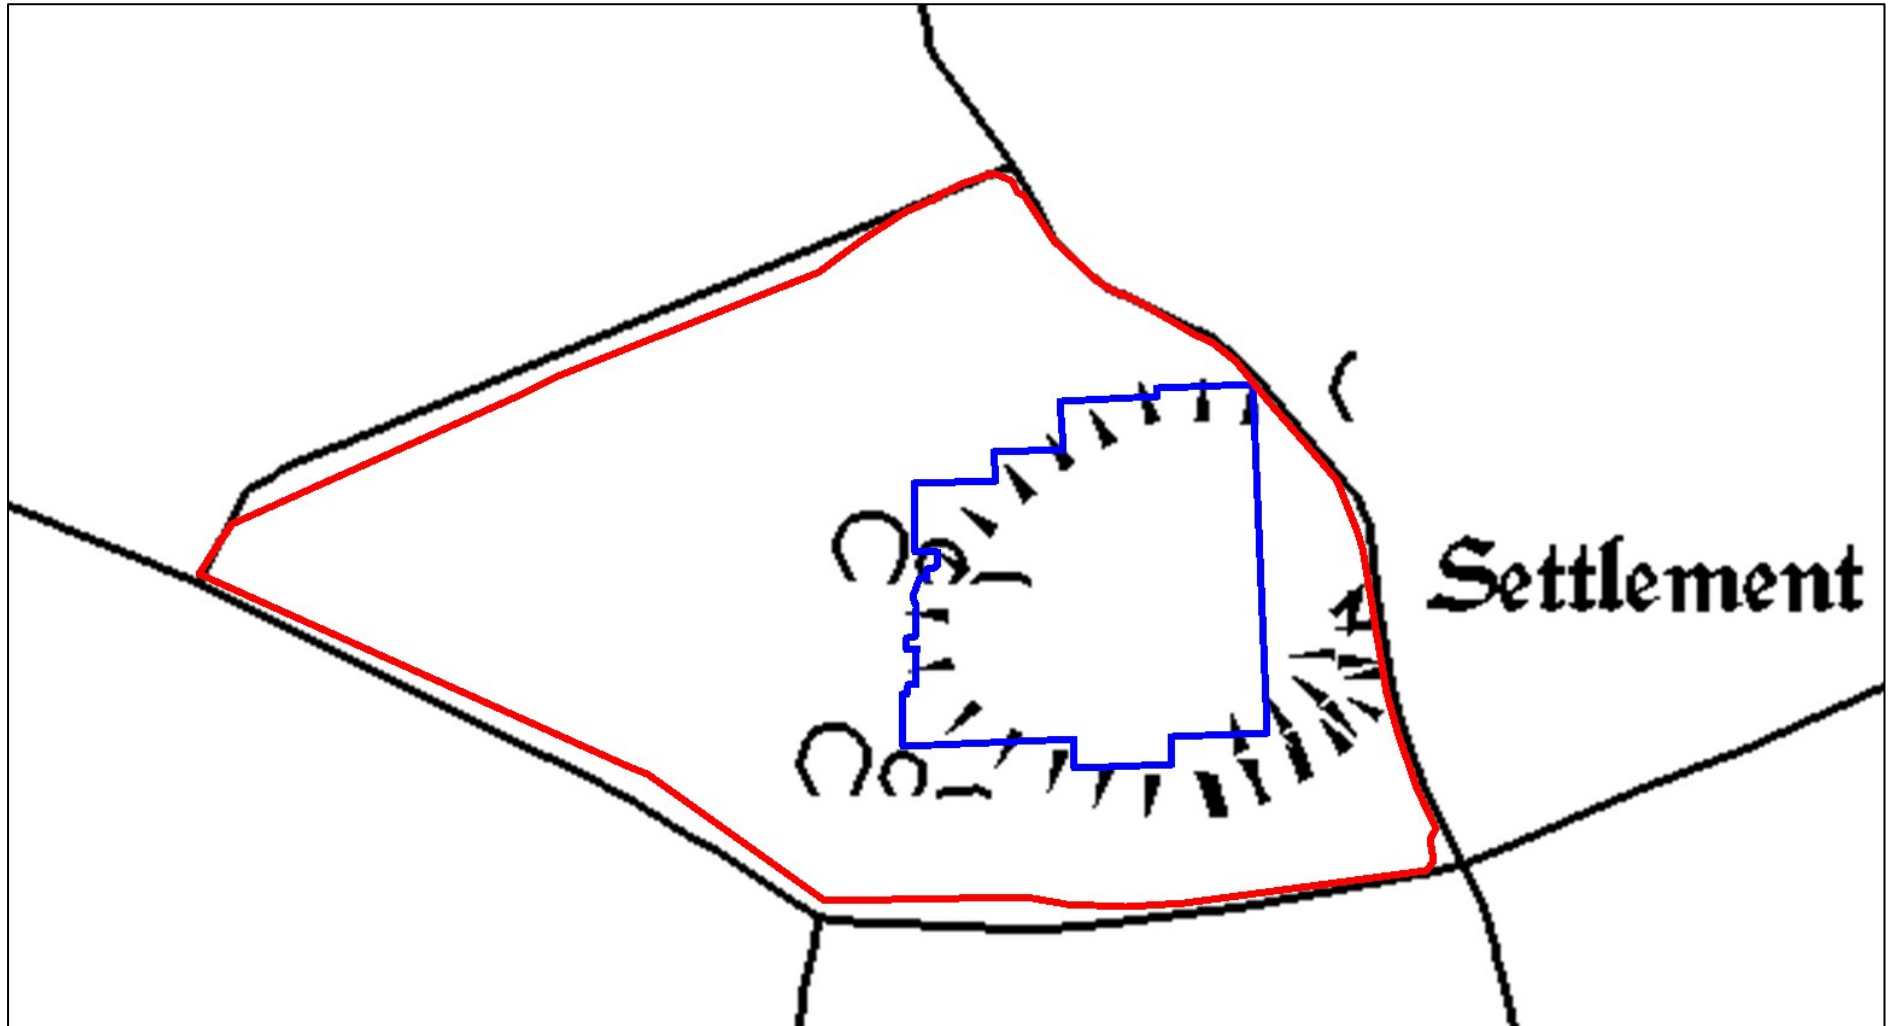
Figure 2: OS 1:10,000 Scale map showing outlines of actual areas of topographical survey (red) and magnetometry survey (blue), superimposed on the modern OS 1:10,000 map

The topographic survey covered approximately 2.46ha and the geophysical survey, c.0.48ha (Figure 2). This report is fully representative of the results of the fieldwork and is complemented by an entry on the Dyfed Archaeological Trust website. All data recovered during the fieldwork will be collated into a site archive structured in accordance with specifications in *Archaeological Archives: a guide to best practice in creation, compilation, transfer and curation* (Brown 2011), and the procedures recommended by the National Monuments Record, Aberystwyth.

The site was surveyed over three days in February 2017. An area of c.0.48ha was surveyed (Figure 2). A Trimble TST was used to tie the survey grid into the local Ordnance Survey grid.

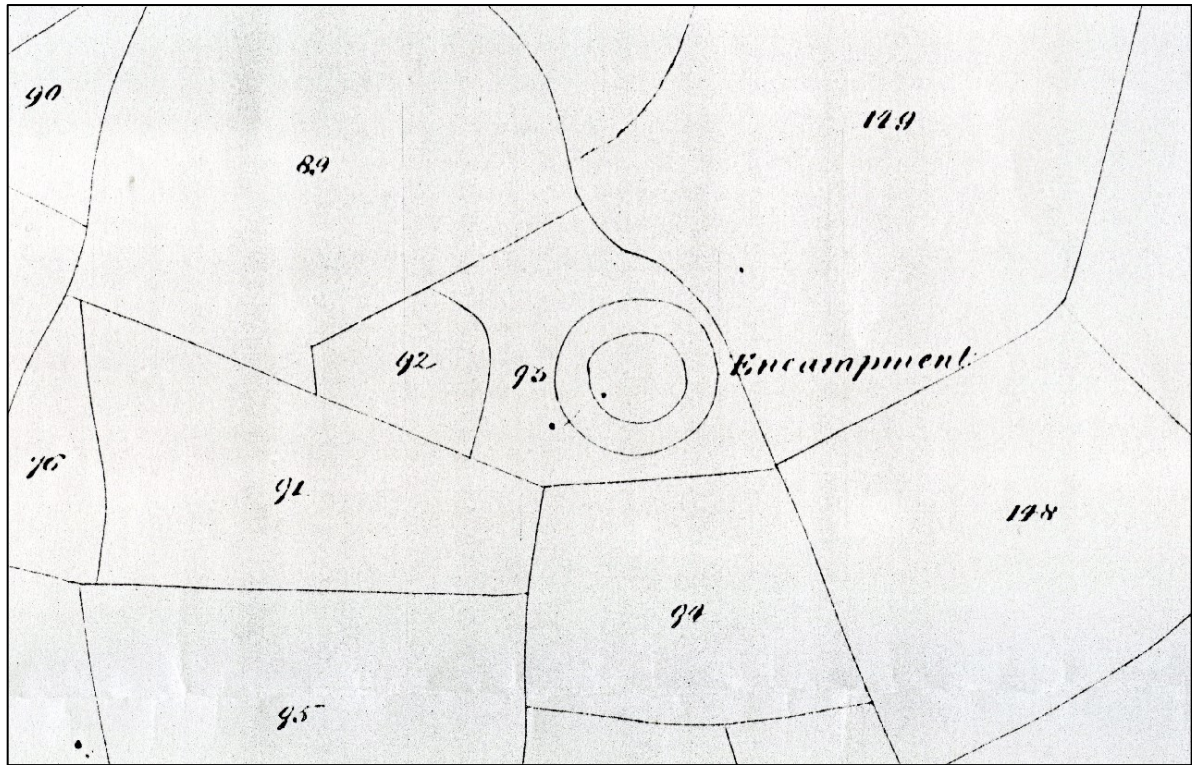
Figure 3: Extract of the Llanstinan Parish tithe Map of 1843

The first map of Castell Pant-y-Phillip is thought to be the Llanstinan Parish tithe Map of 1843 (Figure 3), upon which it is drawn as two concentric circles and labelled 'encampment.'

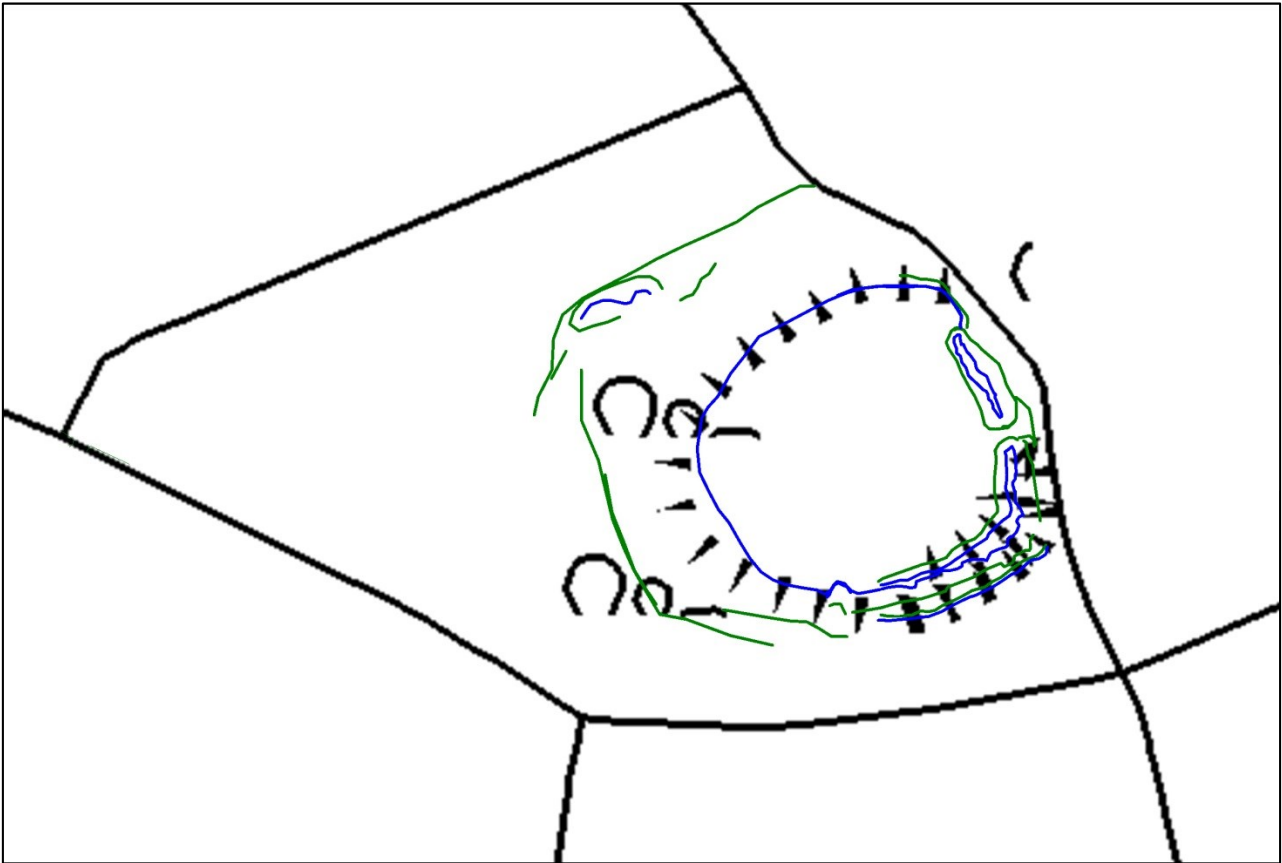
Figure 5: Topographical survey results for Castell Pant-y-Phillip, showing surveyed bank-bottoms (green) and bank-tops (blue), superimposed on the modern OS 1:10,000 map

Figures 5-7 show 2D plan-view representations of the results of the topographical survey.

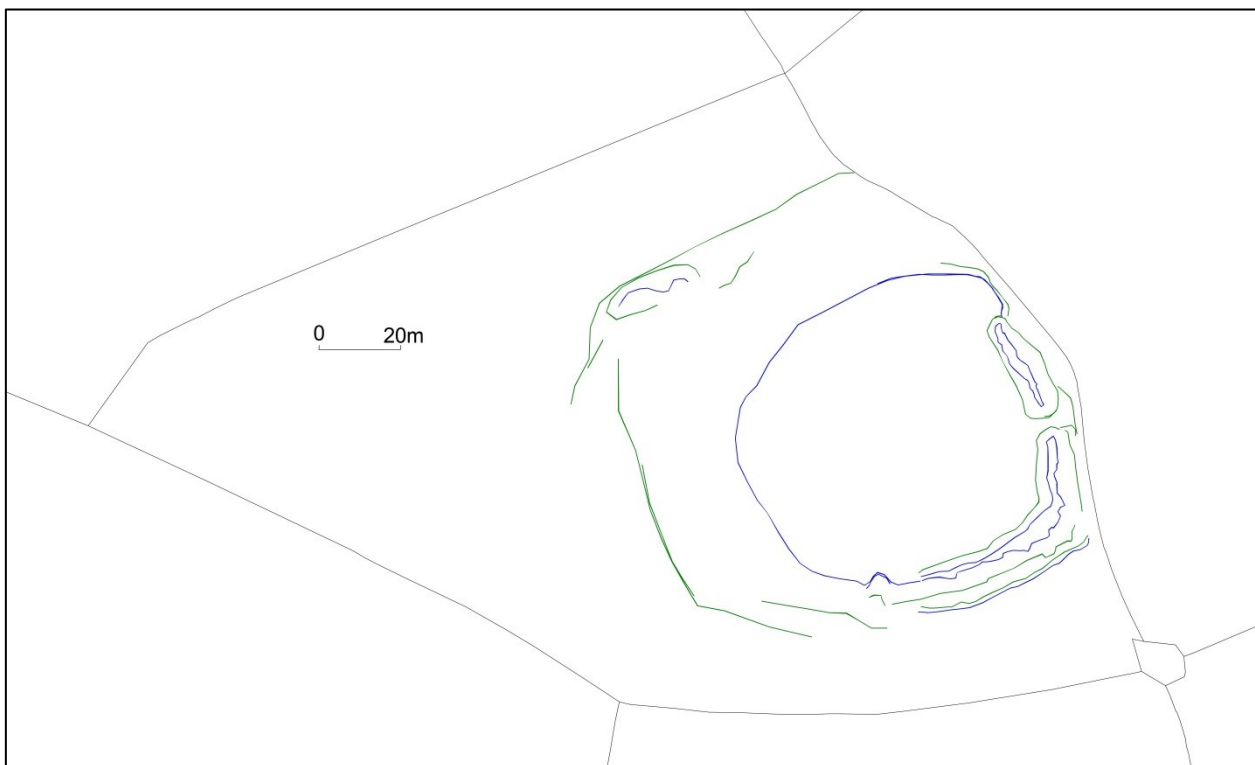
Figure 6: Topographical survey map for Castell Pant-y-Phillip, showing surveyed bank-bottoms (green) and bank-tops (blue)

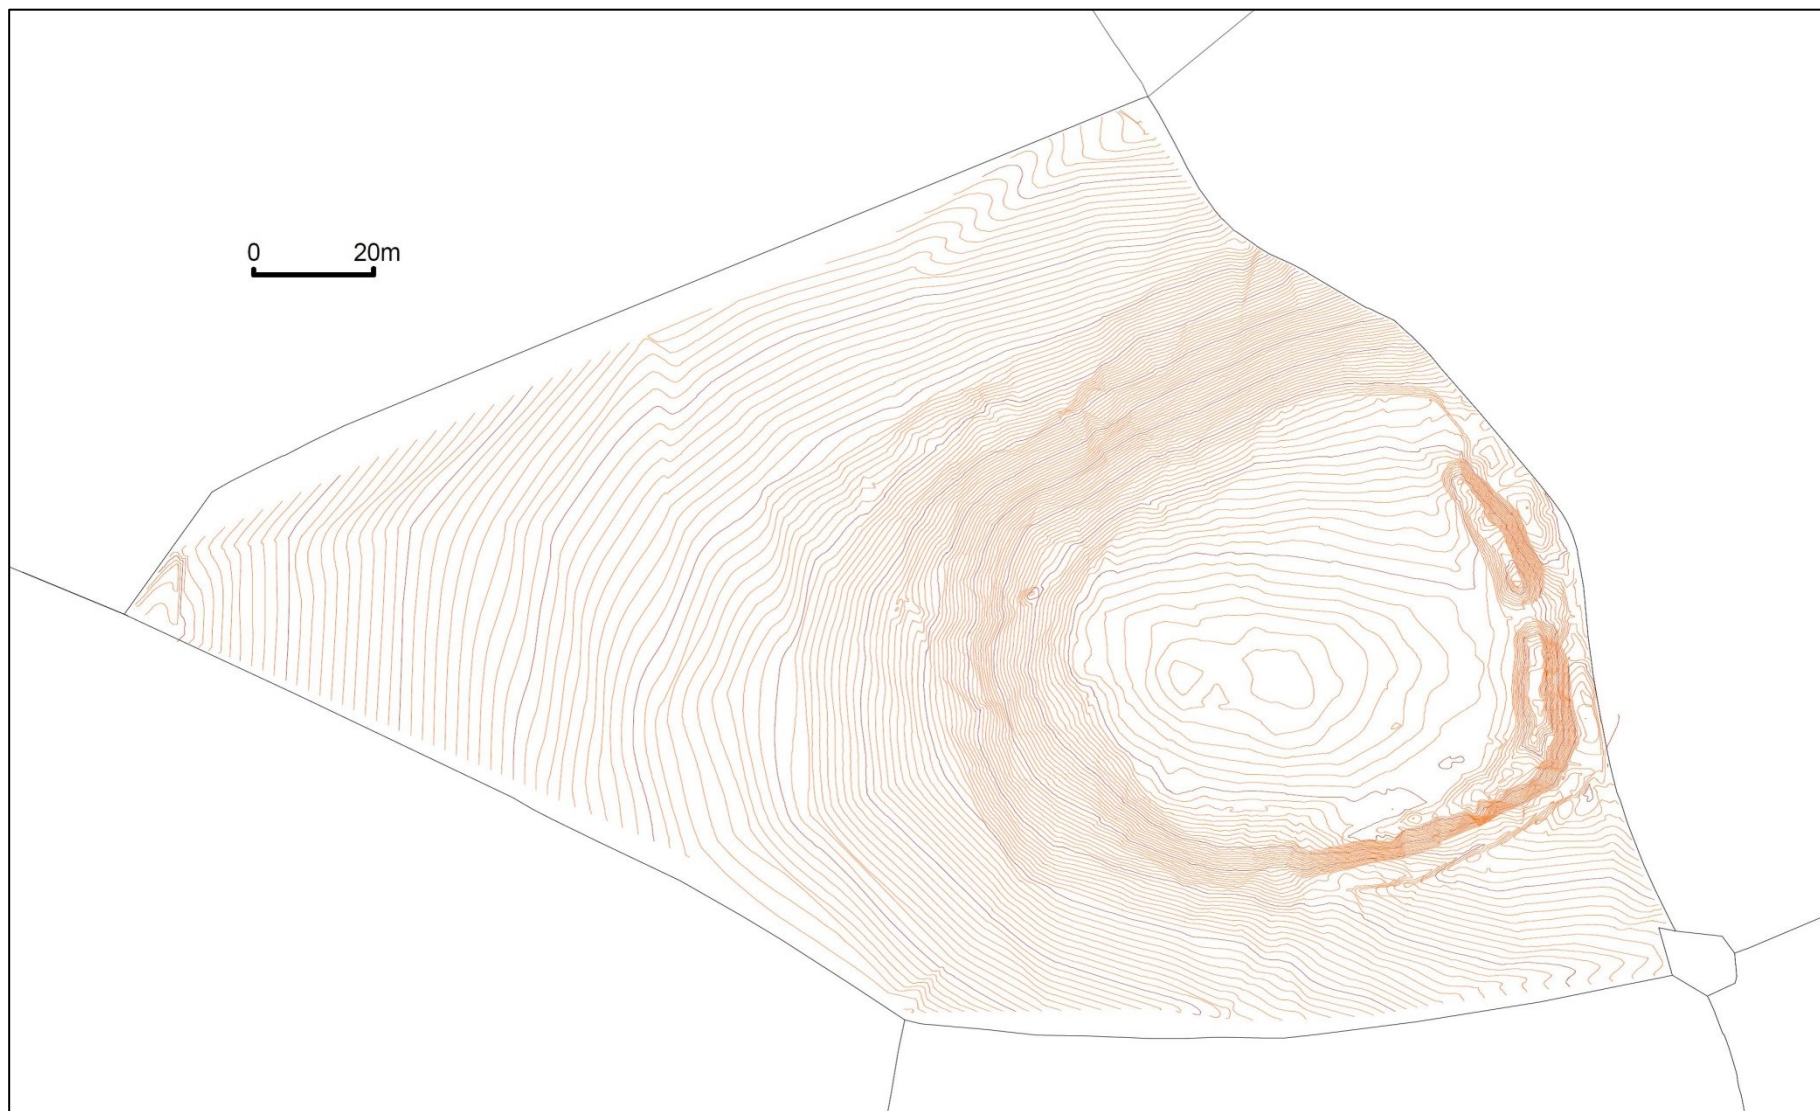
Figure 7: Topographical contour map for Castell Pant-y-Phillip

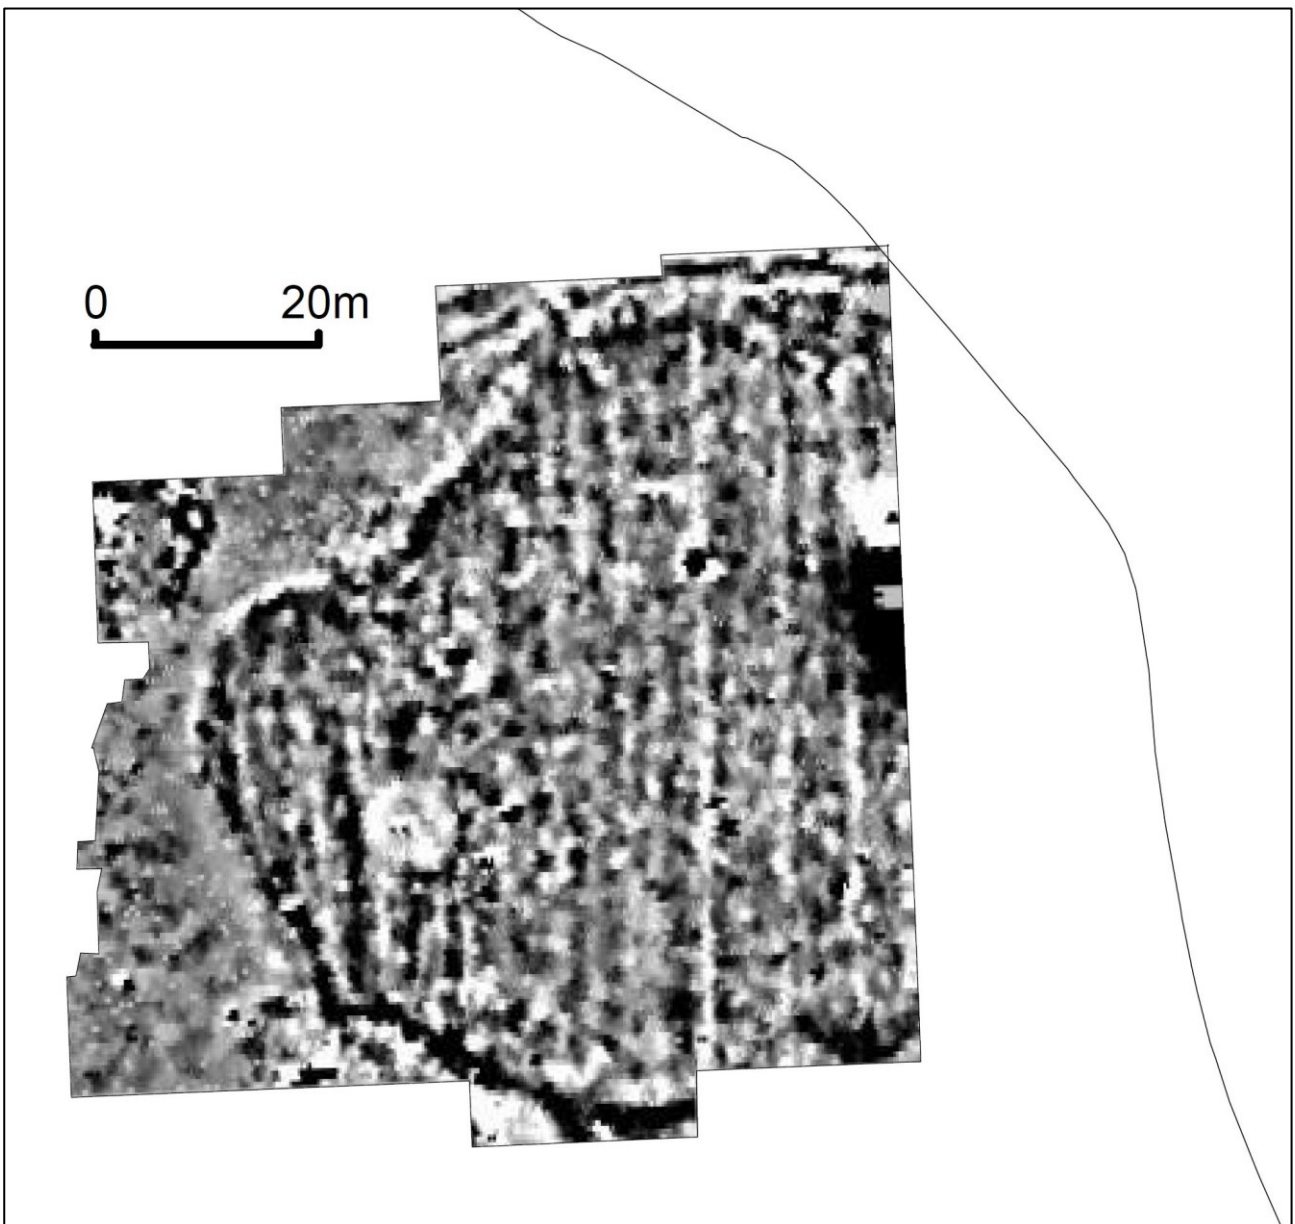
Figure 8 shows a greyscale plot of the surveyed area. The igneous geology does not appear to have caused any major distortions of the geophysical survey results, but the overall results show an uneven but consistent pattern of small areas of positive and negative magnetism that may be due to the bedrock, and are probably strong enough to prevent delicate archaeological features from showing through.

Figure 8: Processed data as a grey-scale plot, overlaid on local topographical features. The results are presented over a range of $\pm 7\text{nT}$ around the local average value of magnetic field strength.

The processed data is presented as greyscale plots overlaid on local topographical features (Figure 8). The main magnetic anomalies have been identified and plotted onto the local topographical features as a level of interpretation (Figures 10 and 11).

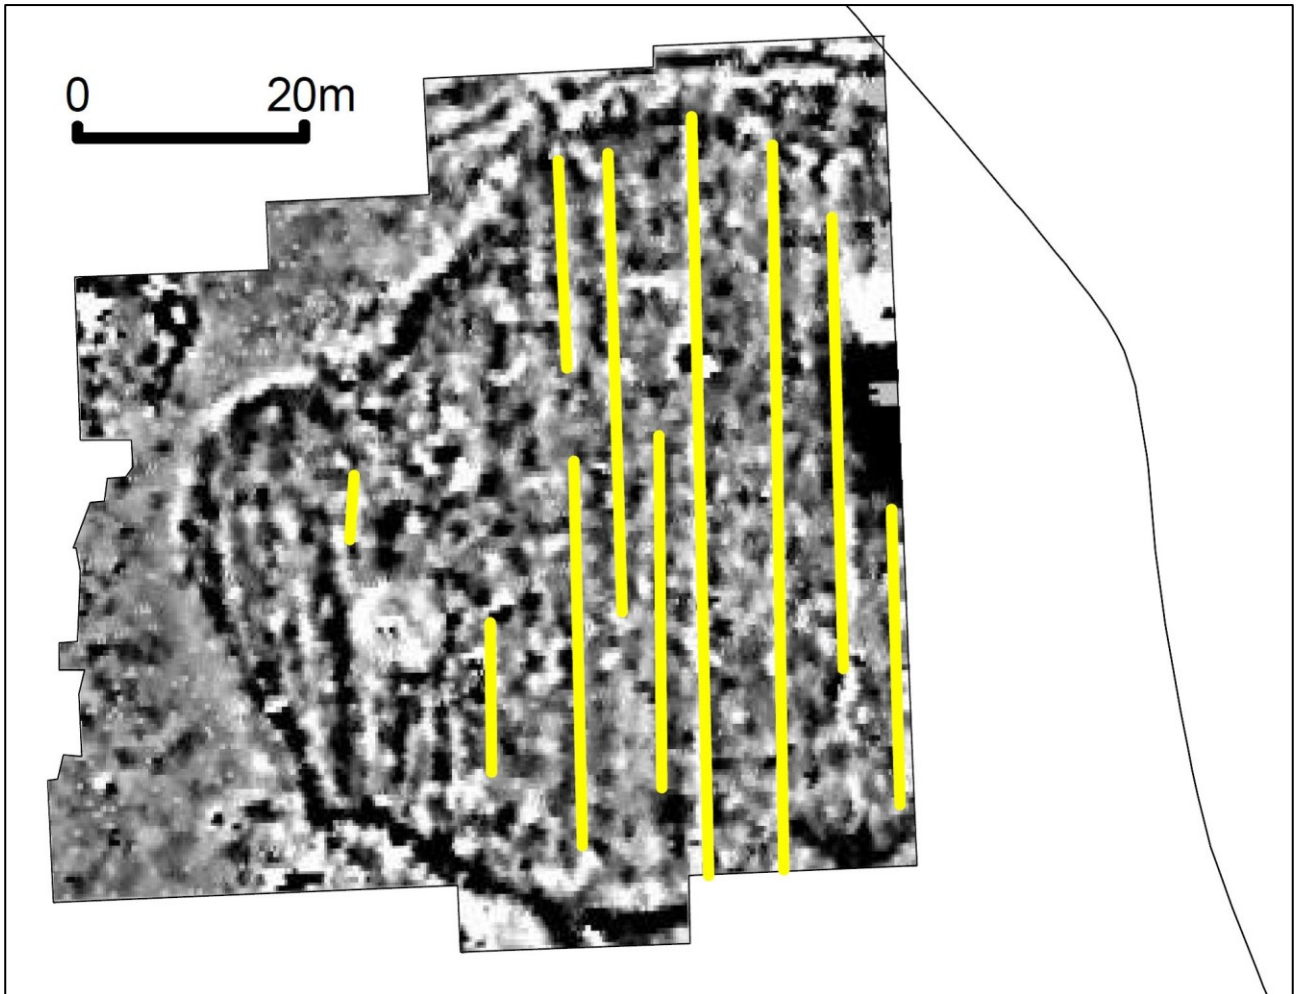
Many plough lines are evident in the data (highlighted in Figure 9), and another interpretation for the coarse-grained pattern seen across the site (described above) is that it derives from the disruption and scattering of dense settlement activity (stones and stonework as discrete negative features, pits as positive features and disturbed hearths as weakened dipolar features).

Figure 9: Processed data as a grey-scale plot, overlaid on local topographical features, with yellow lines indicating plough marks

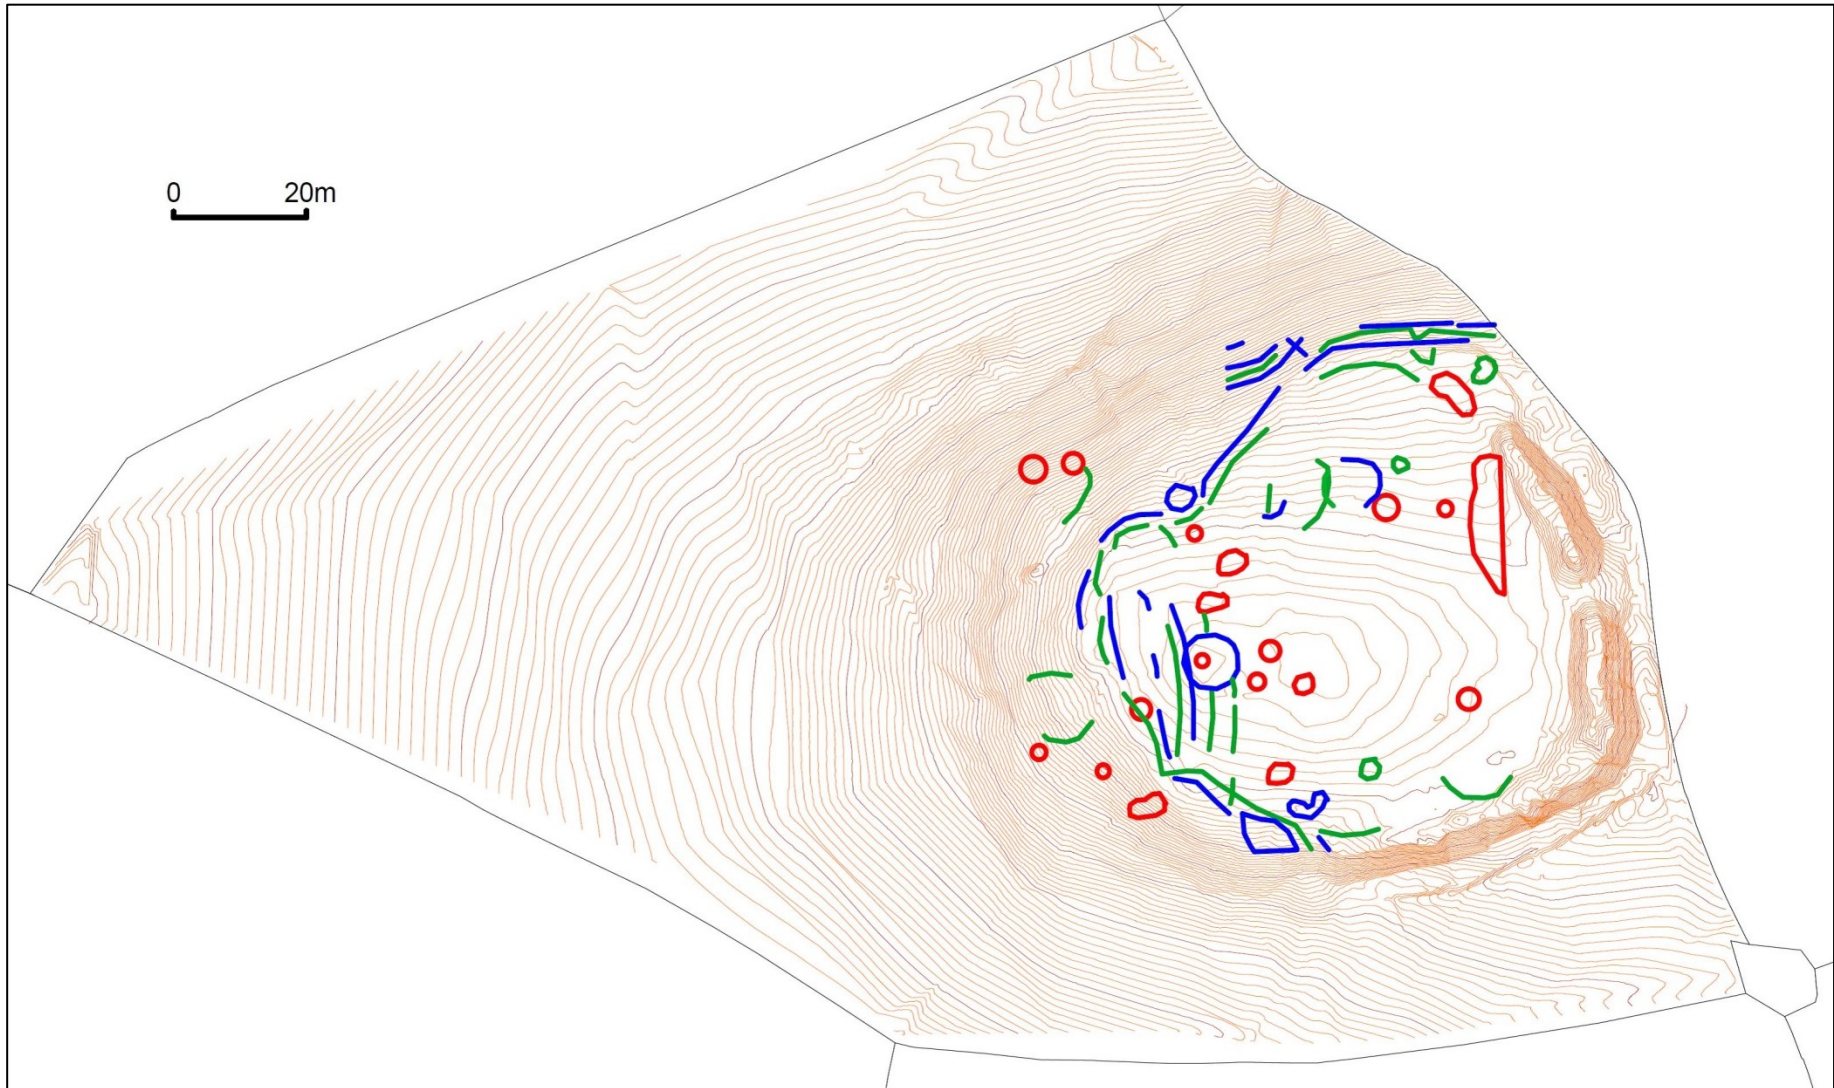
The rest of the linear positive features, of which there are many, represent further soil-filled ditches. It can be seen in Figure 11 that lots of these coincide with the edge of the enclosure's relatively flat top, and thus are considered to show the position of the enclosure ditch. These positive linears are closely paralleled by negative linears of similar length, thought to show the position of

Figure 11: Interpretation of magnetic anomalies overlaid on the contour map derived from the topographical survey data. Dipolar features are represented in red, positive features are represented in green and negative features appear in blue.

Figures 10 and 11 show an interpretation of the geophysical anomalies detected in the data. Figure 11 shows that interpretation overlaid on the contour map produced from the topographical survey.

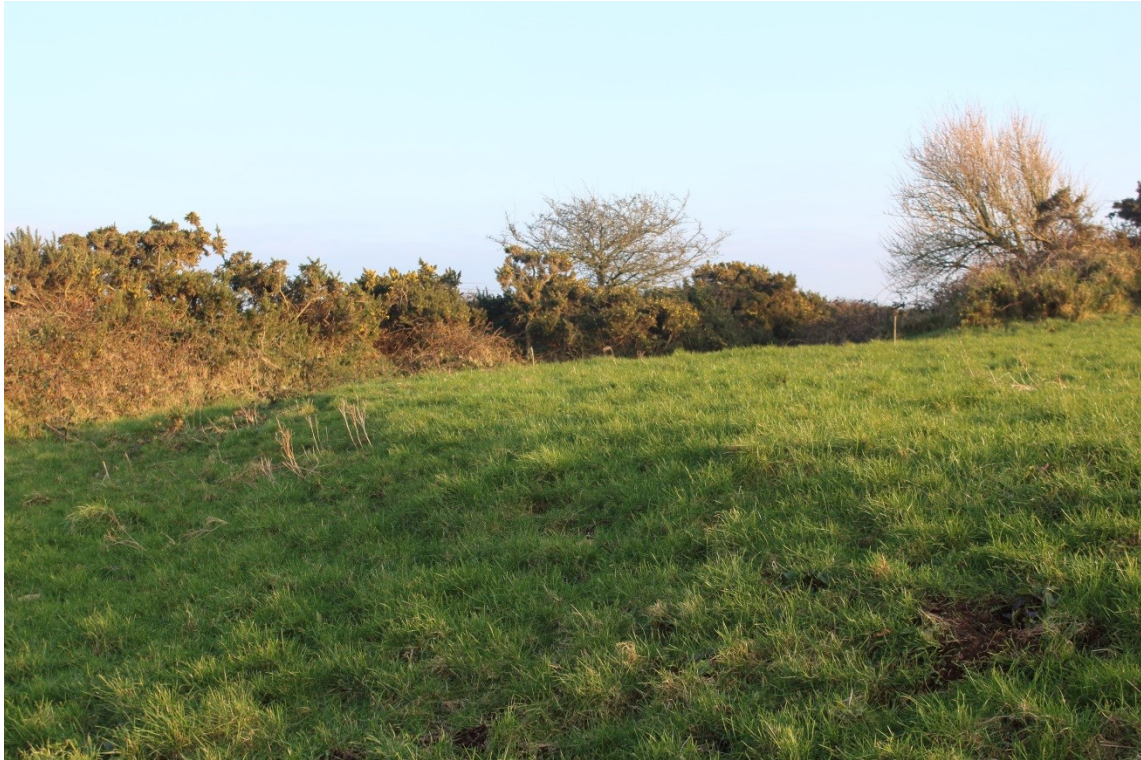
Photo 1: Facing east-southeast. The slight remains of the north rampart where it meets the line of the later field boundary, with northern end of much larger remaining ditch and bank beyond

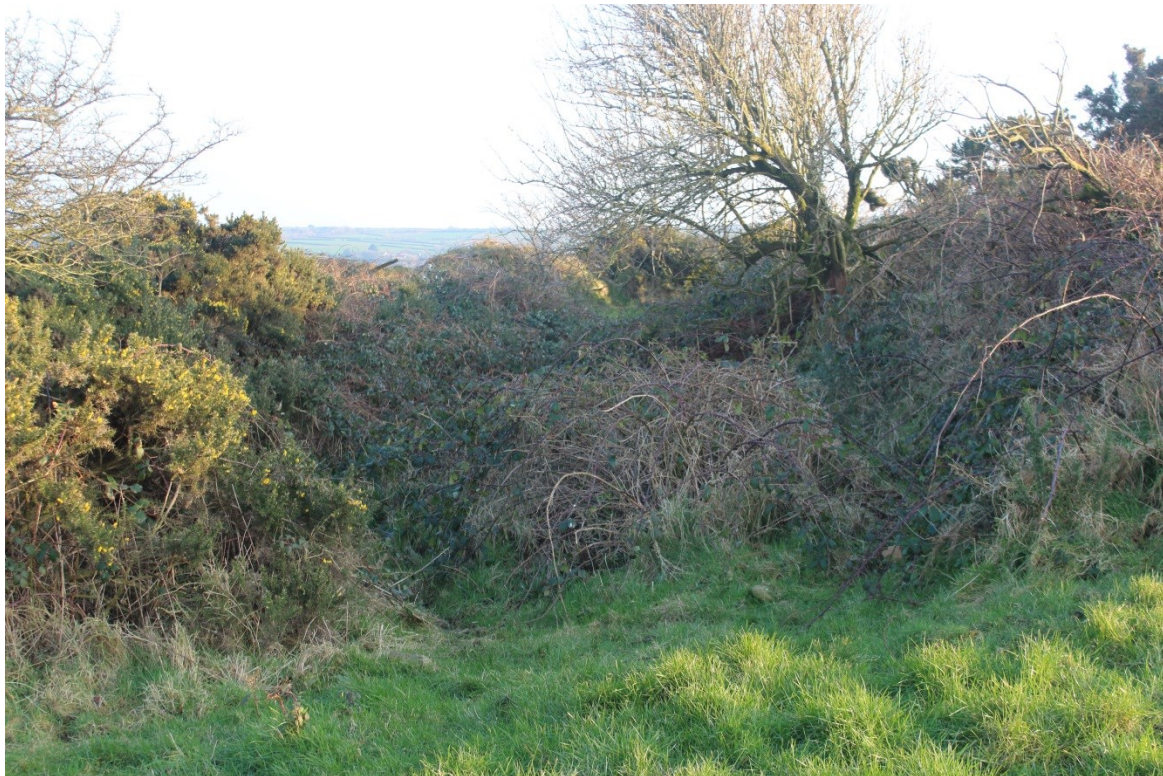
Photo 2: Facing south-southeast. The large bank and ditch on the east side of the enclosure, overgrown with scrub. The bank on the left is a later field boundary, although may incorporate an older bank.

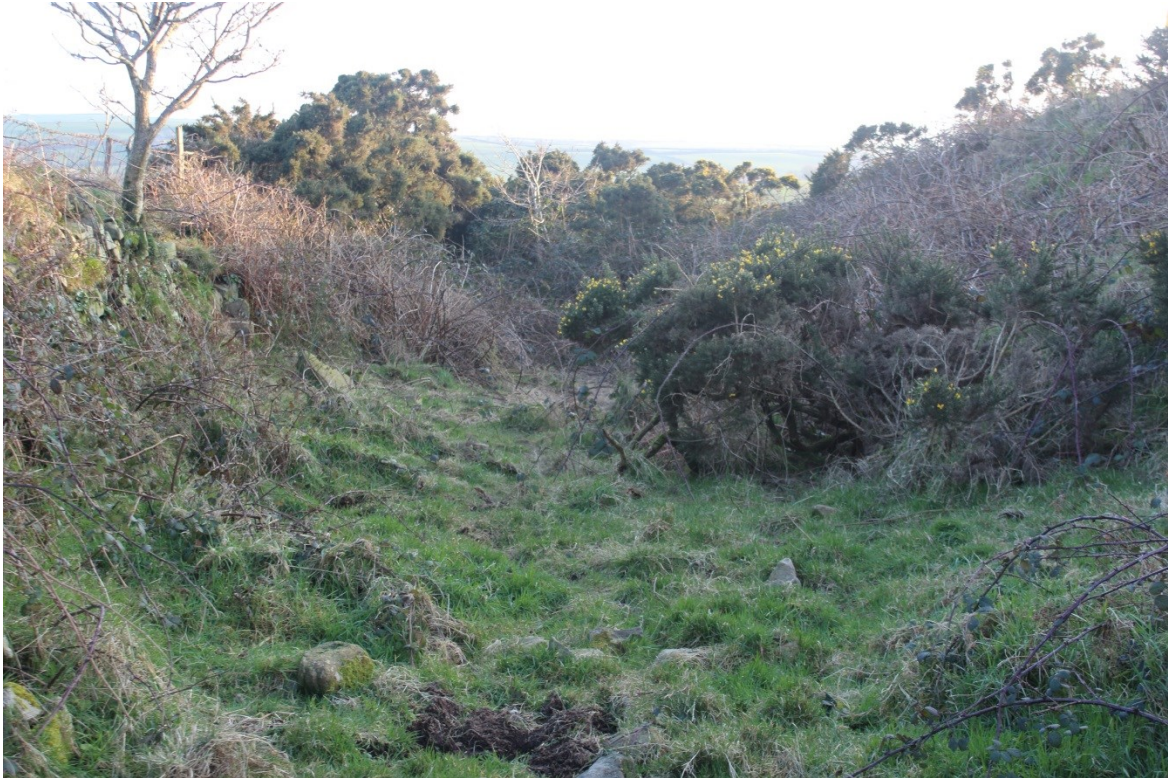
Photo 3: Facing south. The large bank and ditch on the east side of the enclosure, overgrown with scrub. The bank on the left is a later field boundary, although may incorporate an older bank.

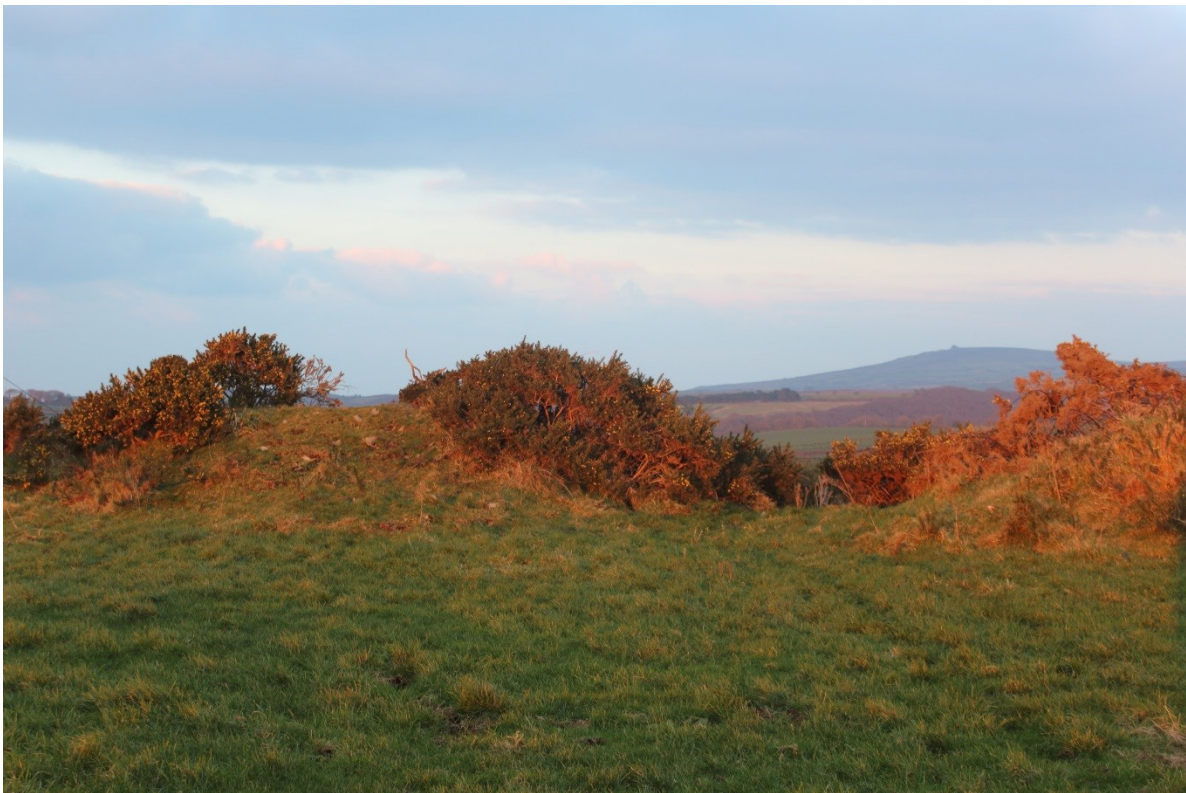
Photo 4: Facing east-northeast, from the interior of the enclosure. The entrance gap in east bank of rampart, framing the mountain Mynydd Dinas beyond.

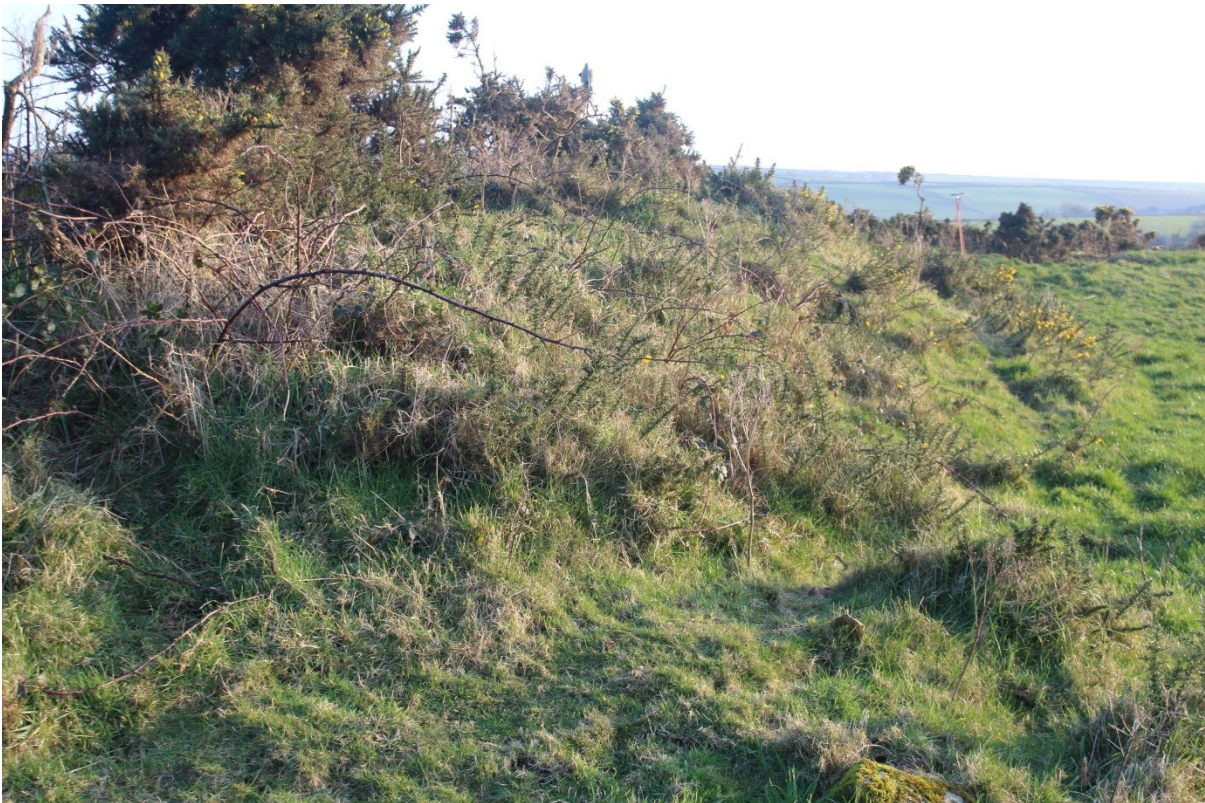
Photo 6: Facing south. The bank on east side of the enclosure,
taken from within the enclosure.

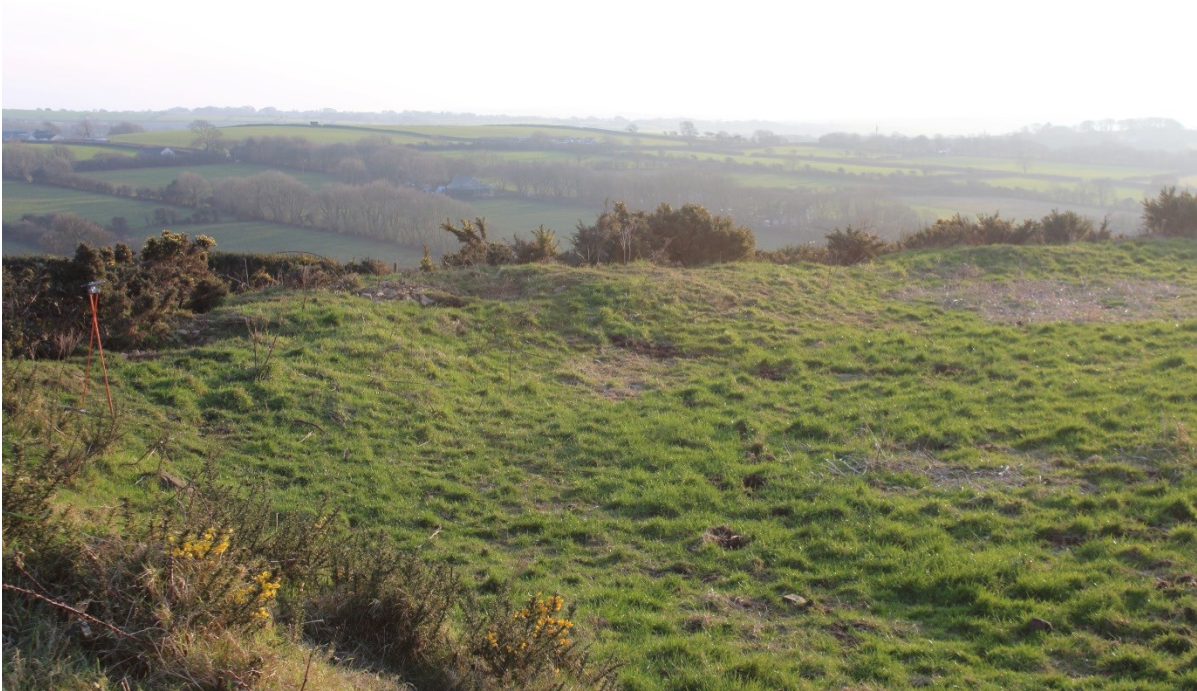
Erosion by badgers is slowly destroying parts of earthworks of Castell Pant-y-Phillip. A site visit late in 2016 showed that a sett had become established on the southeast corner of the defensive bank. The badger damage was clear on the grass-covered top of the bank, but less obvious on the flanks as it was masked by gorse and other low scrub. Although the badgers were confined to this part of the site, they were clearly very active and it seemed likely that their sett would expand along the rest of the bank in the near future.

Photo 7: Facing south-southwest. The interior of the enclosure at its southeast corner, showing lumps and bumps and freshly disturbed earth caused by badgers digging along the top of the bank.

Badger damage at Castell Pant-y-Phillip is severe and ongoing. The information presented in this report can now be used to develop mitigation strategies and a management plan for the Scheduled Ancient Monument, such as fencing-off the worst affected areas in order to prevent access to farm animals that have been observed to compound the badger damage.

Erosion caused by badgers digging their setts was observed on the defensive bank at the southeast corner of Castell Pant-y-Phillip. The damage was clear on the grass-covered top of the bank, but less obvious on the flanks as it was masked by gorse and other low scrub. Although the badgers are currently confined to this part of the site, it seems likely that they will expand their setts along the rest of the bank in the near future. The information gathered during this project and presented in this report can now be used to develop mitigation strategies and a management plan for the Scheduled Ancient Monument. At other sites it has been seen that sheep-scraping can compound badger damage once it has started, so one mitigation strategy might be to fence off the area most affected to prevent access to sheep (although this will not stop the badgers).

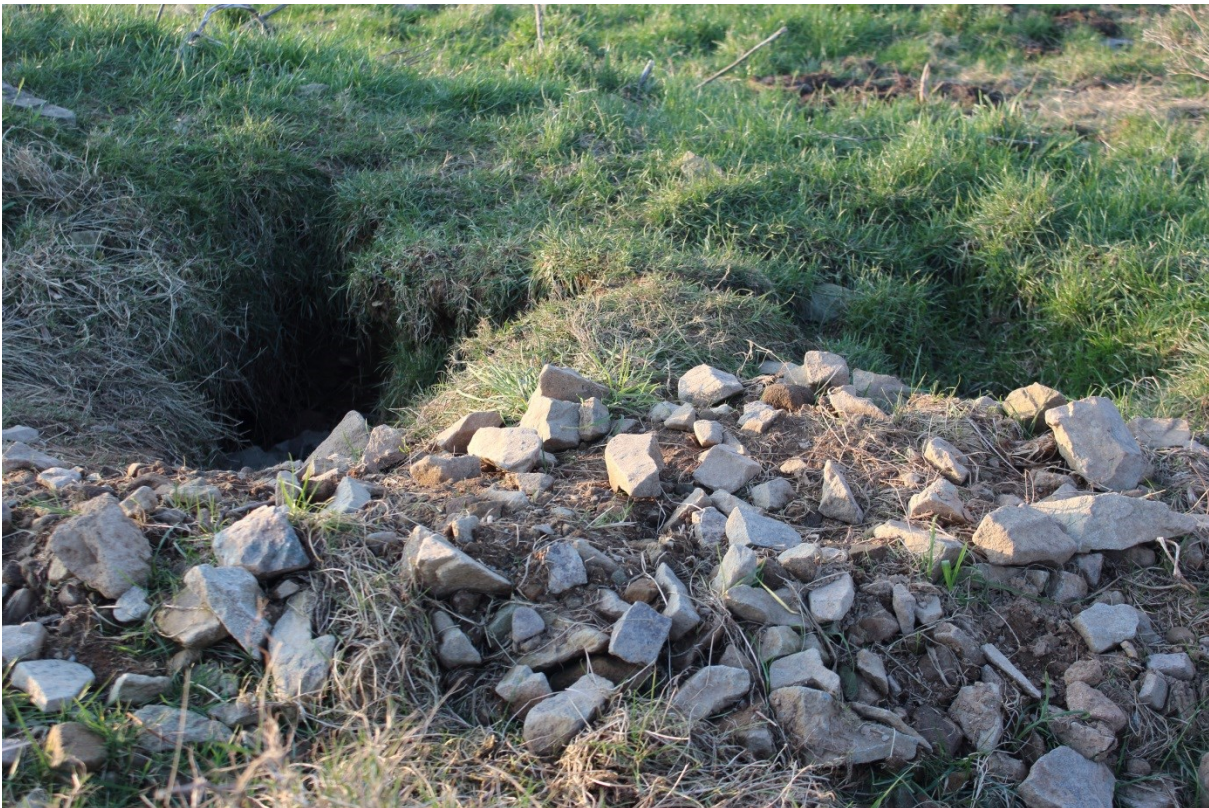
Photo 8: Facing north-northwest. Badger setts on the southern rampart.

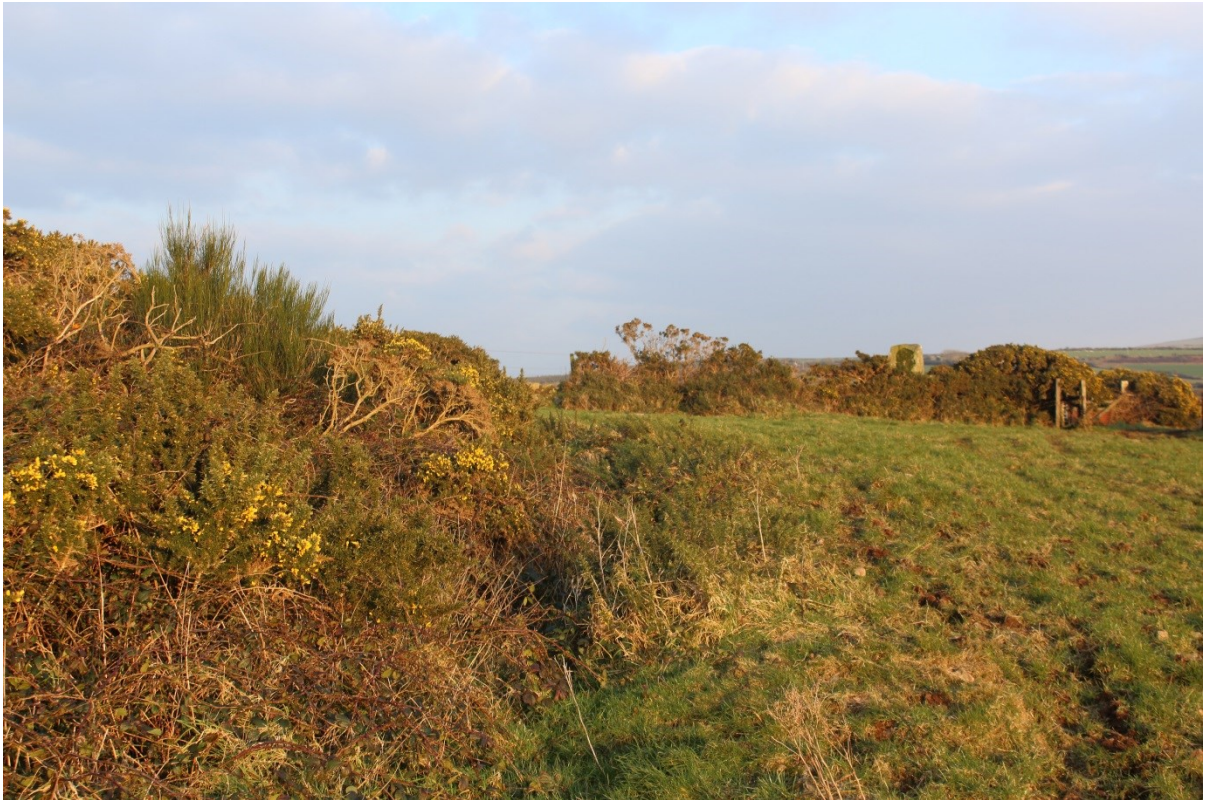
Photo 9: Facing east. Bank and ditch at the southern side of the enclosure, overgrown with scrub, taken from the outside. A standing stone erected in the hedge line by the farmer can also be seen.

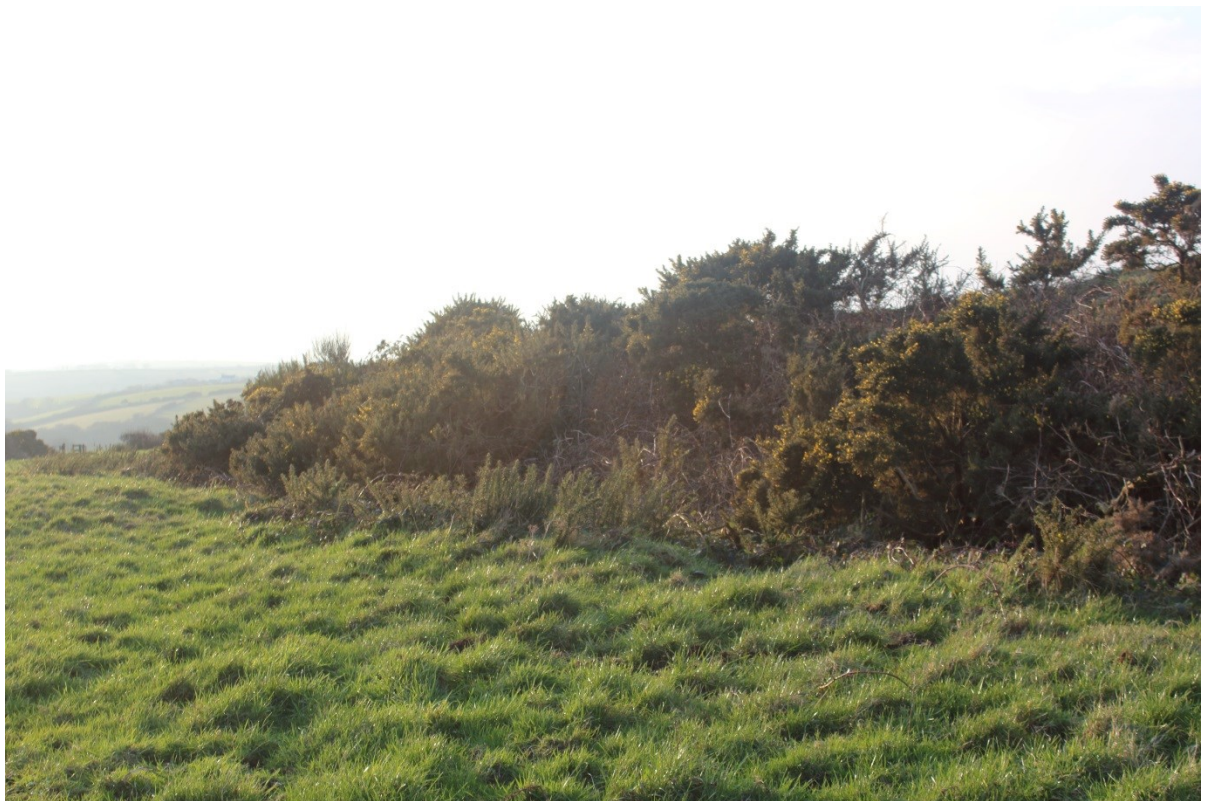
Photo 10: Facing west. Bank and ditch at southern side of the enclosure, overgrown with scrub, taken from outside.
