CASTELL PANT-Y-PHILLIP, SCLEDDAU, PEMBROKESHIRE: GEOPHYSICAL, TOPOGRAPHICAL AND PHOTGRAPHIC SURVEY

Prepared by Dyfed Archaeological Trust
for Cadw

RHIF YR ADRODDIAD / REPORT NO. 2017/10
RHIF Y DIGWYLLIAD / EVENT RECORD NO. 110326
CADW PROJECT NO. DAT A113

Mawrth 2017
March 2017

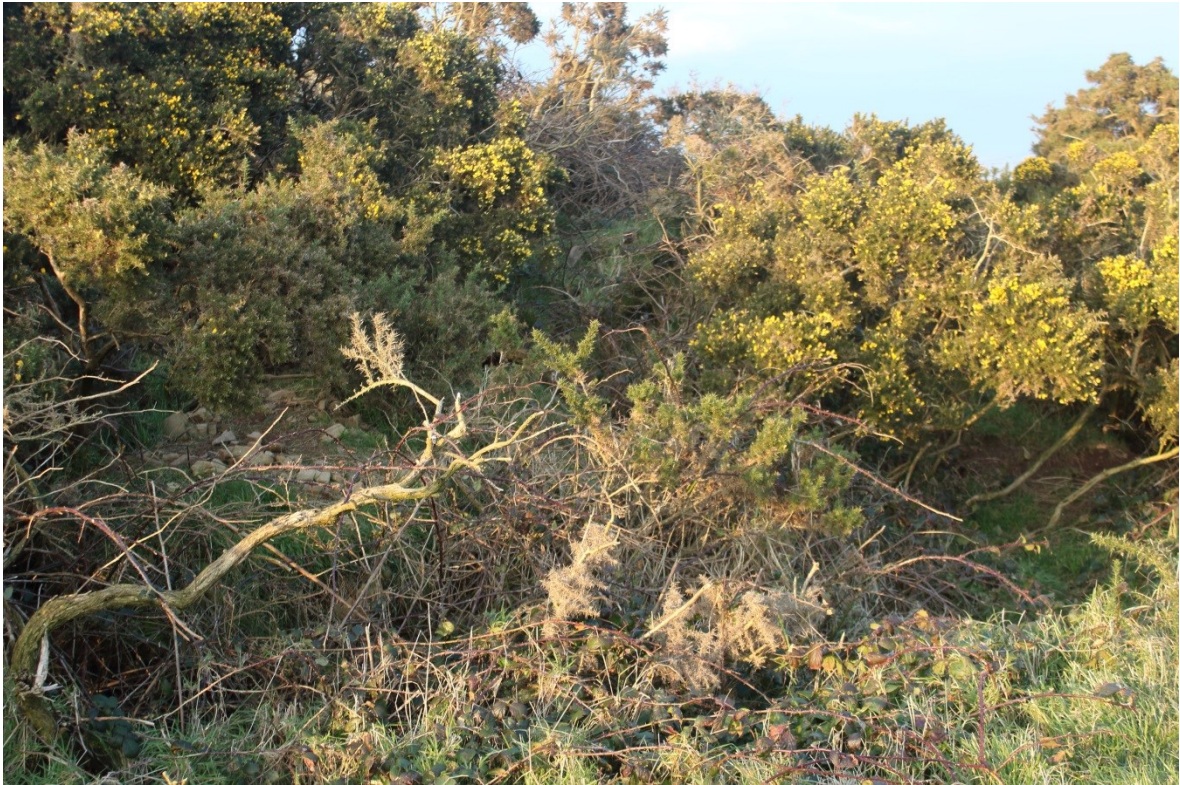
Photo 11: Facing north-northeast. Close up of the bank and ditch at southern side of hillfort, taken from outside, showing badger setts.

Badger damage at Castell Pant-y-Phillip is severe and ongoing. The information presented in this report can now be used to develop mitigation strategies and a management plan for the Scheduled Ancient Monument, such as fencing-off the worst affected areas in order to prevent access to farm animals that have been observed to compound the badger damage.

Erosion caused by badgers digging their setts was observed on the defensive bank at the southeast corner of Castell Pant-y-Phillip. The damage was clear on the grass-covered top of the bank, but less obvious on the flanks as it was masked by gorse and other low scrub. Although the badgers are currently confined to this part of the site, it seems likely that they will expand their setts along the rest of the bank in the near future. The information gathered during this project and presented in this report can now be used to develop mitigation strategies and a management plan for the Scheduled Ancient Monument. At other sites it has been seen that sheep-scraping can compound badger damage once it has started, so one mitigation strategy might be to fence off the area most affected to prevent access to sheep (although this will not stop the badgers).

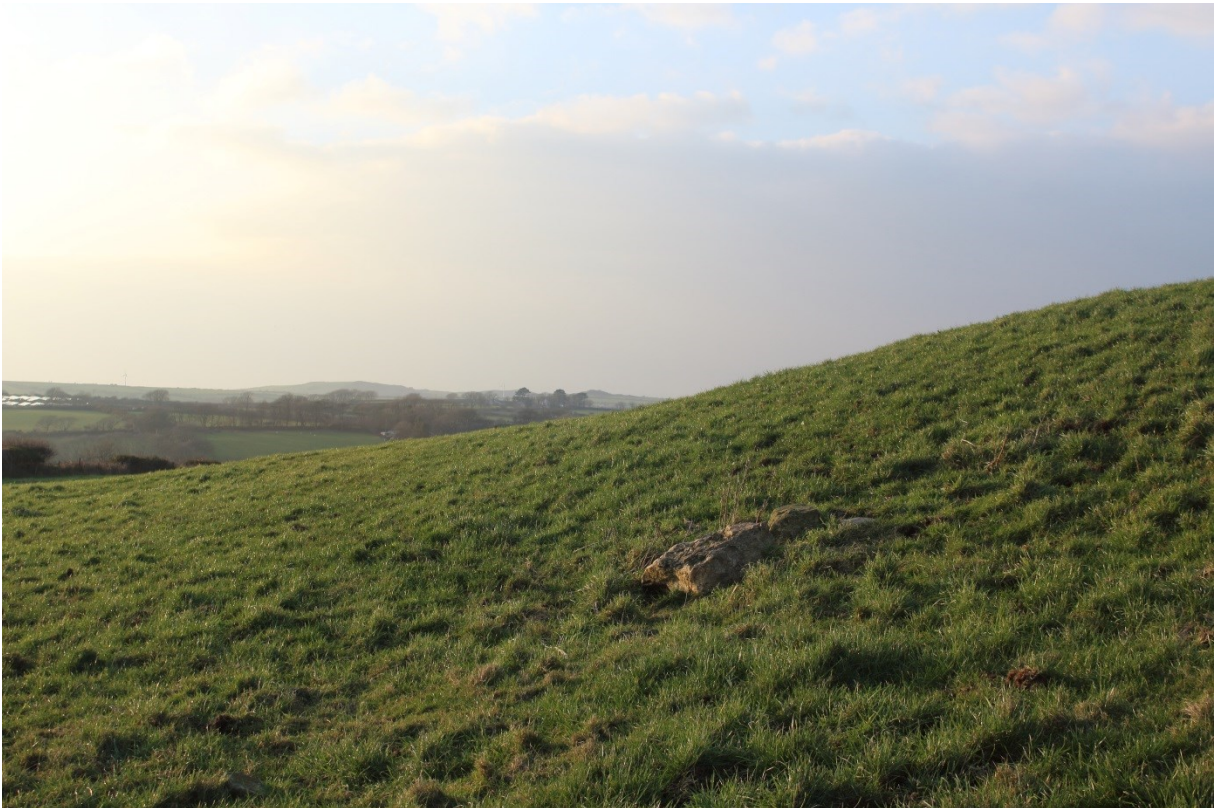
Photo 12: Facing west. Looking along the outside of the bank on the southwest side of the enclosure.
