CASTELL PEN-YR-ALLT, LLANTOOD, PEMBROKESHIRE: GEOPHYSICAL, TOPOGRAPHICAL AND PHOTGRAPHIC SURVEY

Prepared by Dyfed Archaeological Trust
for Cadw

RHIF YR ADRODDIAD / REPORT NO. 2017/11
RHIF Y DIGWYLLIAD / EVENT RECORD NO. 110327
CADW PROJECT NO. DAT A112

Mawrth 2017
March 2017

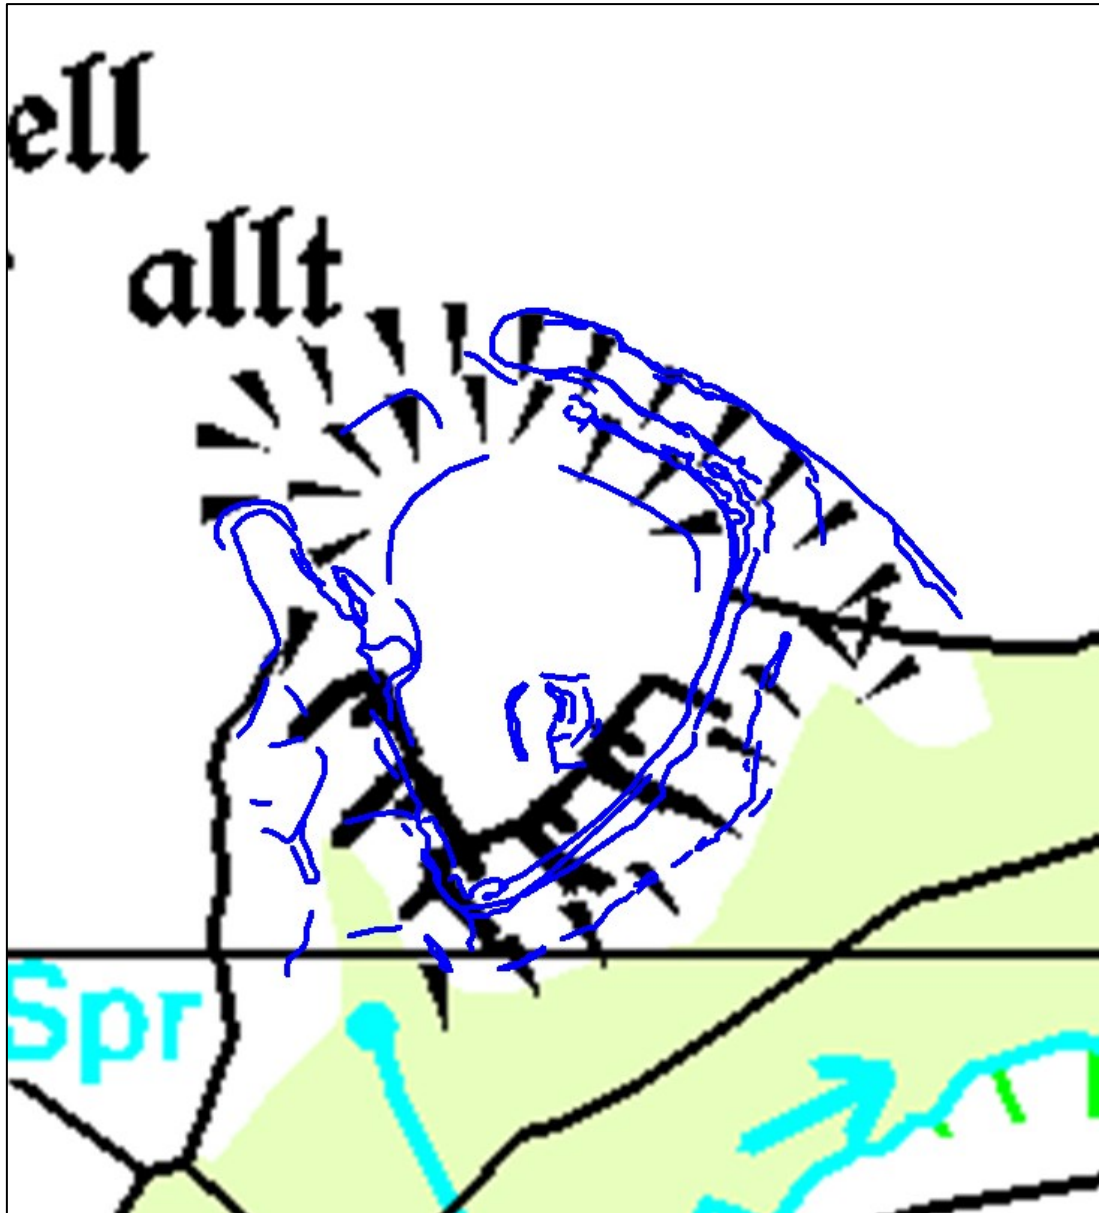
Figure 7: Topographical survey results for Castell Pen-yr-Allt, showing surveyed bank-tops in blue, with OS 1:10,000 backing map for comparison

Figures 7-9 show 2D plan-view representations of the results of the topographical survey.

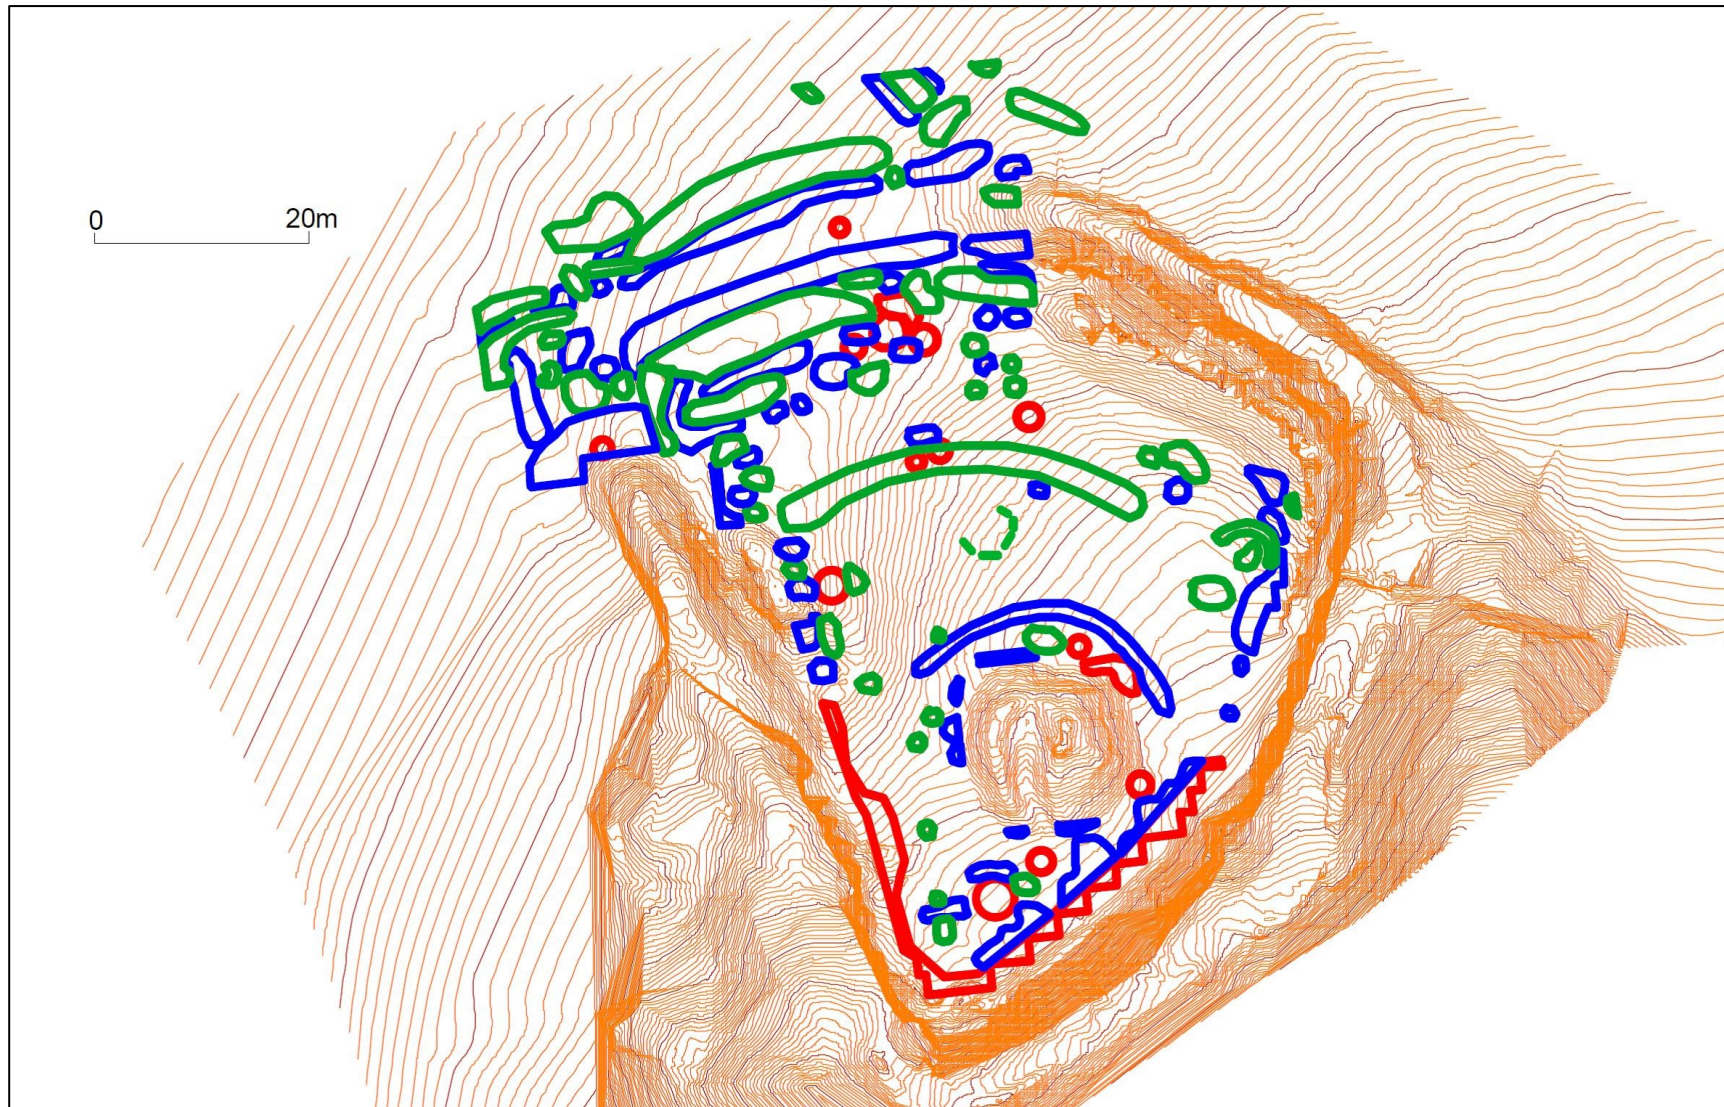
Figure 12: Interpretation of magnetic anomalies overlaid on the contour map derived from the topographical survey data. Dipolar features are represented in red, positive features are represented in green and negative features appear in blue.

The processed data is presented as greyscale plots overlaid on local topographical features (Figure 10). The main magnetic anomalies have been identified and plotted onto the local topographical features as a level of interpretation (Figures 11 and 12).

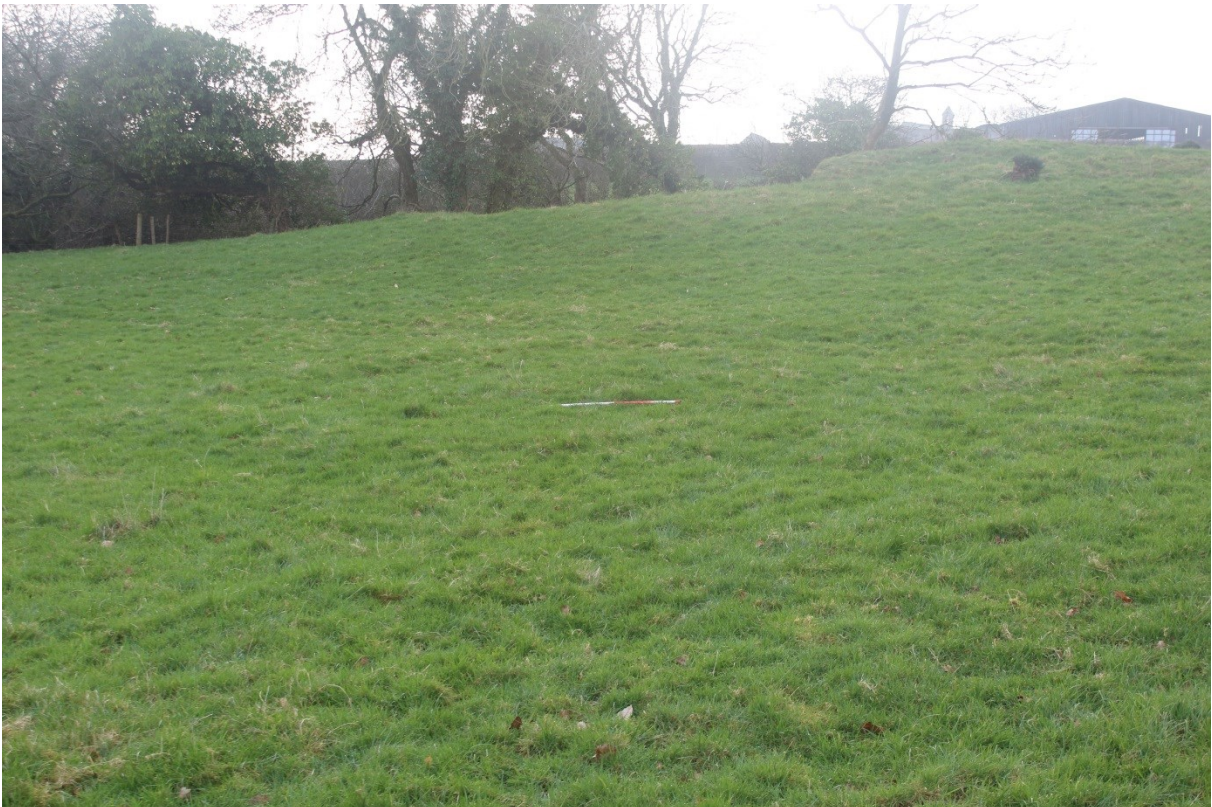
Photo 2: Facing west. Slight circular earthwork in centre of Castell Pen-yr-Allt, north of the motte, with a 1m scale.

Other faint positive ring shapes can be seen north of the motte, including one coinciding with an observed slight earthwork (**H** in Figure 11; Photo 2). These are closer in size to round-houses but again it is possible that they are marks left by large animal feeders.

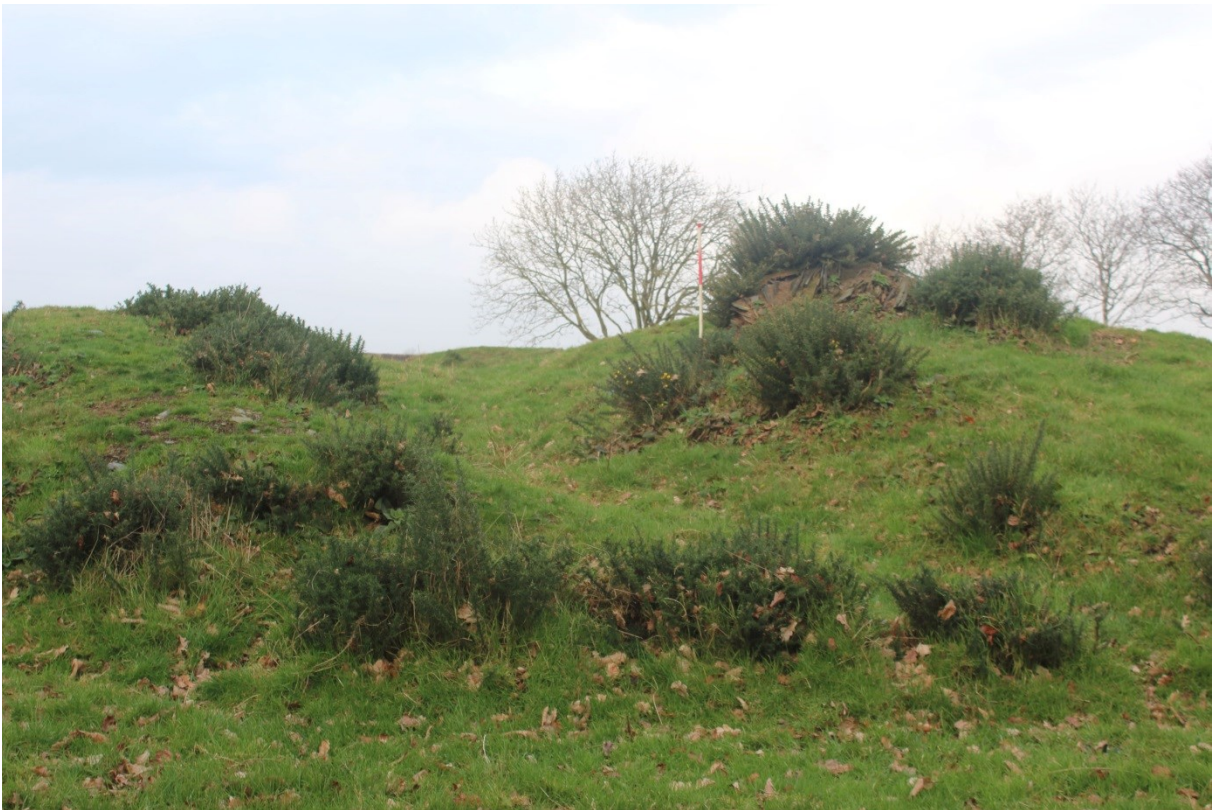
Photo 4: Facing north. The motte at Castell Pen-yr-Allt, showing its current cloven shape and stonework remains on top, with a 1m scale.

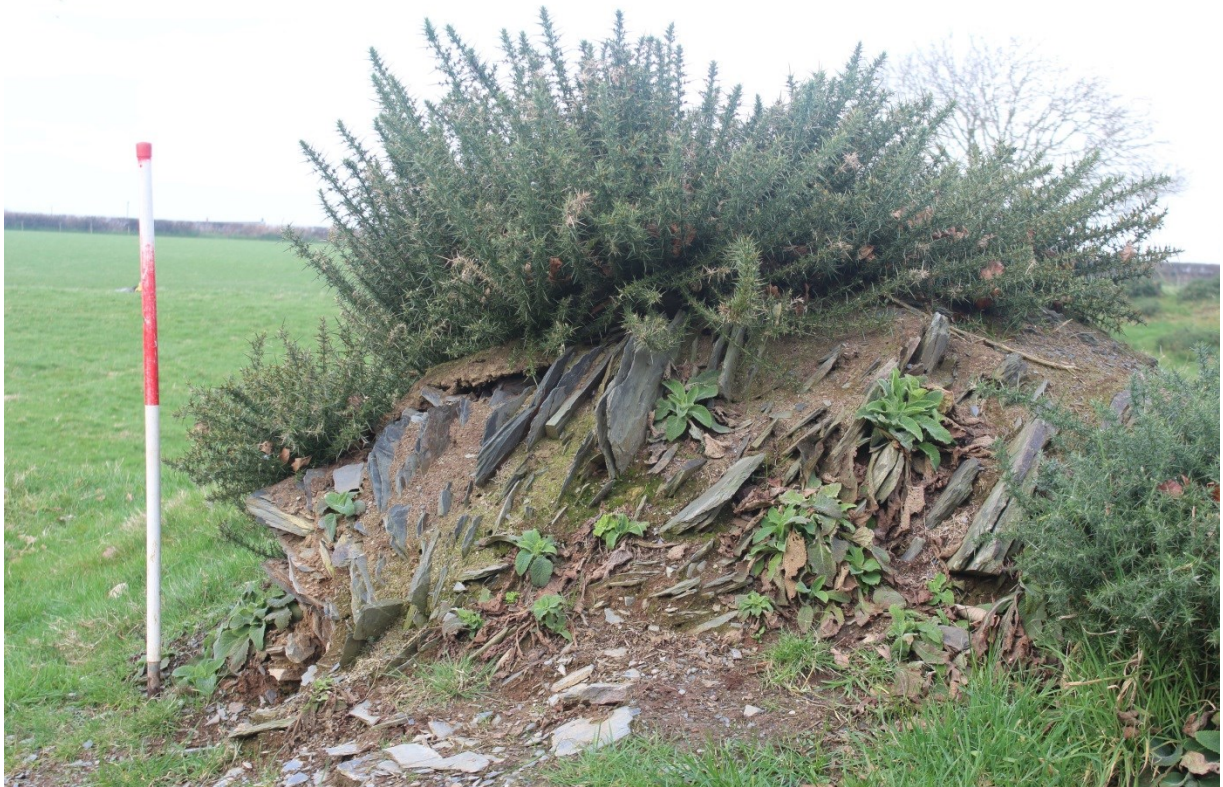
Photo 5: Facing north. Stonework remains on top of the motte at Castell Pen-yr-Allt, with a 1m scale.

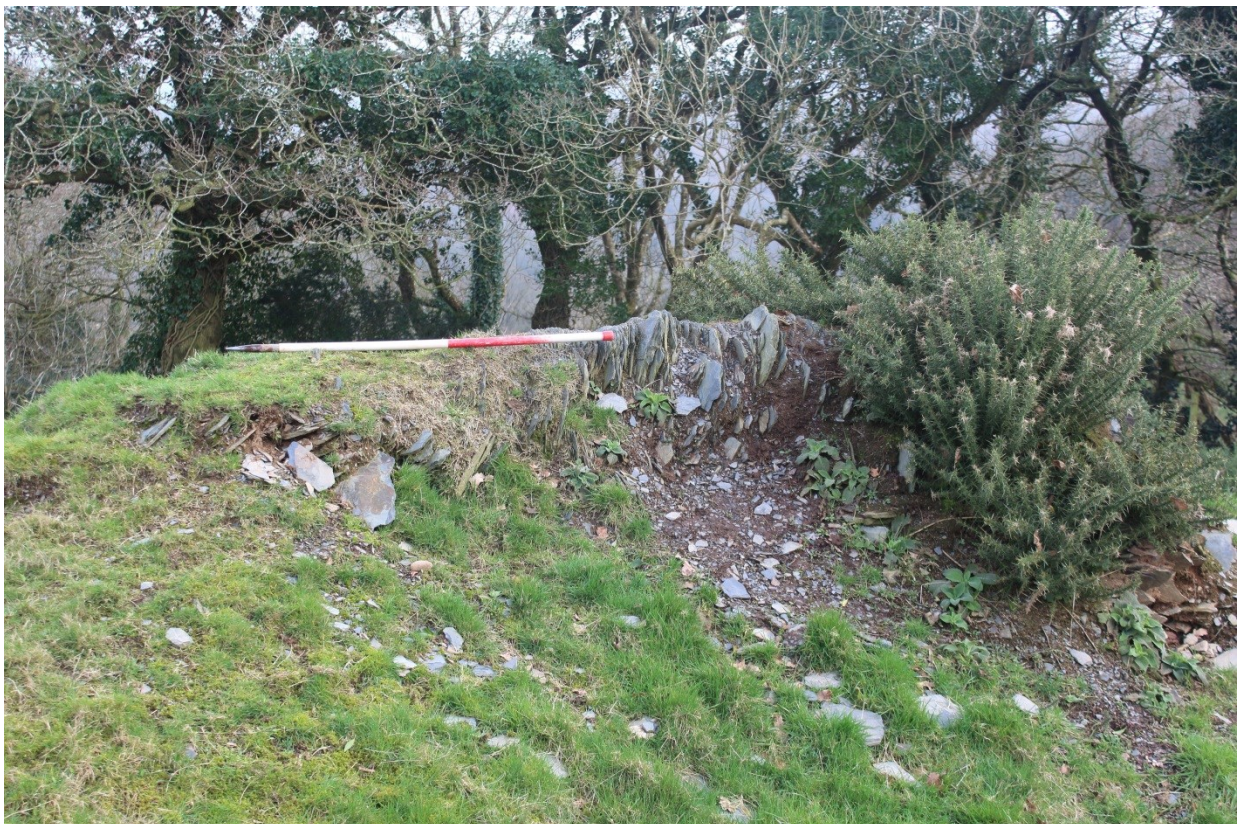
Figure 6: Facing southeast. Stonework remains on top of the motte at Castell Pen-yr-Allt, with a 1m scale.

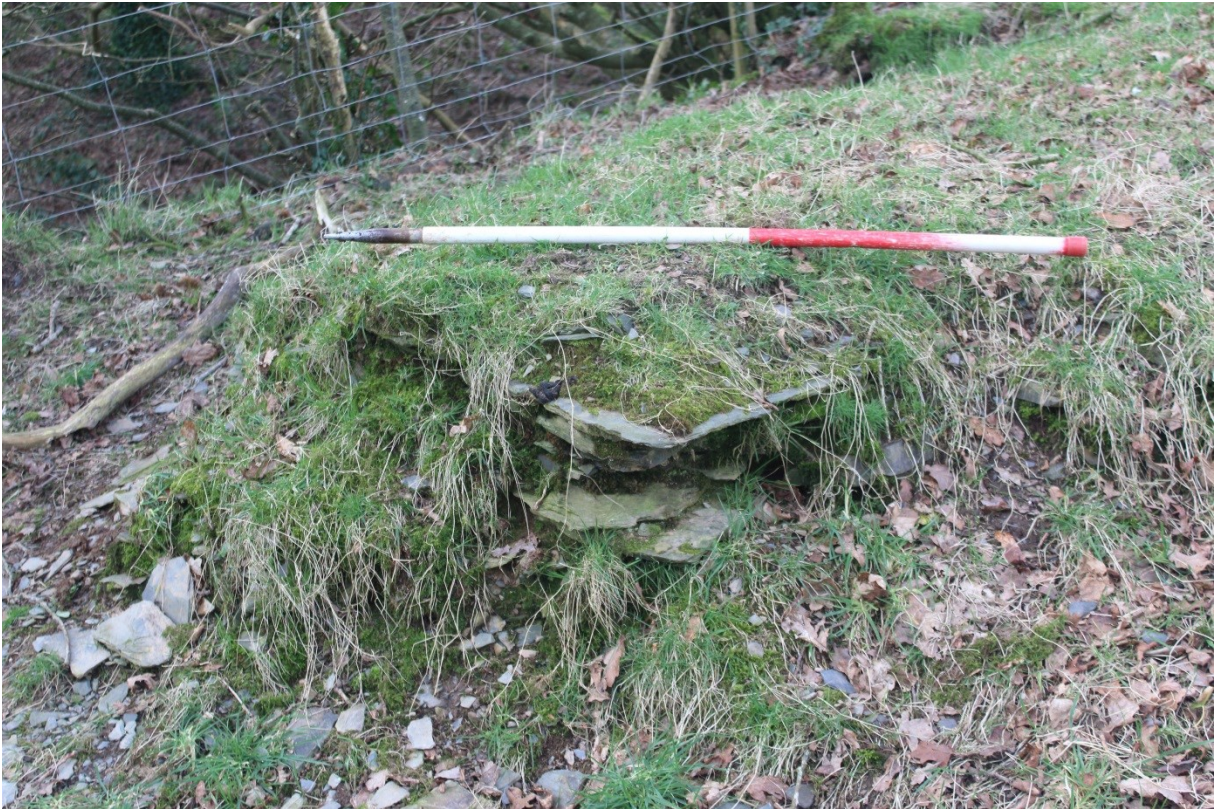
Figure 7: Facing west. Wall remains at interior south corner of Castell Pen-yr-Allt, with a 1m scale.

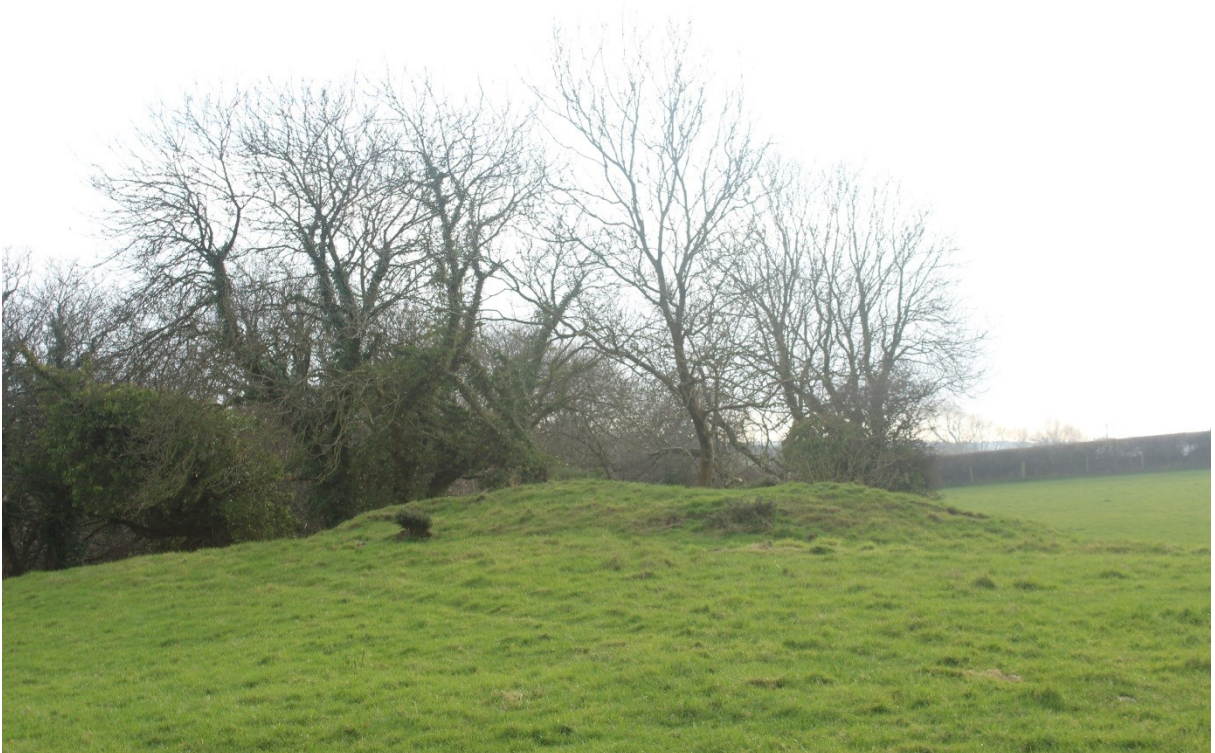
Photo 8: Facing southwest. Remains of a bank and/or stone building on west side of Castell Pen-yr-Allt.

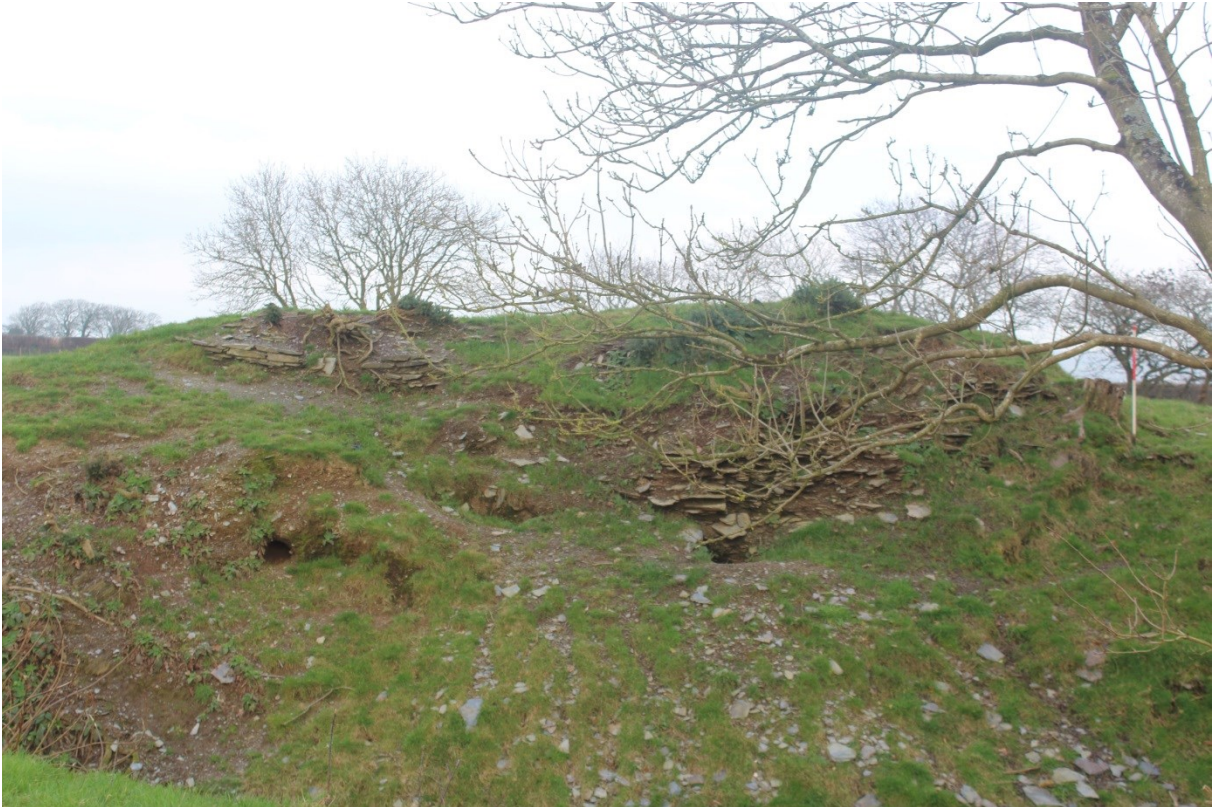
Photo 9: Facing northeast. Remains of a bank and/or stone building on west side of Castell Pen-yr-Allt, with the ditch in the foreground, with a 1m scale.

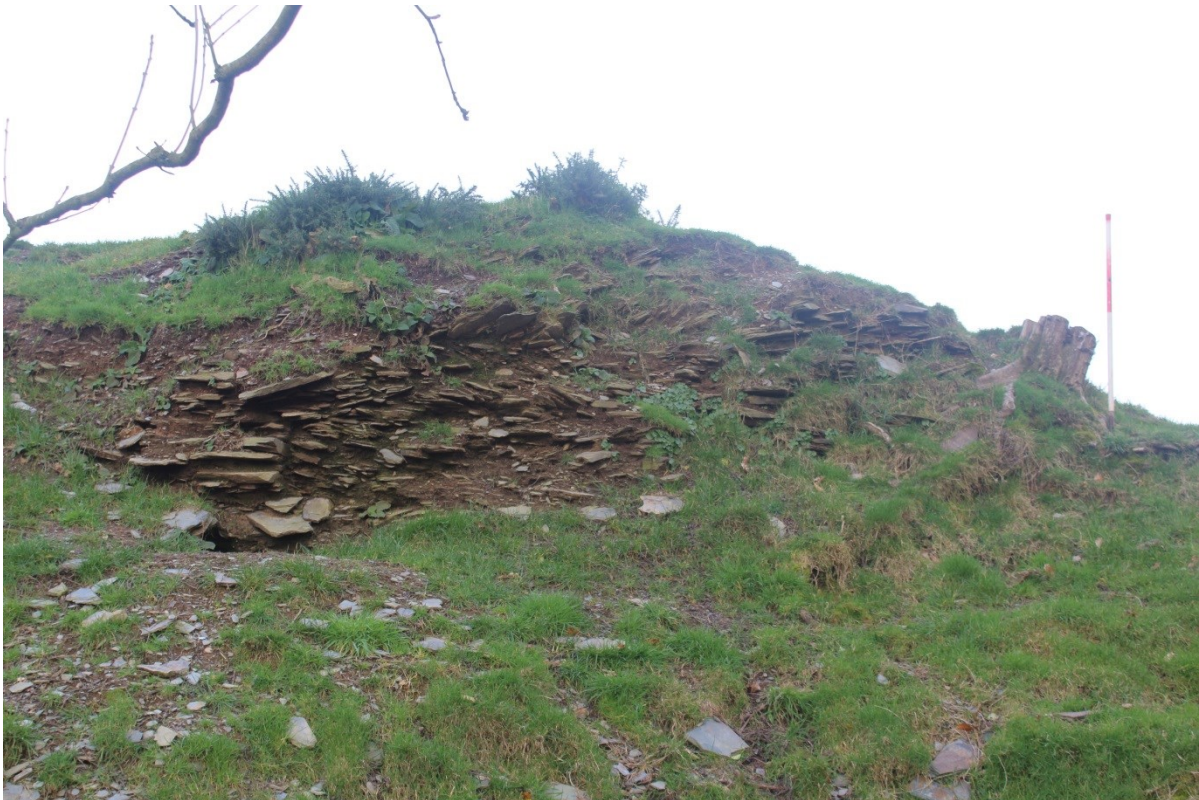
Photo 10: Facing northeast. Part of the remains of a bank and/or stone building on the west side of Castell Pen-yr-Allt, with a 1m scale.

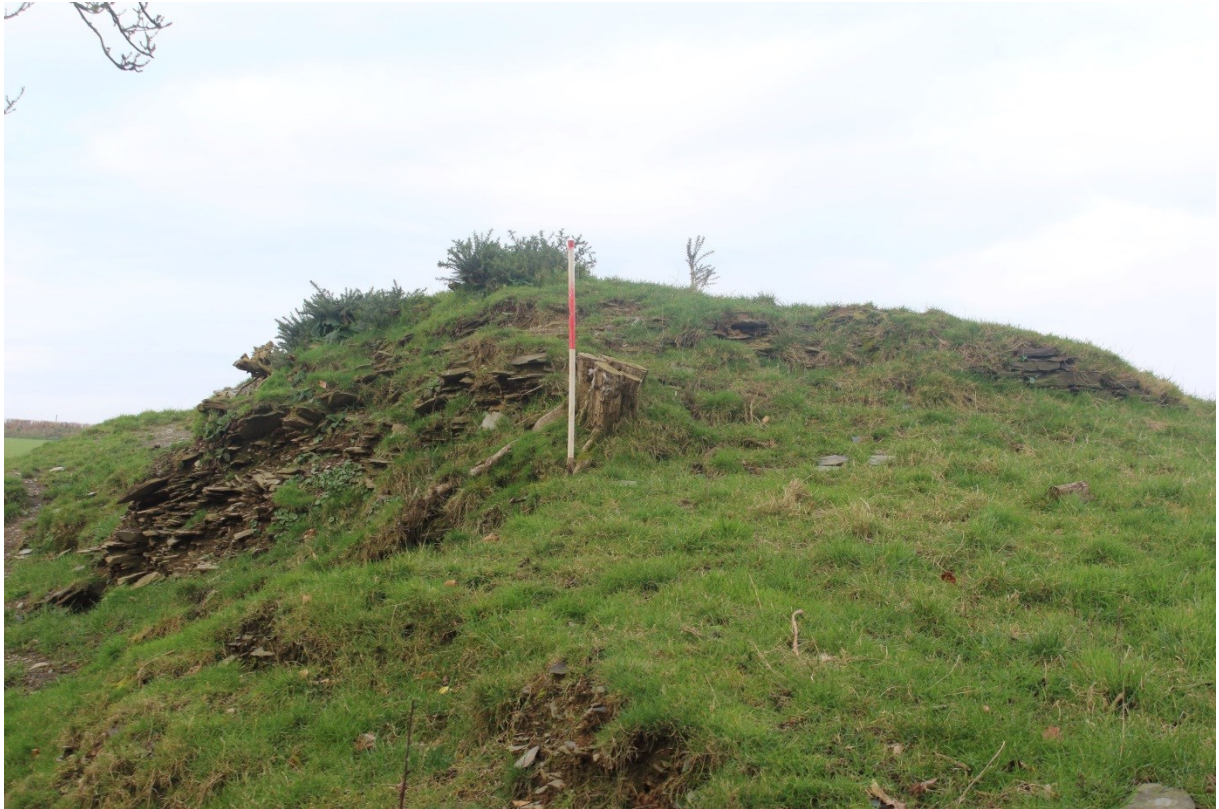
Photo 11: Facing north. Part of the remains of a bank and/or stone building on the west side of Castell Pen-yr-Allt, with a 1m scale.

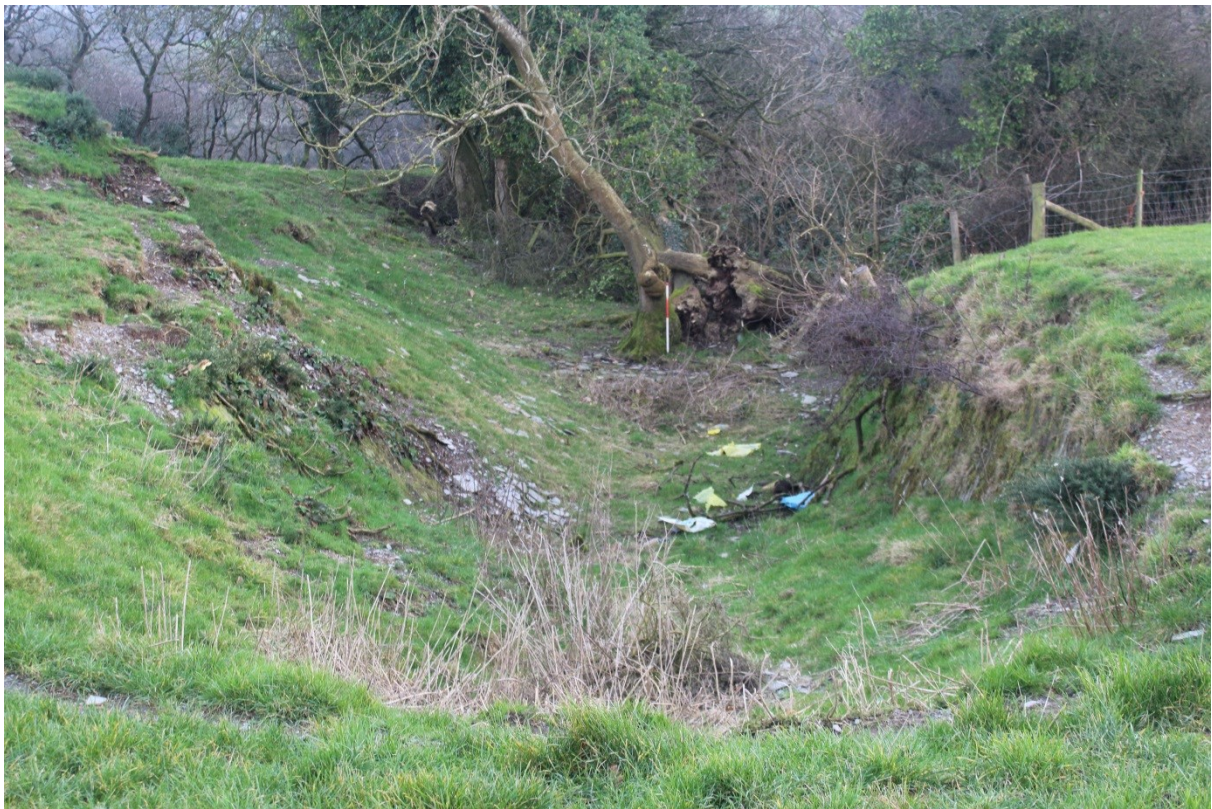
Photo 12: Facing south-southeast. Surviving ditch on west side of Castell Pen-yr-Allt, with a 1m scale.

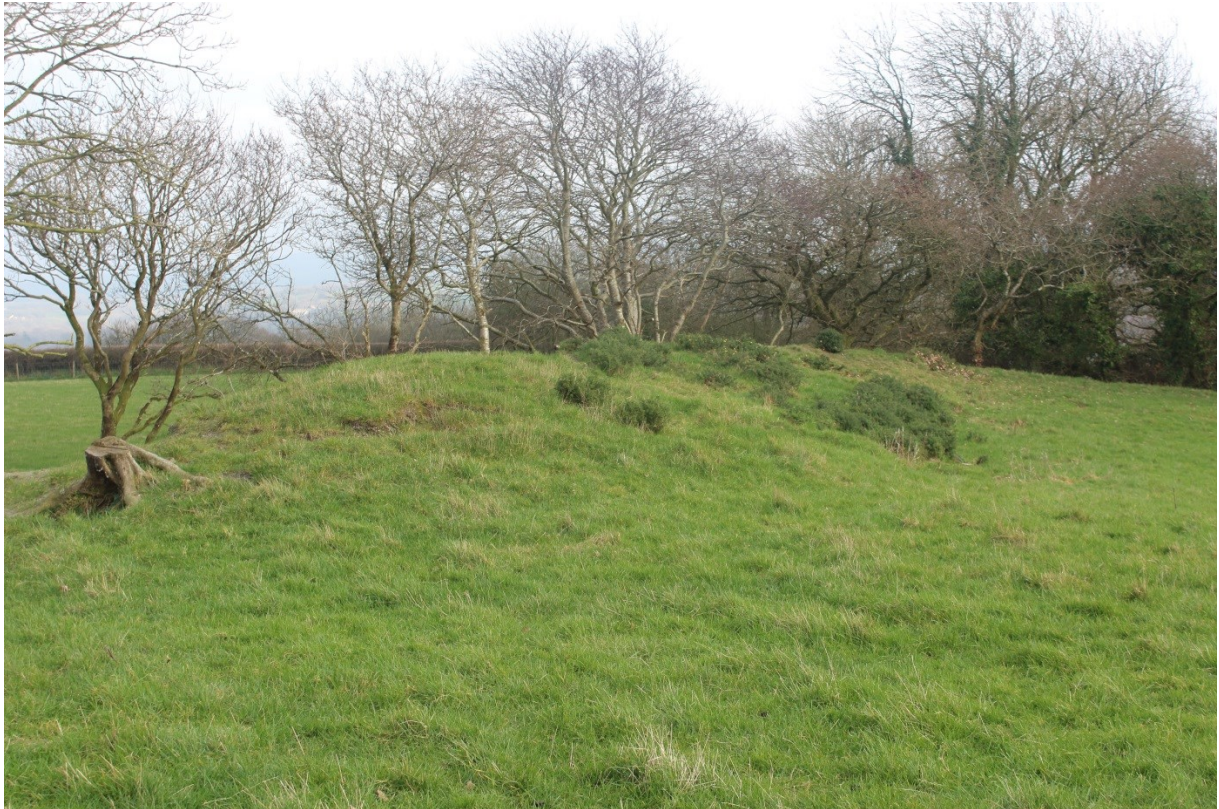
Photo 13: Facing southeast. Bank of Castell Pen-yr-Allt on its northeast side. Trees beyond lie in the ditch.

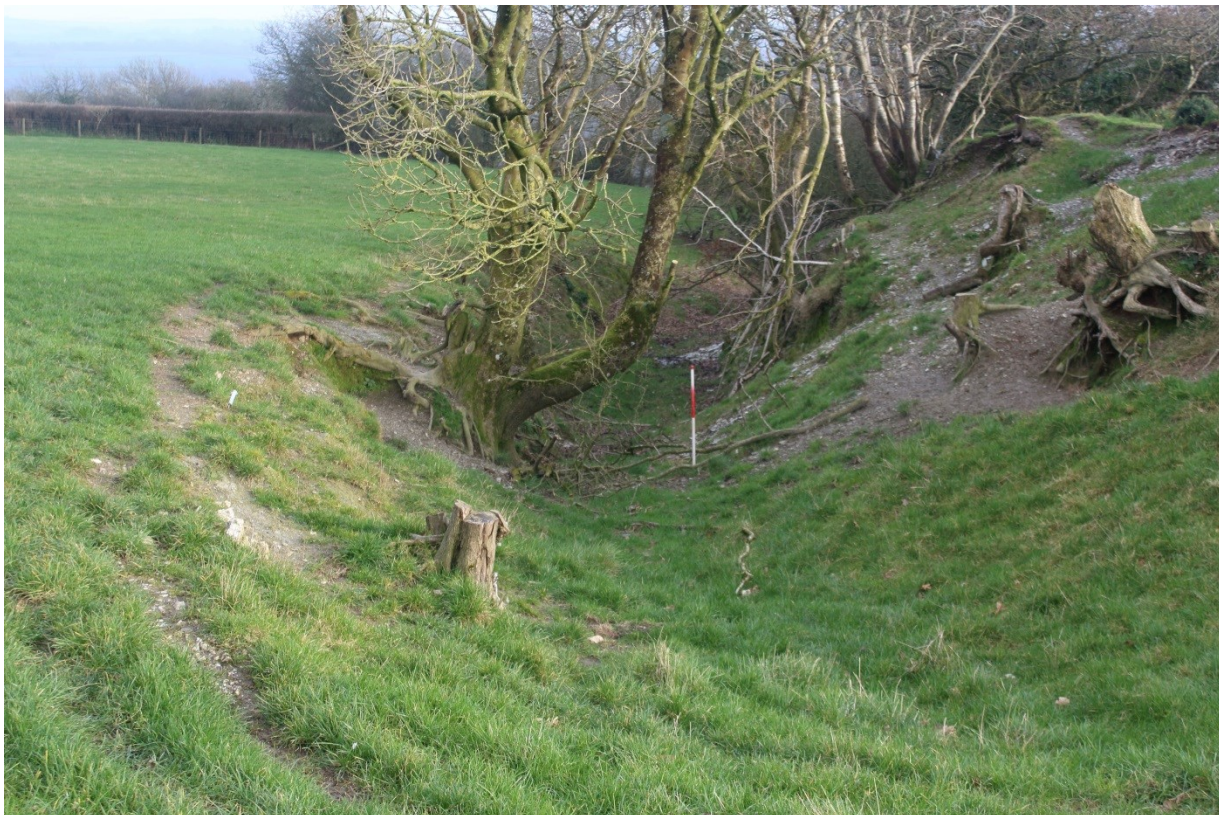
Photo 14: Facing southeast. The ditch and bank on the northeast side of Castell Pen-yr-Allt, with extensive erosion on the bank, with a 1m scale.

Severe erosion was observed on the defensive banks of Castell Pen-yr-Allt, caused by badgers digging their setts and compounded by sheep-scraping on the bare stone and earth bank thus exposed. The information gathered during this project and presented in this report can now be used to develop mitigation strategies and a management plan for the Scheduled Ancient Monument. One such mitigation strategy might be to fence off the area most affected to prevent further erosion by sheep (although the badgers will continue to erode the site).

Badger damage at Castell Pen-yr-Allt is severe and ongoing. The information presented in this report can now be used to develop mitigation strategies and a management plan for the Scheduled Ancient Monument, such as fencing-off the worst affected areas in order to prevent access to farm animals that have been observed to compound the badger damage.

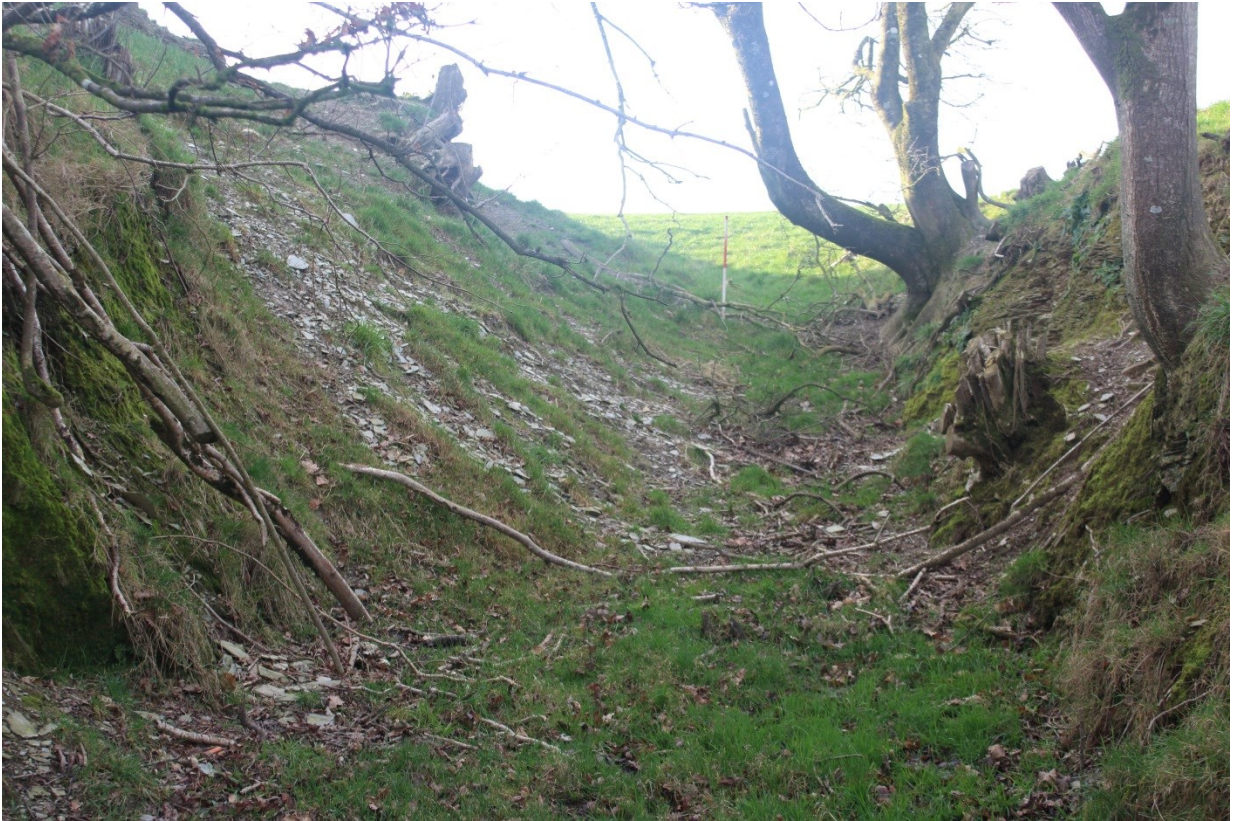
Photo 15: Facing northwest. Inside the extensively eroded ditch on the northeast side of Castell Pen-yr-Allt, with a 1m scale.

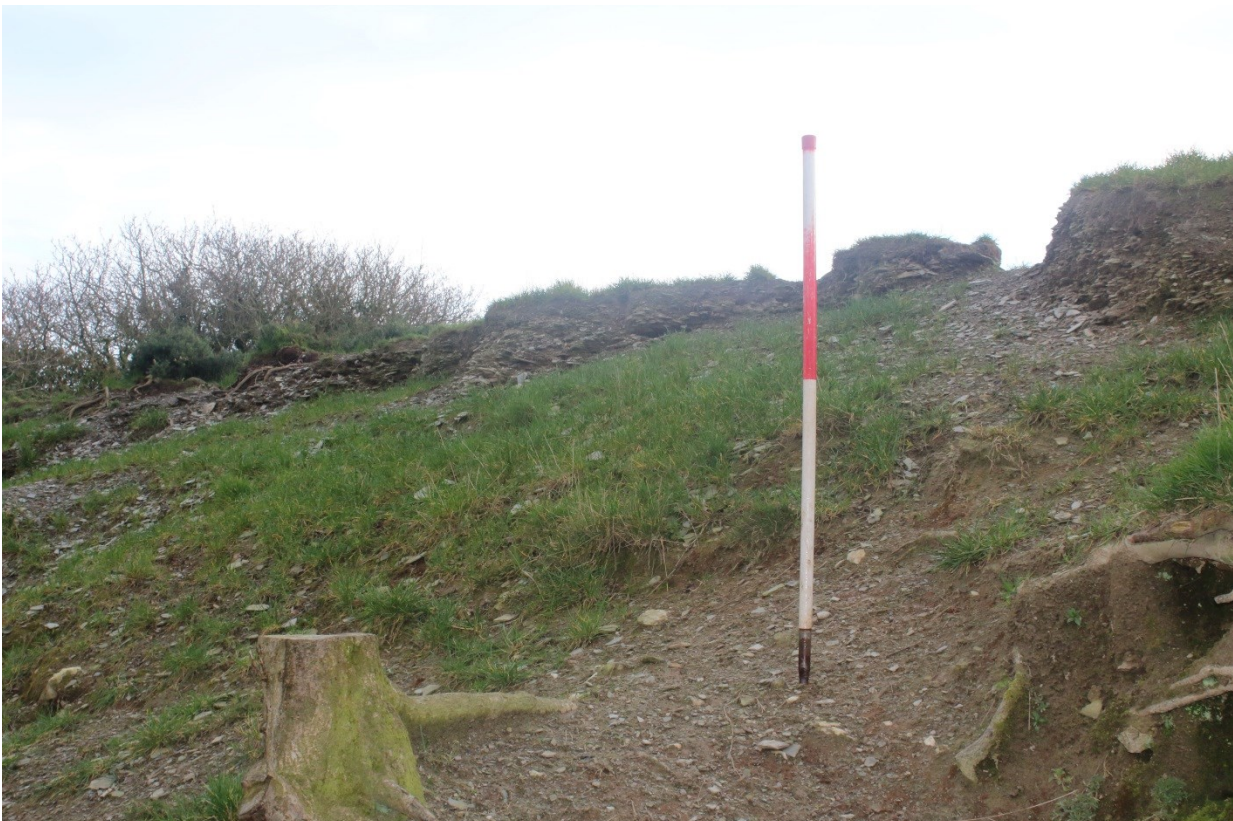
Photo 16: Facing south. Close up of erosion on the outside of the top of the bank on northeast side of Castell Pen-yr-Allt, with a 1m scale.

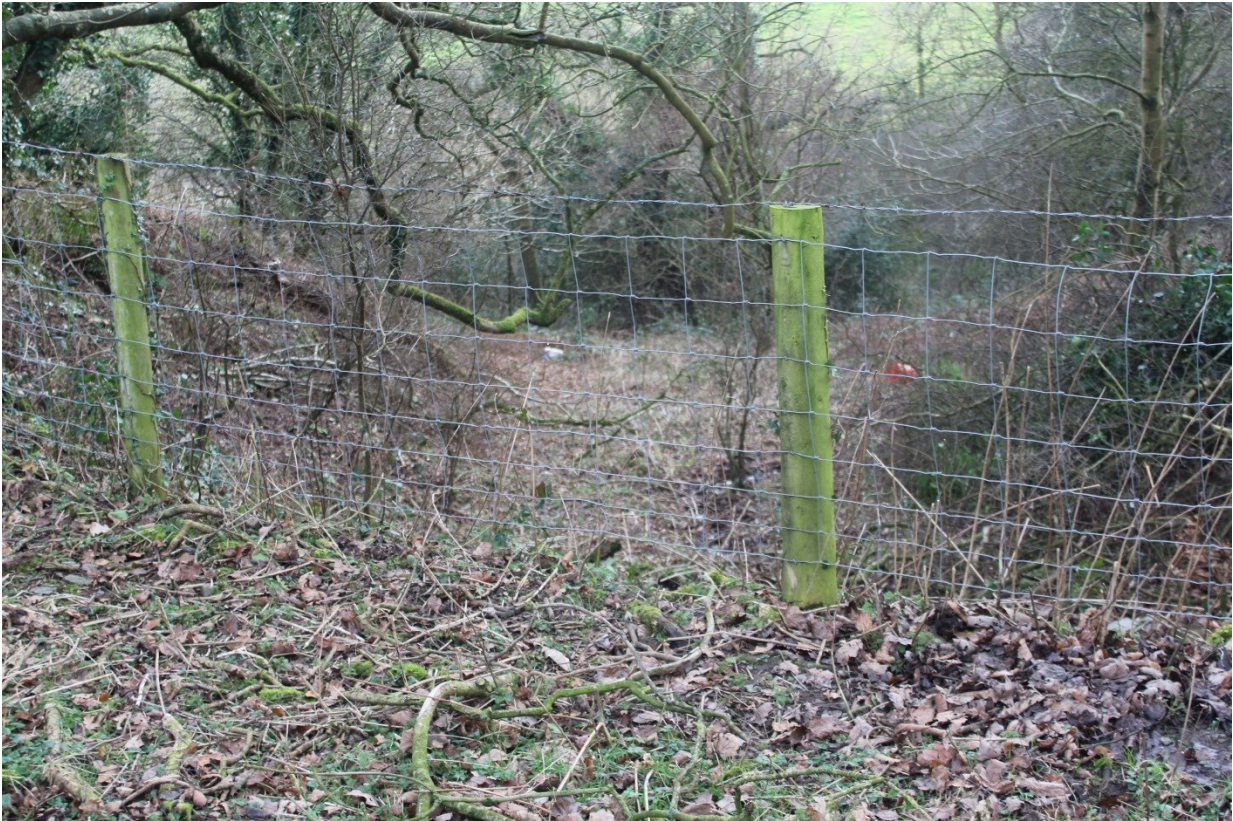
Photo 17: Facing south. Dry water channel heading south-southeast from the east side of Castell Pen-yr-Allt, possibly once joined with the northeast ditch, which contained water.

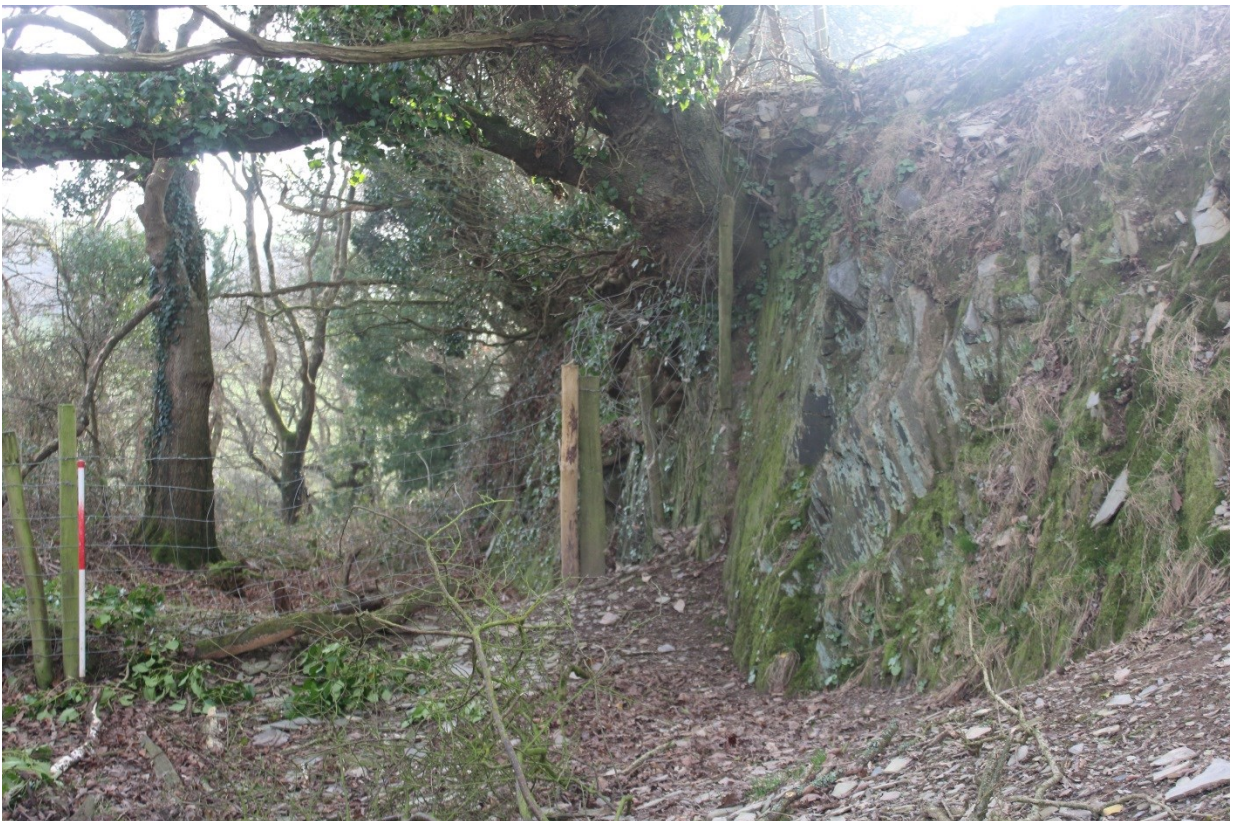
Photo 18: Facing south. Looking along the sheer rock-cut side of the rampart on the east side of Castell Pen-yr-Allt, with a 1m scale.

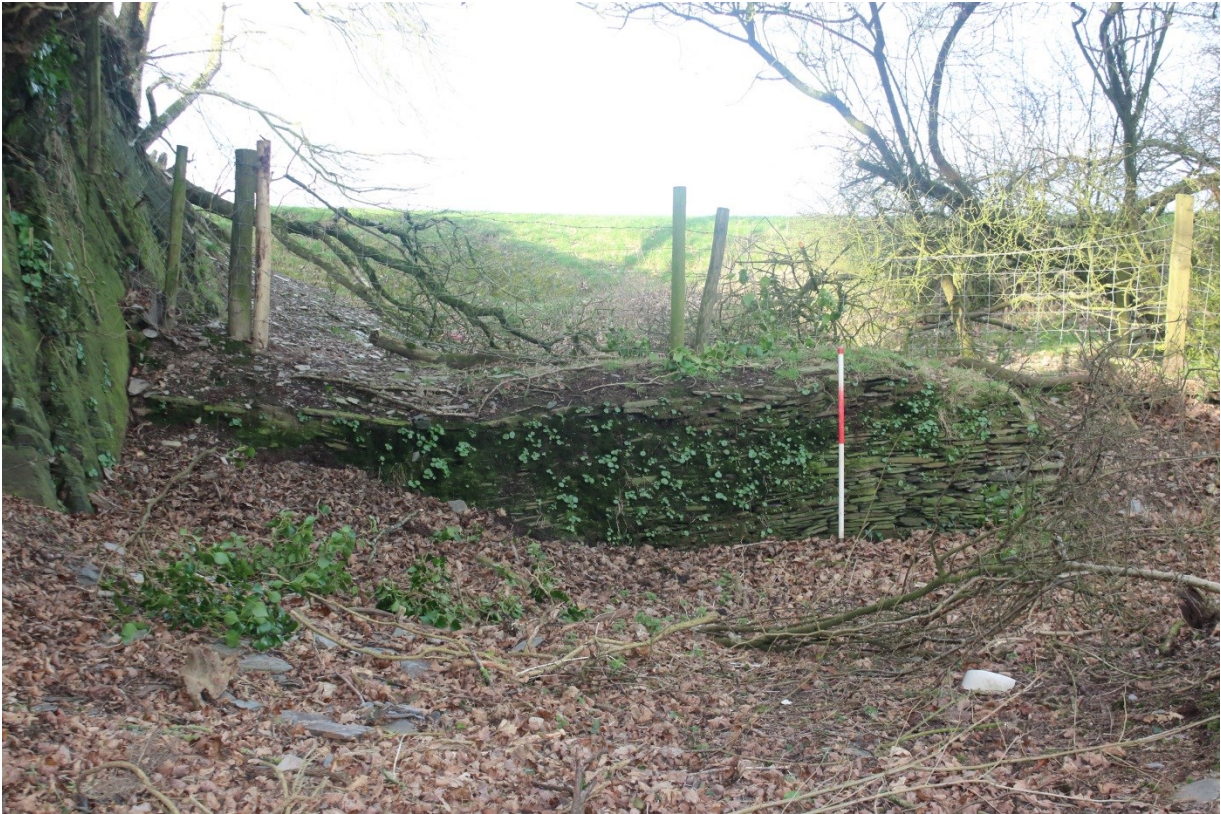
Photo 19: Facing north. Old wall abutting the sheer rock-cut side of the rampart on the east side of Castell Pen-yr-Allt, with a 1m scale. The wall continued along the field boundary to the right.

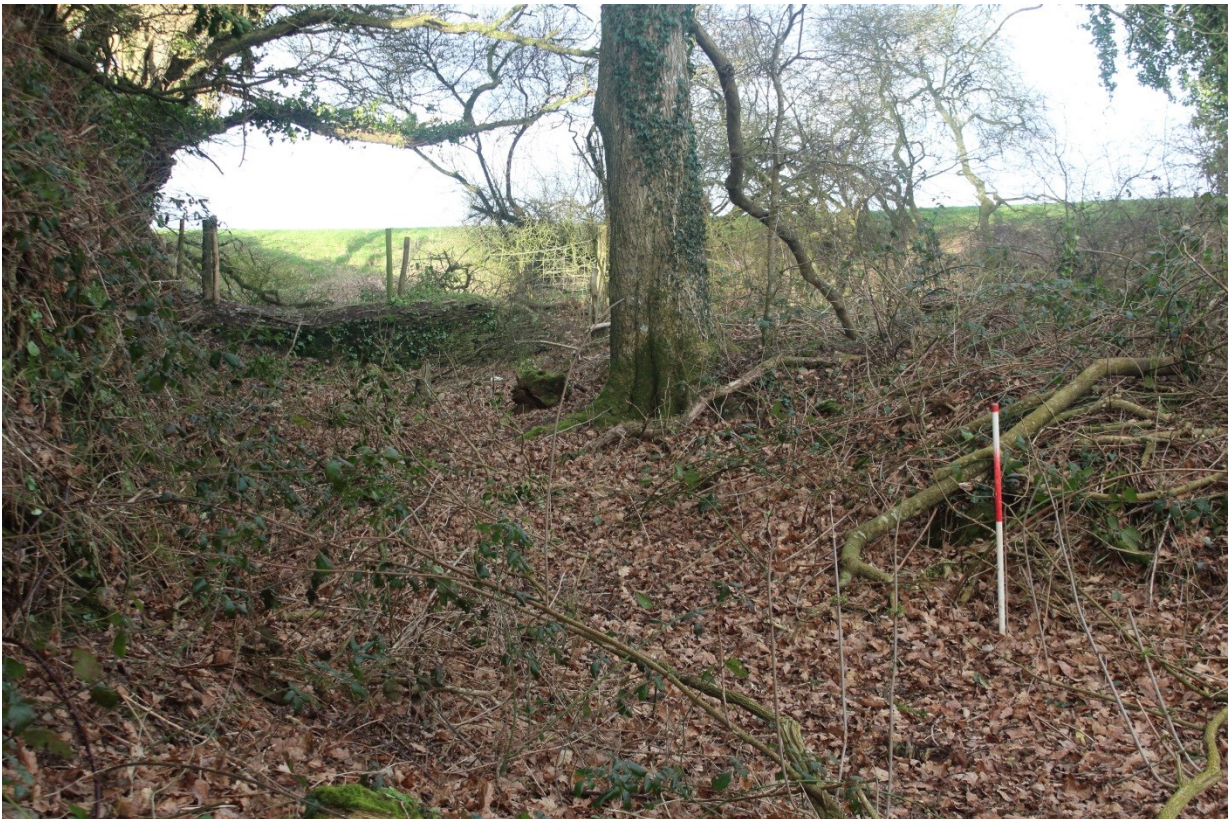
Photo 20: Facing north-northwest. Looking along the sheer rampart with a slight bank running along on the right parallel to it. 1m scale.

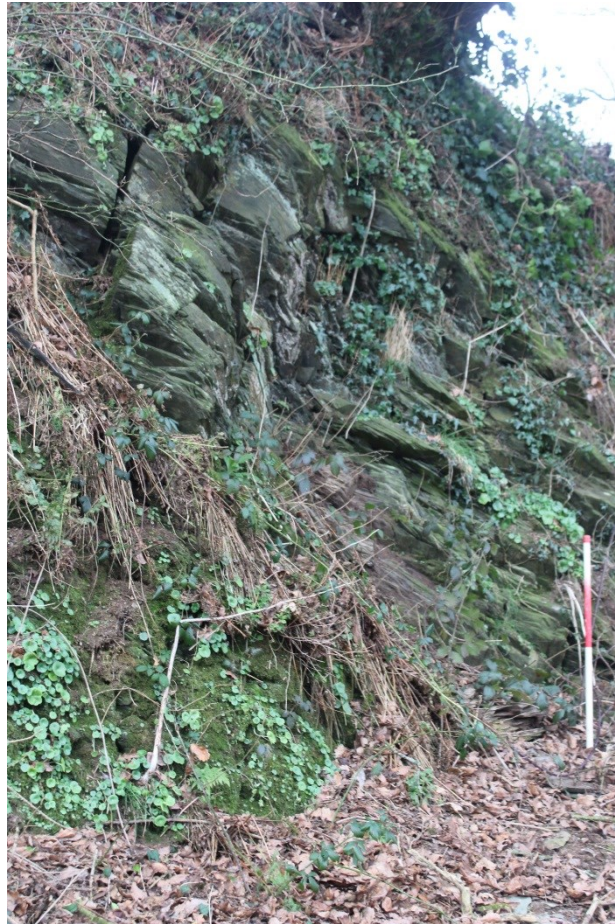
Photo 21: Facing north-northwest. Close-up of the sheer rock-cut side of the rampart on the southeast side of Castell Pen-yr-Allt, with a 1m scale.
